Summary Only

Property Address:
1303 Pine Mills Drive
Richmond Texas 77469

General Summary

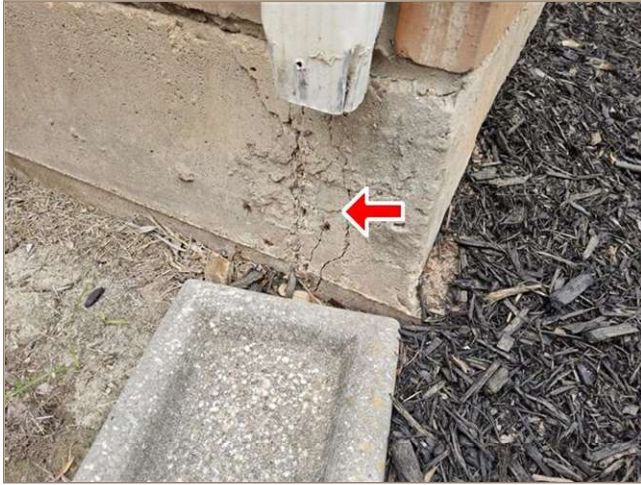
left front corner

The foundation has minor corner pop(s) that are considered cosmetic. Further deterioration may occur if not corrected. I recommend having a qualified person make repairs as needed.

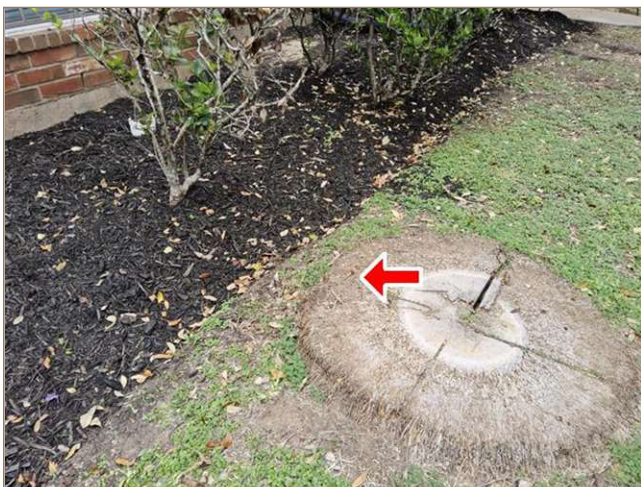
front left

There are trees roots too close to the foundation. I recommend removal or the use of root diverters.

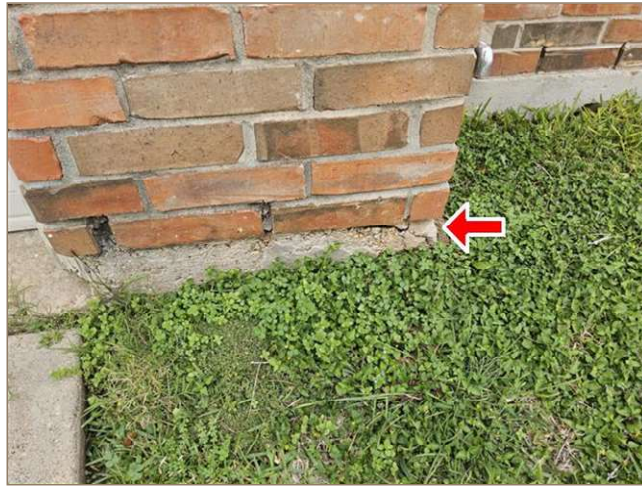
left

The foundation wall appears to be showing signs of flaking and deterioration. I recommend having a qualified person make repairs as needed.

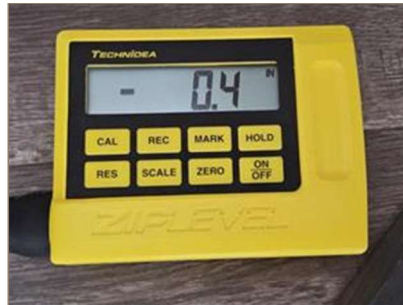
rear right corner living

Relative floor elevation were measured at time of inspection using a water level.

The foundation is showing signs of movement. I recommend consulting with a foundation professional. The home slopes **1.5-inches from rear to front (lower at front of home)**. Majority of this movement could be contributed to poor drainage at front of home. Standing water after rainstorms or negative drainage has adverse effects on foundation movement.

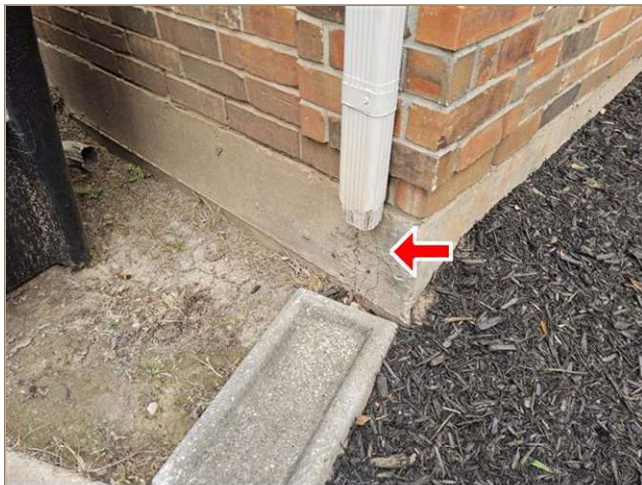
left front corner

The gutters are missing elbows or splashblocks. Erosion is occurring. Have a qualified person repair as needed.
(2)

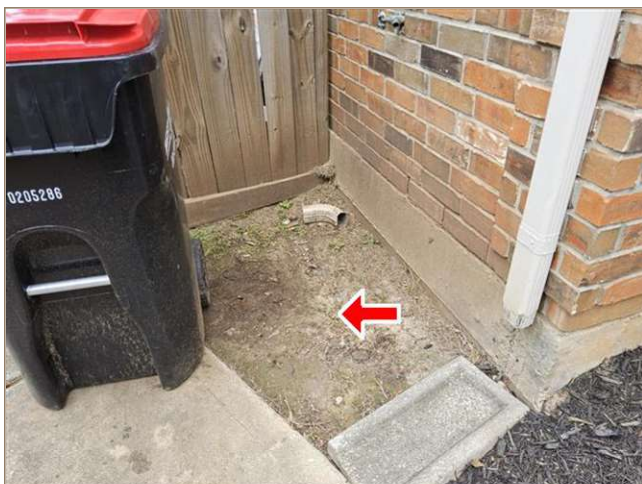
left

There is a negative slope towards foundation at exterior areas. This area does not appear to drain water away from home and needs landscaping and drainage corrected. It's best to have six inches drop in first 10ft away from home. See sample drainage sketch diagram below.

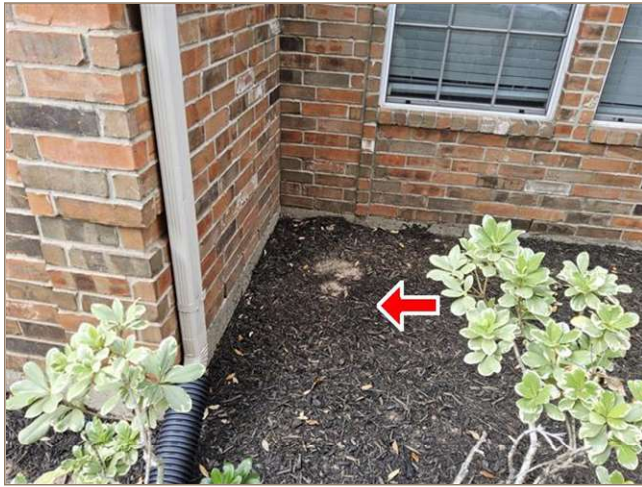
front

The landscape at the exterior may require a trench or drain if water stands or puddles after heavy rain. I am unable to determine due to no rain during inspection period. Areas with missing grass usually have ponding storm water. Repair as needed.

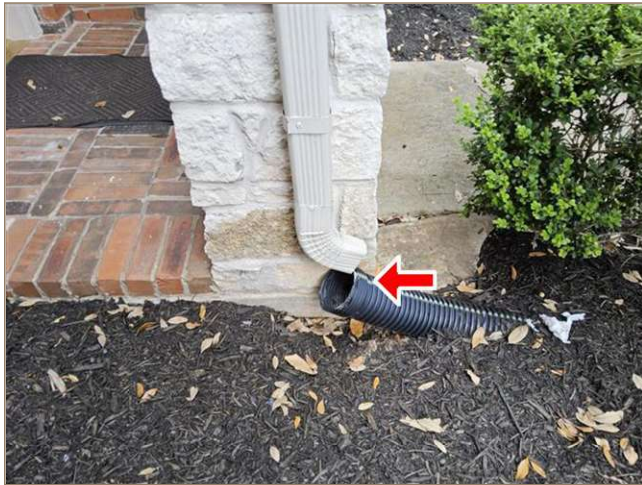
front loose possible settlement

The gutters are missing downspout extenders to move storm water away from foundation. Erosion is occurring. Have a qualified person repair as needed.

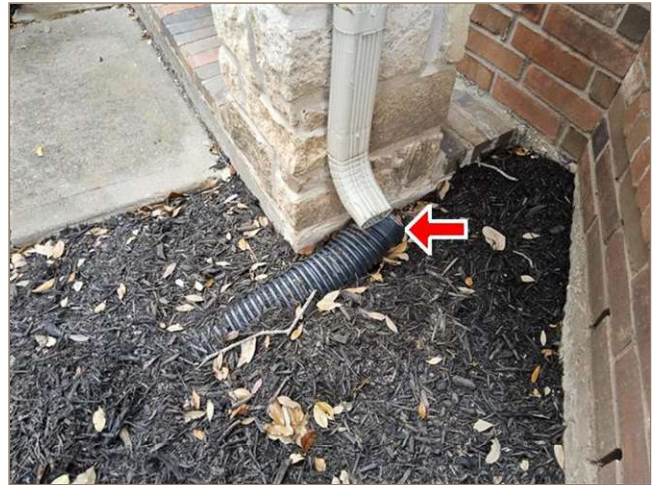
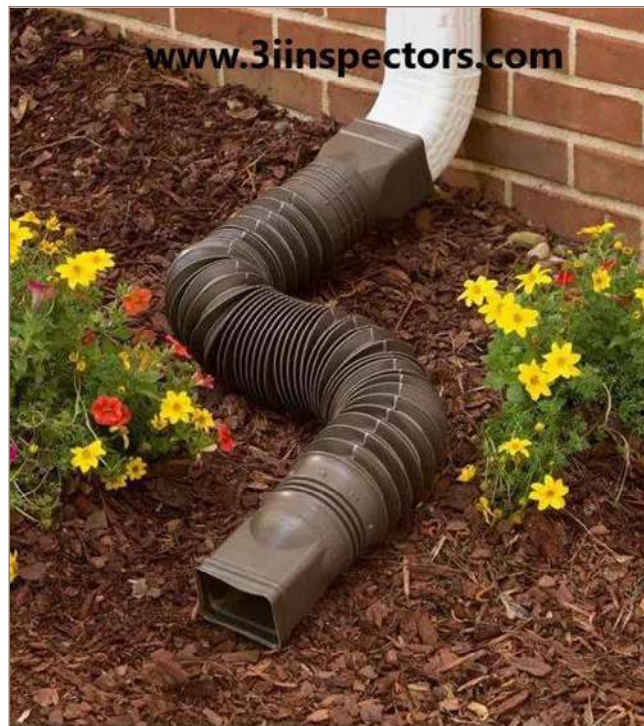
front right loose use hard pipe if buried

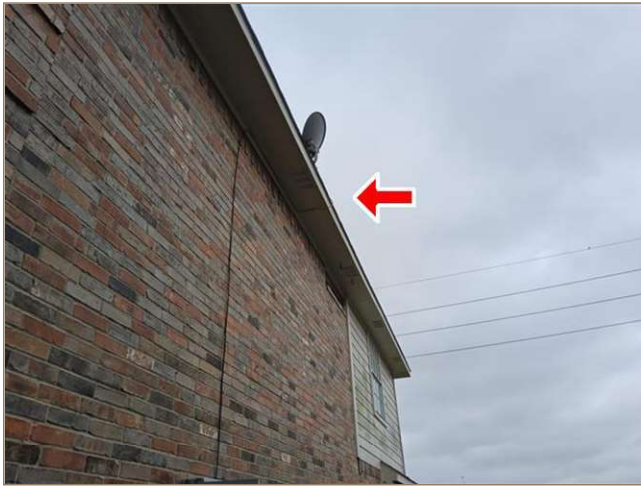
right

Install gutters to improve drainage around exterior perimeter. This will cause erosion at foundation perimeter. Have a qualified person install gutters as needed.

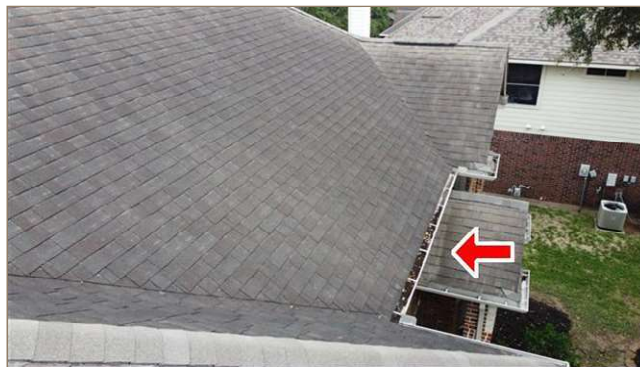
The gutters are full of debris in areas and needs to be cleaned. The debris in gutters can also conceal rust, deterioration or leaks that are not visible until cleaned, and I am unable to determine if such conditions exist.

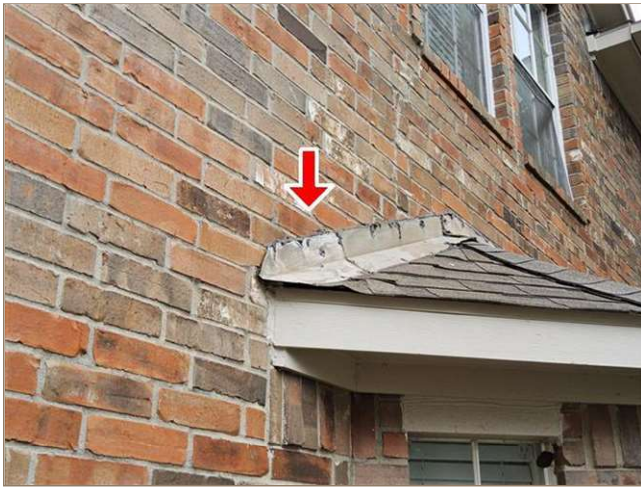
front left

Flashing is loose in areas. I recommend having a qualified person evaluate and make repairs as needed.

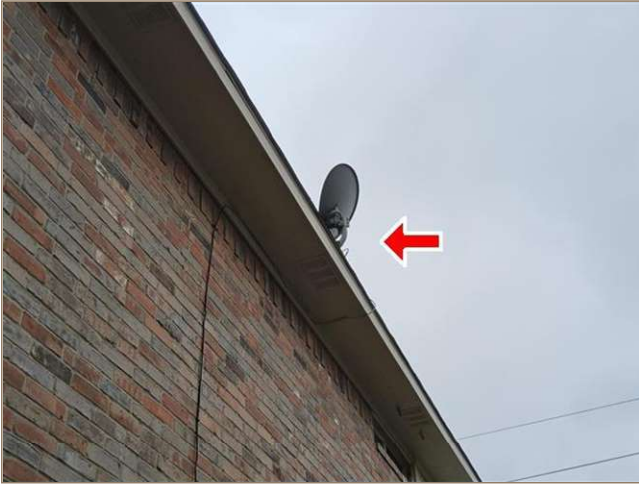
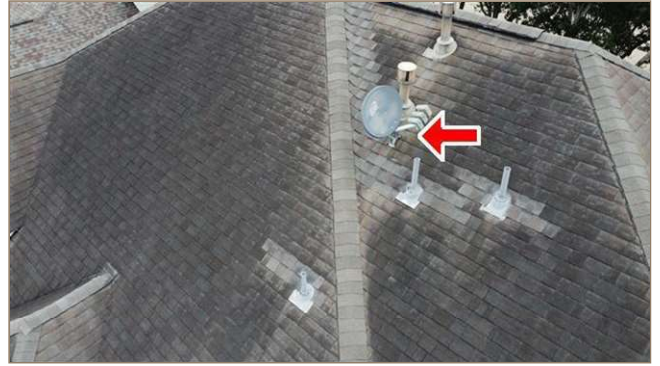
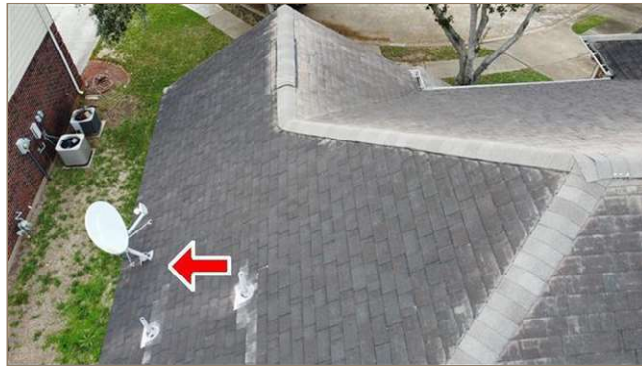
There is a satellite dish bracket mounted on roof that is screwed directly through roofing surface. This is not considered to be today's standard. I recommend having a qualified person remove and patch roofing as needed. (The area will need periodic maintenance)
(3)

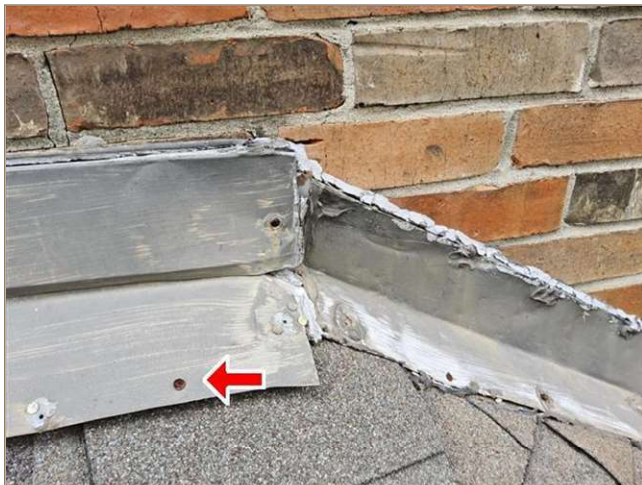
front right

The roofing surface has exposed nail heads that are showing signs of deterioration. Further deterioration will occur if not corrected. I recommend having a qualified person repair or replace as needed, (4)

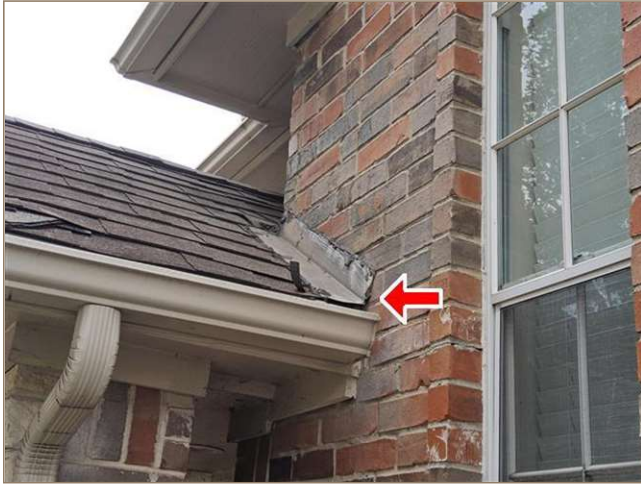
front

The roof flashing is missing kickout flashing in areas. This is not considered today's standard. I recommend having a qualified person evaluate and make repairs as needed.
(5)

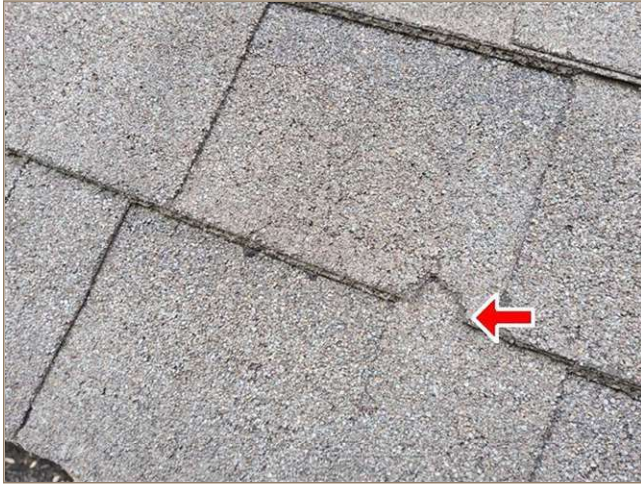
front right

The roof covering is damaged at home. This area will need periodical maintenance. A qualified person should repair or replace as needed.

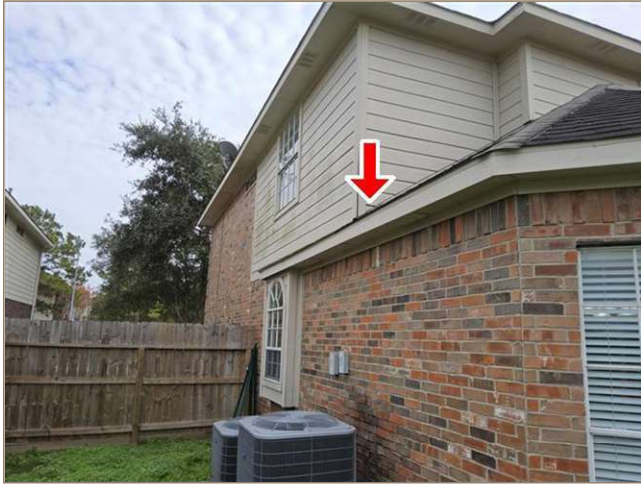
The roof flashing is missing splash guard. This is not considered today's standard. I recommend having a qualified person evaluate and make repairs as needed.

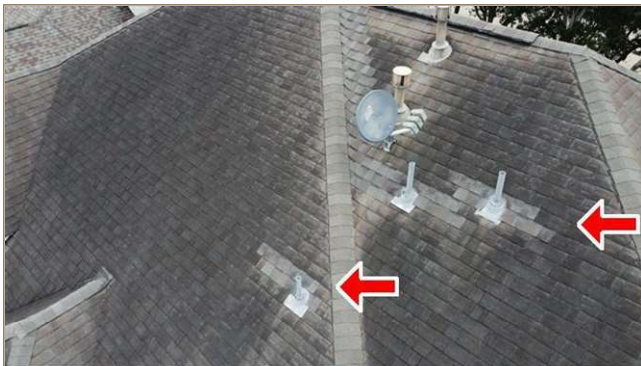
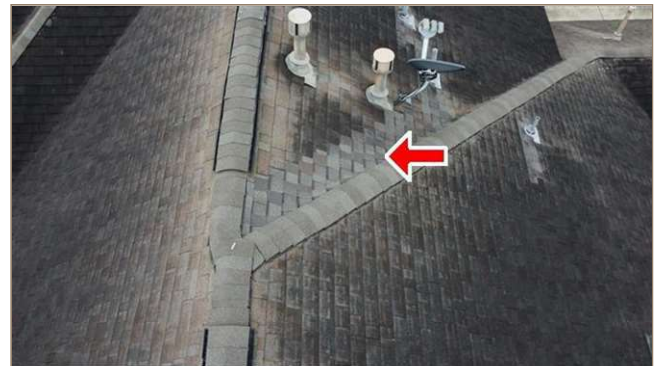
The roof covering is old, and the life of covering has expired. The covering does need to be replaced. While it could last a year or so, some areas may need patching with tar as leaks develop. The roof has a lot of patches and will need to be replaced soon.

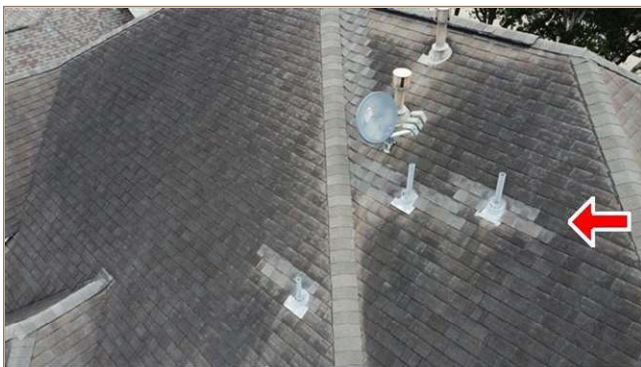
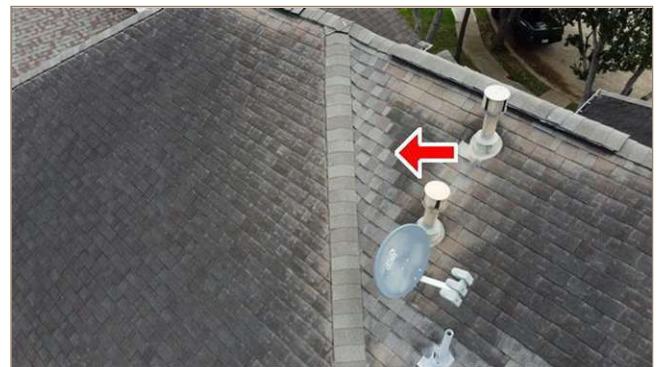
The roof shingles has more than one color in areas. I recommend consulting with a roofing professional.. A qualified contractor should inspect and repair as needed.

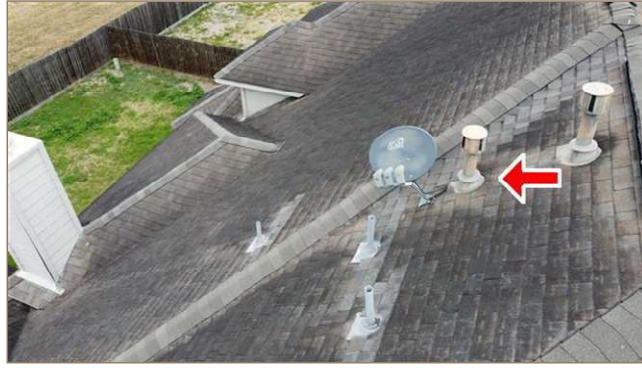
replace all pipe jacks and vents at next re-roof

The plumbing and appliance venting at roof are rusted. This is not considered to be today's standard. I recommend having a qualified person make repairs as needed.

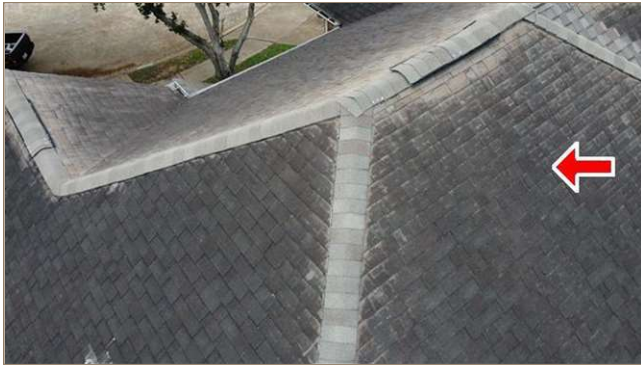
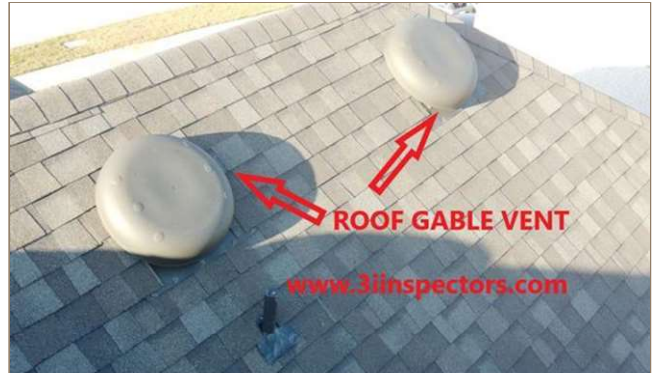
Ventilation was not added, when the most recent roof covering was installed. I recommend increasing the ventilation to promote life expectancy of covering.

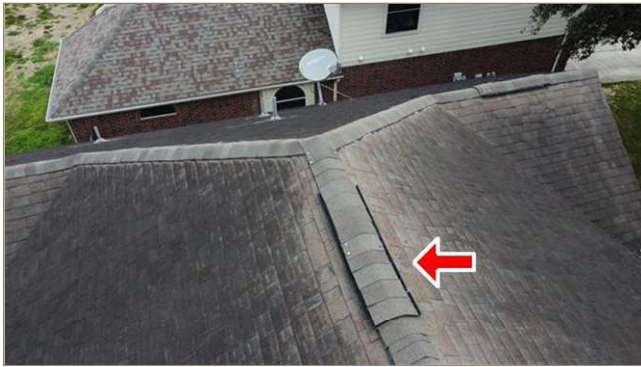
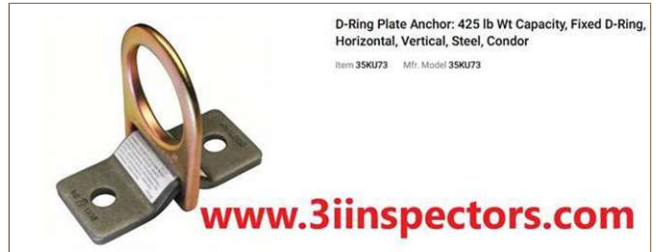
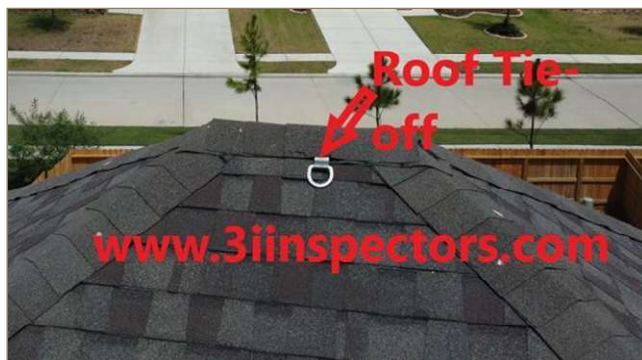
The roof flashing is missing tie-off loops for safety. This is not considered today's standard. I recommend having a qualified person evaluate and make repairs as needed.

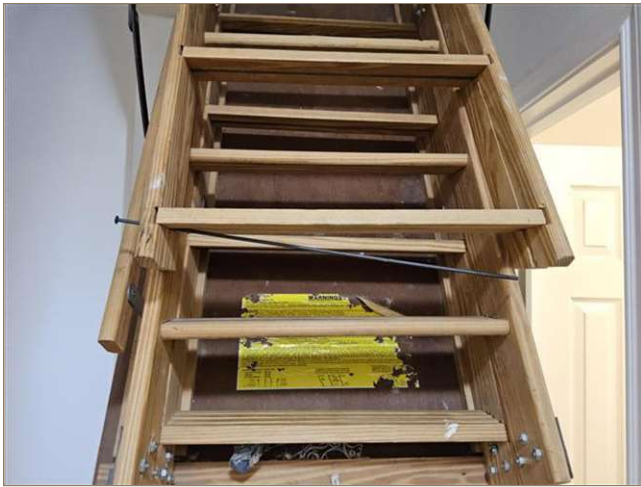
The attic stairs is damaged and weak or unstable. This is a small repair. A qualified person should repair or replace as needed.

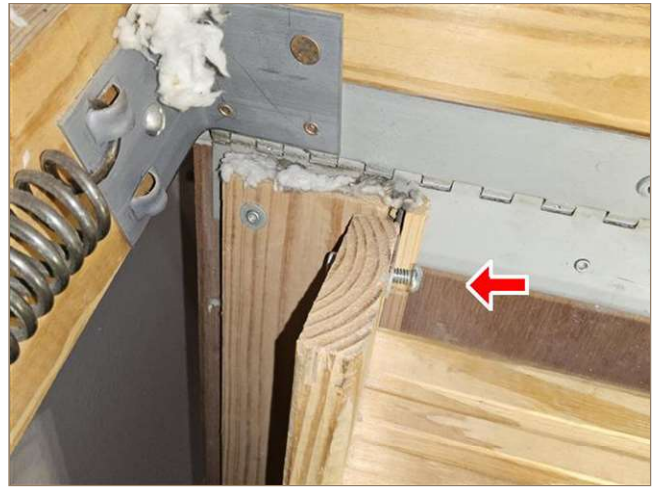
loose screw

pull at close

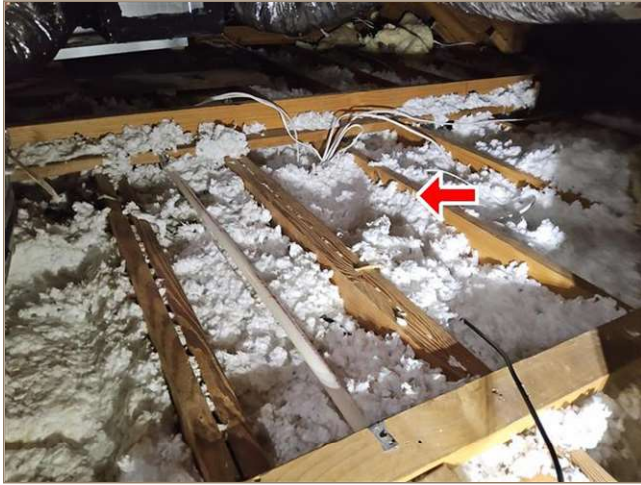
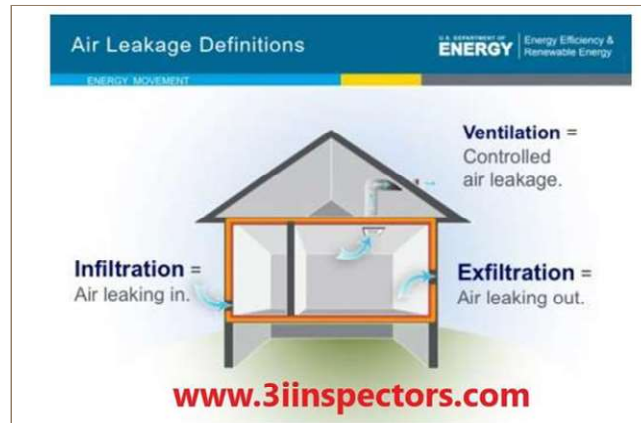
The attic space has area's of missing insulation. This is causing energy loss and is not today's standard. I recommend having a qualified person evaluate and add insulation as needed.

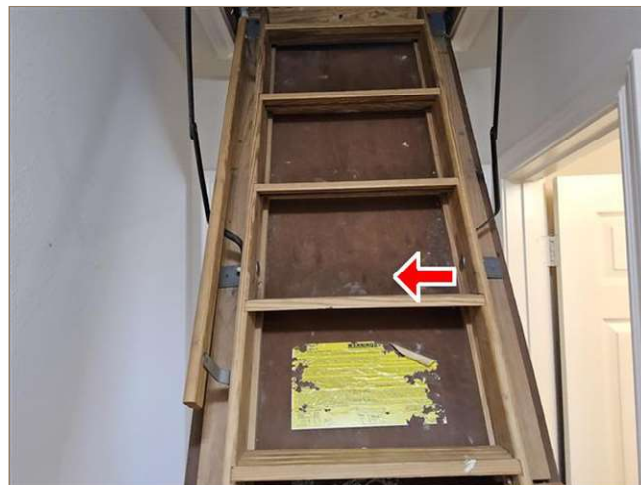
The pull down stairs are not properly insulated. This can cause some heat loss in winter and loss of cool air in summer if not corrected. I recommend repair as desired.

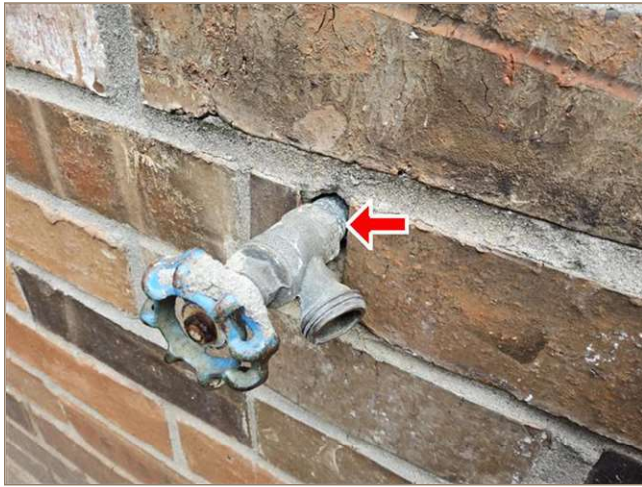
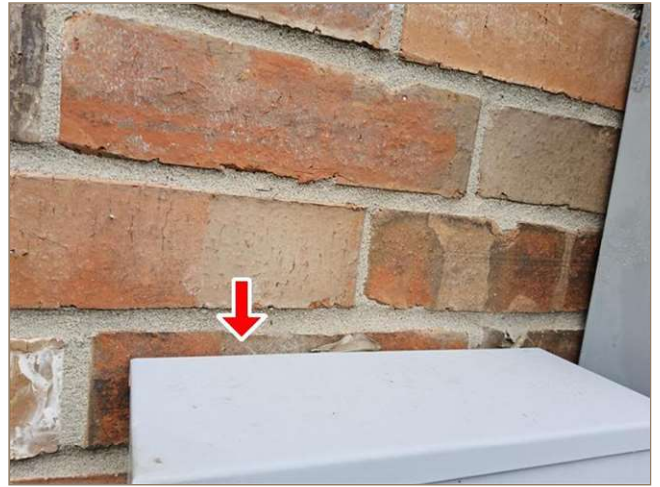
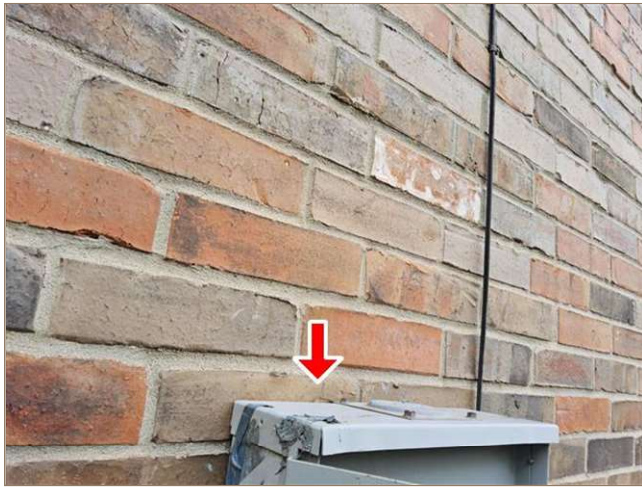
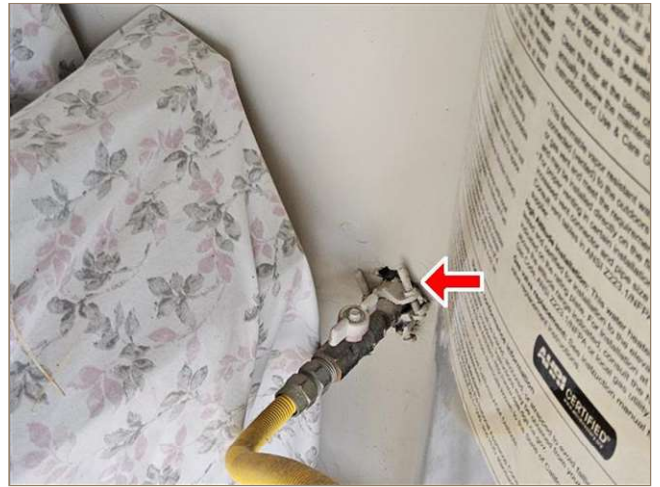
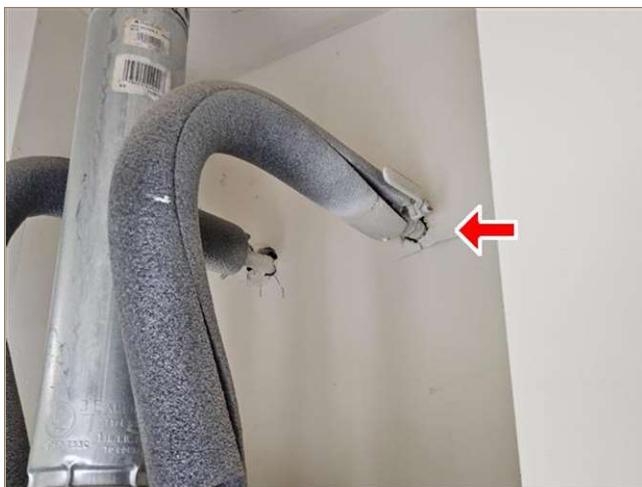
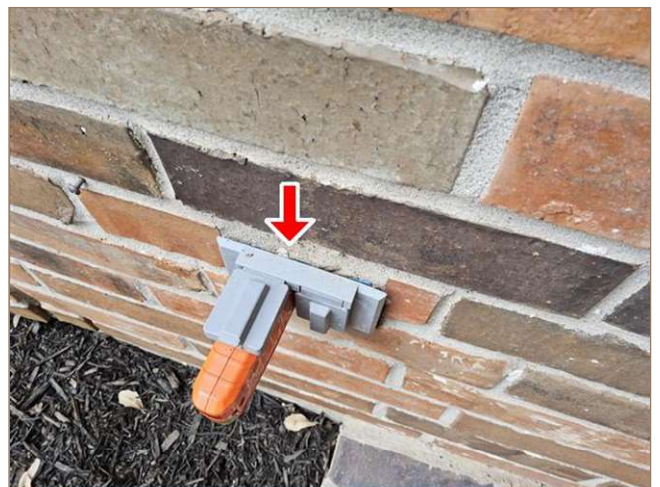
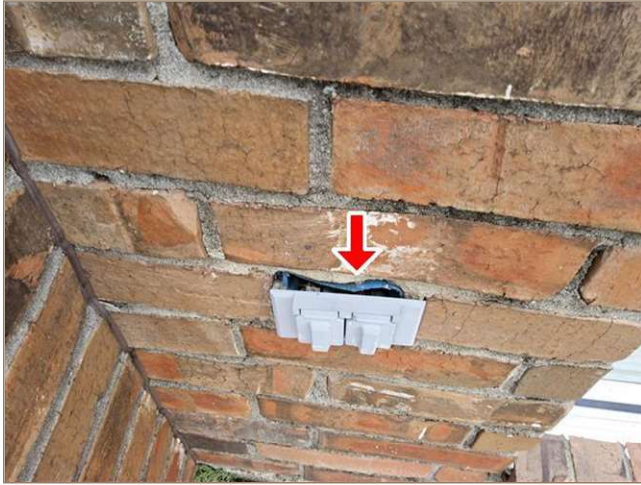
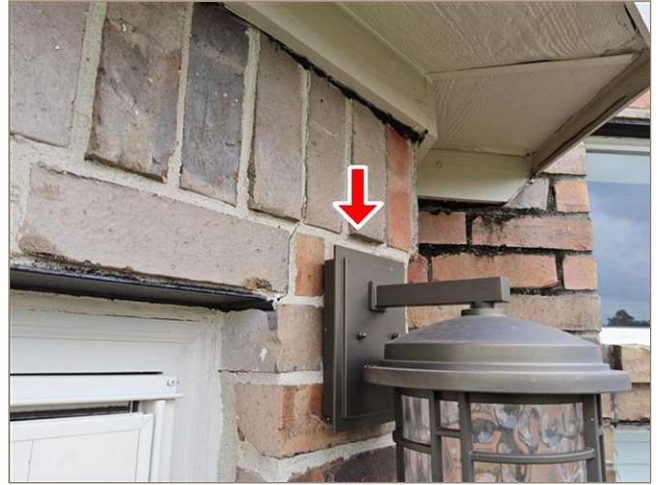
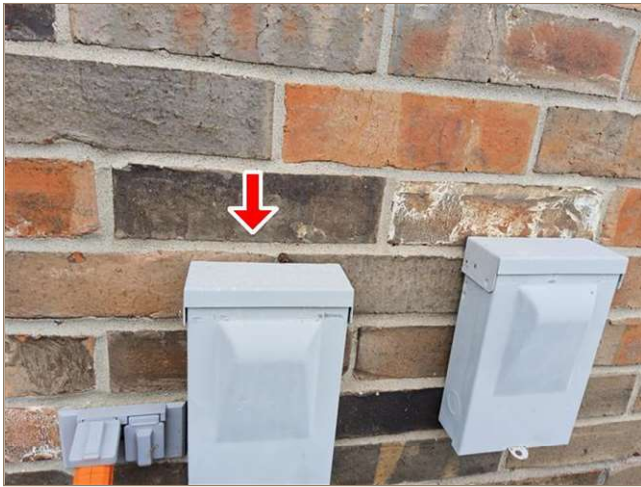
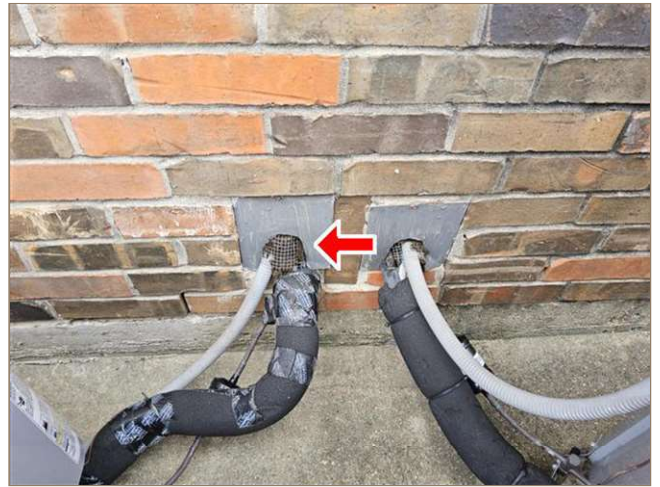
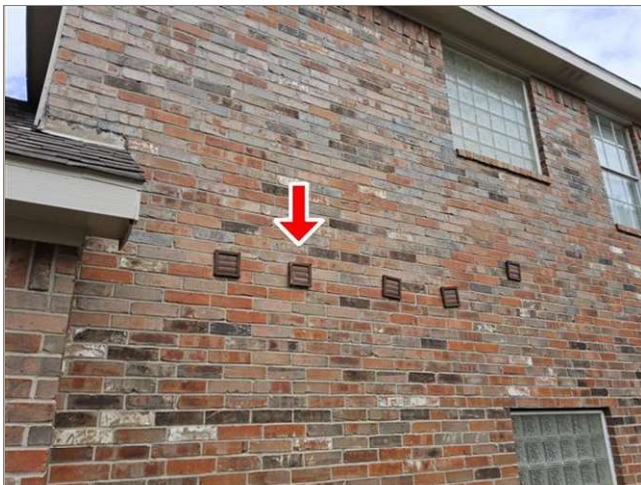
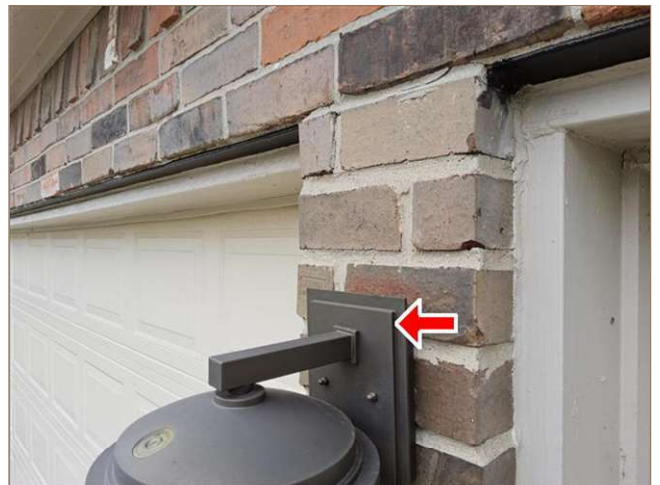
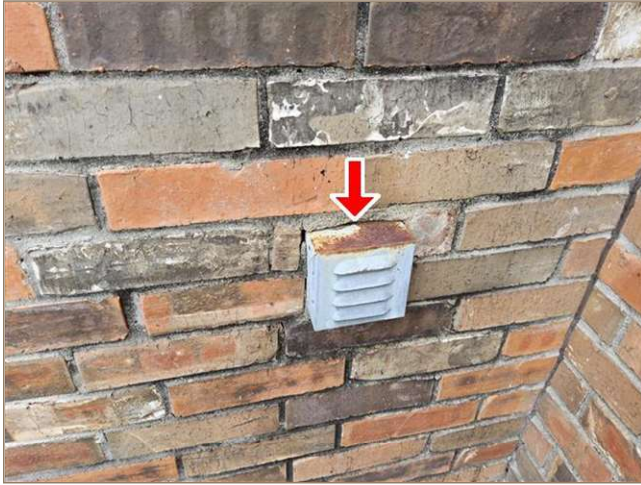
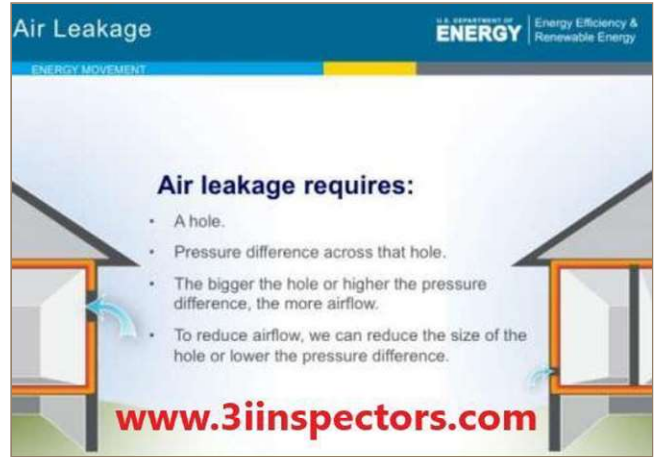
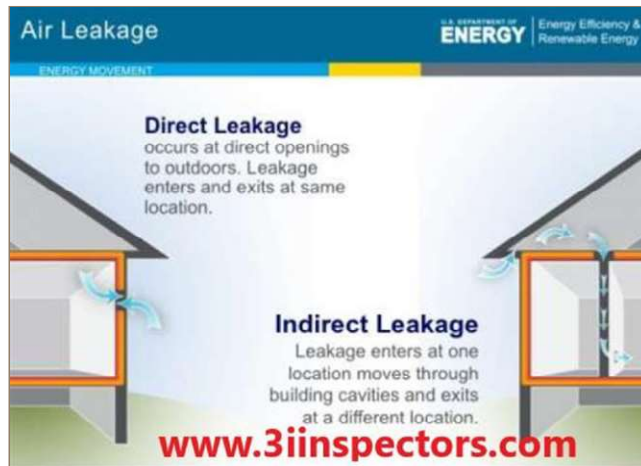
Areas where wiring or piping passes through walls should be sealed. I recommend having a qualified person seal as needed. Use urethane sealant between dissimilar materials or equal.

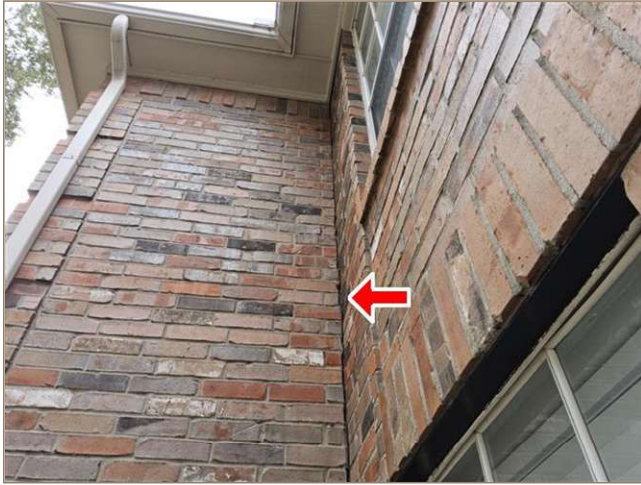
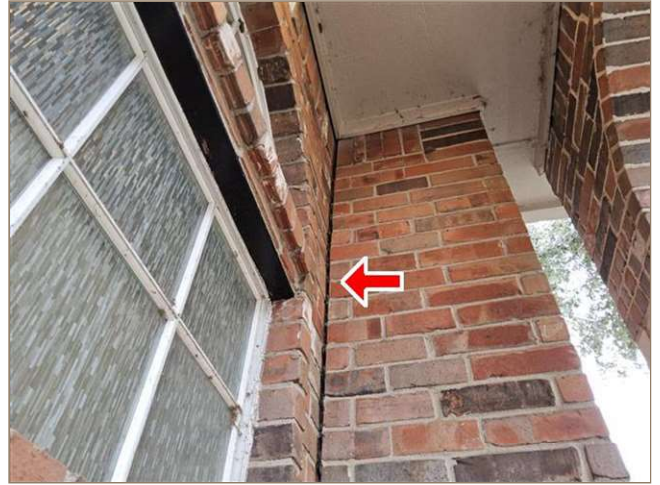
The siding exterior has sealant that is weathered or missing and some lifted nails. Deterioration can eventually occur if not corrected. A qualified person should repair as needed. Use urethane sealant or equal between dissimilar materials.

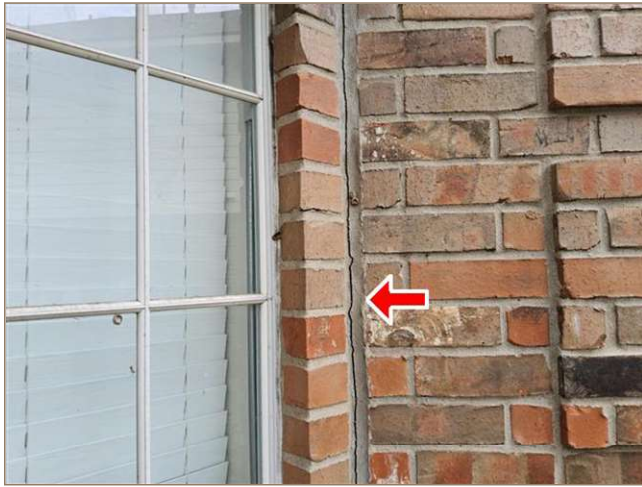
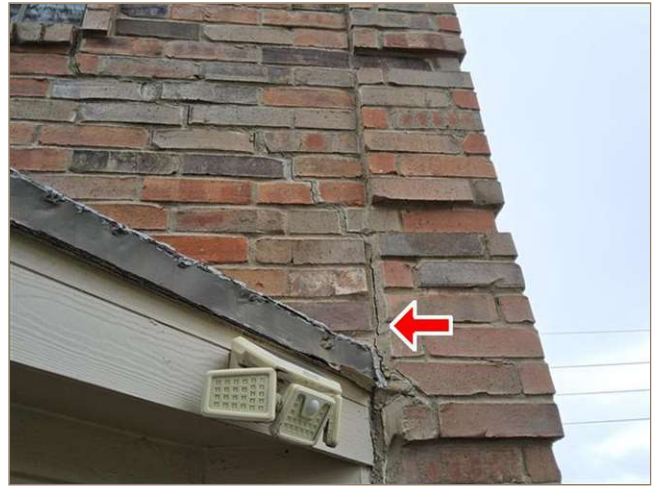
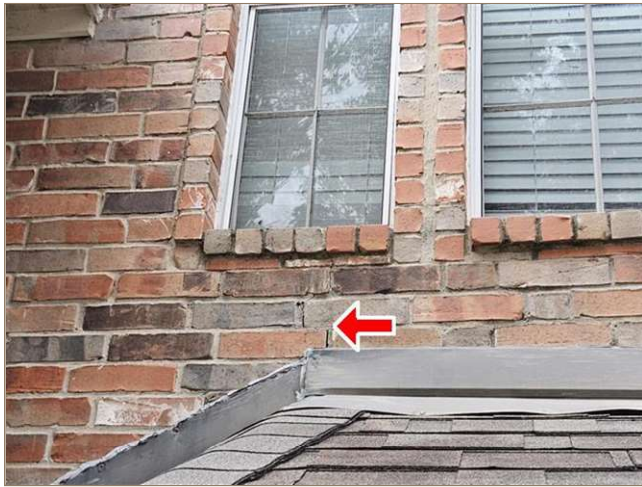
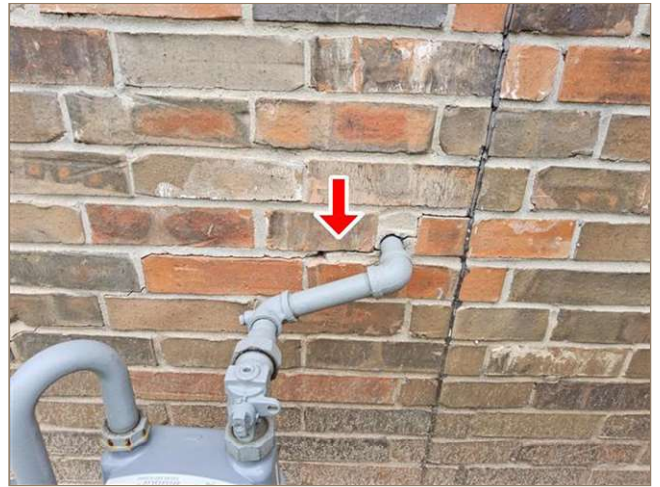
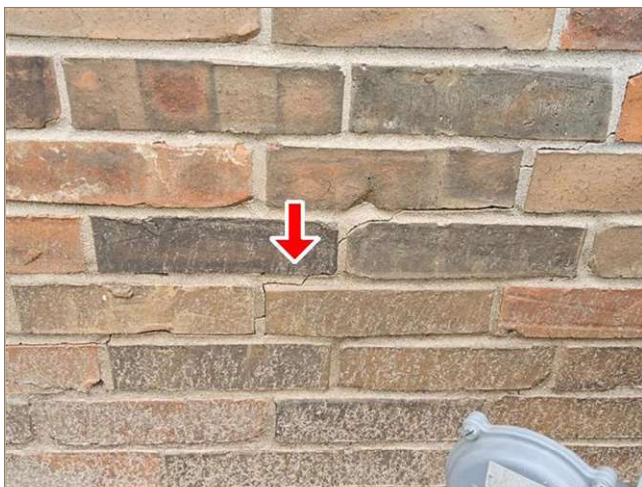
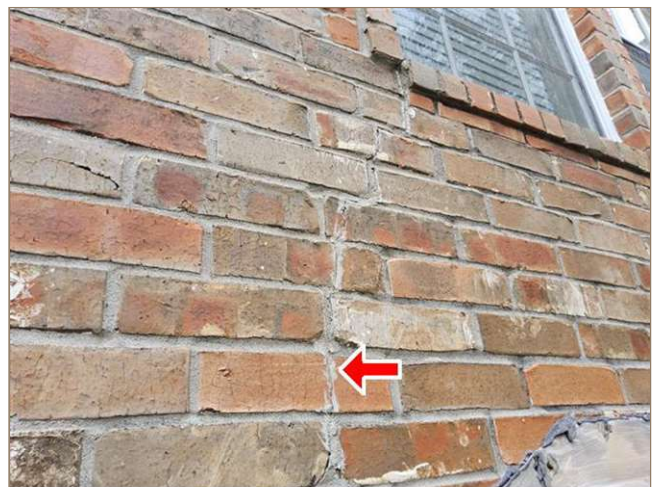
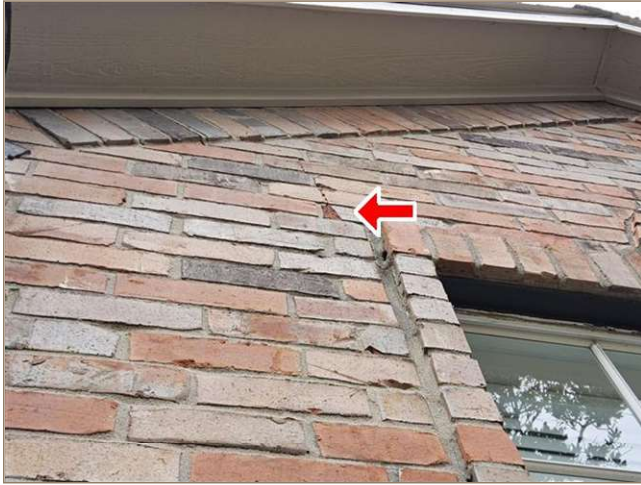
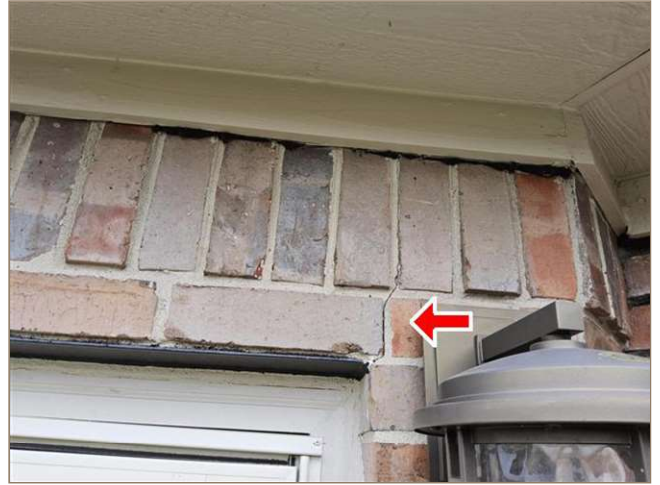
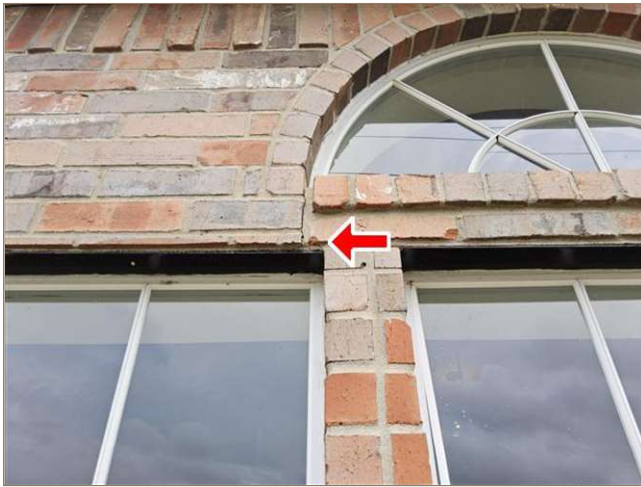
The Brick siding at the exterior has step cracks caused from settlement. Deterioration can eventually occur if not corrected. A qualified contractor should inspect and repair as needed.

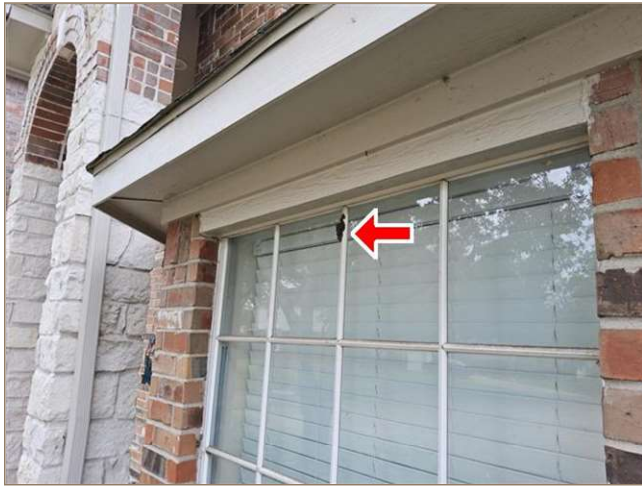
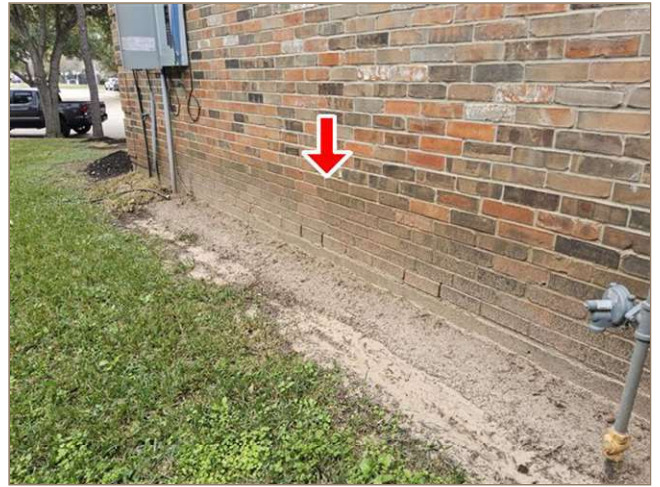
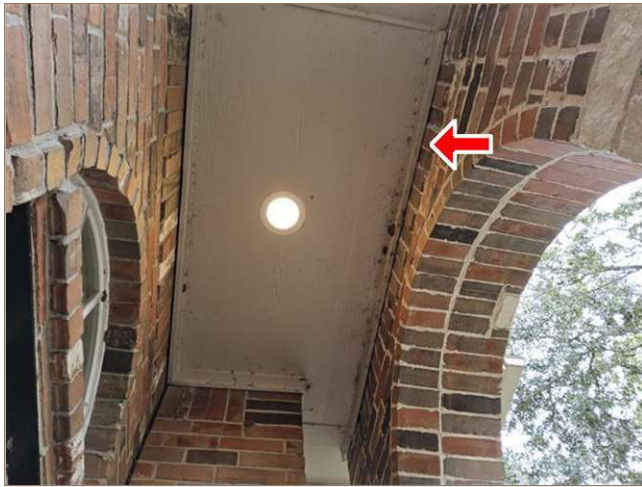
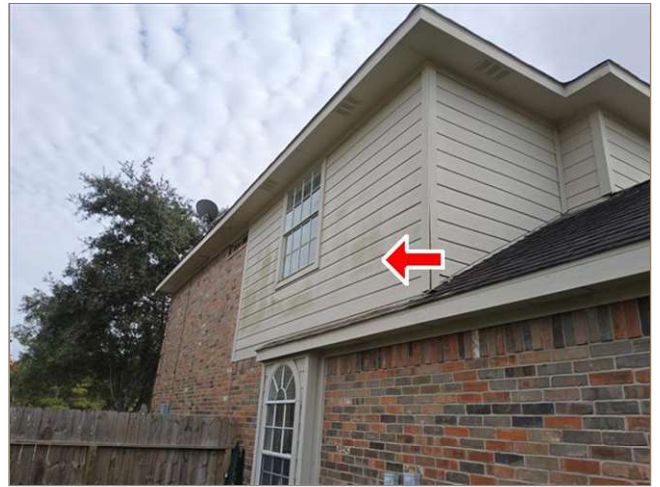
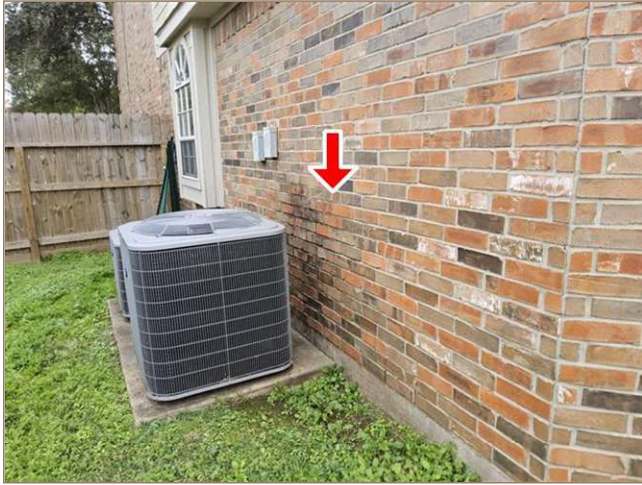
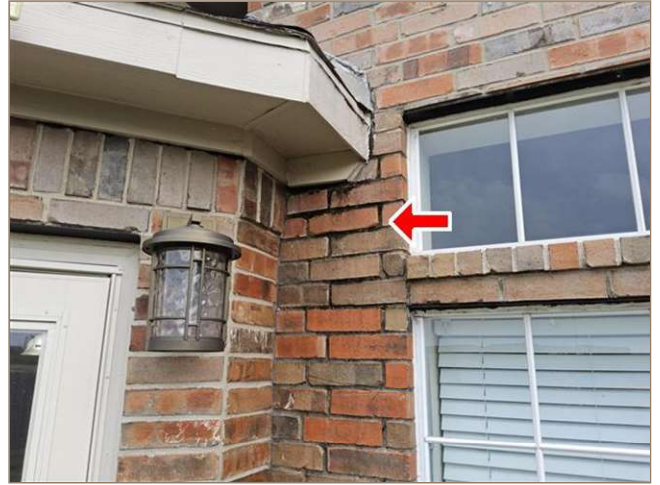
Exterior siding is need of cleaning and routine maintenance. I recommend having a qualified person clean and make repairs as needed,
(5)

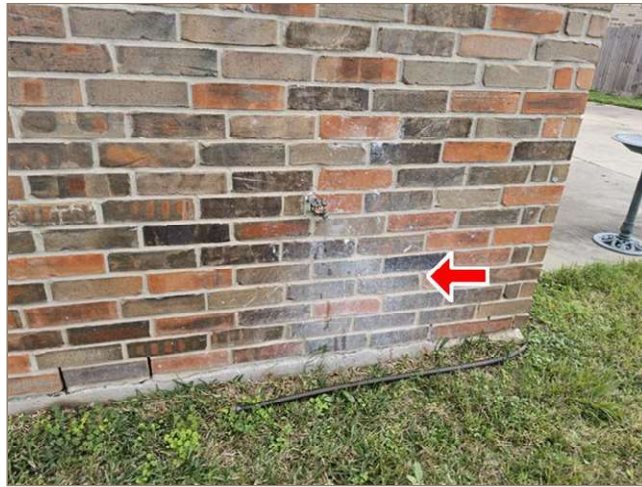
rear clean paint

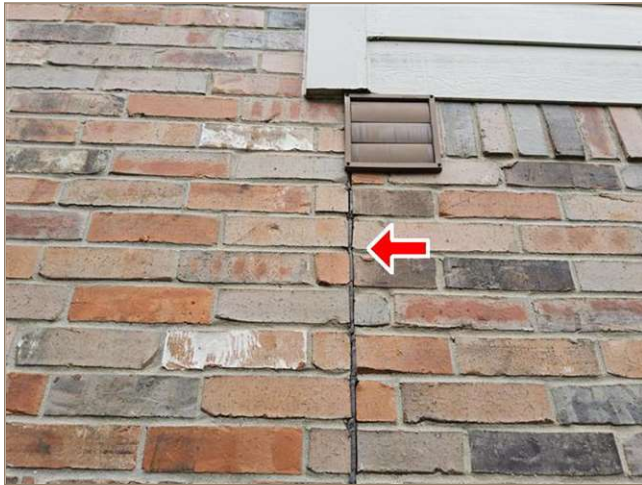
right

The brick siding at the exterior of the home has expansion joint sealant that is weathered or missing. Further deterioration can occur if not corrected. A qualified person should repair or replace as needed.

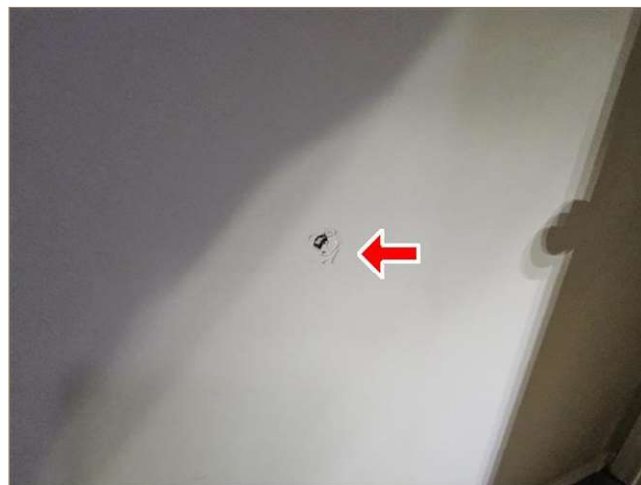
utility room

The drywall on the wall is damaged. While this damage is cosmetic, it needs to be repaired. A qualified person should repair or replace as needed.

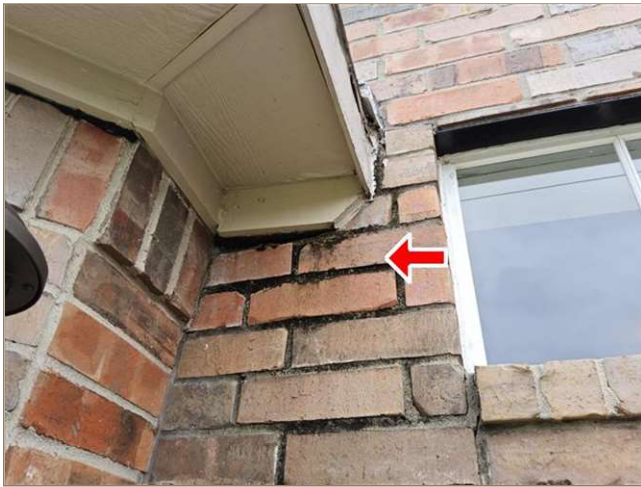
rear patio missing kickout

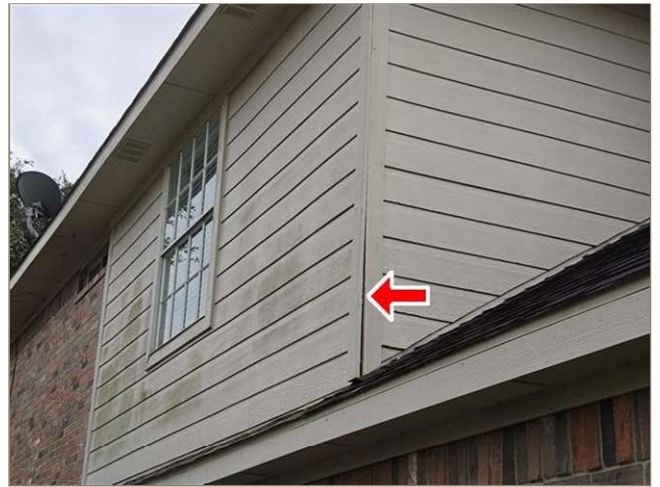
The exterior facade is damaged in areas. Further deterioration can occur if not corrected. A qualified person should repair or replace as needed.
