Summary Only

Property Address:
1303 Pine Mills Drive
Richmond Texas 77469

General Summary

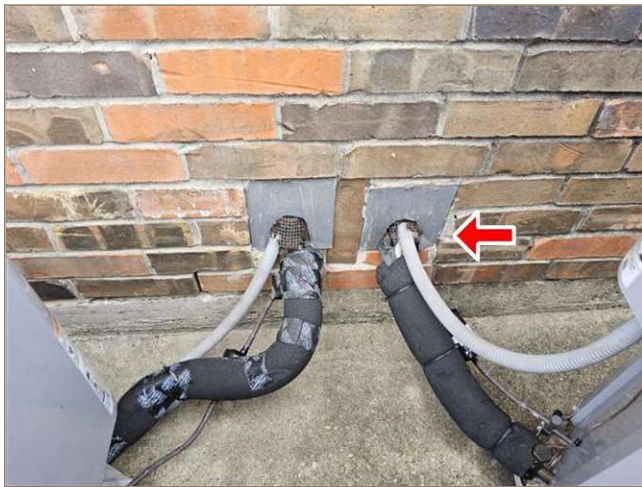
The exterior wall is missing metal flashing at AC penetrations. This is not considered today's standard. Further deterioration can occur if not corrected. A qualified person should repair or replace as needed.

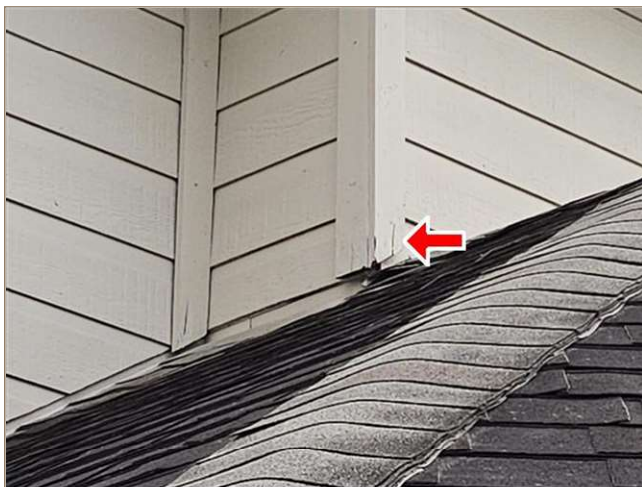
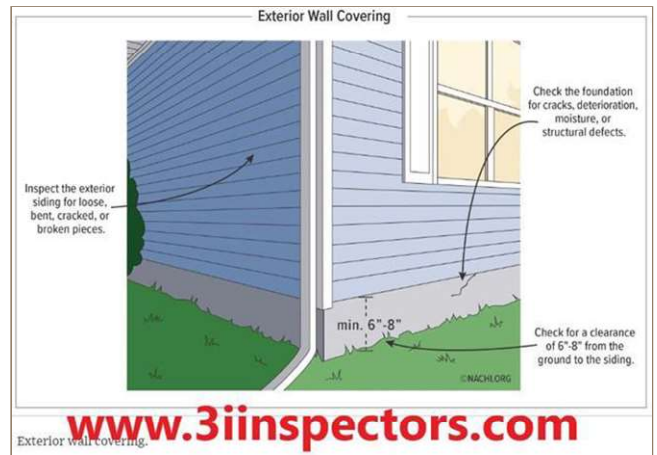
right rear

The exterior siding and trim is deteriorated in areas. Further deterioration will occur if not corrected. A qualified contractor should inspect and repair as needed.

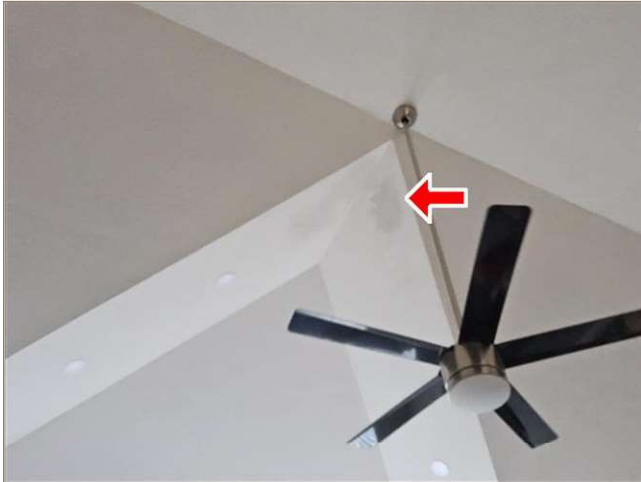
living previously repair possible leak location

The Drywall on the ceiling is damaged at the home. Repairs are needed. A qualified person should repair or replace as needed.

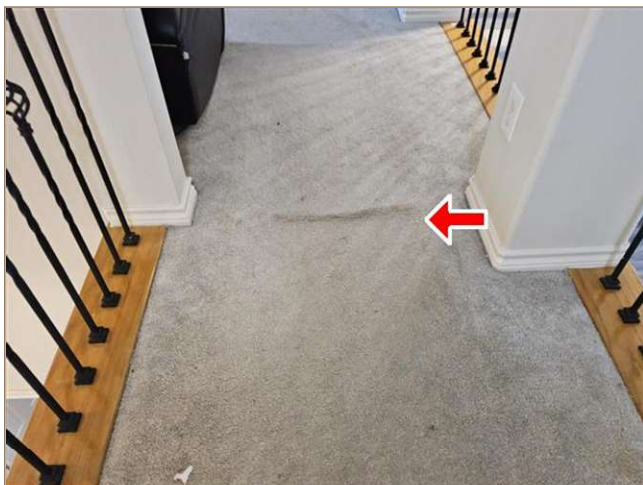
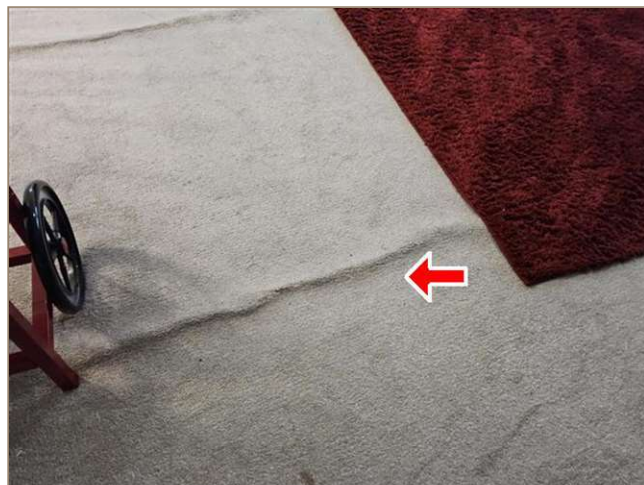
game room

The Carpet is damaged in areas. Repairs are needed.. A qualified contractor should inspect and clean or replace as needed.

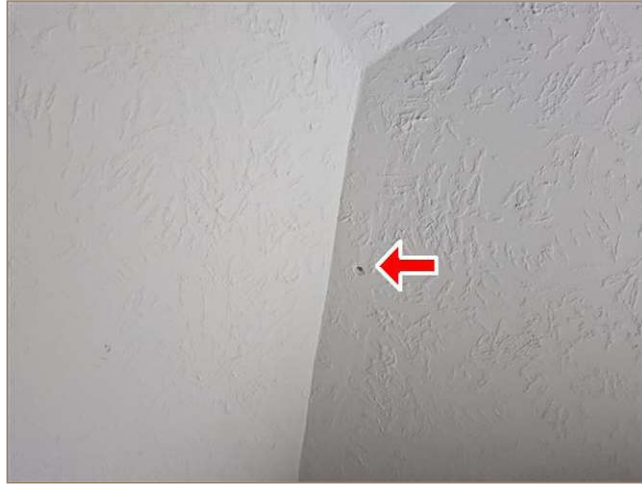
rear right bedroom

The ceiling has a "nail pop" in some areas at upstairs. These are cosmetic where likely the installer missed the ceiling rafter when nailing. I recommend a qualified person correct as desired.

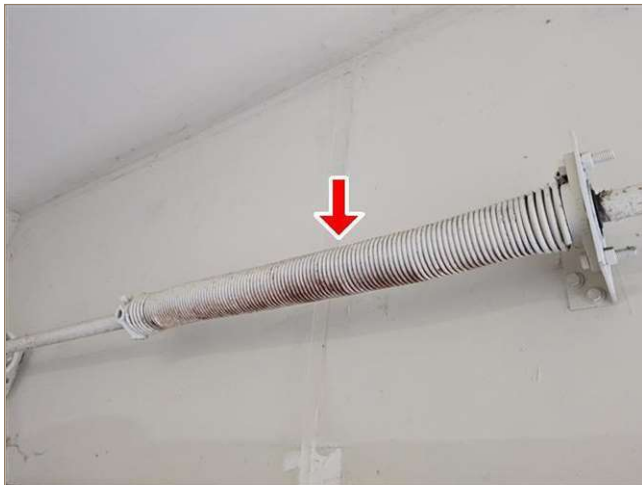
8ft

The door springs are rusted. A repair or replacement is needed. A qualified person should repair or replace as needed.

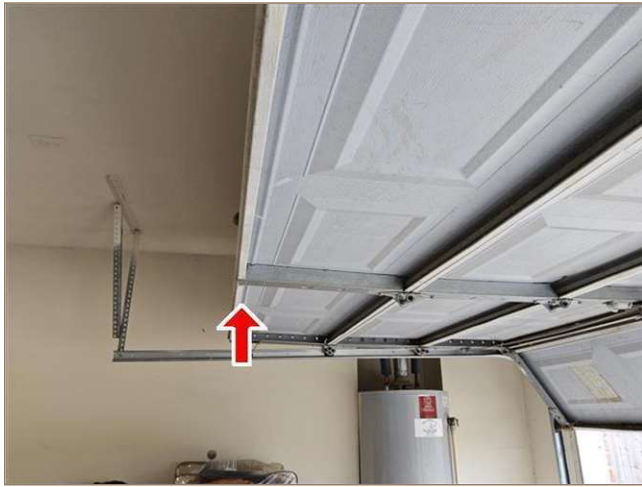
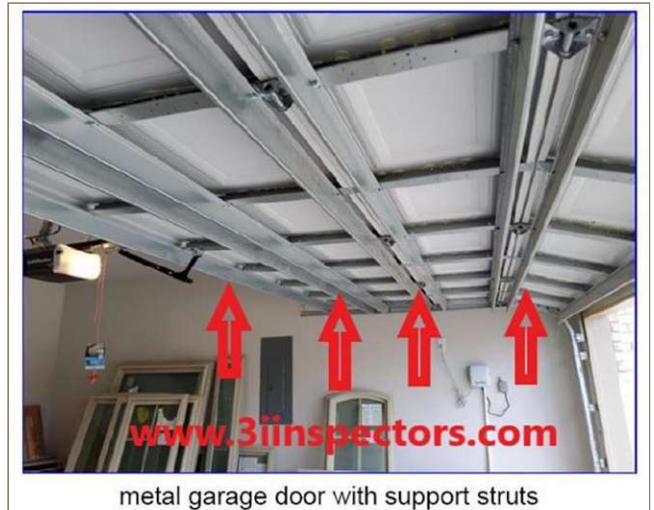
metal garage door with support struts

The door is missing support struts and loose. A repair or replacement is needed. A qualified person should repair or replace as needed.

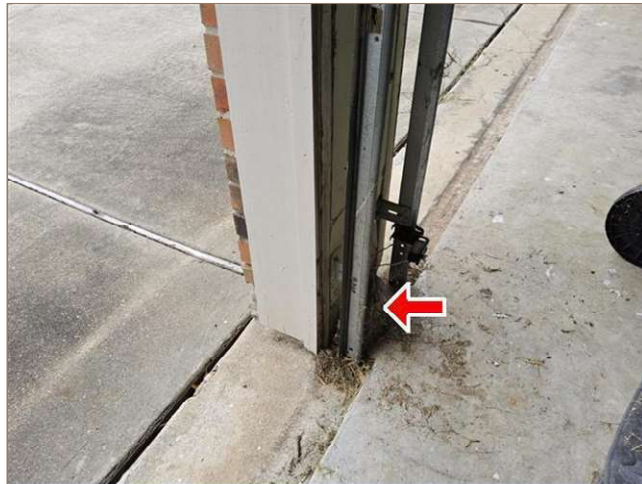
loose rails

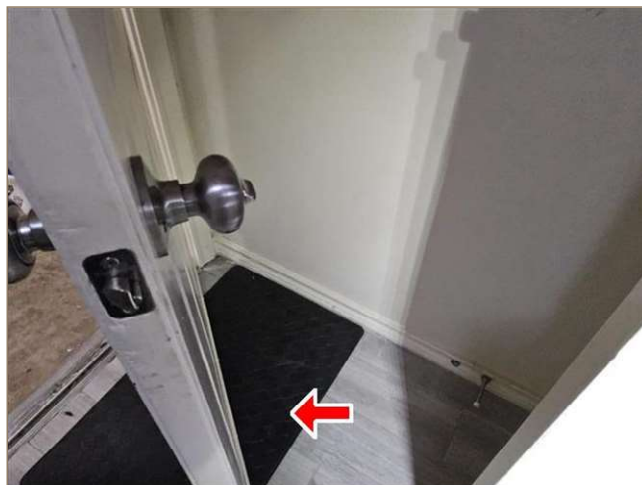
utility to garage

There are door stops missing in the home. This is not considered to be today's standard I recommend having a qualified person make repairs as needed.

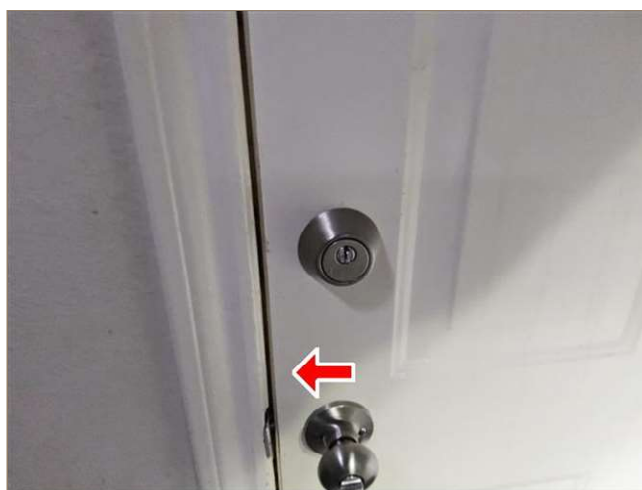
utility to garage

The exterior door has keyed dead bolt lock. This prevents proper egress and is a safety hazard until repaired. I recommend having a qualified person make repairs as needed.

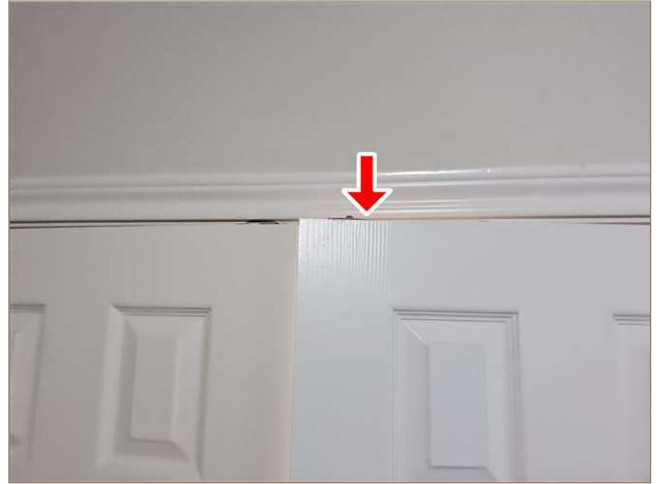
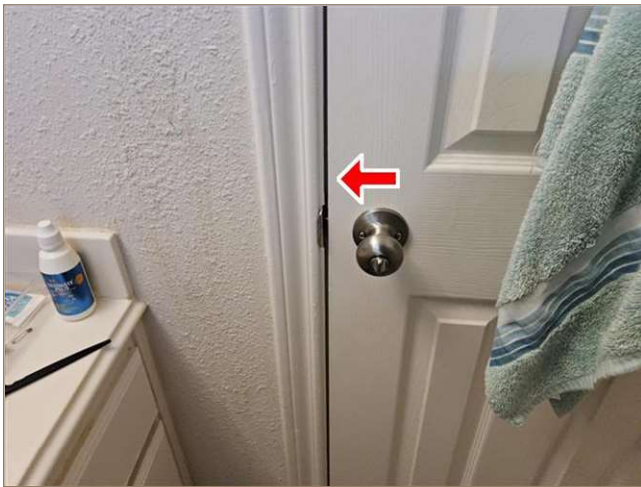
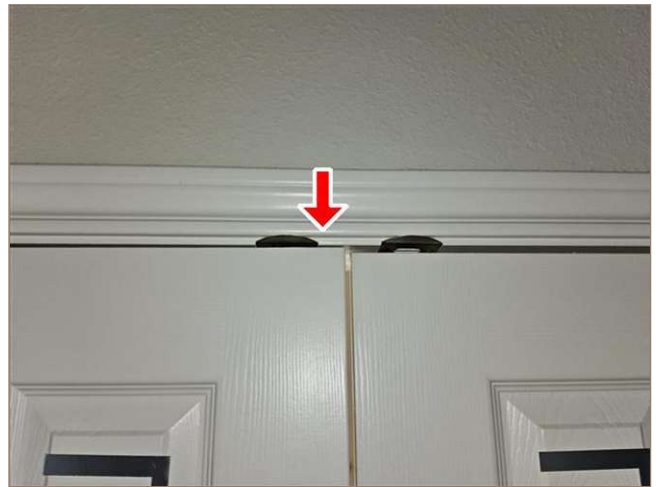
The interior door does not shut and latch properly. This is a maintenance issue and is for your information. A qualified contractor should inspect and repair as needed.

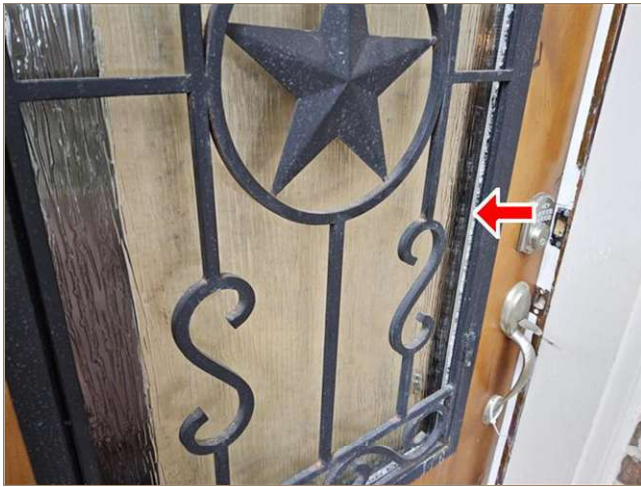
front glass panes broken front entrance

The door is damaged. A repair or replacement is needed. A qualified person should repair or replace as needed.

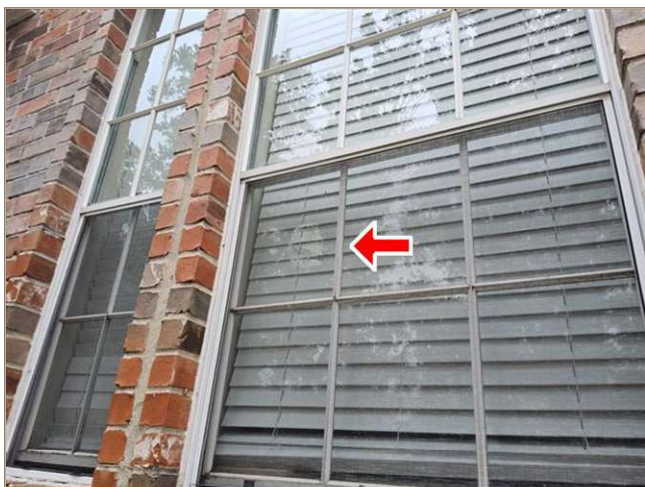
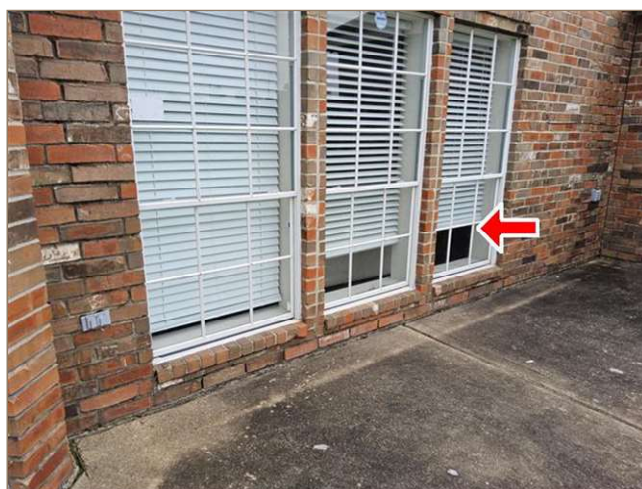
Windows have missing or damaged screens in areas. Further deterioration may occur if not repaired. A qualified person should repair or replace as needed.

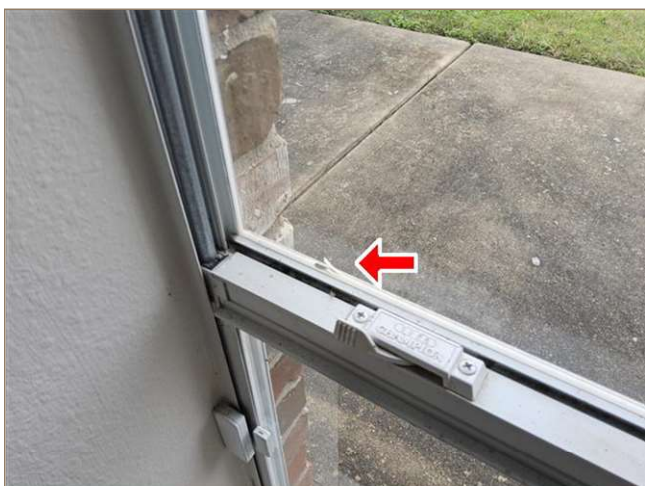
Windows have loose or damaged seals. Further deterioration may occur if not repaired. A qualified person should repair or replace as needed.

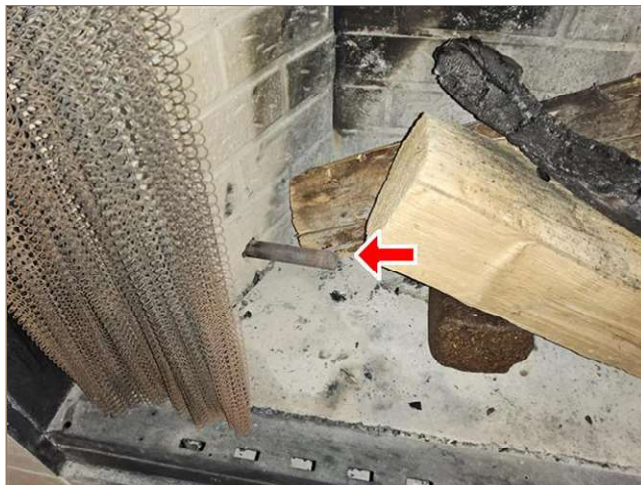
Chimney gas piping is damaged. I recommend having a qualified contractor inspect and repair as needed.

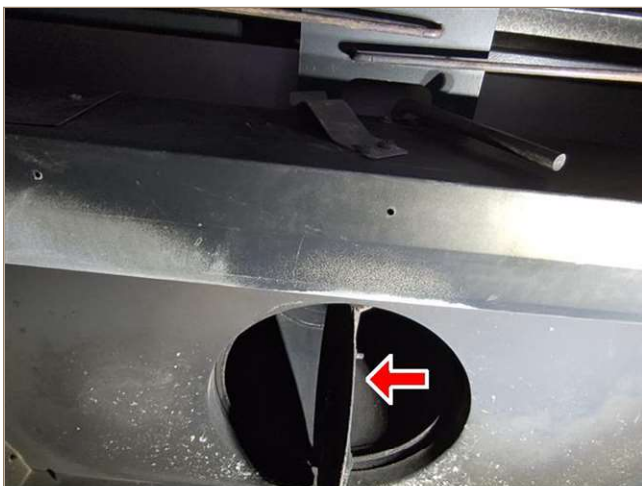
does not stay close

The fireplace dampener is damaged or loose. This is a safety hazard. Have a qualified person repair as needed.

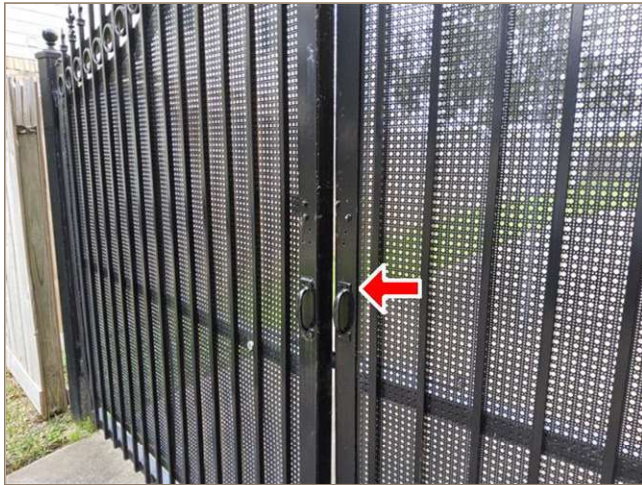
loose

The fence at exterior is damaged. This is a maintenance issue and for your information. A qualified person should repair or replace as needed.

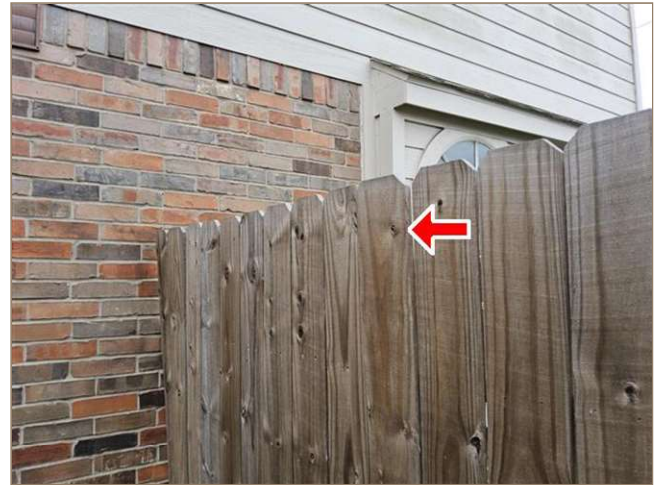
right loose picket

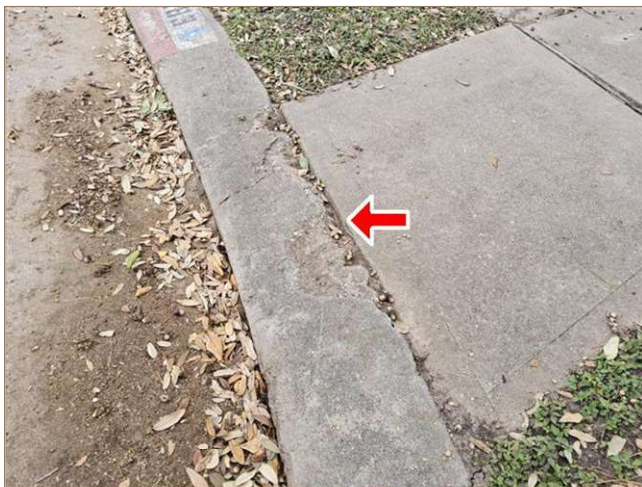
front tripping hazard

The concrete walkway / driveway at the exterior areas deteriorated in areas. Further deterioration can occur if not repaired. A qualified person should repair or replace as needed. Remove wood forms, seal with backer rod and self-leveling sealant.

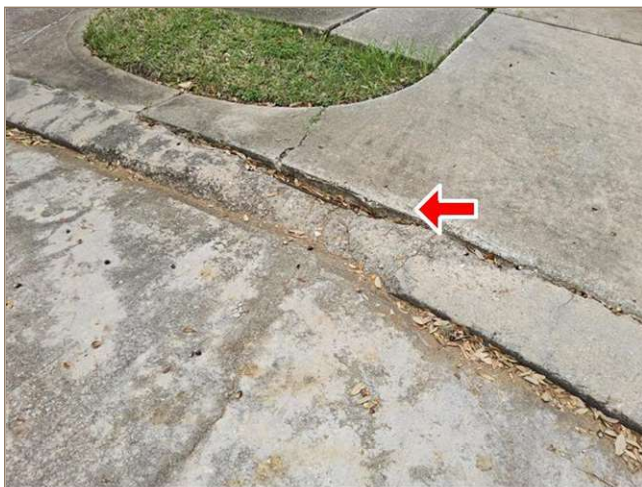
front tripping hazard

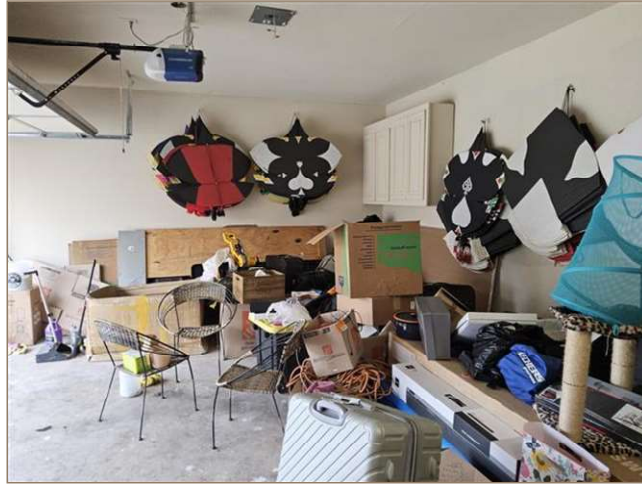
Areas of the home have limited access due to furniture or occupants belongings. This is for your information.
(3)

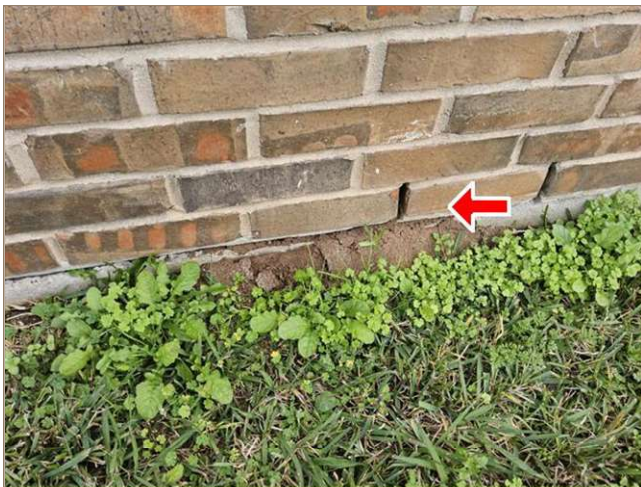
rear

There is what appears to be an active insect / bee colony. I recommend contacting a qualified pest control company to inspect and treat as needed.

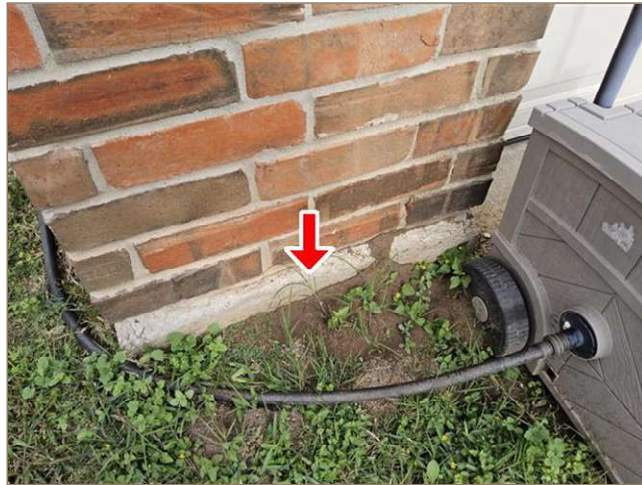
left rear

There is wood to ground to structure contact. This create conducive conditions for certain types of wood destroying insects. I recommend having a qualified pest control company inspect and treat if necessary.

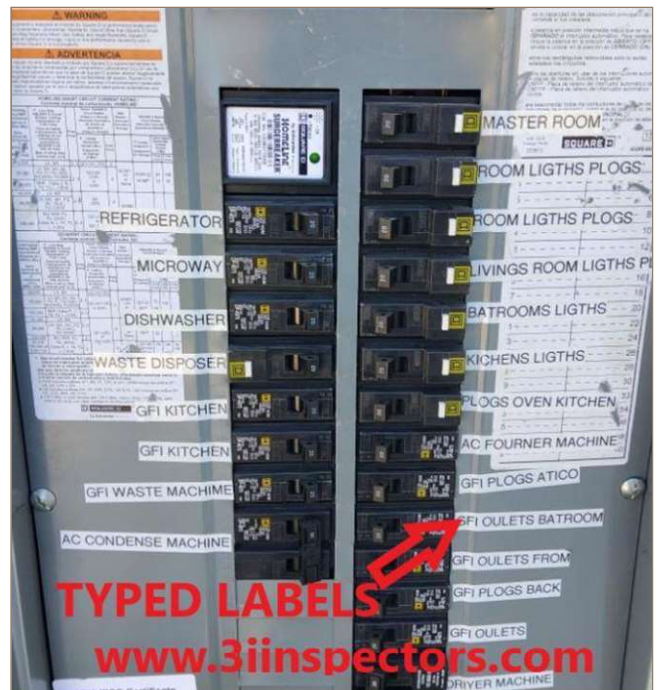
The panel is missing circuit identification. **This is a safety hazard.** I recommend having a qualified person mark circuits as needed.

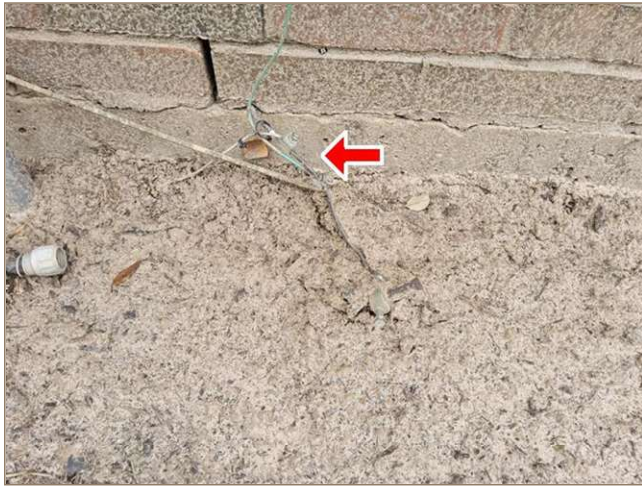
damaged rod

The grounding wire wall anchor is loose and needs repair outside. This is not today's standard.
(3)

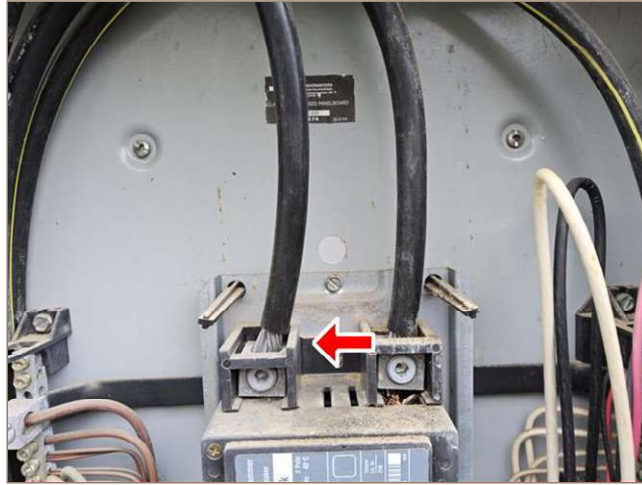
There is no antioxidant on aluminum conductors feeding panel. This is not considered to be today's standard. I recommend having a qualified electrician evaluate make repairs as needed.

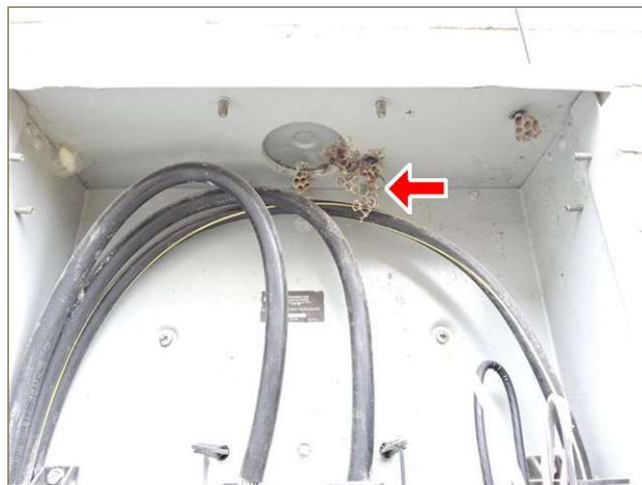
clean debris

Problem(s) discovered with Branch Circuits such as amateur wiring installation, and any other problems that an electrical contractor may discover while performing repairs need correcting. I recommend a licensed electrical contractor inspect further and correct as needed.

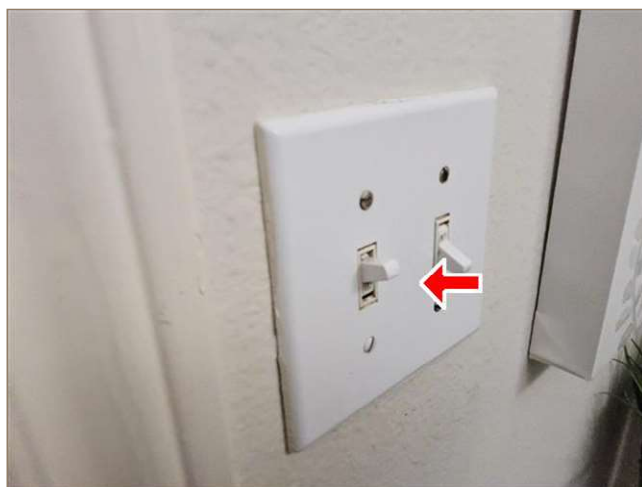
half bath

The light switch is damaged. I recommend having a qualified person repair.

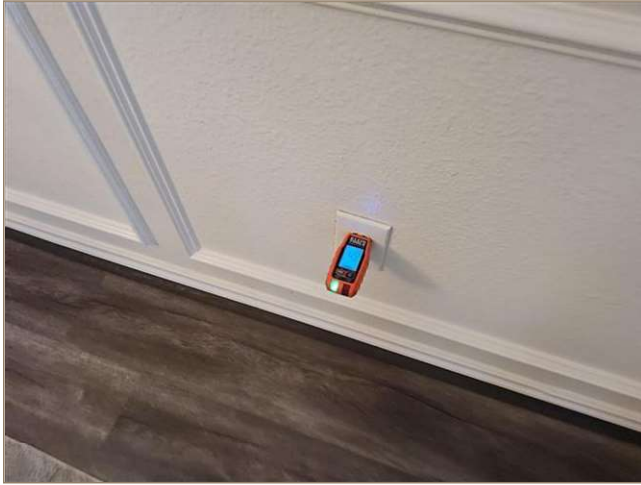
dining room

Outlet(s) loose in wall in areas. Electrical issues are considered a hazard until repaired. A qualified licensed electrical contractor should perform repairs that involve wiring.

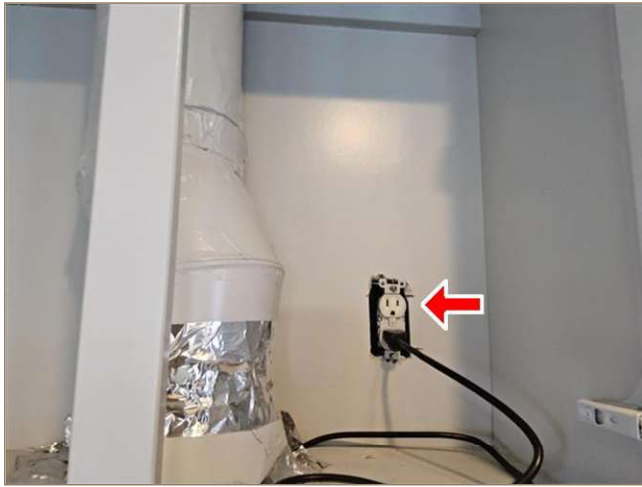
kitchen

The cover is damaged or missing. I recommend having a qualified person repair.
(5)

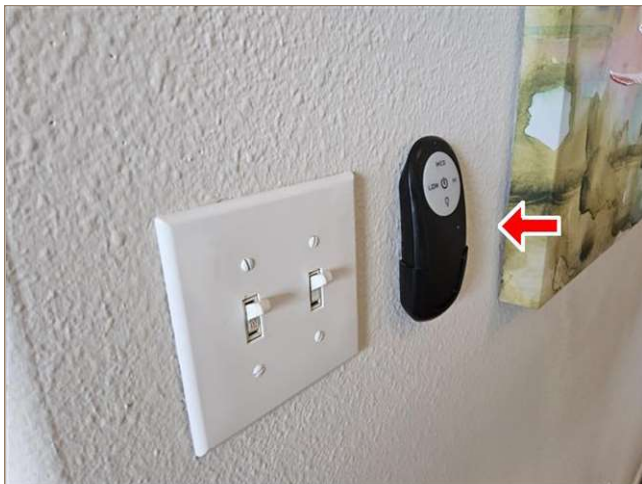
living to fan remote can be lost

The light switch is missing connection. I recommend having a qualified person repair.
(6)

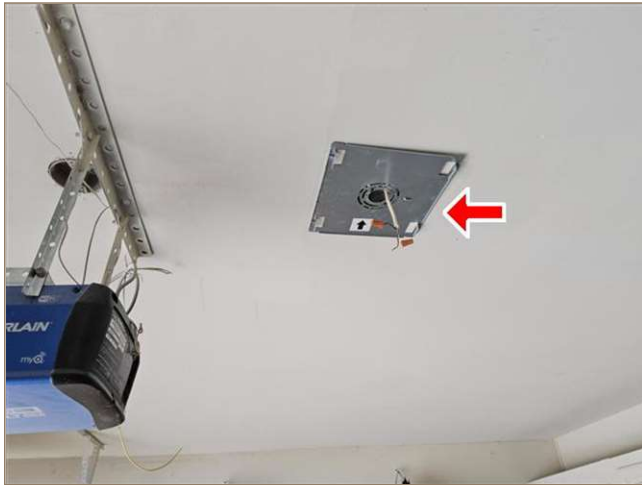
garage

There is exposed wiring in areas of the home. This is a safety hazard. I recommend having a qualified electrician inspect and make repairs as needed.

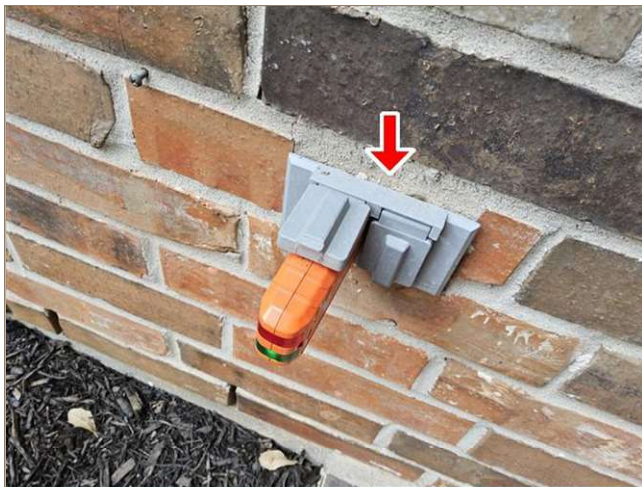
front porch

There are no GFCI protected circuits in required area's. This is not considered to be today's standard. I recommend having a qualified electrician make repairs as needed.

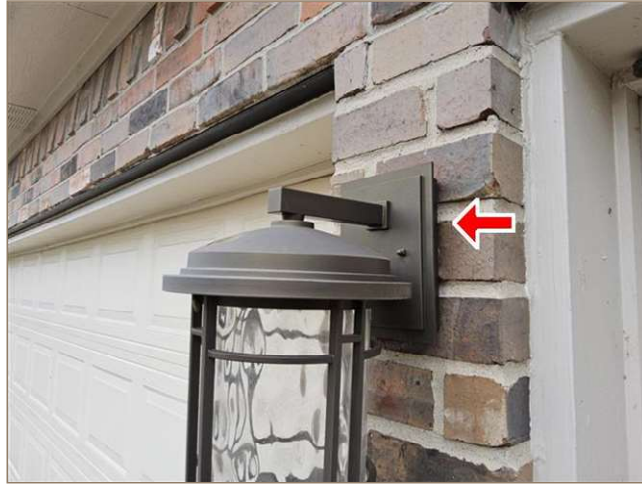
left garage

The electrical fixture is loose. Electrical issues are considered a hazard until repaired. I recommend repair as needed.

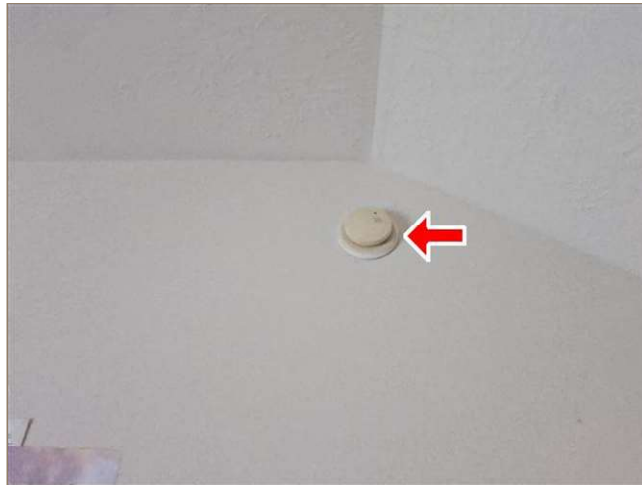
rear right bedroom

Missing or non function smoke detectors at all sleeping rooms, outside sleeping rooms and on each level of the home. Recommend having a qualified contractor install smoke detectors in the mentioned areas.

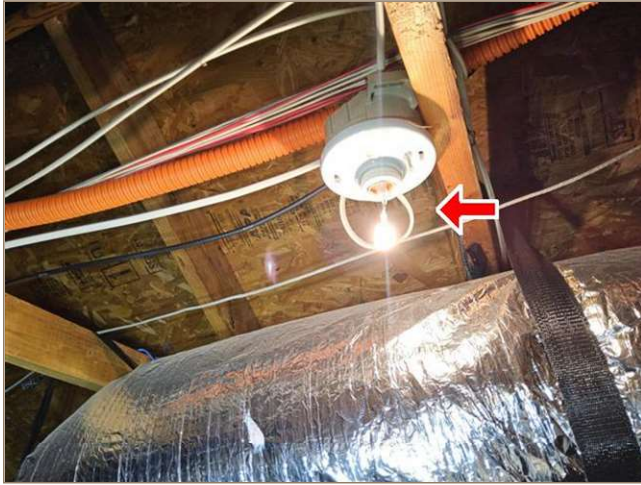
attic

The light bulb is damaged. I recommend having a qualified person repair.
(11)

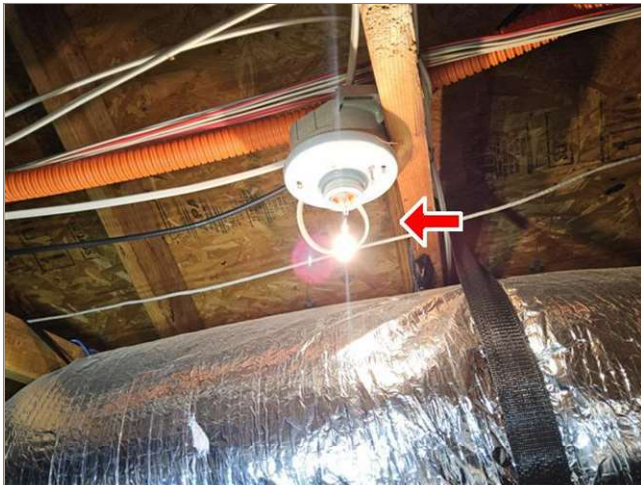
attic

The electrical fixture is missing globe cover. Electrical issues are considered a hazard until repaired. I recommend repair as needed.

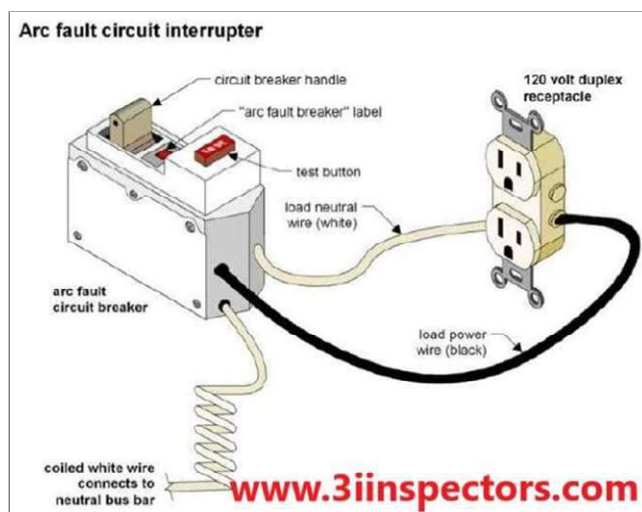
Arc fault Circuit Interrupters (AFCI) is not installed. This is not today's standard. I recommend having a qualified person repair.

AFCI or "Arc Fault Circuit Interrupters" are the latest in electrical safety devices for dwellings. AFCI standards were introduced in the 1999 NEC (National Electrical Code) and are required in new dwelling construction and when installing, extending or updating new circuits in an existing dwelling, or when replacing receptacles located in designated locations. AFCI and GFCI protection devices may look similar, but perform very different functions to protect against different dangers.

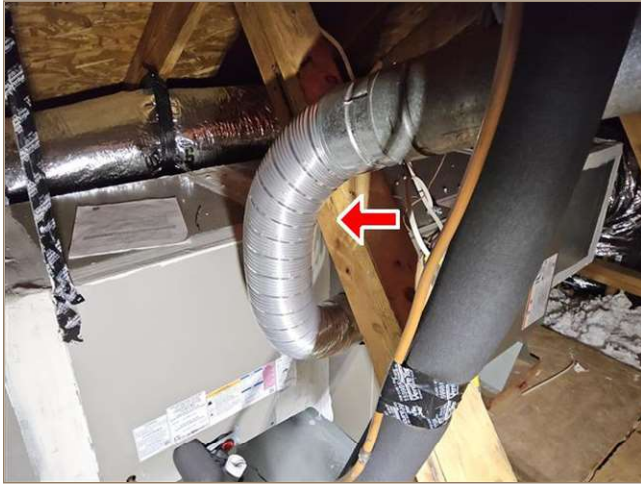
upstairs - missing B-vent

The furnace exhaust flue is loose or improper flue pipe. This is a safety hazard. Have a qualified person repair as needed.

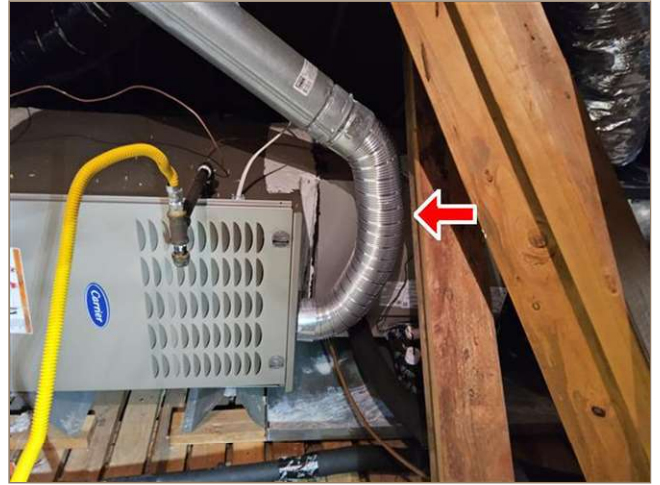
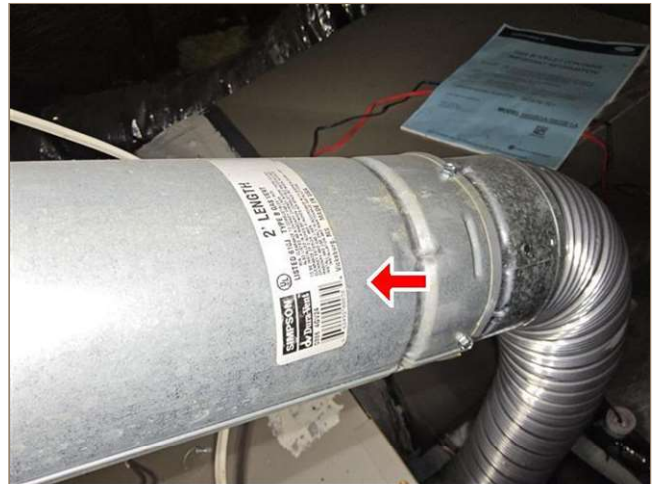
downstairs unit - missing B-vent

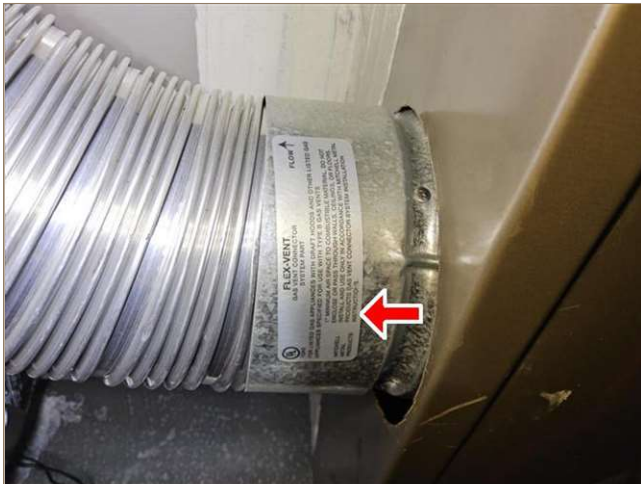
b vent

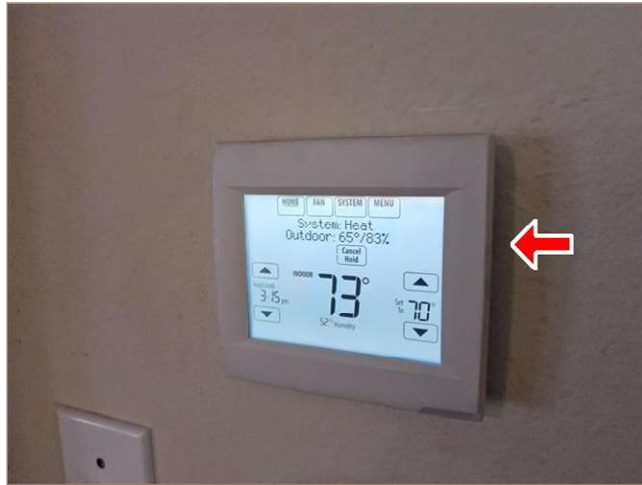
unable to test heater upstairs

The thermostat upstairs is damaged. I recommend repair or replace as needed.

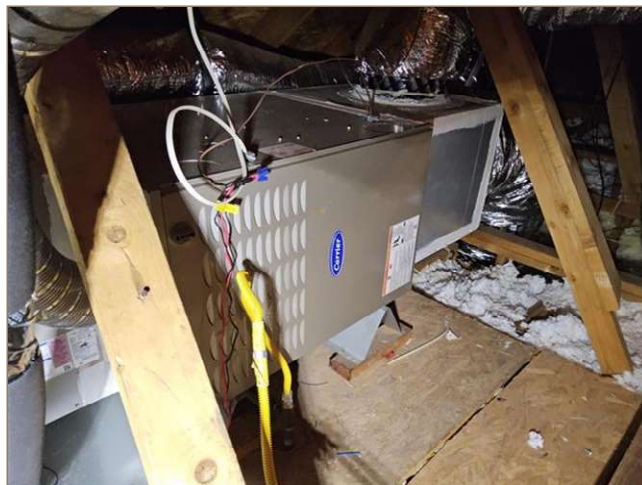
(4)

The heater upstairs did not turn-on at inspection. I recommend repair or replace as needed.

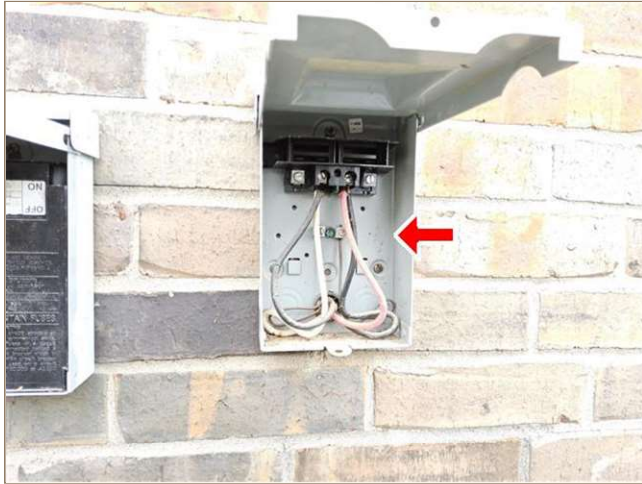
(1)

downstairs unit connected directly safety hazard

Exterior A/C is missing the required service disconnect. This is not today's standard. I recommend a qualified person make repairs as needed,

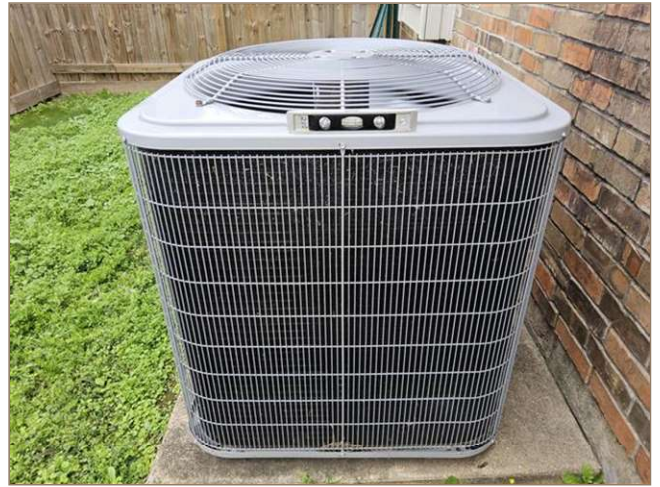
downstairs

The condenser is not level. A replacement is needed This is a safety issue and should be repaired. A licensed HVAC contractor should service or repair unit. This can cause premature failure to compressor and void manufacturers warranty.

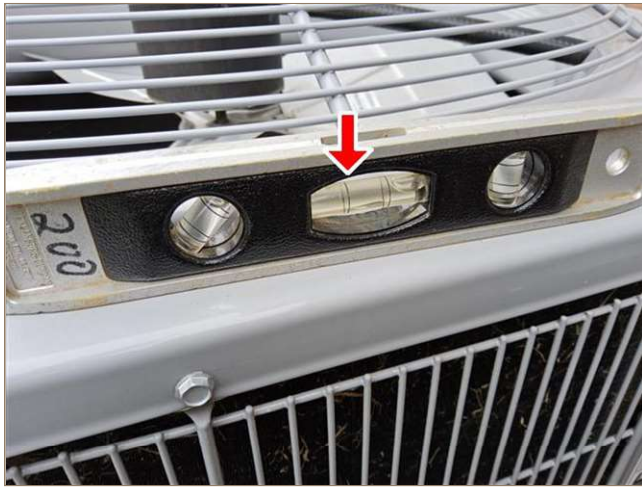
upstairs unit

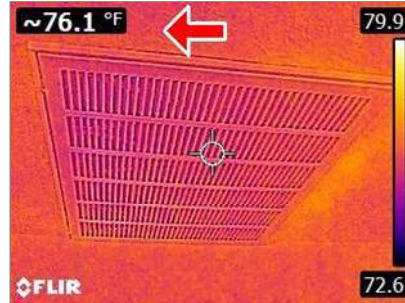
76 return downstairs

The ambient air test was performed by using thermometers on the air handler of Air conditioner to determine if the difference in temperatures of the supply and return air are between 14 degrees and 22 degrees which indicates that the unit is cooling as intended. This indicates the range in temperature drop is normal.

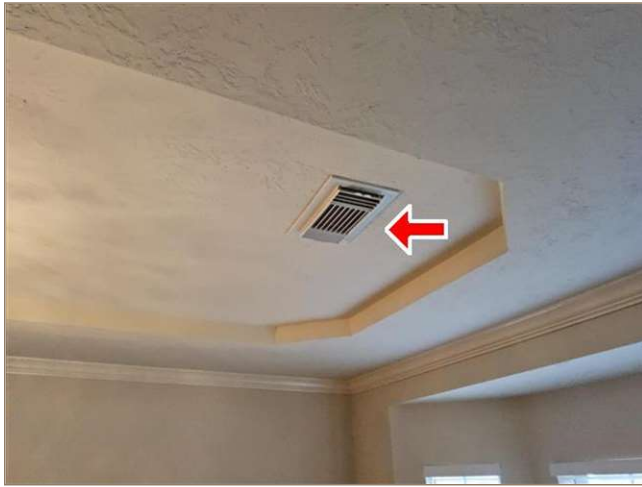
(1)

dining room

The supply to rooms needs adjustment or balances. Repairs are needed.

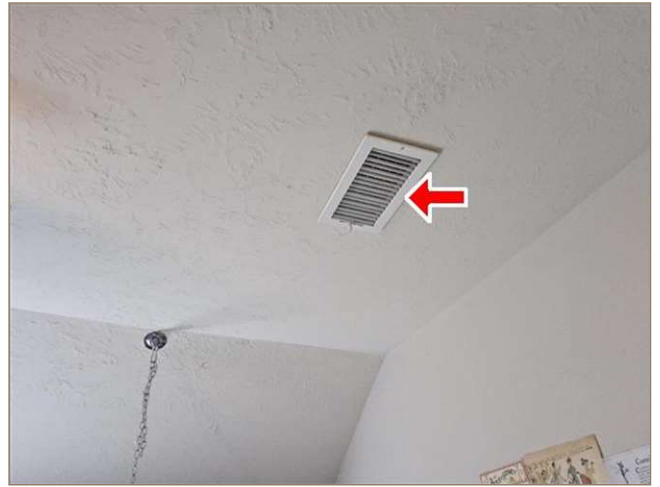
rear right bedroom

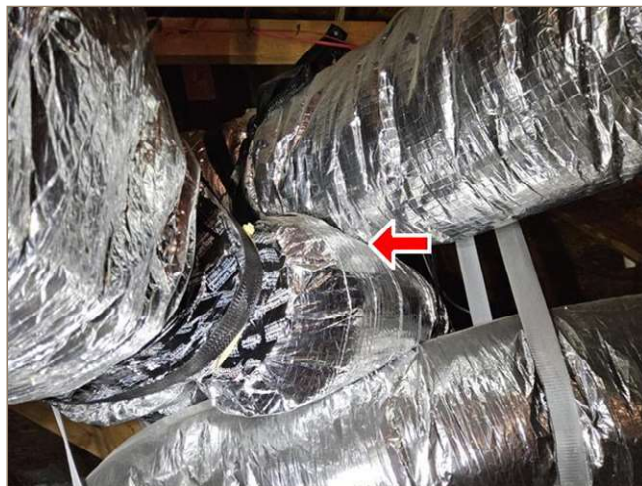
(2)

Duct piping appears to be in contact with one another in the attic space. Condensation could occur if not corrected. I recommend having a qualified HVAC contractor further evaluate and make repairs as needed

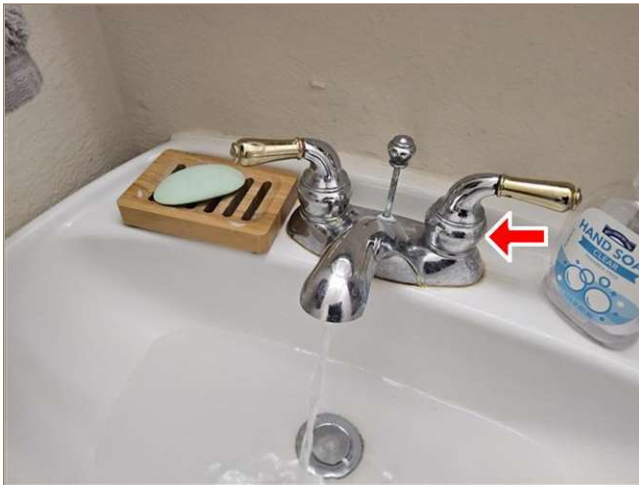
(1)

half bath

The faucet is damaged. Repairs are needed This is not considered up to today's standard. A qualified licensed plumber should repair or correct as needed.

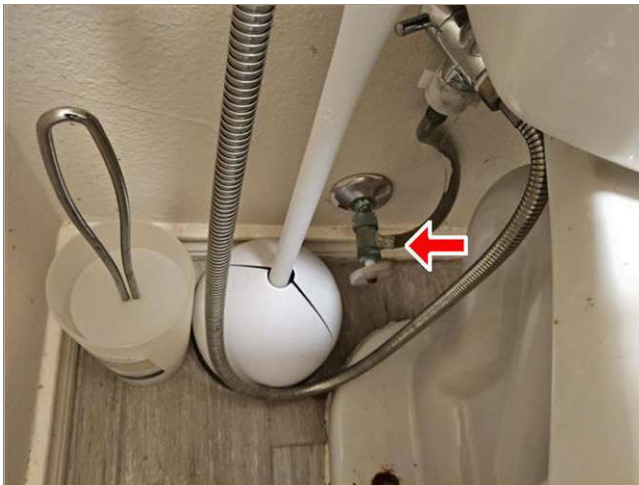
(2)

master bath

The piping has corrosion at fittings. This is a possible leak location. A qualified person should make repairs as needed.

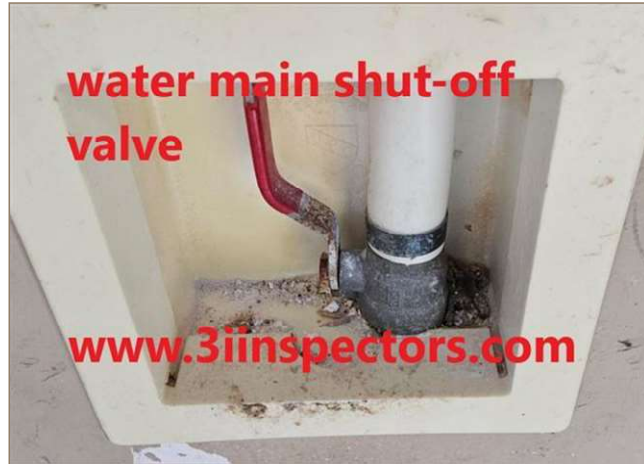
(3)

The water shutoff valve not located. Repairs are needed This is not considered up to today's standard. A qualified licensed plumber should repair or correct as needed.

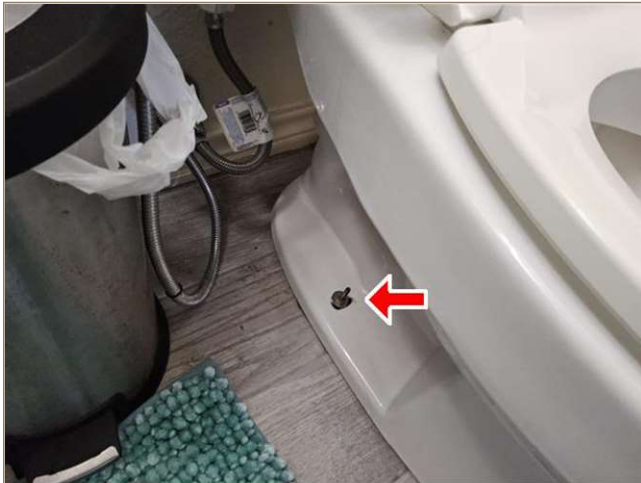
half bath

The toilet is missing cap at screws. Repairs are needed. A qualified licensed plumber should repair or correct as needed.

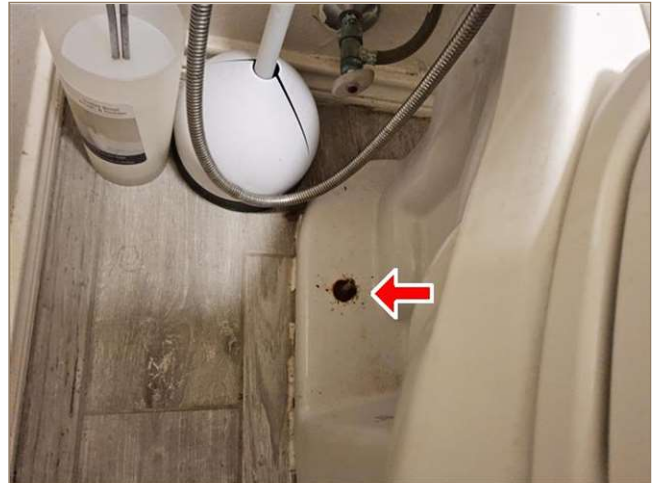
master bath

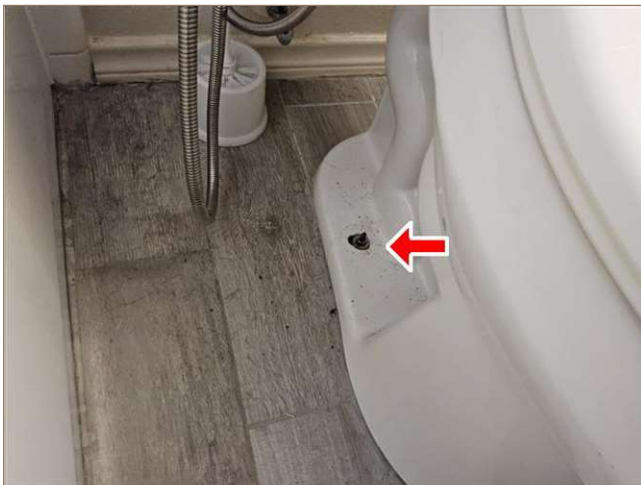
upstairs

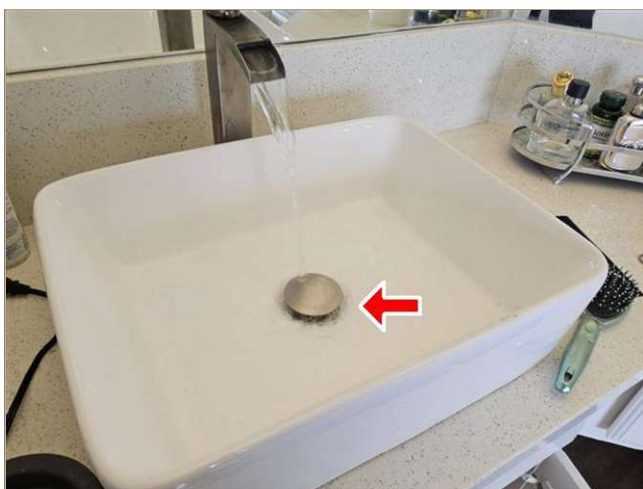
The waste overflow is missing, leaks or does not function / under sized. A qualified licensed plumber should repair or correct as needed.

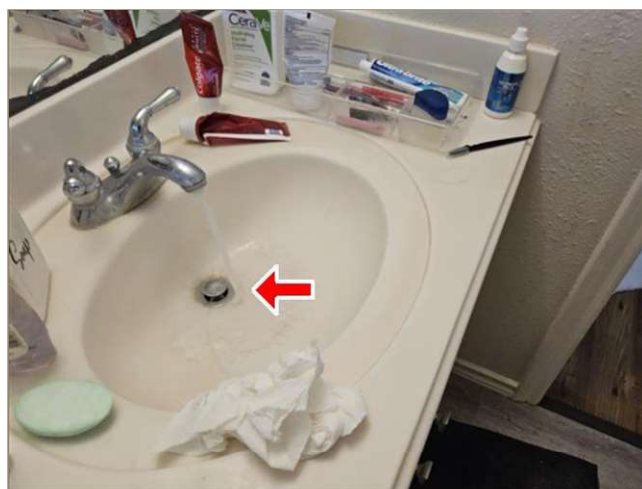
upstairs hallway

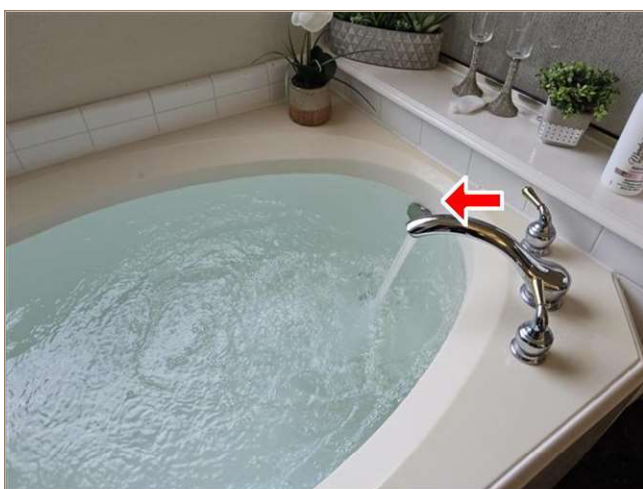
upstairs left bath
