Summary Only

Property Address:
1303 Pine Mills Drive
Richmond Texas 77469

General Summary

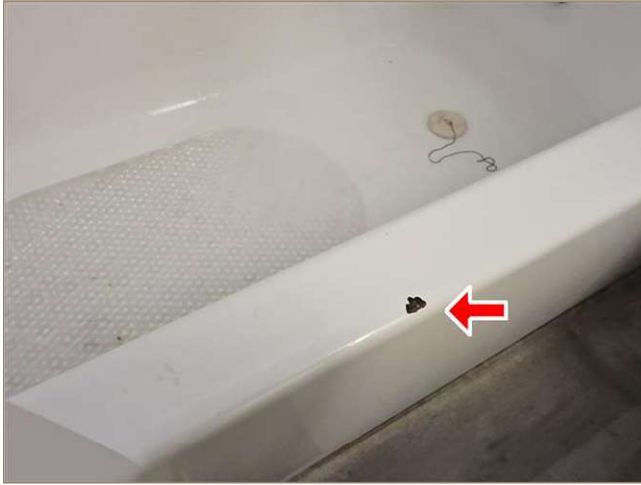
(3)

upstairs

The tub or sink is damaged. Repairs are needed.

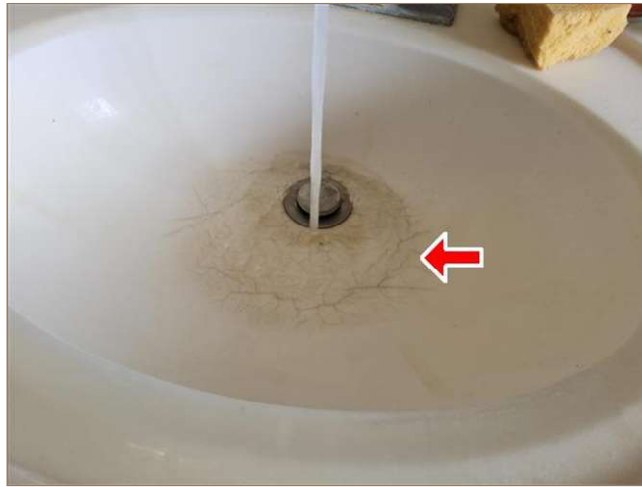
left upstairs bath

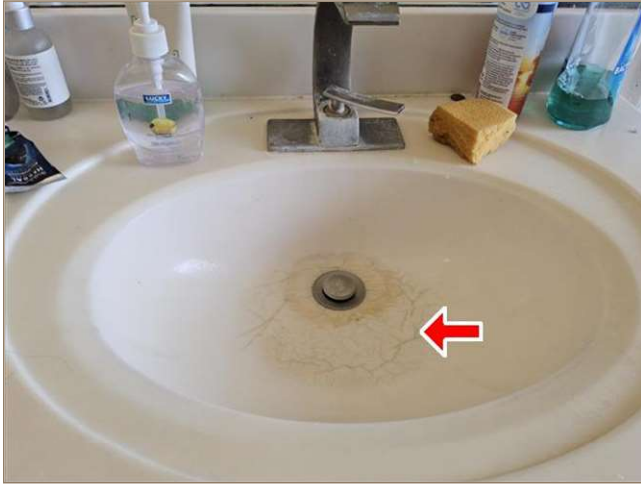
(4)

upstairs left bath x2

The drain stopper does not function as intended at bath sink. Repairs are needed. A qualified licensed plumber should repair or correct as needed.

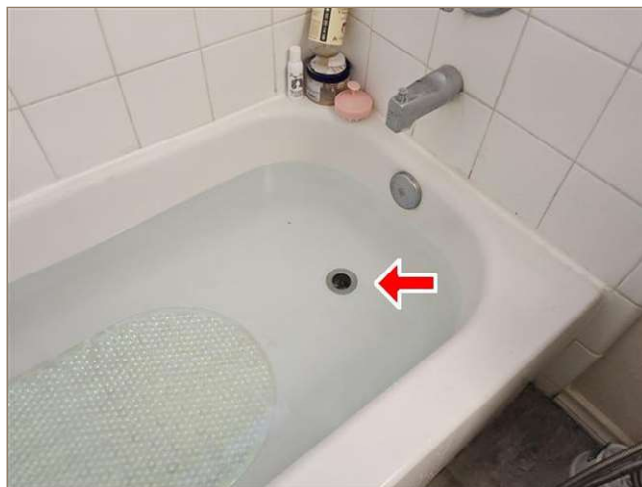
(5)

hair clogged

The tub drain drains slowly under the hall bath. Repairs are needed This is not considered up to today's standard. A qualified licensed plumber should repair or correct as needed.

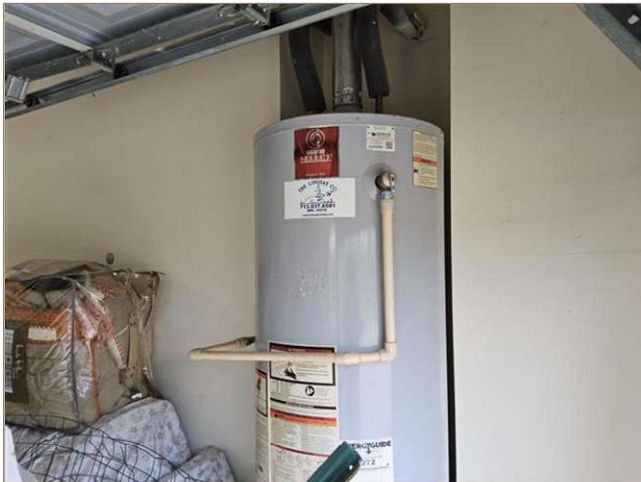
(1)

2015 popping at use

The water heater is very old and may last a few years more, but maybe not. I have seen units fail shortly after a home inspection during the seasonal change from mild to hot weather. I cannot determine how long your water heater will last before a replacement is necessary.

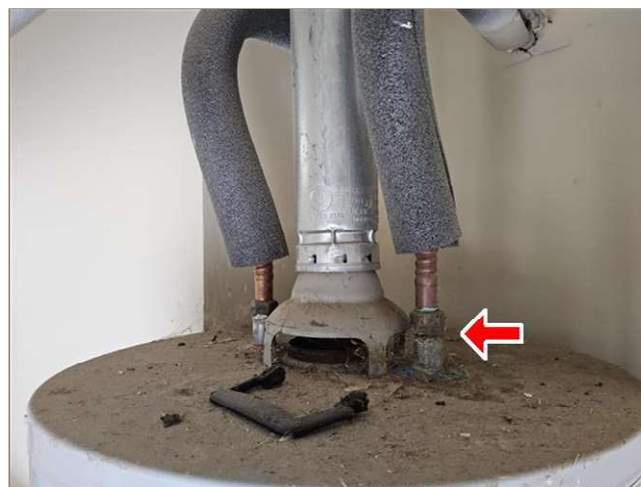
(2)

The water heat has corrosion at fittings. I recommend having a qualified person make repairs as needed.

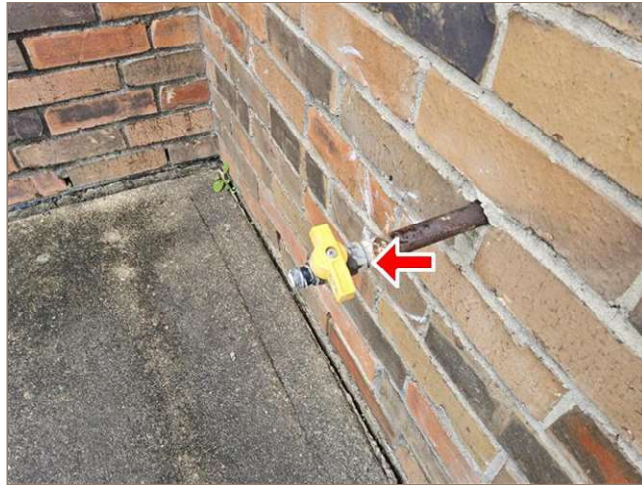
patio kitchen missing cap safety hazard

The gas meter and piping around meter are rusted or deteriorated. Repairs are needed.

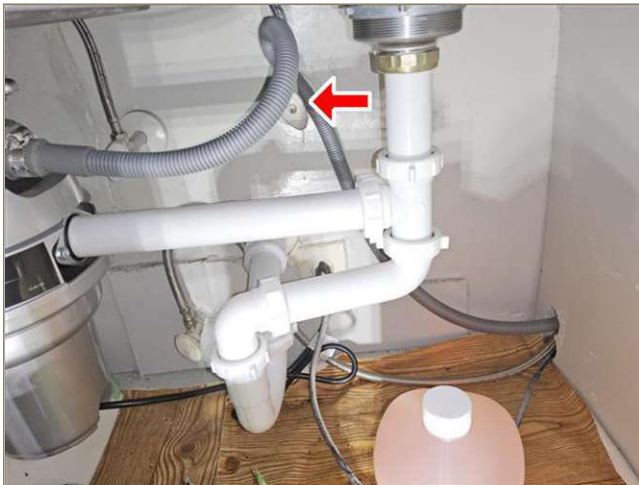
The dishwasher is missing high-loop. I recommend repair as necessary.

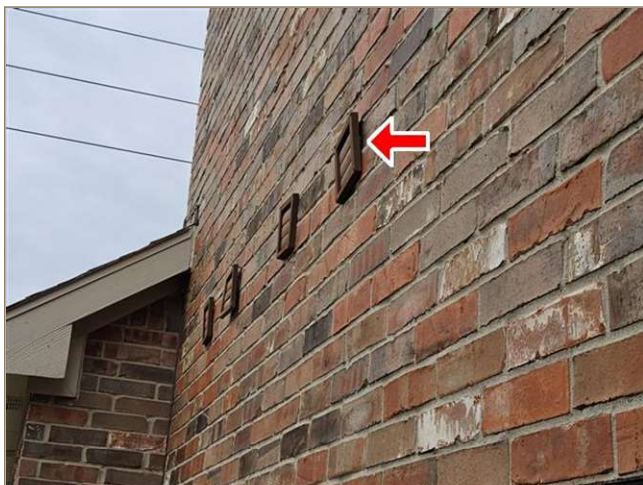
The exhaust vent cover is loose. This is a safety issue. Repairs are needed.

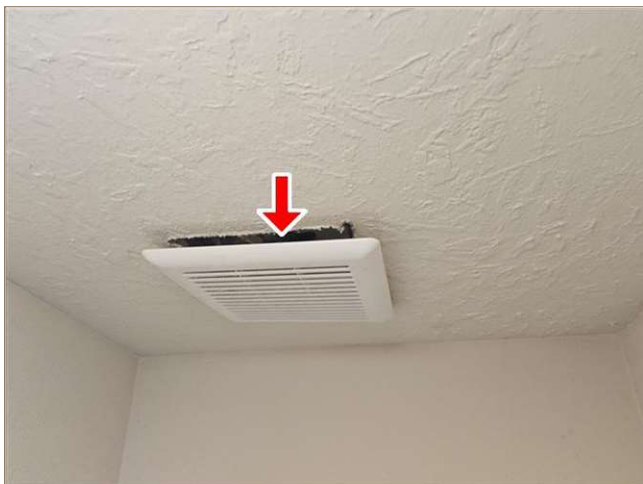
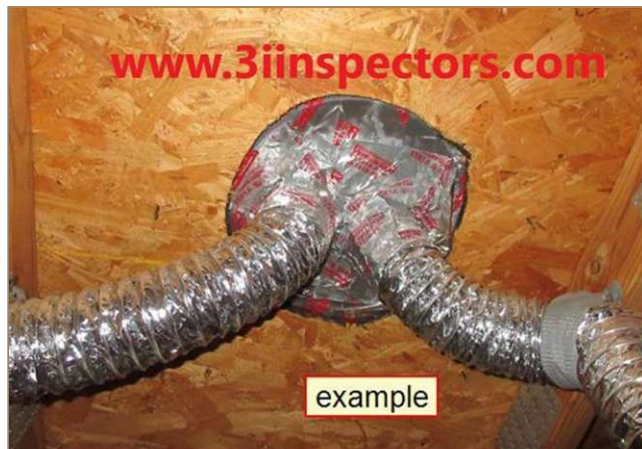
(2)

upstairs left bath

The Exhaust fan is damaged or missing in areas. This is a safety hazard. A qualified person should repair or replace as needed.

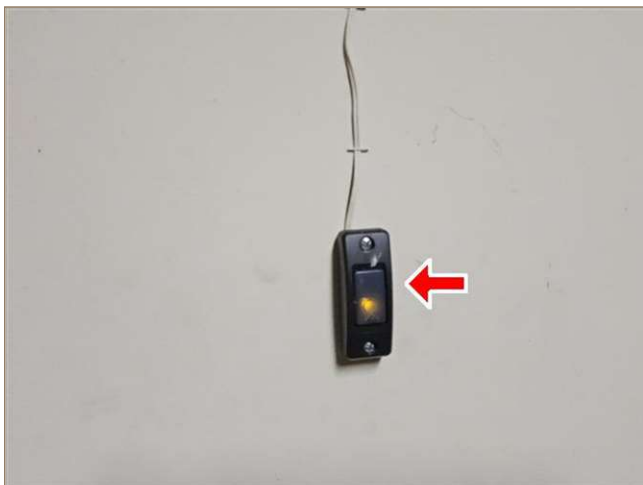
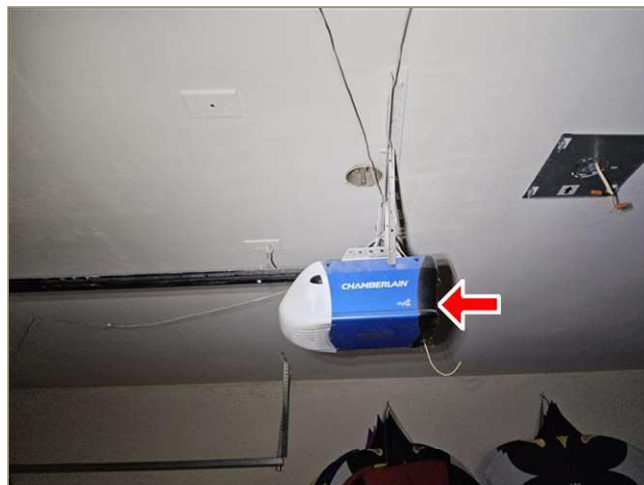
hold down switch to close

The garage door operator is damaged or missing. This is not considered today's standard. Have a qualified person repair as needed.

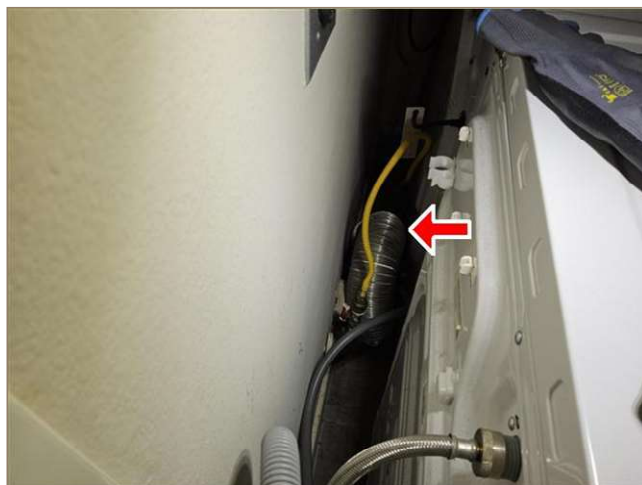
The dryer vent piping is long and vertical which can trap lint at elbow. Vent pipes should be cleaned regularly if they are longer than normal (10 feet or more) or vented vertically. I recommend repair as needed.

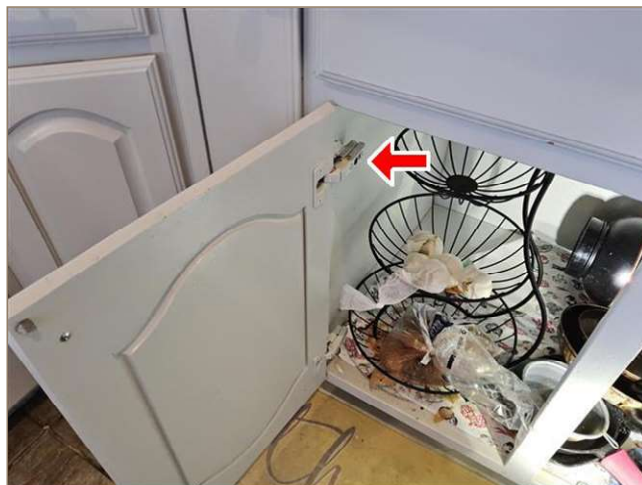
The cabinet door is damaged or loose. This is a cosmetic issue for your information. I recommend repair or replace as necessary.
