RESIDENTIAL INSPECTION REPORT

2755 Longleaf Pines Ln
Humble, TX 77339

PROPERTY INSPECTION REPORT FORM

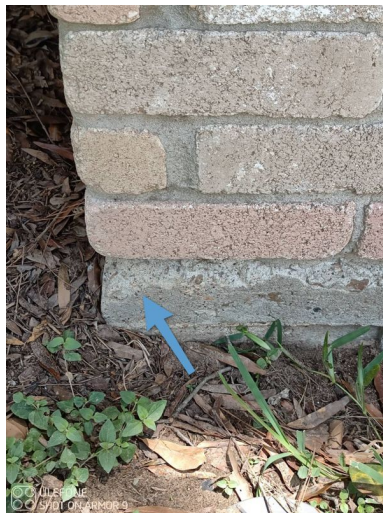
1: Slab: Minor Surface Irregularities

These conditions are typically cosmetic and not associated with structural movement. Examples include, but are not limited to, shear cracks, corner pops and minor cracks.

Shear Crack/ Front Exterior

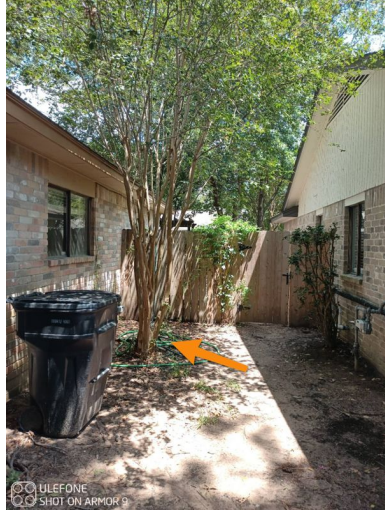
2: Large Trees Too Close

Right Exterior

Root systems of large trees planted too close to the foundation can cause foundation problems. Evaluation and remediation is recommended.

Recommendation: Contact a qualified professional.

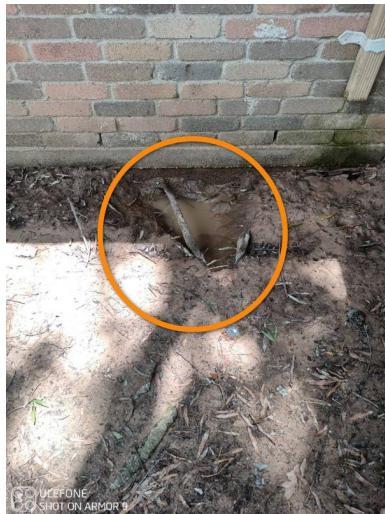
1: Grading & Drainage: Inadequate

Low spots, ruts, soil erosion, negative grading, standing water and/or damaged sod were present at the time of inspection. Evaluation and remediation by a qualified landscaping contractor or foundation contractor so that water flows away from the home is recommended.

Negative grading / rear exterior

Soil erosion/ rear exterior

Recommendation: Contact a qualified landscaping contractor

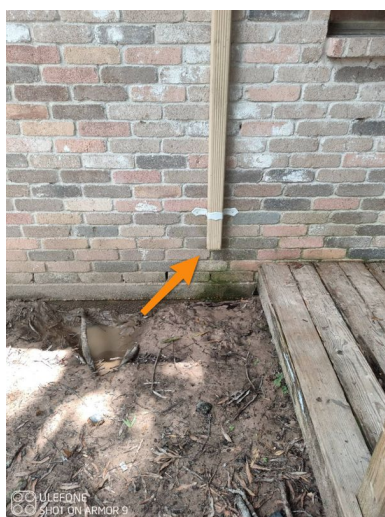
2: Gutters & Downspouts: Defects Present

Gutters and/or downspouts had one or more defects at the time of the inspection. Examples include, but are not limited to:

Missing elbow/ rear exterior

Recommendation: Contact a qualified professional.

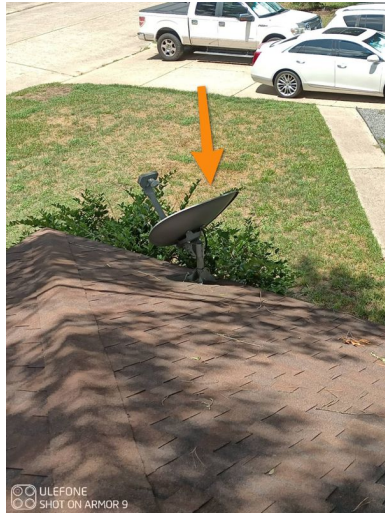
1: Equipment on Roof

Equipment was mounted to the roof, including, but not limited to satellite dishes, solar panels and HVAC equipment. The inspector was unable to determine if the equipment was installed per manufacturer’s specifications. Evaluation and remediation is recommended.

Recommendation: Contact a qualified roofing professional.

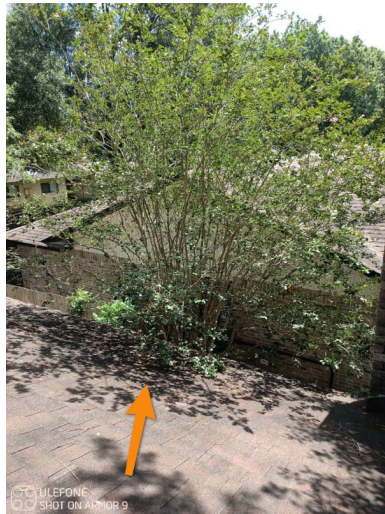
2: Tree Limbs On/Near Roof

Tree limbs that were in contact with roof or hanging near roof should be trimmed to prevent damage to the roofing materials. Evaluation and remediation is recommended.

Recommendation: Contact a qualified professional.

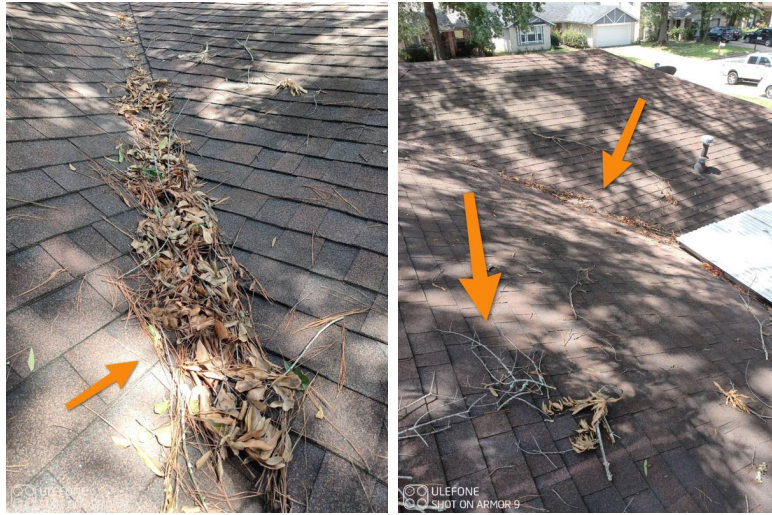
3: Debris on Roof

Debris was present on roof surface. The condition of the roof covering underneath could not be determined. Removal of debris and evaluation of the roofing materials underneath is recommended.

Recommendation: Contact a qualified professional.

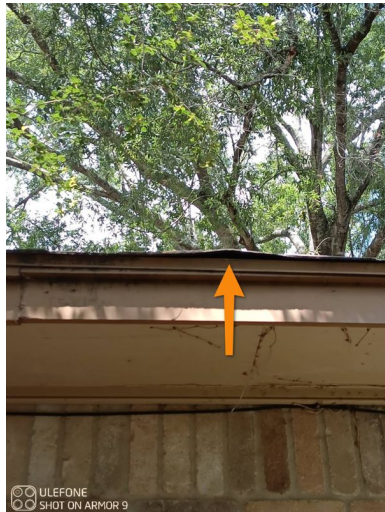
4: Popped Up Nails

Popped up nail heads were observed. Evaluation and remediation is recommended.

Recommendation: Contact a qualified roofing professional.

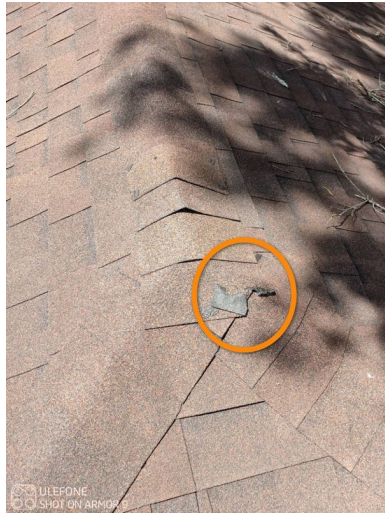
5: Shingles: Damaged/Torn/Missing

Roof shingle material was missing, damaged, or torn in areas. Evaluation and/or repair by a qualified roofing professional is recommended.

Recommendation: Contact a qualified roofing professional.

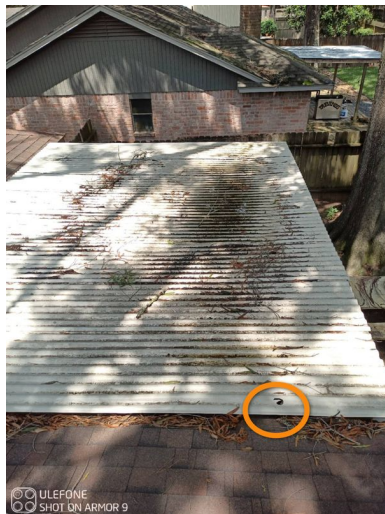
6: Metal Roof: Corrosion

Corrosion was observed on a metal roof. Evaluation and remediation is recommended.

Recommendation: Contact a qualified roofing professional.

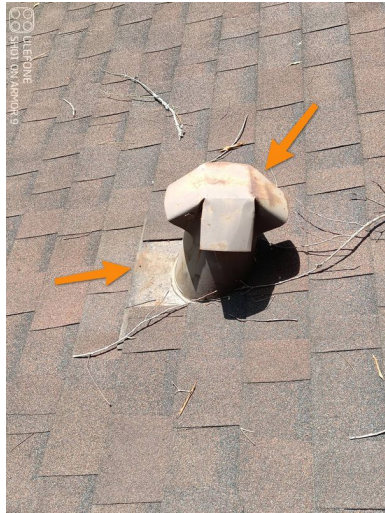
7: Flashing Deficiencies

Corroded, Lifted -

Deficiencies with the flashings were present at the time of inspection. Evaluation and remediation is recommended.

Corroded flashing

Lifted flashing

Recommendation: Contact a qualified roofing professional.

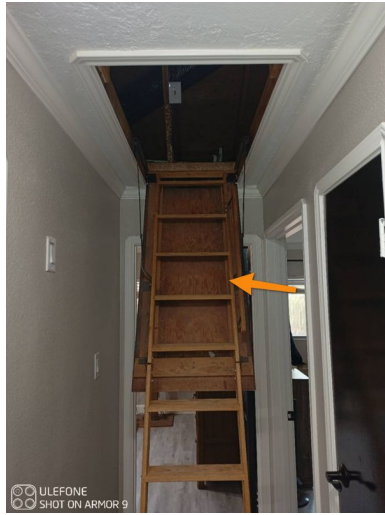
2: Pull-down Stairs/Ladder: Defects Present

The pull-down ladder/stairs had one or more defects at the time of the inspection. Examples include, but are not limited to:

- Lack of weatherstripping/insulation
- Improper seal
- Missing/loose nuts/bolts
- Improper slope
- Lack of fire rating in a garage

Missing weather stripping / insulation

Improper slope

Recommendation: Contact a qualified professional.

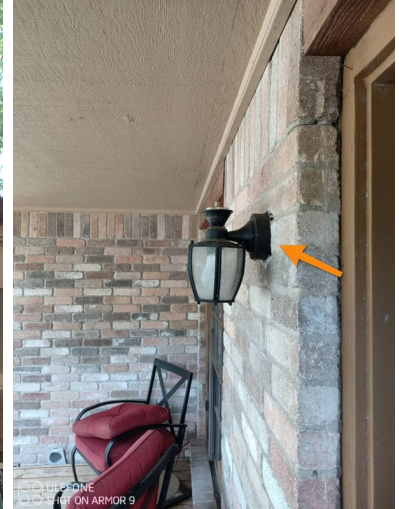
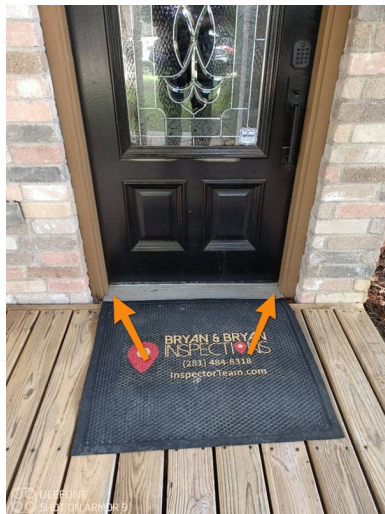
1: Exterior: Seal Wall Fixtures

All Exterior Wall Penetrations, Trim Boards, Electrical Distribution Panel(s), Service Panel(s) -

One or more areas were not properly sealed/caulked. Most exterior sealants have a lifespan of 5 to 8 years and should be regularly maintained with that lifespan in mind. Evaluation and remediation is recommended.

Recommendation: Contact a qualified professional.

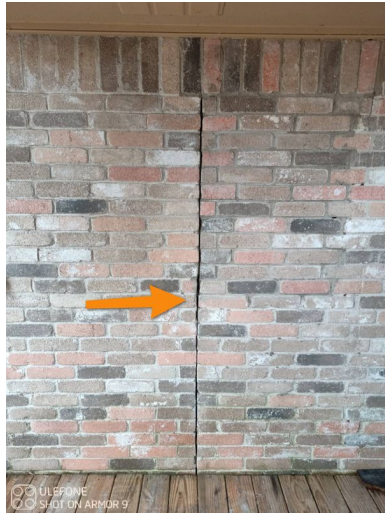
Rear Exterior

2: Masonry: Seal Expansion Joints

Sealant in the expansion joints is missing or has deteriorated. Evaluation and remediation is recommended.

Recommendation: Contact a qualified masonry professional.

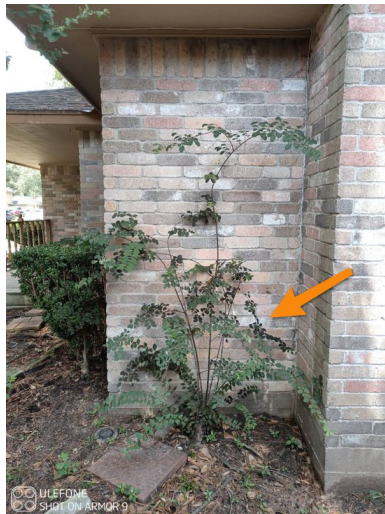
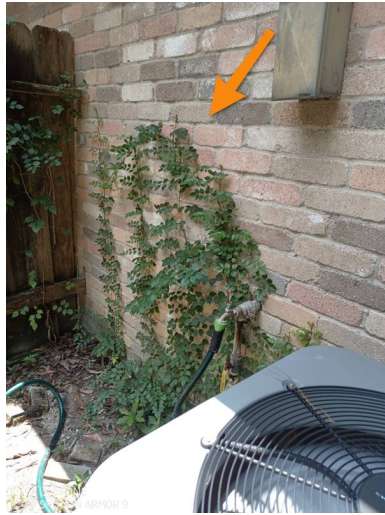
3: Exterior Walls: Foliage Too Close

Foliage that is too close to siding materials can cause moisture buildup and deterioration. Evaluation and remediation is recommended.

Right Exterior

Front Exterior

Recommendation: Contact a qualified professional.

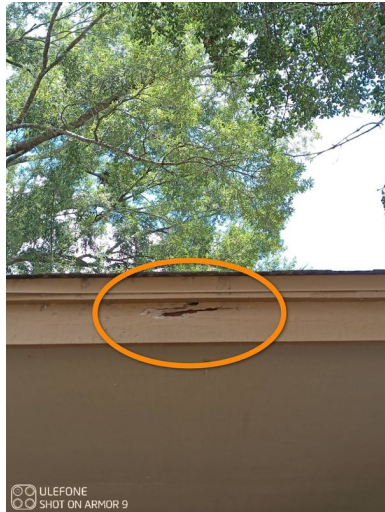
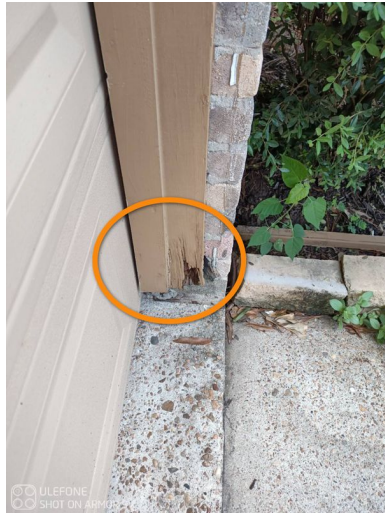
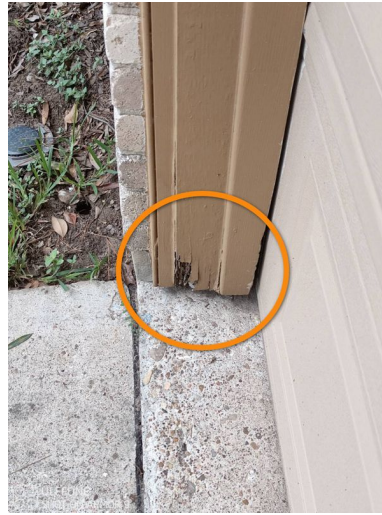
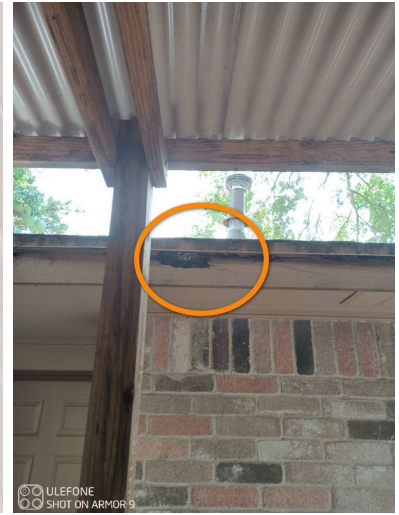
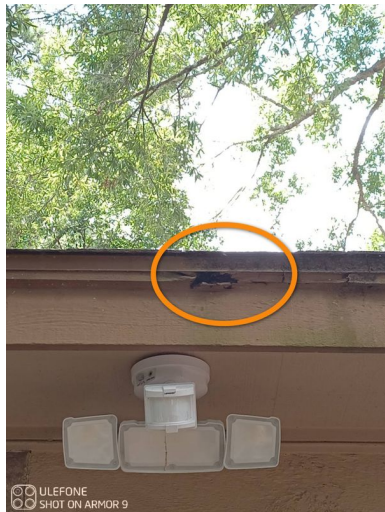
4: Exterior: Evidence of Wood Rot

Wood rot/deterioration was observed. Evaluation and remediation is recommended.

Front Exterior

Left Exterior

Garage

Recommendation: Contact a qualified professional.

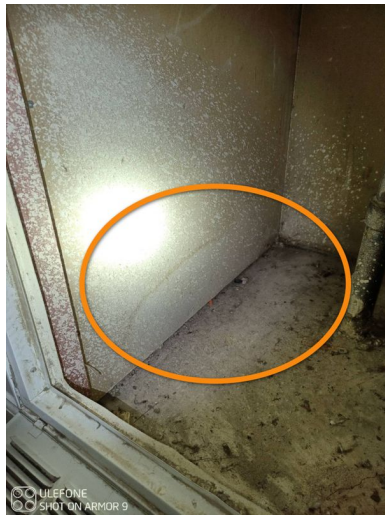
5: Interior Walls: Evidence of Previous Moisture Contact

Wall structure showed signs of previous water intrusion. Tested negative for moisture at the time of the inspection. Evaluation and remediation is recommended.

Return Chase

Recommendation: Contact a qualified professional.

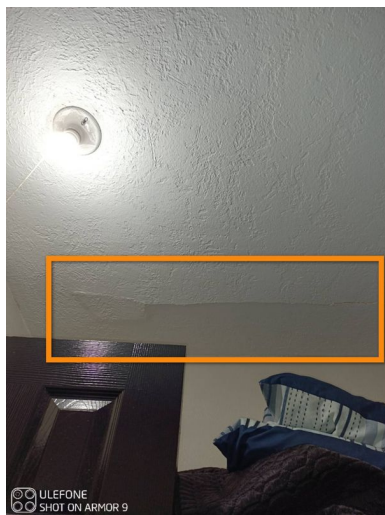
Master Closet

1: Ceiling: Damage

Ceiling damage was present. Evaluation and repair by a qualified drywall or licensed structural engineer is recommended.

Recommendation: Contact a qualified professional.

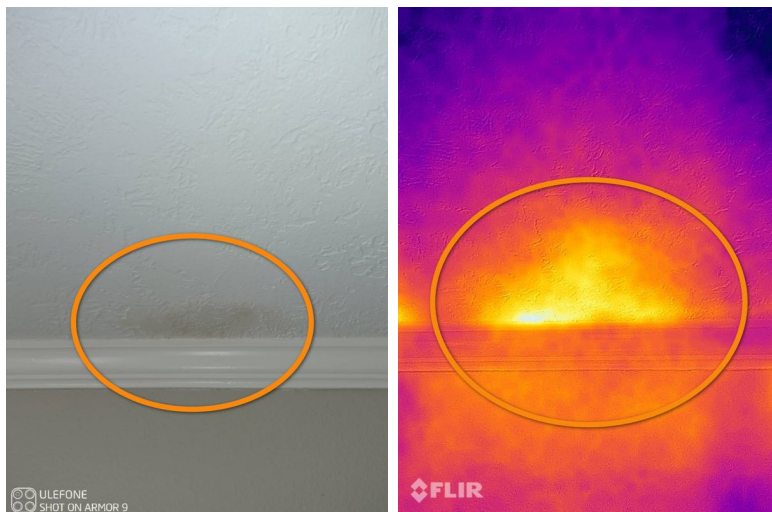
Guest Bed

2: Ceiling: Evidence of Previous Moisture Contact

Ceiling showed signs of previous water intrusion. Tested negative for moisture at the time of the inspection. Evaluation and remediation is recommended.

Recommendation: Contact a qualified professional.

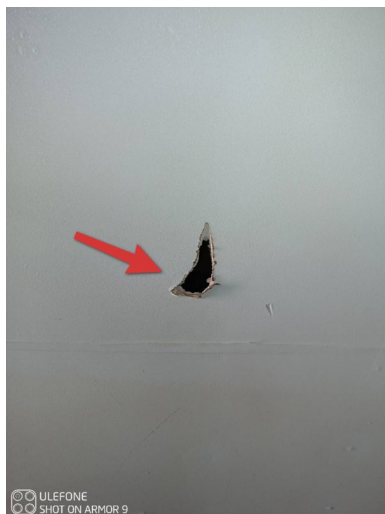
3: Ceiling: Missing Drywall in Garage

There was missing drywall on the ceiling in the attached garage. This is important for fire safety. Evaluation and remediation is recommended.

Recommendation: Contact a qualified professional.

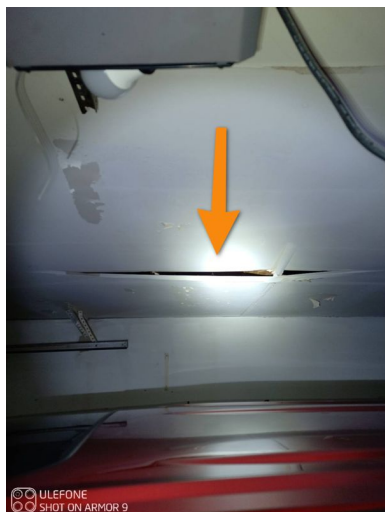
Garage

4: Ceiling: Sagging Drywall

Ceiling drywall sagged visibly at the time of the inspection. The exact cause was not determined, but this condition is typically caused by prior moisture damage. Evaluation and remediation is recommended.

Recommendation: Contact a qualified professional.

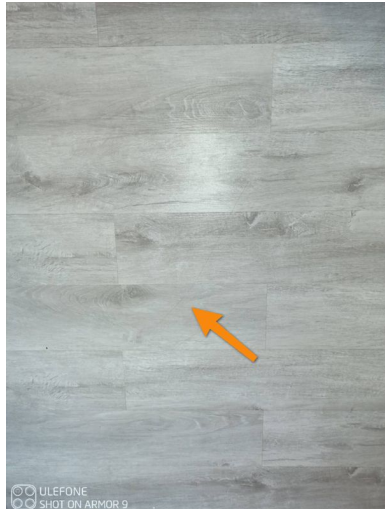
Living Room

Flooring had damage visible at the time of the inspection. Evaluation by a qualified flooring contractor is recommended.

Recommendation: Contact a qualified professional.

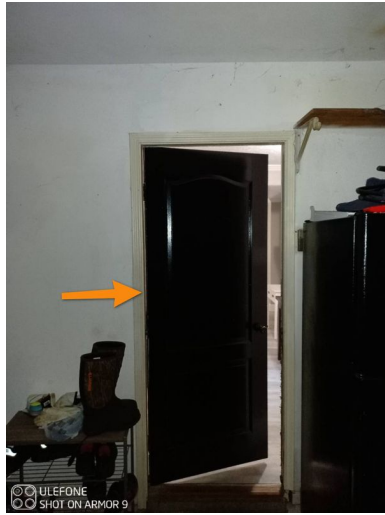
3: Garage Door into Living Space: Self-Closing Mechanism Not Present/Operative

Entry door between the garage and living space should have a functioning self-closing mechanism. Evaluation and remediation is recommended.

Recommendation: Contact a qualified professional.

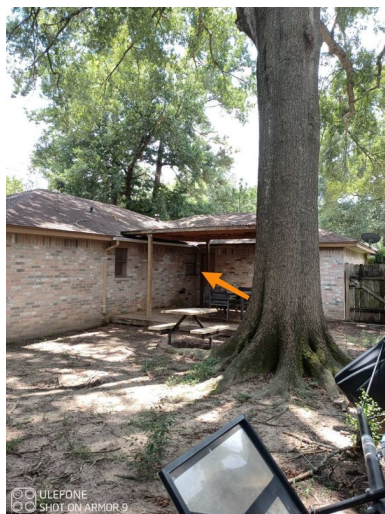
Rear Exterior

2: Windows: Cracked/Broken Glass Panes

Cracked or broken glass panes were present. Evaluation and remediation is recommended.

Recommendation: Contact a qualified window repair/installation contractor.

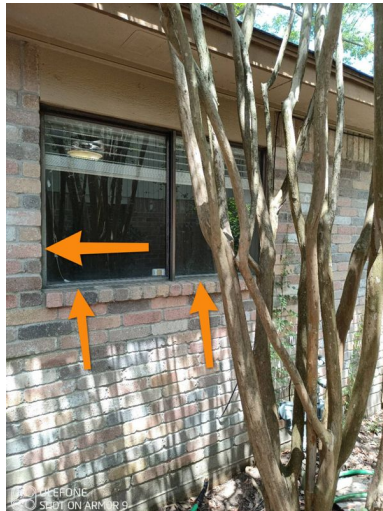
Right Exterior

Caulking around window frames was missing or deteriorated. Most sealants have a lifespan of 5 to 8 years and should be regularly maintained with that lifespan in mind. Evaluation and remediation is recommended.

Recommendation: Contact a qualified professional.

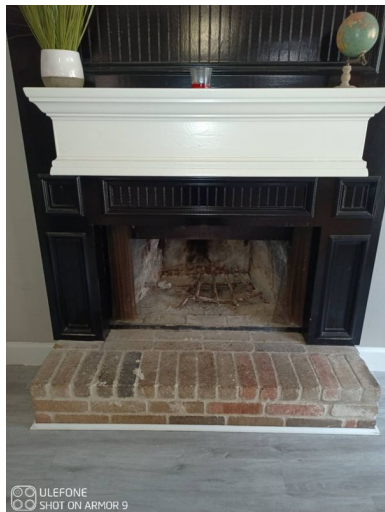
2: Fireplace: Inoperative

The fireplace would not light. Evaluation and remediation is recommended.

Recommendation: Contact a qualified fireplace contractor.

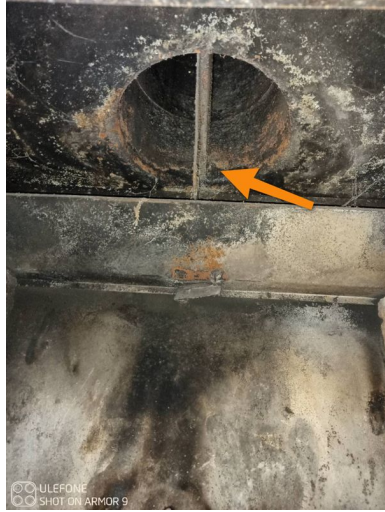
3: Damper: No Clip

No apparent safety clip on the damper. Typically when gas logs are present, a safety clip must be installed on the damper to keep it from closing fully. Evaluation and remediation is recommended.

Recommendation: Contact a qualified professional.

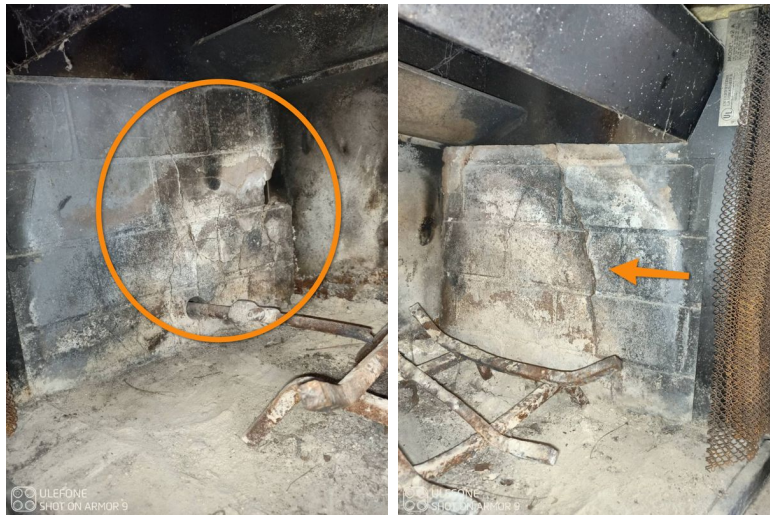
4: Firebox: Firewall Cracked/Deteriorated

The brick lining of the fireplace was cracked or deteriorated in one or more places. This could lead to chimney damage or toxic fumes entering the home. Evaluation and/or repair by a qualified fireplace contractor is recommended.

Recommendation: Contact a qualified fireplace contractor.
