K. Porches, Balconies, Decks, and Carports

II. ELECTRICAL SYSTEMS

III. HEATING, VENTILATION AND AIR CONDITIONING SYSTEMS

IV. PLUMBING SYSTEMS

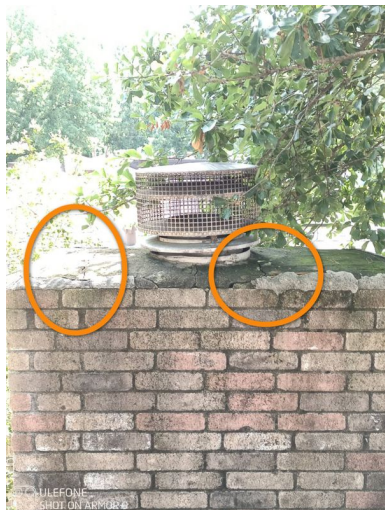
Masonry at the chimney cap was cracked, damaged, and/or deteriorated. This may allow for moisture penetration. Evaluation and remediation is recommended.

Recommendation: Contact a qualified professional.

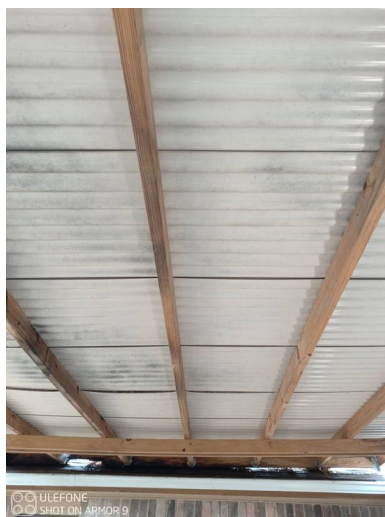
Patio/Roof Attachment:

Unable to determine the attachment means of the patio/roof to the structure. Proper installation methods of the patio roof and its integrity are not covered under the scope of this inspection.

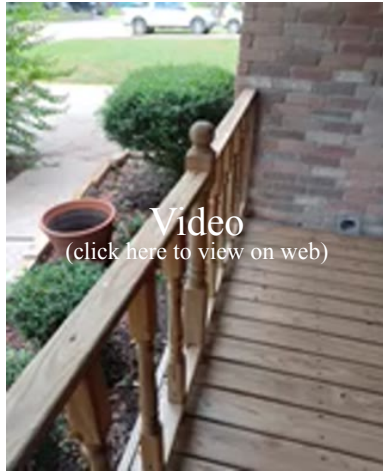
1: Handrails/Guardrails: Inadequate

Loose -

All decks 30 inches or higher above grade require a handrail/guardrail that:

- is at least 36 inches in height from the deck surface
- is not climbable

- has spindle gaps that are no greater than 4 inches

Recommendation: Contact a qualified professional.

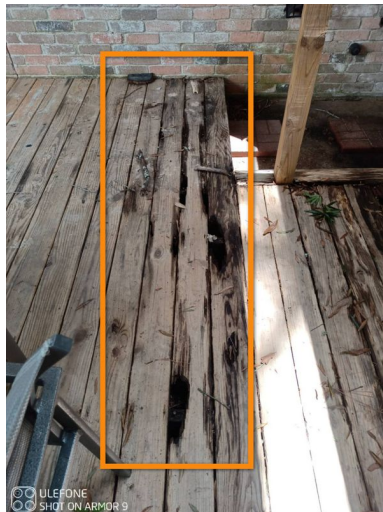
2: Components Loose/Rotted/Damaged

One or more components of the deck/structure were loose, rotted or damaged. Evaluation and/or repair by a qualified contractor is recommended.

Rotted

Recommendation: Contact a qualified professional.

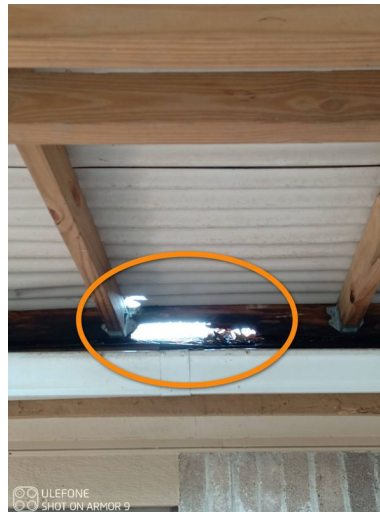
Rotted

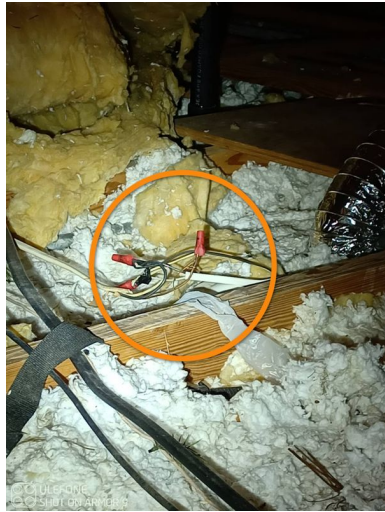
2: Wiring: Exposed Ends & Splices

Attic

Exposed wire connections, splices, and ends were present. All wire connections and charged wires with exposed ends and splices should be covered in junction boxes for safety. Evaluation and remediation by a

licensed electrician is recommended.

Recommendation: Contact a qualified electrical contractor.

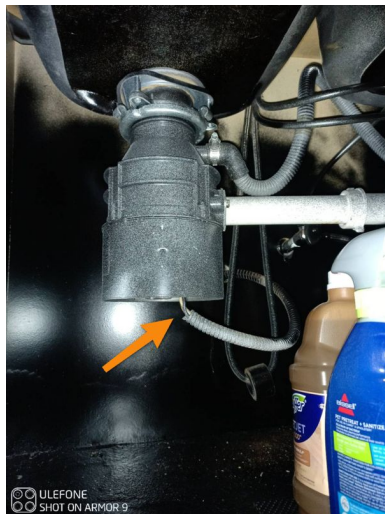
3: Wiring: Gaps in Conduit

Kitchen

There were gaps in conduit. Evaluation and remediation is recommended.

Recommendation: Contact a qualified electrical contractor.

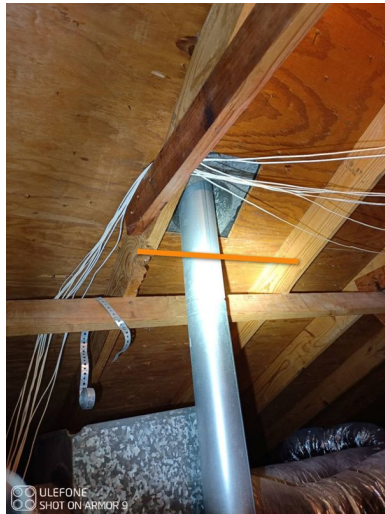
1: Venting: Defects Present

Furnace venting had one or more defects at the time of the inspection. Examples include, but are not limited to:

- Support strapping was not installed
- Single wall vent pipe
- Metal piercing screws installed in vent pipe
- Collar was missing/loose where the flue passes through the ceiling

Missing vent strap

Evaluation and remediation is recommended.

Recommendation: Contact a qualified HVAC professional.

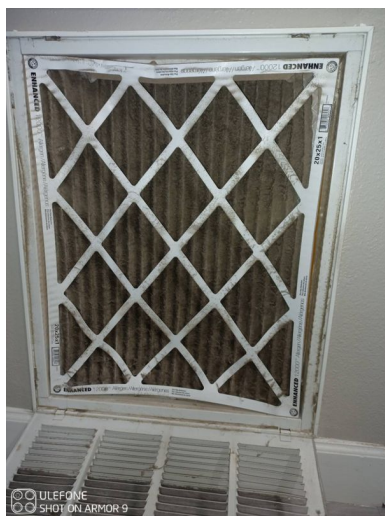
1: Filters: Require Replacement or Missing

The furnace filters may have been beyond their expected lifespan or were missing. In addition, inspector cannot determine what effect this has on the temperature readings. Replacement is recommended.

Recommendation: Recommended DIY Project

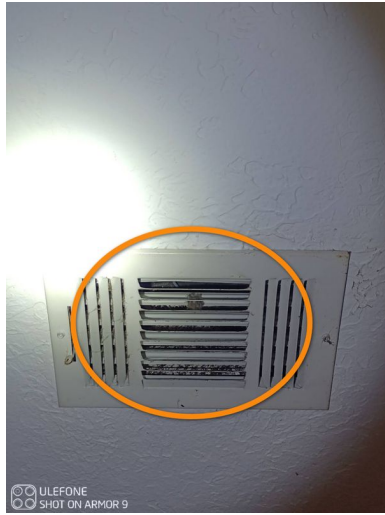
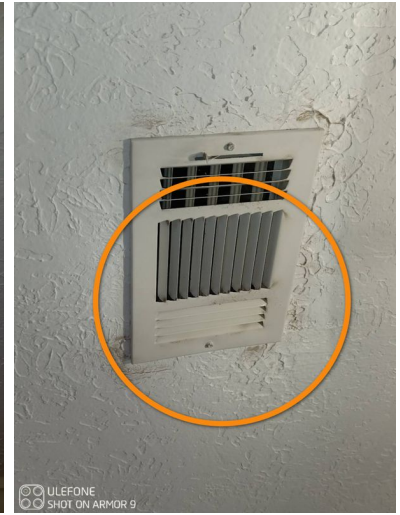
2: Registers: Visible Substance Observed

Multiple Locations

A dark substance was observed on air supply registers in the home. Servicing and cleaning of the system by a qualified HVAC contractor is recommended, as this can be a result of excessive water vapor/humidity in the conditioned air.

Kitchen

Breakfast Area

Living Room

Recommendation: Contact a qualified HVAC professional.

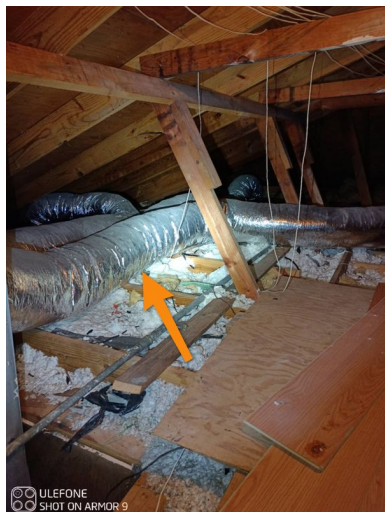
5: Ducts: Defects Present

The HVAC ducts had one or more defects present at the time of the inspection. Examples include, but are not limited to:

- Sections of ducting were resting on the attic floor
- Ducts were in contact with each other
- Non-approved duct tape has been used on sections of ducting
- Ducts were pinched/restricted, leaking or damaged
- Insulation was loose, missing or damaged on various pieces of ducting

Ducks resting on attic floor

Evaluation and remediation is recommended.

Recommendation: Contact a qualified HVAC professional.

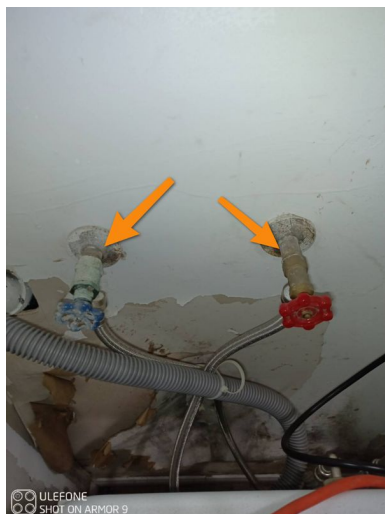
1: Supply Piping: Corrosion on Galvanized Pipes

Multiple Locations

Galvanized water supply piping was corroded. The extent of rusting on the piping is not determined.

Laundry Area

Kitchen

Attic

Evaluation and/or remediation by a licensed plumber is recommended.

Recommendation: Contact a qualified plumbing contractor.

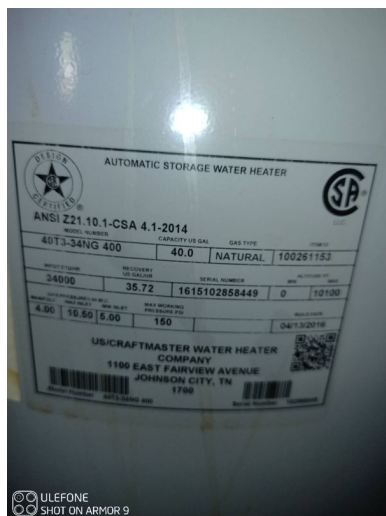
Energy Source: Natural Gas

Capacity: 40 Gallons

Location: Garage

Year of Manufacture: 2016

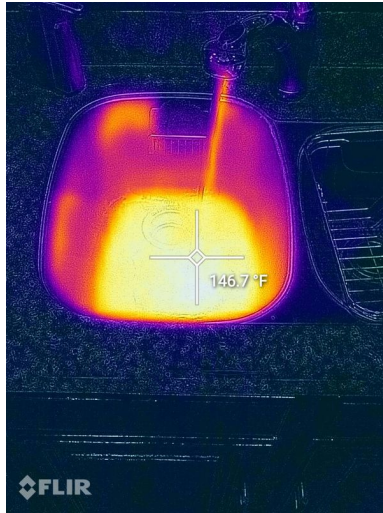
2: Hot Water Temperature Exceeds 140 Degrees F

The hot water temperature was measured and exceeds 140 degrees F, which can cause burns from scalding in a very short time. Refer to the Operating Instructions in the manual for this specific unit for detailed instructions on setting the proper water temperature for your needs. Contact a licensed plumber for further information.

Recommendation: Contact a qualified plumbing contractor.

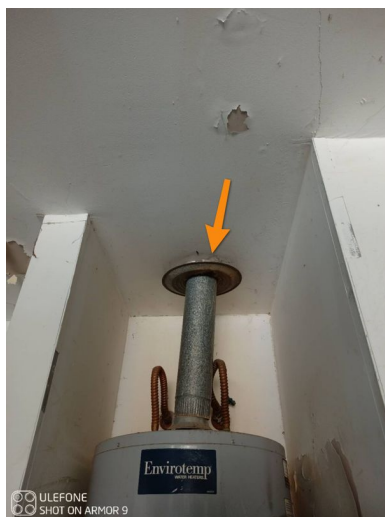
5: Venting System: Defects Present

The water heater venting system had defects present at the time of the inspection. Examples include, but are not limited to:

- Combustion vent pipe was not properly supported/secured with strapping
- Collar was missing/loose where the flue passes through the ceiling
- Metal piercing screws are installed in the water heater vent pipe
- A single wall vent pipe was in use

Loose Callor

Evaluation and remediation is recommended.

Recommendation: Contact a qualified plumbing contractor.

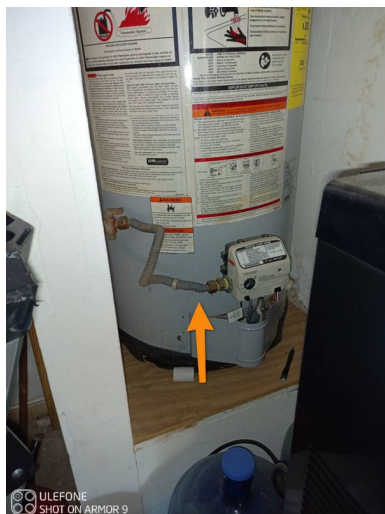
1: Missing/Improper Sediment Traps (Drip Legs)

Water Heater

Sediment traps are installed to help prevent sediment in the gas piping from getting into the gas valve or burner area of an appliance and causing problems. Evaluation and remediation is recommended.

Recommendation: Contact a qualified plumbing contractor.

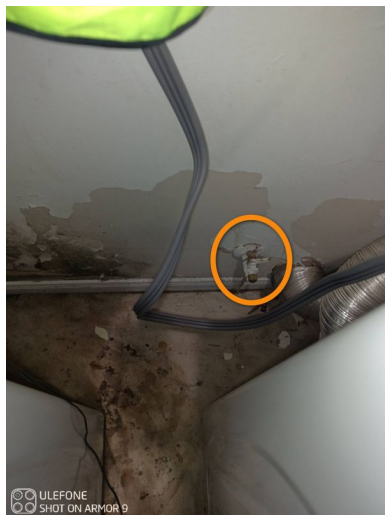
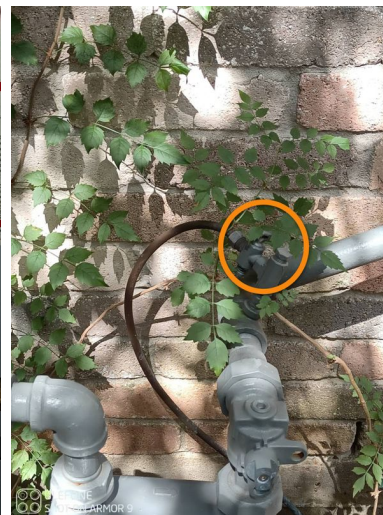
2: Gas Piping: Old Style Valves

Multiple Locations

Older style valves were installed at gas lines. This type of connection is considered beyond its service life. Evaluation and remediation is recommended.

Laundry Area

Water Heater

Recommendation: Contact a qualified plumbing contractor.

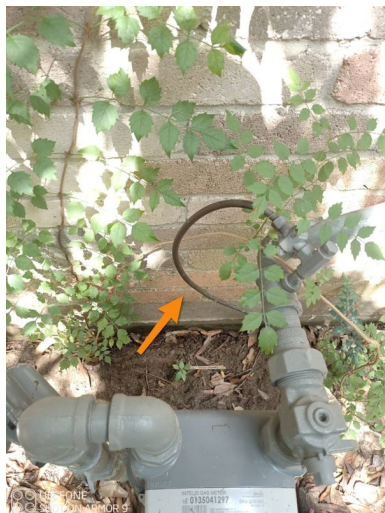
3: Gas Piping: Copper Tubing Present

Current building standards prohibit the use of copper tubing for natural gas lines. Chemical additives in natural gas can deteriorate copper tubing over time. Evaluation and remediation is recommended.

Right Exterior

Recommendation: Contact a qualified plumbing contractor.

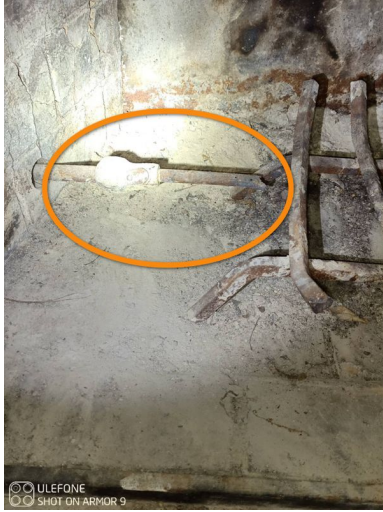
4: Gas Piping: Corroded Lines

Fireplace

The gas service lines were corroded. Evaluation and remediation is recommended.

Recommendation: Contact a qualified plumbing contractor.

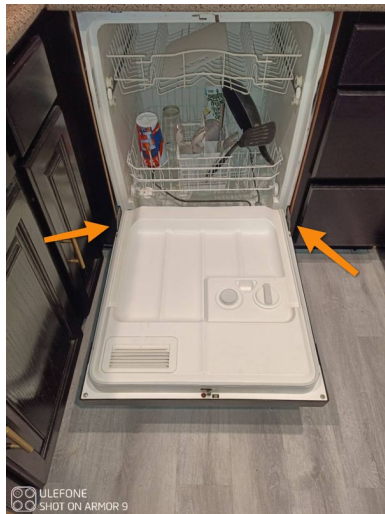
1: Door: Defects Present

The door appeared to be broken/damaged, and was not operating properly. Evaluation and remediation is recommended.

Door Springs Damaged

Recommendation: Contact a qualified professional.

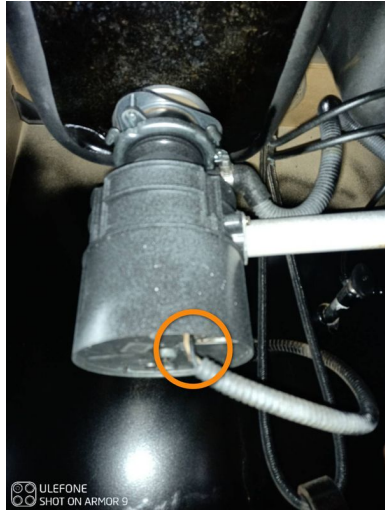
1: Wire Clamp Not Installed

No wire clamp had been installed at the base of the unit. Evaluation and remediation is recommended.

Recommendation: Contact a qualified professional.

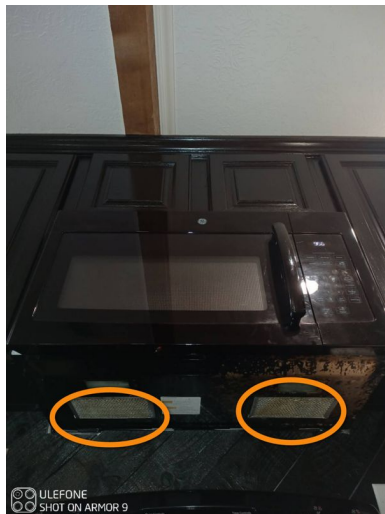
1: Filter: Greasy or Missing

Kitchen exhaust filter had excessive grease build-up or was missing. Clean and/or replace as needed.

Recommendation: Contact a qualified professional.

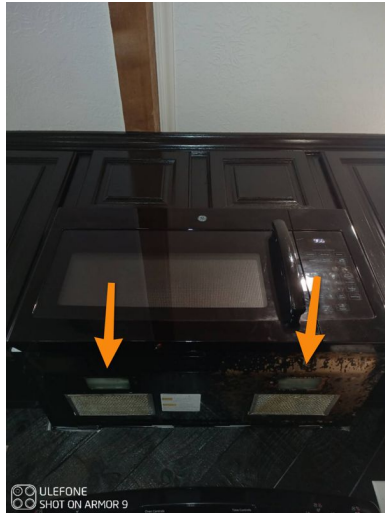
2: Exhaust Light: Inoperative or Missing Cover

The light did not function at the kitchen exhaust or it was missing a cover. Evaluation and remediation is recommended.

Inoperative

Recommendation: Contact a qualified professional.

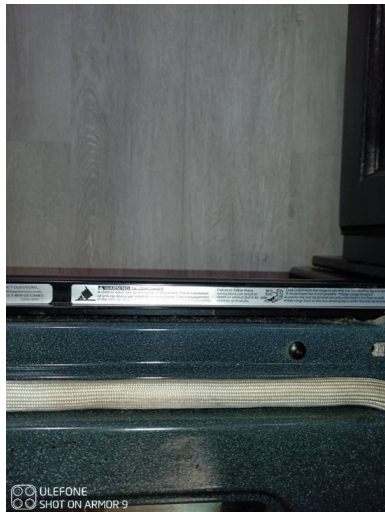
1: Missing Anti-Tip Device

There was no anti-tipping device installed on the oven/range to prevent tipping if the door is climbed on while opened. This is a possible safety hazard. Evaluation and remediation is recommended.

Recommendation: Contact a qualified professional.

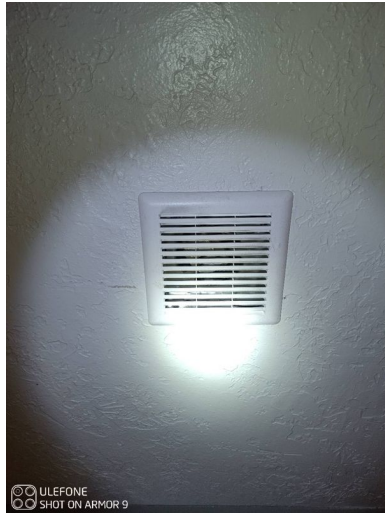
1: Dirty/Loose Vent Covers

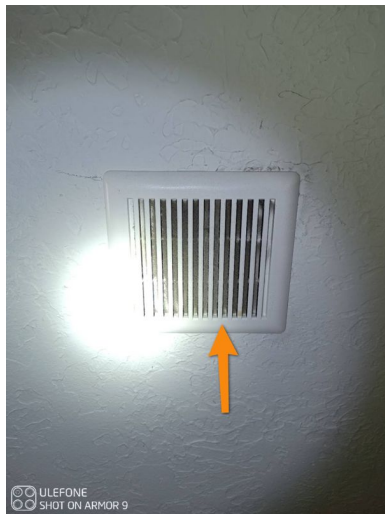
Cleaning or resealing of the exhaust vent cover is needed to ensure proper air flow. Evaluation and remediation is recommended.

Dirty

Recommendation: Contact a qualified professional.

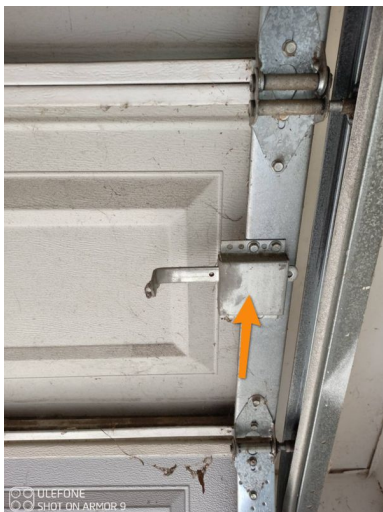
1: Locks Installed/Not Disabled with Door Openers

A secondary locking mechanism was installed. Secondary locking mechanisms should be removed or disabled to prevent damage to the door and/or opener. Evaluation and remediation is recommended.

Recommendation: Contact a qualified professional.

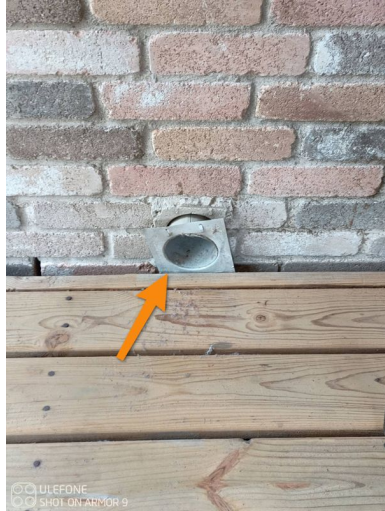
2: Vent Cover Missing/Damaged/Loose

The dryer exhaust vent cover was missing, damaged or loose. Evaluation and remediation is recommended.

Missing

Recommendation: Contact a qualified professional.
