# JP's Real Estate Inspections

## LICENSED PROFESSIONAL INSPECTOR'S CERTIFIED REPORT

**Additional Comments:** The property is a New Construction Two-Story single-family dwelling, built in 2020 on a Slab on Grade Foundation with Brick/Stucco Veneer, Hardi Plank with trim, and composition shingle roof. The house has 4,365 Square feet of Total Living room Living Space with five bedrooms, four full and a half bathroom with a two car attached garage. The house was vacant during the time of Inspection. The Buying

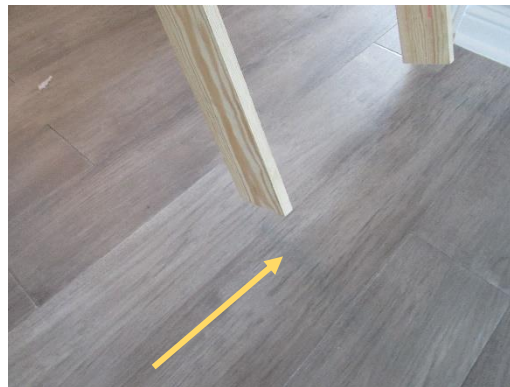
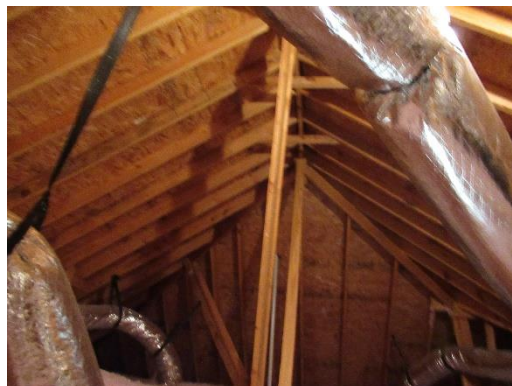
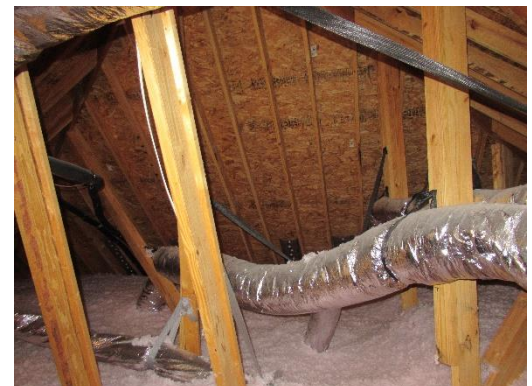
Inspectors' Closing Comment: Appeared to be in good condition during the time of inspection. I recommend the pull-down ladder to be professional installed inside the attic because the stairs are not reaching the floor.

- 1. I recommend the pull-down ladder to be professional installed inside the attic because the stairs are not reaching the floor.**
- 2. The open penetration on the side of the house where the gas meter is located needs to be filled with brick mortar to prevent critters from entering between the walls.**

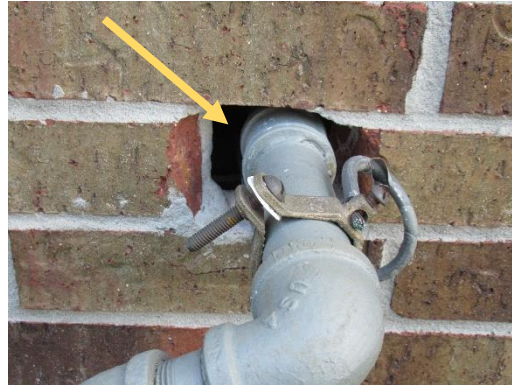
Inspectors' Closing Comment: Appeared to be in good condition during the time of inspection. The open penetration on the side of the house where the gas meter is located needs to be filled with brick mortar to prevent critters from entering between the walls.

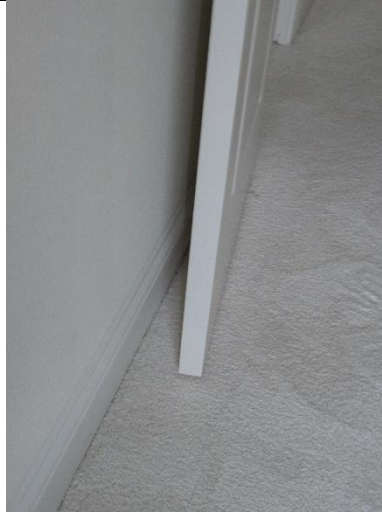
Inspectors' Closing Comment: Appeared to be in good condition during the time of inspection. There are several doors throughout the house need door stops installed behind them because there are none present.

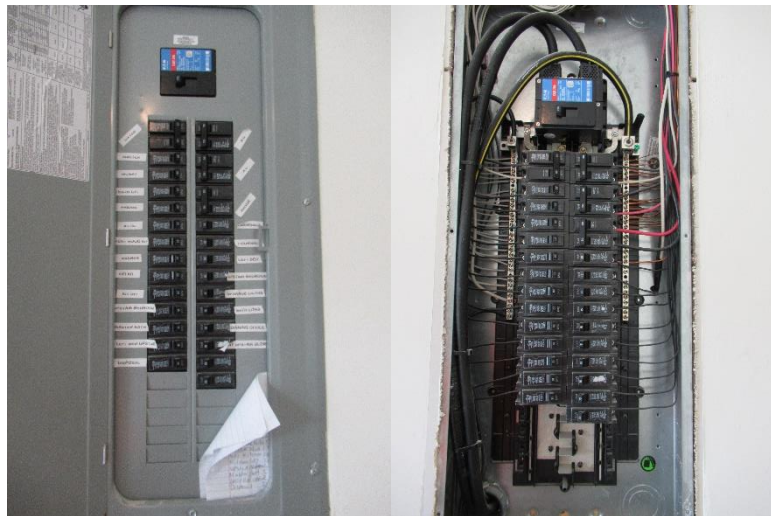
Wire Type: Aluminum (Yes)    Copper (        )

**Deficiencies Found:** If this home has aluminum wiring present for all the branch circuits. There did not appear to be any upgrades to the connection with approve co-lar components, pig tailing or antioxidant present. There is some controversy regarding aluminum wiring as to insurability and safe operations. Recommend having the electrical outlets and switches further evaluated by a licensed electrician.

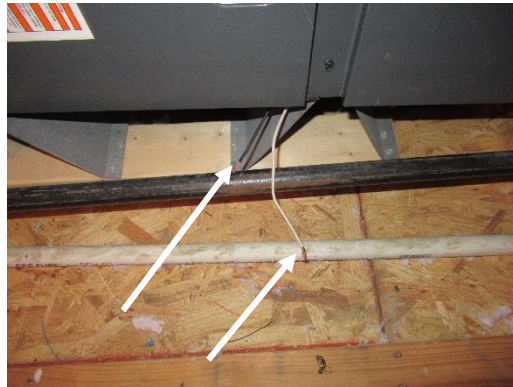
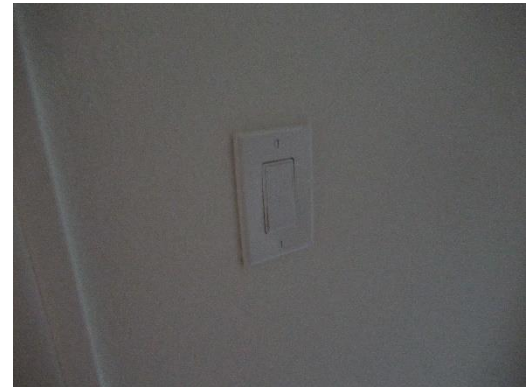
Inspectors’ Closing Comment: The GFCI outlets need to be properly installed in all wet locations such as inside bathrooms, the front and rear porch and inside the garage because there are not working while using the tester. The 3-way switch inside the laundry room needs to be wired properly because the light it is not working properly. The furnace needs to be electrically connected because the wires are exposed inside the attic. The cord on the disposal underneath the kitchen cabinet is too long and it needs to be at least 3 feet long. The ceiling fan in the study needs to be properly hung because it knocks while in the on position. There needs to be a GFCI outlet installed in the area of the jacuzzi bathtub because there is not one present during the time of construction.

3-Way Switch inside the laundry room

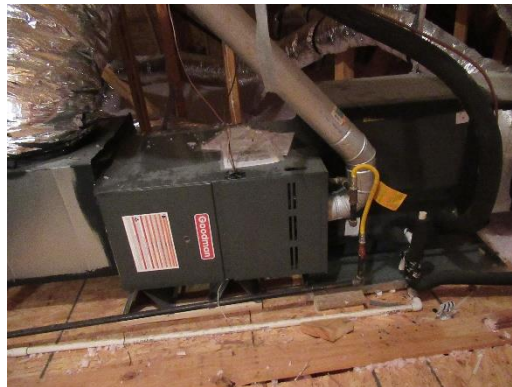
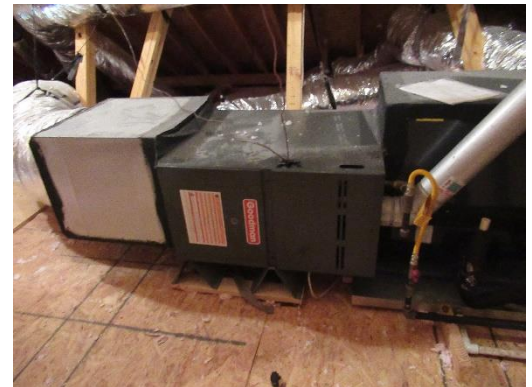
Inspectors' Closing Comment: The complete HVAC System needs to be checked by a professional company because it appears to not be properly installed. The compressor is not turning on the ac unit on the left and the thermostat was not on the unit downstairs which gives an indication it is not working.

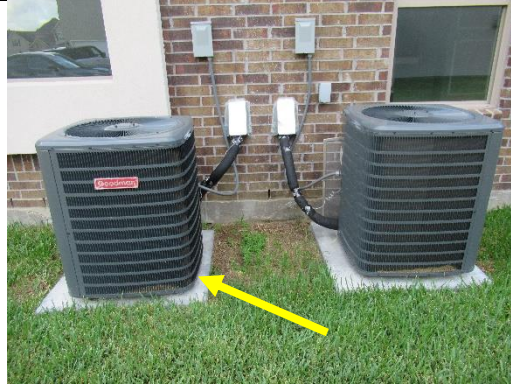
Inspectors' Closing Comment: The complete HVAC System needs to be checked by a professional company because it appears to not be properly installed. The compressor is not turning on the ac unit on the left and the thermostat was not on the unit downstairs which gives an indication it is not working.

The compressor is not working on the ac unit on the left

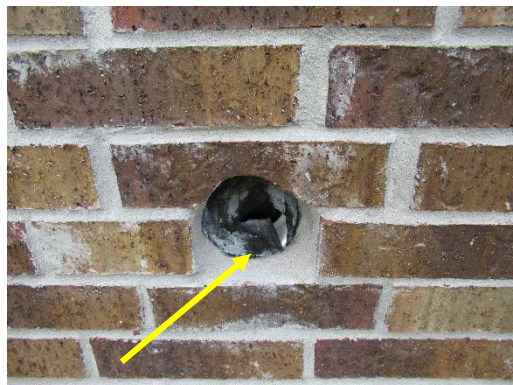
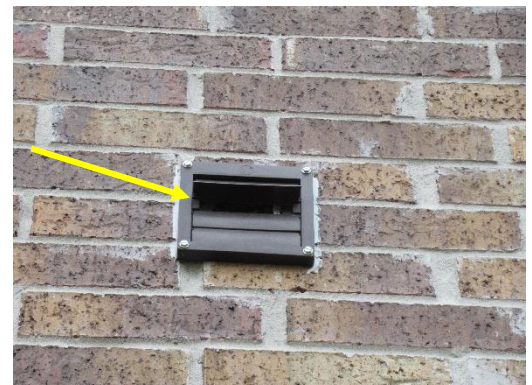
Inspectors' Closing Comment: Appeared to be in good condition during the time of inspection, but the clean out drain cover on the exterior side of the house needs to be replaced because it is broken. The louver on the exterior side of the house needs to be closed to prevent a bird from building a nest inside of the exhaust vent pipe.

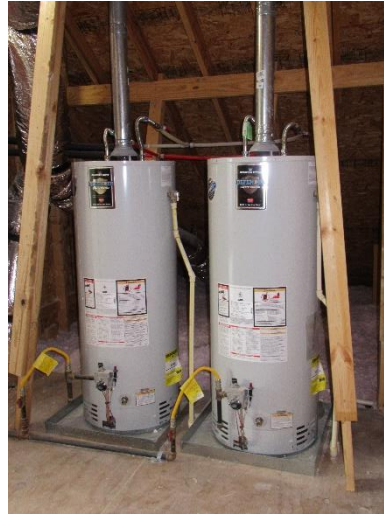
C. Water Heating Equipment (report as in need of repair those conditions specifically listed as recognized hazards by TREC rules).  
*Comments:* Energy Source: Gas  
 Water Brand Name: Bradford White Location: Inside the attic  
 Gallons: 50 each  
 MFG Date Was:

Inspectors' Closing Comment: Appeared to be functioning as intended during the time of inspection.

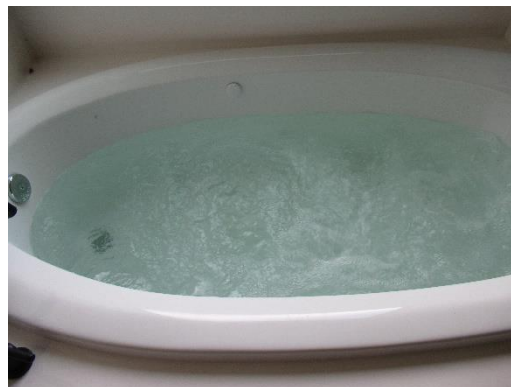
B. Hydro-Massage Therapy Equipment  
*Comments:* Access panel to motor is accessible: No  
 Ground Fault Circuit Interrupter present: No

Inspectors' Closing Comment: Appeared to be functioning as intended during the time of inspection.

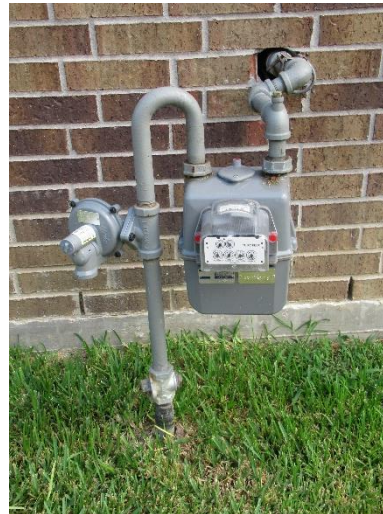
V. Gas Distribution Systems and Gas Appliances  
**Location of gas Meter:** On the side of the house  
**Type of distribution piping material:** Galvanize

Inspectors' Closing Comment: Appeared to be functioning as intended during the time of inspection.
