1907 Foxtail Creek Ct  
Crosby, TX 77532

Inspection Date:  
10/04/2023

# PROPERTY INSPECTION REPORT FORM

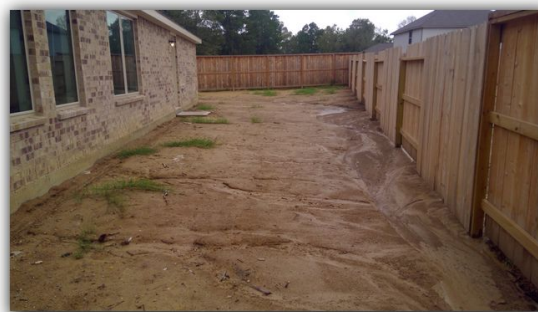
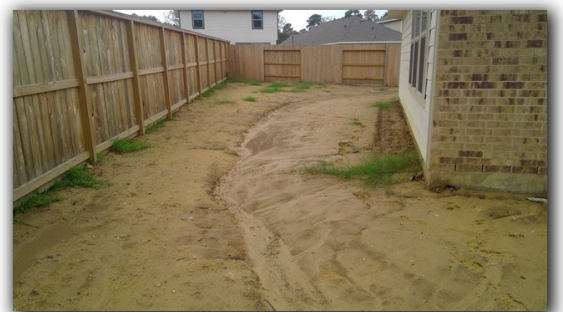
Not completed yet as shown.

Recommend monitoring during the next rainstorm. If standing water is noted 48 hours after the rain has stopped improvements may be necessary.

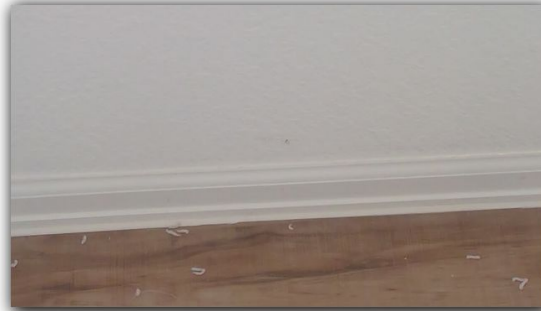
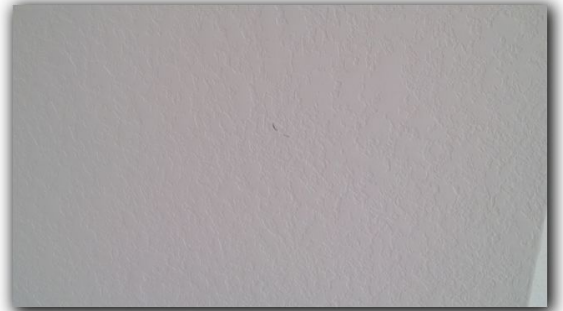
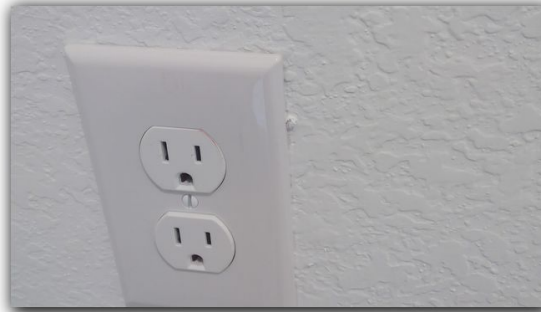
Minor cosmetic issues, typical of a house at this stage of construction.

Note: Pictures are representative, not exhaustive. This is an indication of what to look for during the blue tape walkthrough.

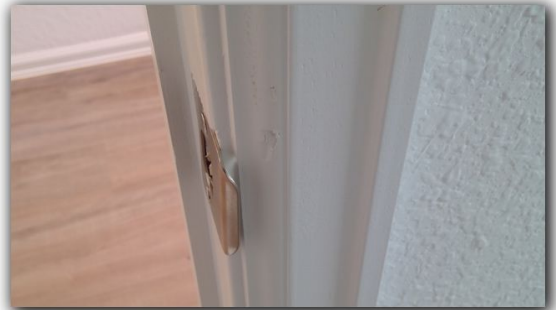
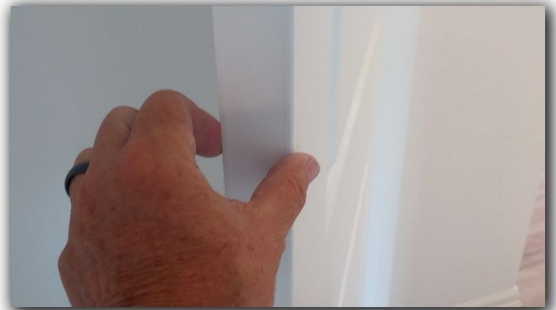
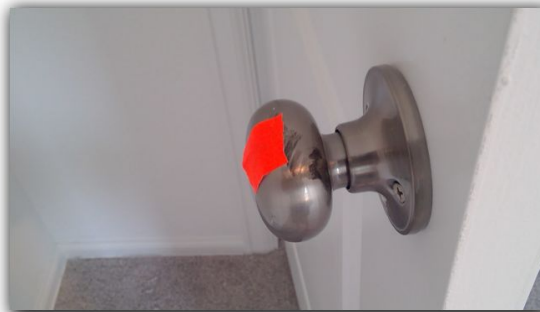
Minor cosmetic issues, typical of a house at this stage of construction.

Note: Pictures are representative, not exhaustive. This is an indication of what to look for during the blue tape walkthrough.

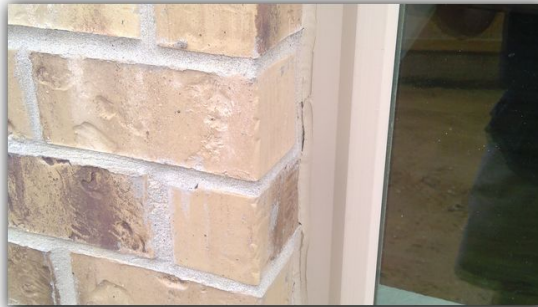
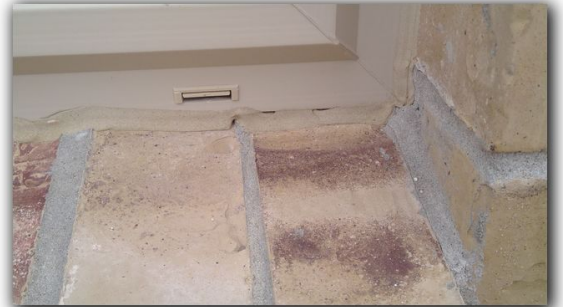
Minor caulking issues, typical of a house at this stage of construction.

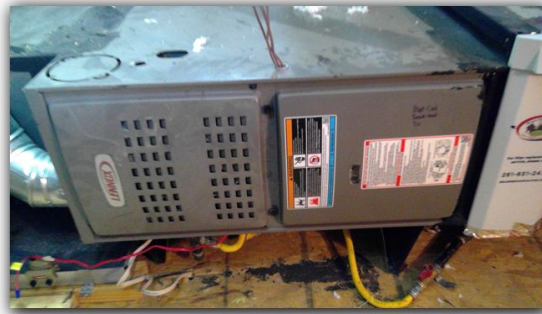
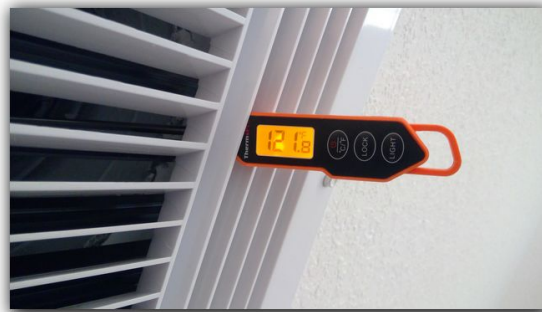
- Unit #1:  
Supply Air Temp: 122 °F

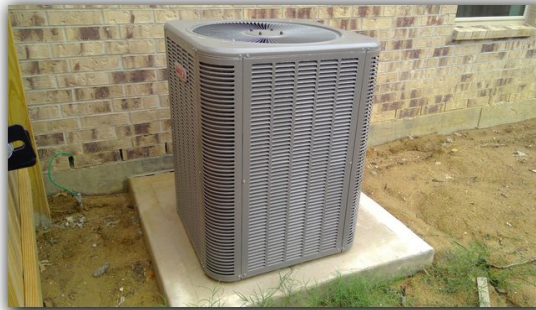
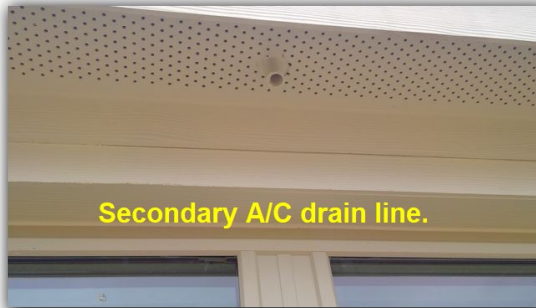
Monitor the secondary A/C drain line, shown below. If water is seen dripping a licensed HVAC tech should be asked to evaluate, the primary drain is likely blocked.

Unit #1:  
 Supply Air Temp: 60 °F    Return Air Temp: 78 °F    Temp. Differential: 18 °F

1 cup of bleach should be poured down the primary A/C drain line every 3-4 months to prevent blockage.

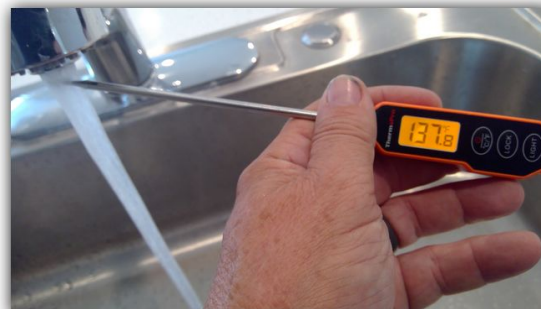
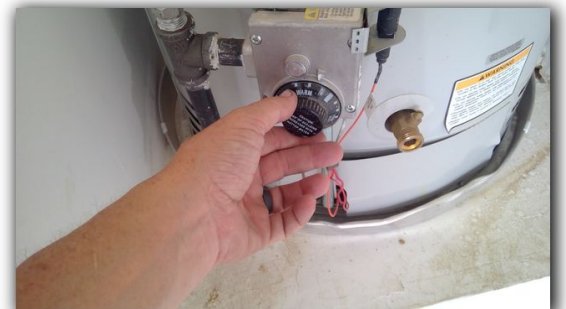
Water temperature: 138°F (Maximum recommended temp is 120°F.) This is considered as safety hazard, particularly with young children. Recommend adjustment.

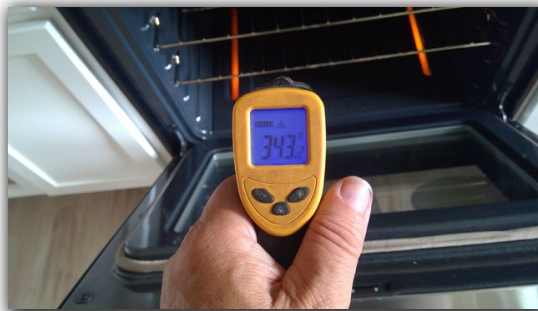
Set to 350°F    Temperature reading: 343 °F
