EXHIBIT A

15714 Craighurst Dr
03/26/2024 12:52 pm

All repairs by sellers are to be completed by qualified professionals prior to buyers' final walk through. Receipts and any applicable warranties will be paid by sellers and provided to buyers prior to closing. Professional quotes attached to Exhibit A were provided by Bosscat Home Services.

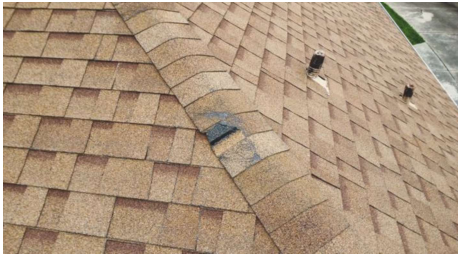
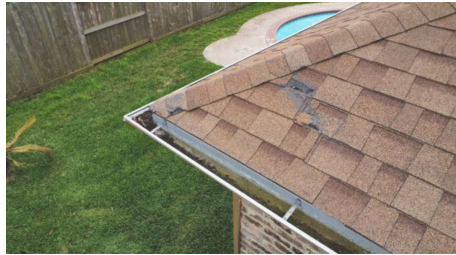
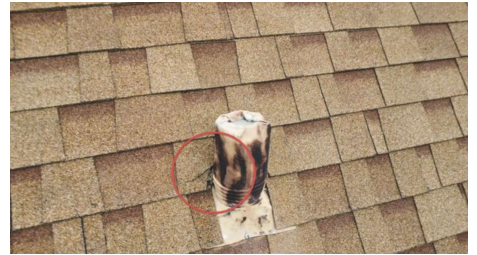
2.3.1 - I. Structural Systems: C. Roof Covering Materials SHINGLES: DAMAGED/MISSING

Damaged/missing shingles were observed to the roof covering at the time of the inspection. These conditions can compromise the integrity of the roof covering. Recommend contacting a professional roofing contractor to evaluate and determine the extent of the repairs needed.

Place/replace damaged/missing shingles at roof to prevent leaks.

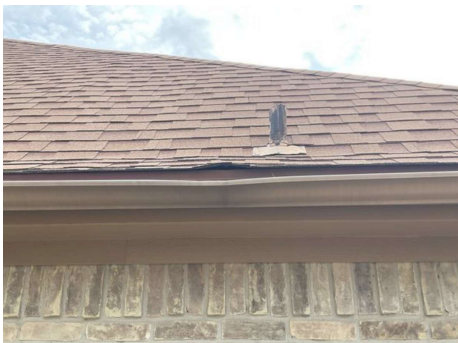
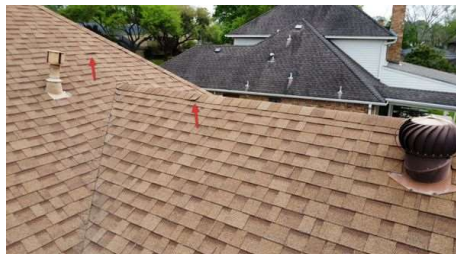
Right

2.3.2 - I. Structural Systems: C. Roof Covering Materials SHINGLES: LIFTING/LOOSE

Multiple shingles were observed to not be properly secured. This could cause lifting of the shingle in the case of high winds or possible moisture intrusion. Recommend contacting a professional roofer to evaluate and determine the extent of repairs needed.

Repair/replace lifting/loose shingles at roof to prevent leaks.

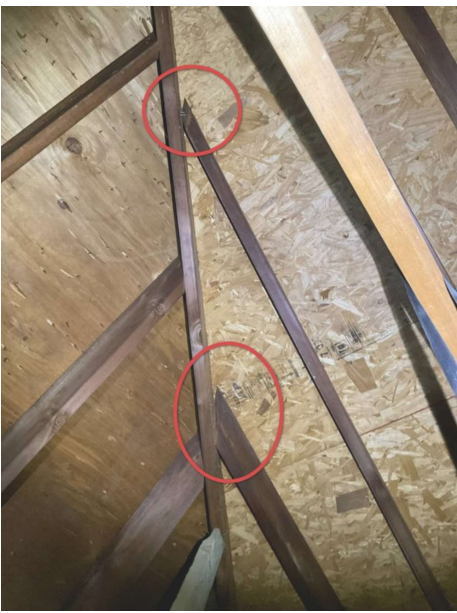
Right attic

2.4.1 - I. Structural Systems: D. Roof Structures and Attics ATTIC: SEPERATION OF HIP AND JACK RAFTERS

Separation has occurred between the hip and jack rafters to some degree and there were also some poorly cut mitres present. Repairs are recommended to be performed by a qualified contractor to ensure no further movement occurs at these rafter to ridge board connections and/or to correct (bring into original position) as needed.

Repair separation of hip and jack rafters at attic to prevent structural issues.

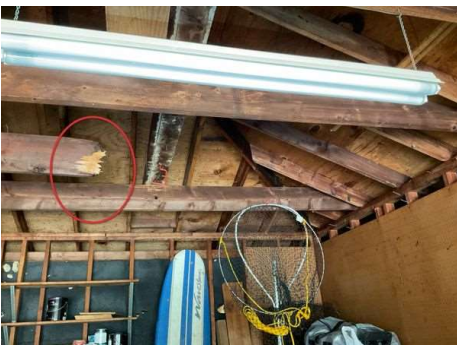
Garage

ATTIC: DAMAGED JOIST

The garage ceiling joist exhibits severe damage and significant cracking, compromising its structural integrity and safety. Recommend contacting a qualified contractor to evaluate and determine the extent of repairs needed.

Repair damaged ceiling joist at garage attic to prevent structural issues.

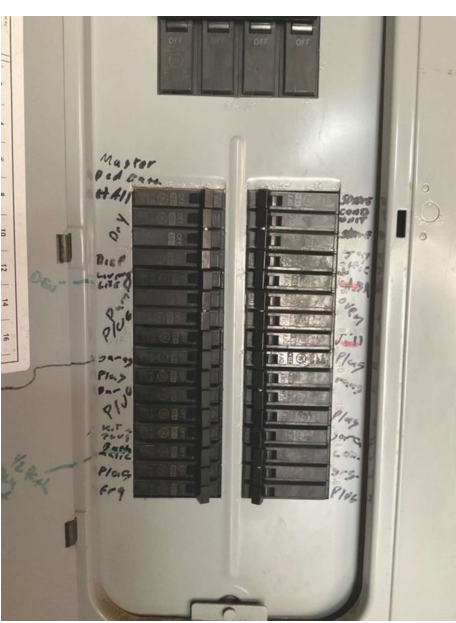
ELECTRICAL PANEL: AFCI BREAKERS

Arc-fault safety protection was not installed for all currently required 15 and 20 amp circuits. AFCI protection is required on all 15-20 amp circuit breakers. Recommend contacting a licensed electrician to satisfy modern code requirements.

Install arc-fault safety protection at electrical panel as noted to satisfy code requirements.

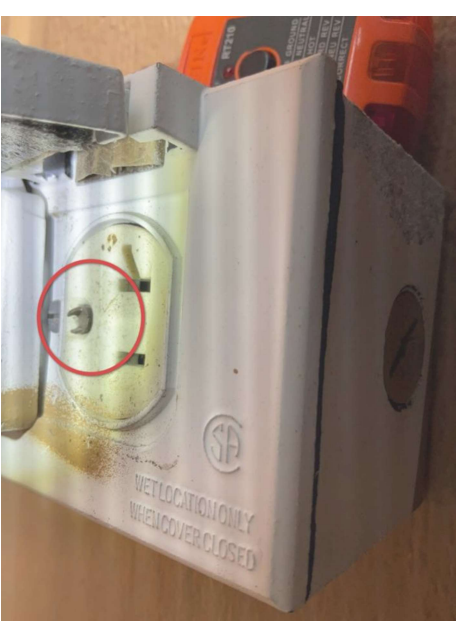
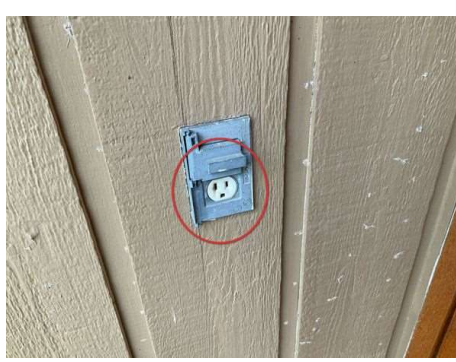
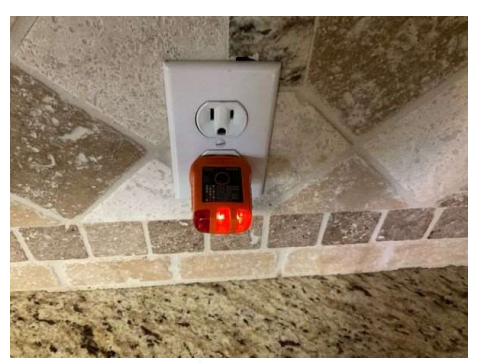
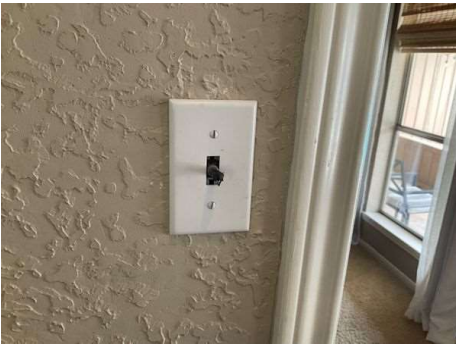
3.2.1 - II. Electrical Systems: B. Branch Circuits, Connected Devices, and Fixtures
ELECTRICAL FIXTURES: MULTIPLE ISSUES

No GFCI protection in required areas, No power to outlets, Objects lodged in outlet, Damaged exterior weathercover, Damaged light switch

Multiple issues were observed to the electrical fixtures at the time of the inspection. Recommend contacting a licensed electrician to evaluate and determine the extent of repairs needed.

- 1) Add GFCI protection to required areas.
- 2) Ensure proper function at all outlets.
- 3) Repair or replace outlets containing lodged items.
- 4) Replace damaged exterior weather-cover and light switch.

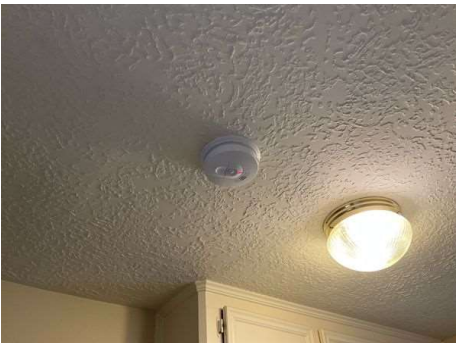
3.2.2 - II. Electrical Systems: B. Branch Circuits, Connected Devices, and Fixtures
SMOKE DETECTORS: NOT INTERCONNECTED

When the smoke alarms were tested, only the unit being tested would sound. When one smoke alarm is tested they should be interconnected in a manner that will set them all off. Recommend further evaluation for safety purposes.

For safety purposes, ensure that smoke detectors are interconnected as noted.

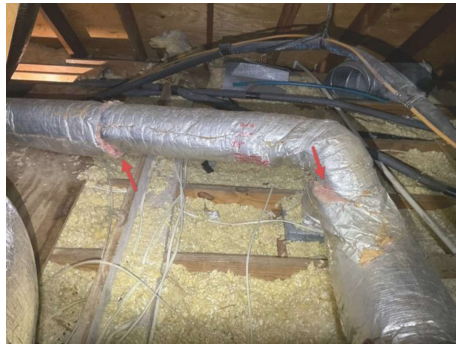
4.3.2 - III. Heating, Ventilation and Air Conditioning Systems: C. Duct Systems, Chases, and Vents
DUCTS: MULTIPLE DAMAGED DUCTS

During the home inspection, damaged air ducts were observed in the heating and cooling system. The ducts appeared to be damaged/deteriorated in several locations, which could cause a loss of energy efficiency and an increase in utility bills. Additionally, damaged air ducts can allow dust, debris, and other contaminants to enter the home's living spaces, potentially compromising indoor air quality and

causing respiratory issues. Recommend contacting a licensed HVAC technician to evaluate and determine the extent of repairs needed.

Repair/replace damaged or deteriorated ducts as recommended by a qualified professional to prevent contaminants in the home, and/or loss of energy efficiency.

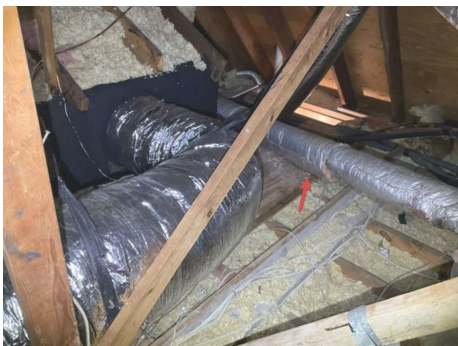
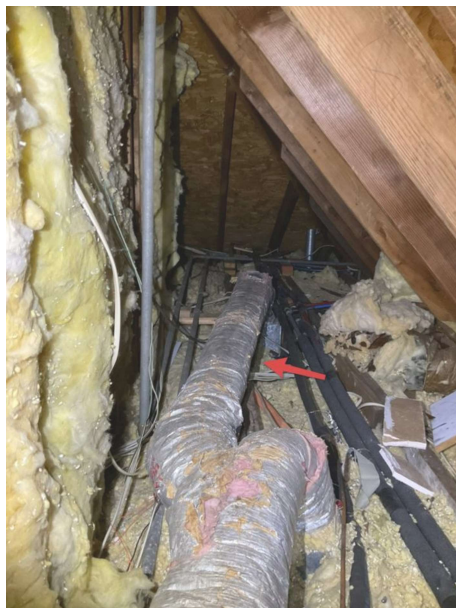
DUCTS: RESTING ON ATTIC FLOOR

Flexible ducts were observed to be resting on the attic floor. All flexible ducts should be hung from the rafters to prevent condensation from forming. Recommend correction to avoid moisture issues.

Correct flexible ducts resting on the attic floor. Ducts should be hung from the rafters as noted to prevent condensation and avoid moisture issues in the home.

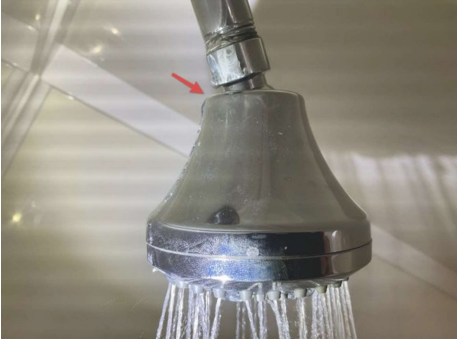
Primary bathroom

SHOWER: LEAK/SPRAYING BEHIND THE SHOWER HEAD

Observed leaking/spraying behind the shower head at the time of the inspection. Recommend contacting a professional plumber to evaluate and determine the extent of repairs needed.

Repair or replace shower head at primary bathroom to correct active leak.

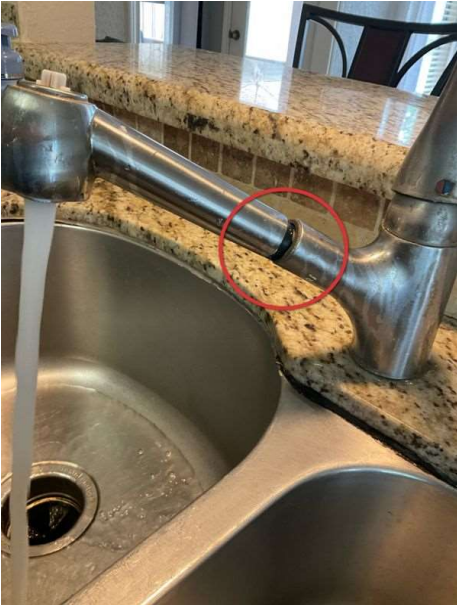
Kitchen

5.1.3 - IV. Plumbing Systems: A. Plumbing Supply, Distribution Systems, and Fixtures
FIXTURES: KITCHEN FAUCET LEAK

The kitchen faucet was observed to be leaking from the stem at the time of the inspection. Recommend further evaluation by a professional plumber.

Repair or replace kitchen faucet to correct active leak.

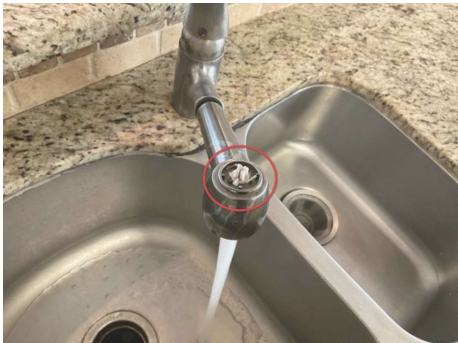
Kitchen

5.1.5 - IV. Plumbing Systems: A. Plumbing Supply, Distribution Systems, and Fixtures
PLUMBING: DAMAGED FAUCET

The kitchen faucet handle nozzle diverter was damaged at the time of the inspection. Recommend contacting a qualified plumber to evaluate and determine the extent of repairs needed.

Repair or replace damaged faucet handle nozzle diverter at kitchen to ensure proper function.

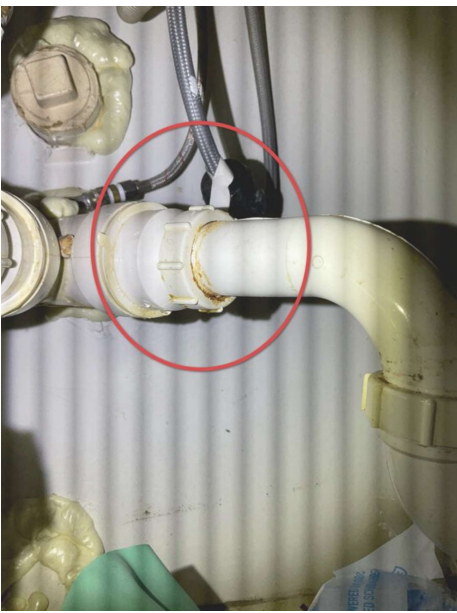
Kitchen

5.2.2 - IV. Plumbing Systems: B. Drains, Wastes, and Vents
DRAINS: ACTIVE LEAK

The inspection revealed a leak in the plumbing drain system. Water was observed dripping from the drain pipe under the kitchen sink. If left unaddressed, this leak can lead to water damage and other related issues. Recommend contacting a licensed plumber to evaluate and determine the extent of repairs needed.

Note: moisture at this drain possibly was caused from the kitchen faucet leak

Qualified professional to repair active leak under kitchen sink.

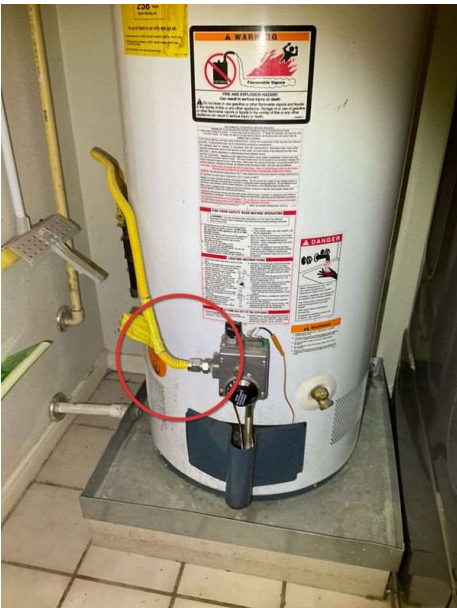
5.4.1 - IV. Plumbing Systems: C. Water Heating Equipment
GAS PIPING: NO SEDIMENT TRAP

The gas line going into an appliance should have a sediment trap(drip leg) so any debris going through the gas line will drop off before entering the appliance. Remedy as needed.

Place missing sediment trap at water heating equipment to prevent debris from entering the appliance.

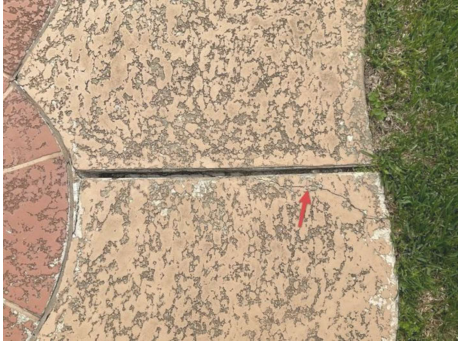
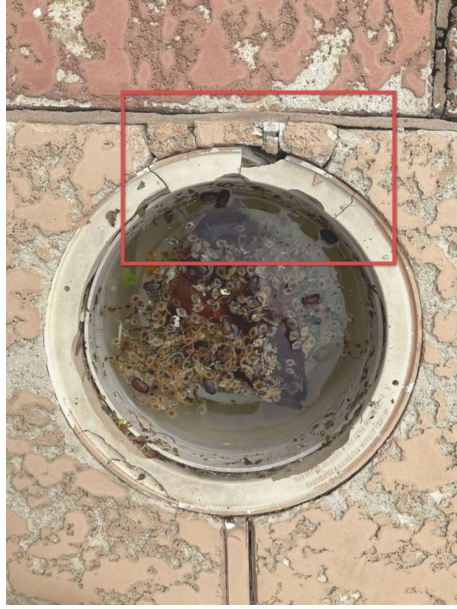
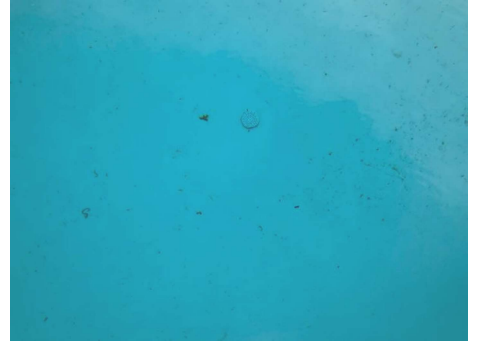
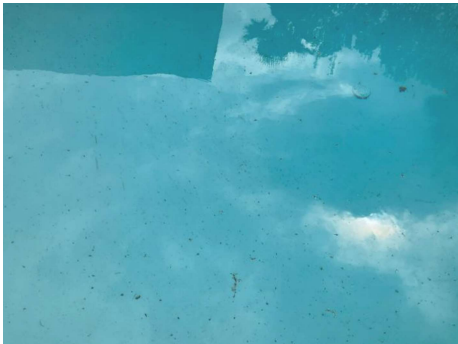
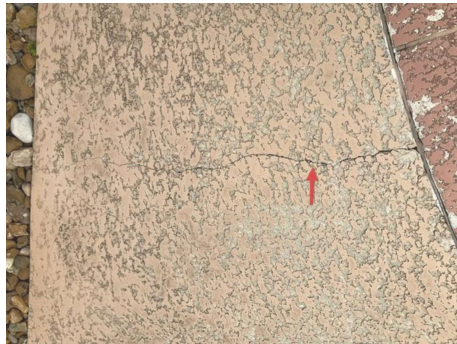
7.1.1 - VI. Optional Systems: B. Swimming Pools, Spas, Hot Tubs, and Equipment
POOL/SPA: MULTIPLE ISSUES

Multiple issues were observed to the pool equipment at the time of the inspection. The issues observed are as follows:

- Low return jet pressure
- Excessive noise from booster pump
- Heaving pool decking
- Debris in pool
- Deteriorated coping sealant

Minor and moderate cracks to decking

Damaged skimmer basket

Inoperable pool light

1) Replace pool pump filters to ensure proper return jet pressure and correct excessive noise from booster pump. Any additional repairs recommended by a qualified professional to correct these items should be completed.

2) Clean all debris from pool and level chemicals as needed prior to buyers' final walk through.

3) Replace damaged skimmer basket.

4) Repair pool light to ensure it is operable.
