Inspection Report

Property Address:
9831 Wright Dr.
Manvel TX 77578

American Dream Inspections TX, llc

PROPERTY INSPECTION REPORT FORM

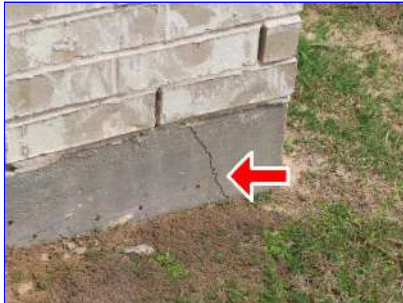
A. Item 1(Picture)

Foundation was operating properly at the time of inspection. All foundation penetrations, gaps and cracks should be sealed properly. Conducive to moisture and insect intrusion.

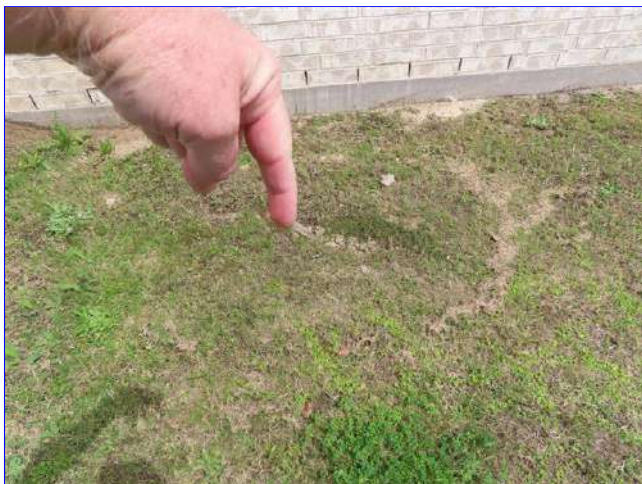
B. Item 1(Picture)

(1) Side yard has soil erosion due to missing gutter at time of inspection. Should have a professional correct properly.

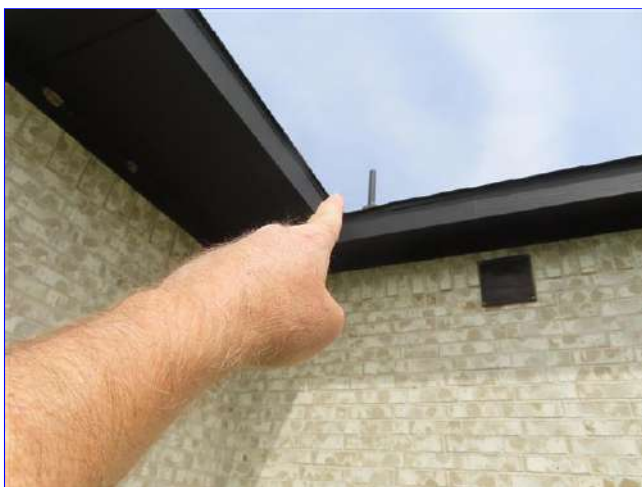
B. Item 2(Picture)

(2) Gutters were missing in several areas of the structure to disperse the water properly away from the foundation and structure at time of inspection. Recommend installing gutters in these areas.

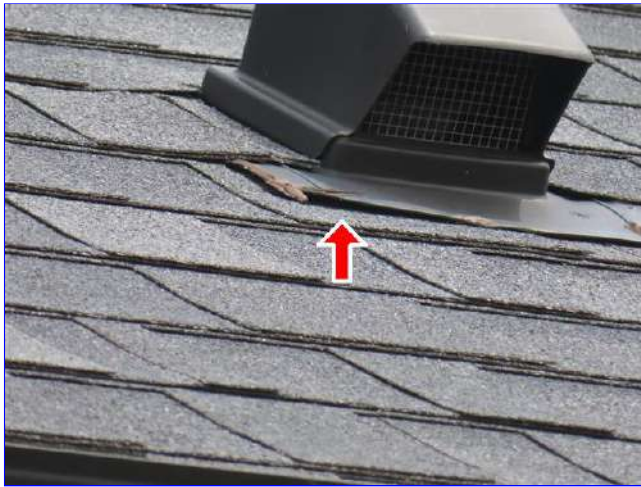
C. Item 1(Picture)

(1) All lifted roof attic vent lifted flashing should be corrected and sealed properly by a professional roofer. Conducive to moisture intrusion and causing possible damage.

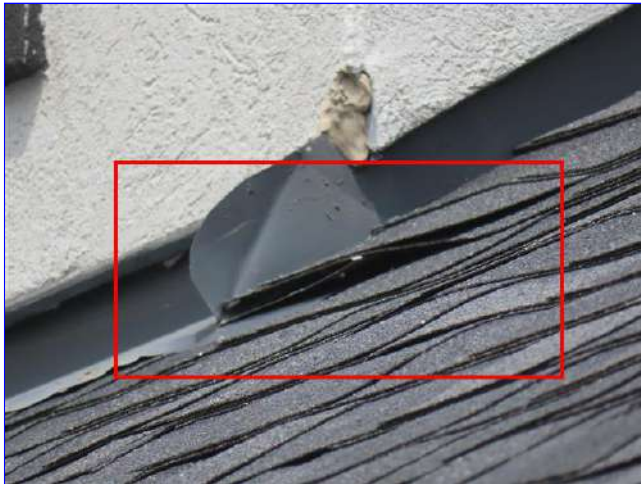
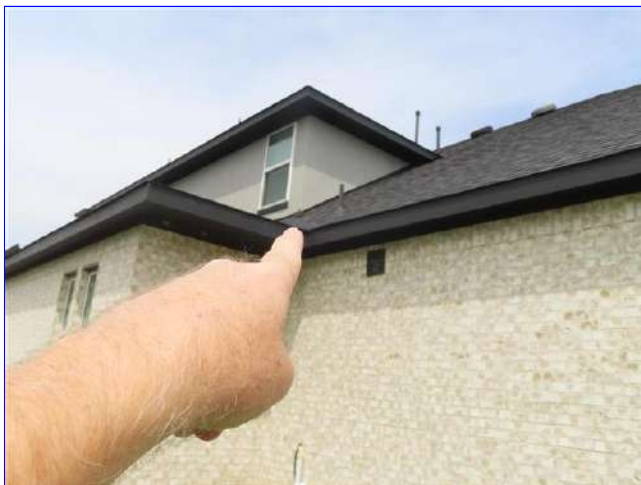
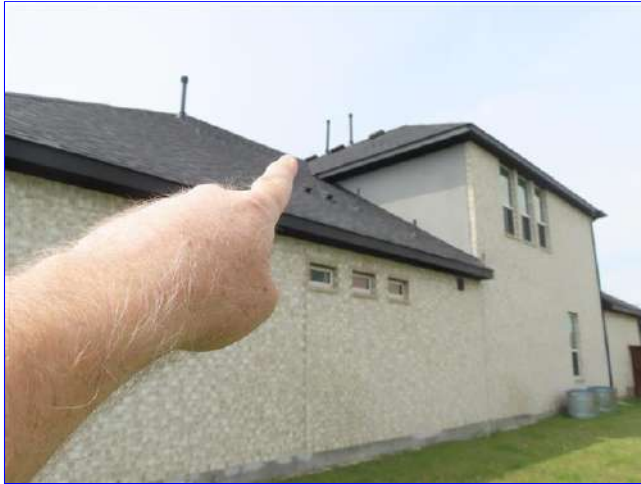
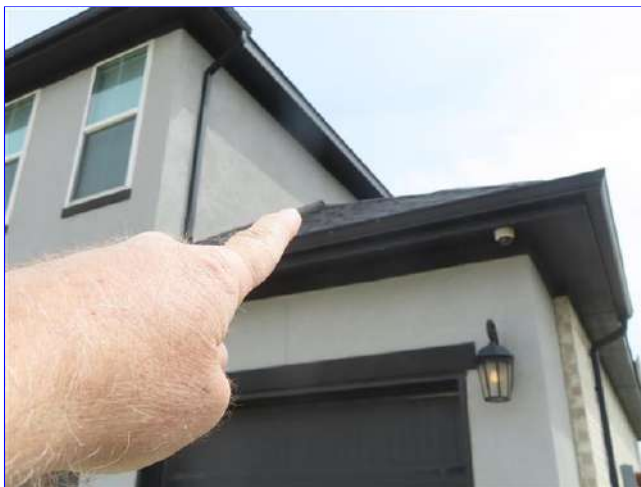
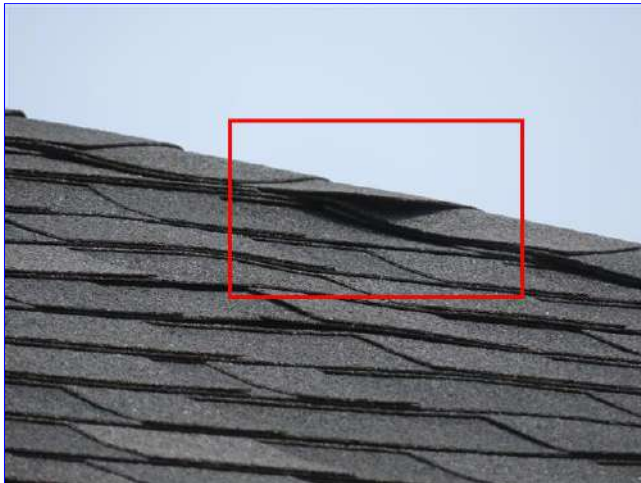
(2) All lifted roof shingles and flashing should be corrected and sealed properly by a professional roofer. Conducive to moisture intrusion and causing possible damage. Should have a professional roofer inspect and evaluate roofing.

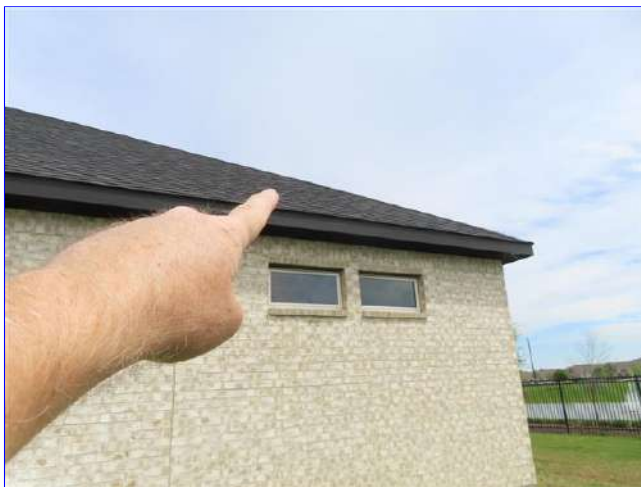
C. Item 12(Picture)

(3) Debris in roof vent should be corrected properly.

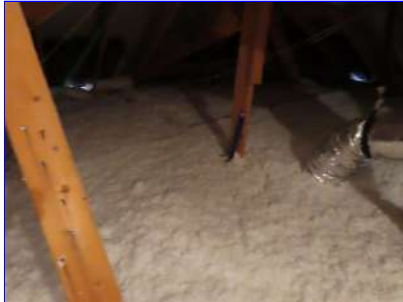
D. Item 1(Picture)

Areas of the attic were not accessible to inspect at time of inspection. These areas were not inspected for any defects or deficiencies at the time of inspection.

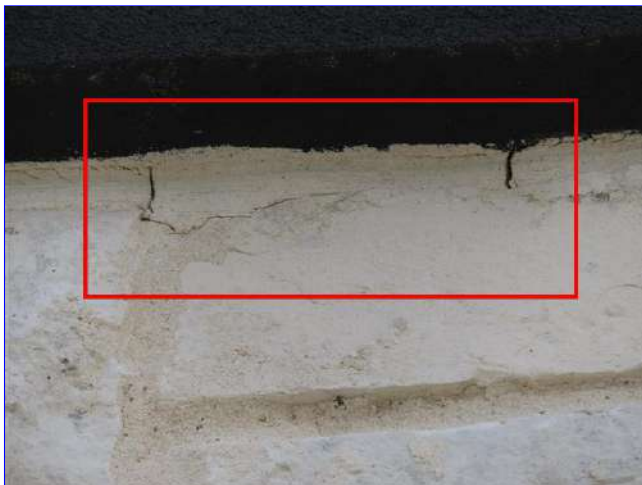
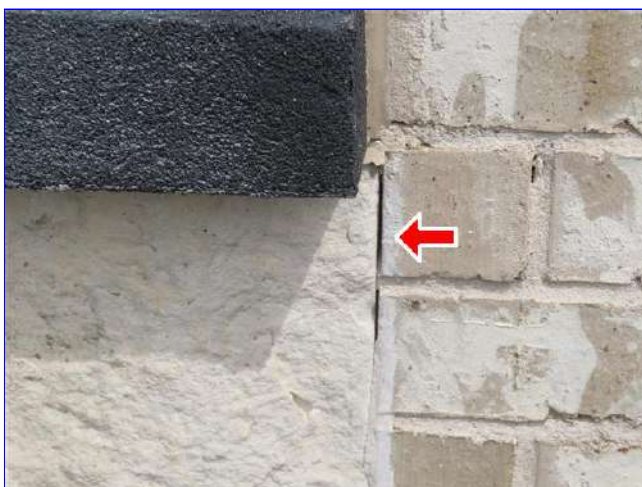
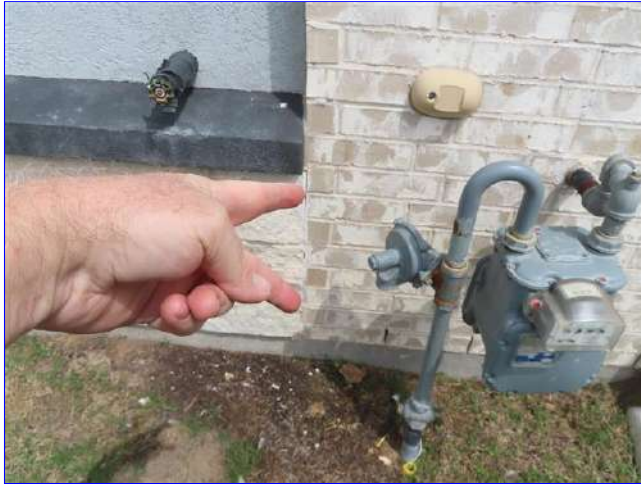
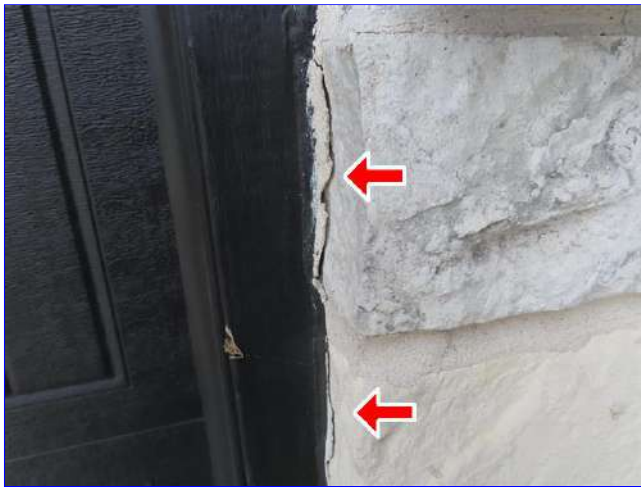
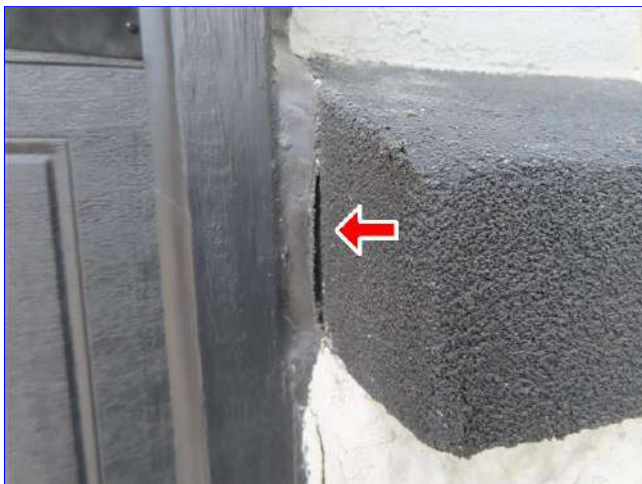
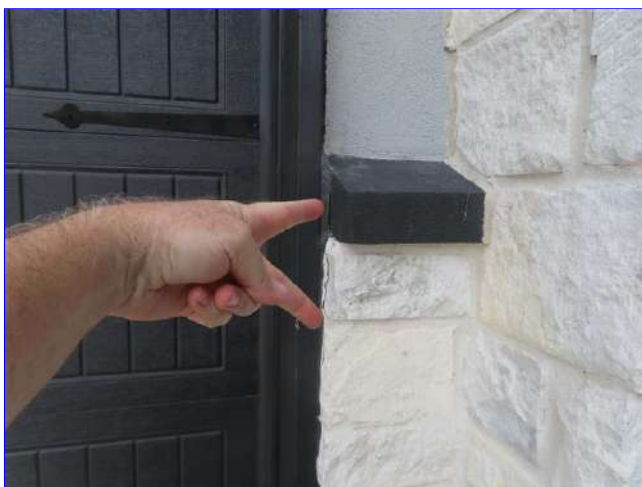
(2) All exterior wall penetrations, gaps or cracks should be sealed properly. Conducive to moisture and WDI (Wood Destroying Insects) intrusion.

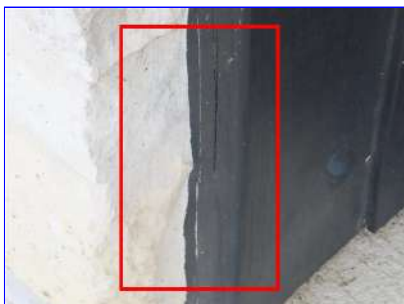
E. Item 9(Picture)

(3) All exterior and interior trim around garage doors should be sealed properly. Conducive to moisture and WDI (Wood Destroying Insect) intrusion.

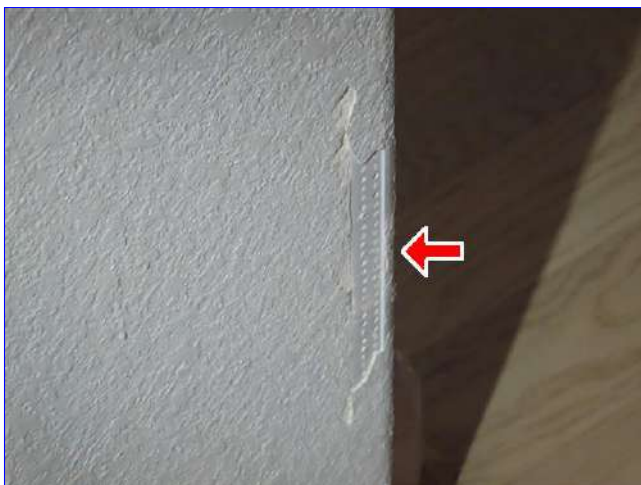
E. Item 12(Picture)

(5) Kitchen wall is damaged at time of inspection. Should have a professional correct properly.

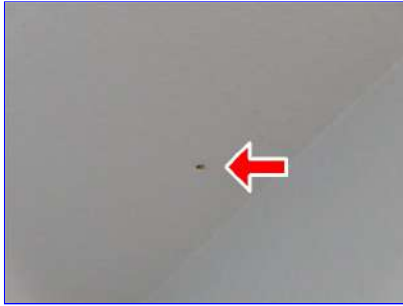
F. Item 1(Picture)

(1) Interior ceilings have nail pops and cracked in several areas at time of inspection. This is possibly due from settling of the structure.

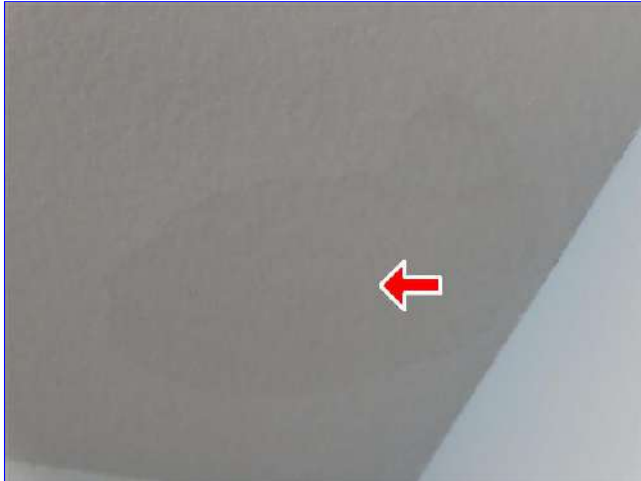
F. Item 4(Picture)

(2) Kitchen ceiling above microwave has moisture staining from a possible leak at time of inspection. Should have a professional inspect and correct properly.

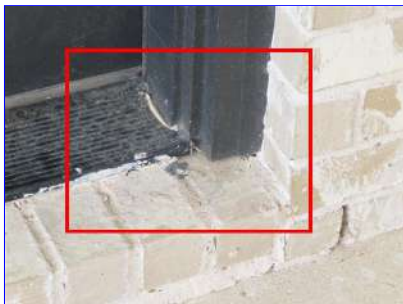
G. Item 1(Picture)

(1) All exterior door frame trim penetrations and gaps should be sealed properly. Conducive to moisture intrusion.

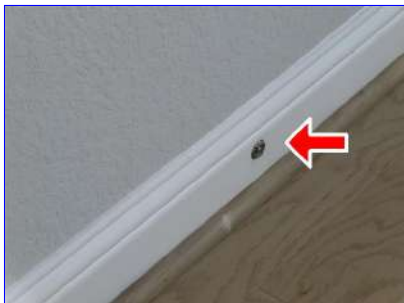
G. Item 2(Picture)

(2) Several interior doors were missing door stoppers at time of inspection.

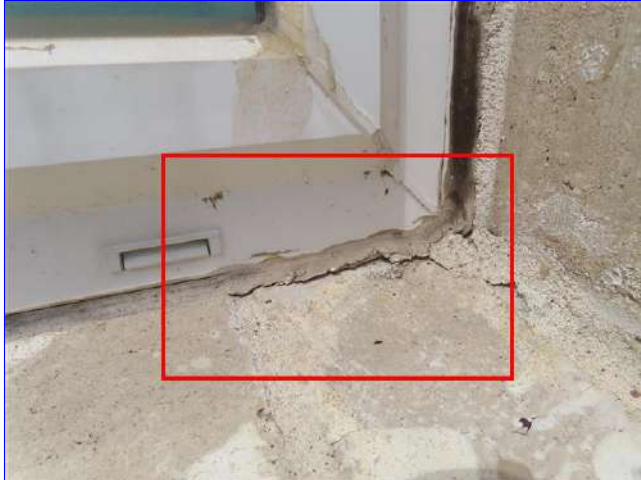
H. Item 1(Picture)

(1) All exterior and interior window penetrations and gaps from structure should be sealed properly. Conducive to moisture and Conducive to moisture intrusion and causing possible damage.

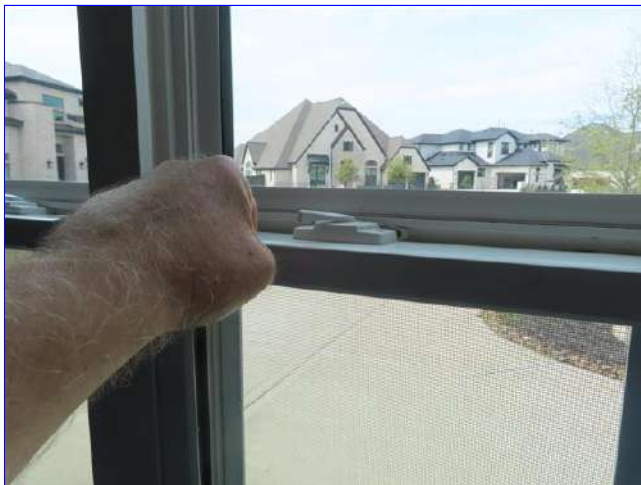
H. Item 2(Picture)

(2) Office window was not latching properly at time of inspection. Should have a professional correct properly.

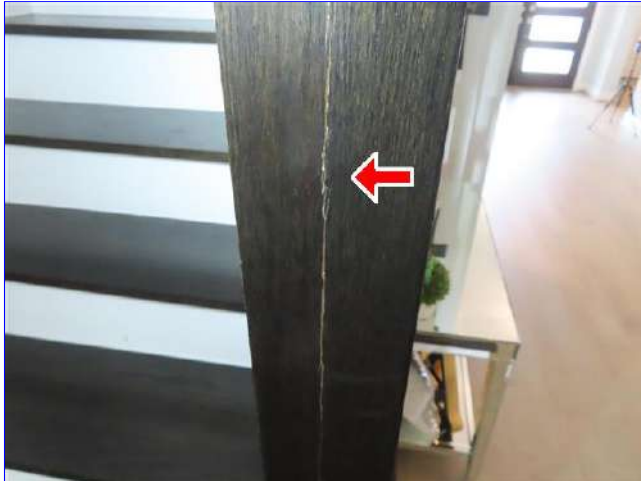
I. Item 1(Picture)

(1) Stair handrail post was cracked at time of inspection. Should have a professional correct properly.

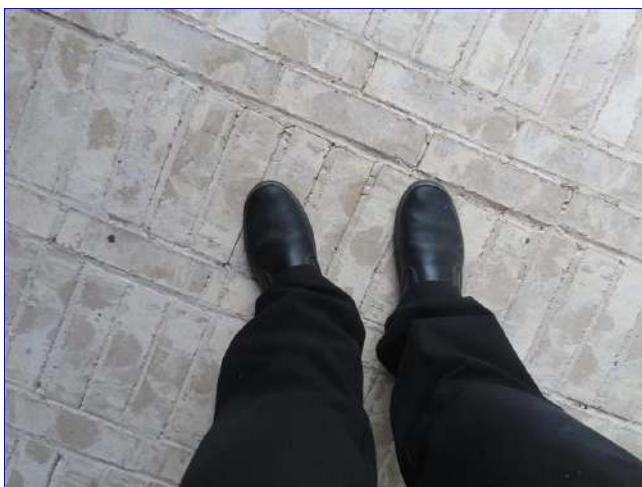
K. Item 1(Picture)

Front porch walkway bricks were loose in several areas at time of inspection. Should have a professional correct properly.

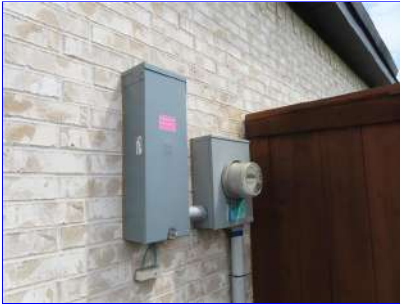
A. Item 1(Picture)

(1) Square D main electrical disconnect box and electric meter. (This is for informational purposes only)

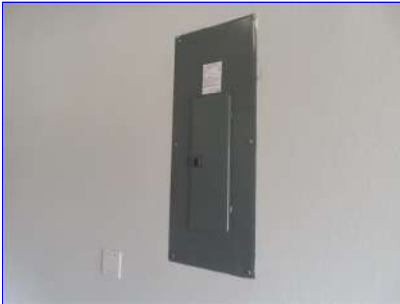
A. Item 2(Picture)

(2) Square D breaker box in the garage. Breakers were labeled at the time of inspection. (This is for informational purposes only)

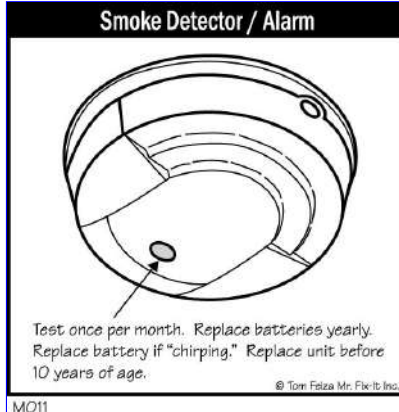
B. Item 2(Picture)

(2) Several interior electrical outlets were loose to the wall at the time of inspection. Should a professional electrician secure properly.

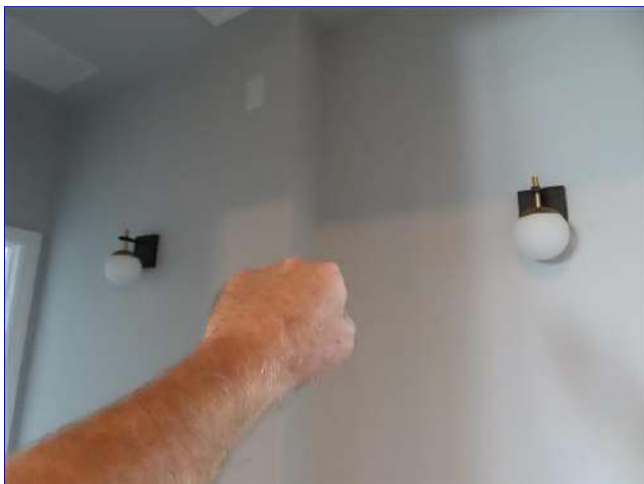
B. Item 4(Picture)

(3) 2nd floor hallway lights were not operating properly at time of inspection. Should have a professional electrician inspect and correct properly.

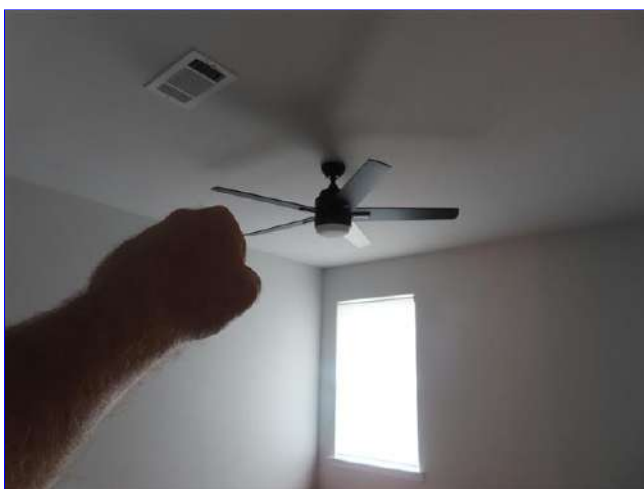
B. Item 5(Picture)

(4) 2nd floor bedroom ceiling and light were not operating properly at time of inspection. Should have a professional electrician inspect and correct properly.

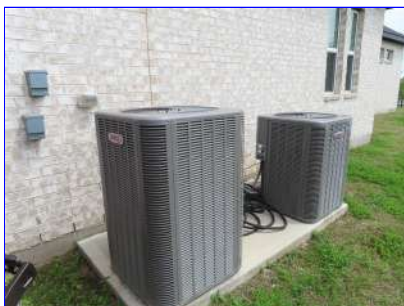
A. Item 1(Picture)

Two 2020 Lennox 2 and 4 ton AC units were operating properly at time of inspection. Recommend having a professional AC Tech inspect and service unit for proper efficiency.

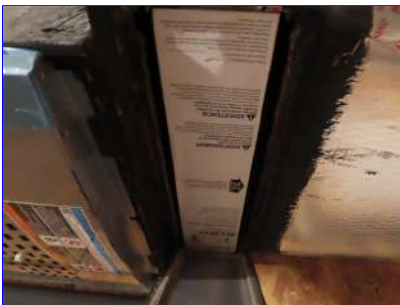
C. Item 1(Picture)

Furnace filters in the attic should be replaced every 4-6 months. (This is for informational purposes only).

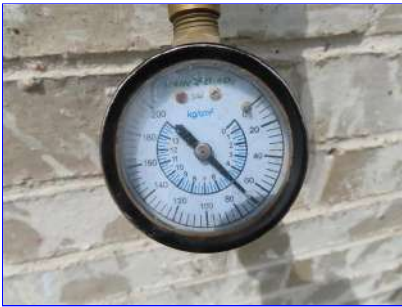
A. Item 1(Picture)

(1) The static water pressure was 70 psi at the time of inspection. (This is for informational purposes only)

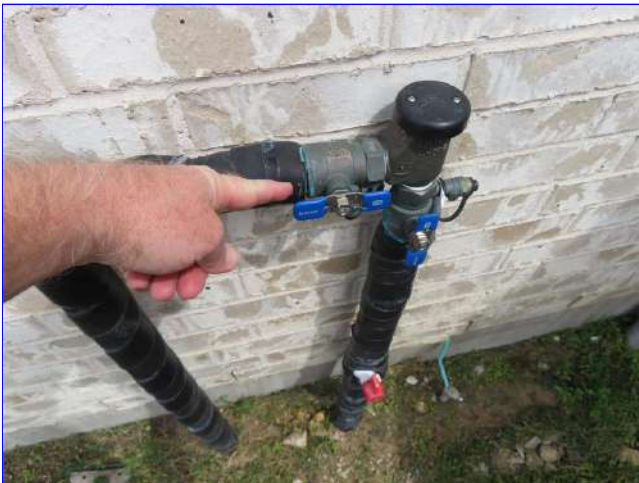
A. Item 2(Picture)

(2) Sprinkler vacuum breaker plumbing was leaking at time of inspection. Should have a professional correct properly.

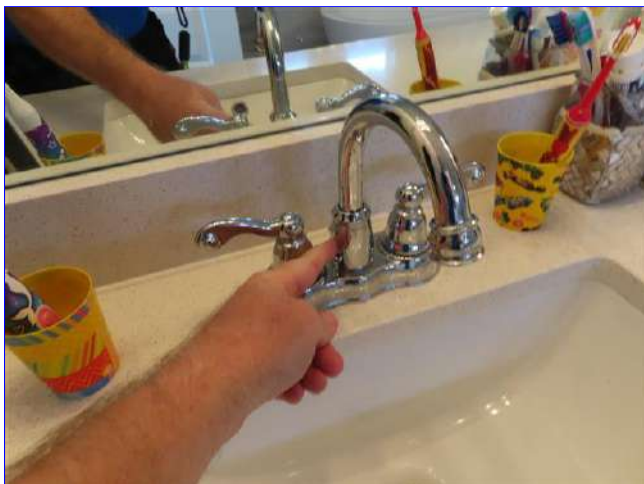
A. Item 3(Picture)

(3) Several bathroom faucets were loose at time of inspection. Should have a professional plumber correct properly.

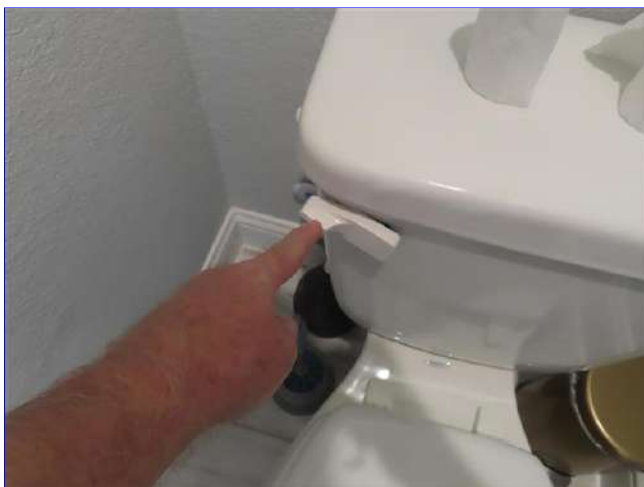
A. Item 4(Picture)

(4) Several toilet levers were loose from bowls at time of inspection. Should have a professional plumber correct properly.

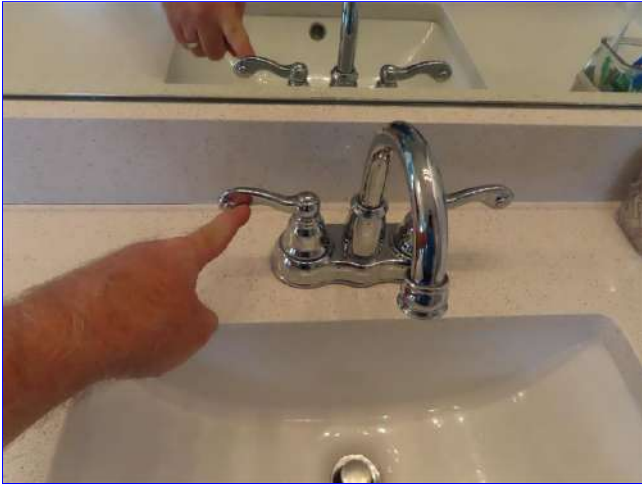
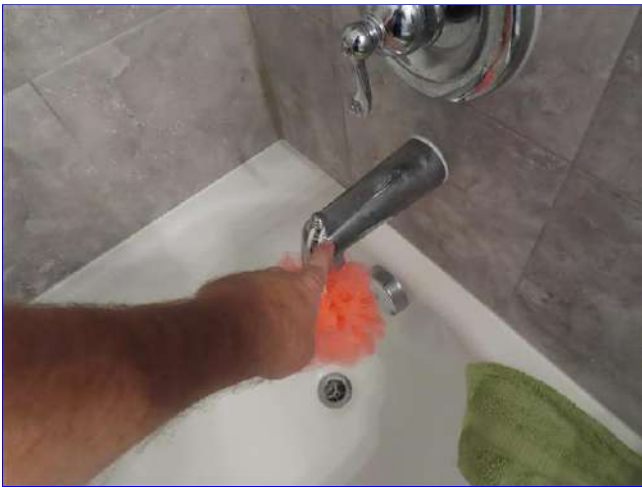
(5) Several plumbing fixtures were loose at the time of inspection. Should have a professional plumber correct properly.

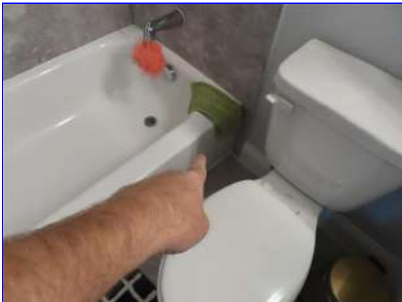
A. Item 7(Picture)

(6) Bathtubs and showers were missing plumbing access panel at time of inspection. Should have a professional plumber correct properly.

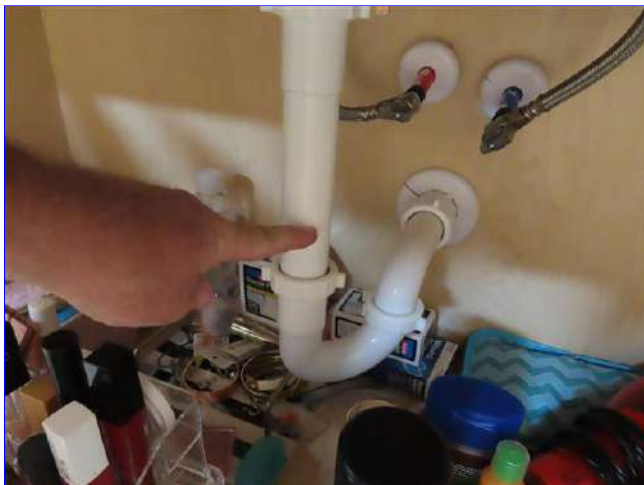
B. Item 1(Picture)

(1) Several bathrooms sink drain plumbing were loose at the time of inspection. Conducive to leaking and causing possible damage. Should have a professional plumber correct.

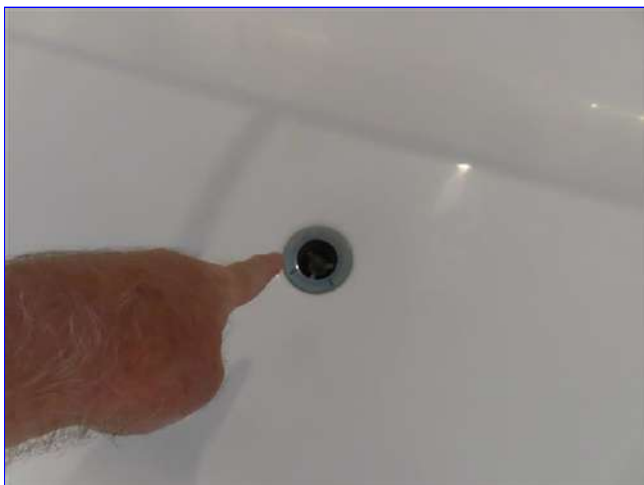
B. Item 2(Picture)

(2) Several bathtubs were missing drain stoppers at time of inspection. Should have a professional plumber correct properly.

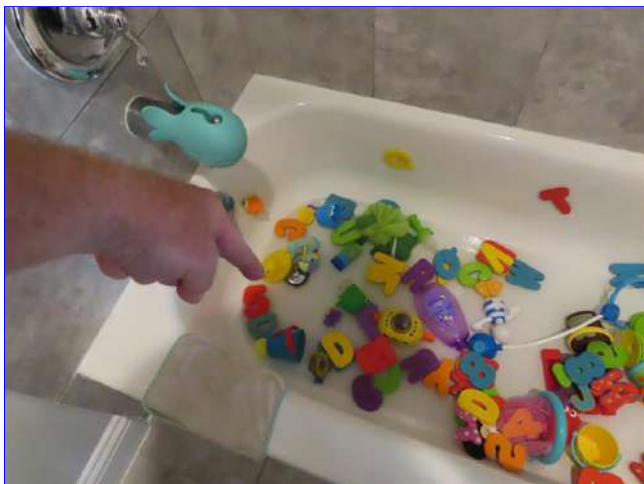
B. Item 3(Picture)

(3) 2nd floor bathtub was not draining properly at time of inspection. Should have a professional plumber inspect and correct properly.

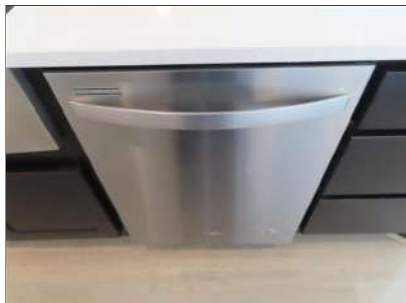
A. Item 1(Picture)

The Whirlpool dishwasher was working properly at the time of inspection.

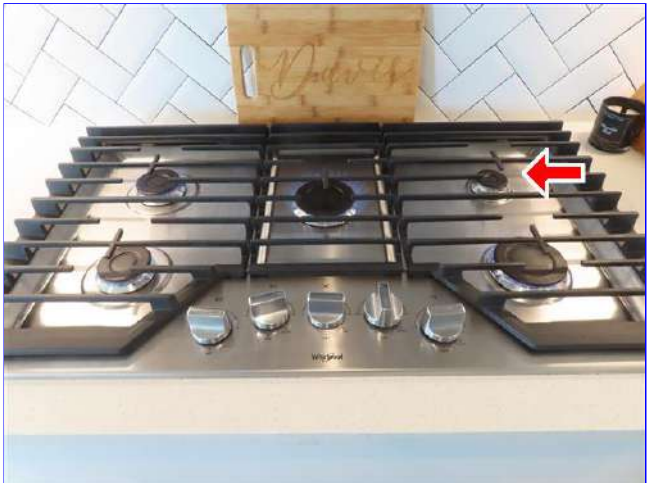
D. Item 1(Picture)

(1) Whirlpool gas cooktop rear right burner was not operating properly at time of inspection. Should have a professional inspect and correct properly.

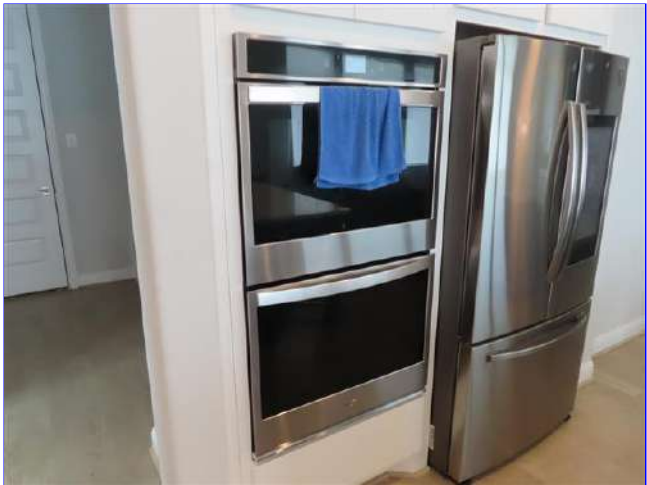
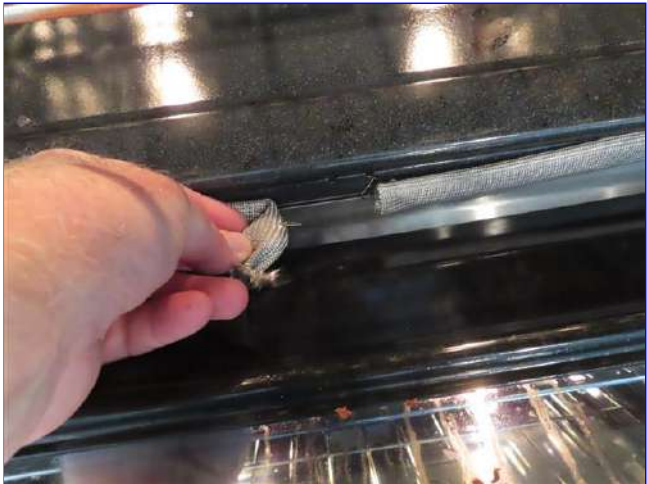
D. Item 2(Picture)

(2) Whirlpool double built in gas ovens were working properly at time of inspection. Bottom oven door gaskets were loose at time of inspection. Should have a professional correct properly.

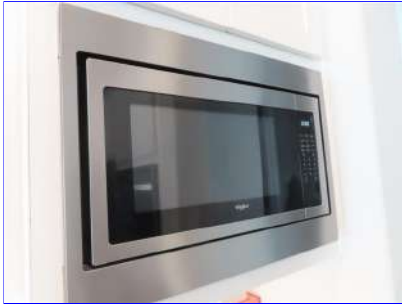
E. Item 1(Picture)

The Whirlpool built-in microwave was working properly at the time of inspection.

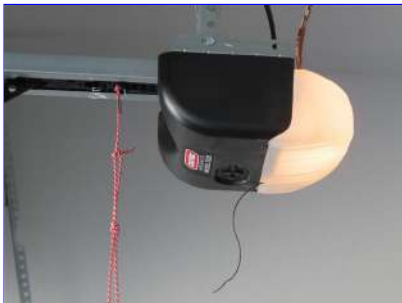
G. Item 1(Picture)

Three Genie garage door openers were working properly at time of inspection.
