G & W Inspections

Property Inspection Report

14411 Mac Lane, Tyler, TX 75750
Inspection prepared for: John Crosby & Kathy Crosby
Real Estate Agent: Chelsi Luke - ReMax

Date of Inspection: 2/6/2021 Time: 10:00
Age of Home: 1999 Size: 2,388 sq. ft.

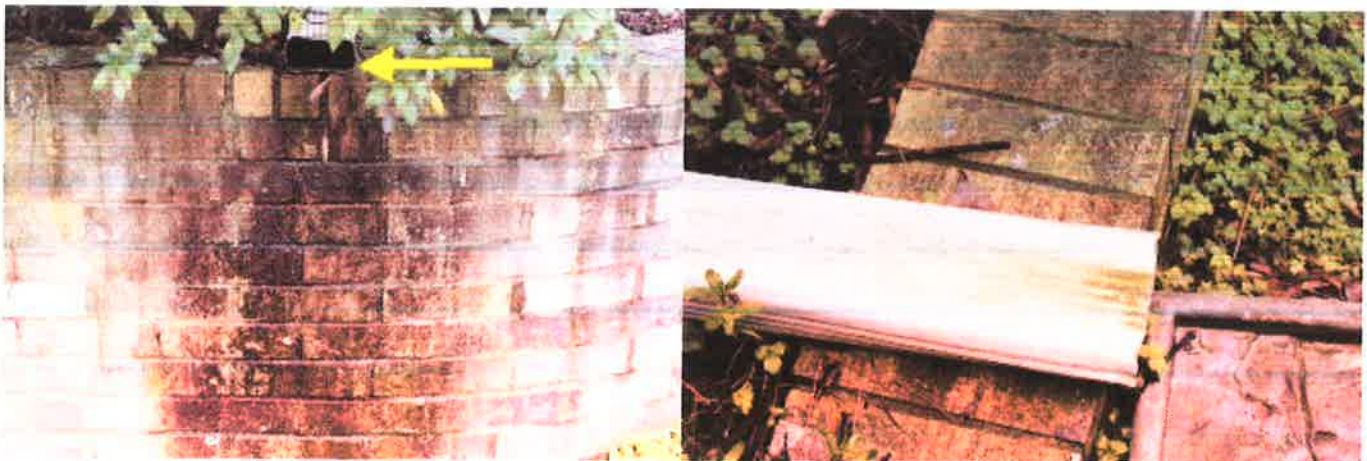
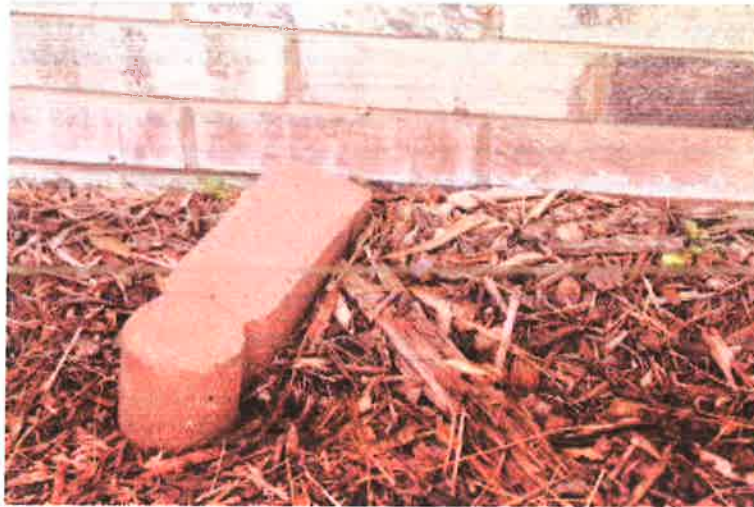
- High soil observed promoting in various locations around the structure. High soil can trap moisture and over time create foundation issues. It is recommended that 4 inches of slab be visible

- Some drains were noted to terminate over masonry and will lead to early deterioration of this area. Consider re-routing. Damaged downspouts should be replaced for proper drainage.

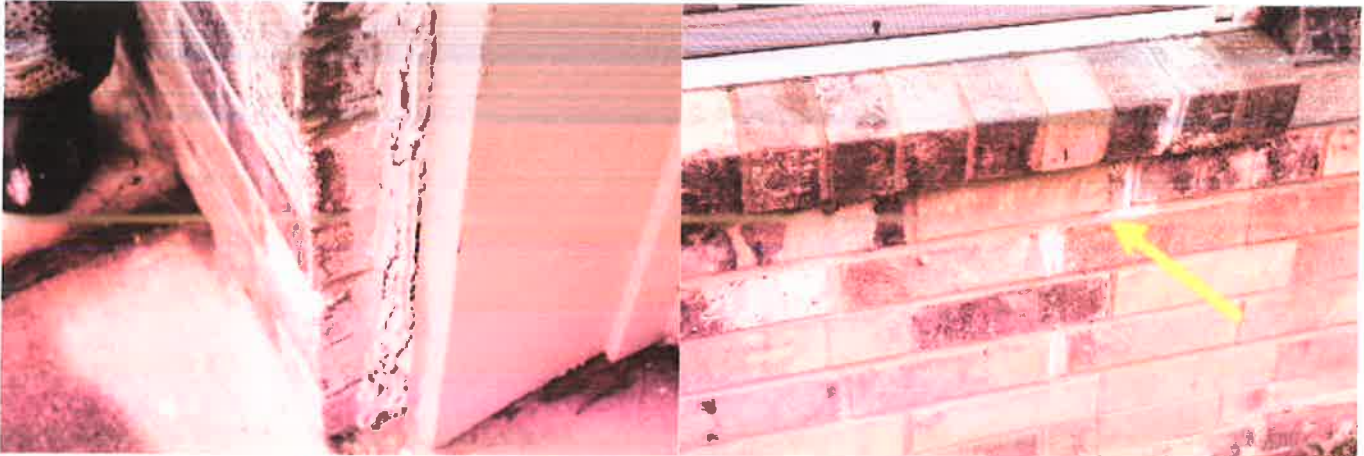
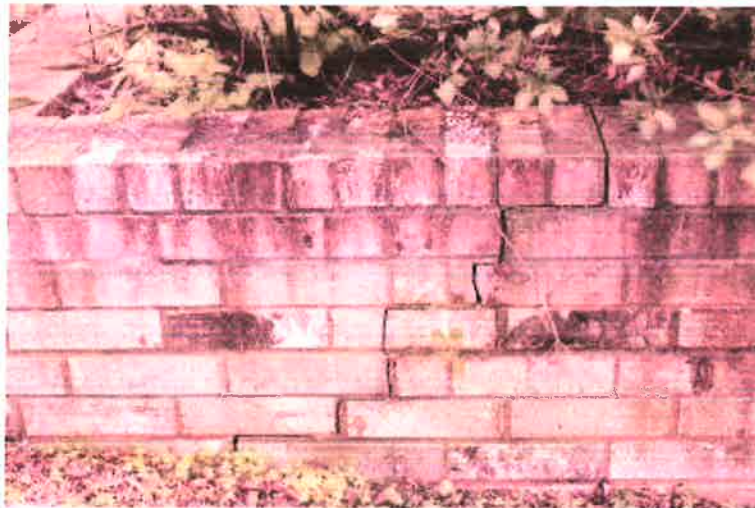
- Elastomeric caulking is recommended for the area between the exterior veneer and the garage door trim boards
- Common step crack noted, with evidence of repair.
- Common step crack noted on flower bed retaining wall. Recommend proper sealing

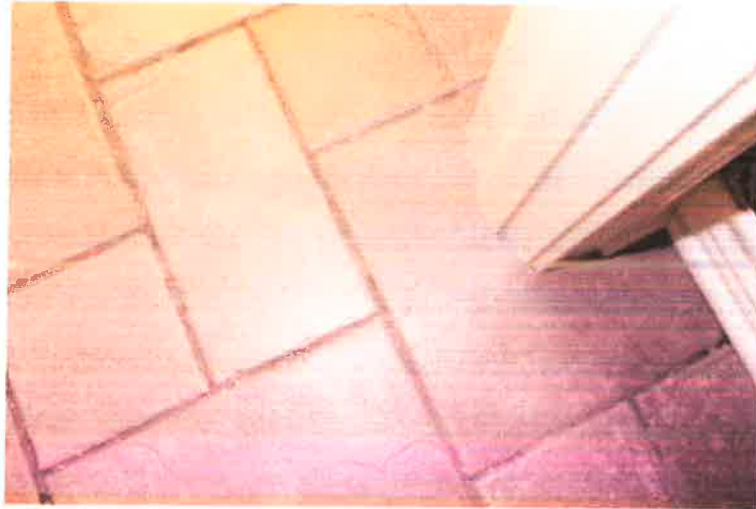
- All components were found to be performing and in satisfactory condition at the time of the inspection
- Hairline cracks in tile noted in master bathroom and main entrance

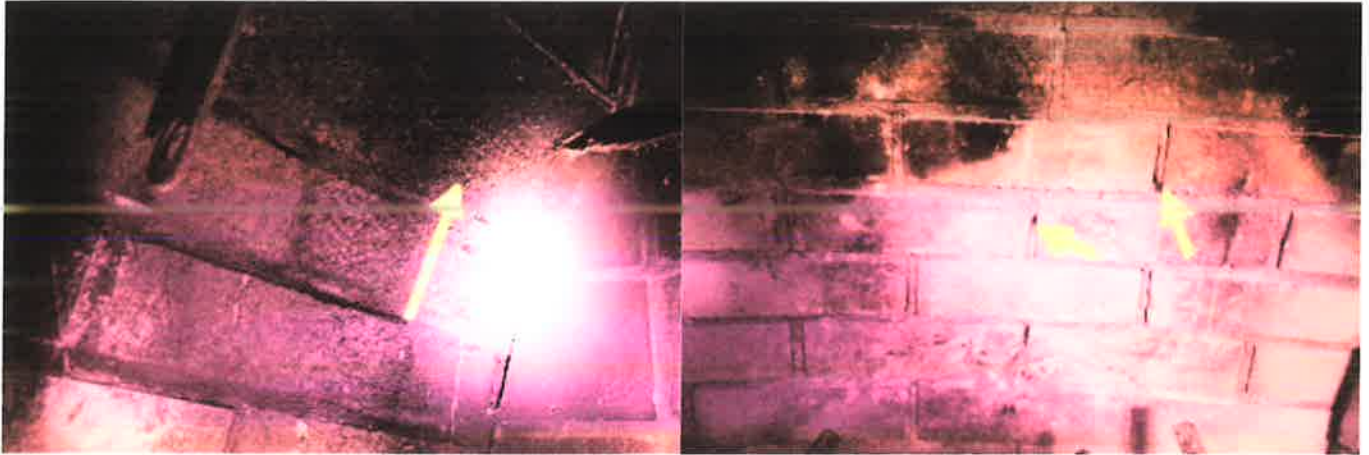
- Moderate creosote build up noted in the fireplace. Recommend cleaning prior to use.
- Recommend mortar improvements at the firebox.

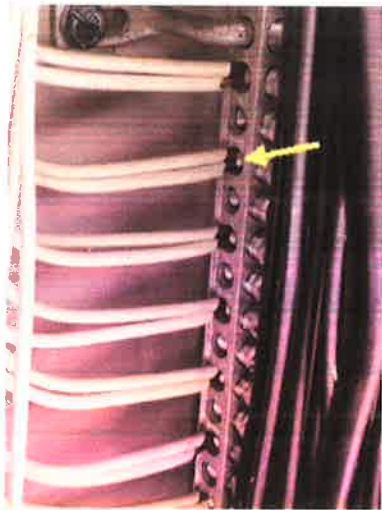
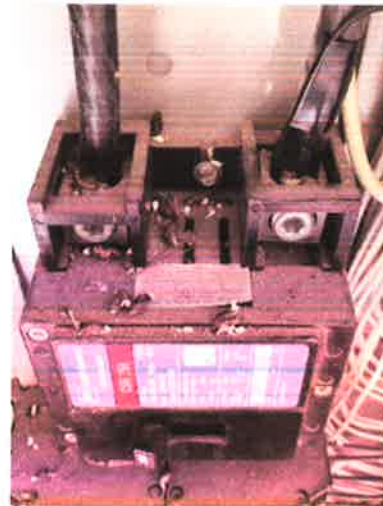
- Service entrance wiring is underground
- ***** SERVICE PANEL *****
- Evidence of insect penetration present in the panel
- ***** SERVICE PANEL *****
- No ARC fault breakers {AFCI} were observed at the service panel at the time of the inspection; although this may not have been a requirement when the home was built. Beginning in 2008; AFCI breakers are required in the panel for 15A/20A branch circuits providing power to family rooms, dining rooms, living rooms, libraries, dens, bedrooms, sunrooms, recreation rooms, closets and hallways. ARCI breakers provide fire protection by opening the circuit when an arcing fault is detected
- Double tapped neutral wires were observed in the service panel. One neutral wire per screw set is the recommended installation requirement

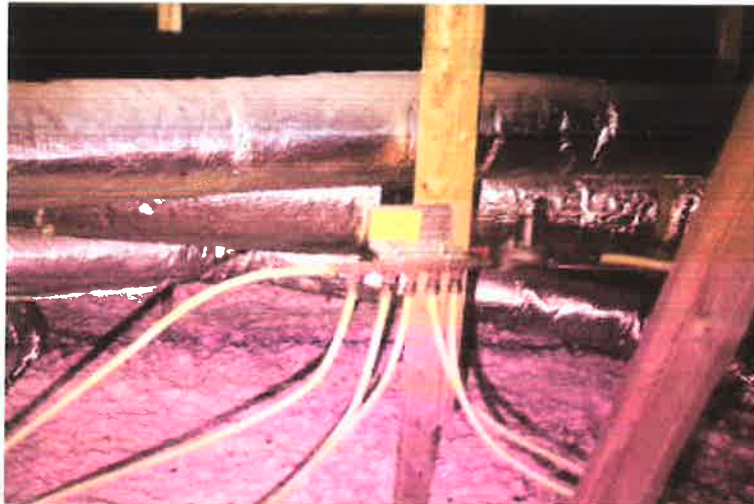
- The doorbell{s} was functional at the time of the inspection
- Inadequate smoke alarm coverage was observed and it is recommended that additional smoke detectors and CO2 detectors be installed in accordance with current building standards.
- Gas manifold noted in attic with CSST lines. This type of line requires proper grounding and bonding. It is recommended that a licensed electrician evaluate the system for safety concerns.

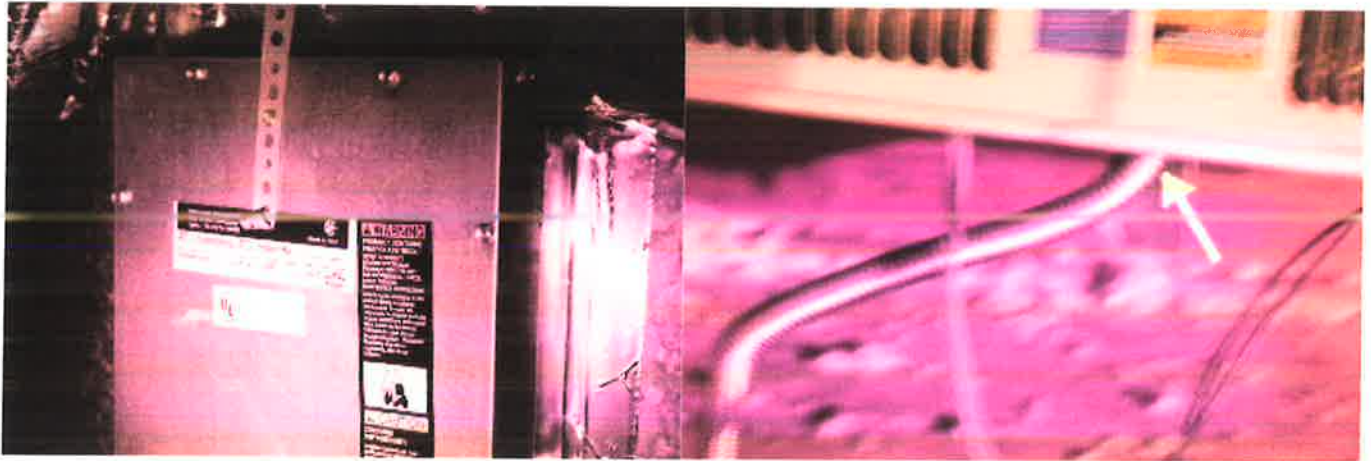
- The unit appeared to be functioning as intended at the time of the inspection
- Unit manufactured in 1998
- Temperature differentials within normal limits.
- The gas line was noted to be CSST. Requiring proper bonding and grounding for safety. Recommend evaluation of installation and grounding/bonding of this system.
- Flex line enters the enclosure. These lines can be damaged from the enclosure and should be replaced by a rigid gas line.

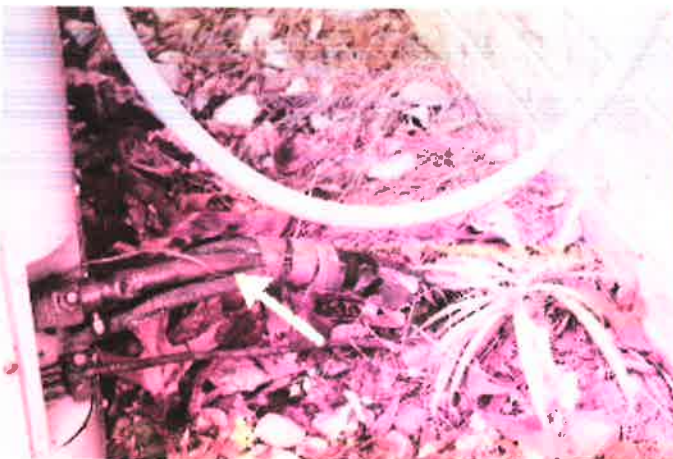
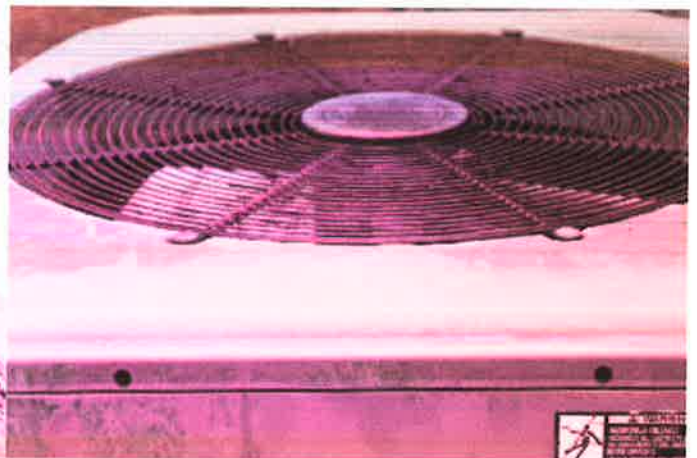
- Refrigerant lines have insulation deterioration at the A/C unit and should be replaced.

- The unit was manufactured in 1998 and has moderate rusting

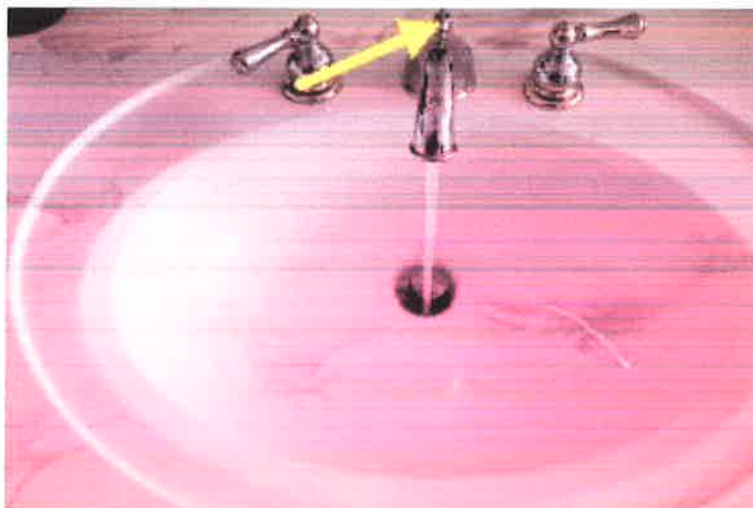
- ***** INTERIOR *****
- ***** SINKS *****
- Damaged drain closure noted in master bathroom and spare bathroom.
- ***** EXTERIOR *****
- The anti static water pressure was observed at 66 within normal limits.
- ***** EXTERIOR *****
- One or more of the exterior water hose bibs {faucets} was not equipped with a back flow and/or anti-siphon {vacuum breaker} device. An anti-siphon device prevents unsanitary water from being pulled back through a garden hose and/or lawn sprinklers and contaminating the household water system

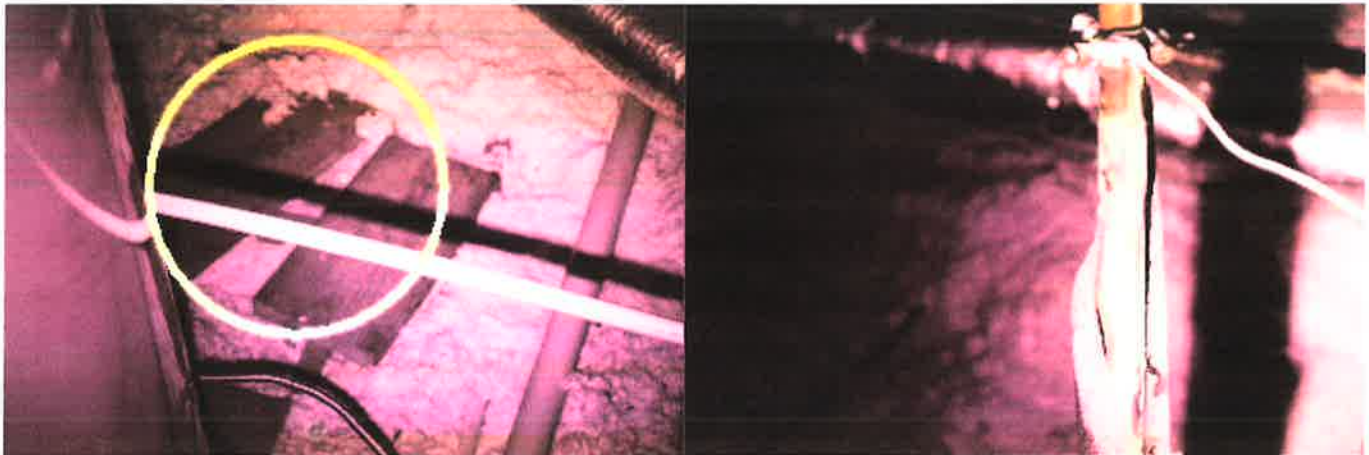
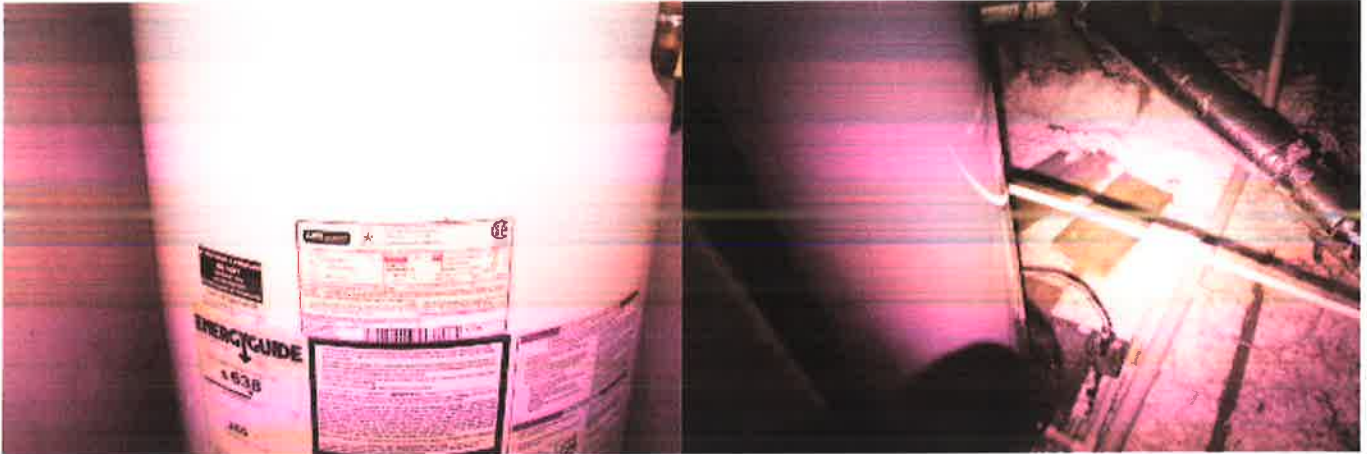
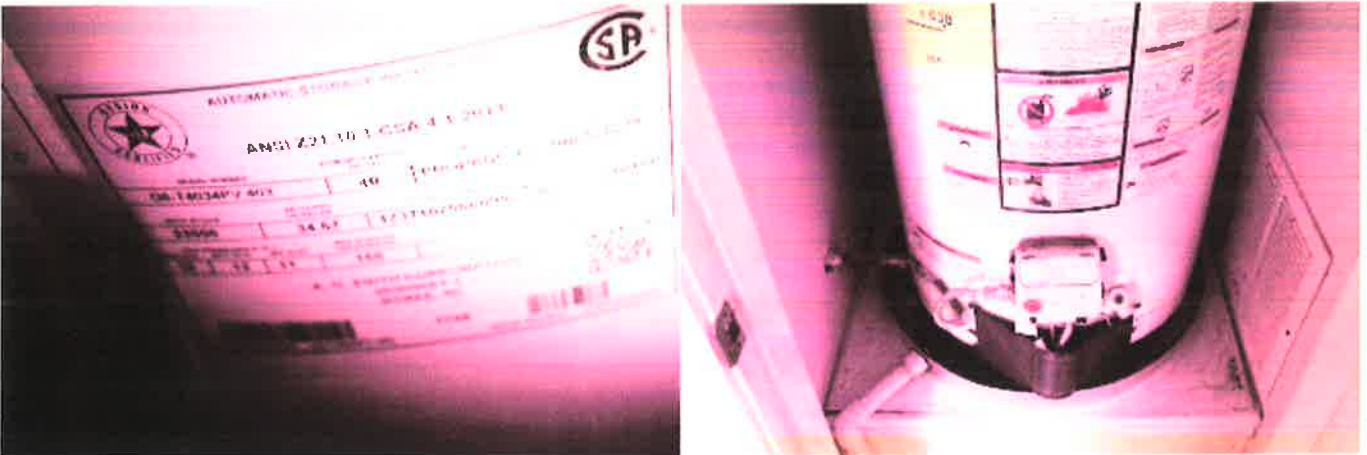
- The water heaters were found to be performing at the time of the inspection
- Unit manufactured in 2017 and 2014
- Insufficient service technician platform noted on attic unit.
- Moderate corrosion noted on supply line, monitor. Attic unit.
- Gas lines noted to not have sediment trap to protect the units. Consider installation

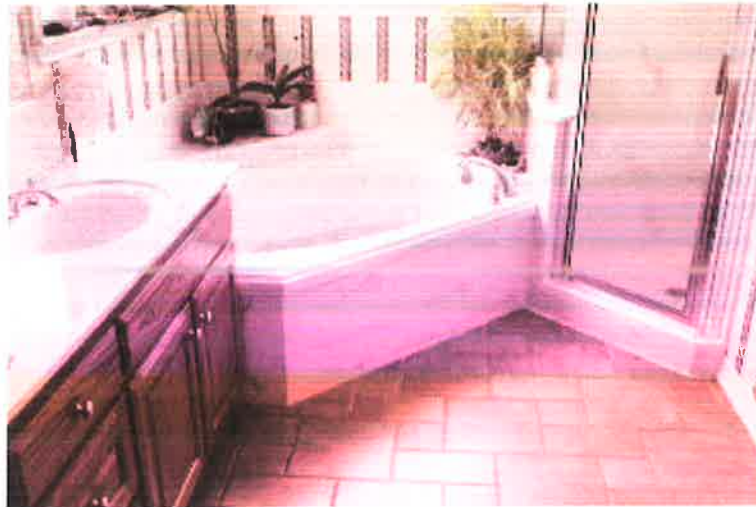
- This component appeared to be functioning as intended at the time of the inspection
- The hydromassage therapy equipment was located in the master bathroom
- It was observed that no access panel(s) were readily available to view the motor and/or equipment lines. This does not meet current building standards

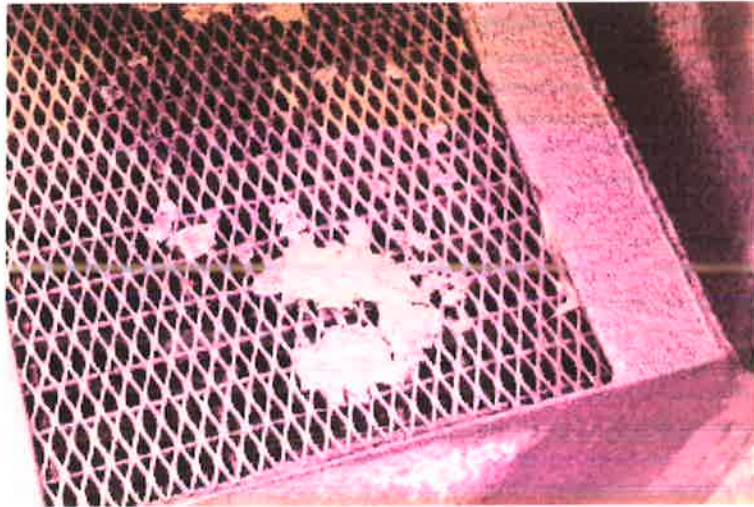
- The dishwasher was found to be performing and satisfactory condition at the time of the inspection
- **Lack of a proper air gap** noted and/or high loop drain line at dishwasher. In the event of a sewer backup this device prevents sewer matter from entering into dishwasher. Recommend having a qualified plumber install a air gap to prevent possible contamination.
