1422 E 32nd 1/2 St
Houston, TX 77022

PROPERTY INSPECTION REPORT FORM

Prat Narayanan <i>Name of Client</i>	04/08/2024 1:00 pm <i>Date of Inspection</i>
1422 E 32nd 1/2 St, Houston, TX 77022 <i>Address of Inspected Property</i>	
Paula Zandstra <i>Name of Inspector</i>	TREC Inspector License #26099 <i>TREC License #</i>
Joshua Hite, License # <i>Name of Sponsor (if applicable)</i>	23833 <i>TREC License #</i>

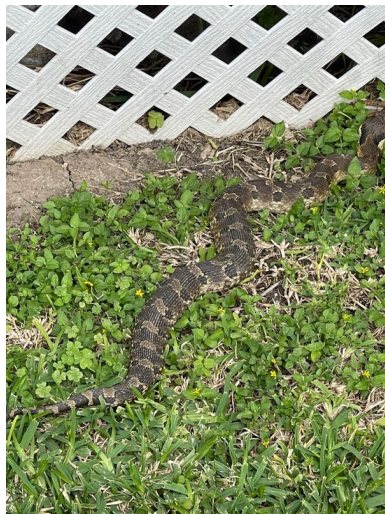
3: Presence of insects/animals noted

Foundation should be inspected monthly to ensure that insects/animals are not gaining access to the house.

Chased out from under home during foundation inspection

Recommendation: Contact a qualified pest control specialist.

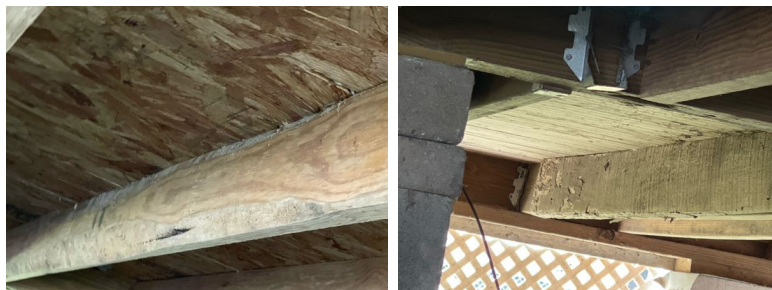
5: Tree is too close to the foundation

Tree roots may shift the foundation if they are able to reach under it. Consider removing tree to prevent foundation from being damaged.

Recommendation: Contact a qualified tree service company.

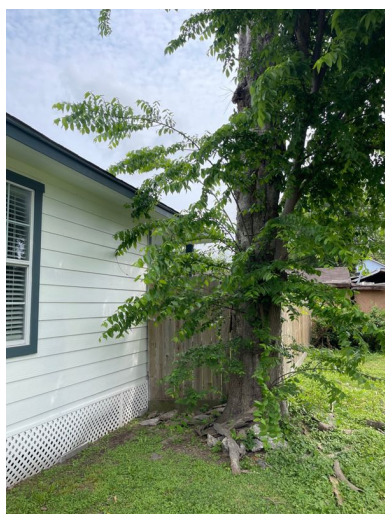
Right Side Exterior

6: Settling noted in the foundation

The home has signs of minor settling, and should be monitored. If signs of more movement occur such as wallboard cracks, foundation cracks, cracked flooring and cracks in exterior walls consult a structural engineer.

Recommendation: Contact a qualified structural engineer.

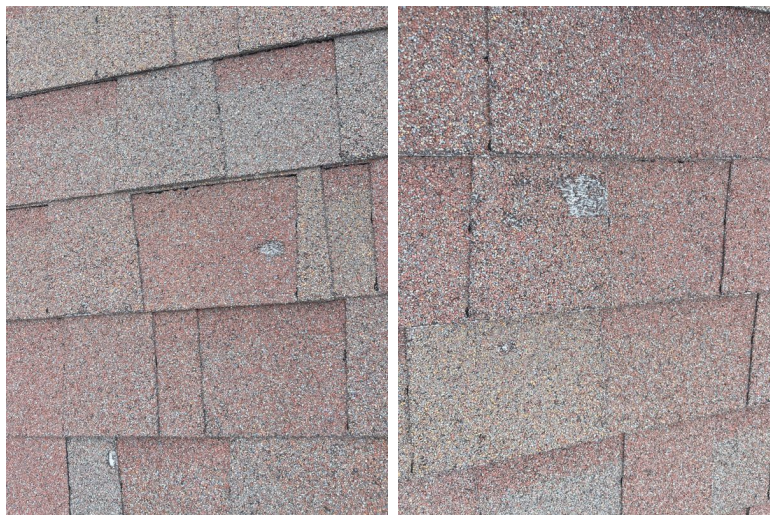
2: Discoloration

[Here is a helpful article](#) on common roof stains.

Recommendation: Contact a qualified roofing professional.

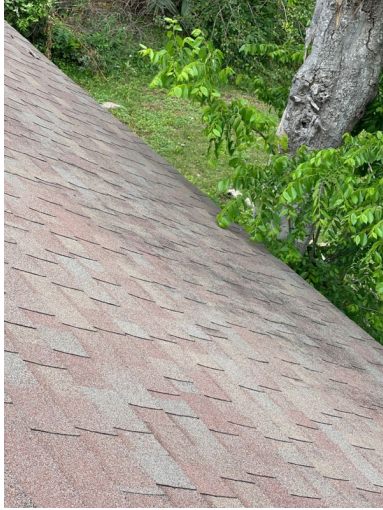
3: Exposed Nails

Under-driven or exposed nails were found in one or more roof coverings. Recommend a qualified roofer evaluate and correct. Unsealed nails will rust and create gaps where water can gain access to components that come become water damaged.

Recommendation: Contact a qualified roofing professional.

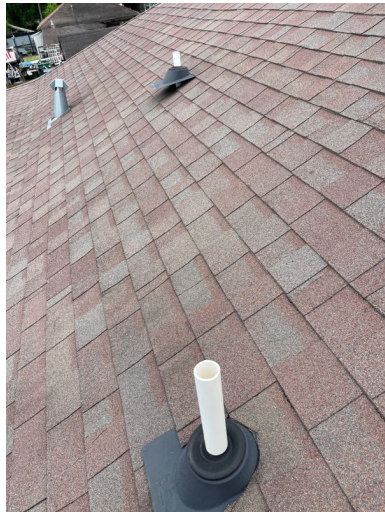
8: PVC is not painted

PVC will deteriorate when exposed to sunlight, which will shorten the lifespan of the material. PVC should be painted or covered to avoid damage.

Recommendation: Contact a handyman or DIY project

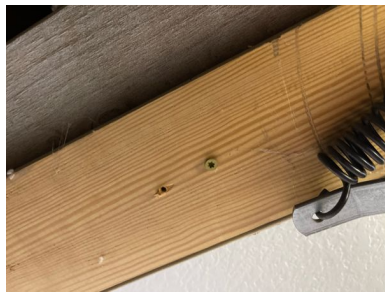
1: Attic entry is not properly secured

Attic entries need to be secured with 16d nails or lag screws. Most attic entries have labels giving instruction on how to properly install the entry. entrance ladder must be secured directly onto the framing without gaps.

Recommendation: Contact a qualified professional.

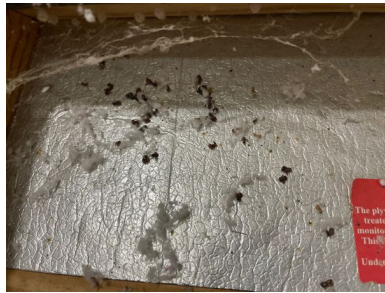
3: Evidence of insect/animals

Seal all penetration into the attic, and consult a pest professional.

Recommendation: Contact a qualified pest control specialist.

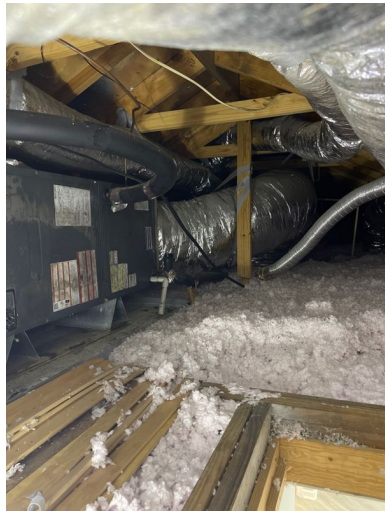
6: Attic is required to have walkway and decking for servicing of all equipment installed in attic

Recommendation: Contact a qualified professional.

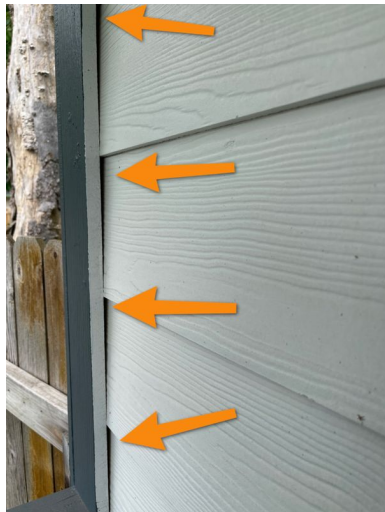
Back

2: Gaps in Siding

Gaps in the siding allow water and insects to penetrate the structure. All gaps should be sealed to prevent damage from interior structural components.

Recommendation: Contact a qualified siding specialist.

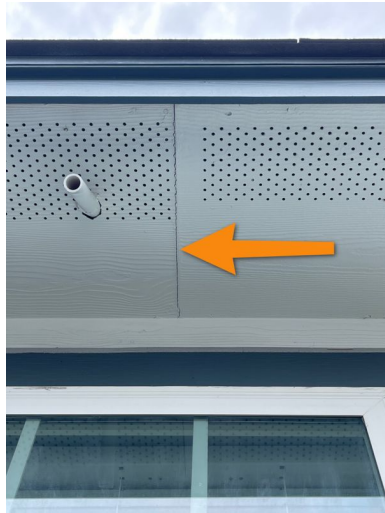
Left Side Exterior

3: Joints are separating in siding

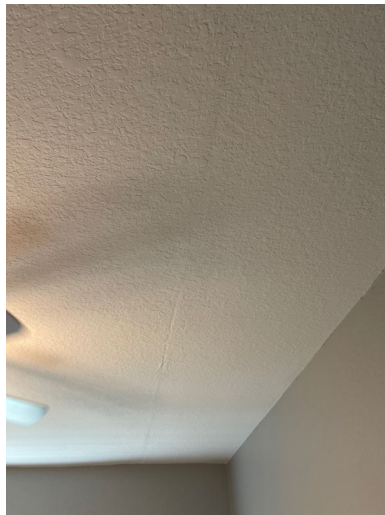
Front Right Bedroom

Reason for previous repairs cannot be determined, and can cover latent defects.

Recommendation: Contact a qualified professional.

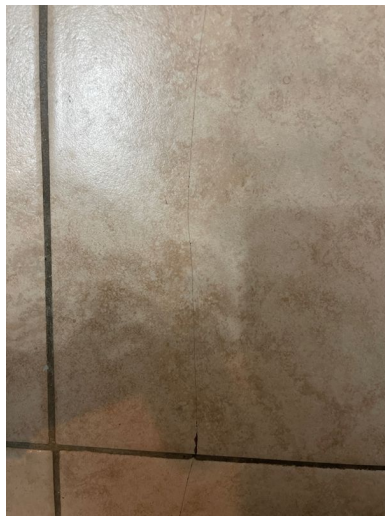
Hallway Bathroom

2: Tile is loose or cracked

Recommendation: Contact a qualified flooring contractor

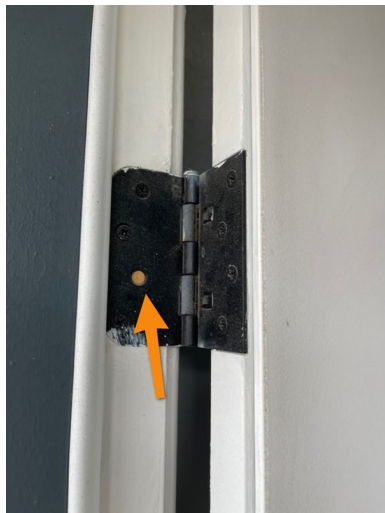
Left Side Exterior

2: Hinge missing screw

[Here is a DIY article](#) on fixing loose hinges.

Recommendation: Recommended DIY Project

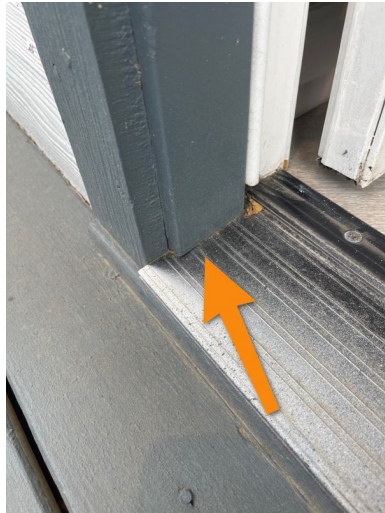
Left Side Exterior

3: Needs sealed at threshold

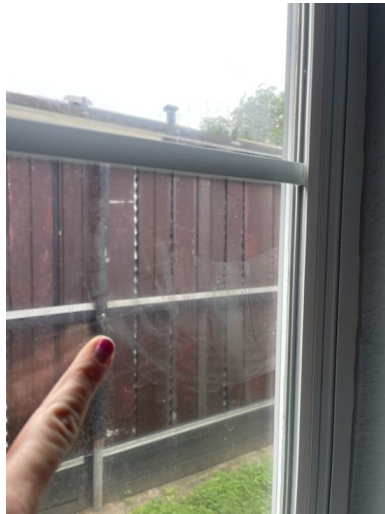
Living Room

Observed condensation between the window panes, indicates a failed seal. Recommend qualified window contractor evaluate and repair or replace as needed.

Recommendation: Contact a qualified window repair/installation contractor.

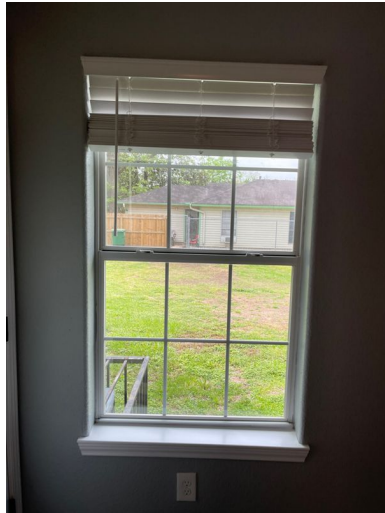
Back Right Bedroom

2: Difficult to open or close

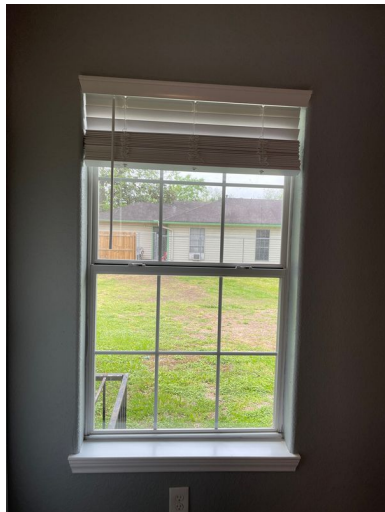
Back Right Bedroom

3: Missing Screen(s)

One or more windows are missing a screen. Screens protect against insect intrusion when the window is open. Recommend replacement.

Recommendation: Contact a qualified window repair/installation contractor.

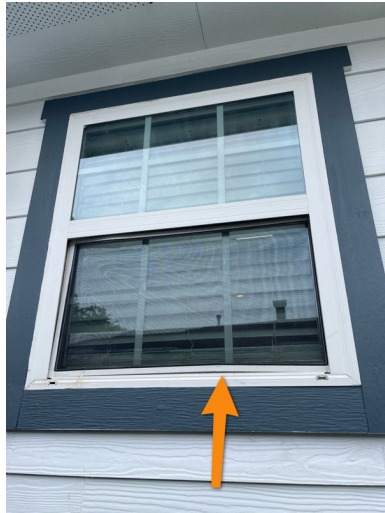
Left Side Exterior

4: Screen is damaged

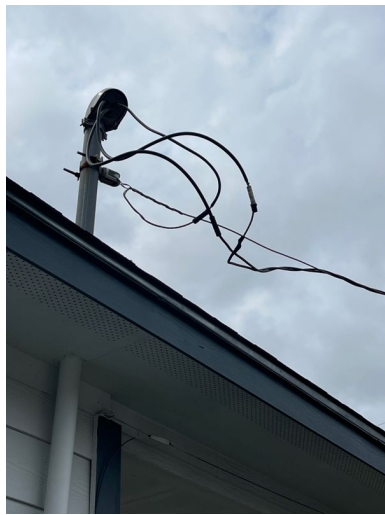
3: Service drops have insufficient Clearance

Recommendation: Contact a qualified electrical contractor.

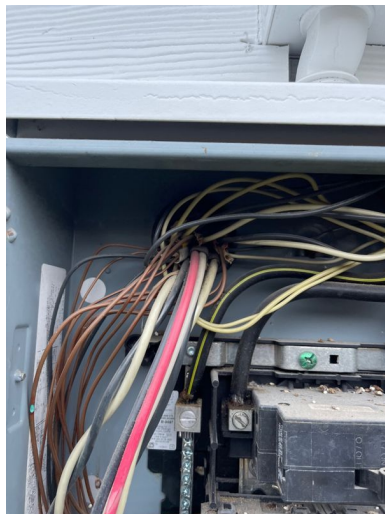
5: Wires are coming in from a single entrance

Recommendation: Contact a qualified electrical contractor.

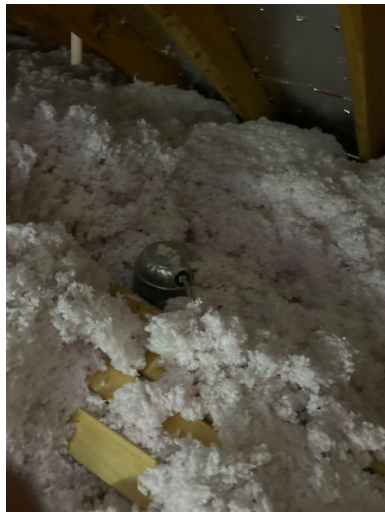
2: Canned lights are touching insulation

Recommendation: Contact a handyman or DIY project

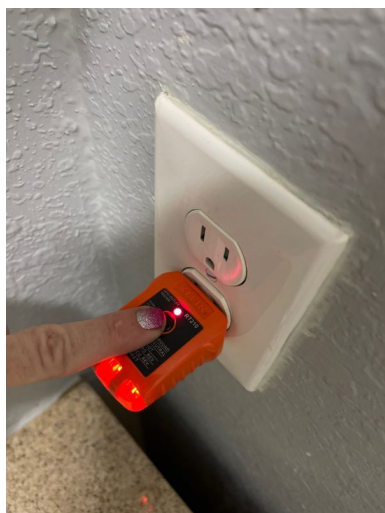
Master Bathroom

4: Missing GFCI protection where required

Recommendation: Contact a qualified electrical contractor.

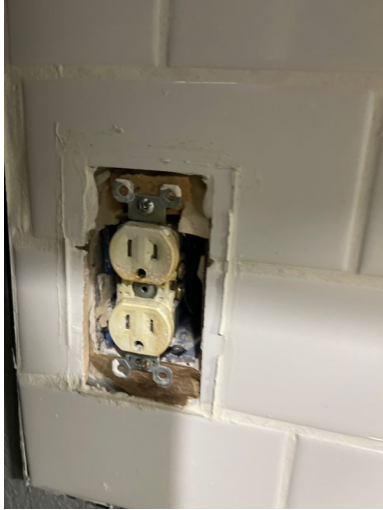
Kitchen

5: Outlet box extension not installed

Recommendation: Contact a qualified professional.

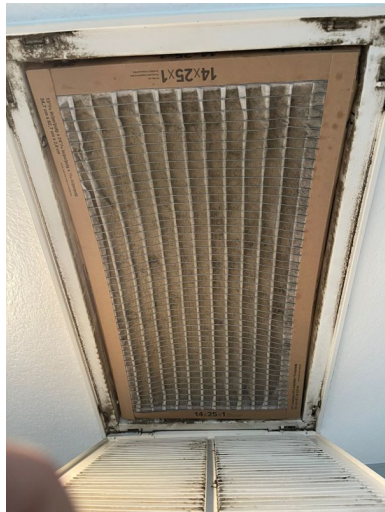
2: Filter requires replacement

Recommendation: Contact a qualified HVAC professional.

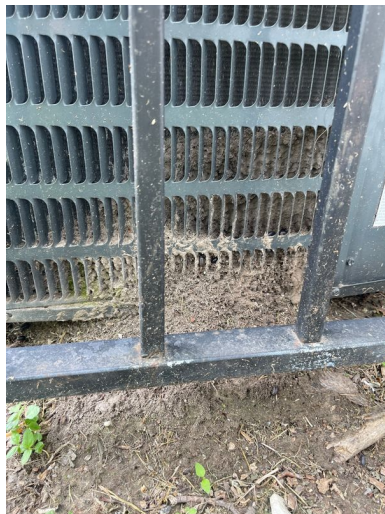
2: Condenser fins are dirty or damaged

Recommendation: Contact a qualified HVAC professional.

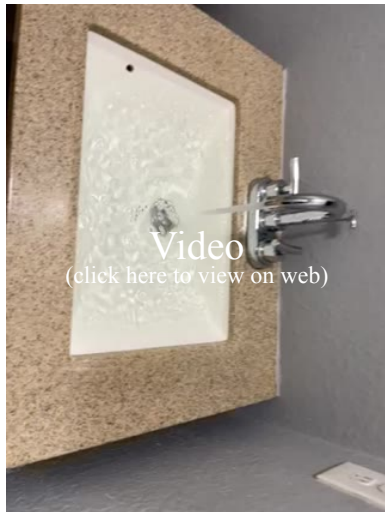
5: Sink overflow is not performing

Recommendation: Contact a qualified professional.
