Inspection Report

Reference No.: HA1110

Structural Inspection of the residence located at:

3618 Vacanti Dr Richmond, TX 77406

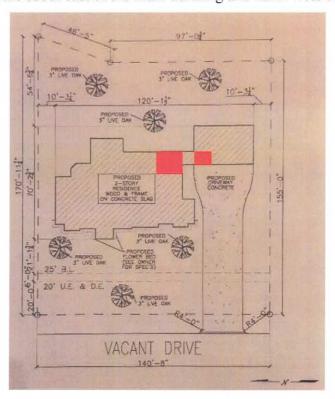
- 1- **Cracks on walls**: There are minor thermal cracks observed on the exterior wall corners which is not due to foundation settlement and can be filled with proper material match with existing fillers.
- 2- Cracks around window frames or exterior doors: There is not any crack around entrance door and window of the house.
- 3- **Sticking doors or windows**: All other doors and windows open and close properly and gaps between doors and frames have not deformed.
- 4- **Foundation cracks**: There is a crack observed on the garage foundation concrete and couple of cracks at ceramic of the house which shown on the below picture in red. Location of the cracks is sign of the foundation settlement at the south east of the main building and north west of car garage building.

The cracks on the brick walls are to be sealed to prevent water intrusion and potential damage due to rain.

Foundation contractor shall fix the foundation level by adding proper piles. At least once a year, the client should carefully inspect the foundation (interior elements and exterior elements) for signs of cracking, insect intrusion, moisture intrusion, or changes of any type (such as the appearance of cracks, or the widening or lengthening of existing cracks).

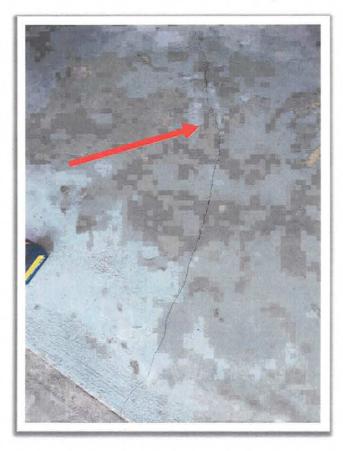
7- Miscellaneous: There is a foundation crack at exterior south east of the garage building which is sign of lack of vibration during concrete pour or rebar placement. This is not a structural issue and can be fixed with proper grout.

Foundation concrte crack at garage

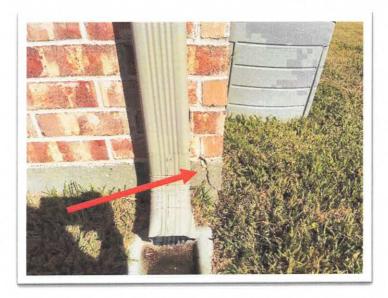
Foundation concrte at exterior south west of the garage

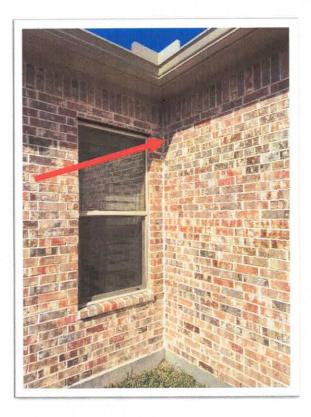
There are few minor thermal cracks on exterior walls which is normal cracks and need to be filed with proper fillers matched with existing materials.

Crack at exterior wall corner

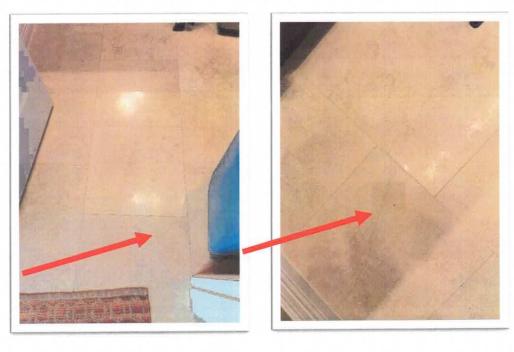
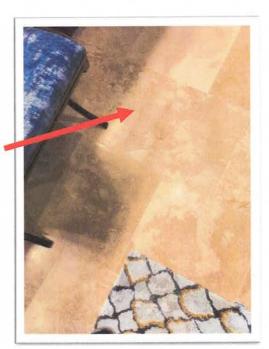
Cracks at cermaics in side of the main building
