HITE TECH INSPECTIONS

PROPERTY INSPECTION REPORT

Concerning: 1007 Shirkmere Rd, Houston TX 77008
(Address or Other Identification of Inspected Property)

By: Spoerle - TREC License #24277 08/03/2021 1:00 pm
(Name and License Number of Inspector) (Date)

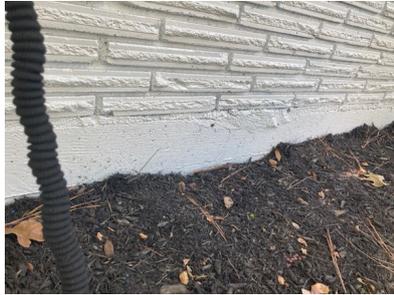
Foundation has been painted/covered which can cover latent defects:

Multiple Locations

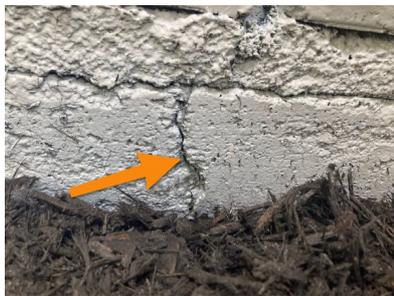
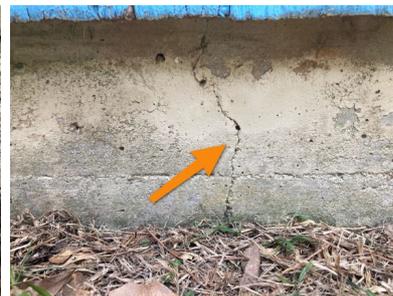
Left side of house

1: Foundation Cracks - Minor

Minor cracking was noted at the foundation. This is common as concrete ages and shrinkage surface cracks are normal. Recommend sealing these cracks with exterior sealant and, monitoring for more serious shifting/displacement.

Recommendation: Contact a handyman or DIY project

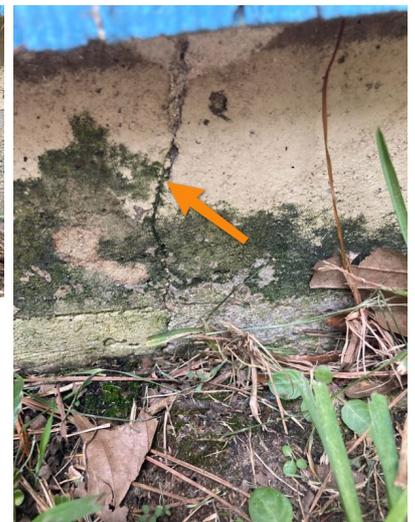
Left side of house

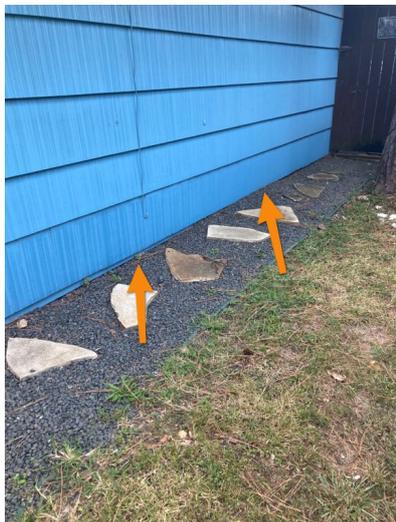
2: Foundation needs to be exposed around perimeter of home

The foundation wall should be exposed at least 4 inches this allows observation of the foundation wall for cracks and pest intrusions.

Recommendation: Contact a qualified grading contractor.

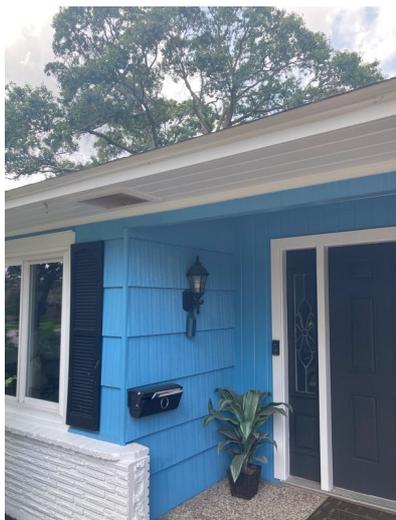
1: Gutters are missing

Gutters are always recommended around the entire roof perimeter to help drain water away from the foundation and siding. This helps keep moisture even around the foundation. Uneven moisture can lead to movement in the foundation. It also keeps water away from the siding, which protects it from deterioration.

Recommendation: Contact a qualified gutter contractor

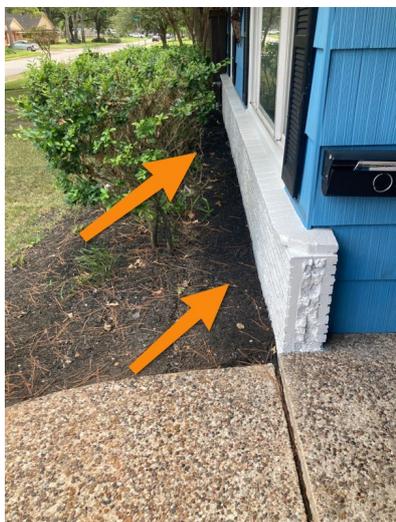
2: Negative Grading

Grading is sloping towards the home in some areas. This could lead to water intrusion and foundation issues. Recommend qualified landscaper or foundation contractor regrade so water flows away from home.

Recommendation: Contact a qualified landscaping contractor

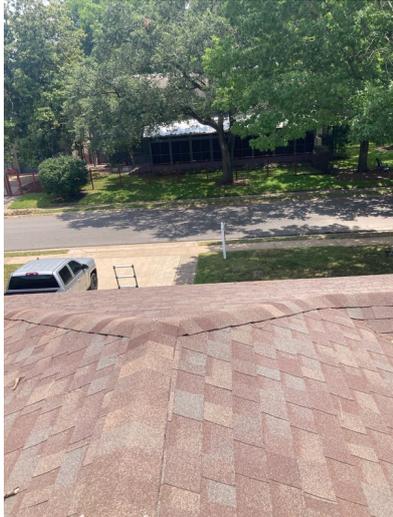
1: Crickets are required on any item installed on the roof that is 30 inches wide or more for proper water drainage on roof

Recommendation: Contact a qualified roofing professional.

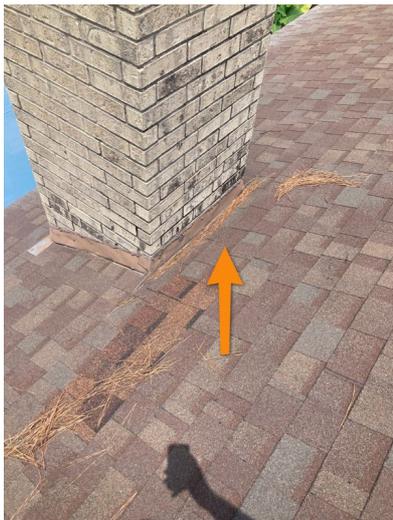
2: Damaged or deteriorated flashing

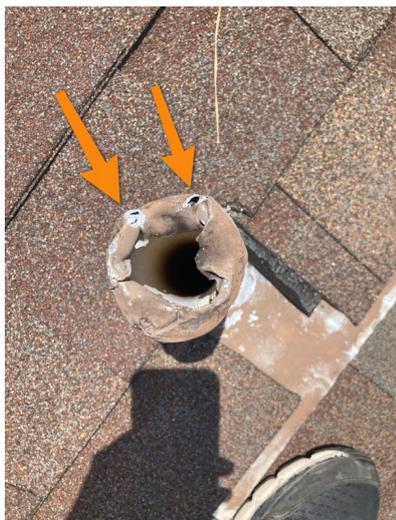
Damaged and deteriorated flashings may not protect against water intrusion as intended.

Recommendation: Contact a qualified roofing professional.

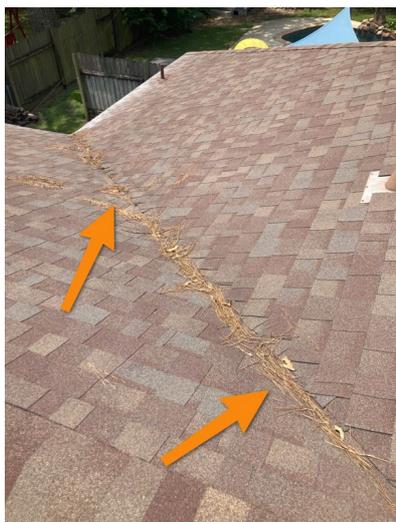
3: Debris on roof

Debris on the roof will hold moisture and deteriorate the roof covering. Roof should be cleaned and kept free from debris to extend life and ensure proper function.

Recommendation: Contact a qualified professional.

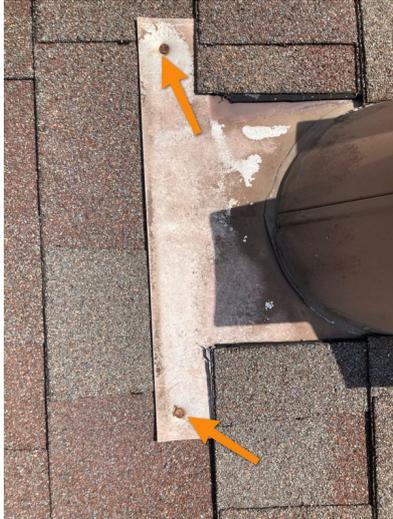
4: Exposed Nails

Under-driven or exposed nails were found in one or more roof coverings. Recommend a qualified roofer evaluate and correct. Unsealed nails will rust and create gaps where water can gain access to components that come become water damaged.

Recommendation: Contact a qualified roofing professional.

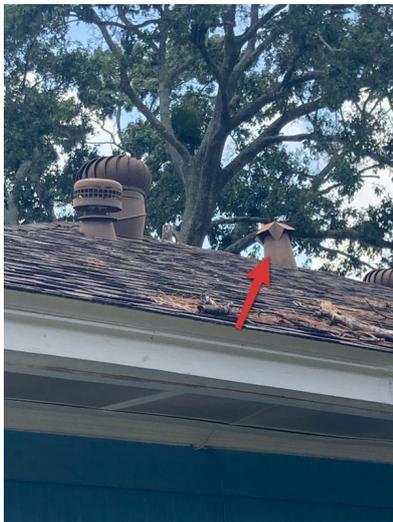
5: Furnace/Water Heater exhaust vent is too short or uses improper cover

Furnace exhaust vents are required to be 3 feet from any surface, and water heaters 2 feet from any surface on the roof to the vent opening. They also must use the appropriate vent cover. This is to help exhaust products draft, and protect materials from being exposed to the high temperatures that can result in shorting of the lifespan of the materials and possibly lead to a fire.

Recommendation: Contact a qualified professional.

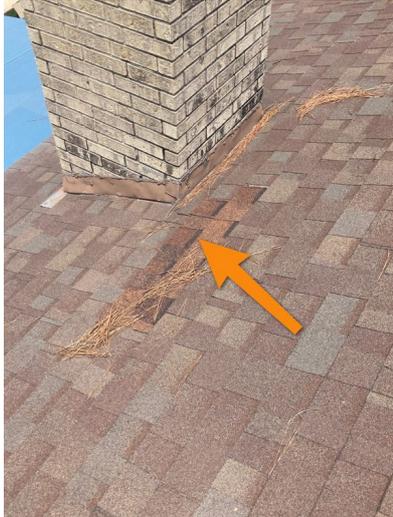
7: Sealant is missing or deteriorated

Sealant protects the roofing structure from water penetration. Any area that has a nail or a gap that could allow water to penetrate, should be sealed with roofing sealant.

Recommendation: Contact a qualified professional.

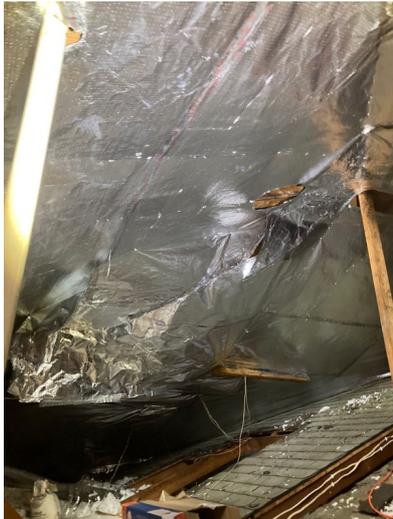
1: Attic entry is not properly secured

Attic entries need to be secured with 16d nails or lag screws. Most attic entries have labels giving instruction on how to properly install the entry. entrance ladder must be secured directly onto the framing without gaps.

Recommendation: Contact a qualified professional.

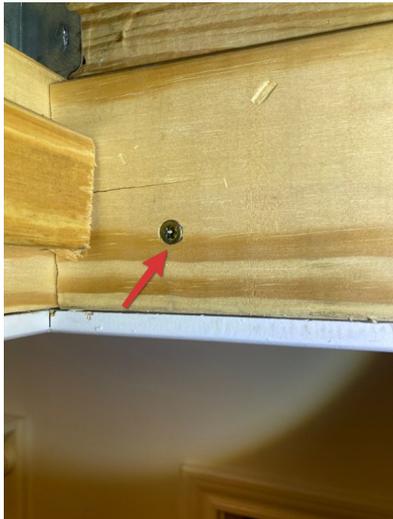
2: Attic entry is uninsulated/unsealed

Recommendation: Contact a qualified professional.

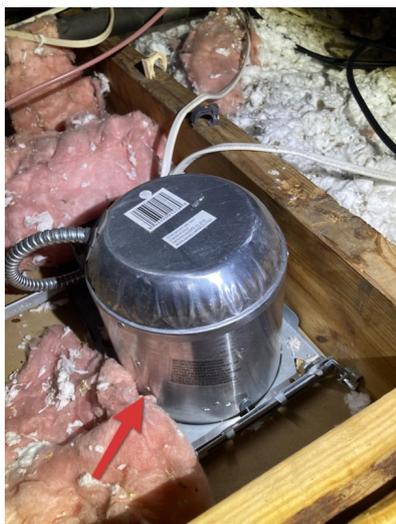
3: Canned lights are touching insulation

Canned lights can get hot and cause a fire if the proper distance is not maintained from combustible items.

Recommendation: Contact a qualified professional.

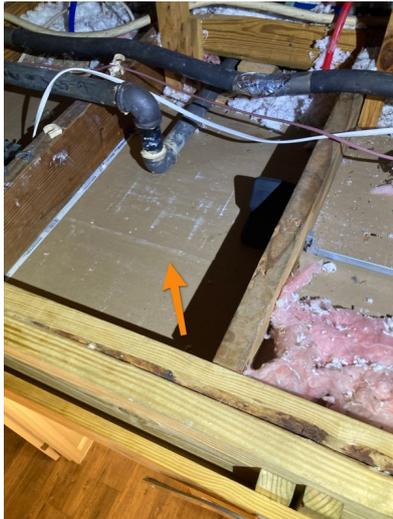
Insulation missing next to attic entry in master closet

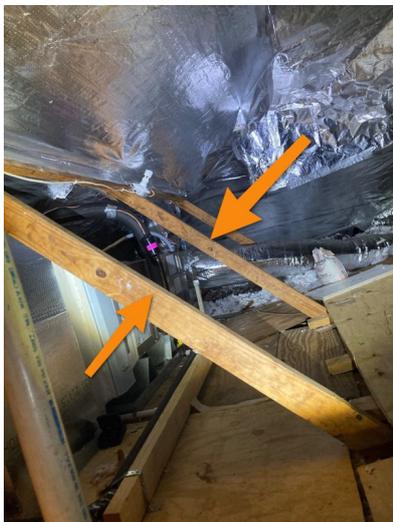
6: Ridge board is supposed to cover the face of the rafter

Recommendation: Contact a qualified professional.

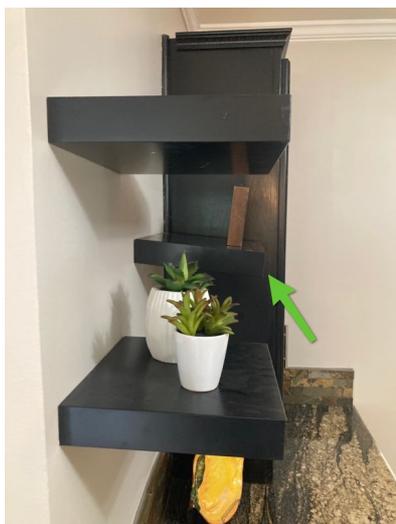
Shelf is not secure

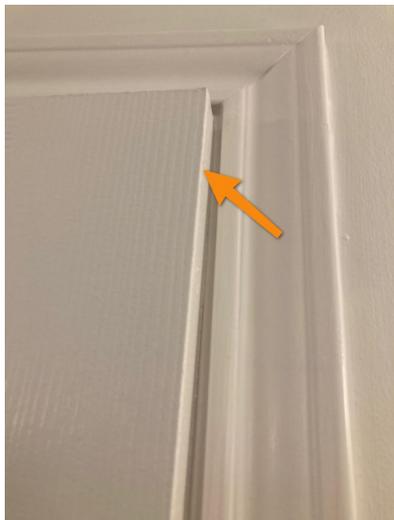
2: Doorstop missing or damaged

Recommendation: Contact a handyman or DIY project

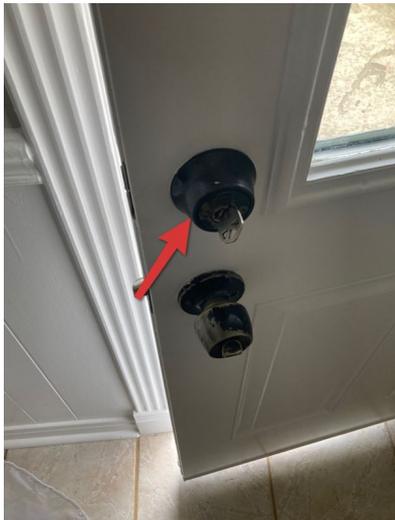
3: Exterior door for egress cannot require a special tool or key

In case of emergency egress doors cannot require a tool or key so occupants can exit quickly.

Recommendation: Contact a qualified professional.

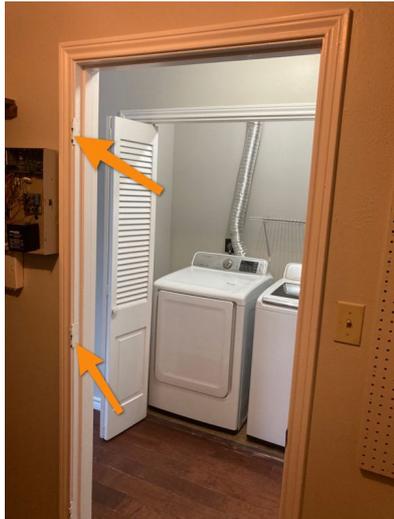
7: Needs sealed at threshold

Sealing will avoid water penetration under the flooring and should be sealed to avoid damage to flooring.

Recommendation: Contact a handyman or DIY project

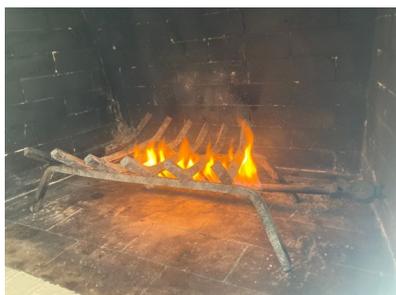
1: Chimney Liner Dirty

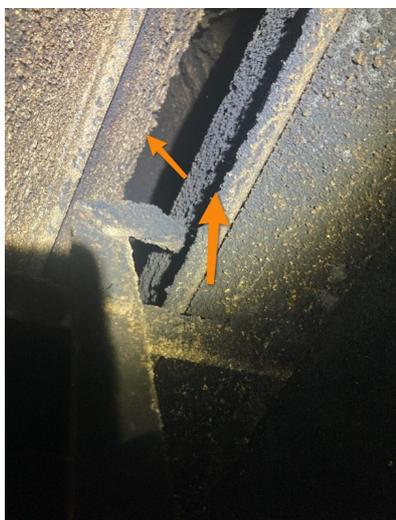
Chimney liner had layer of creosote dust, so underlying structure couldn't be inspected for cracks. Recommend qualified chimney sweep company inspect and/or clean.

Recommendation: Contact a qualified chimney contractor.

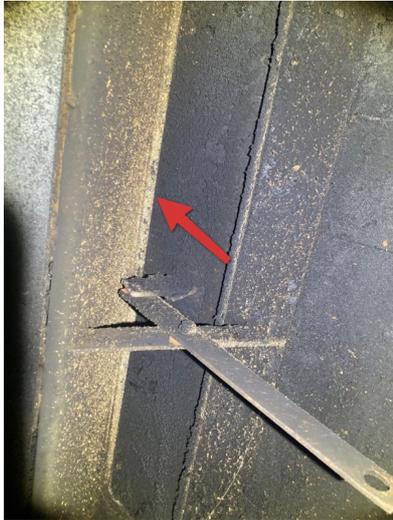
2: Damper needs a lock to keep it open

When gas is installed in a fire place it is important to keep the damper locked open so that any gases can exhaust and do not escape into the home.

Recommendation: Contact a qualified professional.

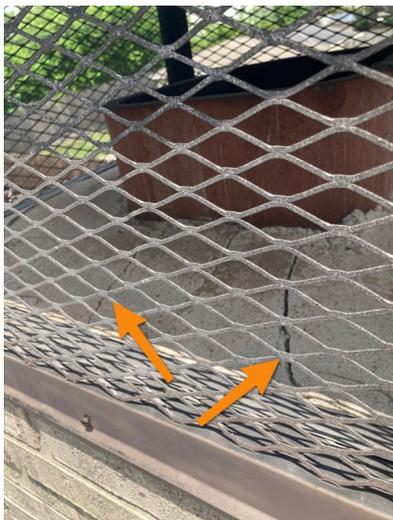
3: Mortar chimney cap is cracked

When cracks develop in a mortar chimney cap they can allow water to work its way into the chimney structure.

Recommendation: Contact a qualified chimney contractor.

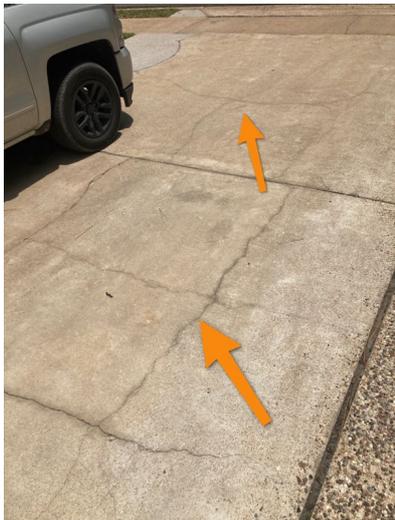
2: Cracked Exterior Floor

Recommendation: Contact a qualified concrete contractor.

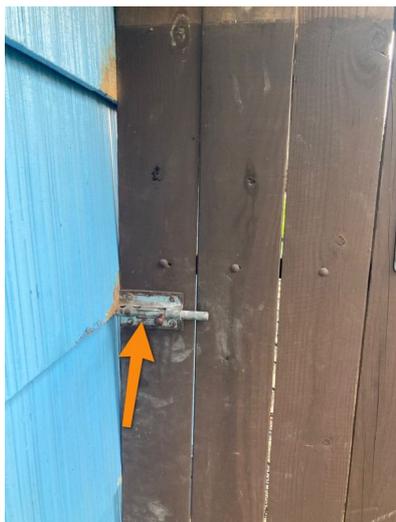
3: Gate needs to automatically close

Having a pool requires all gates leading to the pool area to close and latch automatically.

Gate does not latch

Recommendation: Contact a qualified professional.

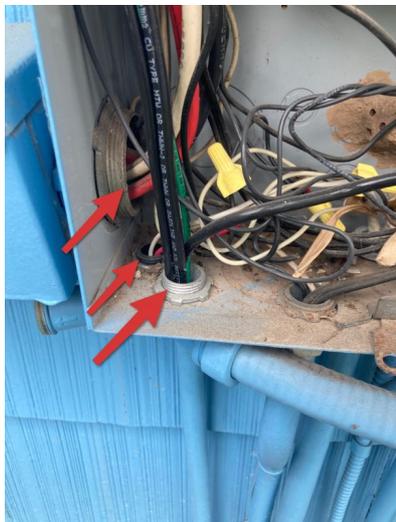
Bushings are installed to protect wires from abrasion when entering the panel box. Without them, the insulation around the wiring can be cut by the sharp metal in the entrance to the panel. This could cause arcing leading to electrical shock or fire.

Recommendation: Contact a qualified professional.

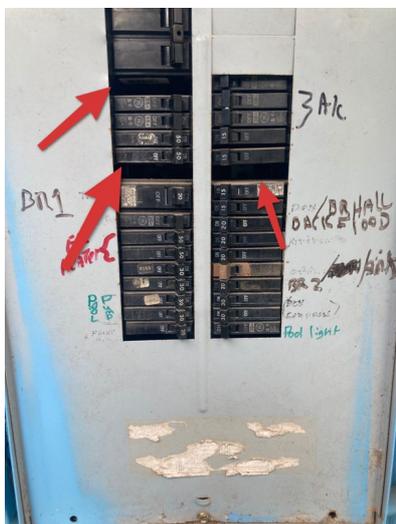
2: Knockouts are open

When knockouts are left open they allow pests into the panel which can pose a fire hazard. It poses a shock hazard to anyone touching the panel.

Recommendation: Contact a qualified professional.

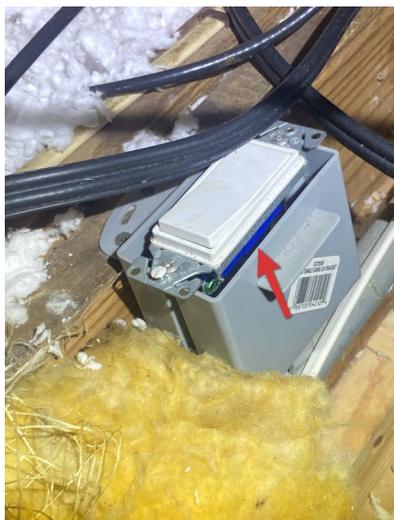
One or more receptacles are missing a cover plates. This causes a shock risk. Recommend installation of plates.

Recommendation: Contact a qualified electrical contractor.

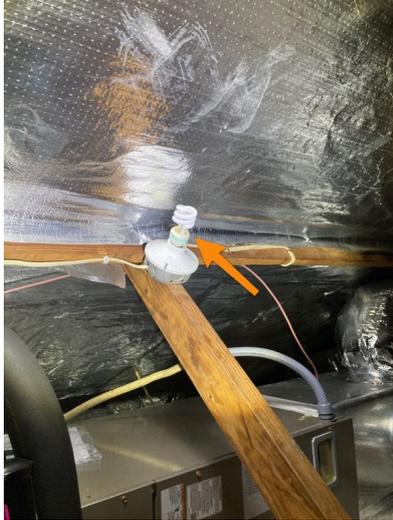
5: Fan wobbles as it rotates

Recommendation: Contact a qualified professional.

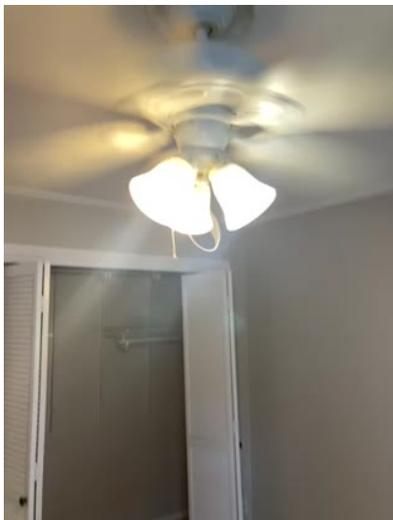
Fans can become loose and fall if they wobble.

Recommendation: Contact a qualified professional.

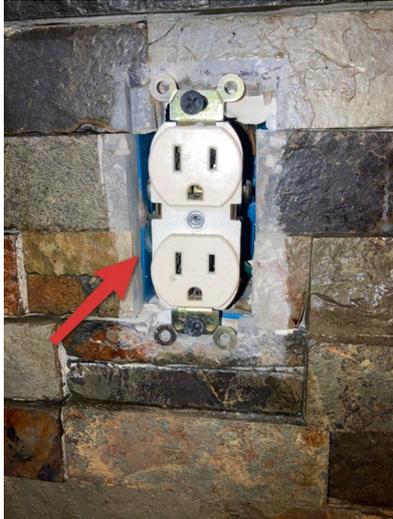
11: Outlet has no power

Have a licensed electrician return power to the outlets.

Recommendation: Contact a qualified electrical contractor.

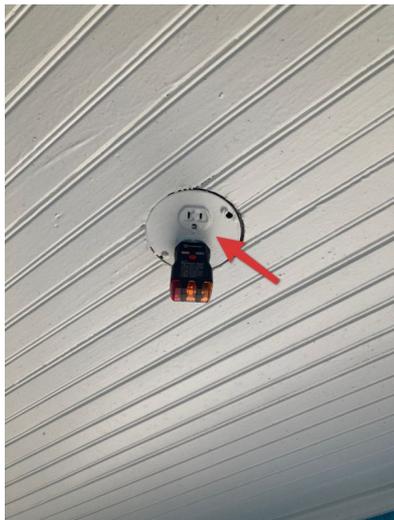
Front porch

13: Outlets, switches or electrical components have paint or combustibile material on them

Paint as well as any combustibile materials should not cover outlets.

Recommendation: Contact a qualified electrical contractor.

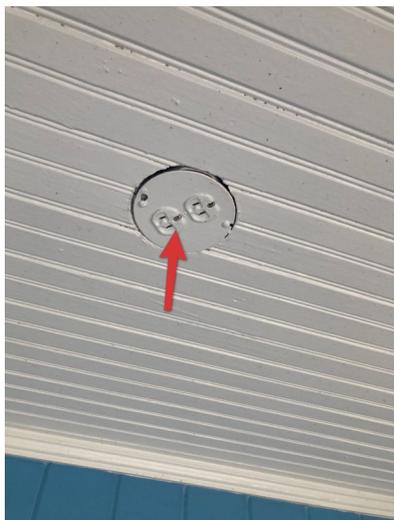
14: Plug or switch is damaged

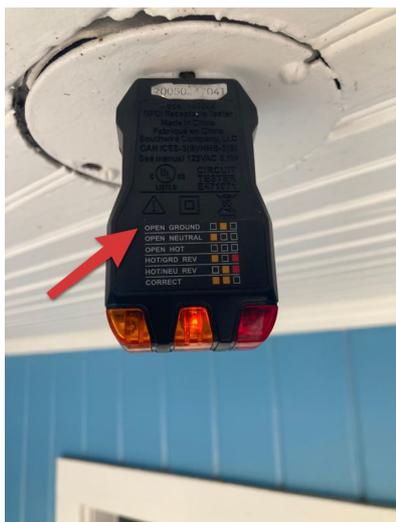
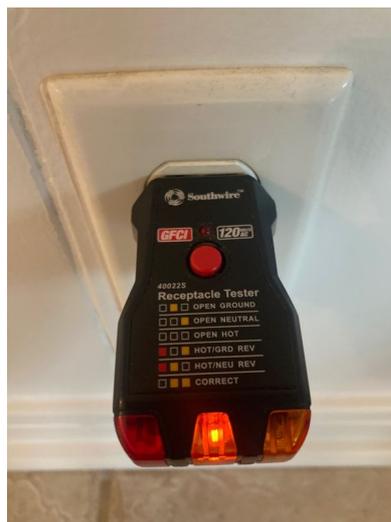
The ground for a plug protects users from equipment malfunctions by providing electricity with a path to ground.

Outlet left a fireplace

Recommendation: Contact a qualified electrical contractor.

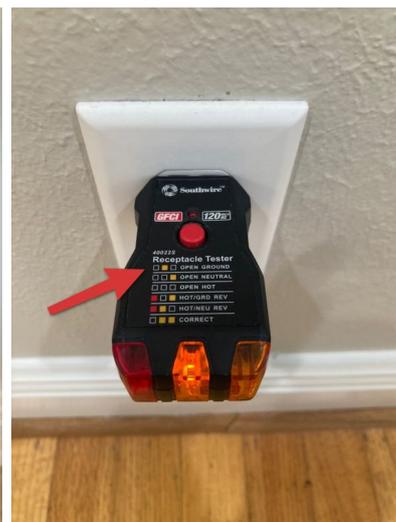
Multiple outlets in front living room

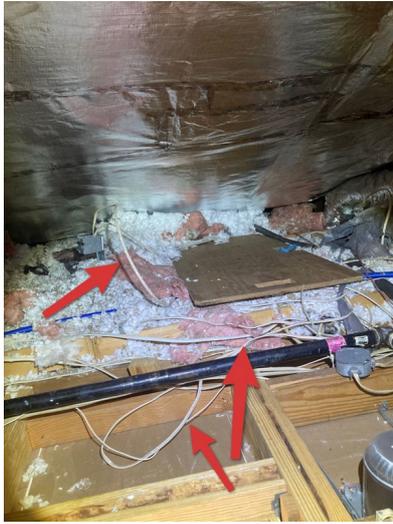
18: Wiring is not properly supported

Wiring needs to be properly supported every 6 feet, to avoid becoming entangled or damaging wiring.

Recommendation: Contact a qualified electrical contractor.

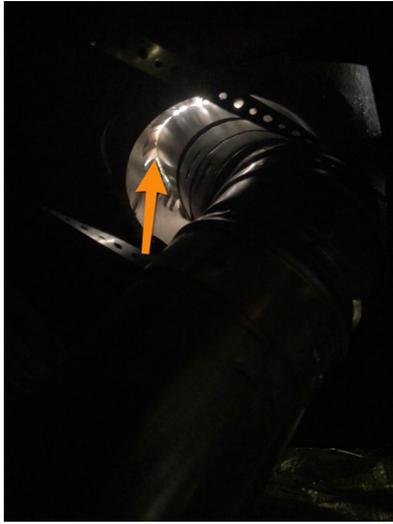
Roof jack should be sealed to a not allow water or insects inside home

Recommendation: Contact a qualified professional.

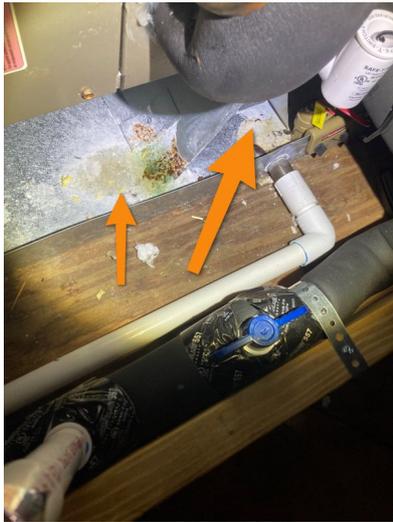
2: Drain pan has evidence of previous moisture

Monitor for moisture in the drain pan, and call an HVAC professional if moisture is discovered.

Recommendation: Contact a qualified professional.

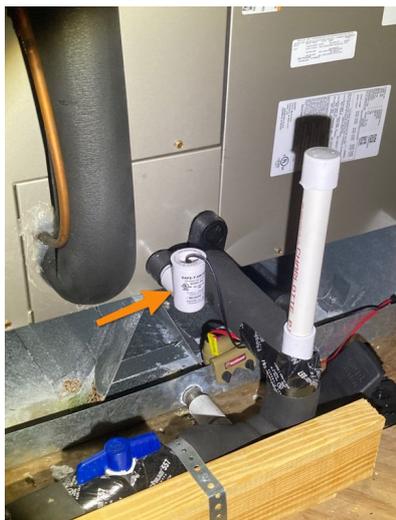
3: Secondary drain missing or not piped properly

Secondary drains are important to allow water to escape when primary drain is clogged. Improper installation or missing secondaries can cause water intrusion into attic, which can enter into lower floors causing water damage. Flexible pipe is not allowed to be used on secondary because it can kink and not allow for proper drainage.

Recommendation: Contact a qualified professional.

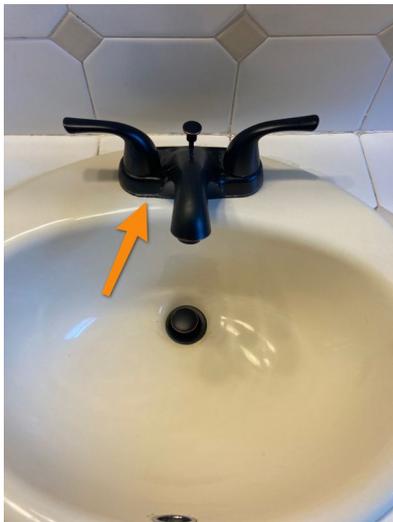
2: Faucet or handle is loose

Loose handles will strip connections and require replacement if not tightened. This will require replacement of the unit. Check all faucets and tighten handles to assure correct function. Loose faucets can leak and will not function correctly.

Recommendation: Contact a qualified plumbing contractor.

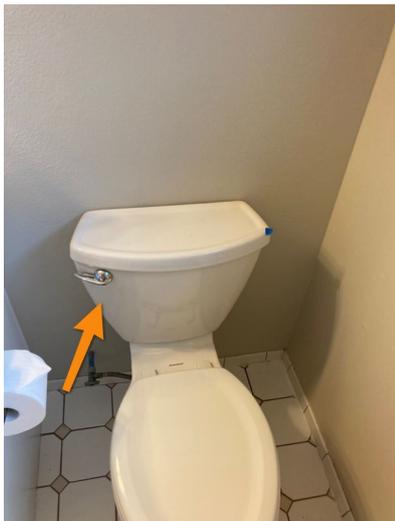
4: Toilet tank is loose

The toilet tank could become detached, which can cause a leak or possibly injure occupants.

Recommendation: Contact a qualified plumbing contractor.

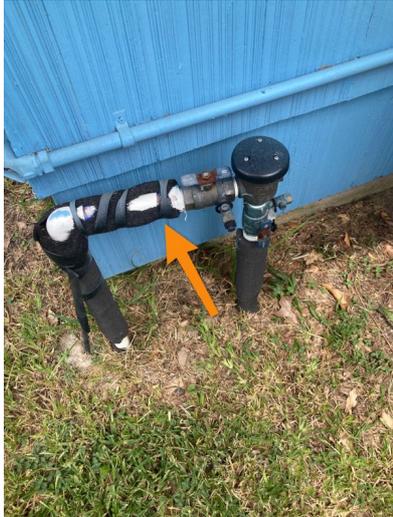
5: Anti-siphon device for sprinkler system needs to be supported.

Left unsupported, the anti-siphon device could be impacted and caused pipes to break or leak

Recommendation: Contact a handyman or DIY project

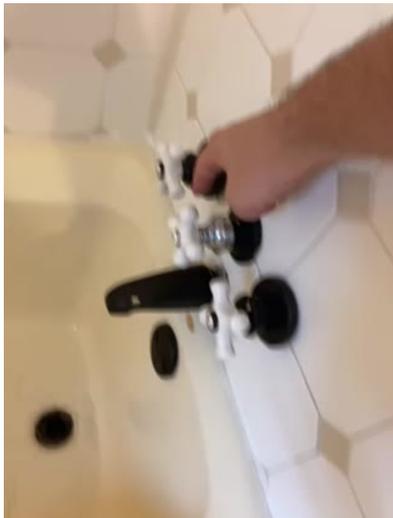
6: Spout diverter is stuck

When the spout diverter is stuck water cannot be switched between the shower head and faucet. Have a plumber correct the problem.

Recommendation: Contact a qualified plumbing contractor.

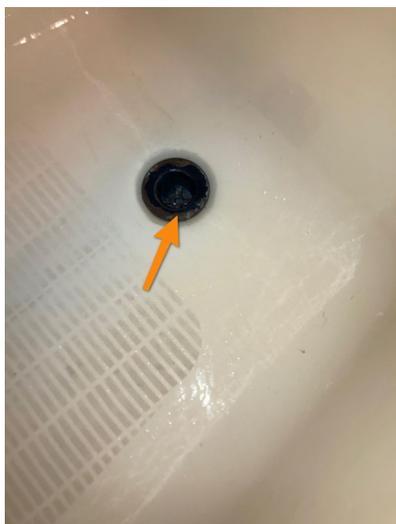
1: Drain stop missing or not working properly

Without a working drain stop drains cannot be tested at a high water volume, and spa tubs cannot be tested.

Recommendation: Contact a qualified professional.

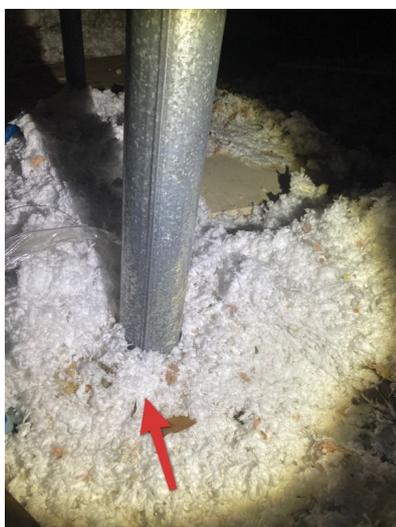
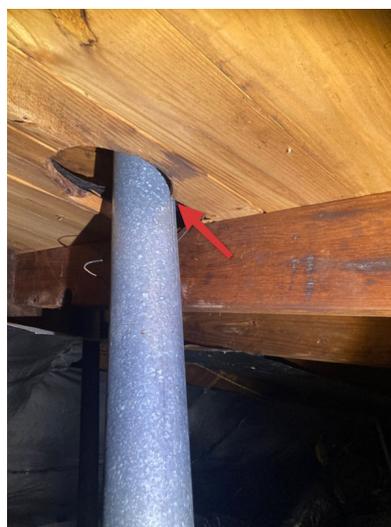
Gas appliance exhaust vents can get hot and should be kept away from combustibles.

Recommendation: Contact a qualified professional.

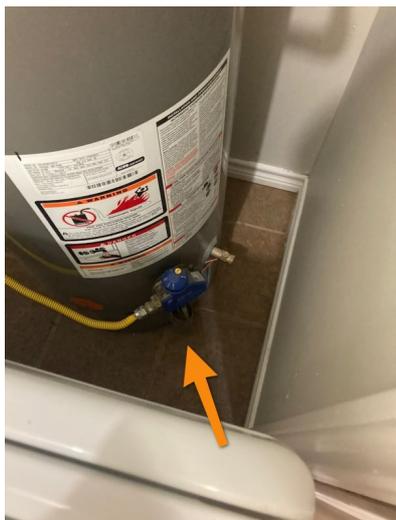
2: Pan is missing or does not cover all possible leak area

If the water heater starts to leak where the pan does not cover the water can damaged finishes and structural components.

Pan is missing

Recommendation: Contact a qualified plumbing contractor.

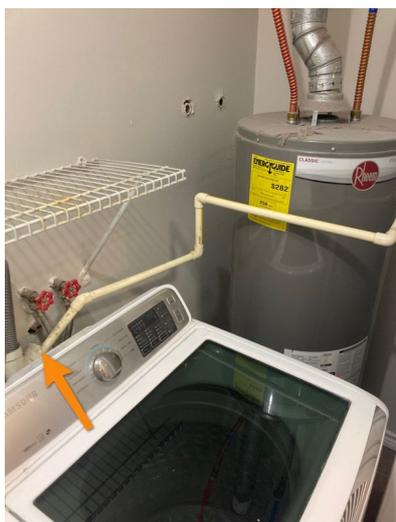
3: TPR and/or pan drain is not piped outside

TPR and pan drains should terminate outside when the water heater is in a location where water could cause damaged to finishes or structural members.

Recommendation: Contact a qualified professional.

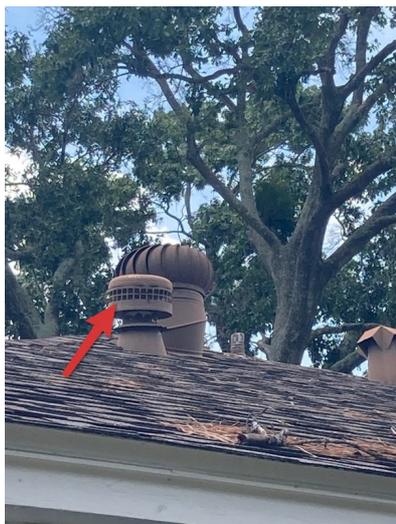
1: Improper dryer vent cover

Dryer vent covers are not allowed to use mesh like materials. These type of materials are known to collect particulates and clog dryer vents, which is a fire hazard. Replace with proper vent cover.

Recommendation: Contact a handyman or DIY project

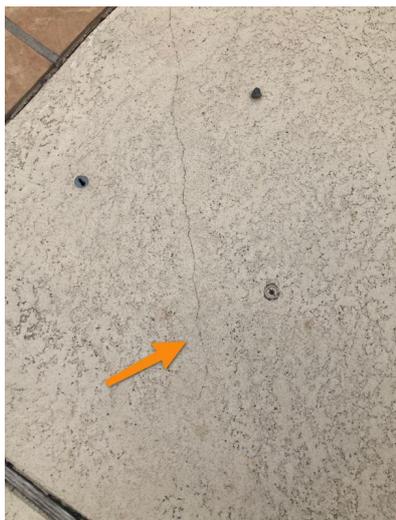
1: Decking is cracked

All cracks in decking need to be sealed to prevent further water penetration that could lead to further cracking.

Recommendation: Contact a qualified professional.

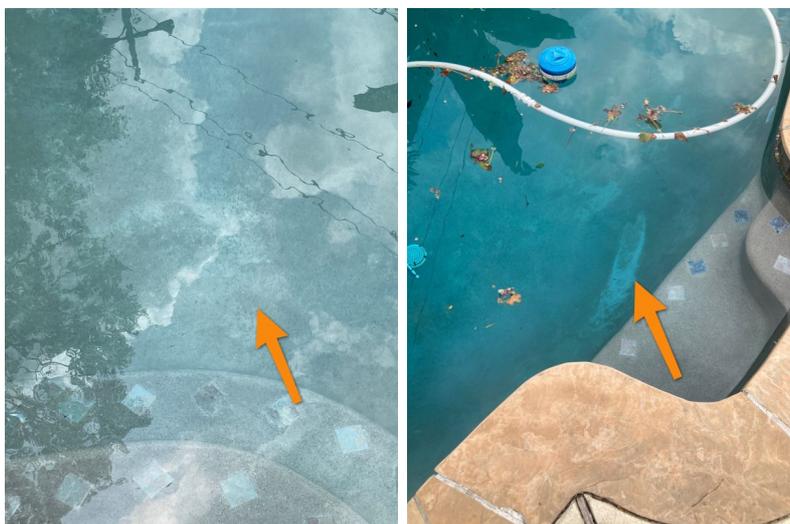
4: Pool bottom is deteriorated

Discoloring in the bottom of the pool indicates that the plaster is deteriorated. Deteriorated pool walls and bottom are rough and unpleasant to exposed skin.

Recommendation: Contact a qualified professional.
