NHI - RESIDENTIAL INSPECTION

988 Crane Ln
Bolivar Peninsula, TX 77650

PROPERTY INSPECTION REPORT FORM

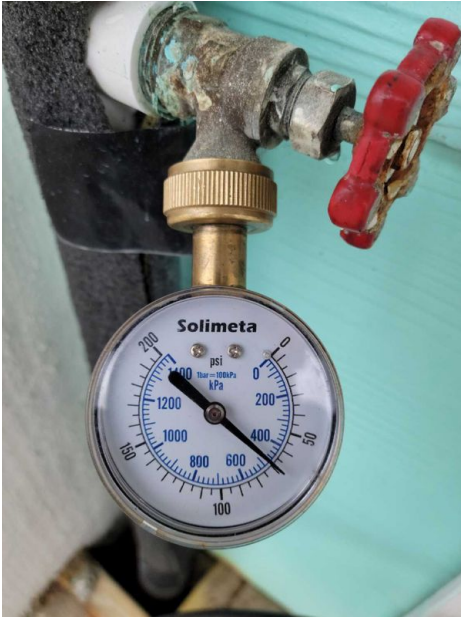
70psi

The water distribution pressure should range from 40 psi to 80 psi. Photos in this section do not represent a pressure deficiency and are for documentation purposes.

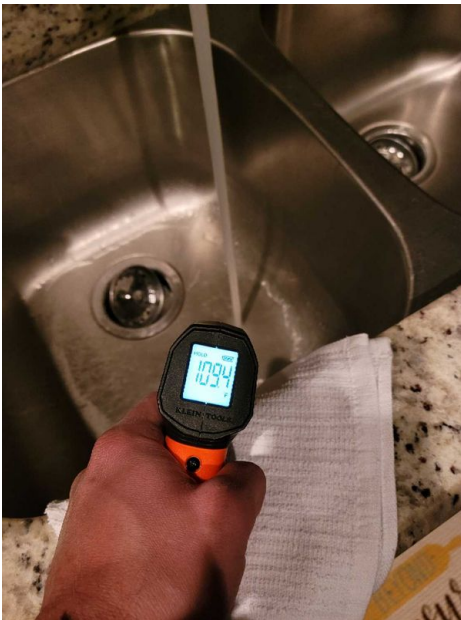
This inspection included a test of the water heater temperature as part of the inspection package.

Generally accepted safe and comfortable water temperature is one-hundred twenty (120) degrees Fahrenheit from a hot water faucet in the home. A temperature over one-hundred thirty (130) degrees Fahrenheit is general considered to be unsafe.

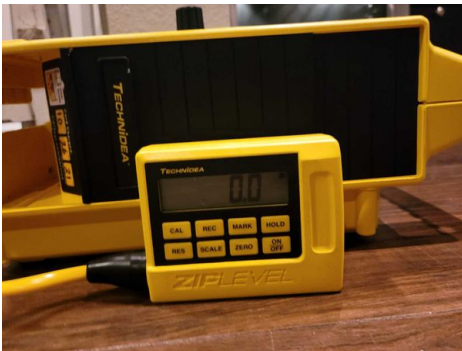
Base location photo(s):

The base location represents the 0-elevation mark where all other elevation readings are based. The other elevations read from the control panel represent the difference in elevation (in inches) from this base.

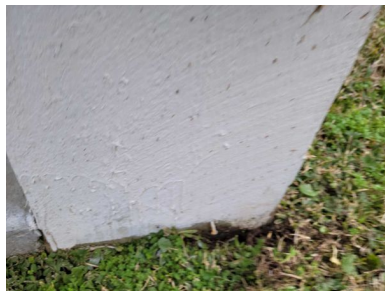
Right Back

1: Minor rot

One or more piers and/or beams show minor rot. These areas should be cleaned sealed and kept free of moisture to prevent further rot and damage to support members

Recommendation: Contact a qualified handyman.

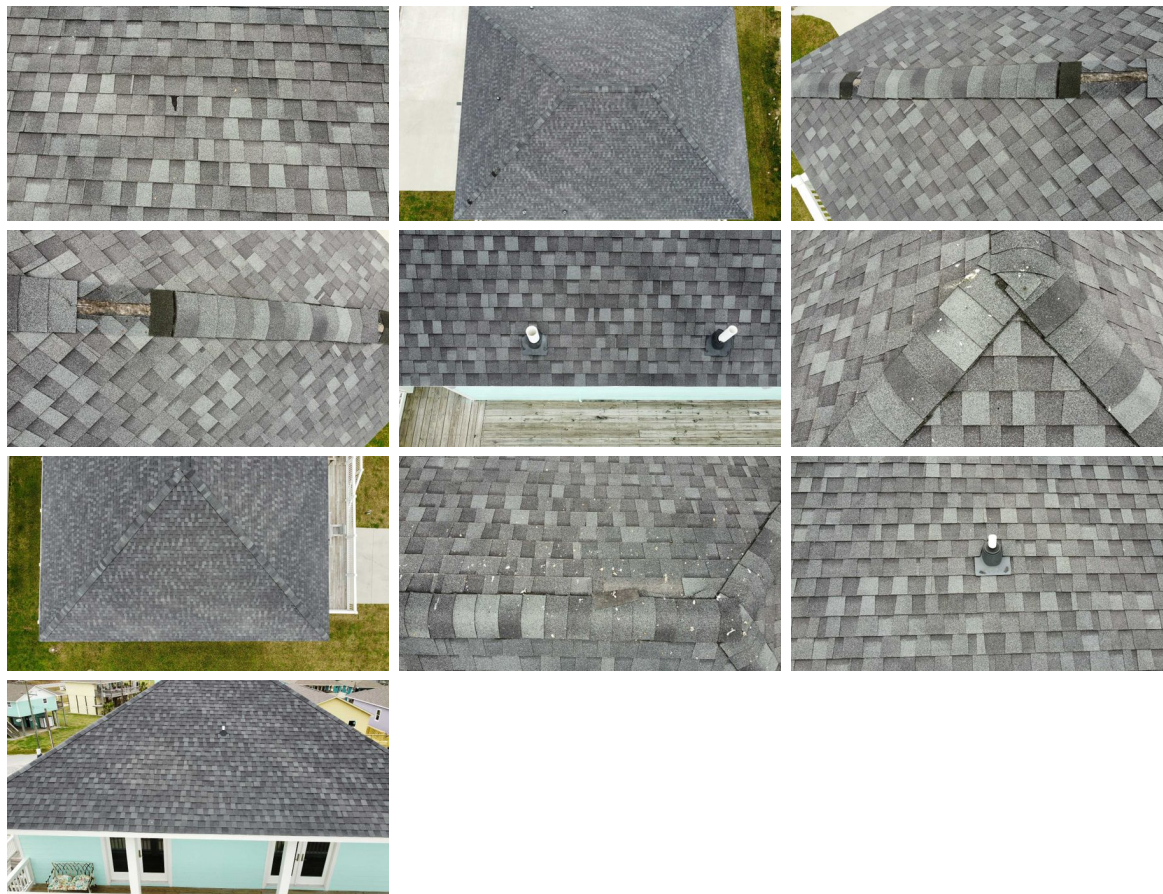
1: Damaged coverings

Roof coverings exhibited general damage that could affect performance. Recommend a qualified roofer evaluate and repair.

Recommendation: Contact a qualified roofing professional.

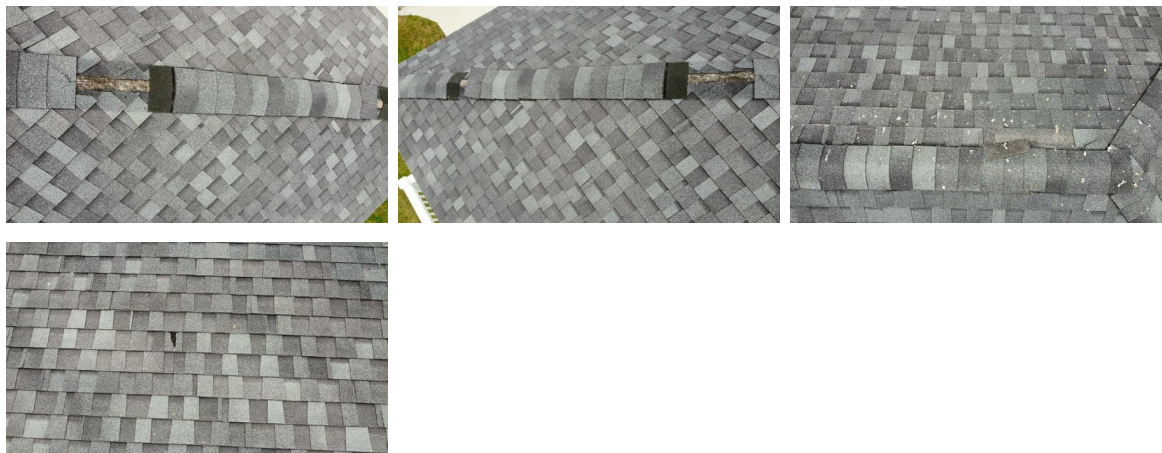
2: Discoloration

Roof shingles were discolored, which can be caused by moisture, rust or soot. Recommend a qualified roofing contractor evaluate and remedy with a roof cleaning or repair.

Recommendation: Contact a qualified roofing professional.

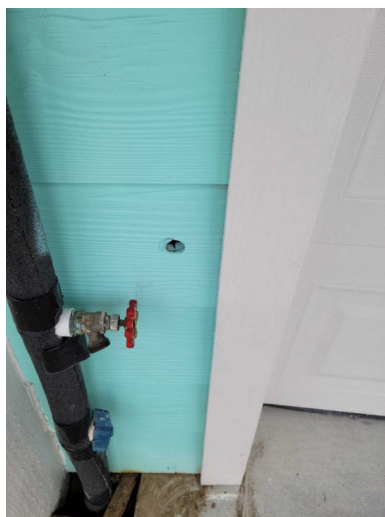
Front Middle

1: Siding is damaged or missing

The siding is damaged in these areas. Recommend a general contractor to resolve, as necessary.

Recommendation: Contact a qualified general contractor.

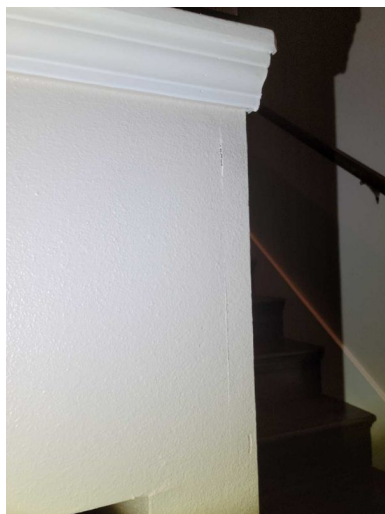
Stairs Middle

2: Cracks minor

Minor cracking was observed in wall structure. This is common in homes this age and is often determined to be cosmetic. Cracks can grow over time; recommend monitoring.

Recommendation: Recommended DIY Project

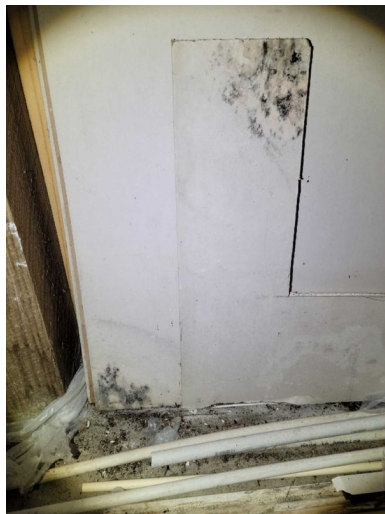
Garage

Observed signs of suspected mold in debris left in garage (discoloration, mold odor, mold spots, etc.)
Recommend mold inspector to inspect other areas

Recommendation: Contact a qualified mold inspection professional.

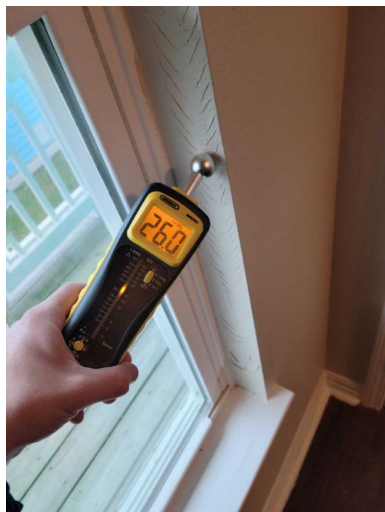
Game Room

4: High levels of moisture present

There are high level areas of moisture present on this wall. This was identified by a water stain or sign of water intrusion (active rot, wrinkled wallpaper, curled paint, expanded wood trim, etc.).

Moisture readings in this area are significantly higher than normal indicating an active building or plumbing water leak. Recommend a mold remediation contractor evaluate the area and a general contractor to determine why the area is experiencing high moisture levels.

Recommendation: Contact a qualified mold remediation contractor

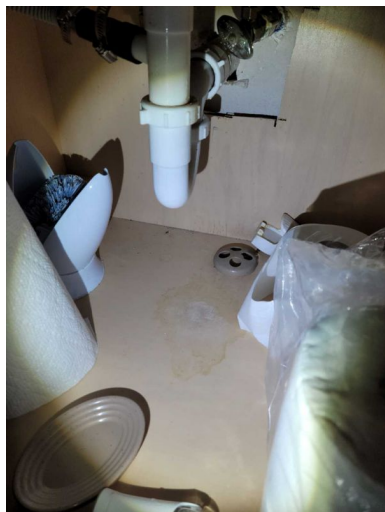
Primary Floor Hall Bathroom

6: Cabinet - water damage

One or more areas of the cabinet show signs of water damage. This is caused by water inundation or active leaking of the plumbing fixtures from above. Particularly in older homes, signs of water damage under the sink cabinets including stains, warping, and sagging flooring could be from previous deficiencies and are common discoveries. Recommend monitoring for future leaking and replacement depending on clients opinion.

Recommendation: Recommend monitoring.

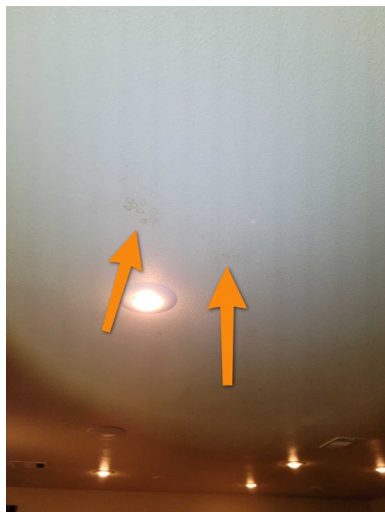
Primary Living above island

1: Ceiling - water stain observed

A stain on the ceiling is present. This stain did not visually appear damp and could be from a previously resolved water leak. Inspector is not always able to perform a spot moisture test on ceiling water stains because of the location and height. Recommend monitoring and addressing as necessary.

Recommendation: Contact a qualified general contractor.

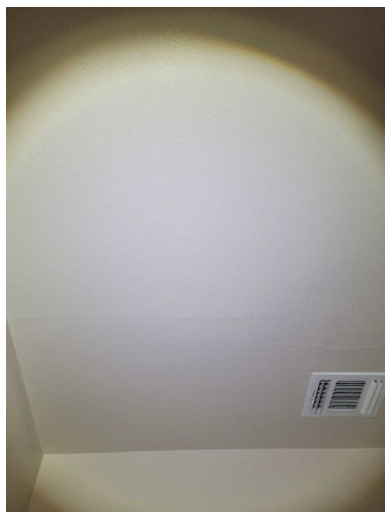
Primary Floor Front Left Bedroom

2: Ceiling - sagging drywall

Ceiling drywall sagged visibly at the time of the inspection. Unable to determine cause and this could just be cosmetic to poor install i reccommend further investigation into cause and repairing area where needed

Recommendation: Contact a qualified drywall contractor.

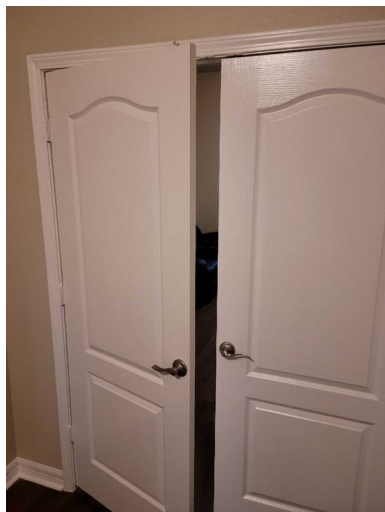
Theater Room

Door doesn't latch or close properly. Recommend handyman repair door, latch, and/or strike plate.

Recommendation: Contact a qualified handyman.

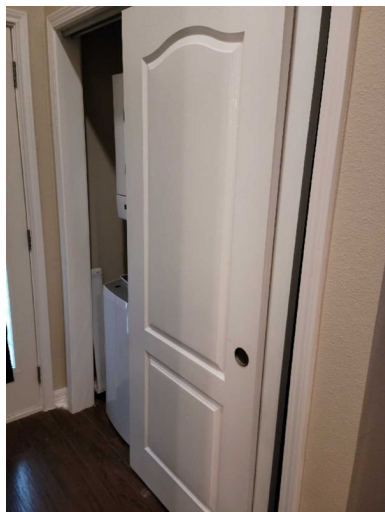
Laundry

4: Door rail issue

The door is not sliding on it's tracks / rails correctly or is off the tracks completely. Recommend a contractor evaluate and reinstall correctly.

Recommendation: Contact a qualified door repair/installation contractor.

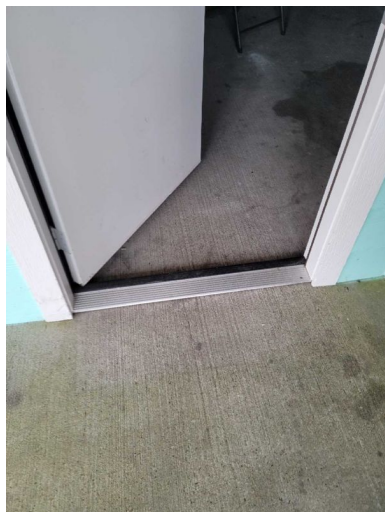
Garage

The door threshold is not fully supported, loose, causing a trip hazard, or is missing. The door threshold provides for an even transition from the exterior of the home to the interior; it also allows for the door to seal properly and transition to the interior flooring. The door threshold should be firm, fully supported, and even across the bottom of the door.

Recommendation: Contact a qualified door repair/installation contractor.

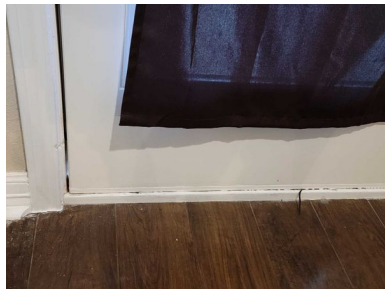
Front

6: Weather-stripping missing or insufficient

Door has missing or insufficient weather-stripping. This can result in significant energy loss and moisture intrusion. Recommend installation of standard weather-stripping.

Recommendation: Recommended DIY Project

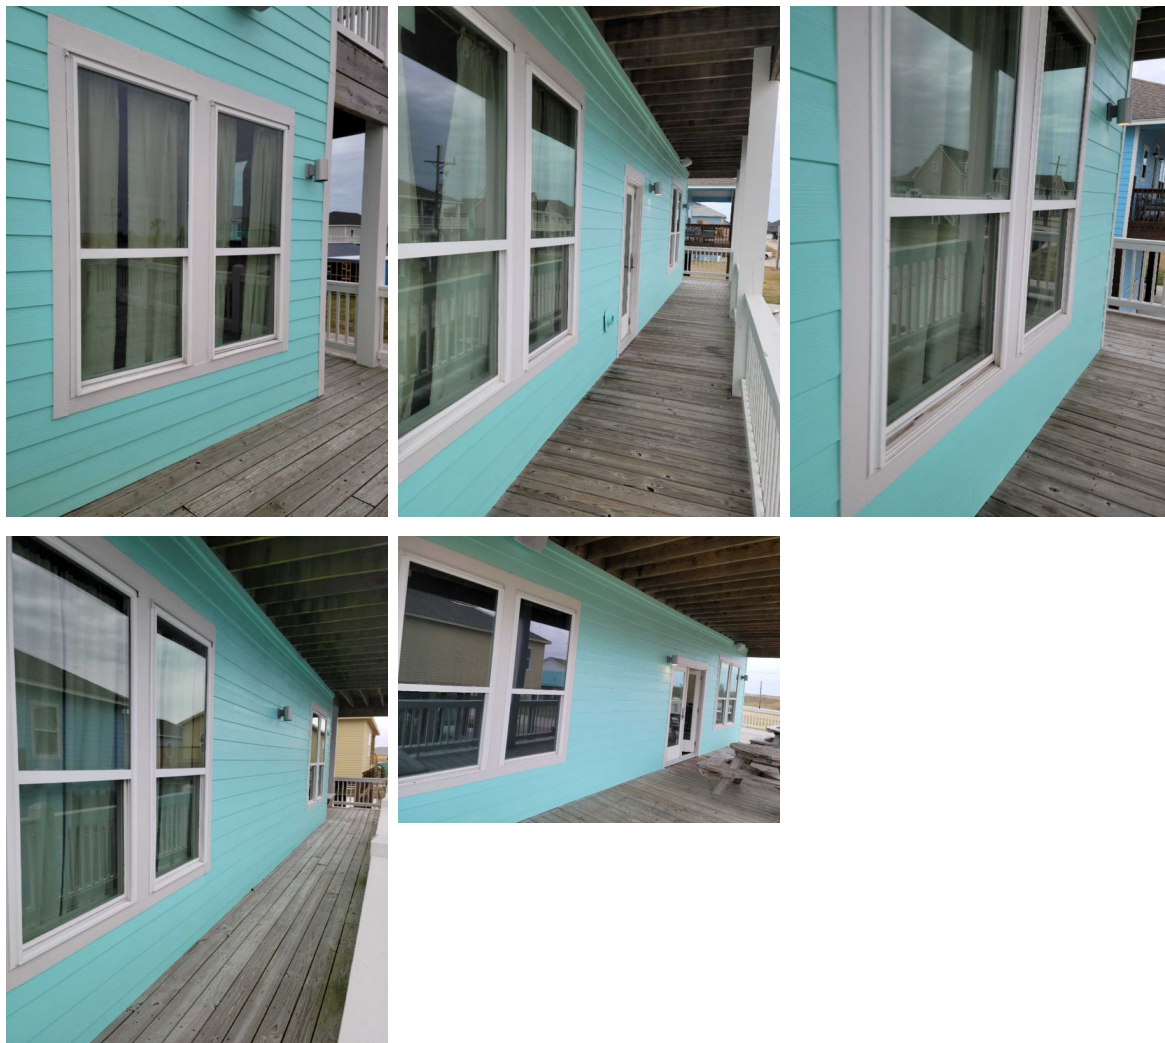
1: Window screen is missing or damaged

One or more windows has a missing or damaged screen. Recommend replacement depending on preference.

Recommendation: Contact a qualified window repair/installation contractor.

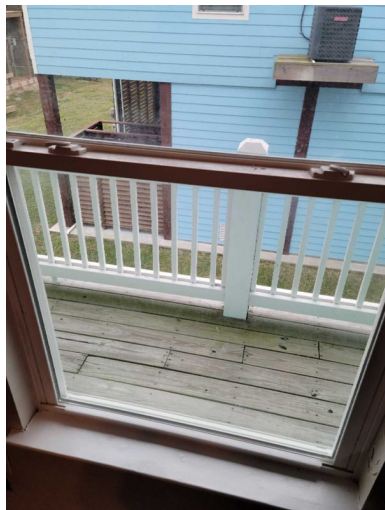
Game Room

2: Window won't open/close fully

One or more windows won't open/close fully. This could be caused by a number of reasons including structural deficiencies in the home, windows are locked, broken, or are painted shut. Recommend windows be restored to functional use by a window repair and installation contractor.

Recommendation: Contact a qualified window repair/installation contractor.

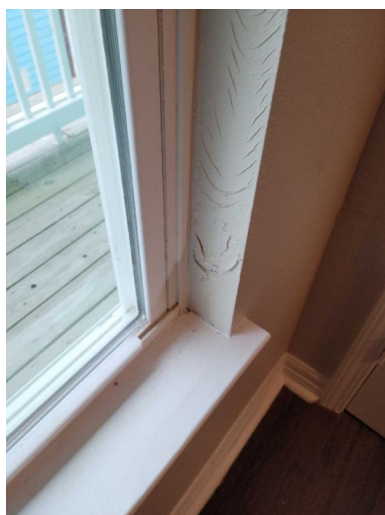
Game room

3: Window leaks at sill

The window sill shows signs of a window leaking water down the walls and onto the sill. This is common on homes that lack the correct flashing or necessary caulking on the exterior siding to prevent water intrusion.

Recommend re-caulking the windows exterior trim or having a siding contractor evaluate a remedy as necessary.

Recommendation: Contact a qualified window repair/installation contractor.

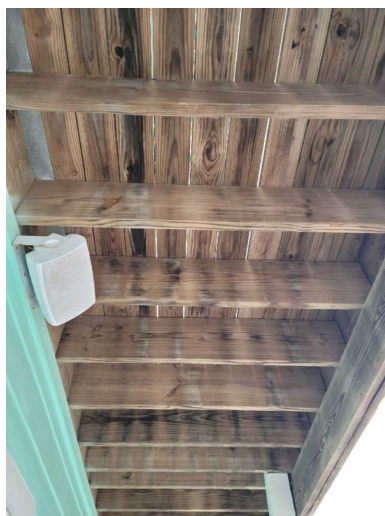
One or more deck boards are showing signs of rot. Recommend a qualified deck contractor replace.

Recommendation: Contact a qualified deck contractor.

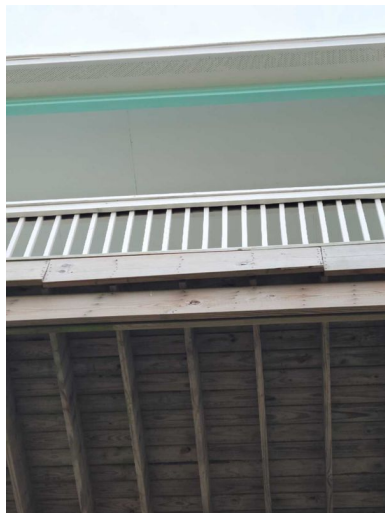
Back Right Top Floor

2: Deck has loose boards

One or more deck boards were observed to be loose. Recommend they be refastened.

Recommendation: Contact a qualified deck contractor.

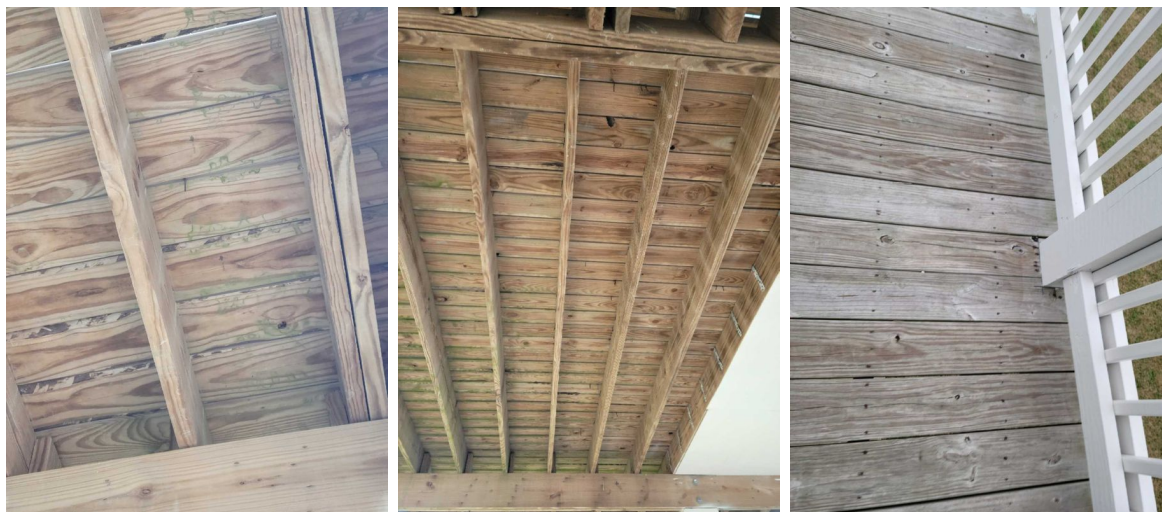
🟡Recommendation

One or more nails / screws were observed to be exposed. Recommend nails be reset.

Recommendation: Contact a qualified deck contractor.

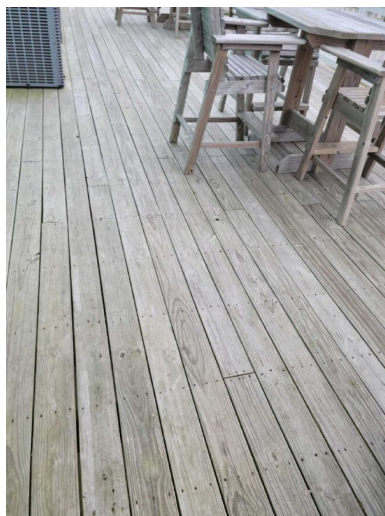
🔴Recommendation

Deck is showing signs of weathering and/or water damage. Recommend water sealant/weatherproofing be applied.

Recommendation: Recommended DIY Project

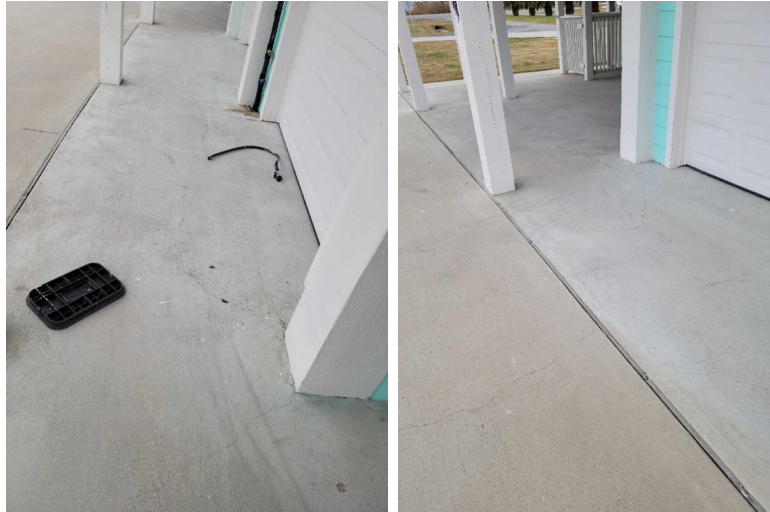
1: New concrete - cracks, separation, and heaving

and/or installed incorrectly. Compromised concrete will continue to exhibit decay, failure, collapse, and uplift if not remediated. Severe cracking can also be a safety hazard for pedestrians.

Recommendation: Contact a qualified concrete contractor.

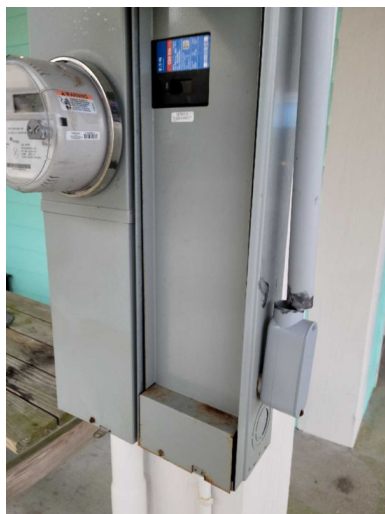
The electrical panel is corroded / rusted. Corrosion in the panel indicates that the box is likely an older model and the presence of moisture. Recommend replacing the box or repainting.

Recommendation: Contact a qualified electrical contractor.

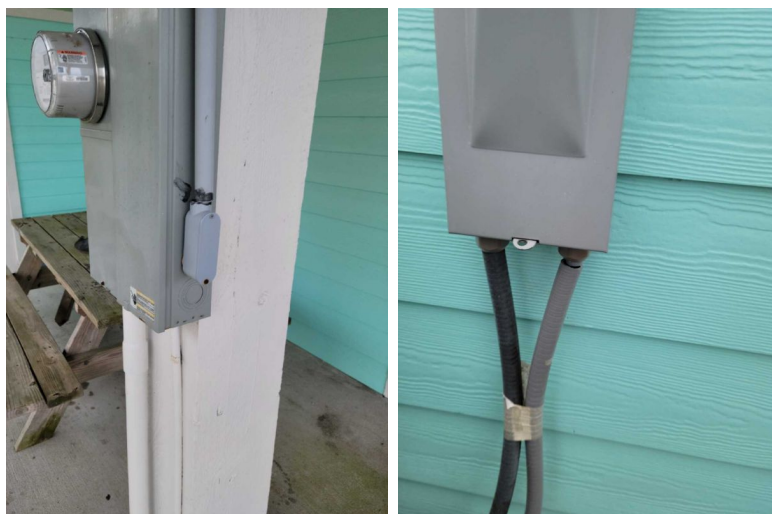
Back A/C Unit

5: Damaged conduit

Conduit is damaged and needs to be replace to prevent any damage to the wires it is ment to protect. This is considered a safety concern considering if wires did become damaged it could lead to shock or risk of fire

Recommendation: Contact a qualified electrical contractor.

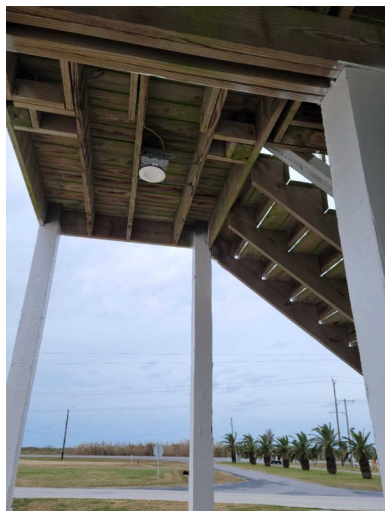
Front Left

2: Light inoperable / bulb needs replacement

One or more light fixtures were inoperable (didn't turn on when nearby switches were operated). Recommend further evaluation by replacing bulbs and/or consulting with the property owner. If replacing bulbs doesn't work and/or no other switch(es) can be found, then recommend that a qualified electrician evaluate and repair or replace light fixtures as necessary.

Recommendation: Contact a qualified electrical contractor.

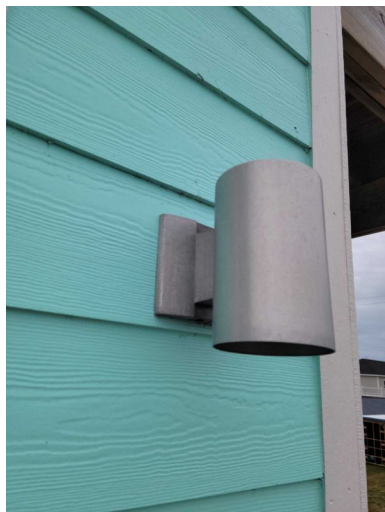
All exterior lights

5: Light fixture improperly sealed

Light fixture improperly sealed from the outdoor elements. Will allow for water penetration and could cause interior damage to home. Recommend reinstallation using approved caulking, sealants, etc.

Recommendation: Contact a qualified professional.

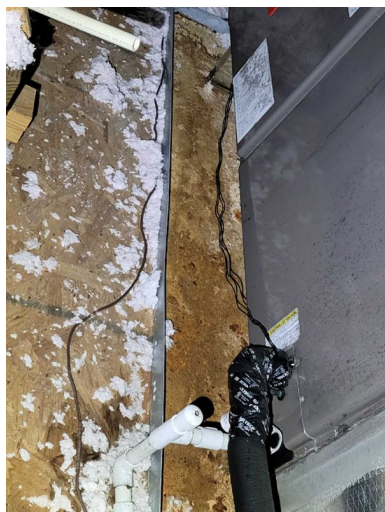
2: Evaporator - rust present in pan

Rust is present in the cooling system emergency overflow pan under the AC evaporator (inside unit). This could be caused by malfunctioning with consistent overflows. No active condensation leak into the pan is observed. Recommend careful monitoring.

Recommendation: Contact a qualified HVAC professional.

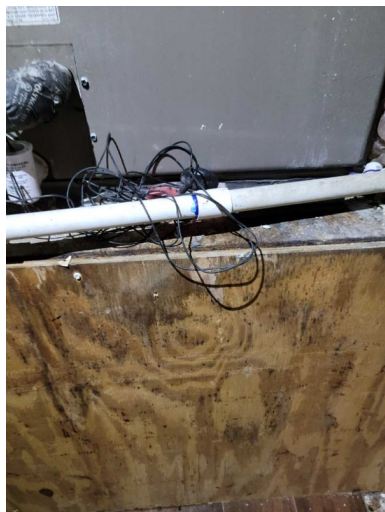
Primary Floor

3: Evaporator - mildew is present

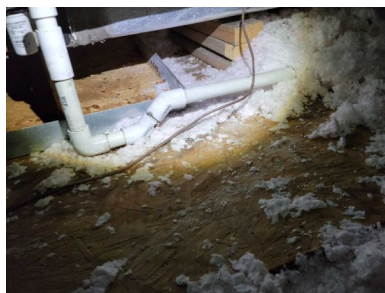
Attic

4: Evaporator - no backup or emergency overflow

In this case, the evaporator backup has been capped and will not divert overflow to a backup. No emergency overflow switch appears to be present. If the primary backup is clogged, the evaporator will become inundated with condensation and the unit will overflow, flooding what is beneath it.

Recommendation: Contact a qualified HVAC professional.

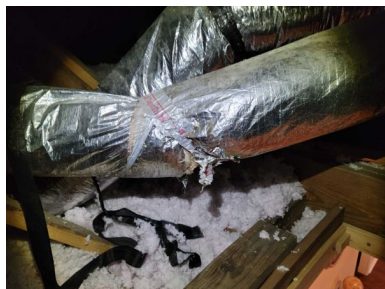
1: Duct damaged

Air supply duct was damaged. Recommend a qualified HVAC contractor repair.

Recommendation: Contact a qualified HVAC professional.

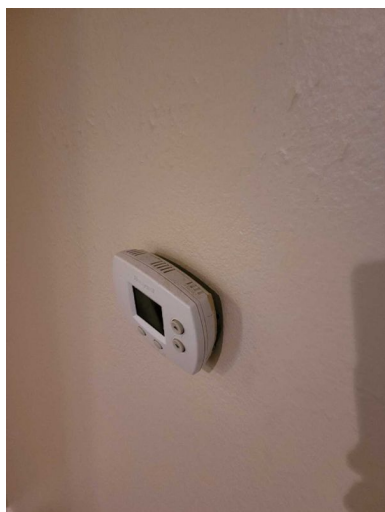
Top Floor

The thermostat is not mounted correctly and should be remounted to be sturdy.

Recommendation: Recommended DIY Project

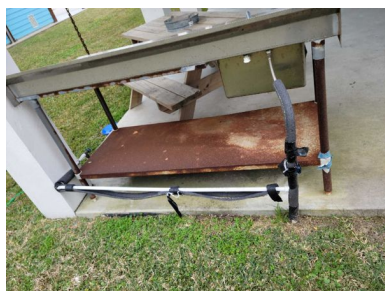
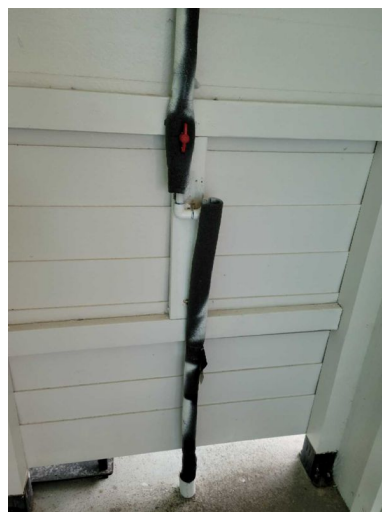
1: Pipe insulation damaged / missing

Water line insulation is important to keep distribution lines from freezing and bursting in cold weather. This includes areas in the attic, garage, or exterior areas where freezing temperatures can occur. Water lines should be insulated regardless of their type. Missing or damaged water line insulation was discovered and should be replaced.

Recommendation: Recommended DIY Project

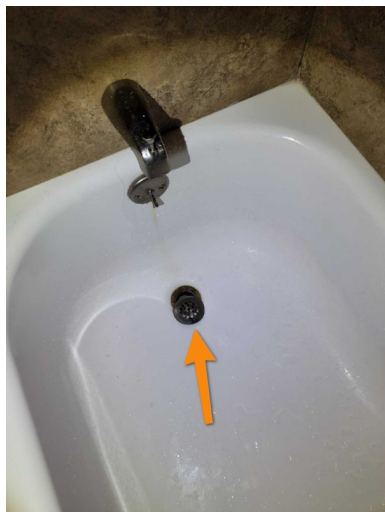
Primary Floor Front Hall Bathroom

2: Faucet / spigot drain pull issue

The faucet / spigot drain pull is not functioning properly or missing. Recommend plumbing contractor to resolve issue.

Recommendation: Contact a qualified plumbing contractor.

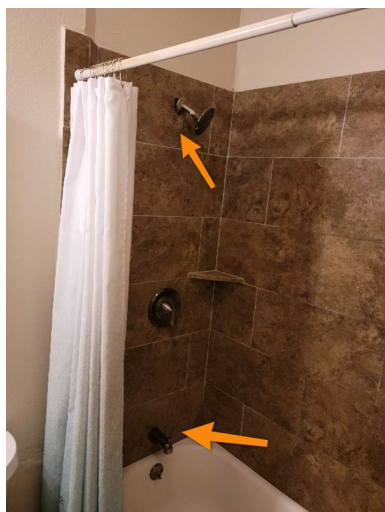
Primary Floor Front Hall Bathroom

3: Loose fixture

Plumbing fixture is loose. Recommend hiring a plumber to tighten fixture.

Recommendation: Contact a qualified plumbing contractor.

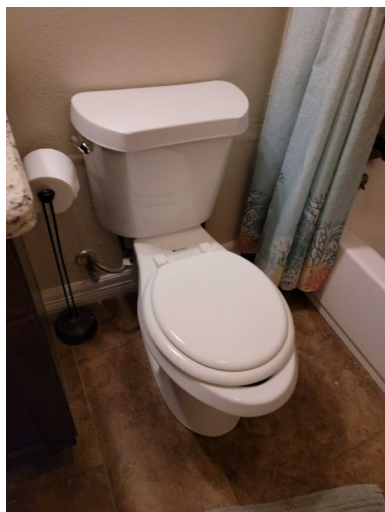
Primary Floor Front Hall Bathroom

5: Toilet is loose

The toilet is loose and not stable. This could be at the connection with the ground or at the bowl connection with the tank. Recommend tightening the toilet bolts or hiring a qualified plumbing contractor to tighten and further investigate.

Recommendation: Contact a qualified plumbing contractor.

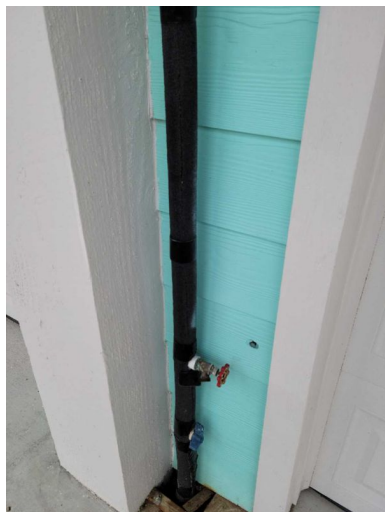
Front Middle

Water pipe has poor support and can move and flex easily causing risk of damage and leak recommend installing support to prevent the free moving of pipe

Recommendation: Contact a qualified professional.

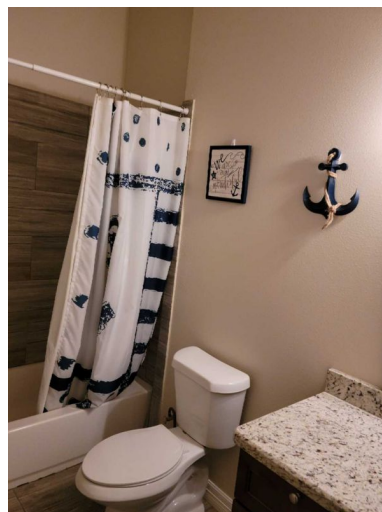
Top Floor 2nd Bedroom Bathroom

8: Excessive pipe noise

Pipes make loud noises when water is being used. This can be due to poor pipe support or to high pressure to pipes or possibly other issues. I recommend plumber further investigate to prevent any damage or leaks to pipe

Recommendation: Contact a qualified plumbing contractor.

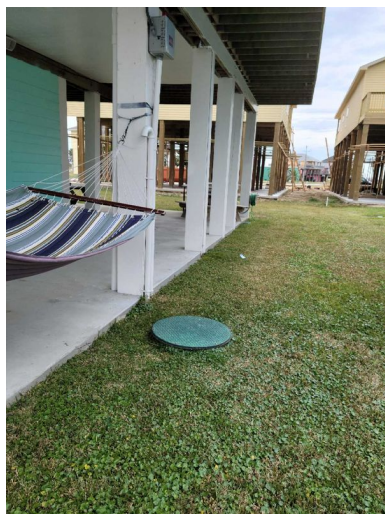
1: Poor / slow drainage

Poor/slow drainage was observed at time of inspection. Recommend a qualified plumber evaluate and repair.

Recommendation: Contact a qualified plumbing contractor.

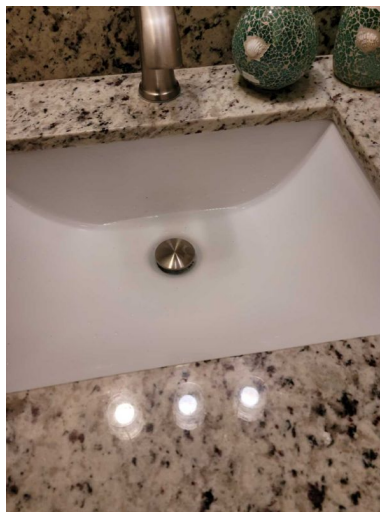
Top Floor 3rd Bedroom Bathroom

2: Leak

Sewage drain pipe appears to be leaking recommend further investigation by a plumber because if this is sewage water it is a potential health risk and the added moisture around structural support can be damaged

Recommendation: Contact a qualified plumbing contractor.

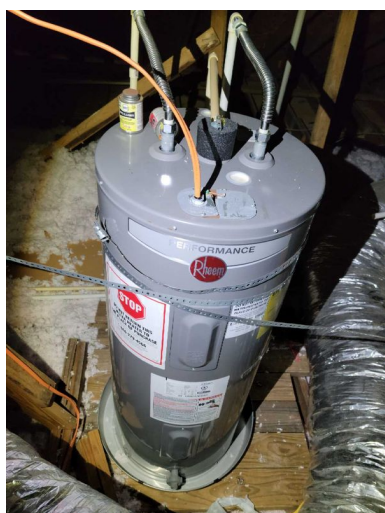
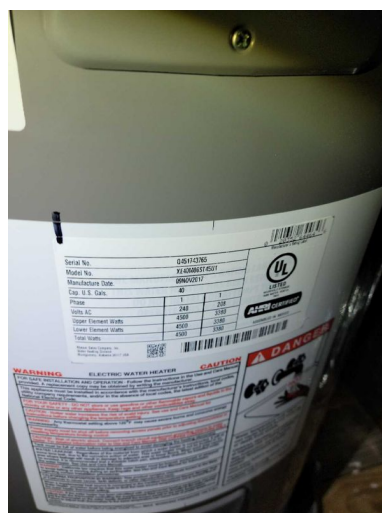
1: Electric - no disconnect

The water heater has no electrical disconnect. This is important because it would allow a person to directly disconnect the power to the water heater in the event of an emergency. Recommend hiring an electrical contractor to install a disconnect.

Recommendation: Contact a qualified electrical contractor.
