**104 S Timber Top Dr  
Spring, TX 77380**

TEXAS OFFICIAL WOOD DESTROYING INSECT REPORT

5. Single family dwelling List structure(s) inspected that may include residence, detached garages and other structures on the property. (Refer to Part A, Scope of Inspection)

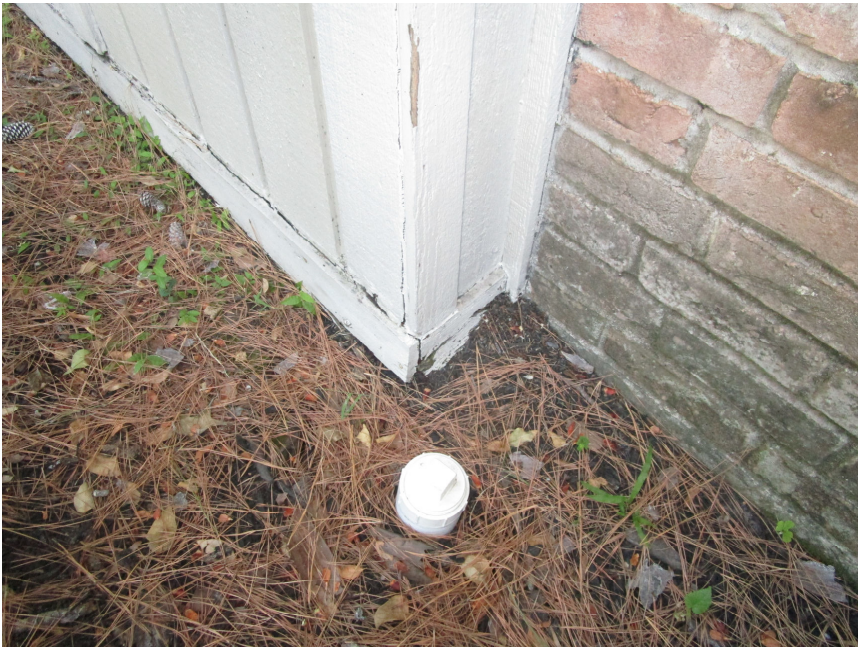
**Soil line too high / Wood rot / Wood to earth contact**

Specify reason: recommend lowering soil line, eliminating any wood rot, wood to earth contact, excessive moisture, and trimming foliage away from home in areas noted  
Refer to Scope of Inspection Part J

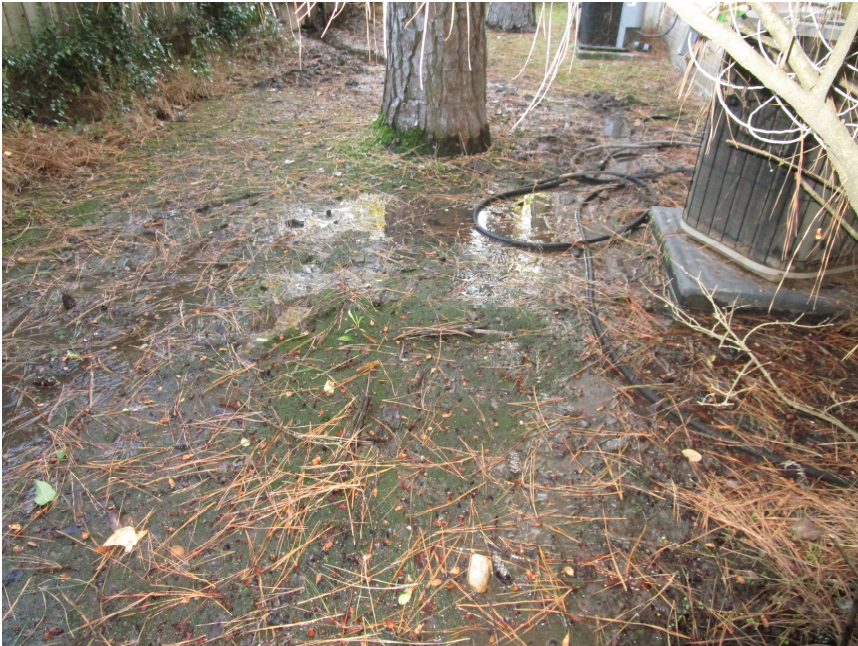
**Excessive moisture**
