HTX HOME INSPECTIONS
(281) 816-7007
info@htxhomeinspections.com
<http://www.htxhomeinspections.com>

TREC REI 7-6
7311 Keechi Pl
Mont Belvieu, TX 77523

PROPERTY INSPECTION REPORT FORM

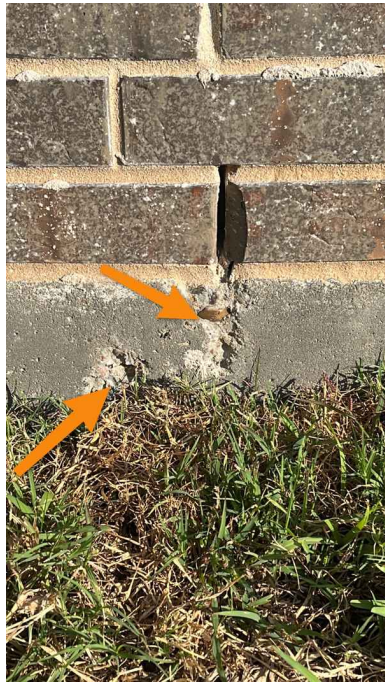
Right Side- chipping

1: Foundation Cracks/Chipping

Observed cracked or chipping in foundation at time of inspection. Vertical cracking in foundation sidewall is the most common and least severe type of foundation cracks. Foundation cracks occur for a multitude of reasons, from poor foundation construction, standing water, inadequate drainage system, type of soil, flooding, plumbing leaks, evaporation, soil condition, large trees and improper soil compaction. If cracks appear to be widening over time we recommend contacting a qualified professional or structural engineer for further evaluation. Cracks that exceed 1/8" in width can be a sign that the concrete slab has been structurally compromised. Chipping in foundation walls typically occur during the initial pour of the foundation. From removal of foundation form boards to impact from tools or equipment chipping of the foundation wall, in most cases, doesn't impact the structural integrity of the foundation.

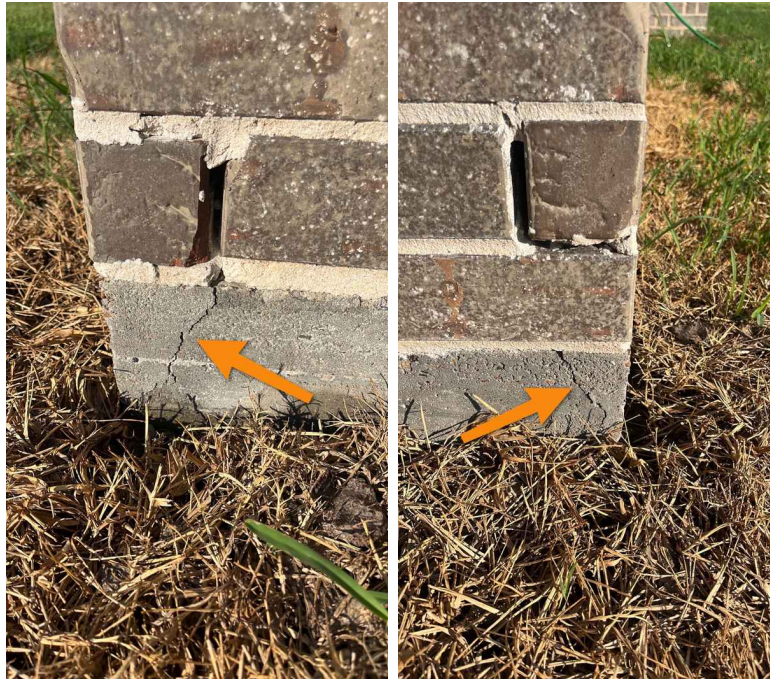
Rear Left

2: Foundation Cracks- Corner

Foundation corner crack(s) observed. Corner cracks are a common occurrence with foundations, in some cases its due to the changes in temperature between the foundation and the brick veneer. They can also occur from normal settlement of the home.

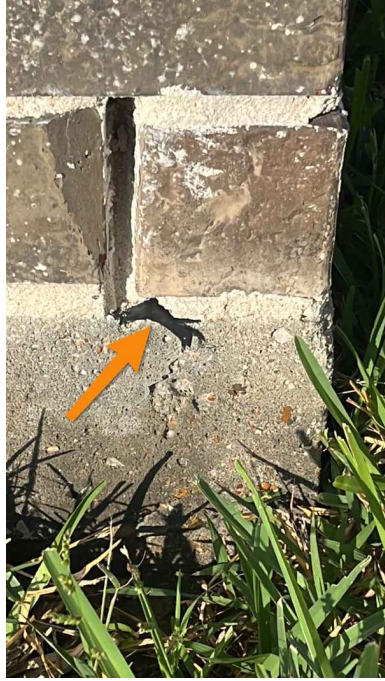
Rear Right

3: Foundation Moisture Barrier- Exposed

Observed exposed moisture barrier in one or more locations around foundation. Recommend trimming material to allow visual inspection of foundation wall and to prevent possible pest infestation from going unnoticed.

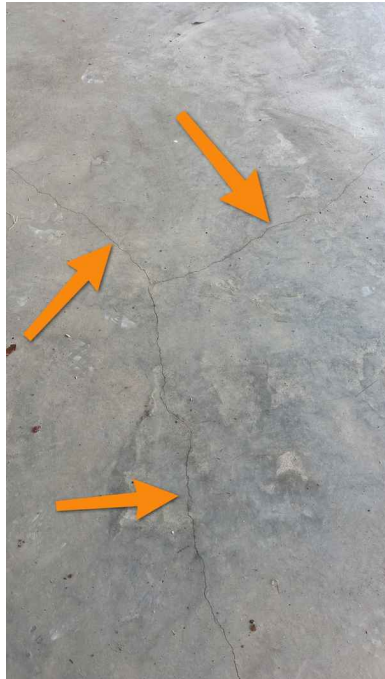
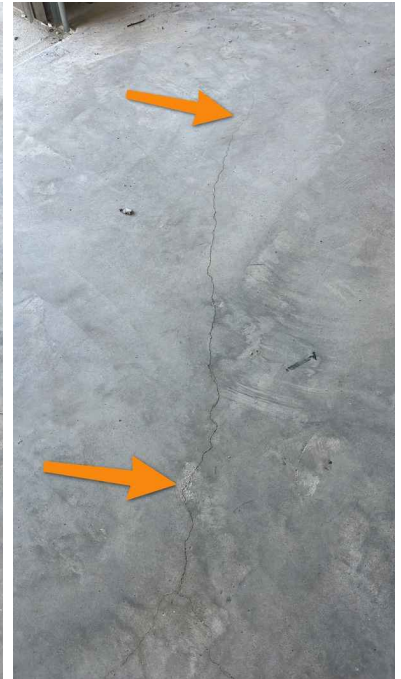
Garage

4: Hairline Cracks

Observed what appears to be surface cracks in concrete floor, driveway, garage or patio during inspection. Cracking occurs when shrinkage forces become greater than the strength of the concrete. When surface moisture of recently placed concrete evaporates faster than it can be replaced by water in the concrete mix that is pushed upwards, causing the surface concrete to shrink more than the interior concrete. Concrete shrinkage is common; as long as cracks don't exceed 1/8" in width. Cracks that exceed 1/8" in width can be a sign that the foundation, walking surface, garage or patio floor has been structurally compromised.

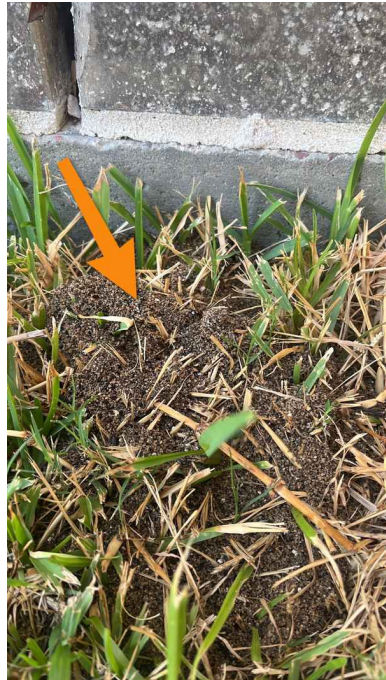
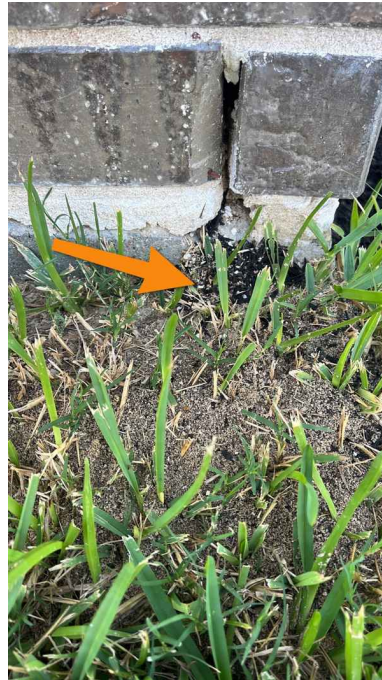
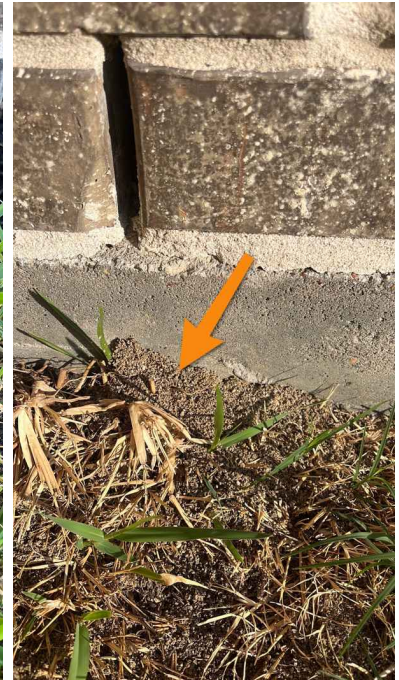
Right Side- ants

Observed signs of pest intrusion at time of inspection. Pest identifiers such as chewing/tearing on fiberglass insulation or foam pipe coverings, rodent droppings, rodent traps, mud tubes on exterior foundation walls, actual sightings of pest during inspection and nest are an indication that there has been previous pest control attempts or current pest activity. Pest such as ants and wood destroying insects build nest utilizing the soil and can go undetected if soil level or grass is not kept at a proper height around foundation wall. Pest intrusion that has caused damage to structure could be an indication that wood destroying insects or termites have been present or are currently present.

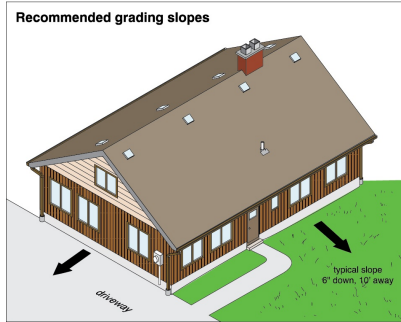
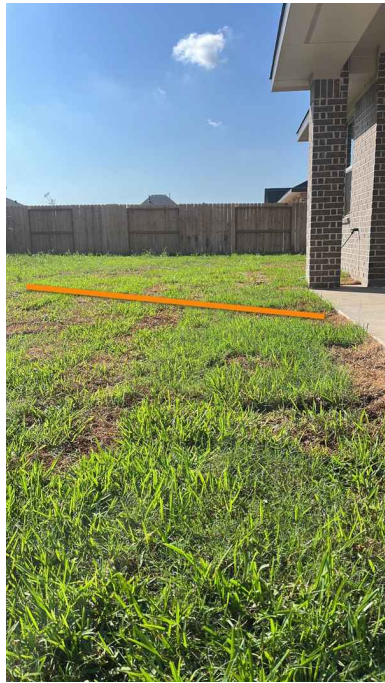
Rear

Observed improper grading in one or more areas of the yard. Grading should fall 6" within first 10' extending from the foundation wall outwards towards property line. If grading meets the required specifications runoff will properly drain, pooling won't occur and wet grading will dry out in a more timely manner.

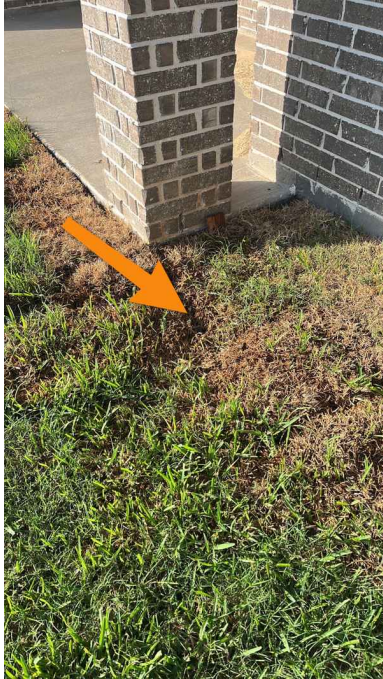
Rear Right

Observed a hole/low spot in yard at time of inspection. This could pose a trip hazard, allow for pooling of water and improper drainage of run-off. If low spot is near foundation this will allow water to pool next to foundation wall and eventually work its way under foundation; this will cause the soil below the foundation to erode. It is recommended that the low spots be filled with top soil to create a level surface and achieve proper drainage of water.

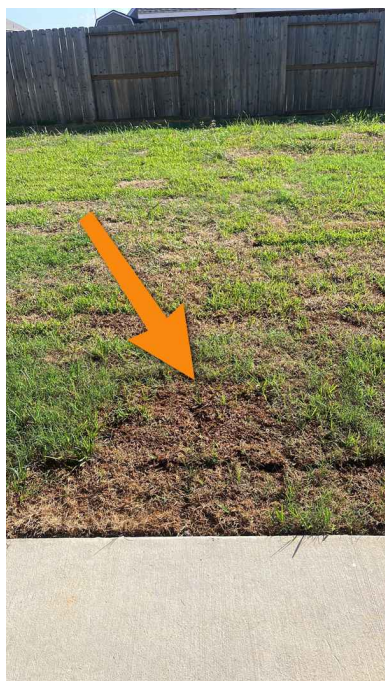
Rear

Standing water or saturated grading observed, which could indicate poor drainage, insufficient/improper grading, recent/current rain during inspection or a water line leak. Recommend a qualified landscaping or qualified professional for further evaluation.

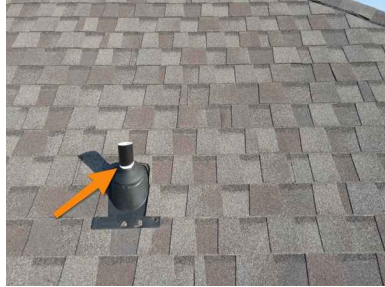
Observed unpainted or deteriorating paint on roof exhaust or air vents. Adding a coat of weather resistant paint to exhaust and air vents will minimize rust and prevent UV damage to PVC air vents. Painting will also blend those vents with the homes exterior finishes.

Right Side- needs to be fully painted

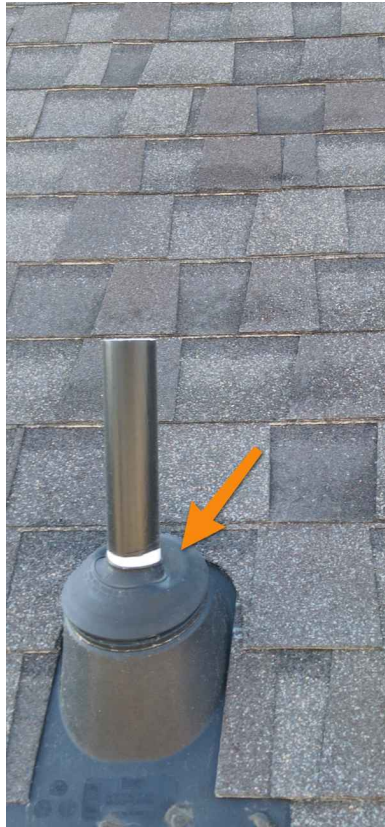
Left Side

Observed boot on vent stack indented at time of inspection. Indentions in the rubber around the air vent will allow moisture to sit and eventually erosion or cracking in the rubber or sealant will occur which will lead to leaks into the attic space.

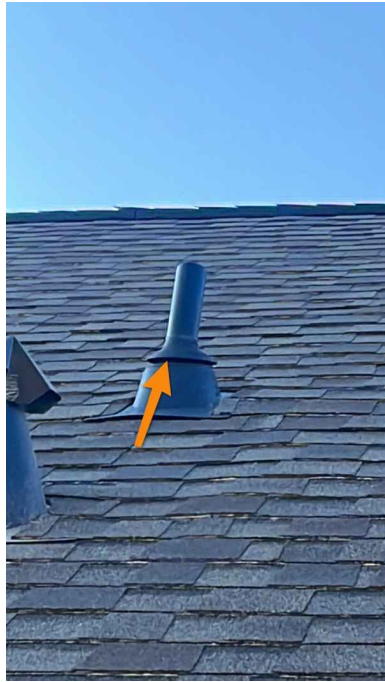
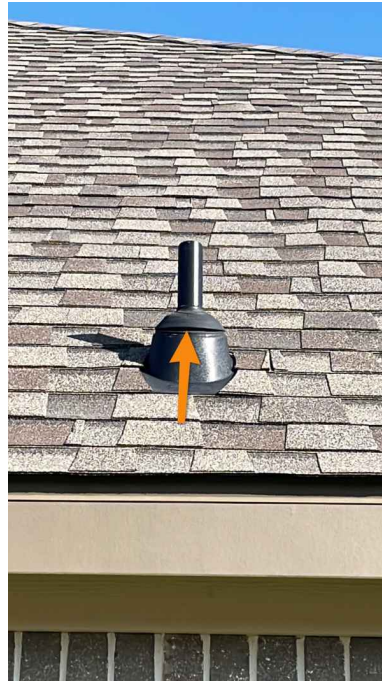
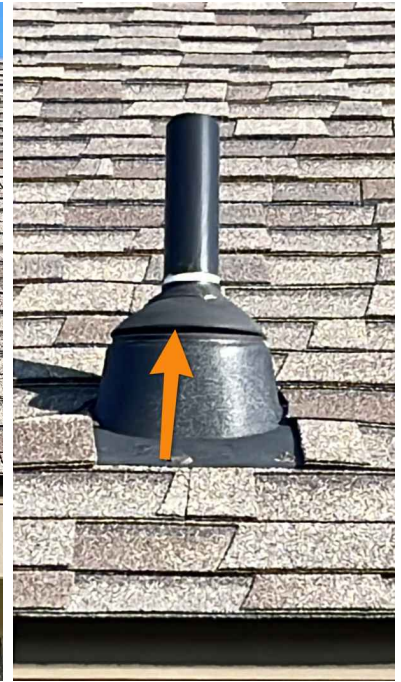
Left Side

Observed air vent gasket that appear to be improperly seated on base at time of inspection. Exposed space between rubber gasket and base could potentially allow moisture penetration into attic structure.

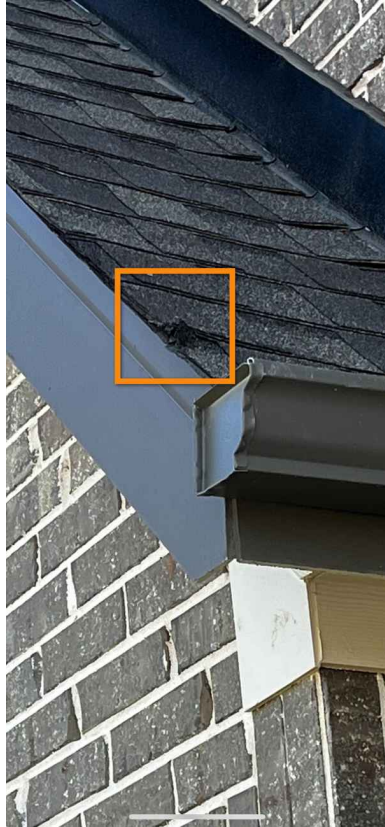
Front entryway area

4: Roof Covering Condition

Observed damaged/missing roof covering in one or more locations of roof surface at time of inspection. Depending on severity of damage, defected roof covering may allow moisture penetration into roof structure and expedite degradation of roof decking materials. Tree branches in contact with roof surface, extreme weather conditions, wear and tear, manufacturer defects, and walking on stone roof are all conditions that can negatively impact the integrity and condition of roof coverings.

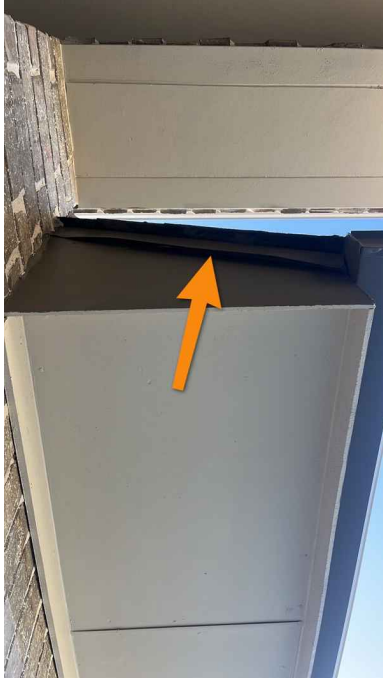
Front entryway

Observed what appears to be missing, damaged or improperly installed drip edge at roof raking. Drip edge acts as a moisture barrier that covers edge of roof decking and laps fascia to prevent moisture from potentially entering attic or soffit areas. Recommend a qualified roofing professional for further evaluation.

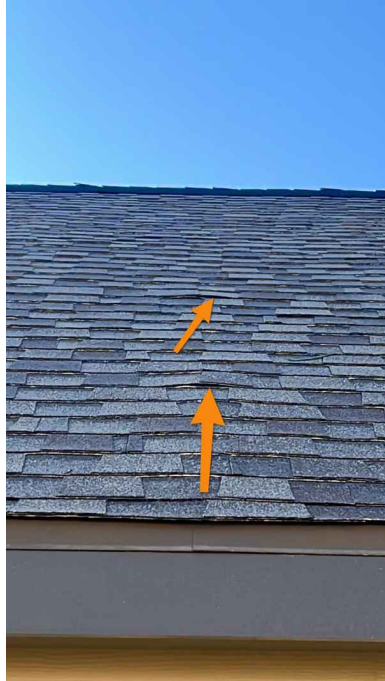
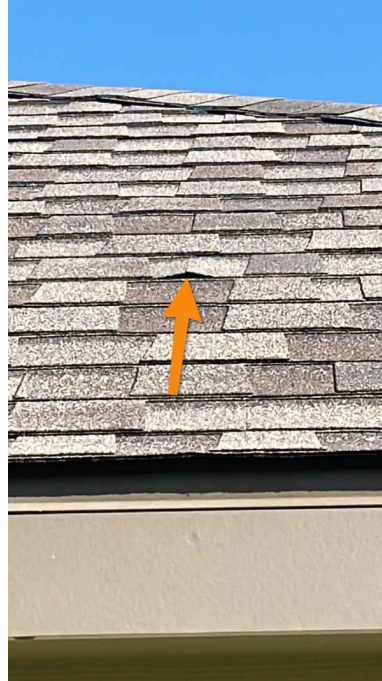
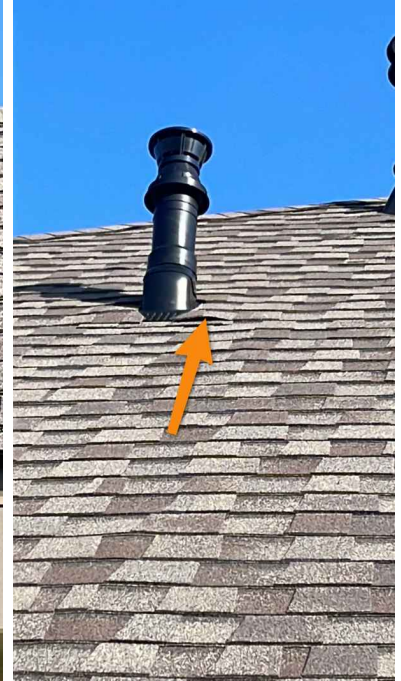
Left Side

Observed lifted/buckled shingles or roof covering at one or more locations on the roof. Lifted shingles can potentially allow moisture to enter roof structure. Buckling may be related to structural movement, improper installation, incomplete nailing, missing plywood clips on roof decking material or previous moisture penetration of decking material prior to installation.

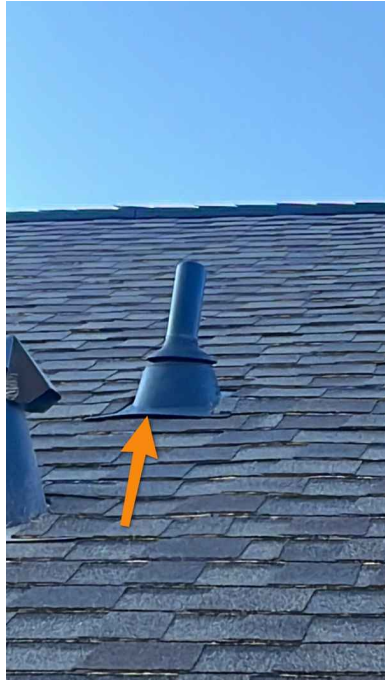
Left Side

Observed lifted flashing at base of roof penetration at time of inspection. Base should be flush to roof surface to prevent possible moisture intrusion of attic space. Recommend a qualified roofing professional for further evaluation.

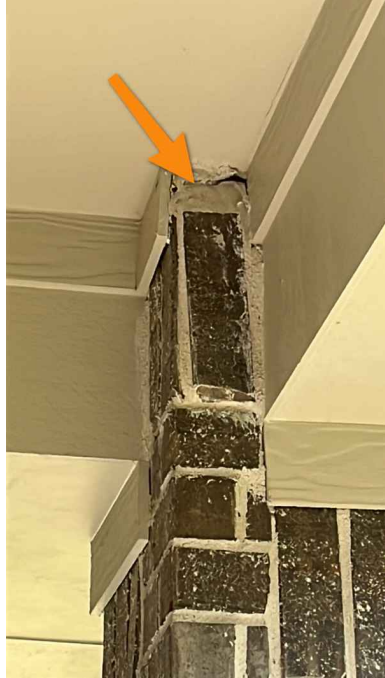
Rear- back patio area

1: Fascia- Missing/Uninstalled

Observed what appears to be missing or damaged fascia in area around wall and soffit location(s). Openings as such can allow for pest or moisture intrusion at impacted site.

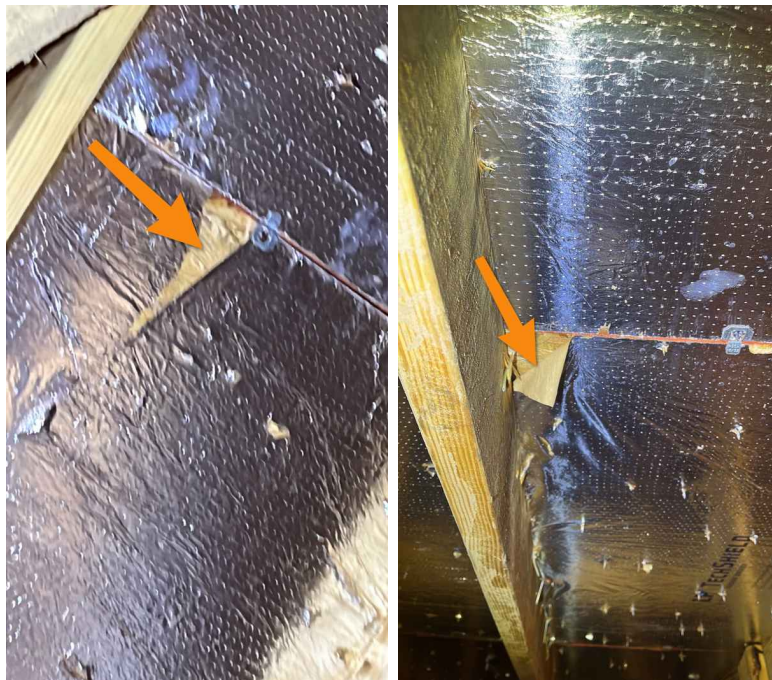
Observed radiant barrier peeling away from roof decking material. This could be caused by moisture, damaged when initially installed, poor ventilation or defect in actual material.

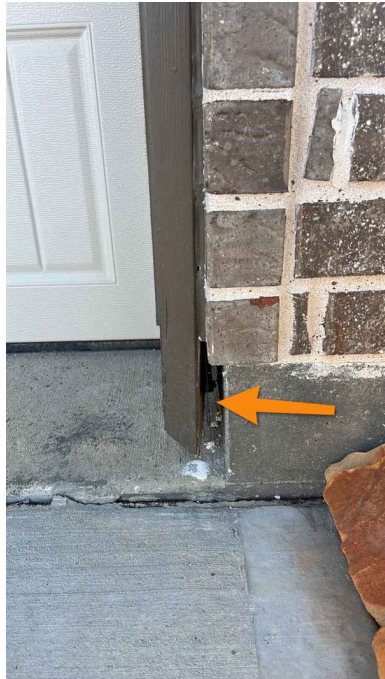
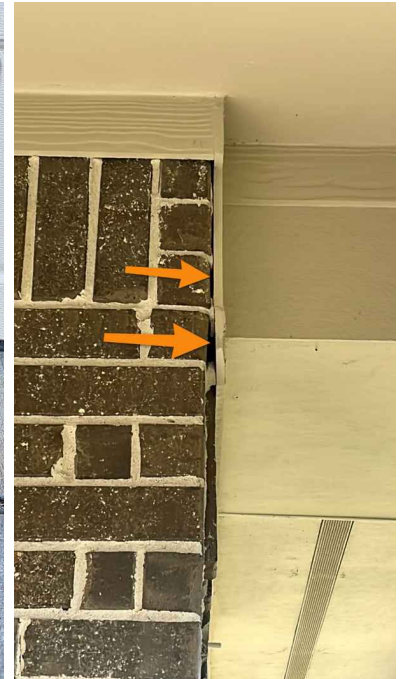
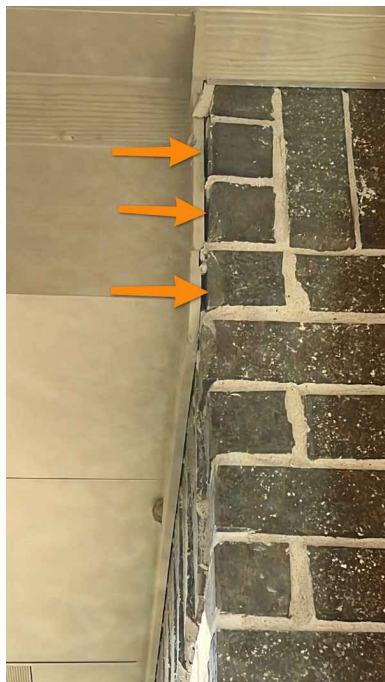
Right Side- of single car garage

1: Caulk- Deteriorating/Shrinkage/Missing

Observed deteriorating, shrinking or missing caulk in one or more locations. Caulk is used to help seal joints where moisture can penetrate, help prevent pest intrusion and works as a finishing product in the home building process. Depending on location, it is beyond the scope of this inspection to determine if moisture penetration has occurred and/or is present in non-visible areas, such as behind wall coverings.

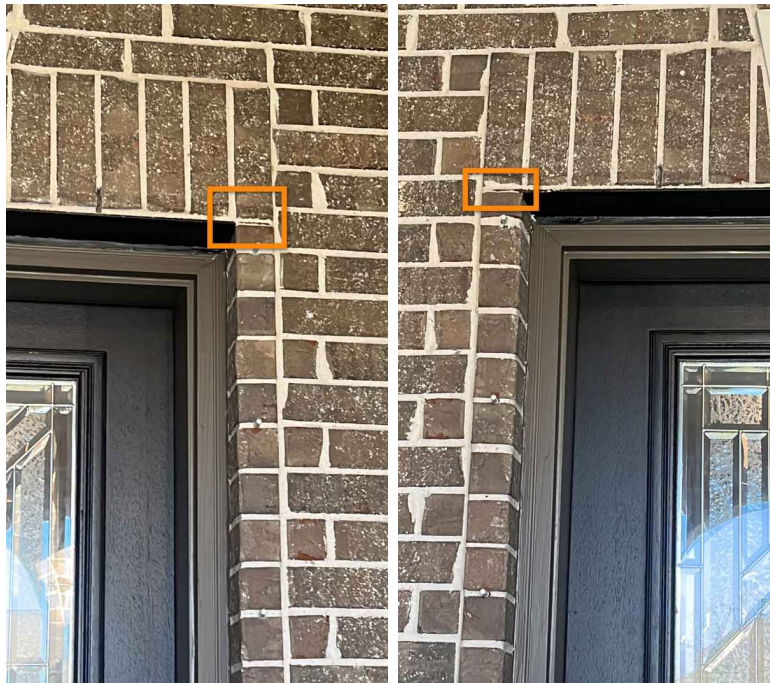
Front door

2: Lintel- Rusted/Exposed

Observed exposed and rust on lintels above windows/doors on exterior wall. Rusting of lintels cause expansion of the steel which may cause further damage to exterior wall structure. We recommend that the lintels be primed sanded, primed and painted to prevent rust and corrosion from forming.

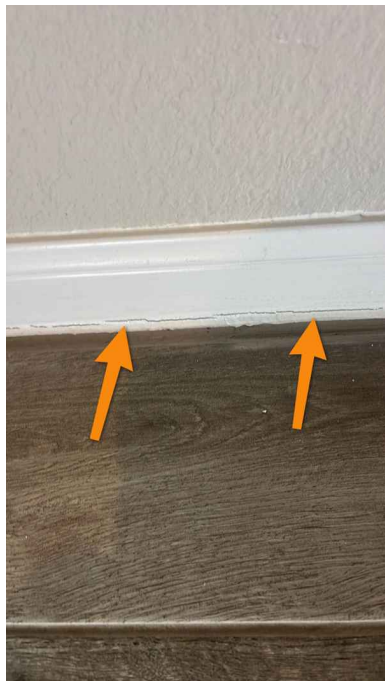
Coat closet

1: Caulk Shrinkage/Deterioration

Observed caulk shrinkage or deterioration at time of inspection in one or more areas. Caulking shrinks over time due to drying out of building materials or deterioration caused by normal wear and tear.

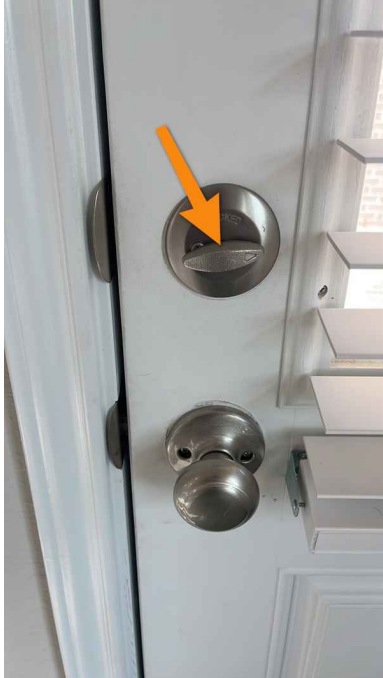
Backdoor from primary bedroom

Door lock doesn't function properly, align with strike plate, rusted/damaged or door needs adjustment. At time of inspection door has to be pulled, pushed or lifted in order for locking mechanism to be engaged.

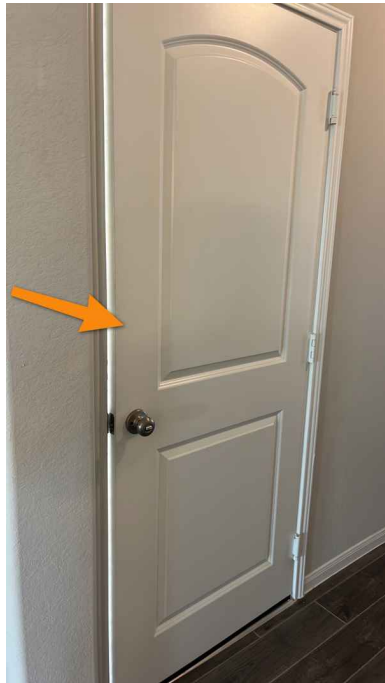
Garage entry door- does not fully close

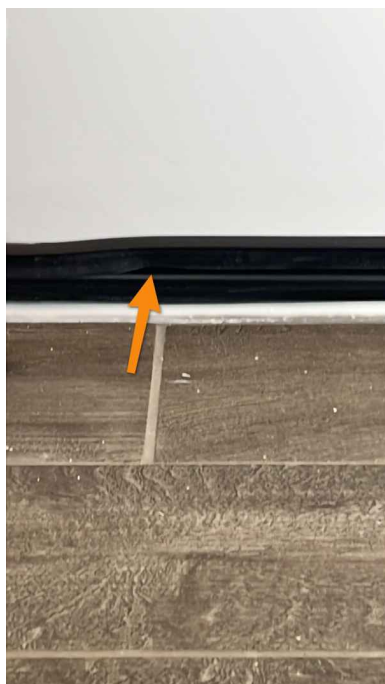
Backdoor from kitchen

Observed insufficient, uninstalled or damaged door sweep at time of inspection. Recommend replacing or installing door sweep to prevent conditioned air loss, possible pest intrusion and moisture from entering home.

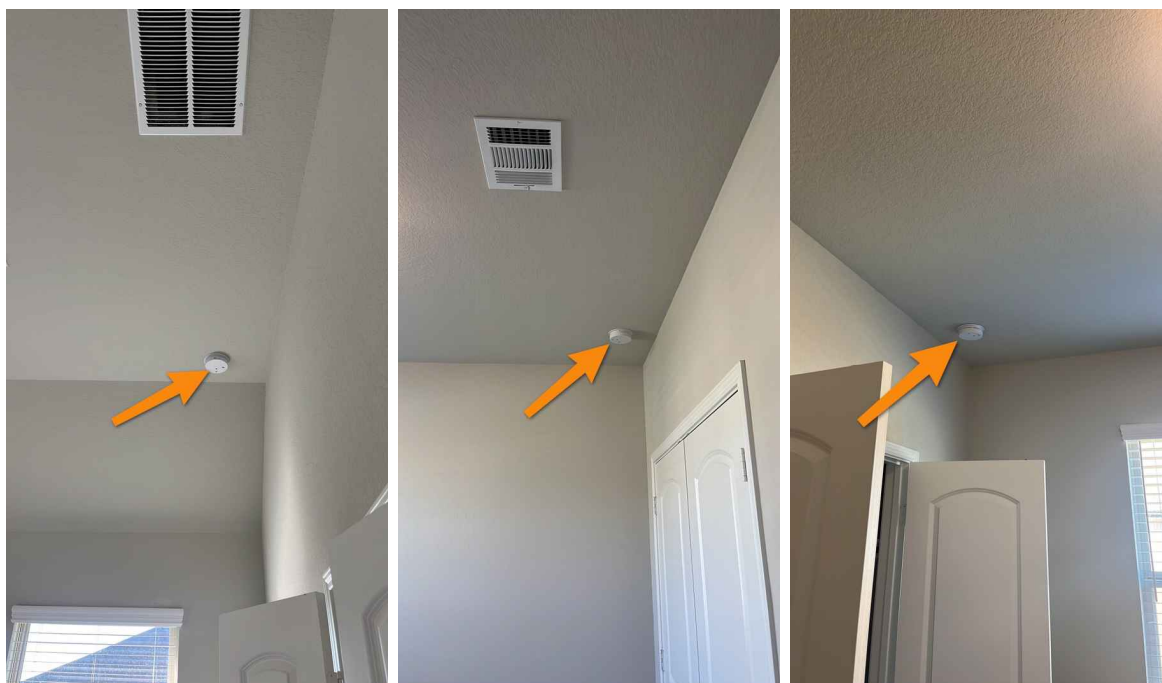
Priamry bedroom

Observed smoke detectors placed beyond the recommended location at time of inspection. The locations for ceiling-mounted smoke detectors installed on a smooth ceiling for a single or double doorway must match the centerline of the doorway no more than five feet from the door and no closer than 12" to the doorway.

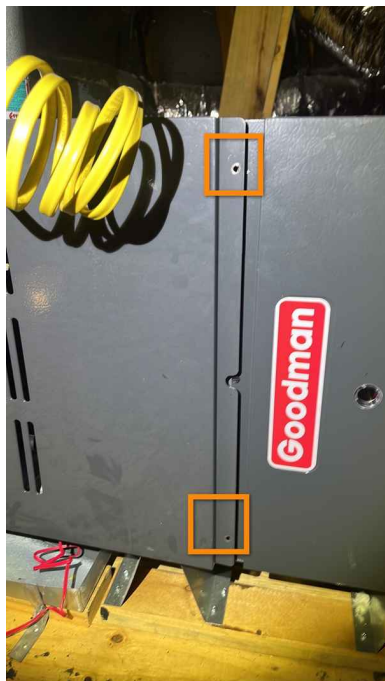
Observed missing, loosely fastened or sealed cover panel on furnace unit during inspection. Furnace cover panel should not be sealed due to periodic maintenance and will prevent a thorough inspection of the furnace burners and other mechanical parts within space. Loosely fastened or missing cover panels can possibly allow carbon monoxide gases into attic space; this will create a safety concern when in use.

Missing screws

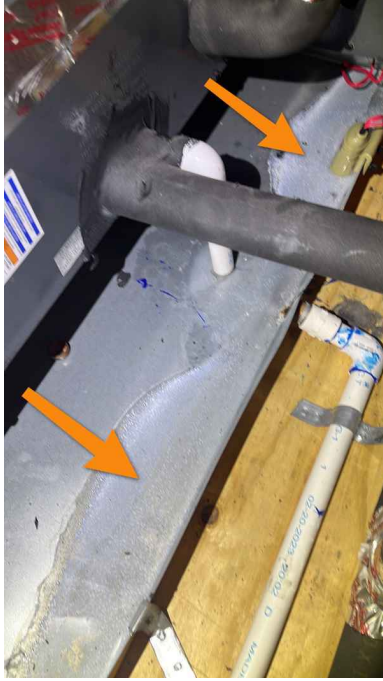
Observed sitting water or moisture in secondary drain pan at time of inspection. Appears that the evaporator primary drain pipe is clogged or condensation from evaporator cabinet. Recommend a qualified HVAC professional to further evaluate.

Standing water in pan

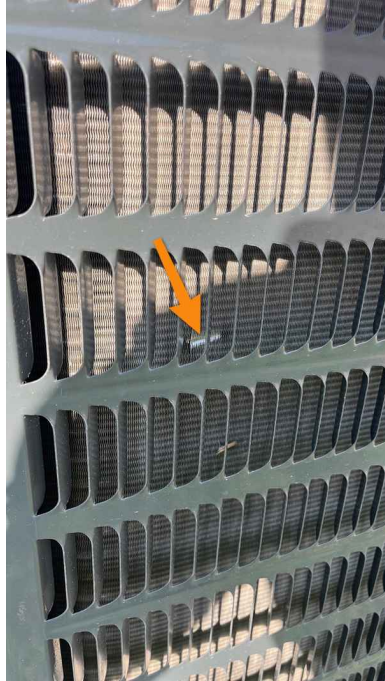
Observed condenser unit that has one or more of the following; coil damage, rust in one or more locations or dirty coils. Dirt build up and damaged fins on condenser coils may contribute to increased energy bills, negatively impact the units cooling capabilities and can cause a breakdown of the cooling system. Rust on moving parts restricts the air conditioner's ability to function. It can ruin capacitors, crucial electrical components that send voltage to the motors, and force the compressor to seize up.

Damaged coil

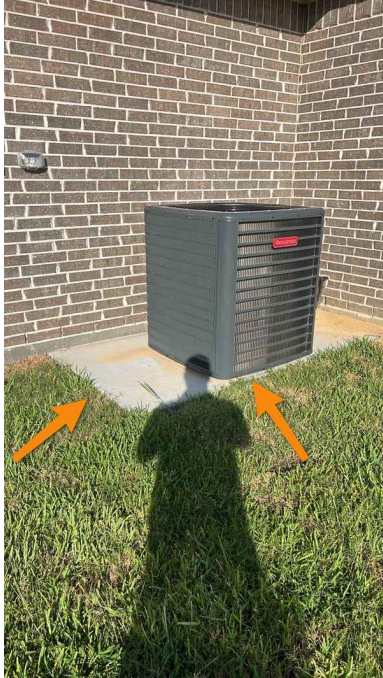
Observed condenser pad that is level or below grade at time of inspection. Condenser pad should be at least 4" above grade.

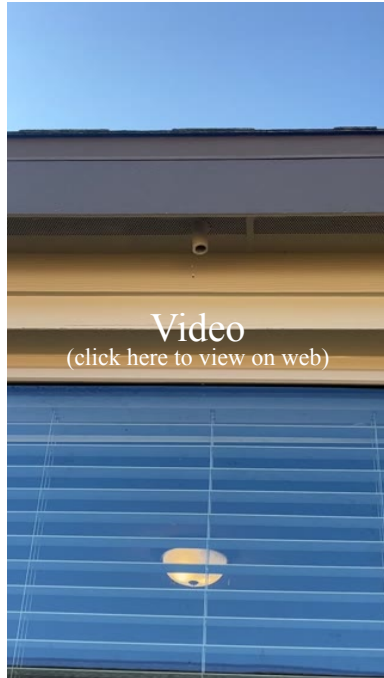
Left side

Observed leaking evaporator drain pipe at time of inspection. Leaking drain pipe(s) are a sign that the primary drainage line is clogged causing it to drain into the secondary line and flow into the secondary drain pan. A clogged drain pipe is the most common cause of standing water in the drain pan. As air passes over the evaporator coils, it cools down and loses some of its humidity. This humidity is left behind in the form of condensation on the coils. The condensation drips off into the condensate drain pan and exits the system through the drain line. Air that blows over these coils can leave behind dust and dirt; if the dirt drips off in the water, it can move down the drain line and ultimately cause a clog.

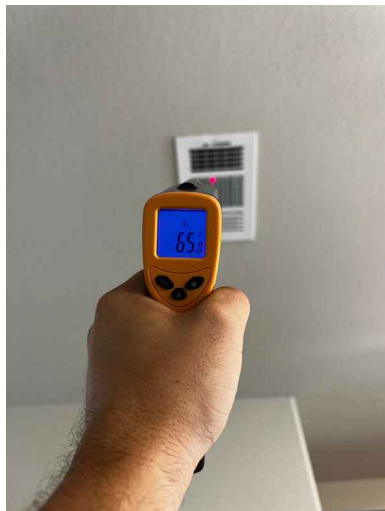
Kitchen

When testing for sufficient cooling the air conditioner performance is based on the difference between the supply and return air vent cooling at range between 15 and 22 degrees fahrenheit. At time of inspection the difference was either too low/high therefore rendering the unit to not function as intended. If variance is too low it could mean insufficient levels of refrigerant, leaky reverse valves, leaky return ducts or weakening compressor valves. If variance is too high it could be a dirty air filter or evaporator that needs cleaning, ductwork that isn't big enough or a fan set at the wrong speed. Temperatures are tested using an infrared thermometer at the supply and return vents that are closest to the air conditioning unit. We recommend a qualified HVAC contractor for further evaluation.

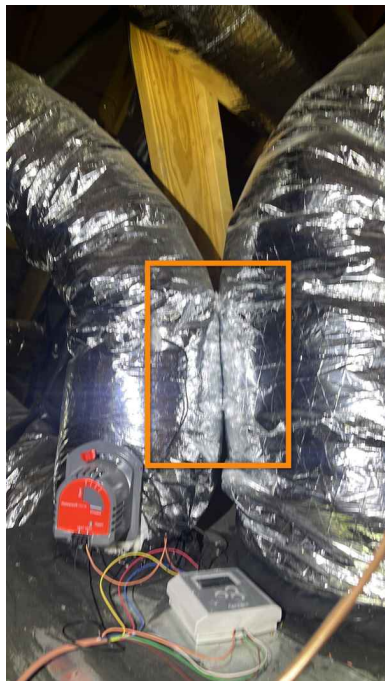
Observed ductwork that is touching or in contact with other ducts at time of inspection. Where ductwork is touching it forms a cold spot and could potentially cause condensation to form.

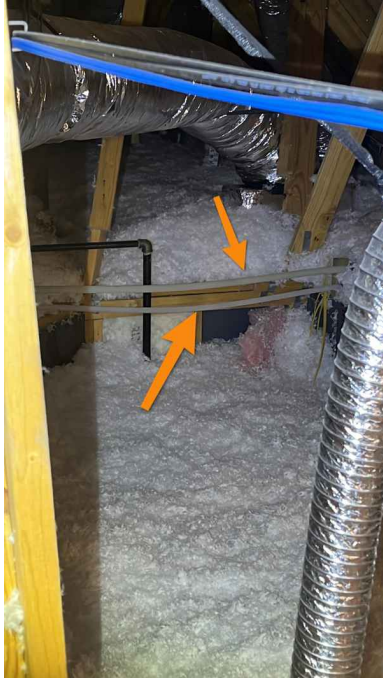
Observed damaged or missing water pipe line insulation at time of inspection. We recommend wrapping pipes that supply water to home that are located in uninsulated areas, within attic space or exterior of home.

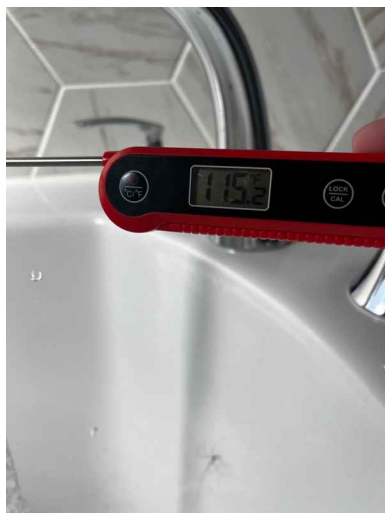
Primary tub

Observed inadequate heating of water supply when testing faucet fixtures for hot water. Depending on type of water heater or disruptions with supply water to home prior to inspection, testing of these fixtures may have depleted the tank of reserves or the faucet mixing valve may need adjusting. Also over time, sediment can build up in the bottom of the tank, where the burner usually is. This can lead to slower heating or poor efficiency in your water heater, meaning lukewarm water rather than hot water. The recommended temperature for domestic water is 120 degrees.

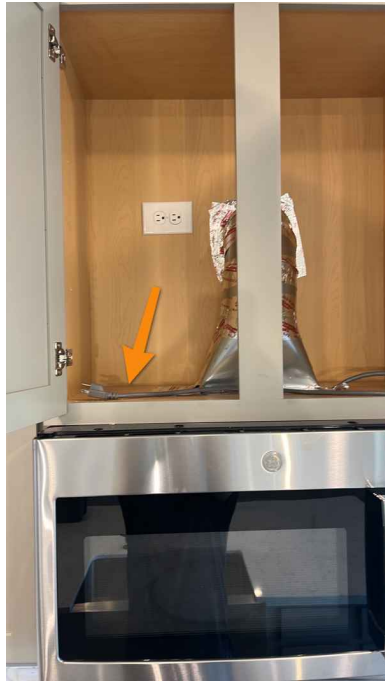
Exhaust fan appliance was inoperable or appeared to not function properly at time of inspection. Recommend a qualified professional for further evaluation.

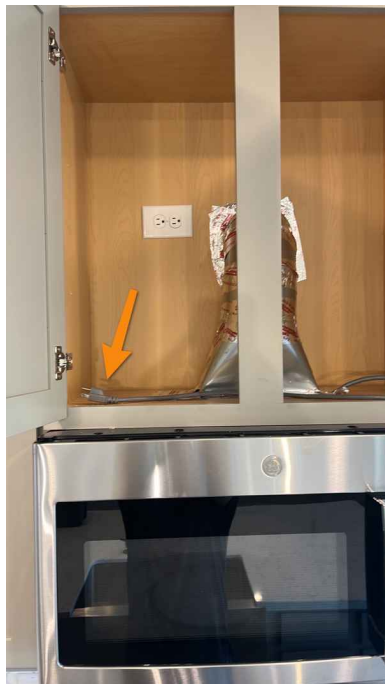
When testing, microwave did not function as intended. Inoperable turntable or not heating properly was observed during testing. The average microwave oven lasts about seven years with normal use, and even less with heavy use and poor maintenance.
