**SUMMARY**  
 5326 Isidore Ln, Missouri City, TX  
 77459  
 Reena Hudson  
 May 14, 2024

RASHID ANSARI  
 TREC#23479 MAC#1667 TDA#0856094  
 2-Inspect  
 (713) 865-3722,(334) 233-6011  
 ansaree33@icloud.com

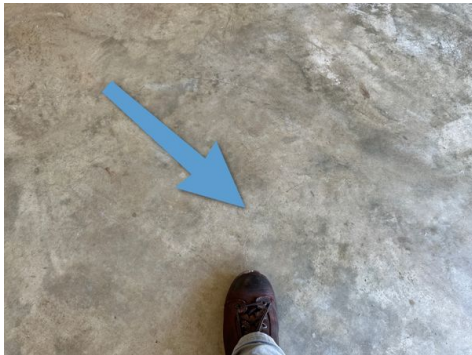
For example: Garage

2.1.1 A. Foundations  
**SHRINKAGE CRACKS**

Observed shrinkage cracks in the garage slab at the time of inspection. Shrinkage cracks are considered cosmetic. Remedy as needed.

Recommendation  
 Contact your builder.

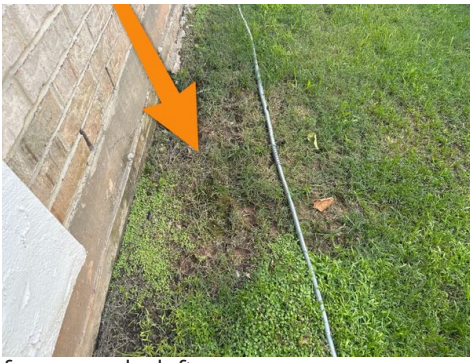
for example: left

2.2.1 B. Grading and Drainage  
**GRADING & DRAINAGE: INDEQUATE DRAINAGE OR STANDING WATER**

inadequate drainage or standing water was observed, which could indicate poor drainage and/or grading. Monitor and/or remedy as needed.

**Note:** Low spots, ruts, and/or damaged sod are all indicative of inadequate grading and drainage.

Recommendation  
 Contact a qualified landscaping contractor

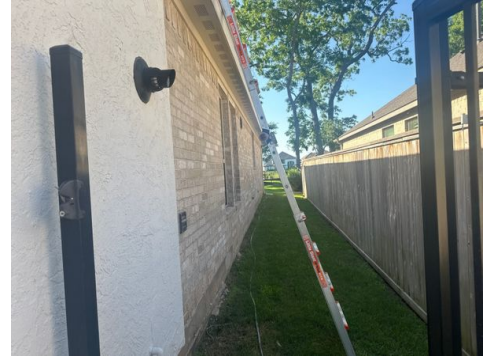
#### **GUTTERS & DOWNSPOUTS: CLOGGED**

Recommend clear gutters of debris to improve drainage. Badly clogged gutters can cause water to back up under the roof covering and cause damage.

Contact a qualified grading contractor.

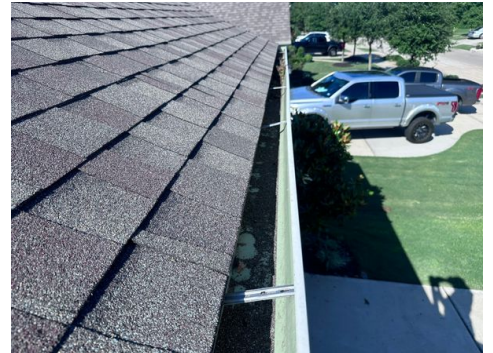
#### **GRANULE LOSS LOCALIZED**

Localized granule loss on the shingle surface was observed. Among other things, this can be a result of mechanical damage, impurities in the asphalt, or anomalies in the manufacturing process. Remedy as needed.

Contact a qualified roofing professional.

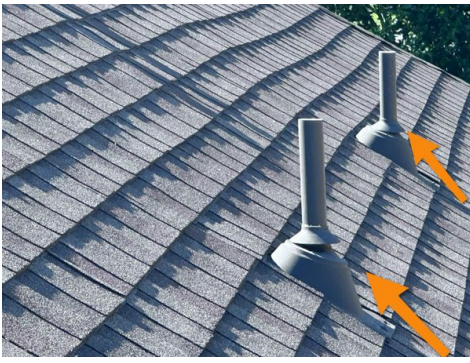
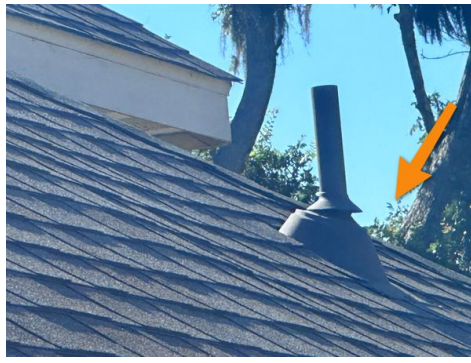
#### **SEAL BOOTS**

Observed unsealed plumbing boots or roof jacks at the time of inspection. Evaluate and remedy as needed.

Contact a qualified professional.

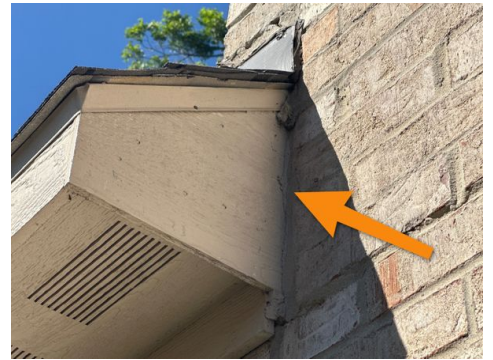
for example: Right

**EXTERIOR: SEAL**

Trim Boards, - were not properly sealed. Remedy as needed.

**Note:** Modern building practices recommend sealing around components that are mounted on or pass through the exterior wall to limit moisture intrusion.

Recommendation  
Recommended DIY Project

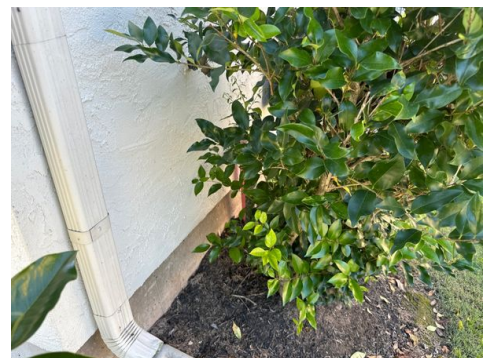
For example: left

**EXTERIOR: FOLIAGE TOO CLOSE**

Foliage that is too close to siding materials can cause moisture buildup and deterioration. Remedy as needed.

Recommendation  
Contact a qualified professional.

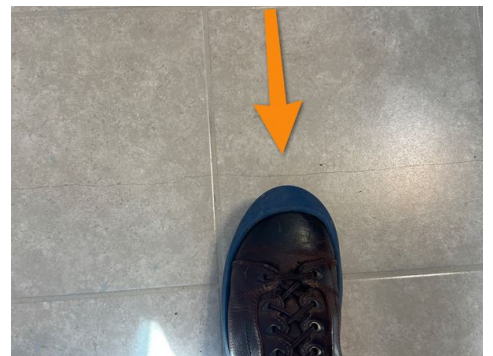
For example: powder room upstairs

**FLOORING: TILES CRACK/CHIP/LOOSE**

Floor tiles were cracked or chipped or loose or damaged grout. Remedy as needed.

Recommendation  
Contact a qualified tile contractor

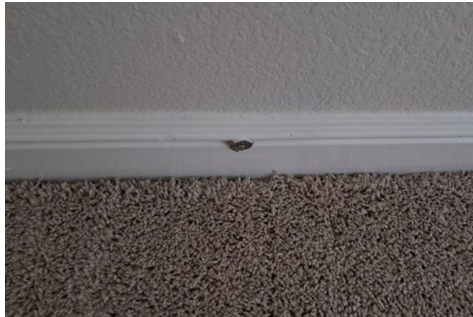
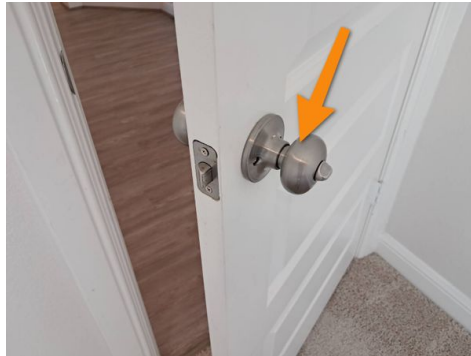
**DOOR: HARDWARE**

Door Stops Missing/Damaged, Door Lock Missing or Loose

One or more door(s) has loose or missing or damaged hardware. Remedy as needed.

Contact a qualified professional.

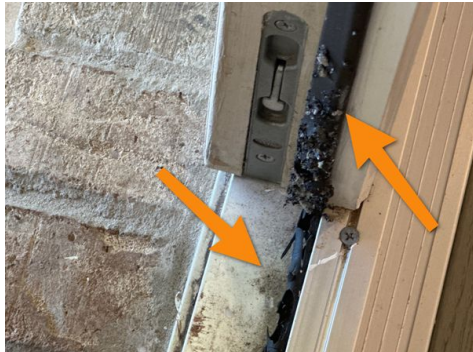
For example: rear

**DOOR: WEATHERSTRIPPING MISSING/DAMAGE/INEFFECTIVE**

Door is missing a functional weatherstripping. This can result in significant energy loss and moisture intrusion. The visible day light is an indicative of the weather stripping being ineffective. Remedy as needed.

Contact a qualified door repair/installation contractor.

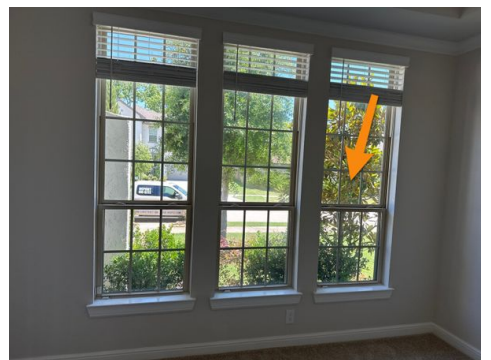
For example: office

**DIFFICULT OPERATION**

Windows were not operating properly. Evaluate and remedy as needed.

Contact a qualified window repair/installation contractor.

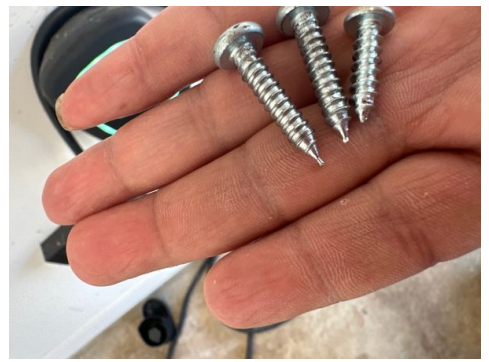
**SCREW(S) MISSING/IMPROPER**

Screws that mount the cover to the electrical panel were missing/improper. Remedy as needed.

Note: Blunt tip screws designed for this application are recommended to prevent puncturing electrical wiring insulation.

Contact a qualified electrical contractor.

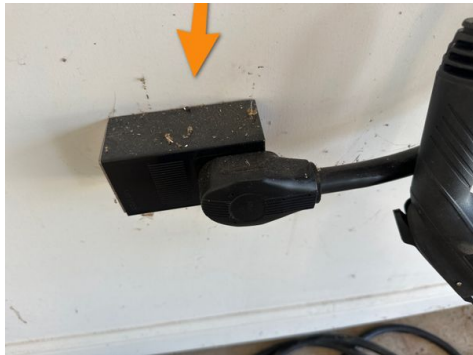
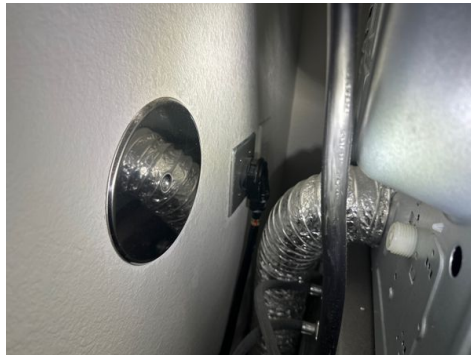
**RECEPTACLES: GFCI PROTECTION MISSING/INADEQUATE**

Garage, Laundry Room

GFCI Protection was missing or inadequate. Current building standards require for ground fault protection in the following areas:

GFCI Protection was not present in one or more of these locations. Evaluate and remedy as needed.

Contact a qualified professional.

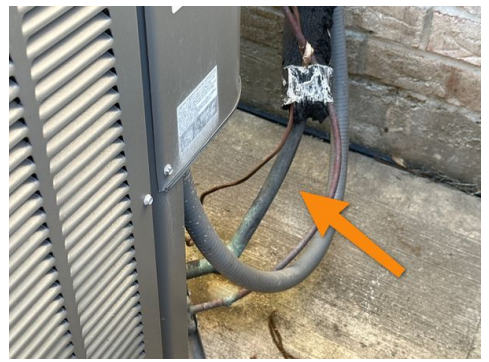
**CONDENSER: INSULATION MISSING/DAMAGED ON REFRIGERANT LINES**

Missing or damaged insulation on refrigerant line can cause energy loss and condensation. Remedy as needed.

Contact a qualified heating and cooling contractor

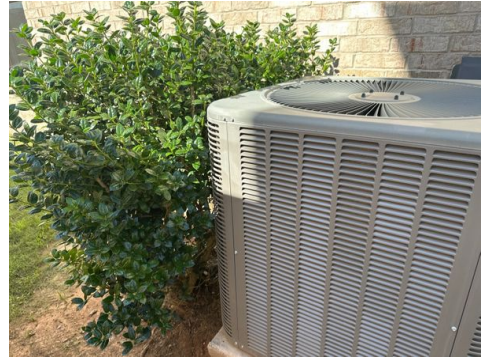
**CONDENSER: HEAVY FOLIAGE**

Heavy foliage should be removed from around condensing unit. Remedy as needed.

Contact a handyman or DIY project

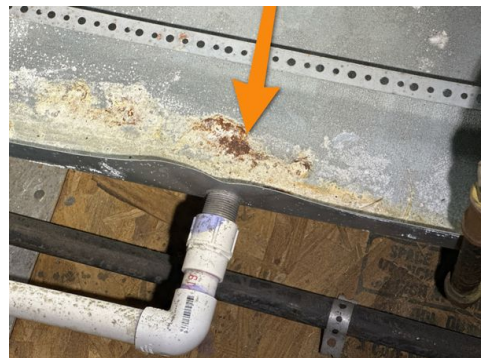
**CONDENSATION SYSTEM: RUSTED PAN**

The emergency overflow pan was rusted. Evaluate and remedy as needed.

Contact a qualified heating and cooling contractor

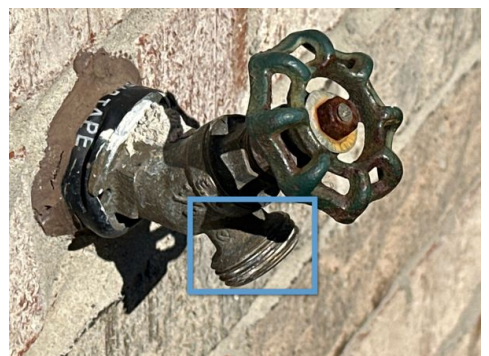
for example: Right

**HOSE BIBB (EXTERIOR FAUCET): BACKFLOW PREVENTION MISSING**

A hose bibb was missing a backflow preventer. These devices are inexpensive and easily installed, and help to prevent contamination of potable water. Remedy as needed.

Contact a qualified plumbing contractor.

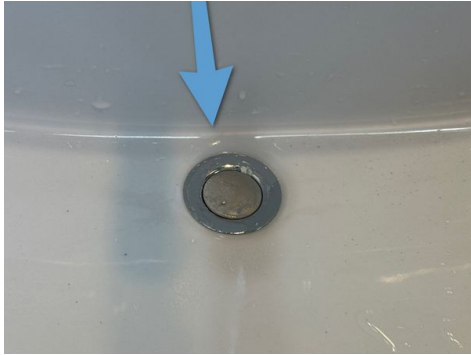
For example: powder room upstairs

**FIXTURE: DRAIN STOPS**

Drain stops had issues that prevented them from working properly (holding water). Remedy as needed.

Contact a qualified plumbing contractor.

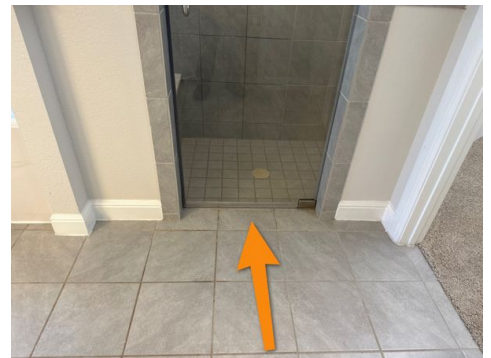
For example: master bathroom

#### **SHOWER: DOOR SEAL MISSING/DAMAGED**

The shower door seal (also known as gasket or floor sweep) was missing or damaged. Remedy as needed.

Contact a qualified plumbing contractor.

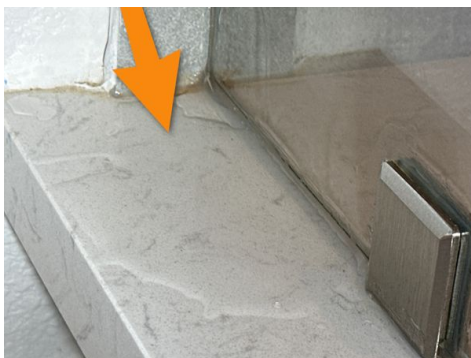
For example: master bathroom

#### **SHOWER ENCLOSURE LEAK**

Observed shower enclosure leaking at the time of inspection. Remedy as needed.

Contact a qualified professional.

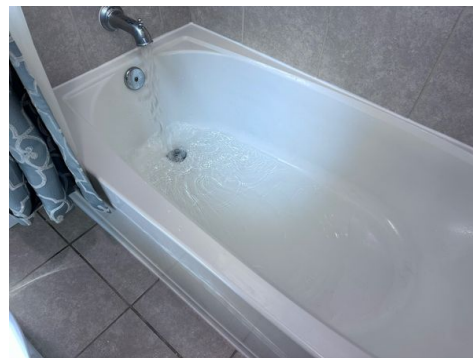
#### **DRAIN PIPING: SLOW DRAIN**

Slow drainage was observed at time of inspection. Remedy as needed.

Recommendation  
Contact a qualified plumbing contractor.

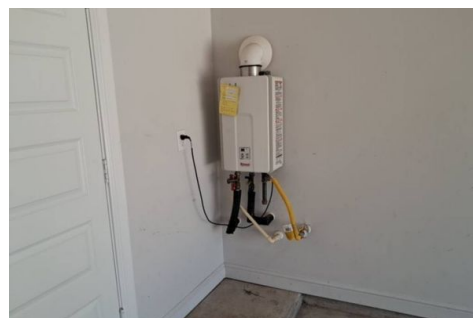
### 5.3.2 C. Water Heating Equipment **TANK: DRAIN PAN**

The drain pan was missing. Remedy as needed.

Recommendation  
Contact a qualified plumbing contractor.

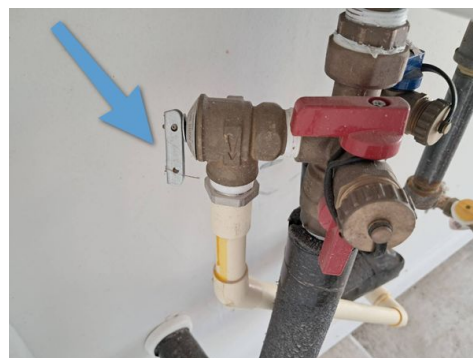
### 5.3.3 C. Water Heating Equipment **TPR VALVE: REPLACEMENT**

**Note:** The manufacturer recommends replacement of the pressure relief valve every 3 years to ensure proper emergency function. The inspector did not test TPR valves due to safety hazard or possible damage to unit.

Recommendation  
Contact a qualified plumbing contractor.

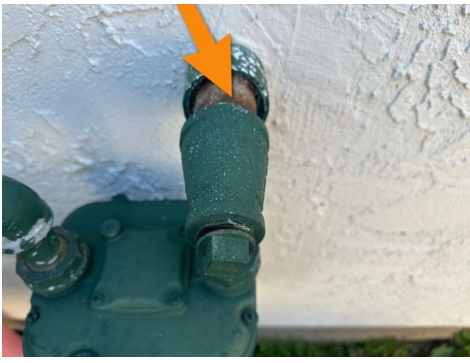
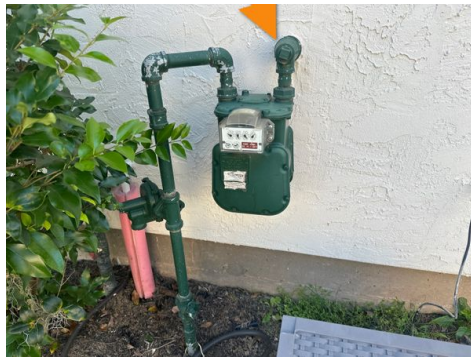
### 5.5.1 E. Gas Distribution Systems and Gas Appliances **GAS PIPING: RUSTED SERVICE LINE**

The gas service running from the meter into the home was rusted. Remedy as needed.

Recommendation  
Contact a qualified plumbing contractor.

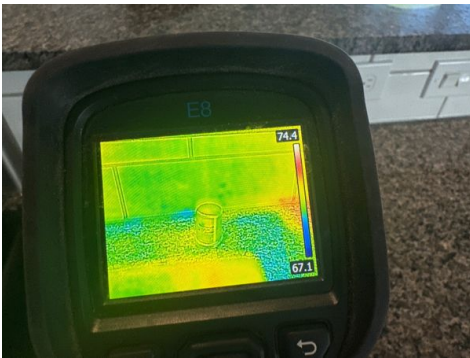
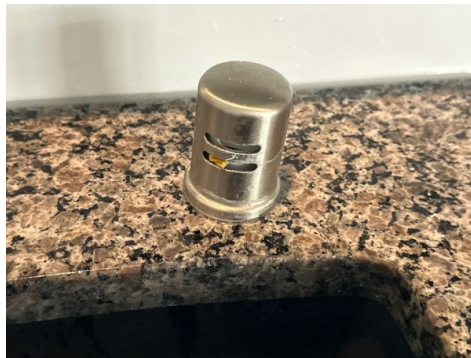
6.1.1 A. Dishwashers  
**AIR GAP LEAK**

Water leak out of the air gap device near the sink which indicates a possible restriction or clog in the drain line. Remedy as needed.

Recommendation  
Contact a qualified professional.

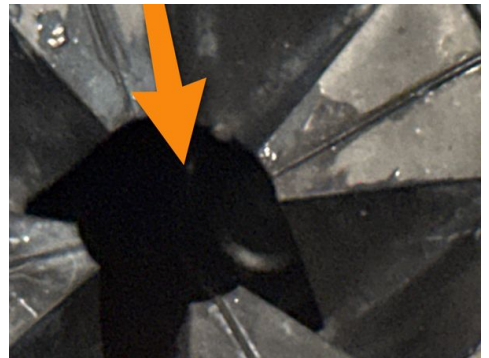
6.2.1 B. Food Waste Disposers  
**RUSTED/CORRODED COMPONENTS**

Interior components of the disposal were rusted or corroded. Evaluated and remedy as needed.

Recommendation  
Contact a qualified professional.

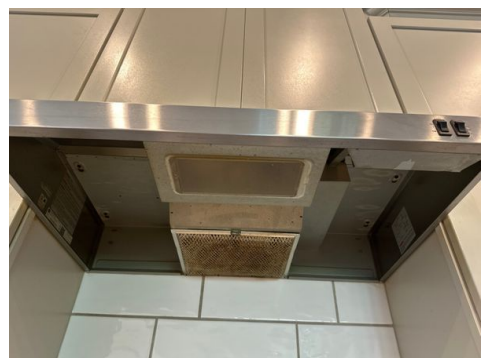
6.3.1 C. Range Hood and Exhaust Systems  
**FILTER MISSING/DIRTY**

Observed missing or dirty exhaust filter. Remedy as needed.

Recommendation  
Contact a qualified professional.

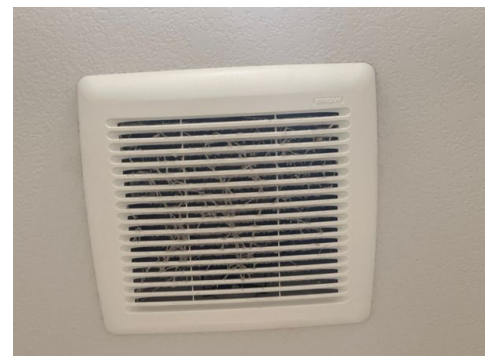
For example: master bathroom

#### **VENT COVER DIRTY**

Cleaning of the exhaust vent cover is needed to ensure unrestricted airflow.

Contact a qualified professional.

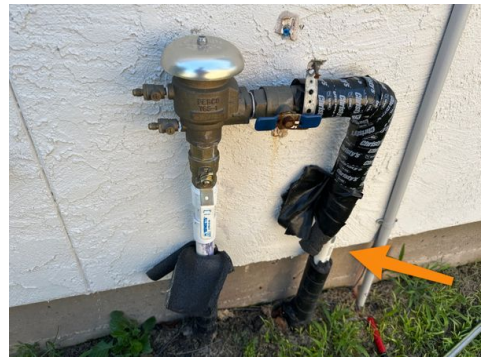
#### **INSULATION DAMAGED/MISSING**

Observed damaged or missing insulation on sprinkler vacuum breaker at time of inspection. Remedy as needed.

Recommendation  
Contact a qualified professional.

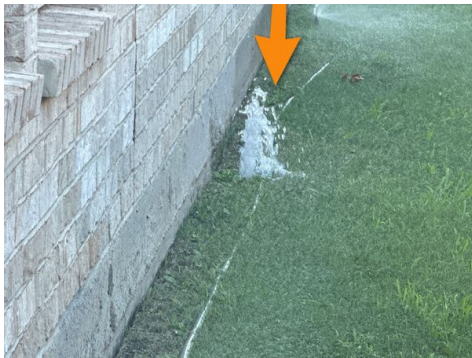
for example: Left

**HEAD DAMAGED/MISSING**

Observed damaged or missing sprinkler head at the time of inspection. Evaluate and remedy as needed.

Recommendation  
Contact a qualified professional.

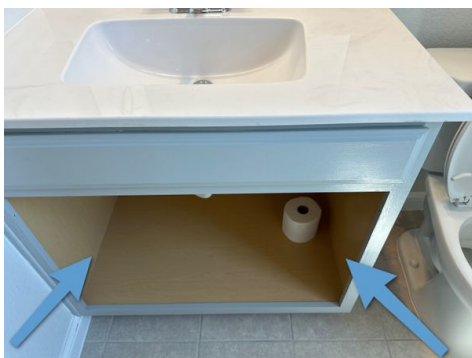
For example: powder room upstairs

8.2.1 Items not finished  
**ITEMS NOT FINISHED**

Some of the items were not finished at the time of inspection.

Recommendation  
Contact a qualified professional.
