STANDARD HOME INSPECTION

5326 Isidore Ln
Missouri City, TX 77459

PROPERTY INSPECTION REPORT FORM

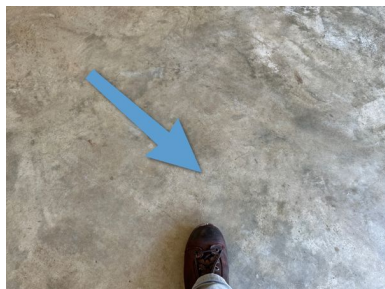
For example: Garage

1: Shrinkage cracks

Observed shrinkage cracks in the garage slab at the time of inspection. Shrinkage cracks are considered cosmetic. Remedy as needed.

Recommendation: Contact your builder.

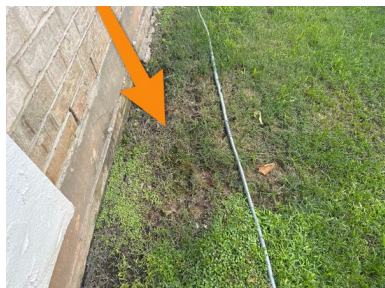
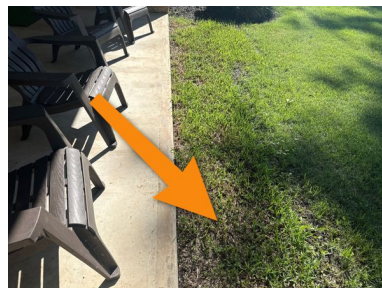
1: Grading & Drainage: Inadequate Drainage or Standing Water

inadequate drainage or standing water was observed, which could indicate poor drainage and/or grading. Monitor and/or remedy as needed.

Note: Low spots, ruts, and/or damaged sod are all indicative of inadequate grading and drainage.

Recommendation: Contact a qualified landscaping contractor

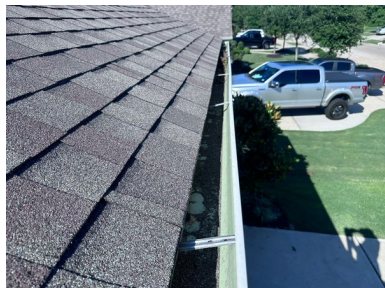
1: Granule Loss Localized

Localized granule loss on the shingle surface was observed. Among other things, this can be a result of mechanical damage, impurities in the asphalt, or anomalies in the manufacturing process. Remedy as needed.

Recommendation: Contact a qualified roofing professional.

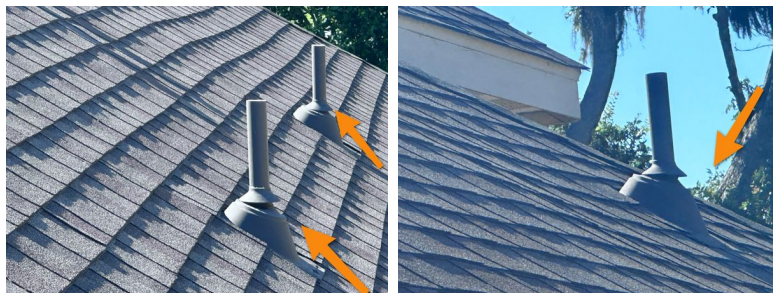
2: Seal Boots

Observed unsealed plumbing boots or roof jacks at the time of inspection. Evaluate and remedy as needed.

Recommendation: Contact a qualified professional.

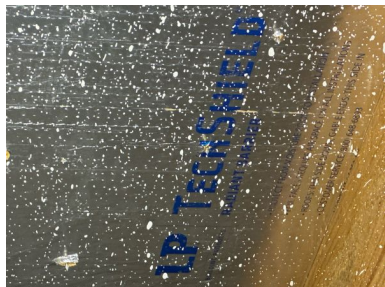
Note: A radiant barrier was installed on the roof decking. This may conceal possible evidence of water penetration and limit evaluation of the decking material.

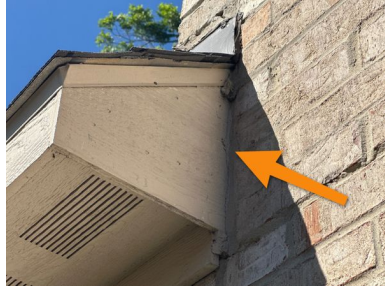
for example: Right

Note: Modern building practices recommend sealing around components that are mounted on or pass through the exterior wall to limit moisture intrusion.

Recommendation: Recommended DIY Project

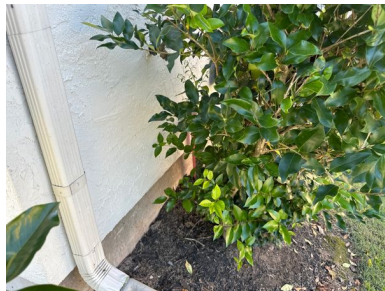
For example: left

2: Exterior: Foliage Too Close

Foliage that is too close to siding materials can cause moisture buildup and deterioration. Remedy as needed.

Recommendation: Contact a qualified professional.

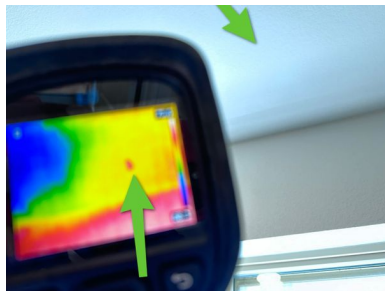
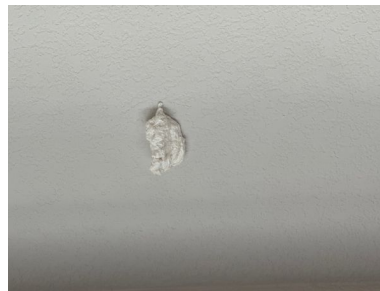
Common bathroom

Previous Repairs :

Previous repairs were observed. Recommend obtaining repair documentation or further explanation from the seller.

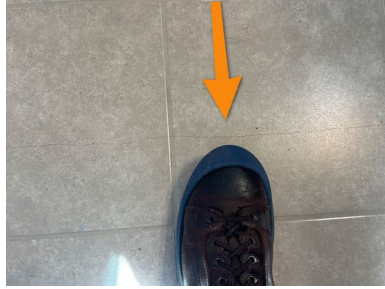
For example: powder room upstairs

1: Flooring: Tiles Crack/Chip/Loose

Floor tiles were cracked or chipped or loose or damaged grout. Remedy as needed.

Recommendation: Contact a qualified tile contractor

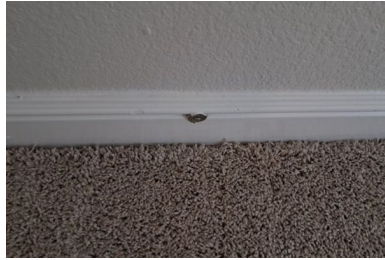
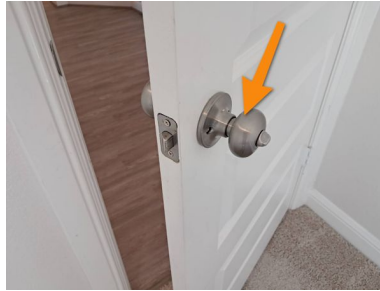
Door Stops Missing/Damaged, Door Lock Missing or Loose -

One or more door(s) has loose or missing or damaged hardware. Remedy as needed.

Recommendation: Contact a qualified professional.

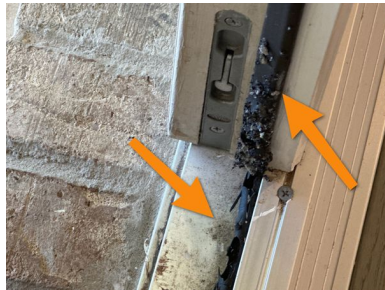
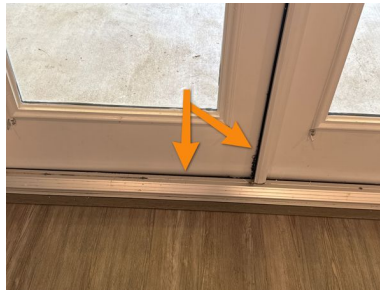
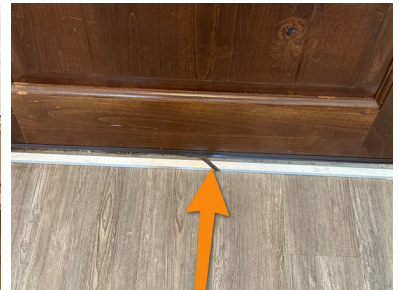
2: Door: Weatherstripping Missing/Damage/Ineffective

Door is missing a functional weatherstripping. This can result in significant energy loss and moisture intrusion. The visible day light is an indicative of the weather stripping being ineffective. Remedy as needed.

Recommendation: Contact a qualified door repair/installation contractor.

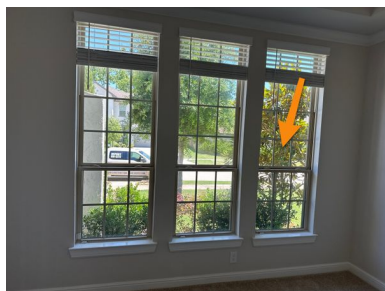
For example: office

Windows were not operating properly. Evaluate and remedy as needed.

Recommendation: Contact a qualified window repair/installation contractor.

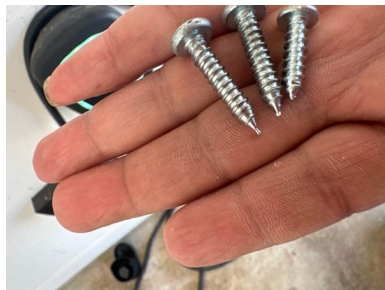
1: Screw(s) Missing/Improper

Screws that mnt the cover to the electrical panel were missing/improper. Remedy as needed.

Note: Blunt tip screws designed for this application are recommended to prevent puncturing electrical wiring insulation.

Recommendation: Contact a qualified electrical contractor.

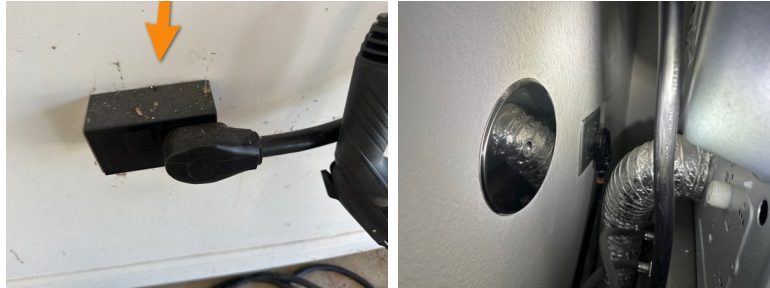
1: Receptacles: GFCI Protection Missing/Inadequate

GFCI Protection was missing or inadequate. Current building standards require for ground fault protection in the following areas:

GFCI Protection was not present in one or more of these locations. Evaluate and remedy as needed.

Recommendation: Contact a qualified professional.

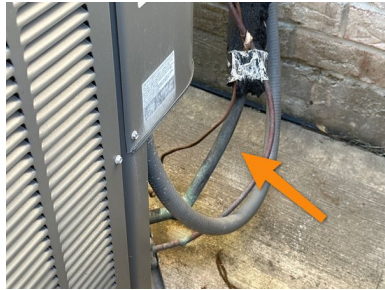
1: Condenser: Insulation Missing/Damaged on Refrigerant Lines

Missing or damaged insulation on refrigerant line can cause energy loss and condensation. Remedy as needed.

Recommendation: Contact a qualified heating and cooling contractor

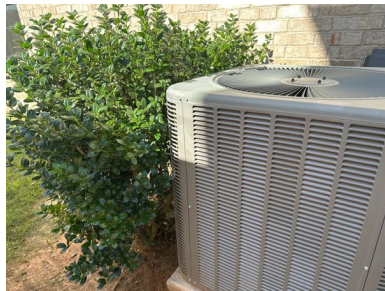
2: Condenser: Heavy Foliage

Heavy foliage should be removed from around condensing unit. Remedy as needed.

Recommendation: Contact a handyman or DIY project

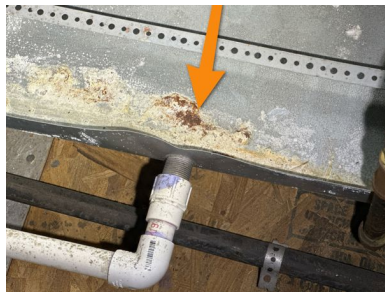
3: Condensation System: Rusted Pan

The emergency overflow pan was rusted. Evaluate and remedy as needed.

Recommendation: Contact a qualified heating and cooling contractor

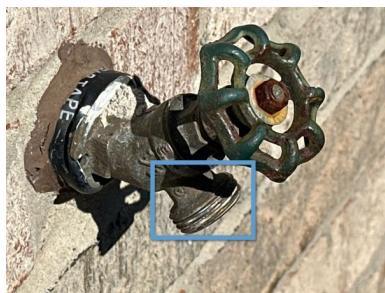
for example: Right

1: Hose Bibb (Exterior Faucet): Backflow Prevention Missing

A hose bibb was missing a backflow preventer. These devices are inexpensive and easily installed, and help to prevent contamination of potable water. Remedy as needed.

Recommendation: Contact a qualified plumbing contractor.

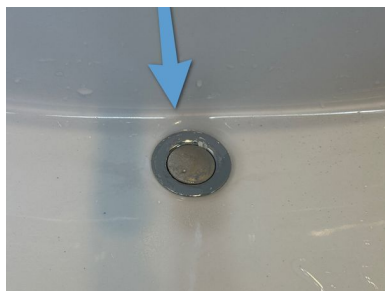
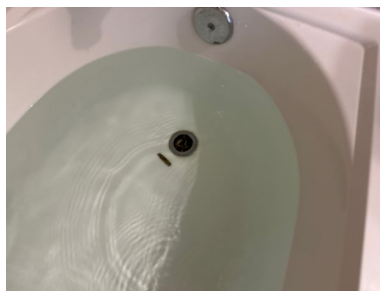
2: Fixture: Drain Stops

Drain stops had issues that prevented them from working properly (holding water). Remedy as needed.

Recommendation: Contact a qualified plumbing contractor.

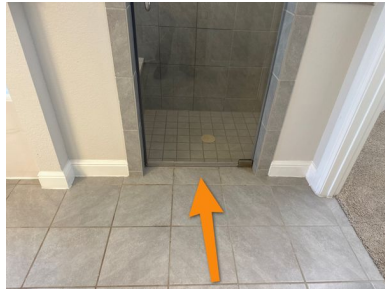
For example: master bathroom

3: Shower: Door Seal Missing/Damaged

The shower door seal (also known as gasket or floor sweep) was missing or damaged. Remedy as needed.

Recommendation: Contact a qualified plumbing contractor.

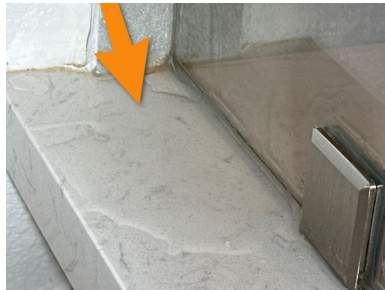
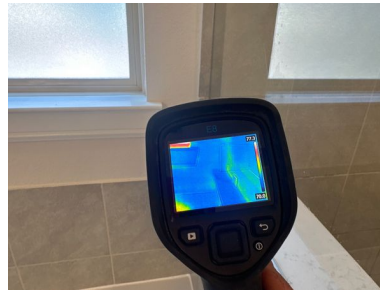
4: Shower enclosure leak

Observed shower enclosure leaking at the time of inspection. Remedy as needed.

Recommendation: Contact a qualified professional.

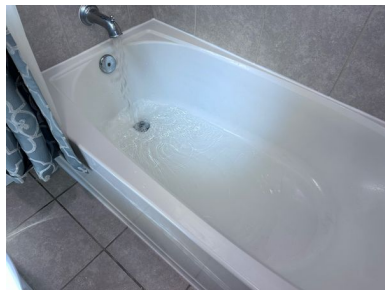
1: Drain Piping: Slow Drain

Slow drainage was observed at time of inspection. Remedy as needed.

Recommendation: Contact a qualified plumbing contractor.

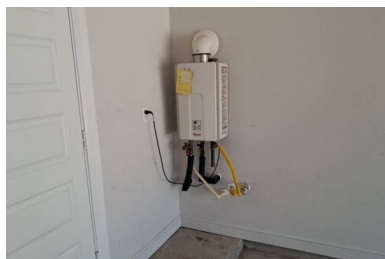
The drain pan was missing. Remedy as needed.

Recommendation: Contact a qualified plumbing contractor.

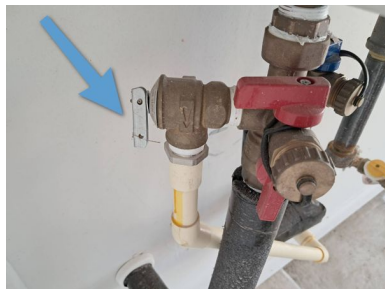
3: TPR Valve: Replacement

Note: The manufacturer recommends replacement of the pressure relief valve every 3 years to ensure proper emergency function. The inspector did not test TPR valves due to safety hazard or possible damage to unit.

Recommendation: Contact a qualified plumbing contractor.

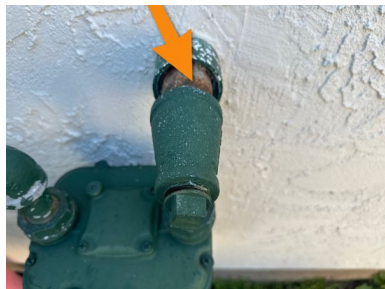
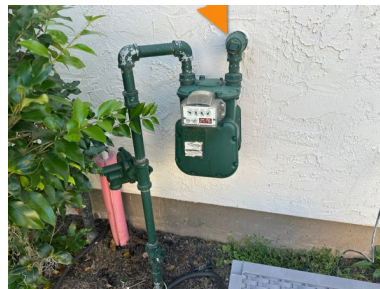
1: Gas Piping: Rusted Service Line

The gas service running from the meter into the home was rusted. Remedy as needed.

Recommendation: Contact a qualified plumbing contractor.

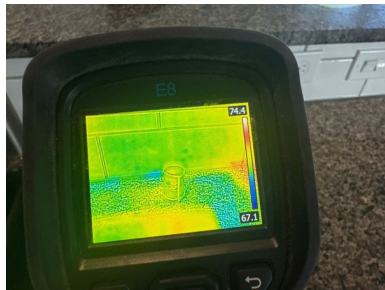
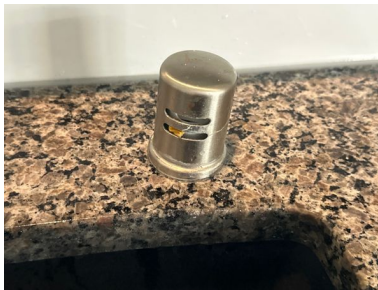
1: Air Gap Leak

Water leak out of the air gap device near the sink which indicates a possible restriction or clog in the drain line. Remedy as needed.

Recommendation: Contact a qualified professional.

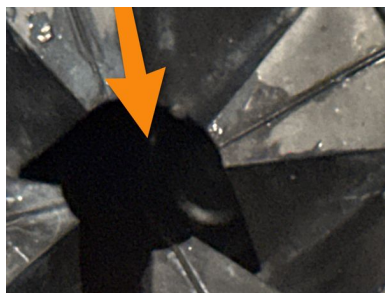
1: Rusted/Corroded Components

Interior components of the disposal were rusted or corroded. Evaluated and remedy as needed.

Recommendation: Contact a qualified professional.

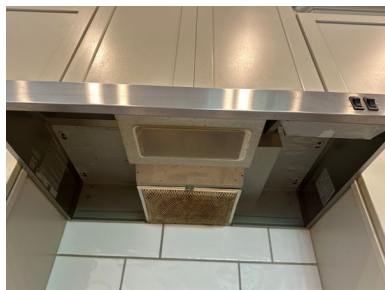
1: Filter Missing/Dirty

Observed missing or dirty exhaust filter. Remedy as needed.

Recommendation: Contact a qualified professional.

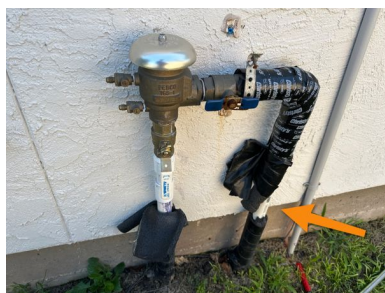
1: Insulation Damaged/Missing

Observed damaged or missing insulation on sprinkler vacuum breaker at time of inspection. Remedy as needed.

Recommendation: Contact a qualified professional.

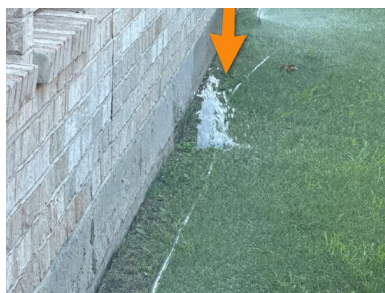
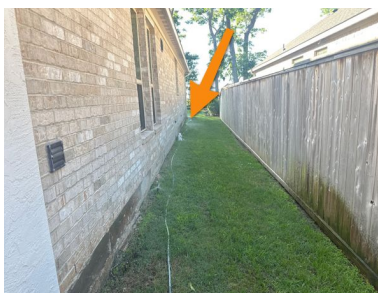
2: Head Damaged/Missing

Observed damaged or missing sprinkler head at the time of inspection. Evaluate and remedy as needed.

Recommendation: Contact a qualified professional.

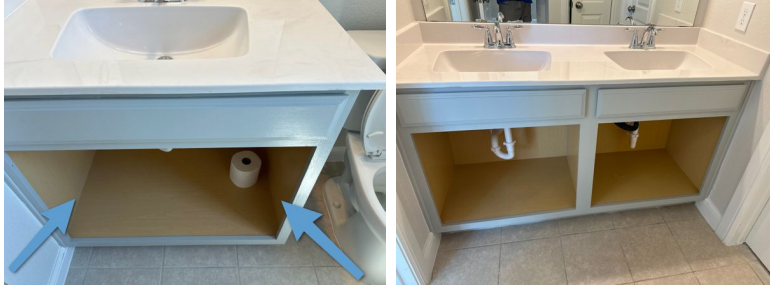
For example: powder room upstairs

Some of the items were not finished at the time of inspection.

Recommendation: Contact a qualified professional.
