Inspection Report

Property Address:
1514 Freedonia Dr
Houston TX 77055

HG Home Inspection/Hilsher Group LLC

PROPERTY INSPECTION REPORT FORM

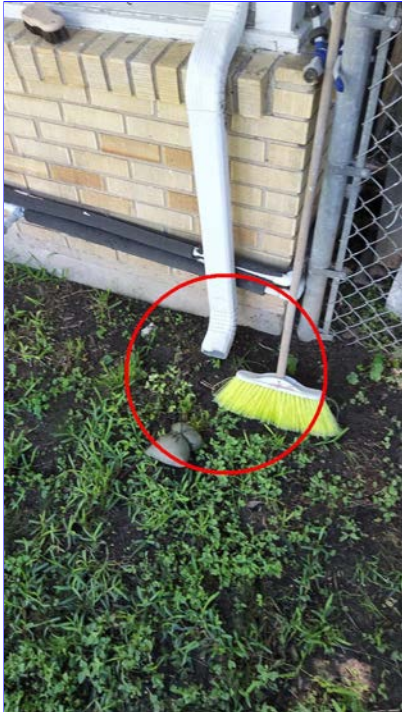
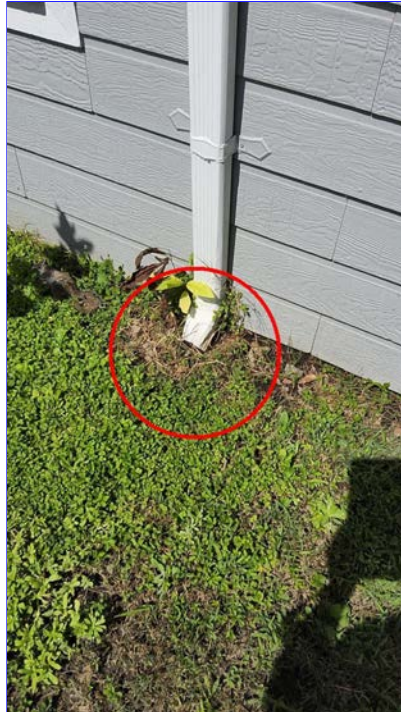
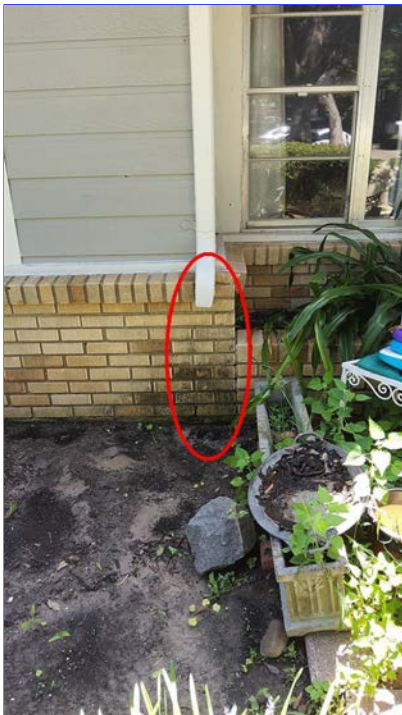
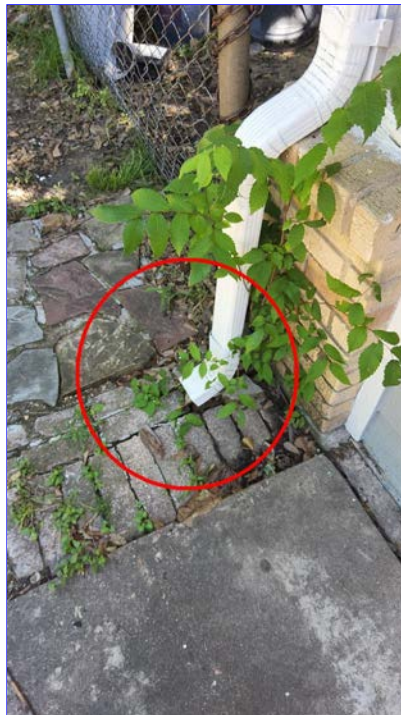
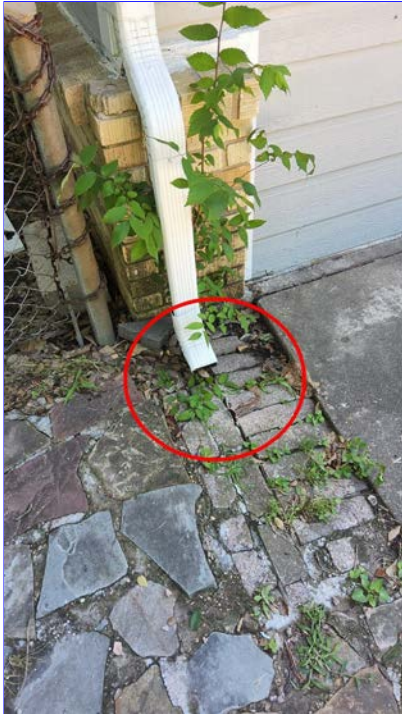
(2) The gutter downspout(s) missing deflector(s) at the exterior. Erosion can continue or become worse if not corrected. A qualified contractor should inspect and replace as needed.

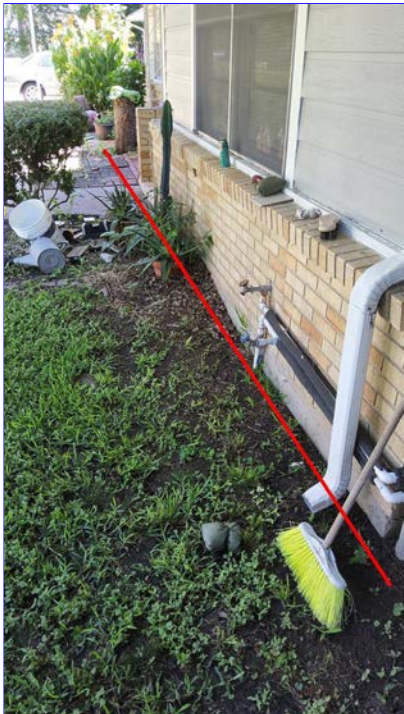
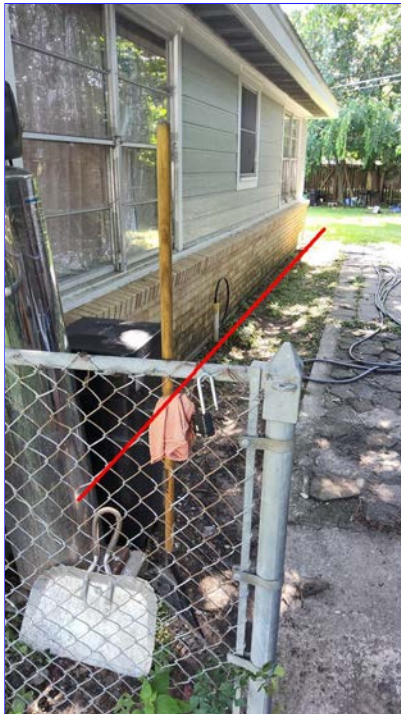
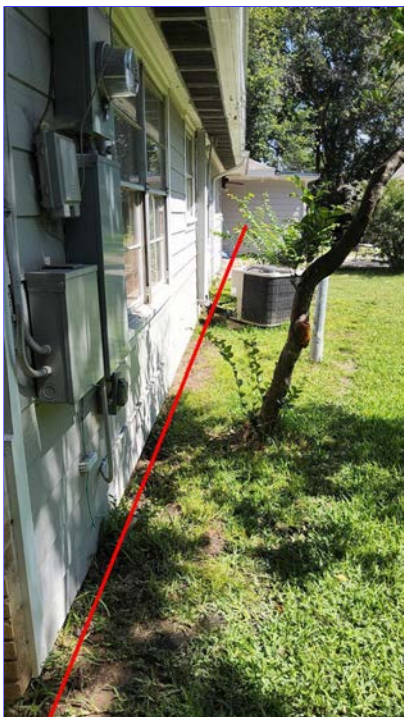
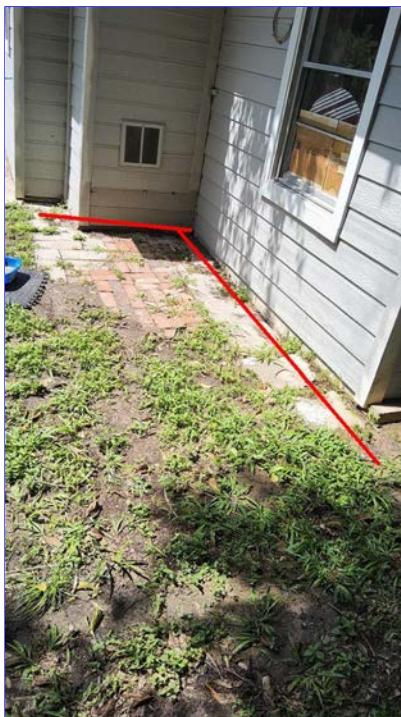
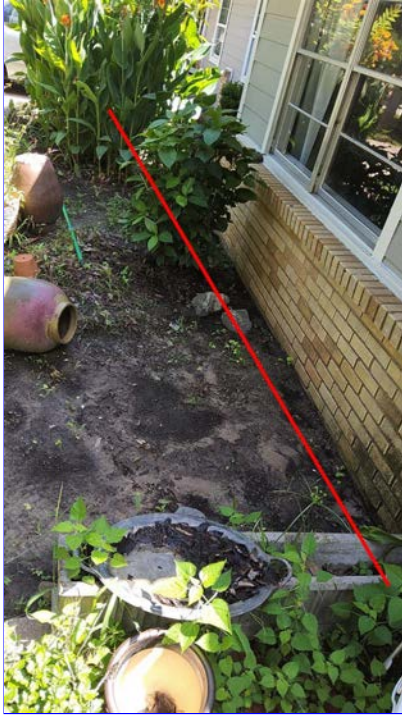
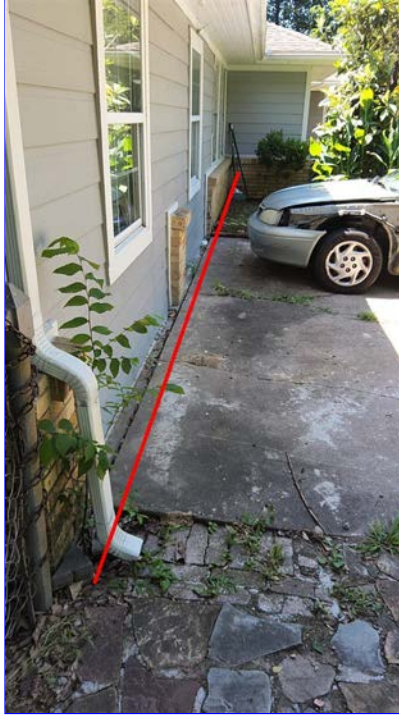
(5) The home does not appear to have adequate drainage. This will cause erosion if not corrected. I recommend having a qualified person install needed gutters.

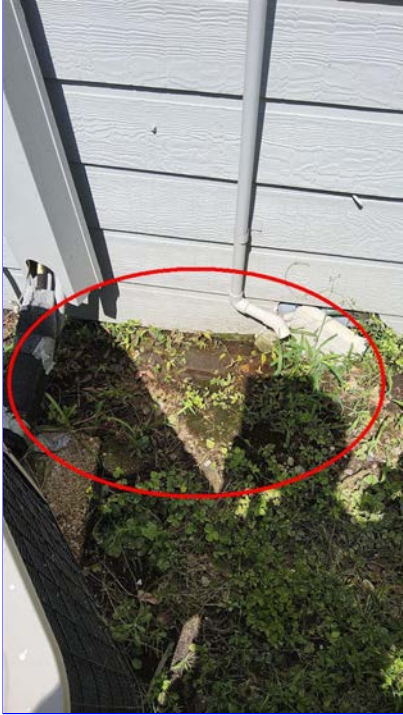
B. Item 17 (Picture)

(7) The landscape at the exterior may require a trench or drain if water stands or puddles after heavy rain. I am unable to determine due to no rain during inspection period.

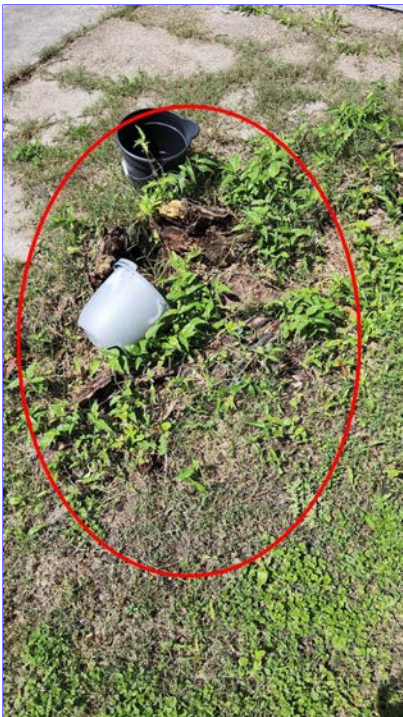
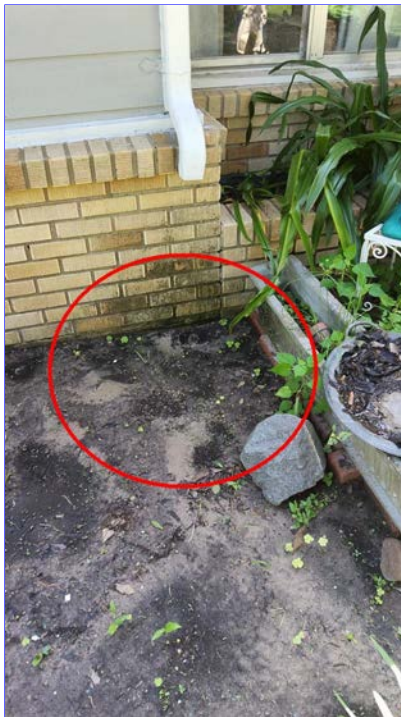
(8) The downspouts need elbows and splash-blocks at the exterior areas.

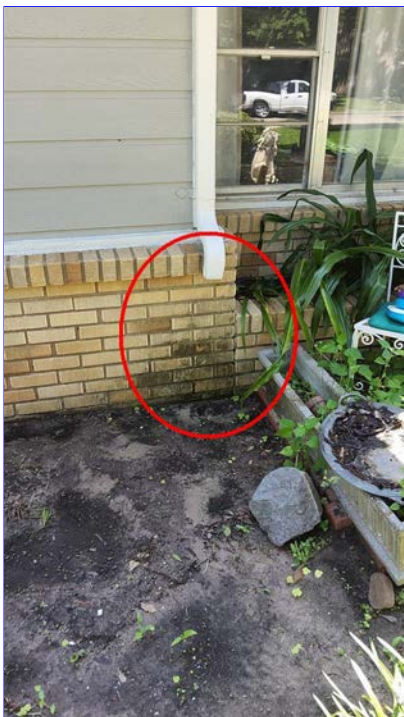
B. Item 20 (Picture)

(9) Gutters are not properly secured to the home. Further deterioration or erosion can occur if not corrected. I recommend having a qualified person make repairs as needed.

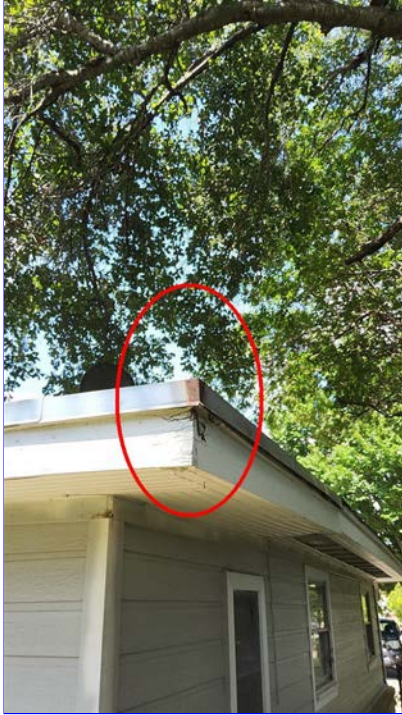
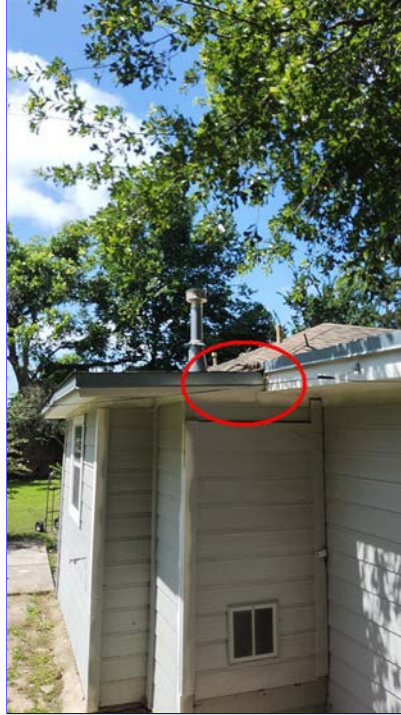
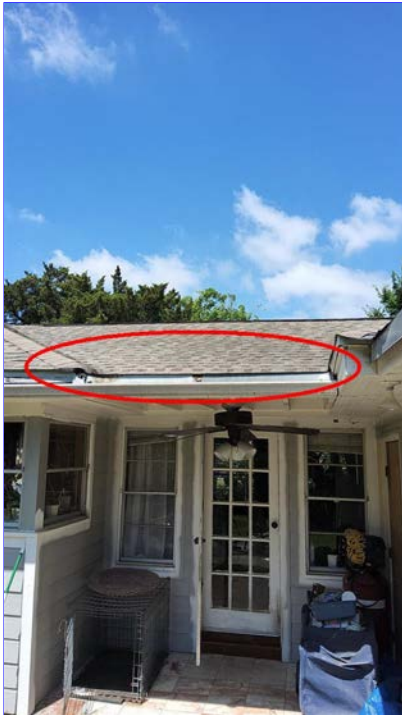
(3) The roof covering is damaged in areas. These areas may need replacement and or periodic maintenance. A qualified roofing contractor should inspect and repair as needed.

(4) Shingles appear to be lifted in areas of the roof. Damage could occur if not corrected. I recommend having a qualified roofing contractor further evaluate and make repairs as needed.

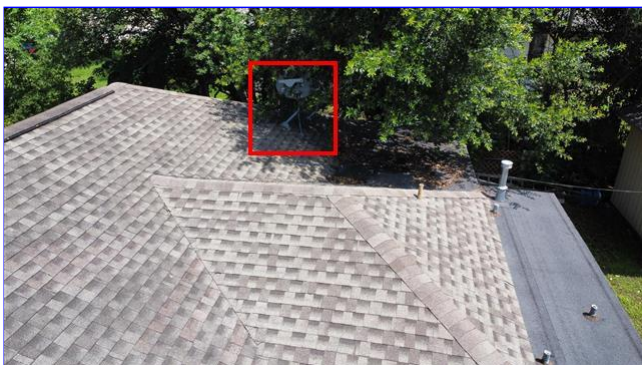
C. Item 5 (Picture)

- (7) The tree limbs that are in contact with roof or hanging near roof should be trimmed.

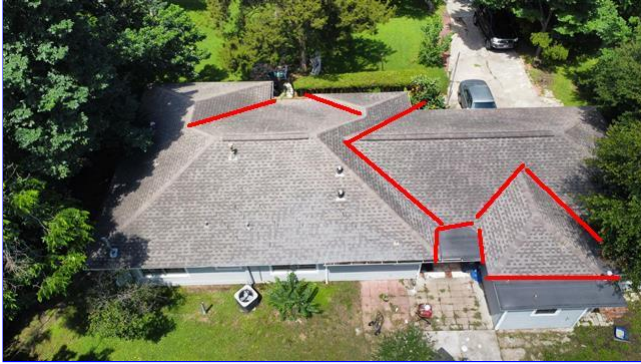
C. Item 12 (Picture)

(10) The flashing is not clearly visible and I am unable to verify proper installation and condition. I recommend consulting with a roofing professional to evaluate and make any necessary repairs.

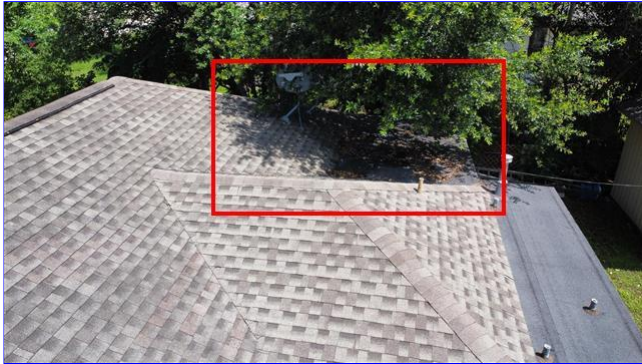
C. Item 15 (Picture)

(11) Debris is present on roof surface in multiple areas. Having debris present can lead to shingle deterioration and possible moisture problems. I recommend having a qualified contractor remove, inspect and make repairs as needed.

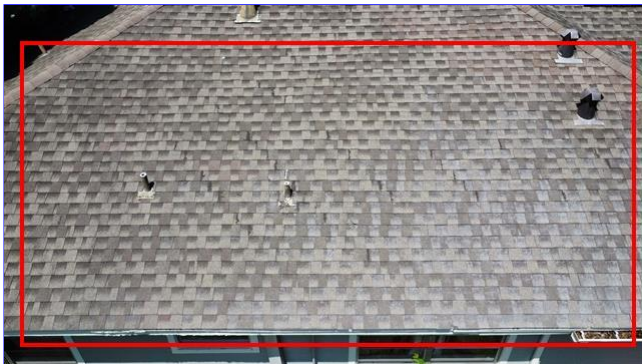
C. Item 16 (Picture)

(12) The roof shingles showing wear and granular loss. (Granules provide UV protection for shingles. Once the granules erode away the sun is able to deteriorate the asphalt and shortens the life of the roofing material.) I recommend consulting with a roofing professional.. A qualified person should repair or replace as needed.

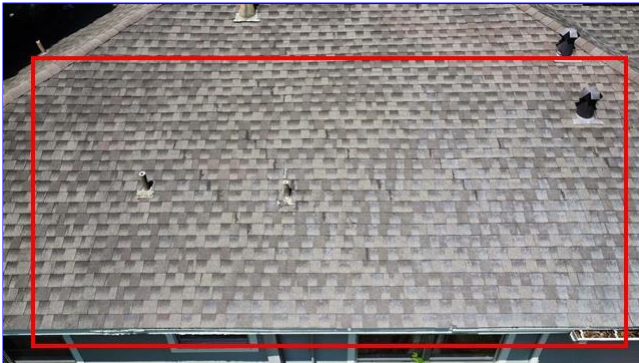
C. Item 20 (Picture)

(13) The roof covering has been repaired at the "entire roof". I recommend consulting with a roofing professional.. A qualified contractor should inspect and repair as needed.

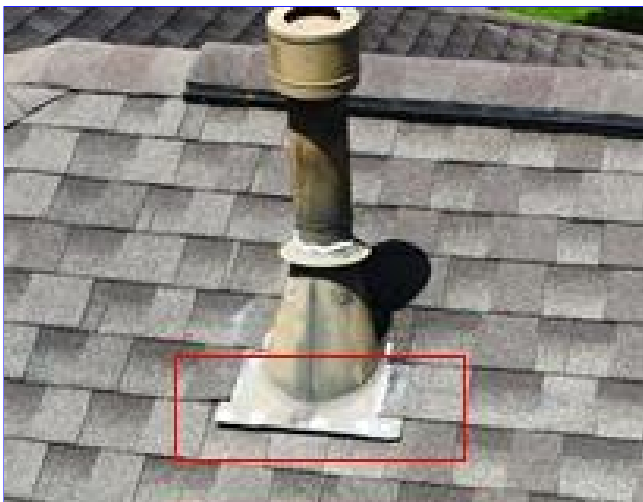
C. Item 21 (Picture)

(14) The metal drip edge deteriorated along rake/eave at the exterior areas. Further deterioration may occur if not repaired. A qualified contractor should inspect and repair as needed.

(15) The roofing surface has exposed nail heads that are showing signs of deterioration. Further deterioration will occur if not corrected. I recommend having a qualified person repair or replace as needed.

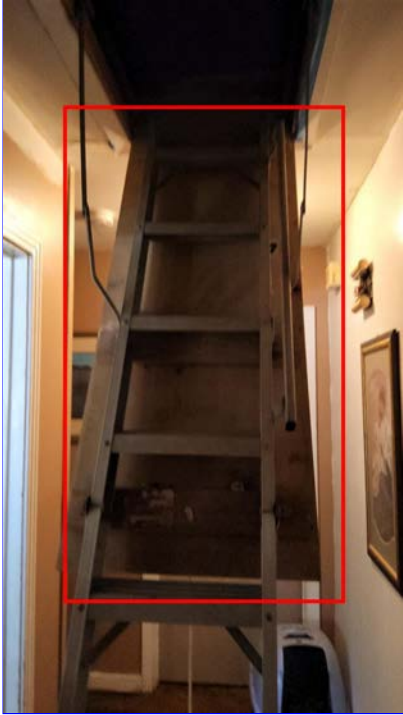
D. Item 1 (Picture)

(2) The pull down stairs are not properly insulated. This can cause some heat loss in winter and loss of cool air in summer if not corrected. I recommend repair as desired.

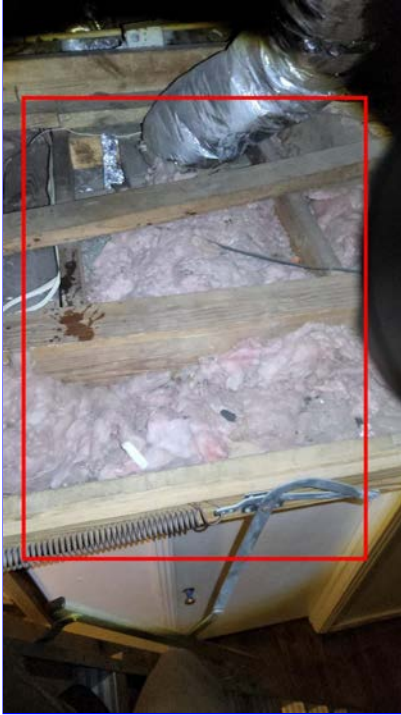
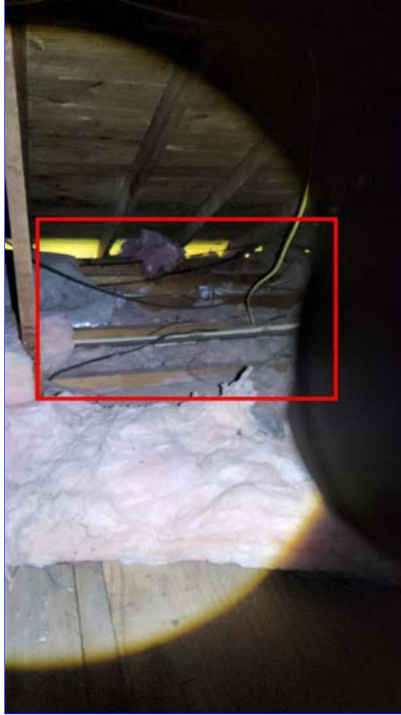
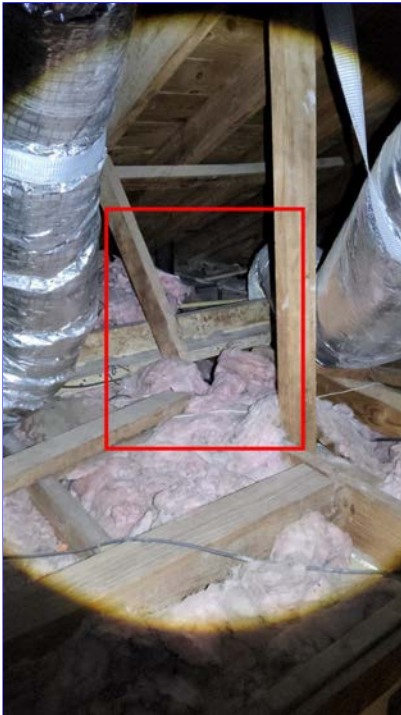
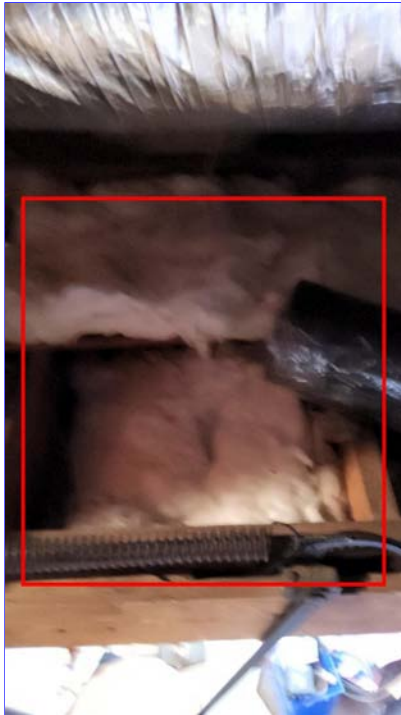
(3) The attic space has areas of thin insulation. This is causing energy loss and is not today's standard. I recommend having a qualified person evaluate and add insulation as needed.

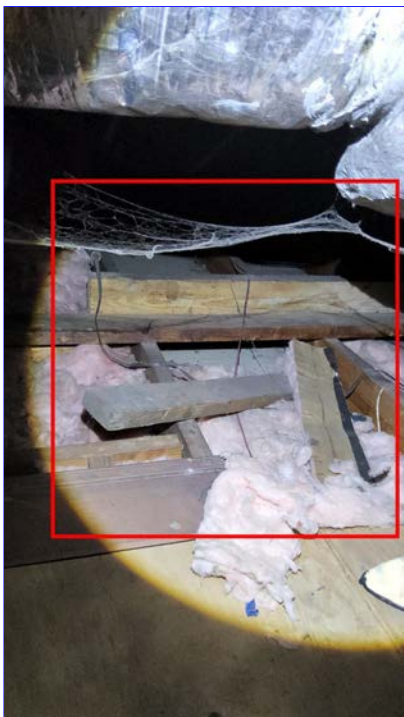
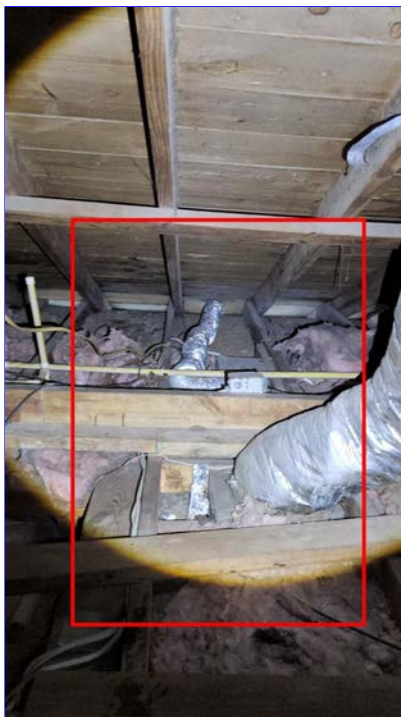
(4) The attic space has areas of missing insulation. This is causing energy loss and is not today's standard. I recommend having a qualified person evaluate and add insulation as needed.

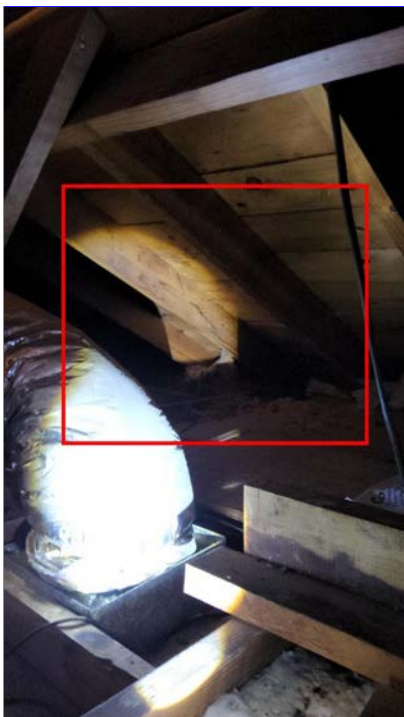
D. Item 13 (Picture)

(6) Inadequate purlin brace sizing and spacing. This is not up to today's standards and should be corrected. Have a qualified contractor evaluate and remedy as needed.

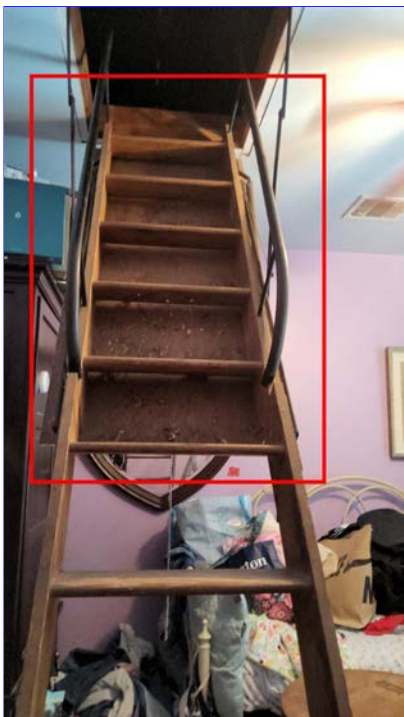
D. Item 14 (Picture) bedroom 4

(7) The pull down stairs does not shut properly, has no insulation, no longer shuts tight when closed. This can cause some heat loss in winter and loss of cool air in summer if not corrected, Injury could result if not repaired. A qualified contractor should inspect and repair as needed.

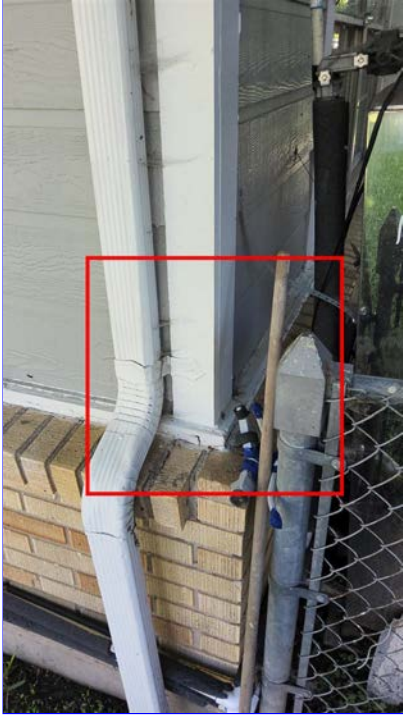
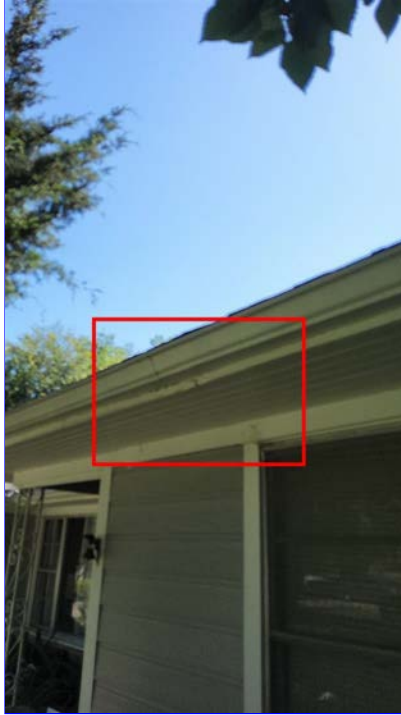
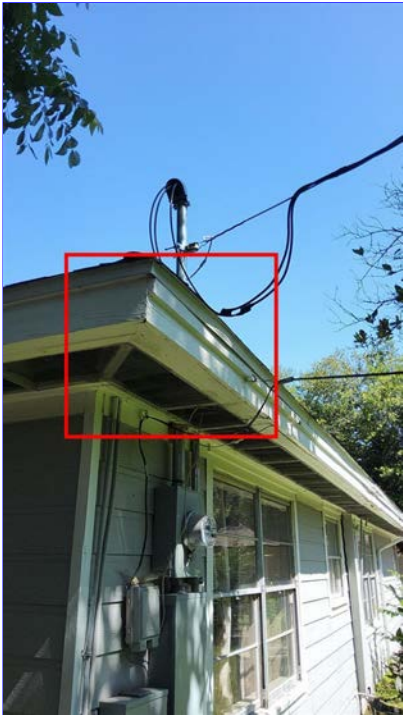
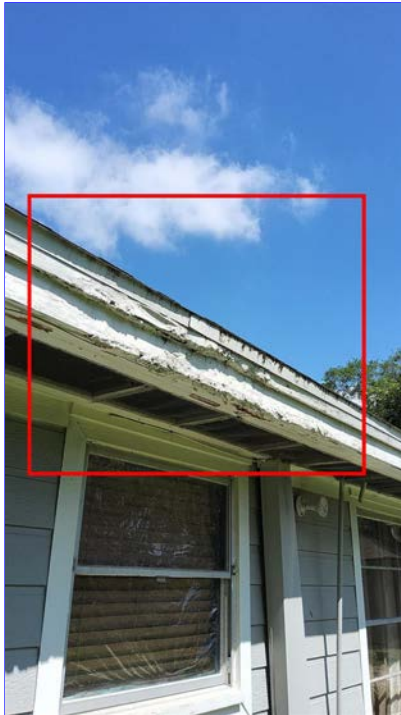
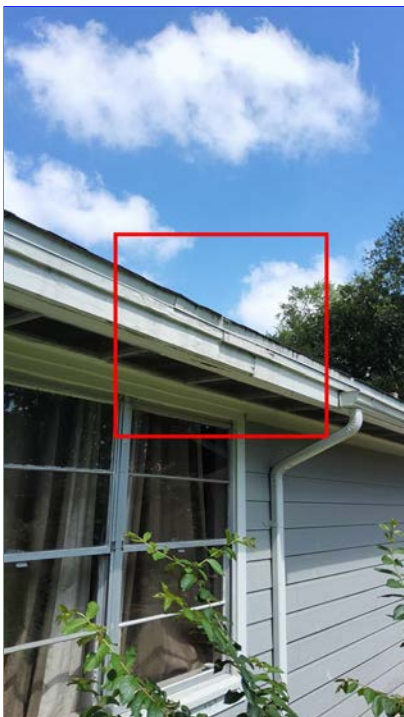
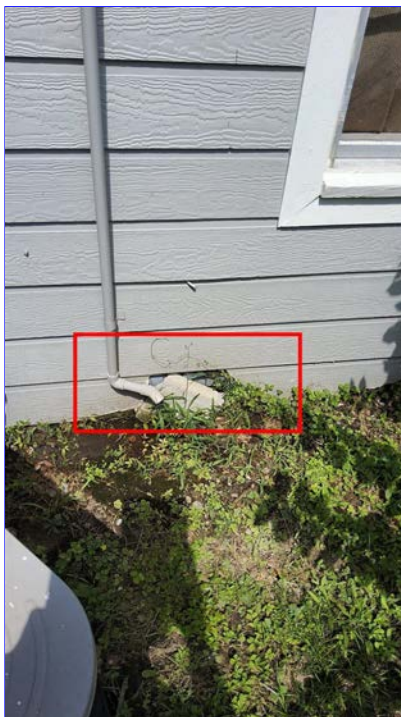
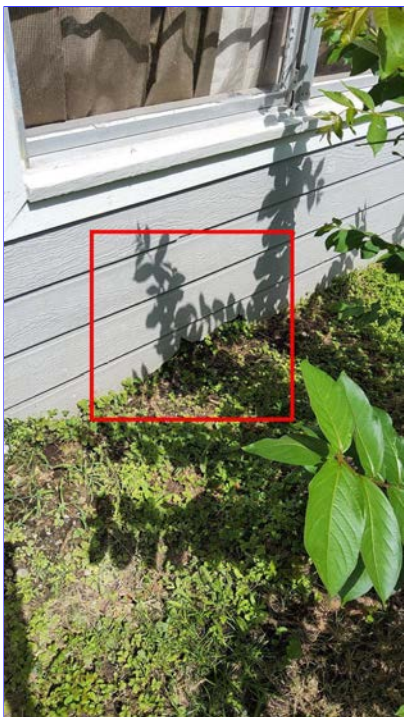
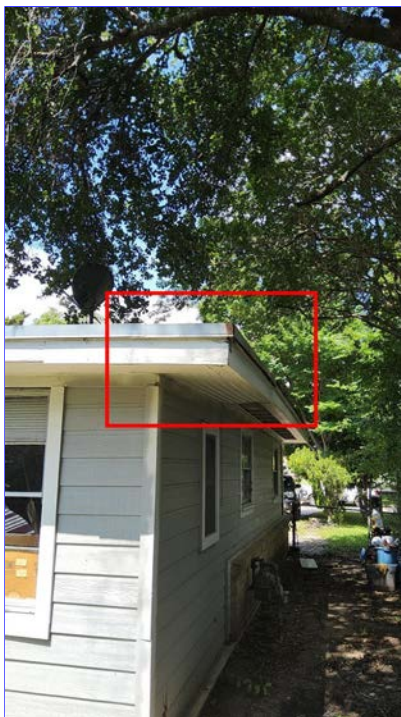
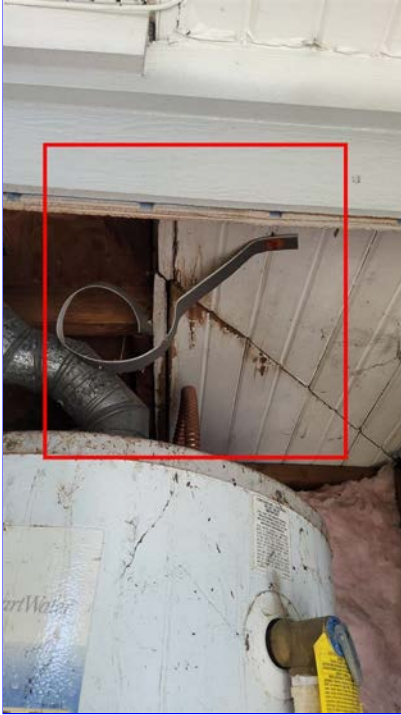
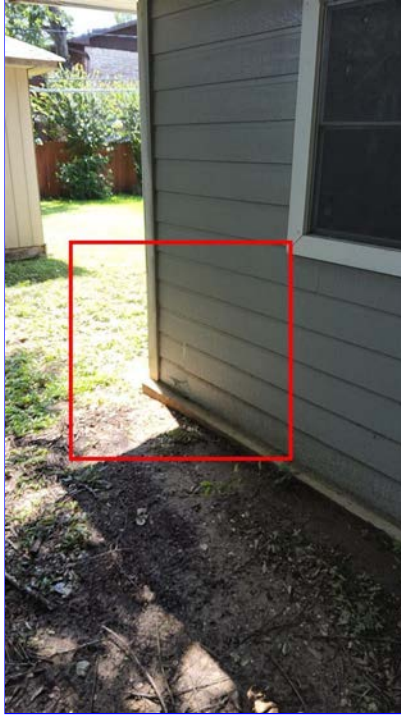
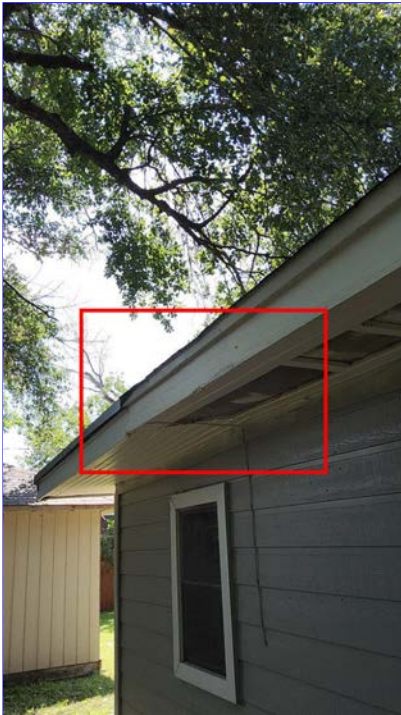
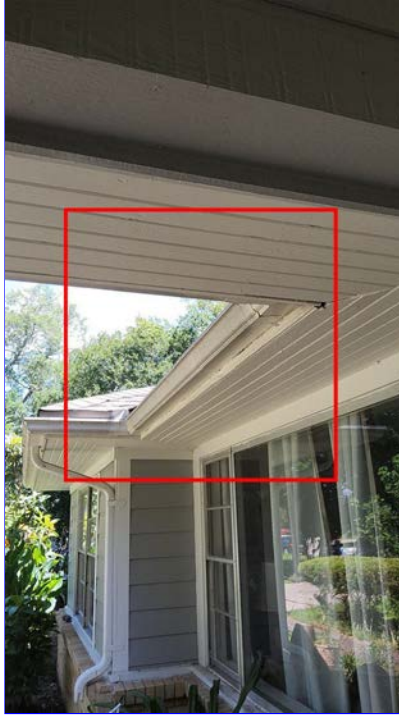
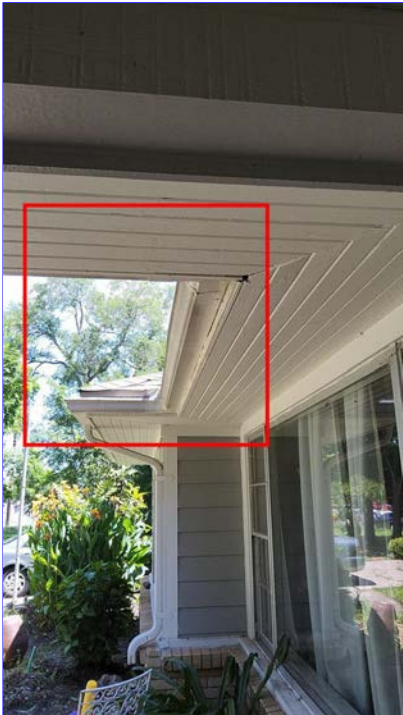
(1) The exterior siding and trim is deteriorated in areas. Further deterioration will occur if not corrected. A qualified contractor should inspect and repair as needed.

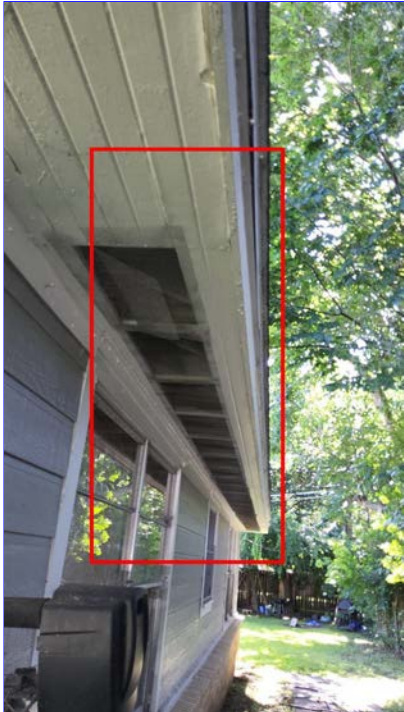
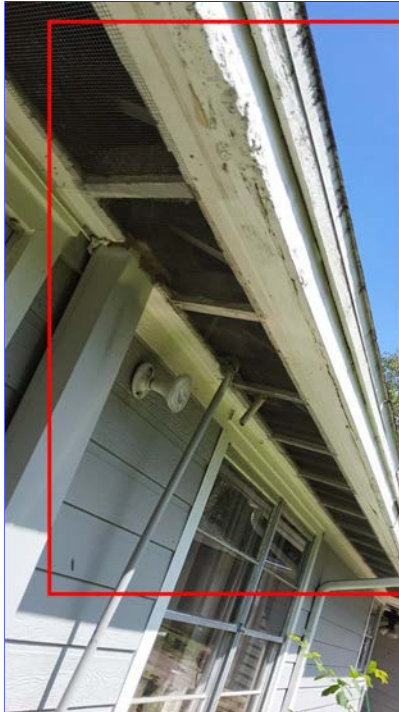
(2) The soffit panels at eave on the exterior damaged. Further deterioration may occur if not repaired. A qualified person should repair or replace as needed.

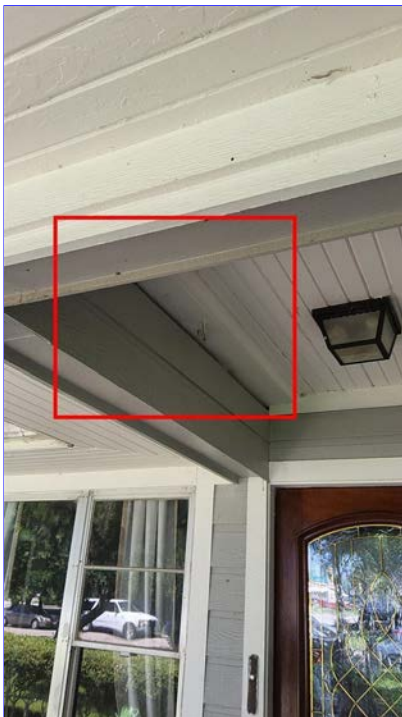
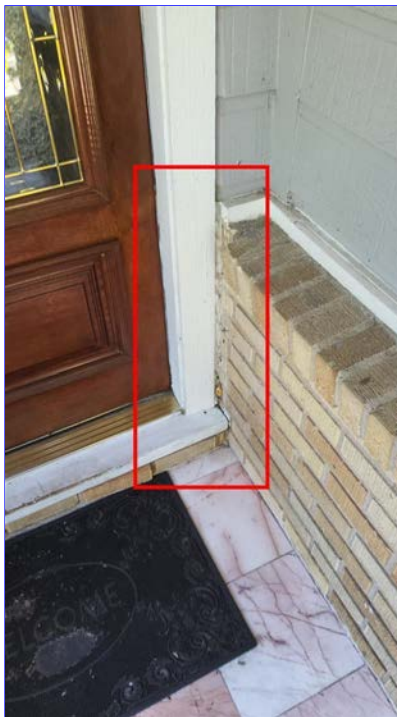
(5) The siding exterior has caulking that is weathered or missing and some lifted nails. Deterioration can eventually occur if not corrected. A qualified person should repair as needed.

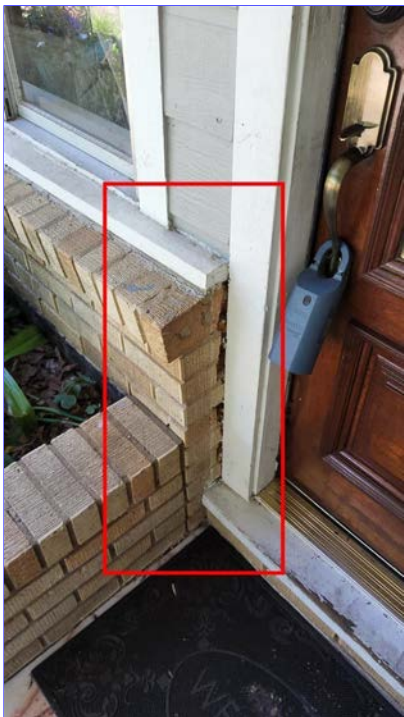
E. Item 27 (Picture)

(8) The Brick siding exterior missing weep holes. Deterioration can eventually occur if not corrected. A qualified contractor should inspect and repair as needed.

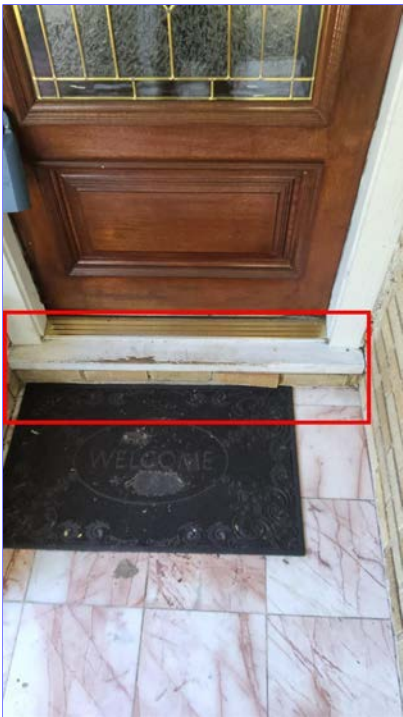
E. Item 29 (Picture)

(9) The Brick siding exterior damaged, deteriorated, loose. Further deterioration can occur if not corrected. A qualified contractor should inspect and repair as needed.

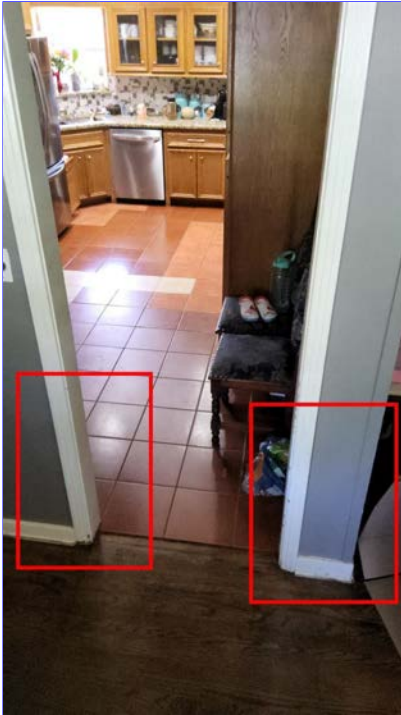
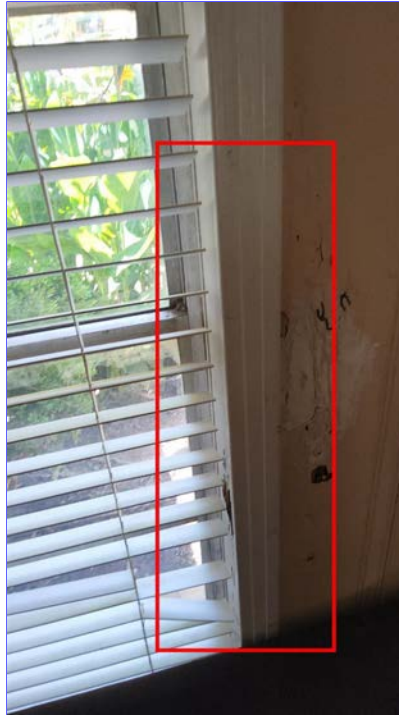
(10) Most if not all Interior trim is damaged or peeling paint in areas. This is a cosmetic issue. I recommend repair as desired.

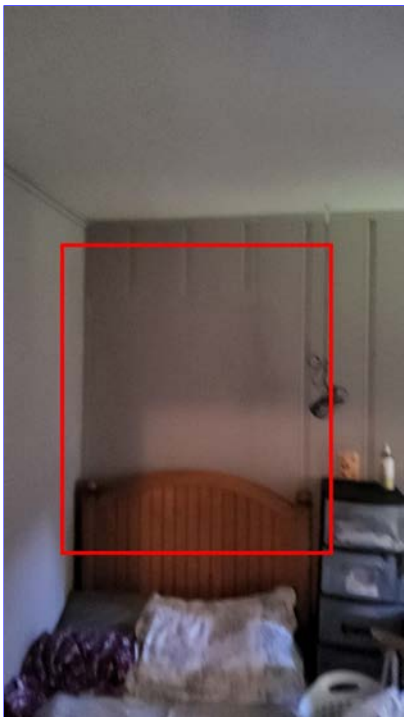
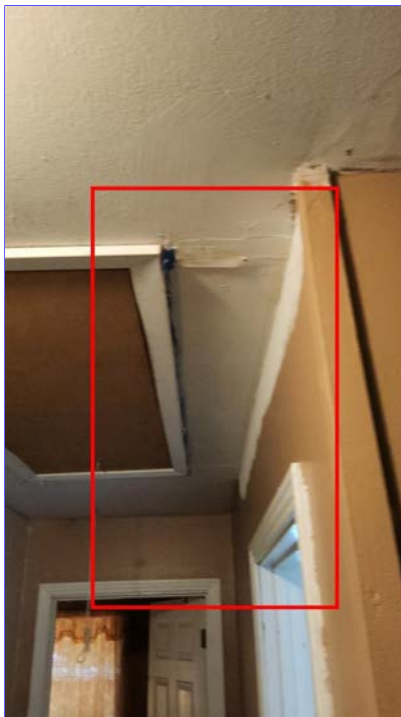
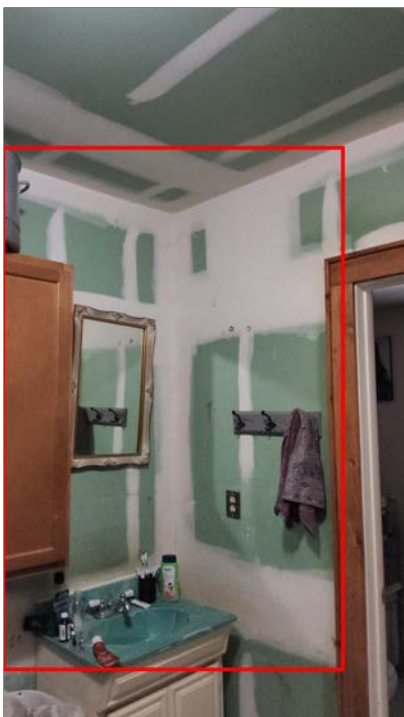
(11) Drywall shows signs of repairs in areas. This is a cosmetic issue. I recommend having a qualified contractor inspect and repair as needed.

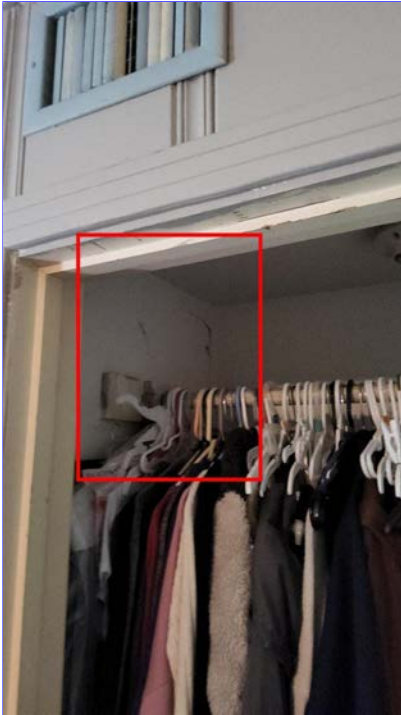
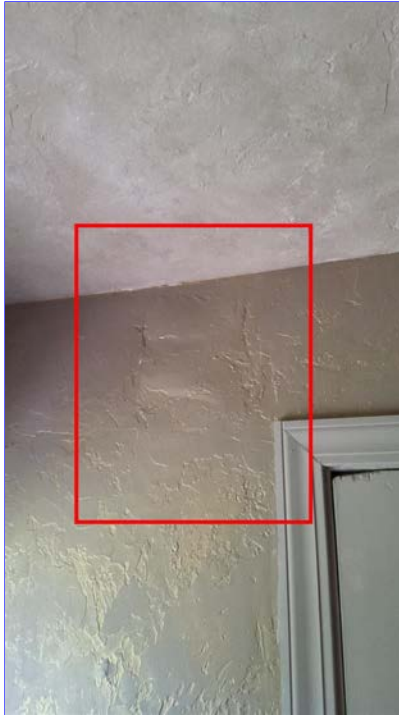
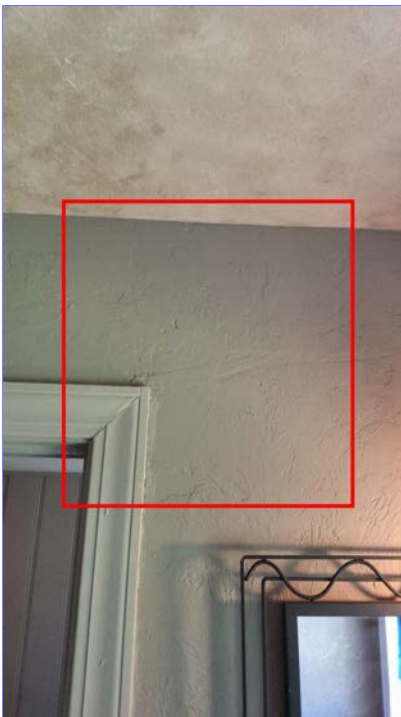
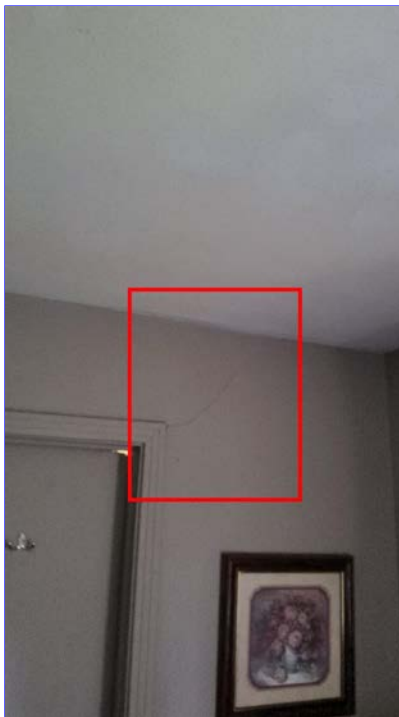
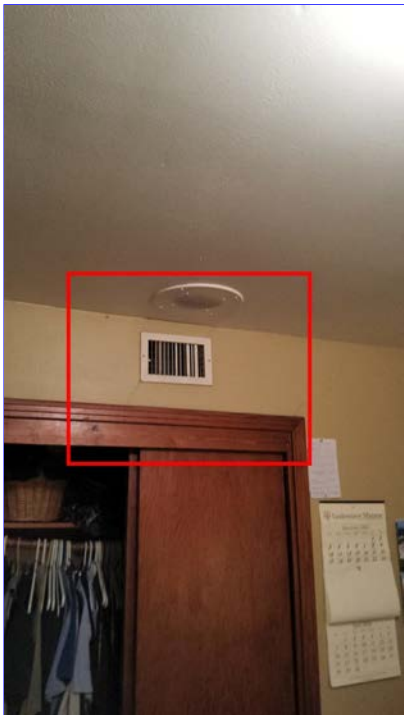
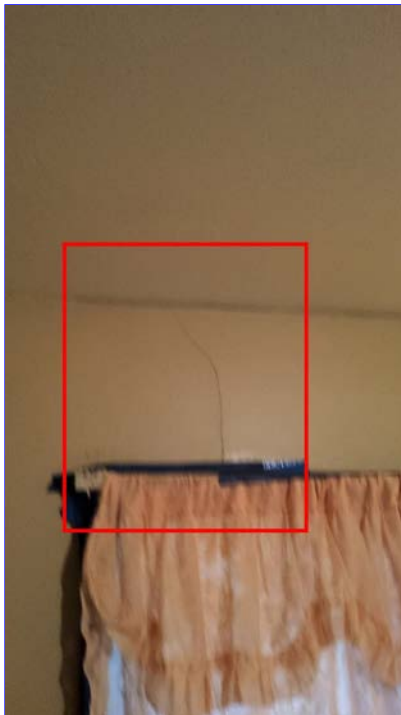
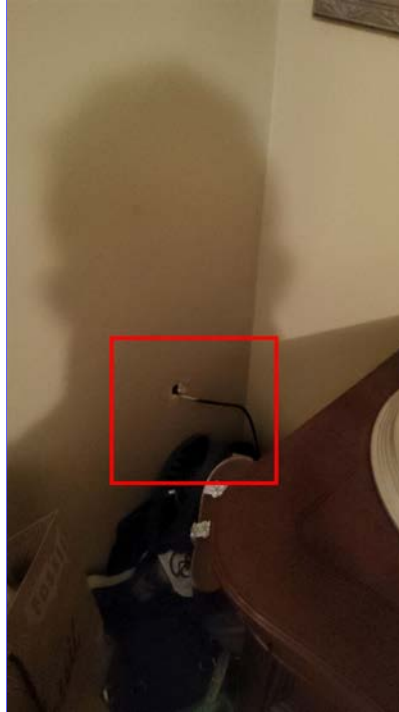
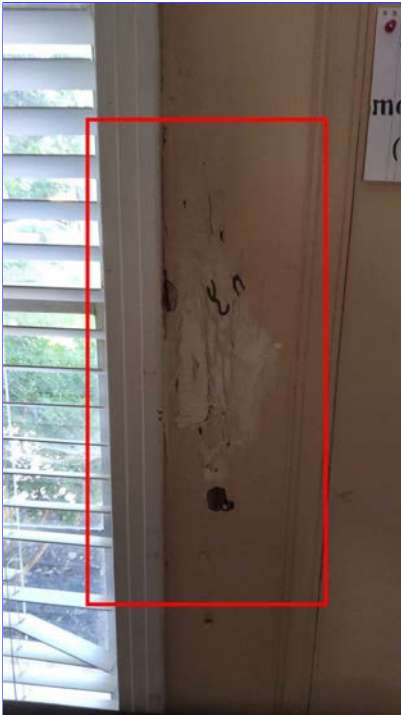
(12) The drywall on the wall is damaged, has several hairline cracks in areas. While this damage is cosmetic, it needs to be repaired. A qualified person should repair or replace as needed.

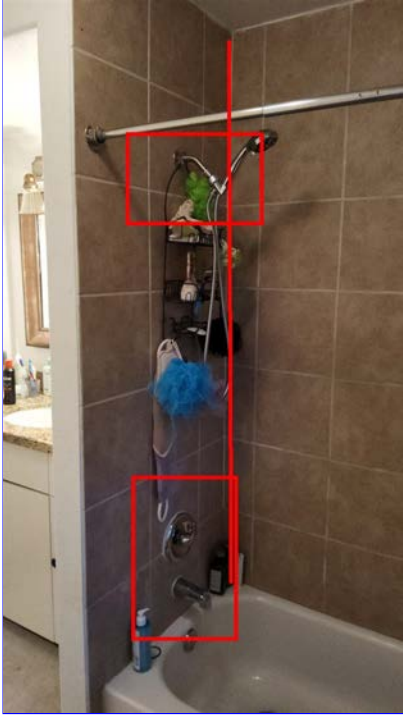
E. Item 47 (Picture)

(13) The Tile surround at bathtub on the wall missing silicone caulking around control knob cover-plate and at the corners where the Tile rests at the tub in the hall bath. This is a small repair issue for your information. A qualified person should repair or replace as needed.

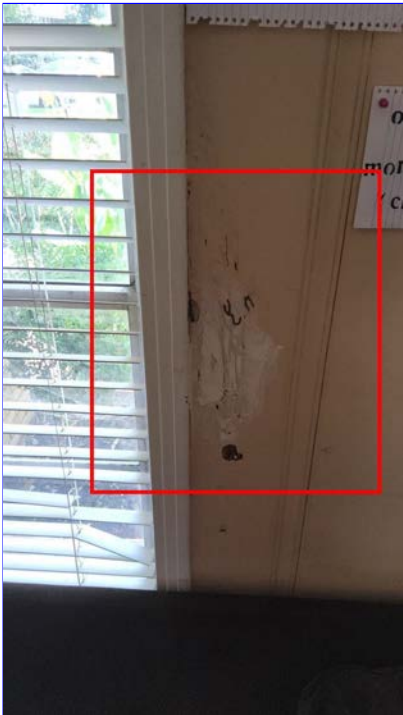
E. Item 48 (Picture)

(14) The paneling on the wall shows wet stains indicating moisture or intrusion did or still may occur in areas. The moisture meter was used and it did not indicate an active leak. A qualified contractor should inspect and repair as needed.

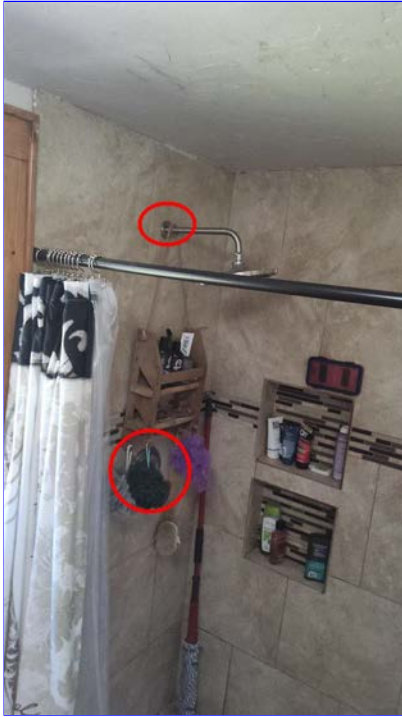
E. Item 49 (Picture)

(15) The Tile surround at shower on the wall missing silicone caulking around control knob cover-plate, missing silicone caulk at inside corners and at shower pan (floor) perimeter at the hall bath. This is a small repair issue for your information. A qualified contractor should inspect and repair as needed.

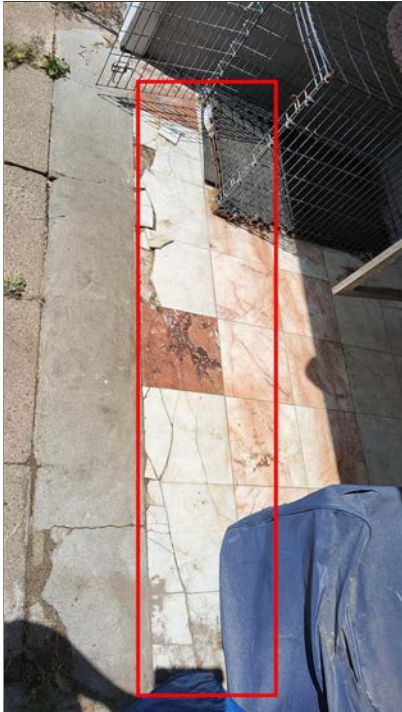
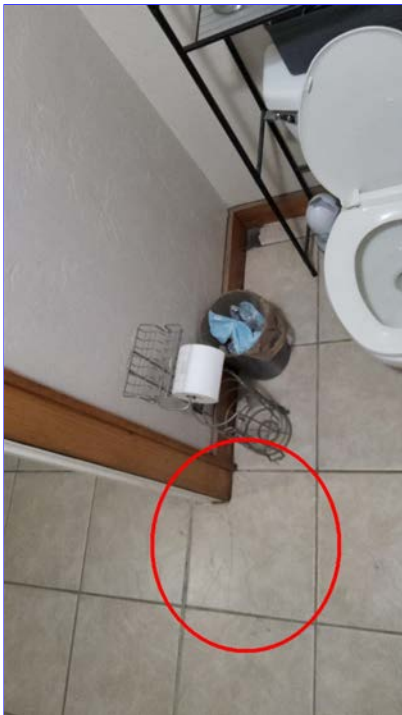
(1) The tile flooring is cracked/damaged. This damage is considered cosmetic. I recommend repair as desired.

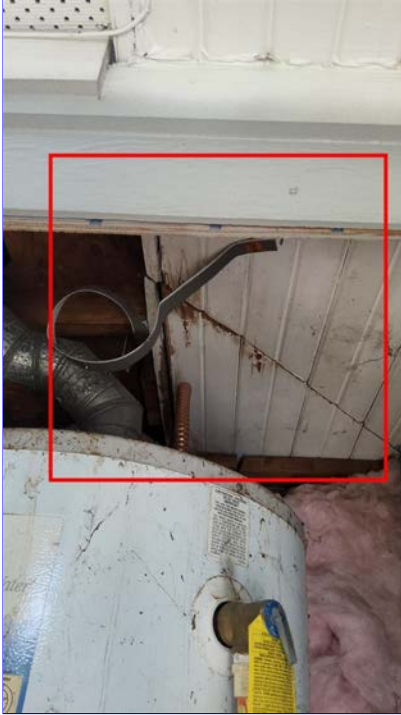
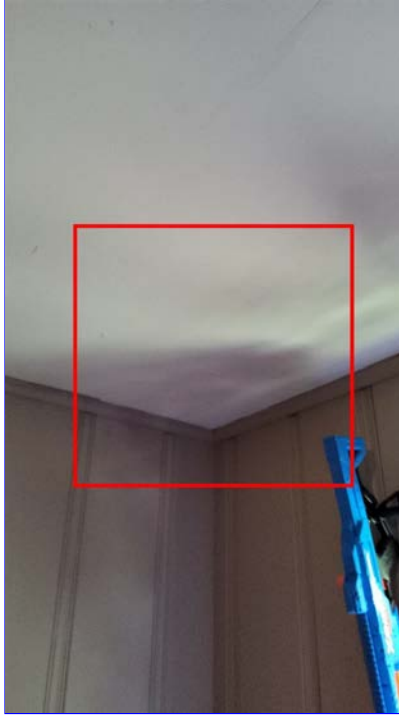
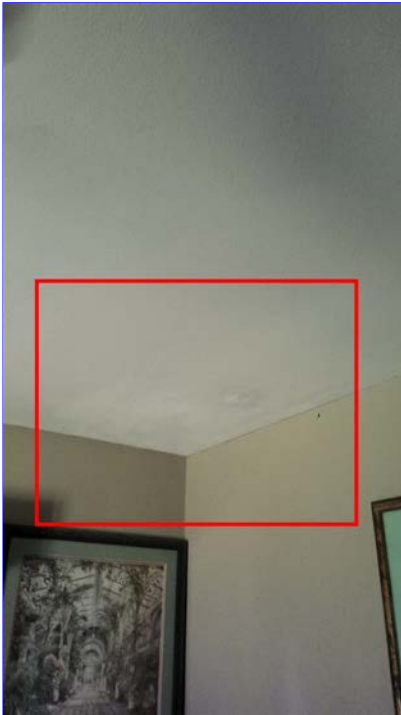
(2) The Wood panels and sheetrock on the ceiling reveals a water stain indicating a leak did or still exists in areas. The moisture meter was used and it did not indicate an active leak. A qualified contractor should inspect and repair as needed.
