Inspection Report

Property Address:
1514 Freedonia Dr
Houston TX 77055

HG Home Inspection/Hilsher Group LLC

PROPERTY INSPECTION REPORT FORM

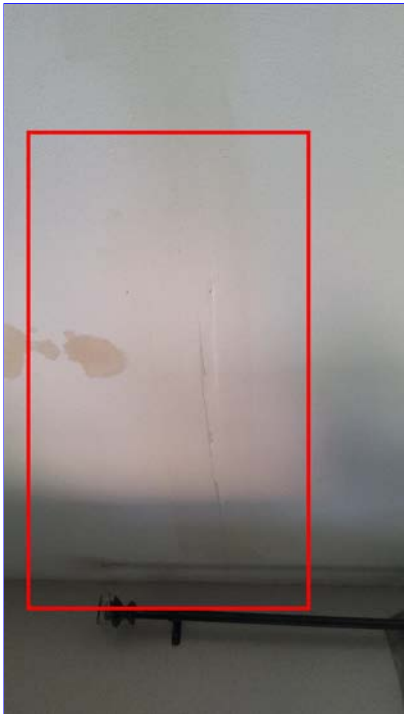
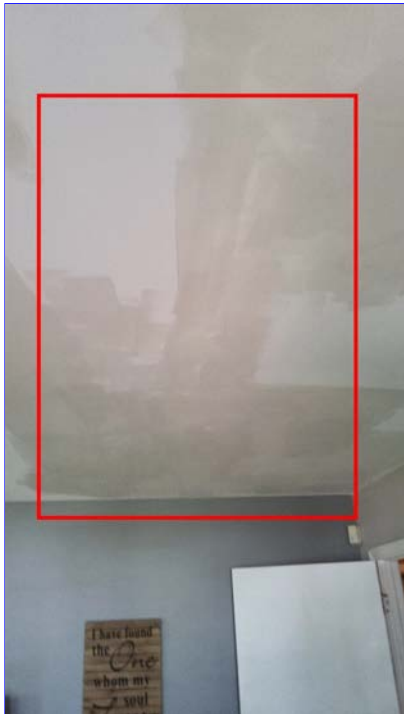
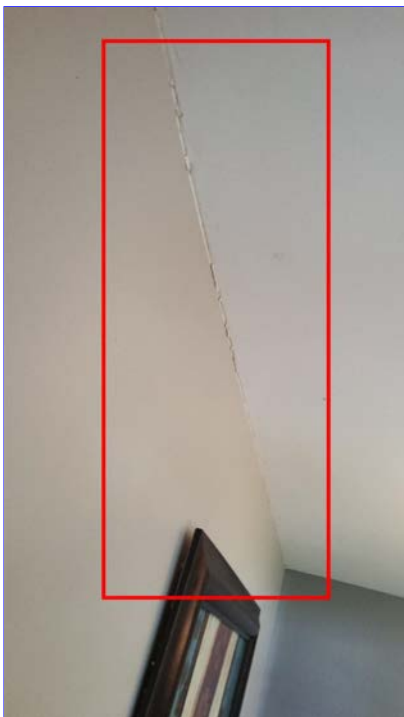
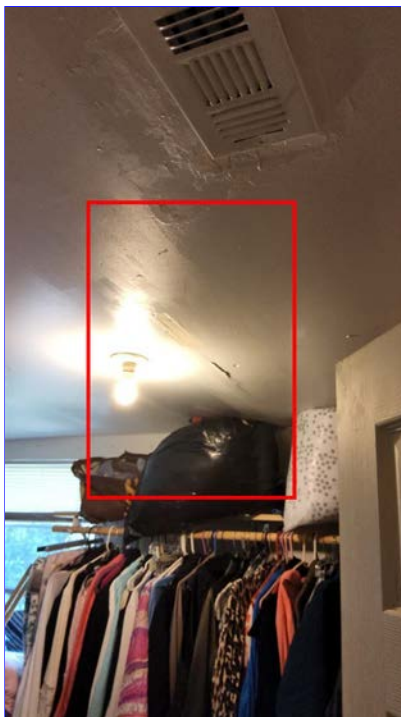
(3) The Sheetrock on the ceiling has several hairline cracks (cosmetic) in areas. This damage is considered cosmetic. A qualified contractor should inspect and repair as needed.

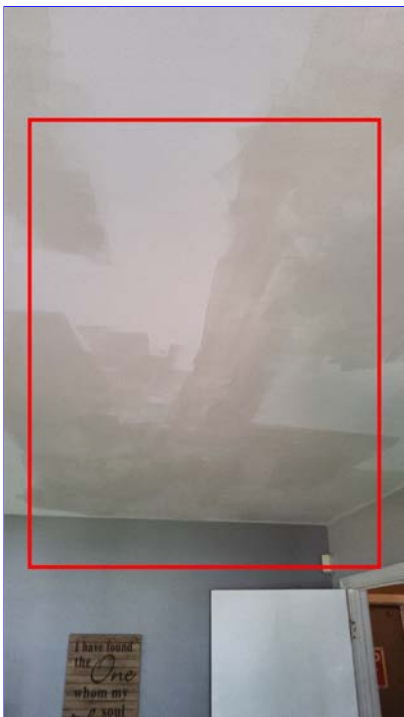
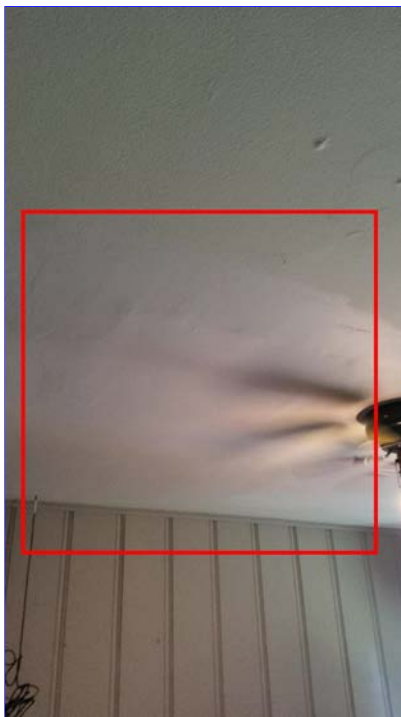
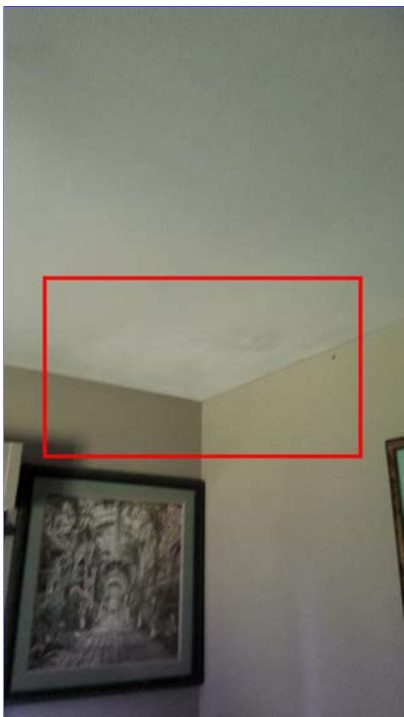
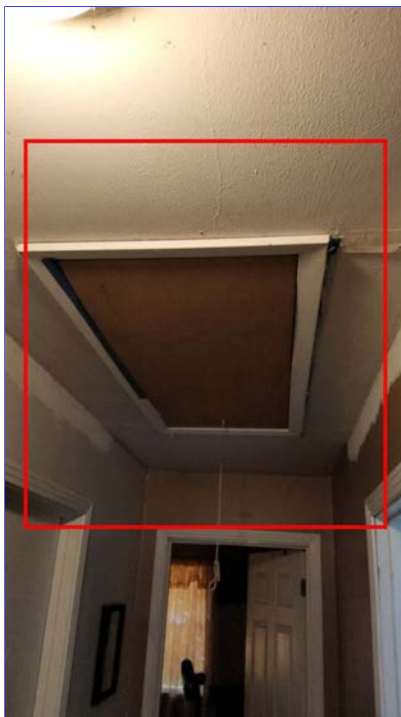
(4) The Sheetrock on the ceiling shows repair signs in areas. This is a cosmetic issue for your information. A qualified contractor should inspect and repair as needed.

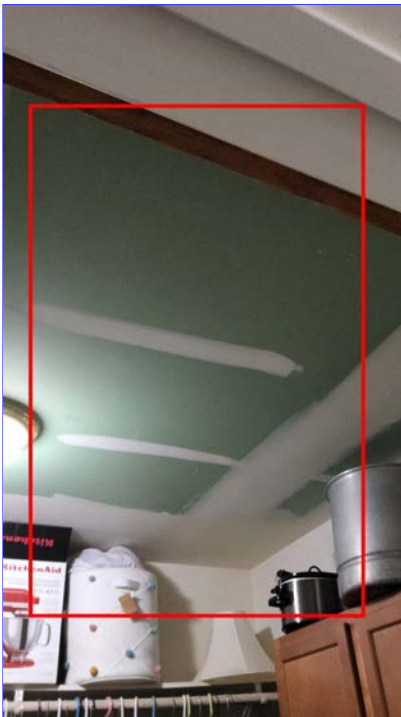
F. Item 19 (Picture) utility room

(5) The Sheetrock on the ceiling reveals a water stain indicating a leak did or still exists in areas. The moisture meter was used and it did not indicate an active leak. A qualified contractor should inspect and repair as needed.

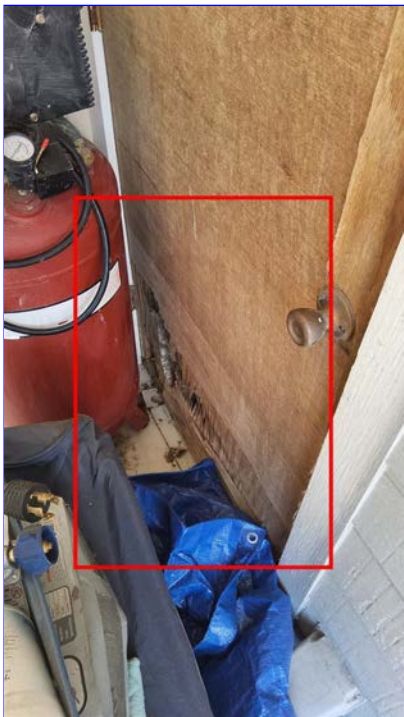
G. Item 1 (Picture)

(1) Exterior door is damaged and deteriorated and is in need of replacement. Have a qualified contractor evaluate and remedy as needed.

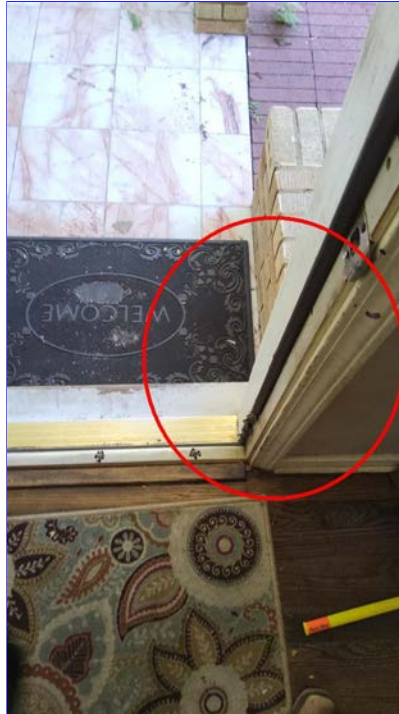
G. Item 6 (Picture)

(4) The Entry door has damaged knob hardware in areas. This is a maintenance issue and is for your information. A qualified person should repair or replace as needed.

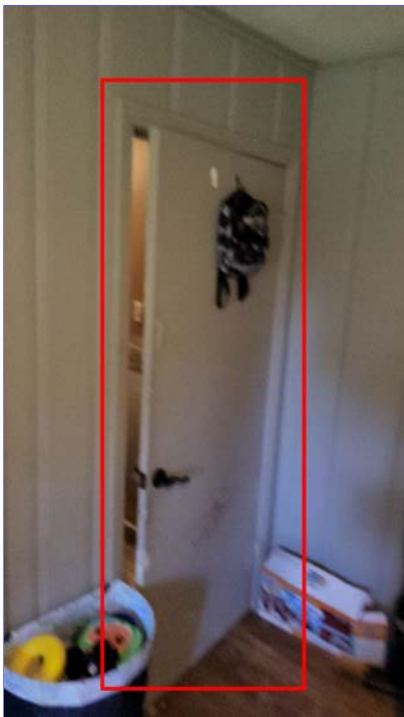
G. Item 9 (Picture) bedroom 1

(5) The Entry door rubs at top when closing, does not shut properly in areas. This is a maintenance issue and is for your information. A qualified contractor should inspect and repair as needed.

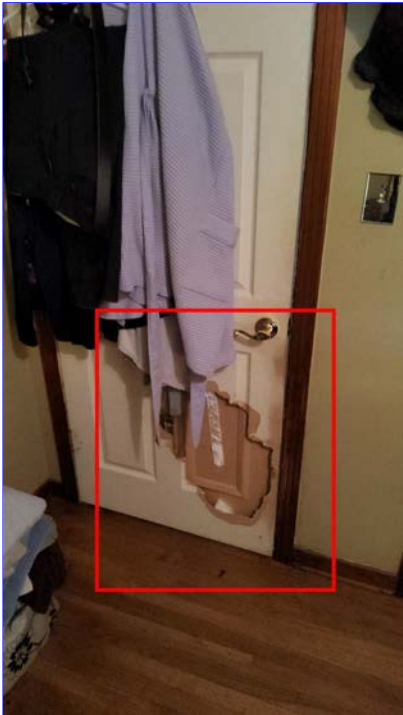
G. Item 12 (Picture) bedroom 3

(7) The interior door does not shut and latch properly. This is a maintenance issue and is for your information. A qualified contractor should inspect and repair as needed.

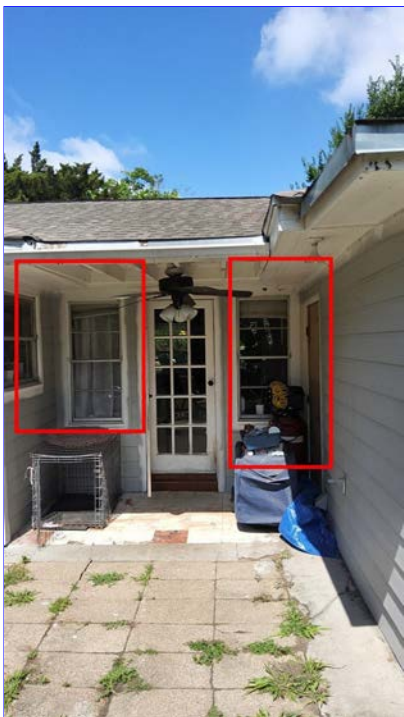
H. Item 5 (Picture)

(2) There is a cracked glass pane in window. I recommend having a qualified person make repairs as needed.

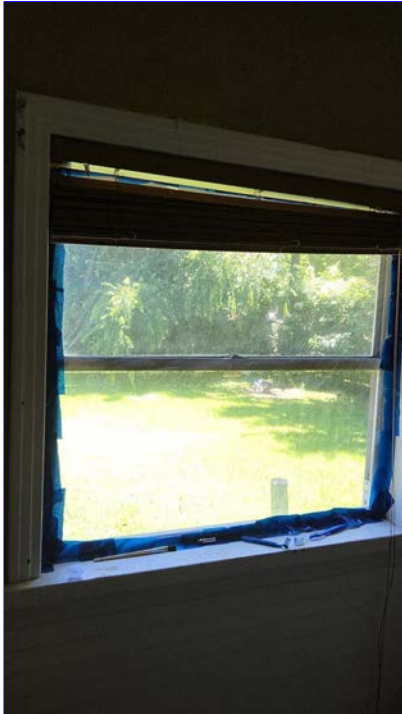
H. Item 12 (Picture) bedroom 1 bathroom

(7) Some windows stuck or painted shut, is not considered a functional window Private bath. Deterioration may occur if not corrected. A qualified contractor should inspect and repair as needed.

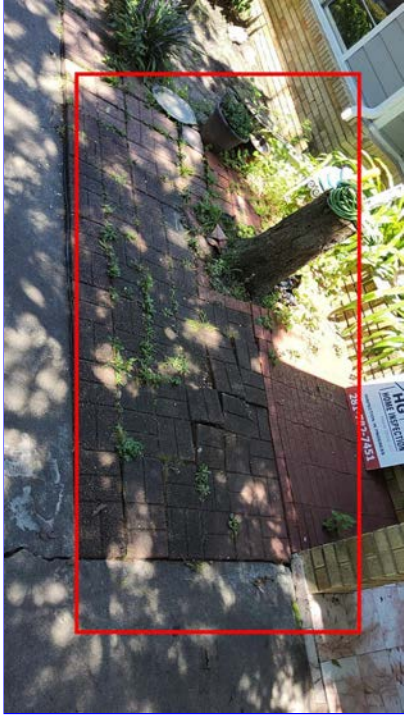
K. Item 1 (Picture)

(2) The concrete floor, tile floor, brick floor on the patio at the exterior areas has loose tile and mortar (small area) has cracked in some areas (which are cosmetic), beginning to deteriorate. Further deterioration can occur if not repaired. A qualified person should repair or replace as needed.

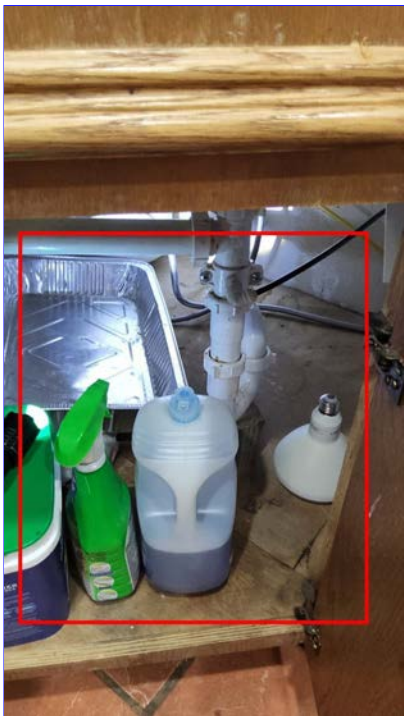
L. Item 16 (Picture) kitchen

(4) Evidence of previous water leak under sink. The stain appears old. I recommend having a qualified person repair as needed.

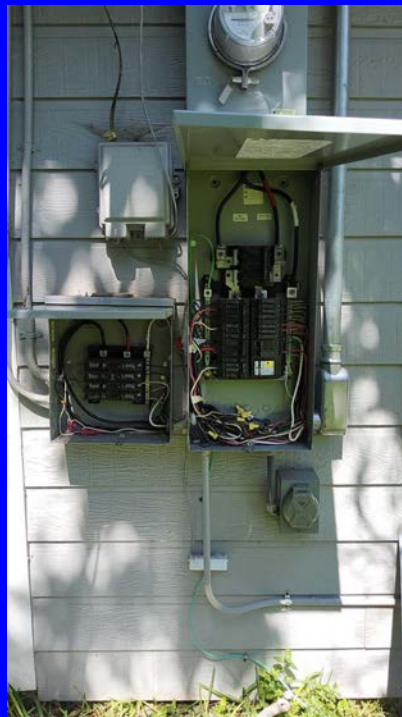
150amp main service panel and sub panel backyard

(1) The electrical panel has branch circuit wires bundled together that are entering the panel through one to two entry points. This is not considered today's standard. It is recommended that each sheathed wire enter the panel independently and be sealed for fire blocking purposes. I recommend having a qualified electrician evaluate and make repairs as needed.

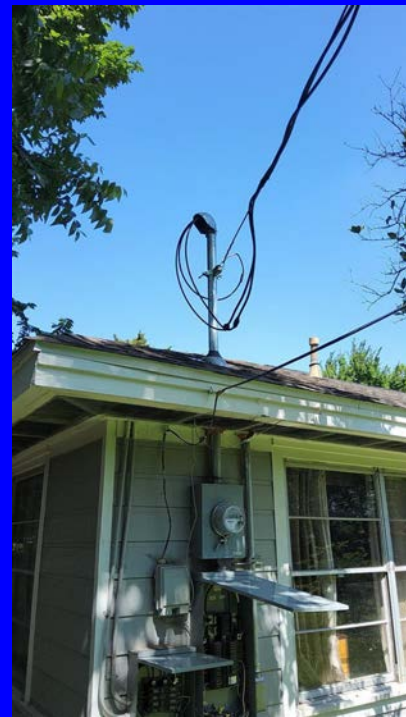
electrical meter backyard

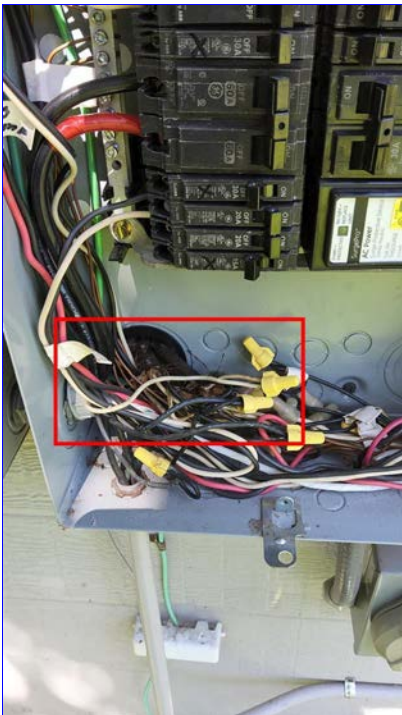
A. Item 2 (Picture)

(2) The electrical service conductors are frayed at wire sheathing outside and needs repair or replace.

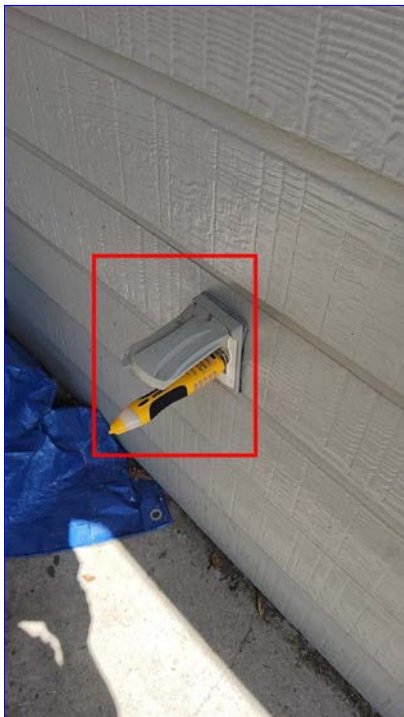
B. Item 6 (Picture)

(5) The exterior outlet at the rear of home not grounded. Further inspection is needed by a qualified

licensed electrical contractor. A qualified licensed electrical contractor should perform repairs that involve wiring.

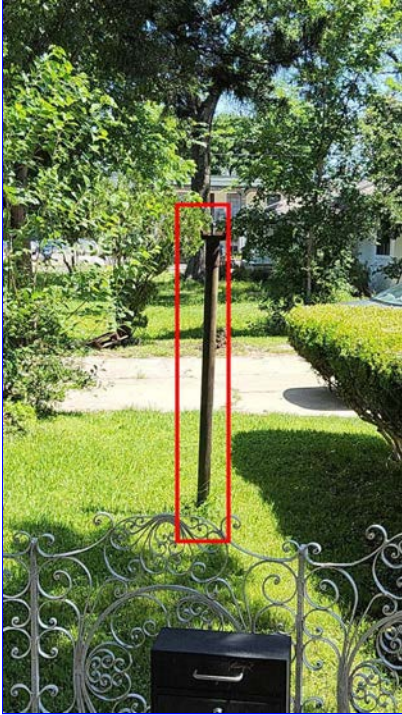
B. Item 7 (Picture)

(6) The light fixture does not work, is damaged, is old and rusted at the in areas. Electrical issues are considered a hazard until repaired. A qualified licensed electrical contractor should perform repairs that involve wiring.

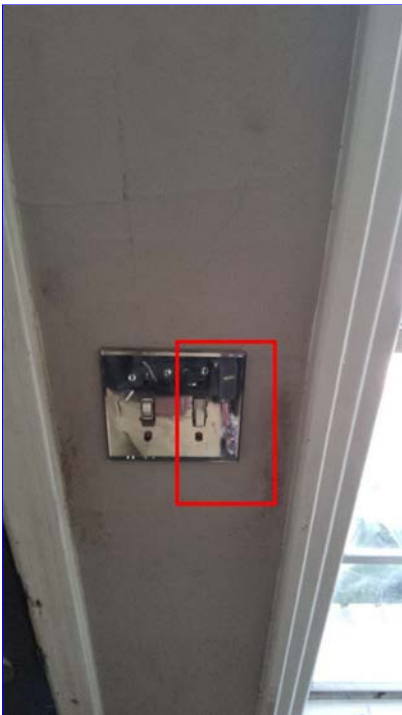
B. Item 9 (Picture) front entrance

(7) The wall switch purpose is unknown (could not identify) at the in areas. This is for your information. A qualified licensed electrical contractor should perform repairs that involve wiring.

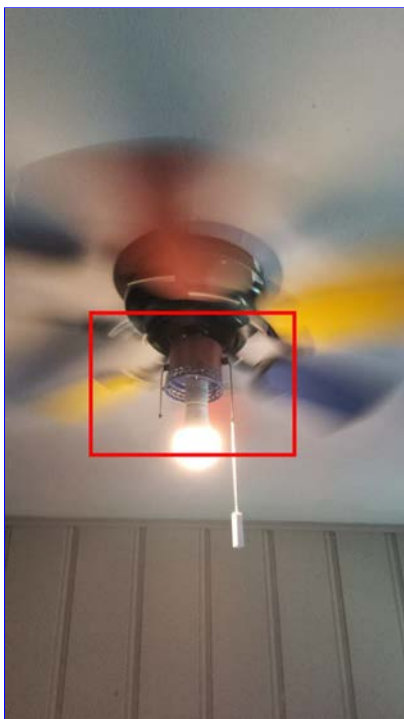
B. Item 11 (Picture)

(9) The light fixture is damaged, is missing glass at the in areas. This is for your information. I recommend repair as needed.

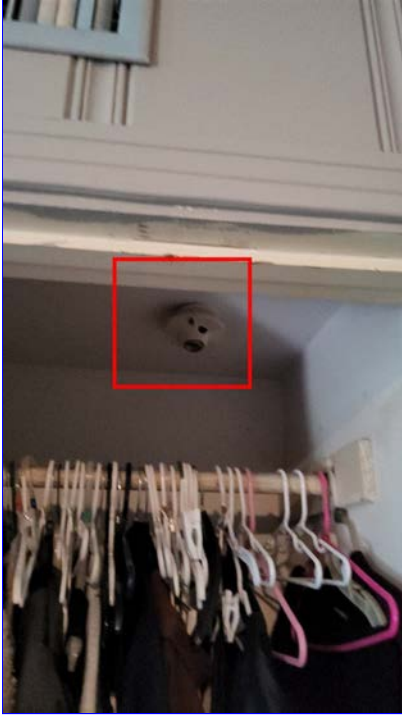
B. Item 13 (Picture)

(10) The light fixture is loose at the in areas. This is a safety issue that needs to be corrected. A qualified licensed electrical contractor should perform repairs that involve wiring.

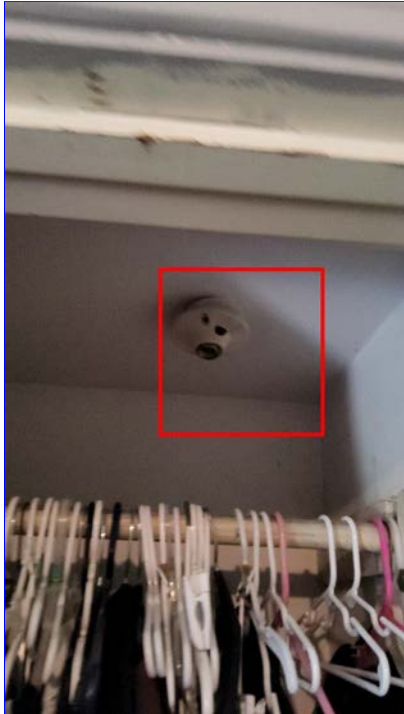
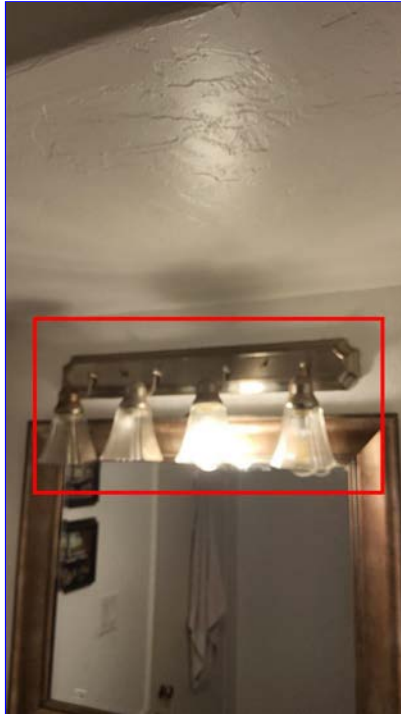
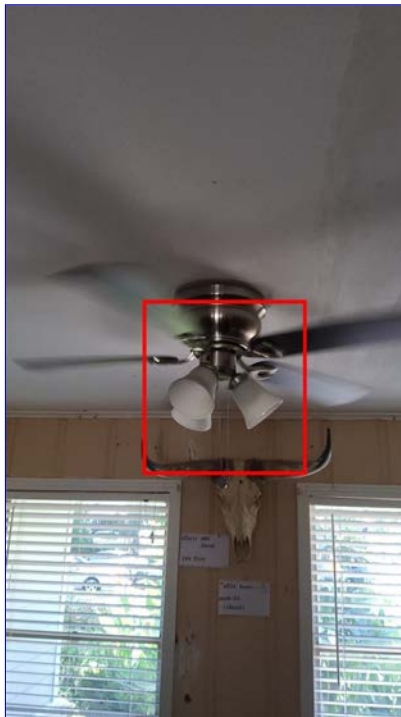
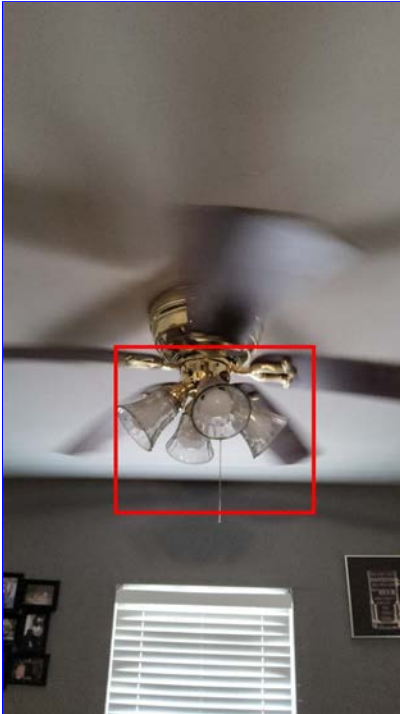
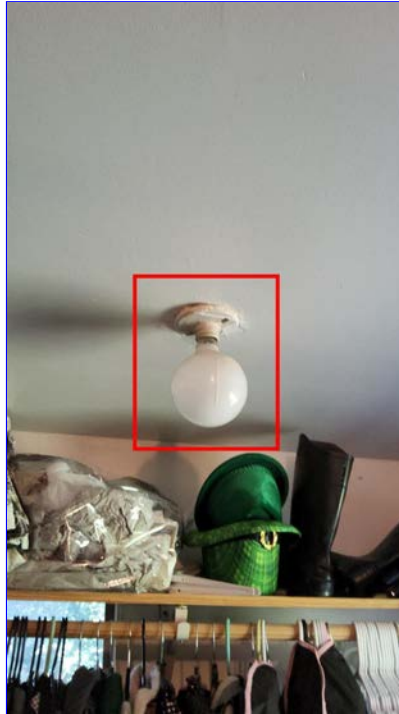
(11) The light fixture does not work (try bulb first). Electrical issues are considered a hazard until repaired. A qualified licensed electrical contractor should perform repairs that involve wiring.

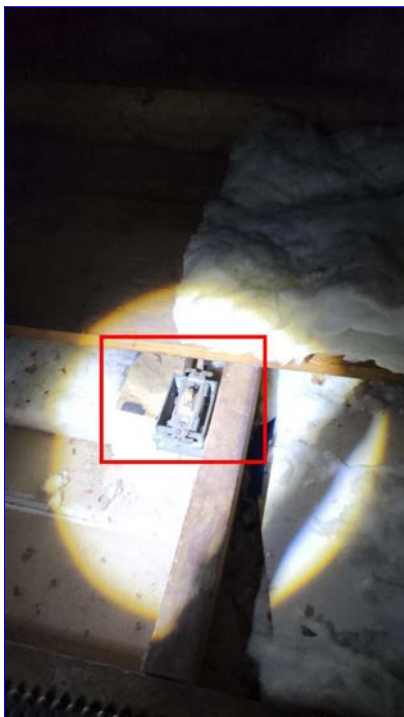
B. Item 20 (Picture)

(15) There is exposed wiring in areas of the home. This is a safety hazard. I recommend having a qualified electrician inspect and make repairs as needed.

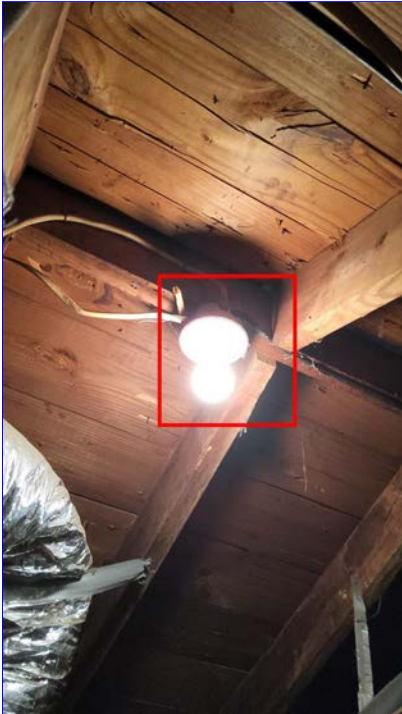
B. Item 22 (Picture)

(16) Light fixture(s) is missing cover in the attic space. Recommend repair or replace as needed.

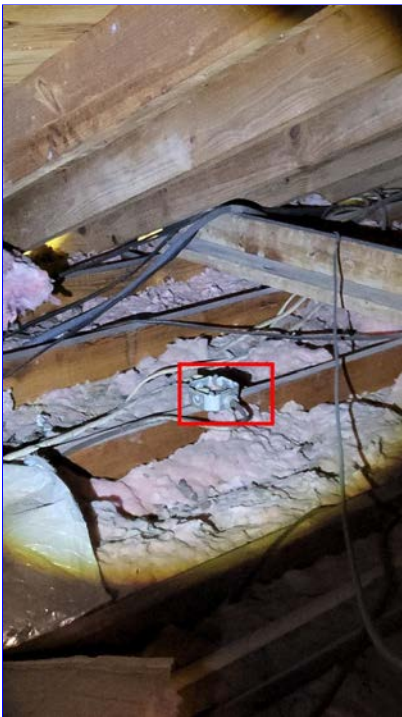
B. Item 23 (Picture)

(17) There is exposed wiring in areas of the home. This is a safety hazard. I recommend having a qualified electrician inspect and make repairs as needed.

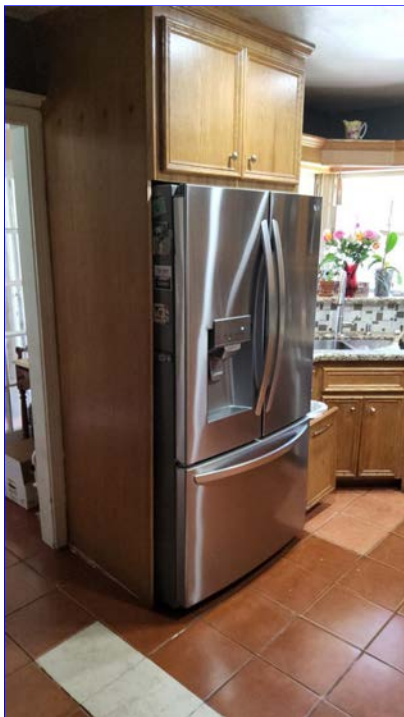
B. Item 24 (Picture)

(18) I could not identify or inspect the outlet for refrigerator. I do not move refrigerators in order to access the outlet.

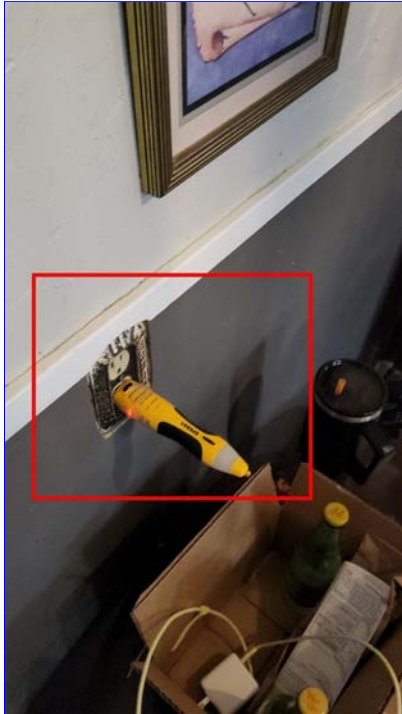
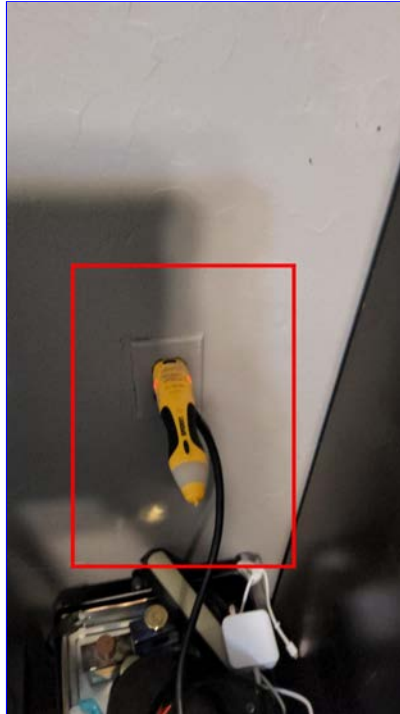
(19) At least one "three-prong" outlet is not grounded in most if not all rooms. Electrical issues are considered a hazard until repaired. A qualified licensed electrical contractor should perform repairs that involve wiring.

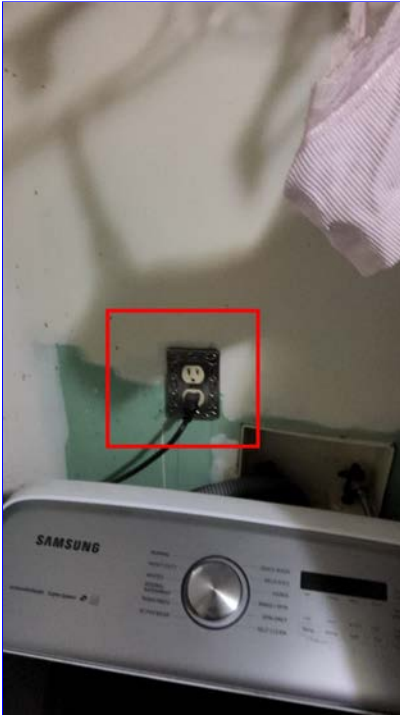
B. Item 28 (Picture)

(21) At least one "three-prong" outlet is loose in wall in most if not all rooms. This is a safety issue that needs to be corrected. A qualified licensed electrical contractor should perform repairs that involve wiring.

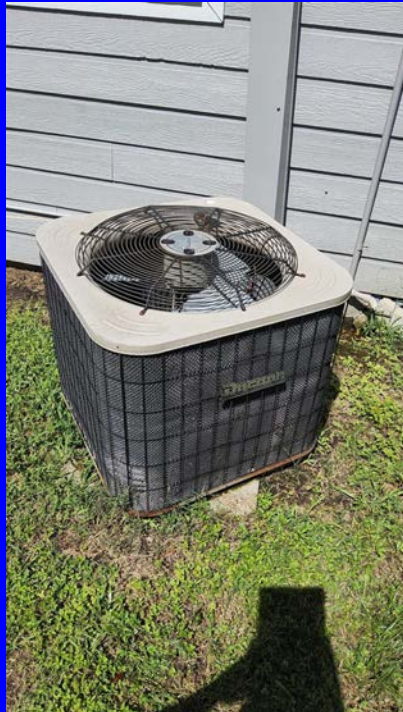
HVAC system backyard

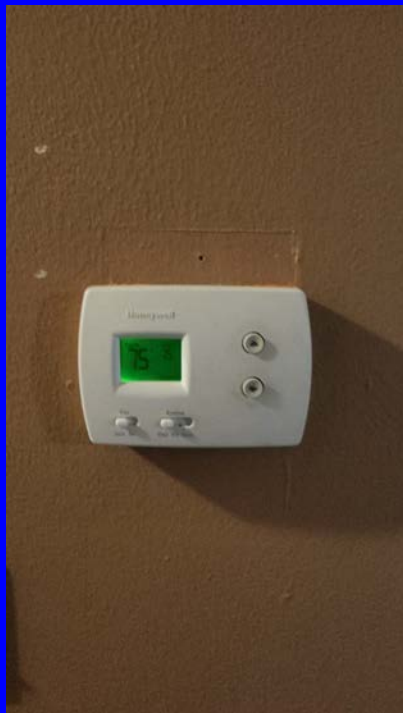
arrival temp

(8) The ambient air test was performed by using infrared thermal equipment at the supply vents of Air conditioner to determine if the difference in temperatures of the supply and return air are between 15 degrees and 22 degrees which indicates that the unit is cooling as intended. The supply air temperature on your system read 73 degrees and the return air temperature was 52 degrees. This indicates the range in temperature drop is normal.

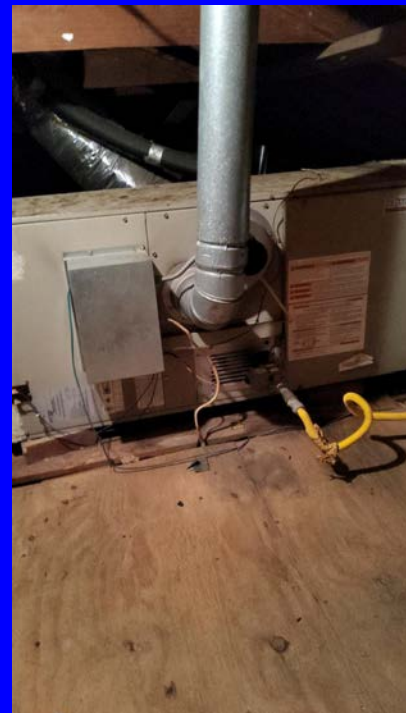
gas furnace in attic

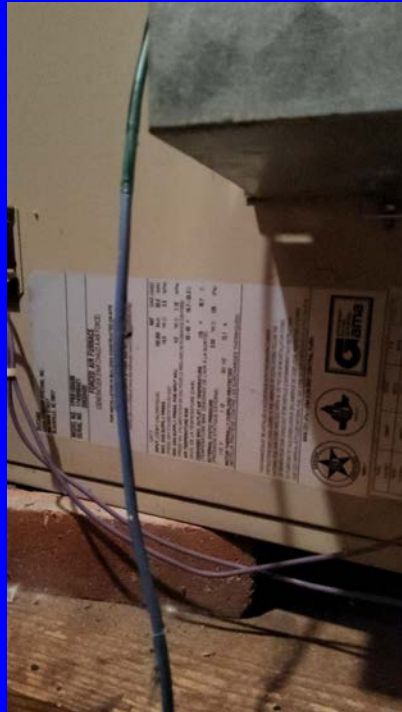
furnace data plate

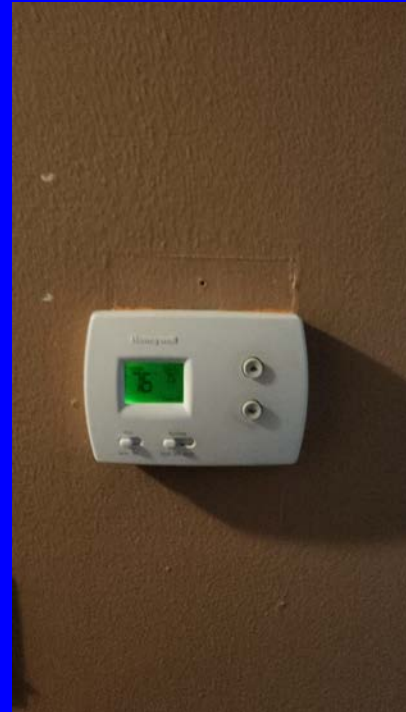
departure temp

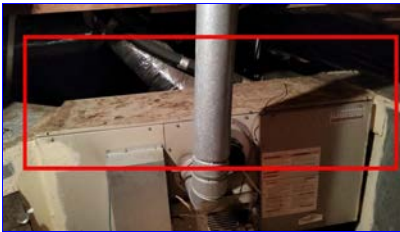
A. Item 3 (Picture)

(5) The furnace is very old and housing is rusted but did work at time of inspection. I am unable to determine life remaining.

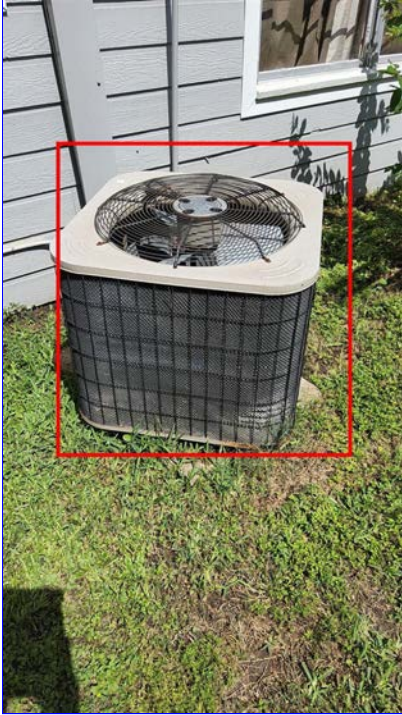
B. Item 1 (Picture)

(1) The condenser outside (AC unit) is very old and may last a few years more, but maybe not. I have seen units fail shortly after a home inspection during the seasonal change from mild to hot weather. I cannot determine how long your AC will last before a replacement is necessary.

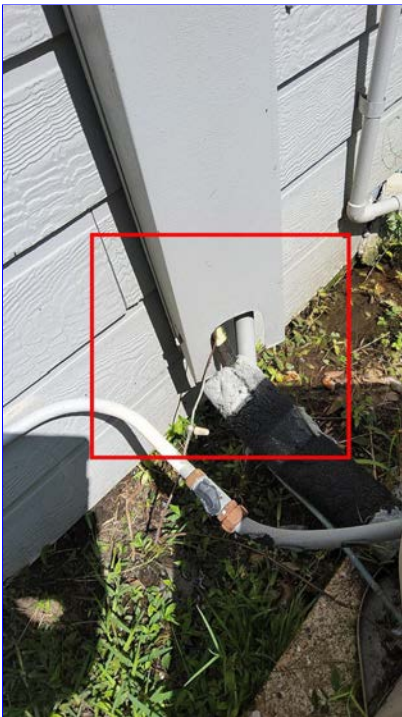
B. Item 2 (Picture)

(2) The condenser is missing foam sleeve in area(s). A replacement is needed. A licensed HVAC contractor should service or repair unit.

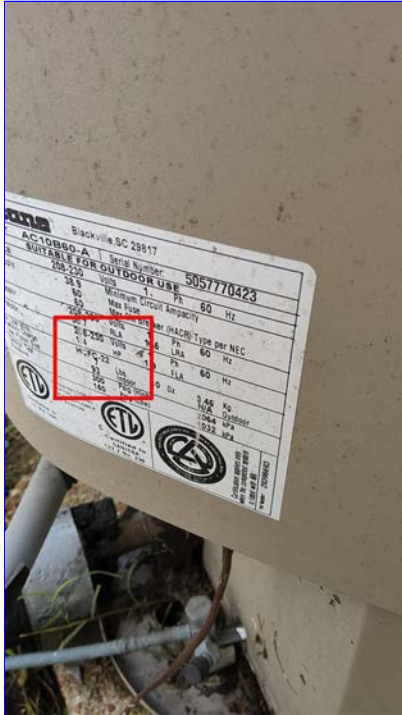
B. Item 3 (Picture)

(3) The HVAC system appears to be an R22 unit (unless it's been Retro fitted and not marked). R22

refrigerant ceased production in 2020. This will make refrigerant availability limited and components may not be able to be repaired or replaced in the future because of a lack of availability. If purchaser is buying a home warranty, Research should be done to make sure that warranty company covers R22 refrigerant. Click [here](#) for more information

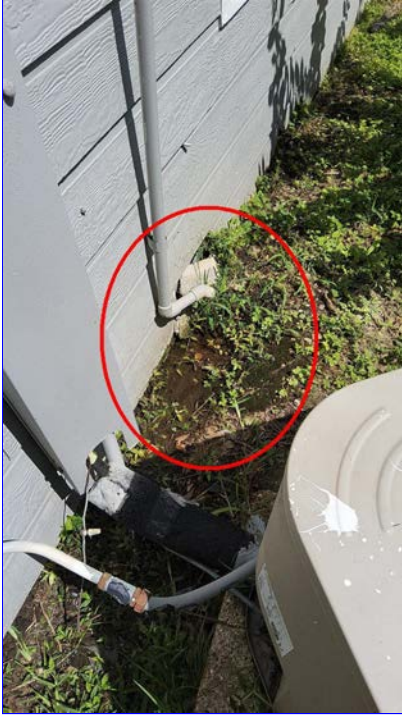
B. Item 4 (Picture)

(4) Secondary drain at exterior of home is dripping water. This could indicate the primary drain line is clogged and may need servicing. Deterioration will occur if not corrected. I recommend having a qualified HVAC technician inspect and make repairs as needed.

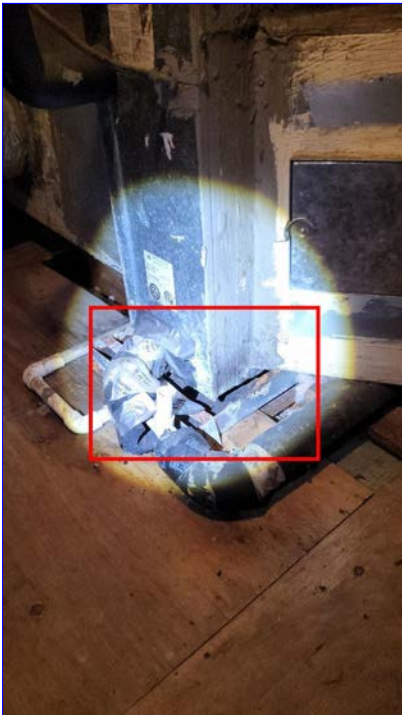
B. Item 5 (Picture)

(5) The emergency overflow drain pan for the HVAC system is showing signs of deterioration and signs of failure leaks in attic. Further deterioration may occur if not corrected. I recommend having a qualified person make repairs as needed.

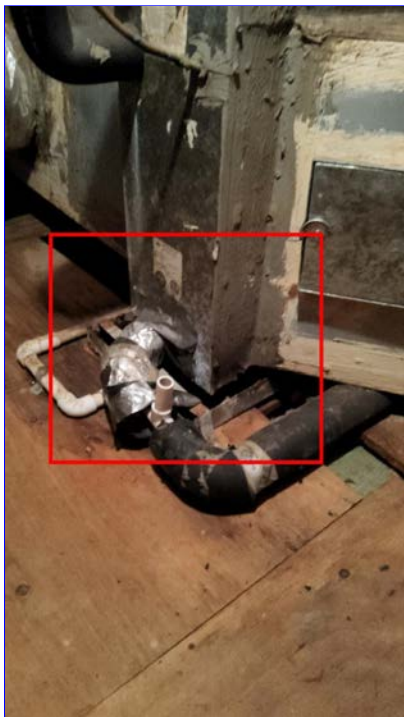
B. Item 6 (Picture)

(6) Unit is located in the attic space, however the secondary drain pan does not have a pan switch. I recommend having a qualified HVAC contractor make repairs as needed.

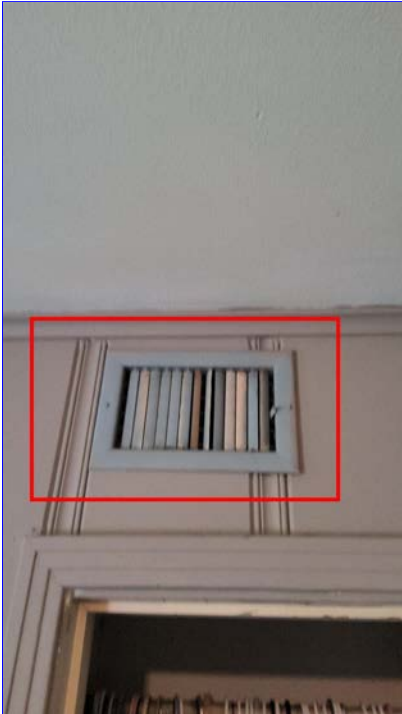
C. Item 1 (Picture)

- (1) I recommend changing all HVAC filters upon move in.
- (2) Supply register is dirty/damaged. I recommend having a qualified HVAC contractor further evaluate and make any necessary repairs.

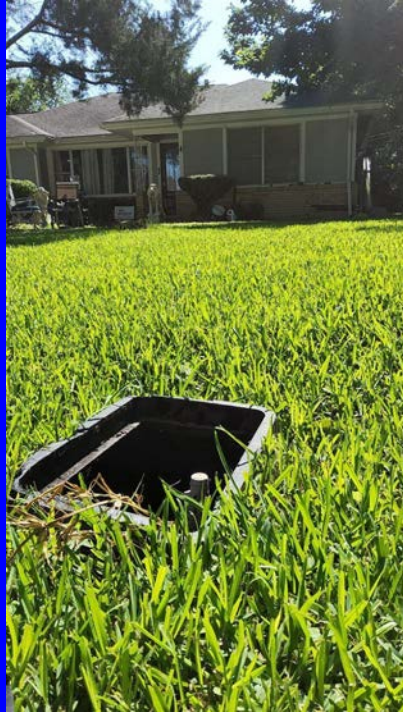
water meter front right by street

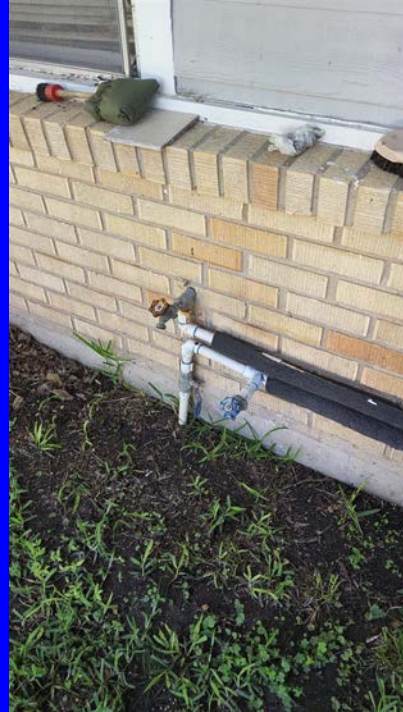
water main shut off out front

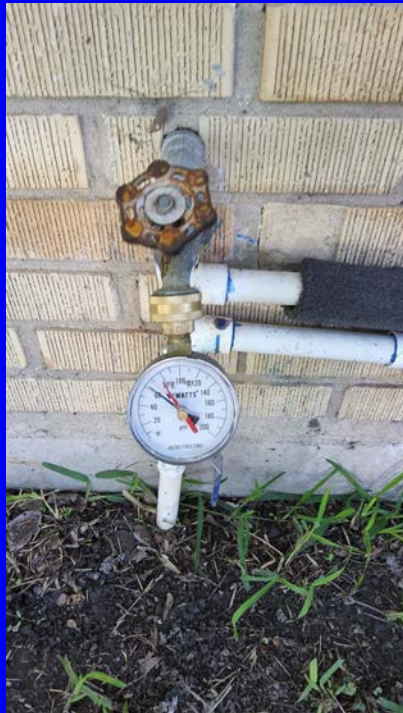
62psi water pressure

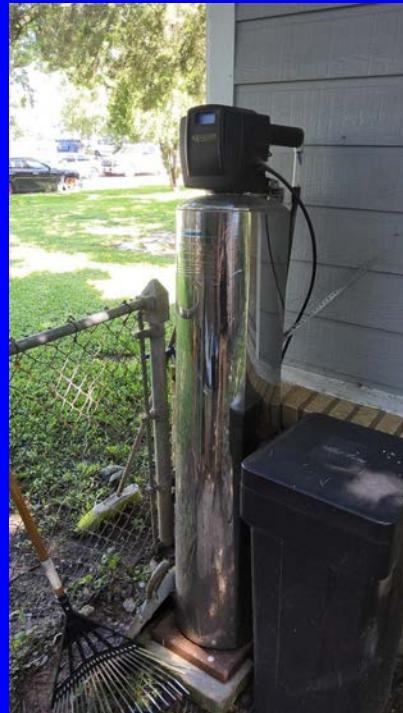
water conditioner back right (not inspected)

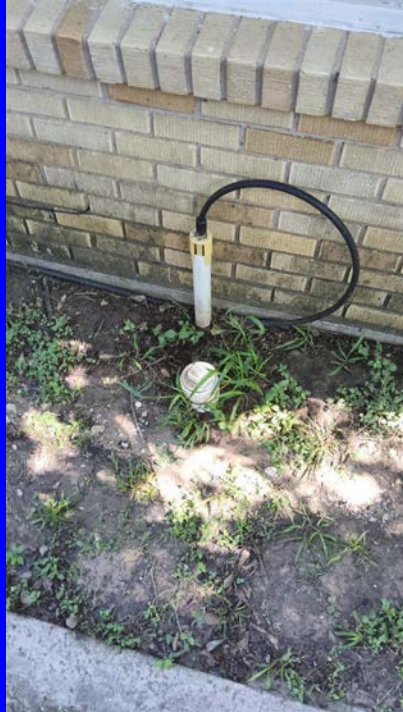
plumbing main clean out back right

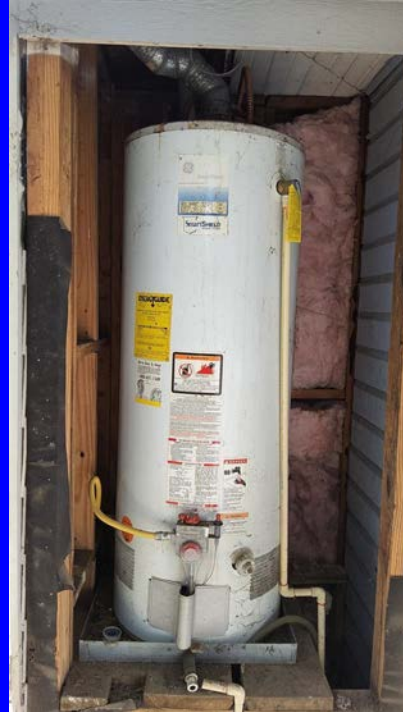
50gal gas water heater in utility room

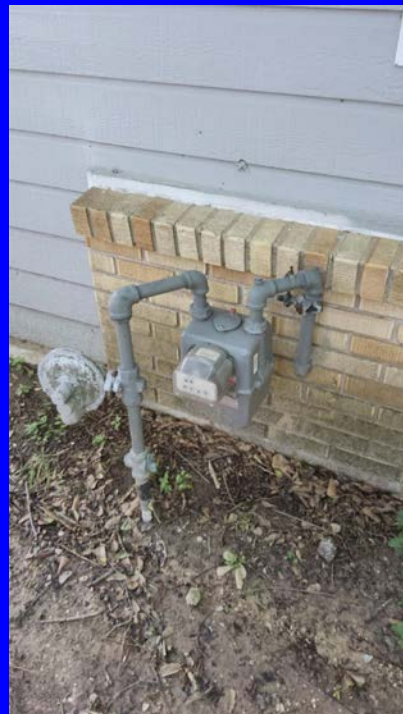
gas meter back left

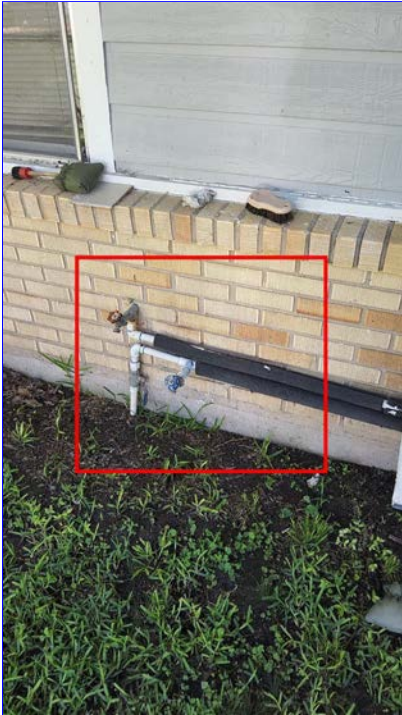
A. Item 1 (Picture)

(2) Supply line is not properly insulated in areas. I recommend having a qualified plumber inspect and repair as needed.

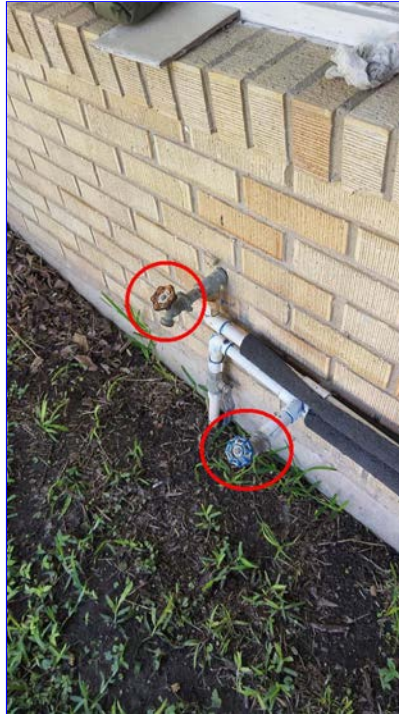
A. Item 3 (Picture)

(3) There is no Anti Siphon device installed on exterior faucet(s). This is not considered to be today's standard. I recommend having a qualified person make repairs as needed.

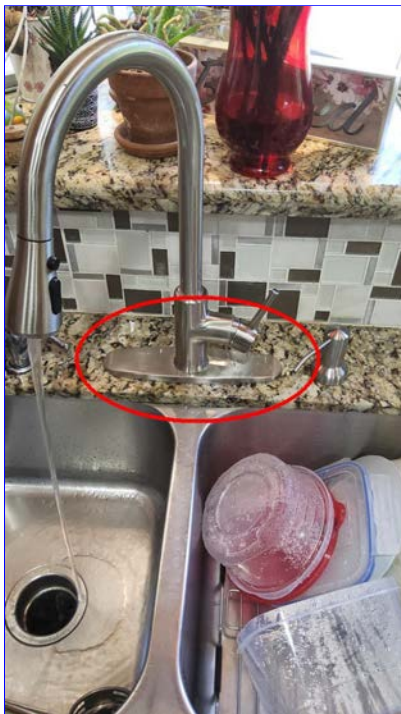
A. Item 4 (Picture)

- (4) Galvanized piping is present at time of inspection process. Galvanized piping is an older style of piping. I recommend having a qualified plumber further evaluate and make any necessary repairs.
- (5) The faucet leaks leaks around mount at the kitchen sink. Repairs are needed. A qualified licensed plumber should repair or correct as needed.

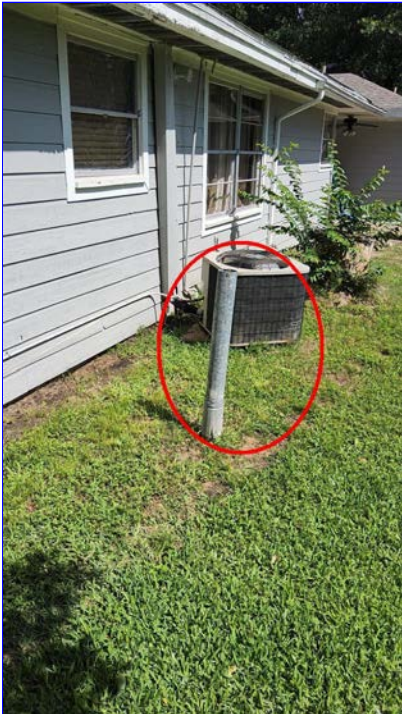
B. Item 1 (Picture)

(2) Plumbing clean out has missing or damaged cover. This can effect drainage and should be corrected in order to determine if drainage is performing properly.

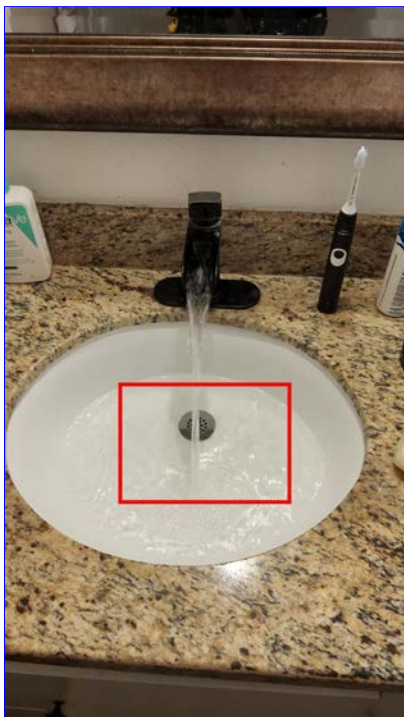
B. Item 6 (Picture)

(7) Tub drain is damaged or missing and no longer operates. A drain plug is being used instead at hall bath.

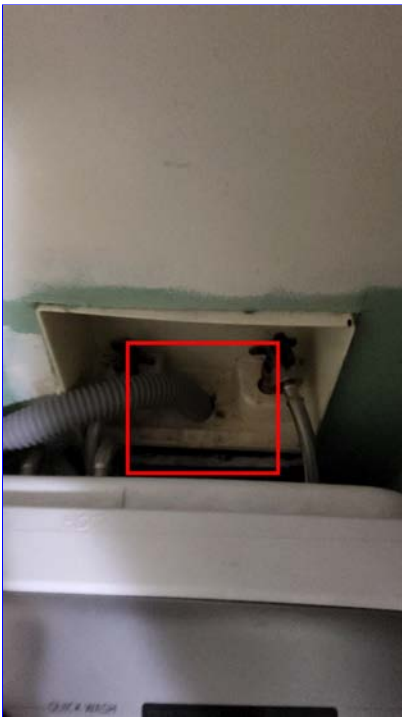
B. Item 9 (Picture)

(9) Washing machine drain size is not adequate for today's standards. Recommend size is 2in. Have a qualified plumber evaluate and remedy as needed.

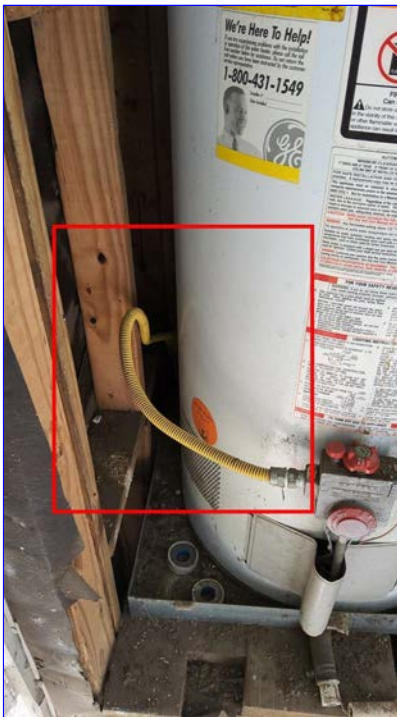
C. Item 2 (Picture)

(2) The water heater has corrosion at fittings. I recommend having a qualified person make repairs as needed.

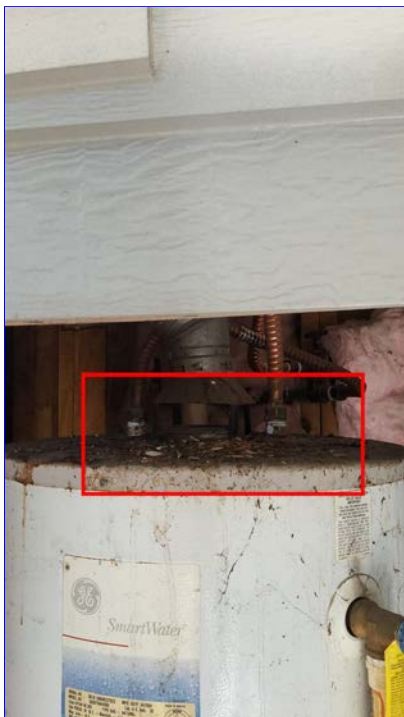
C. Item 3 (Picture)

(3) The emergency over flow drain pan for the unit is deteriorated. I recommend replacement.

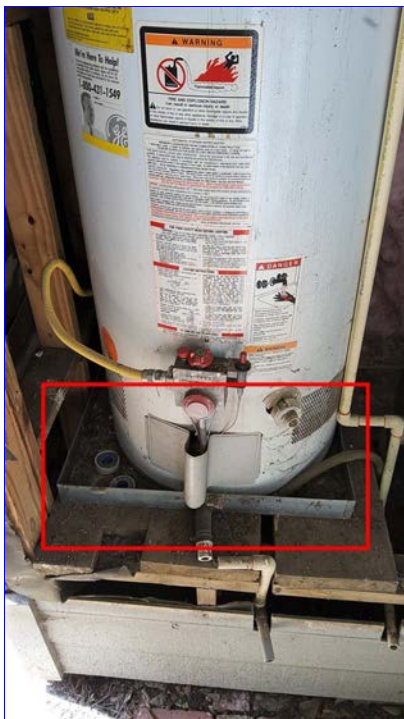
C. Item 4 (Picture)

(4) The water heater is old, rusted and at the end of its life expectancy. No leaks at present. A more

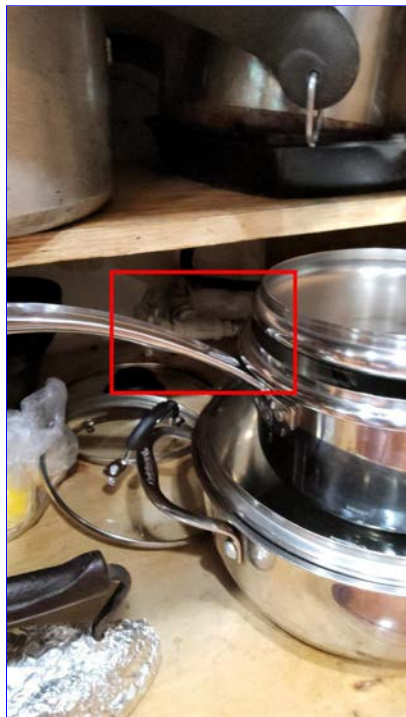
E. Item 1 (Picture)

(1) Gas lines are using older style brass valves that are known for breaking and fail. I recommend have a plumber evaluate and remedy as needed.

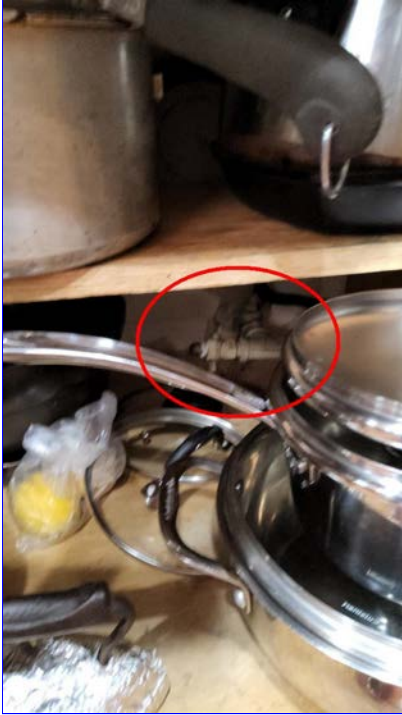
E. Item 2 (Picture)

(2) There are multiple unused gas lines that are not capped. This should be corrected. Have a qualified plumber further evaluate and make repairs as needed.

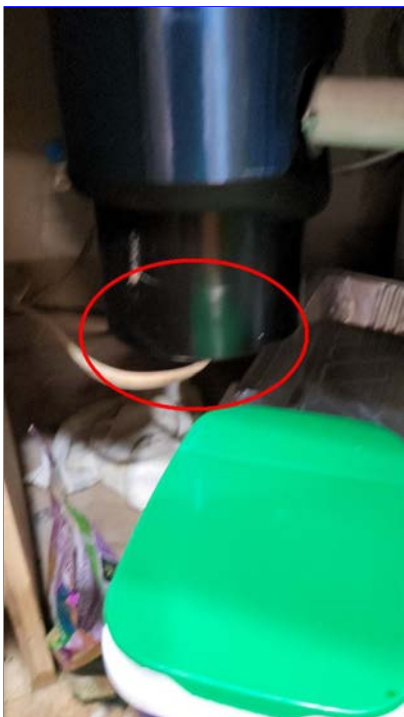
B. Item 1 (Picture)

(2) The food disposer has an obstruction inside. I recommend repair as needed.

(3) The food disposer wiring is missing a wire connector (anti-strain device). I recommend repair as needed.

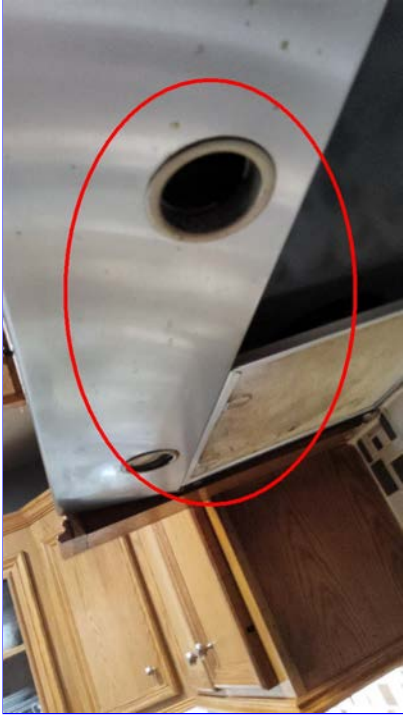
C. Item 1 (Picture)

- (1) Tested and working properly at the time of inspection.
- (2) The light bulb for fan did not work when tested. I recommend repair or replace as needed.
