Inspection Report

Property Address:
1514 Freedonia Dr
Houston TX 77055

HG Home Inspection/Hilsher Group LLC

PROPERTY INSPECTION REPORT FORM

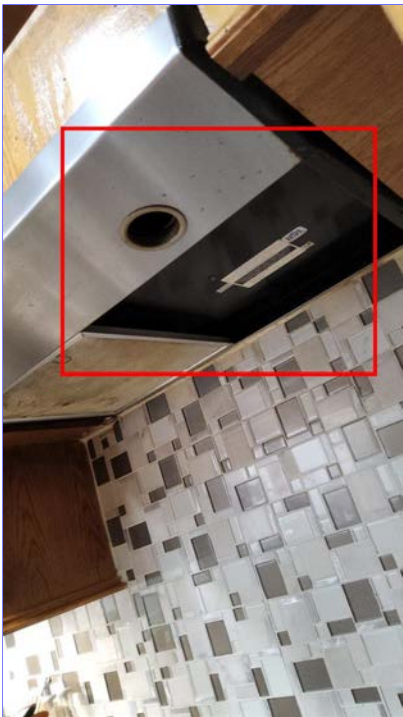
C. Item 2 (Picture)

(3) The range hood fan has crust or grime build-up, is missing grease catch. I recommend repair or replace as needed.
