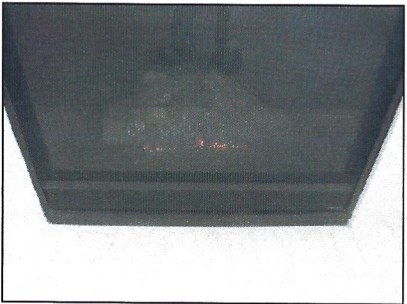
No deficiencies were observed at the time of inspection.

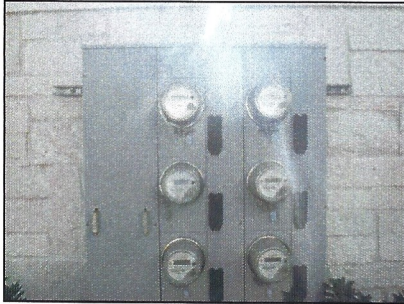
System panels installed correctly, grounded and bonded.

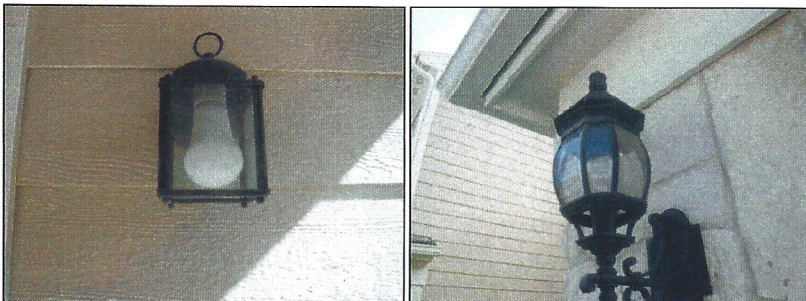
Some lights were not functioning. These are usually just a case of burned out bulbs. Recommend replacing bulbs before closing as needed. If fixtures are still not functioning, then a licensed electrician should diagnose for deficiencies.

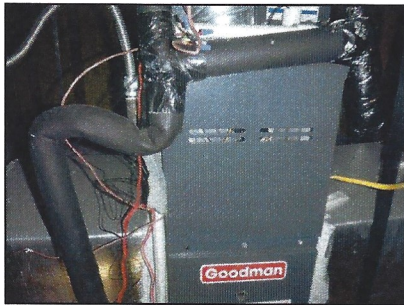
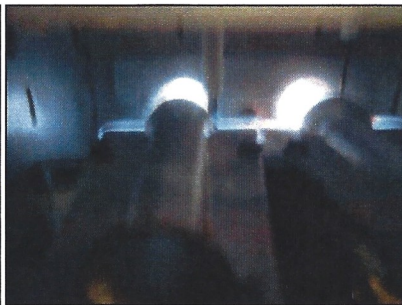
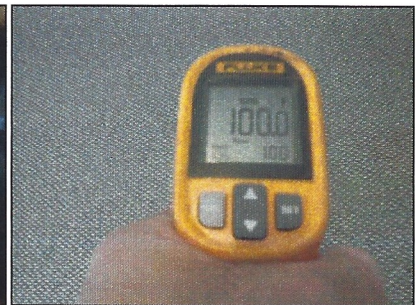
The unit functioned at the time of inspection. Proper heating operation is determined by at minimum of 100 degrees being supplied from all home supply grills.

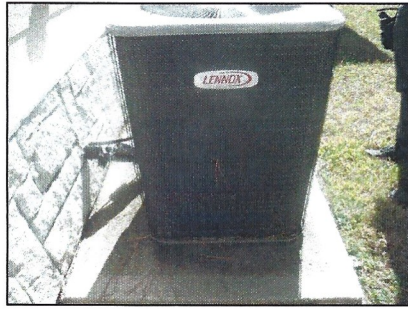
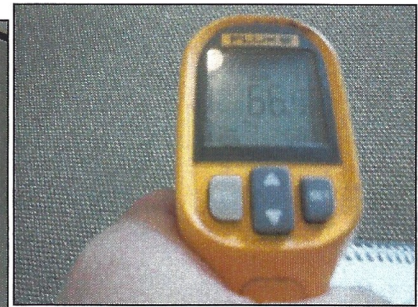
Return a/c vent.

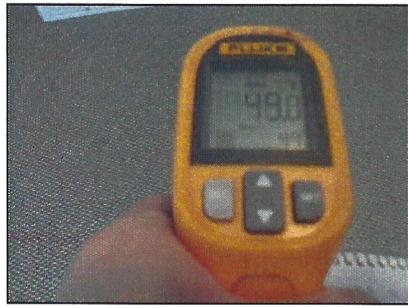
Supply a/c vent.

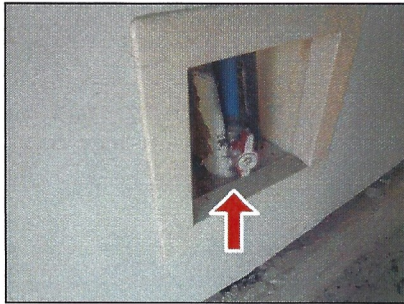
Fixtures functional. Flow/Volume acceptable. The toilets flushed properly. Water pressure into home from city 40 PSI. Recommended satisfactory range 40 PSI – 80 PSI. Meter tested with no leaks or bypass concerns noted.

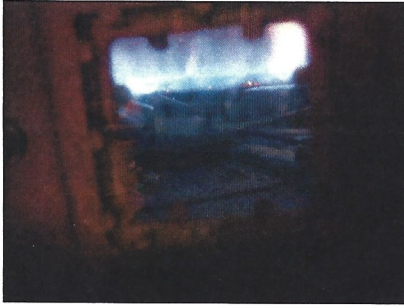
Drains and vents functioned normally. All sinks/tubs were filled to perform leak test of P-trap with concerns noted.

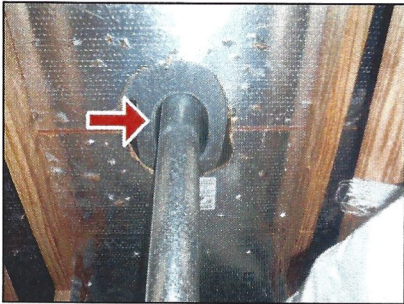
The flue from water heater as it terminates through roof is not strapped to rafters. Recommend properly securing flue to rafters with metal straps at rafters.

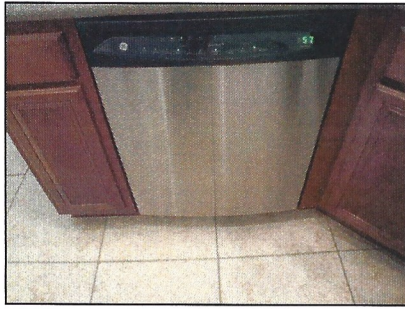
Comments:
The appliance was functional when tested in short/normal cycle. The spray bars activated, as well as the detergent dispenser. Average life expectancy - 10 years: Life expectancies have been determined through research and testing based on regular recommended maintenance and conditions of normal wear and tear.

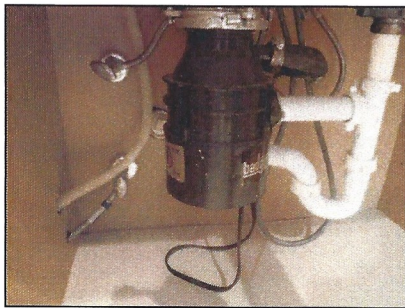
Appliance was not functional at time of inspection. Average life expectancy - 12 years: Life expectancies have been determined through research and testing based on regular recommended maintenance and conditions of normal wear and tear.

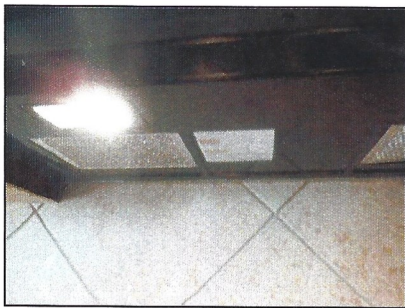
Functional with no concerns noted. Average life expectancy - 15 years: Life expectancies have been determined through research and testing based on regular recommended maintenance and conditions of normal wear and tear.

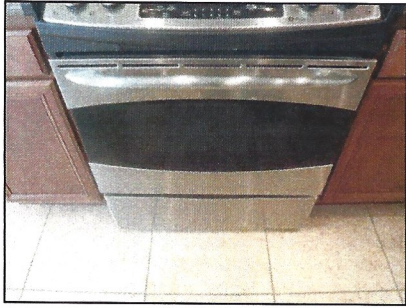
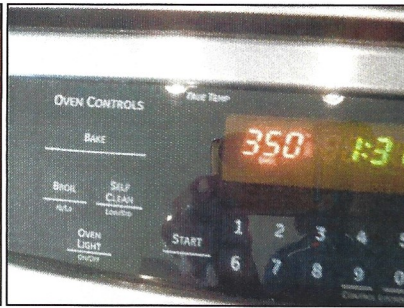
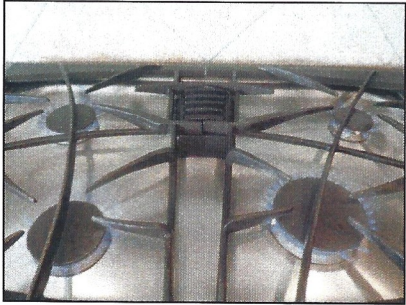
Cooktop and oven functional at time of inspection. Average industry average life expectancy 10 to 18 years. Life expectancies have been determined through research and testing based on regular recommended maintenance and conditions of normal wear and tear.

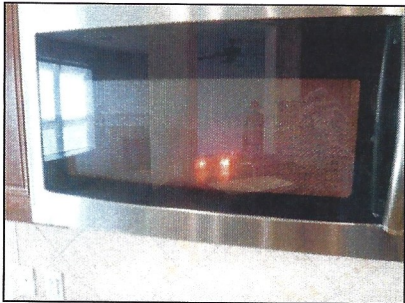
Appliance was functional at time of inspection. Average life expectancy - 10 years. Life expectancies have been determined through research and testing based on regular recommended maintenance and conditions of normal wear and tear.

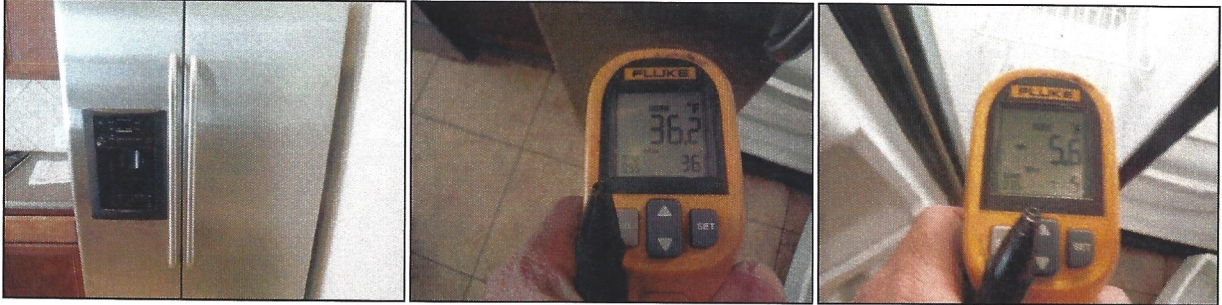
Refrigerators are not included as part of an inspection. As a courtesy I checked the operating temperatures in the unit, and they appeared to be within normal range.
