PROPERTY INSPECTION REPORT FORM

30123 Bashaw Dr, Spring, TX 77386

04/25/2024 1:00 pm

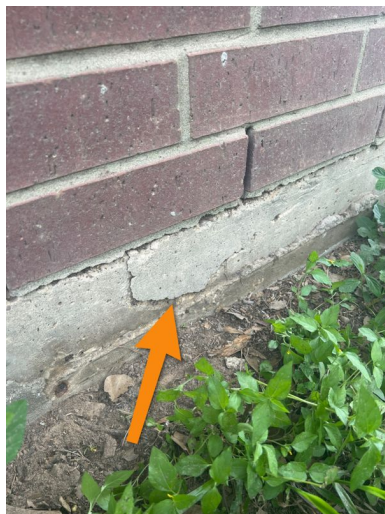
Back Exterior

1: Foundation Cracks - Minor

Minor cracking was noted at the foundation. This is common as concrete ages and shrinkage surface cracks are normal. Recommend sealing these cracks with exterior sealant and, monitoring for more serious shifting/displacement.

Recommendation: Contact a handyman or DIY project

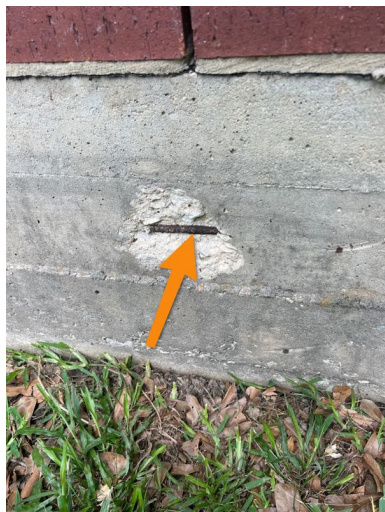
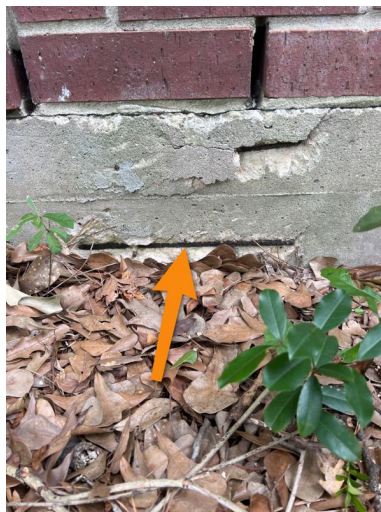
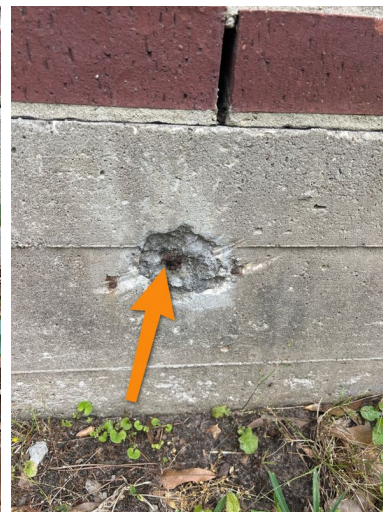
3: Wedge crack in edges of foundation

Wedge cracks appear because of the lack of steel in the corners of the slab. They are only cosmetic, and do not affect the structure. Make sure and keep these places sealed to keep water out of the cracks and prevent insect intrusion into the home.

Recommendation: Contact a handyman or DIY project

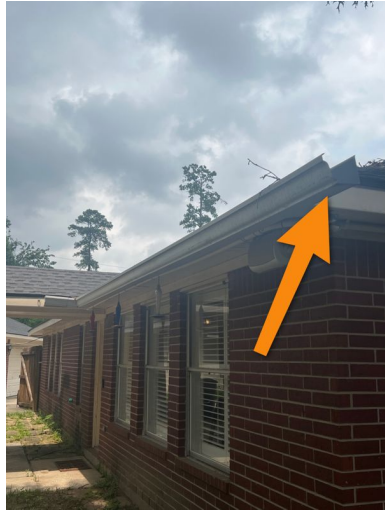
Back Exterior

2: Gutters are missing

Debris can cause water to be directed away from the downspouts, and may not allow water to discharge properly. As a result, water may overflow from the gutters onto the soffit, fascia, or siding causing deterioration.

Recommendation: Contact a handyman or DIY project

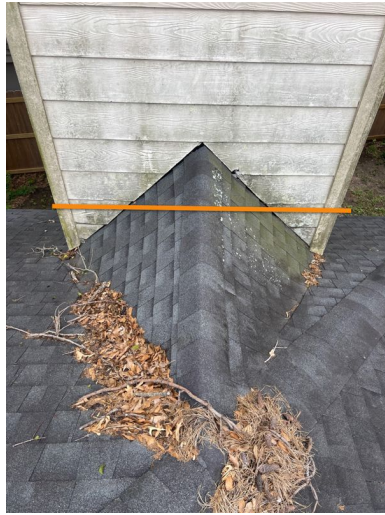
2: Damaged Coverings

🔴 Recommendation

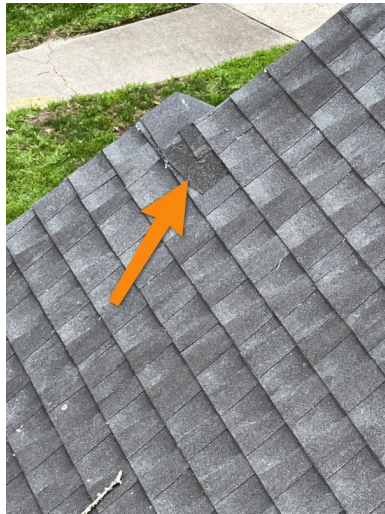
Garage

Roof coverings exhibited general damage that could affect performance. Recommend a qualified roofer evaluate and repair.

Recommendation: Contact a qualified roofing professional.

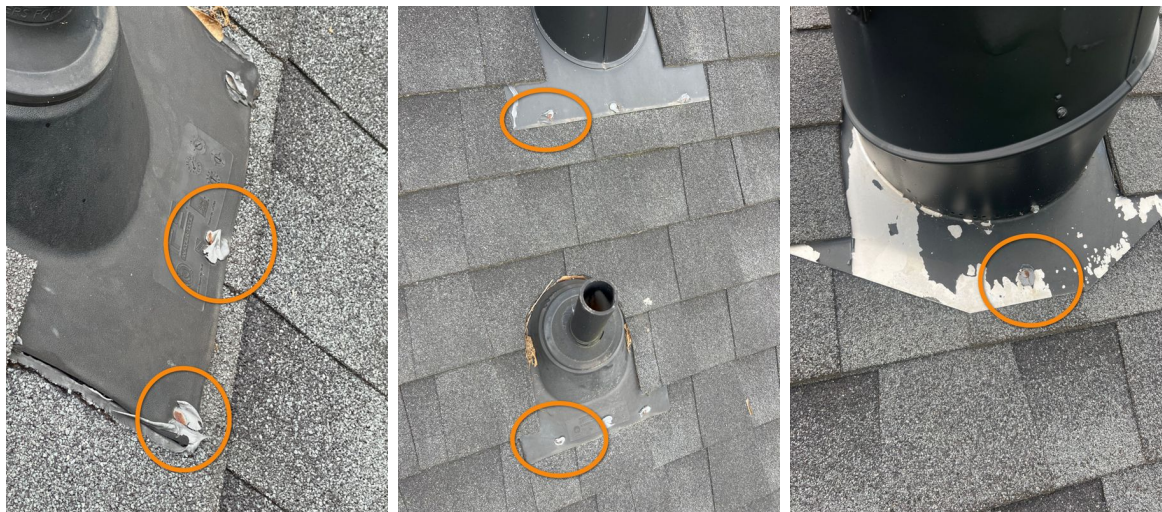
6: Furnace/Water Heater exhaust vent is too short or uses improper cover

Furnace exhaust vents are required to be 3 feet from any surface, and water heaters 2 feet from any surface on the roof to the vent opening. They also must use the appropriate vent cover. This is to help exhaust products draft and protect materials from being exposed to the high temperatures that can result in shorting of the lifespan of the materials and possibly lead to a fire.

Recommendation: Contact a qualified professional.

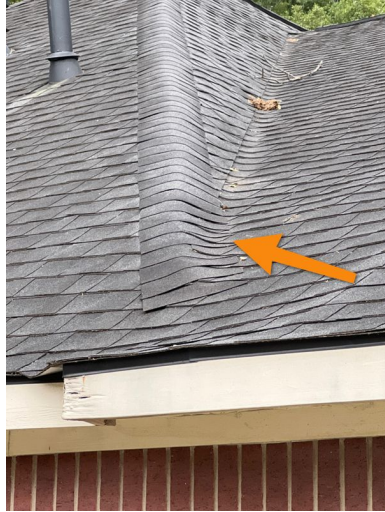
Shingles should not be woven in valleys

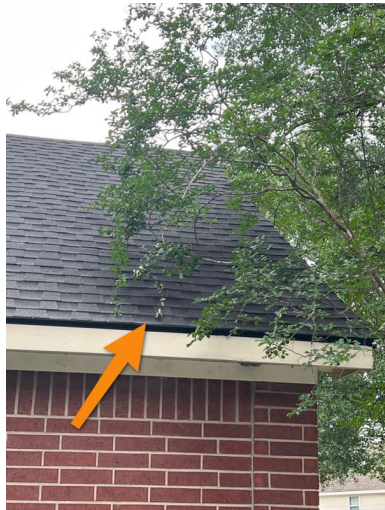
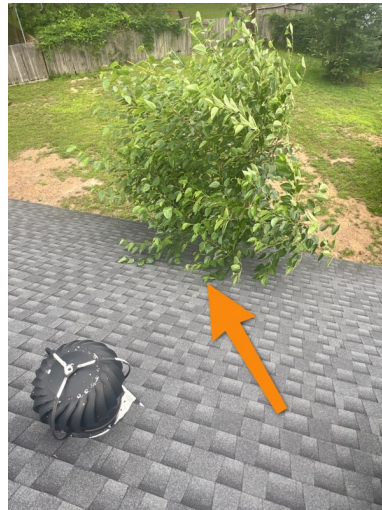
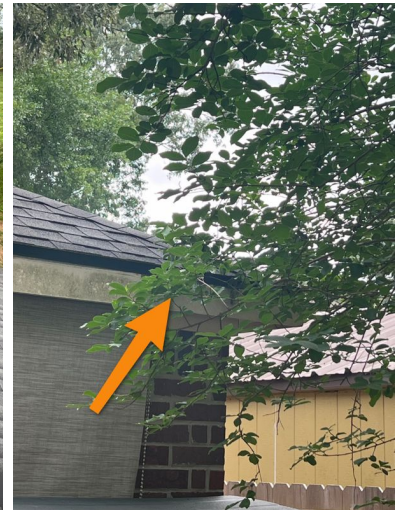
Left Side Exterior

9: Plants touching the roof covering

Plants will cause premature aging of roofing material due to abrasion and holding water on the surface of the roof. They should be trimmed to a length of 3 ft from the roof surface.

Recommendation: Contact a qualified professional.

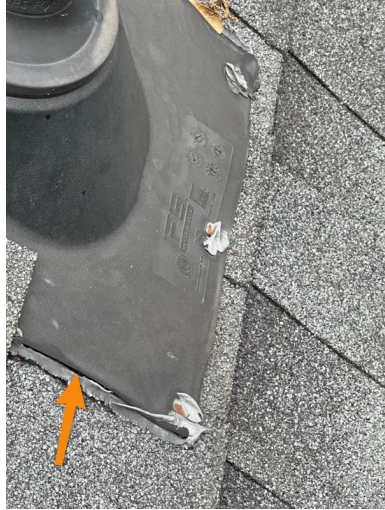
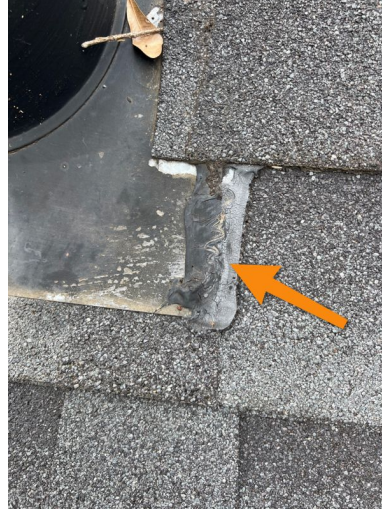
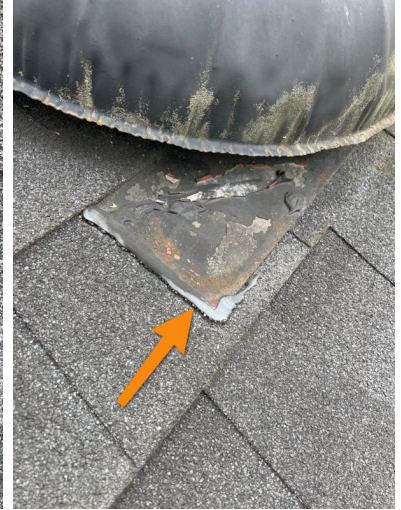
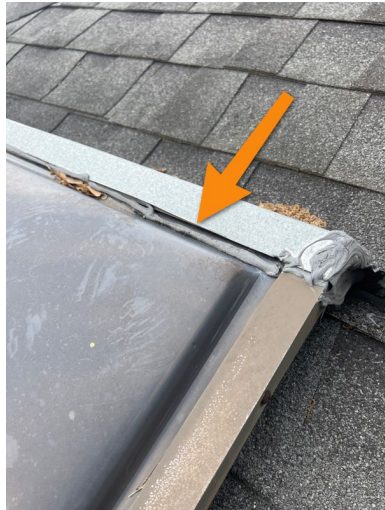
10: Sealant is missing or deteriorated

Sealant protects the roofing structure from water penetration. Any area that has a nail or a gap that could allow water to penetrate, should be sealed with roofing sealant.

Recommendation: Contact a qualified professional.

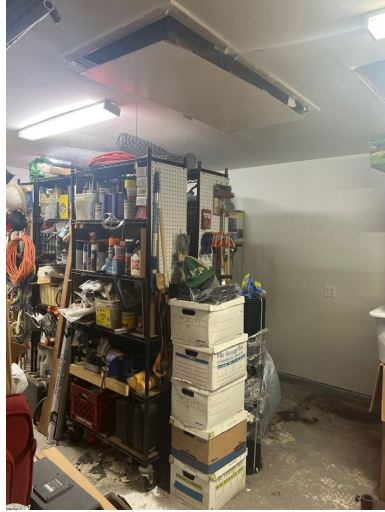
1: Attic entry in the garage is not fire rated

Recommendation: Contact a qualified professional.

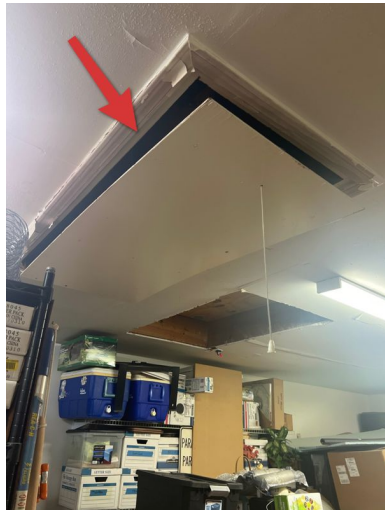
3: Attic entry is not properly secured

Recommendation: Contact a qualified professional.

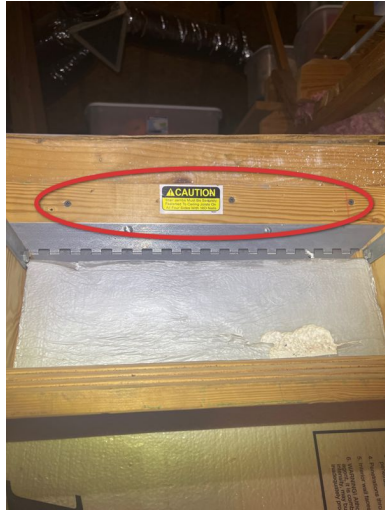
Screws Used

4: Damaged structural members

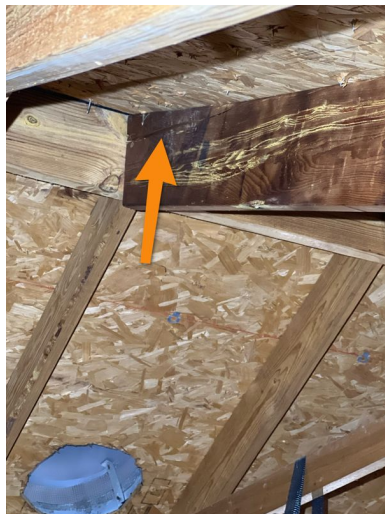
Cracked Rafter

Damaged structural members should be replaced to provide proper support to the structure.

Recommendation: Contact a qualified general contractor.

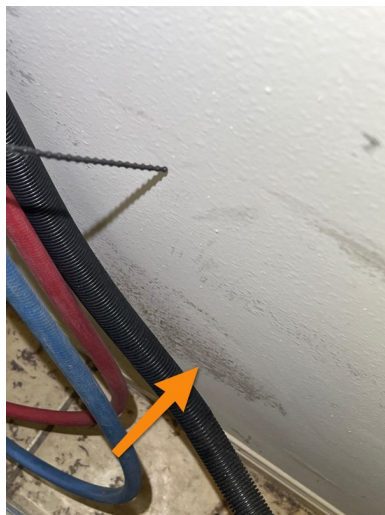
Laundry Room

Observed signs of bio growth in one or more areas in the wall structure. Area should be cleaned, and , if bio growth returns home should be tested for mold.

Recommendation: Contact a handyman or DIY project

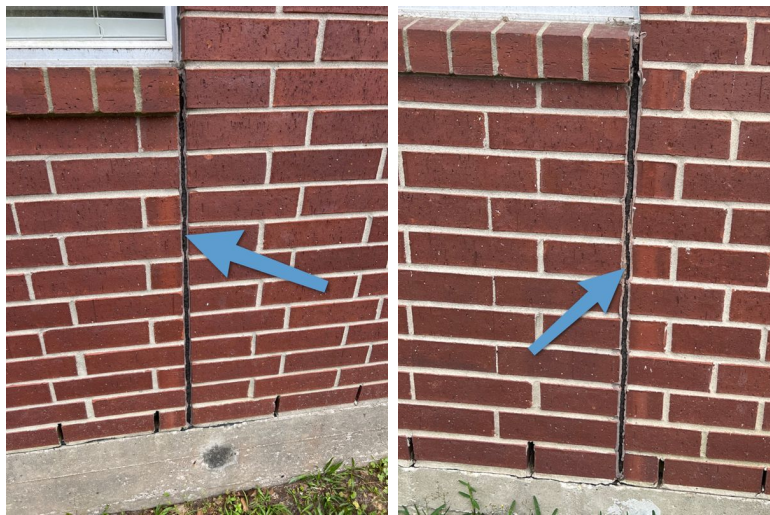
Expansion Joint - Right Side Exterior

Gaps in the caulking/sealant let insects and water penetrate the structure. When caulking starts to separate or crack it is time to replace it.

Recommendation: Contact a handyman or DIY project

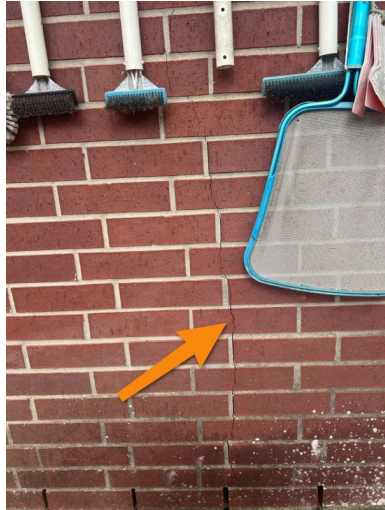
Left Side Exterior

5: Evidence of previous termite activity

A pest control professional should be consulted to investigate the property. Previous termite activity leads to a higher probability of re-infestation.

Recommendation: Contact a qualified pest control specialist.

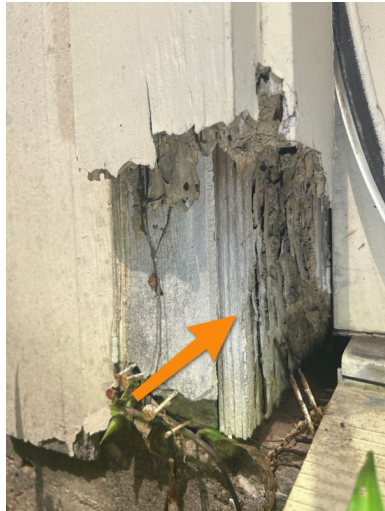
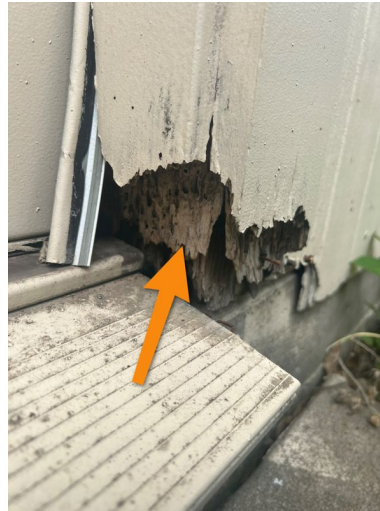
Garage

6: Gaps in Siding

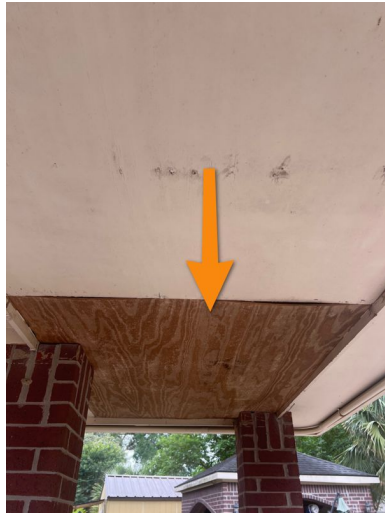
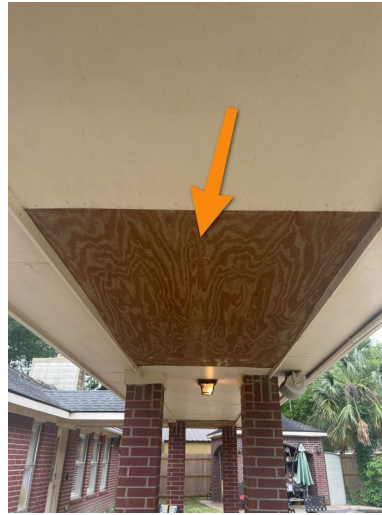
7: Evidence of previous repair

Reasons for previous repair are unknown, and can hide latent defects.

Recommendation: Contact a qualified professional.

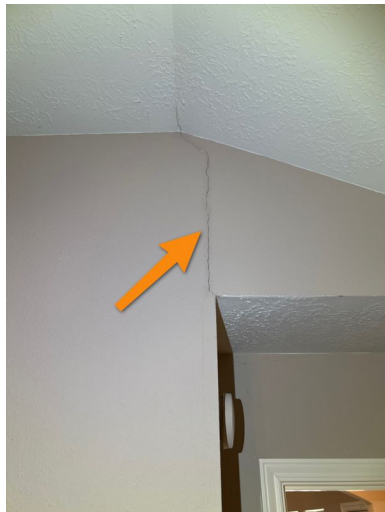
Master Bedroom

8: Settlement crack in wall board

Settlement crack in wall board is normal and can be a sign of movement if coupled with other indicators. Crack should be sealed and monitored for further movement.

Recommendation: Contact a qualified professional.

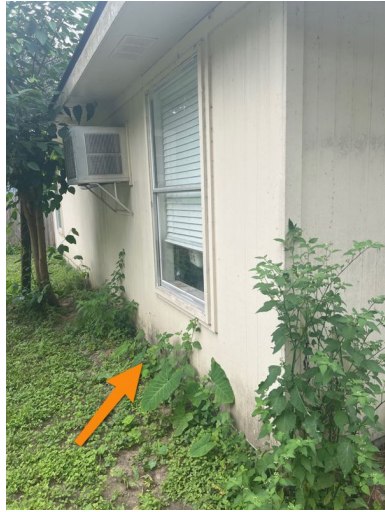
Garage

All siding should be a minimum of 6 inches above grade to avoid prolonged contact with moisture. Exposure to moisture could allow for water penetration and water damage of interior components as well as deterioration of siding.

Recommendation: Contact a qualified professional.

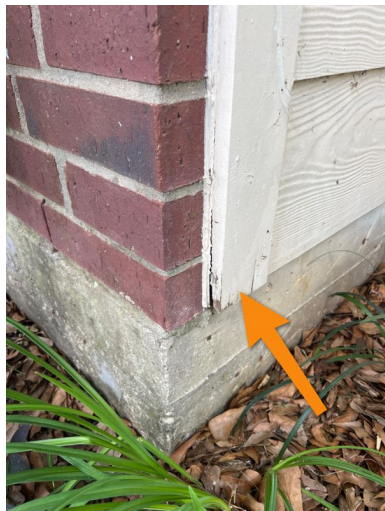
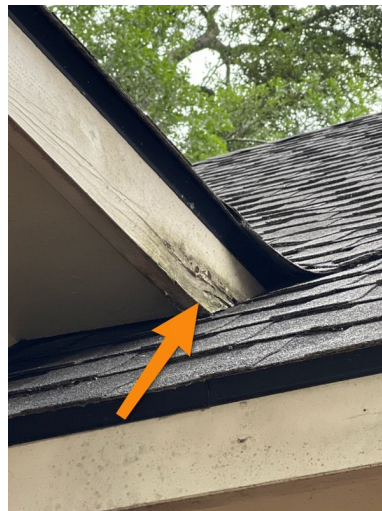
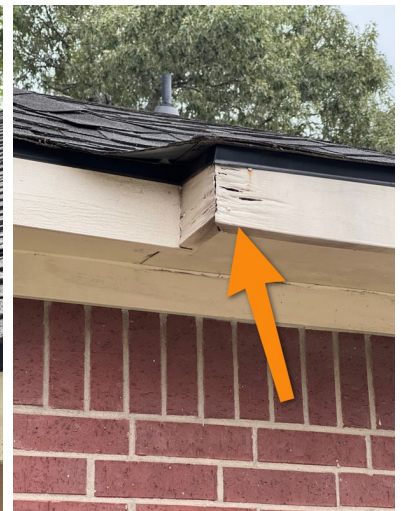
10: Siding or trim is damaged or deteriorated

Damaged or deteriorated siding and trim can allow access to water and insects into the home. Have damaged or deteriorated areas replaced.

Recommendation: Contact a qualified siding specialist.

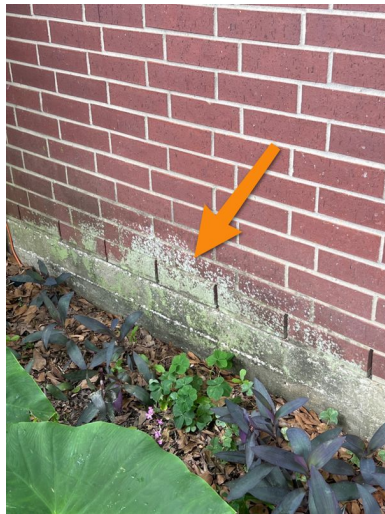
Left Side Exterior

11: Moss growing on siding

Moss can retain moisture and caused damage to siding. Siding should be power washed and cleaned to remove growth and stains.

Recommendation: Contact a handyman or DIY project

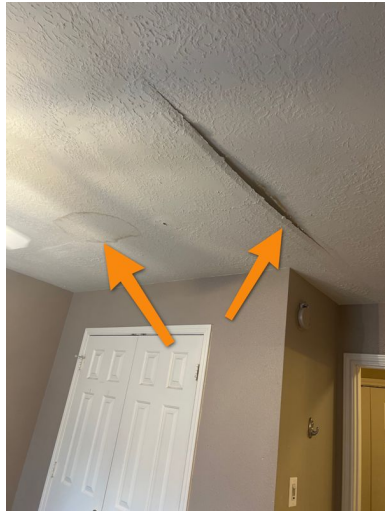
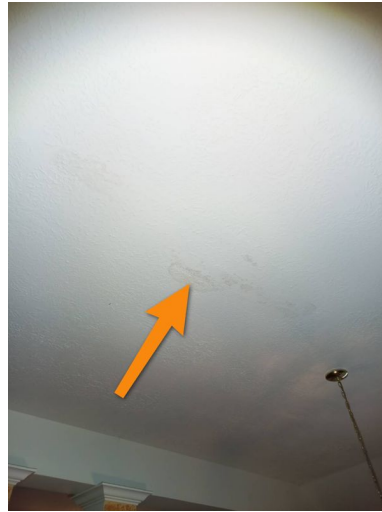
These places had evidence of previous moisture, but were dry at the time of the inspection. They can change with the weather and should be monitored for further change. If further changes occur have moisture source

identified, and corrected.

Recommendation: Contact a qualified professional.

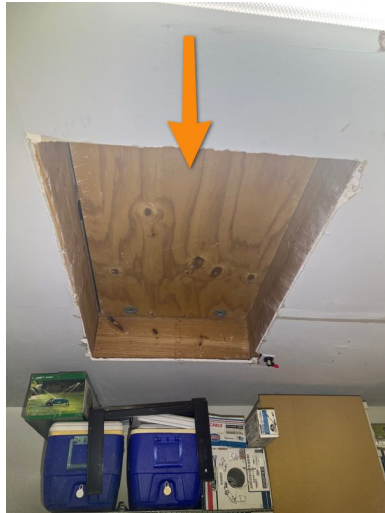
Garage

2: Wallboard is damaged or cracked

Normally this is cosmetic and only requires repairs to make the area attractive.

Recommendation: Contact a qualified general contractor.

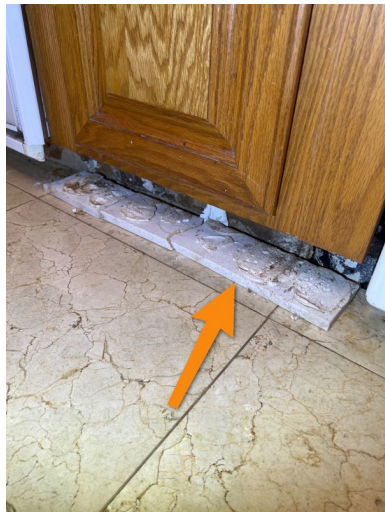
Kitchen

3: Tile is loose or cracked

Recommendation: Contact a qualified flooring contractor

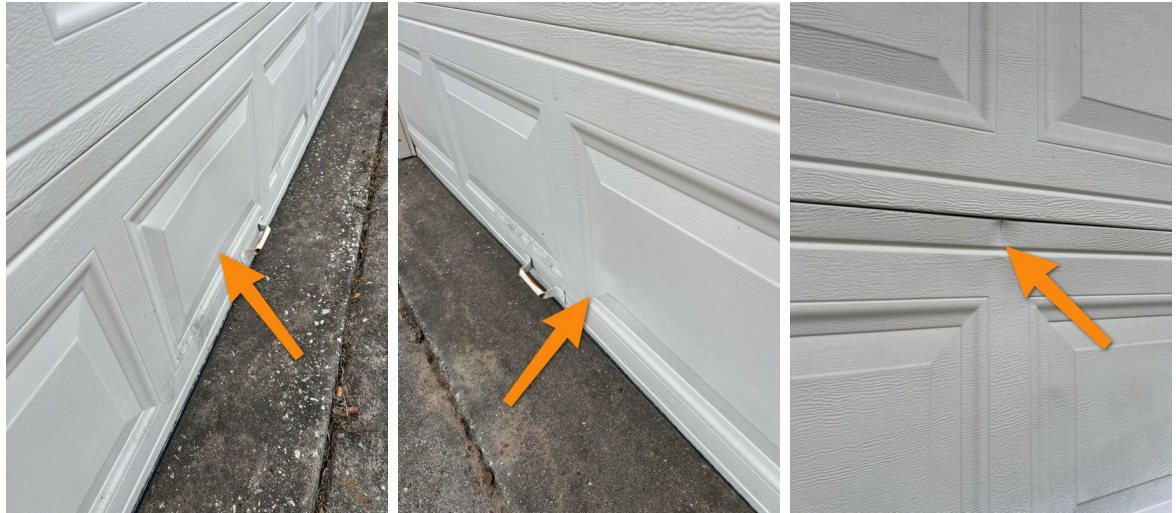
1: Damaged or deteriorated

Have door repaired, and source of deterioration remedied.

Recommendation: Contact a qualified door repair/installation contractor.

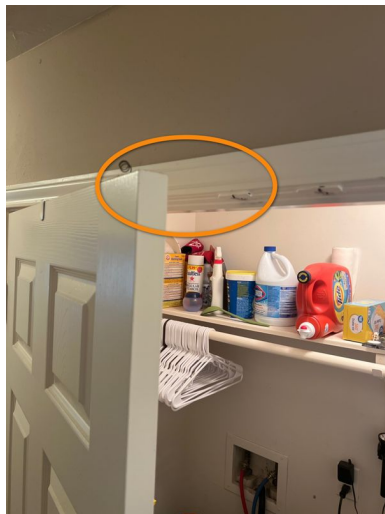
Laundry Room

2: Door does not latch

Door doesn't latch properly. Recommend handyman repair latch and/or strike plate.

Recommendation: Contact a qualified handyman.

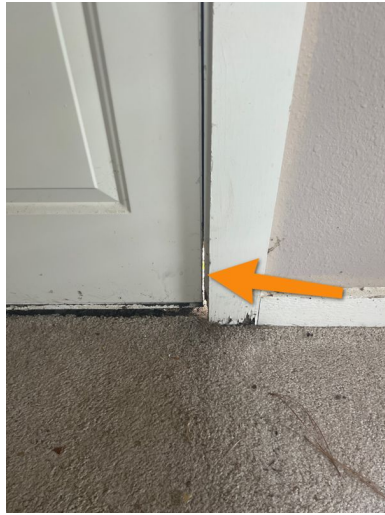
Garage

3: Weatherstripping Insufficient or Damaged

Missing or damaged weatherstripping can result in significant energy loss and moisture intrusion. Recommend installation of standard weatherstripping.

Recommendation: Recommended DIY Project

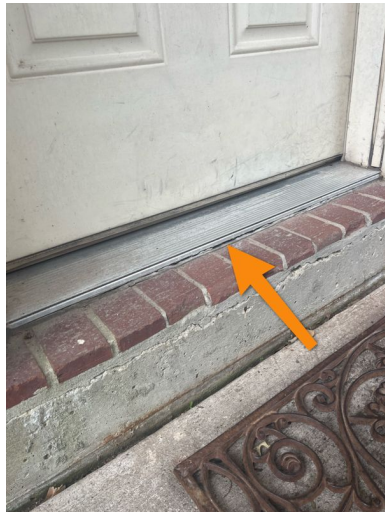
Back Exterior

4: Needs sealed at threshold

Sealing will avoid water penetration under the flooring and should be sealed to avoid damage to flooring.

Recommendation: Contact a handyman or DIY project

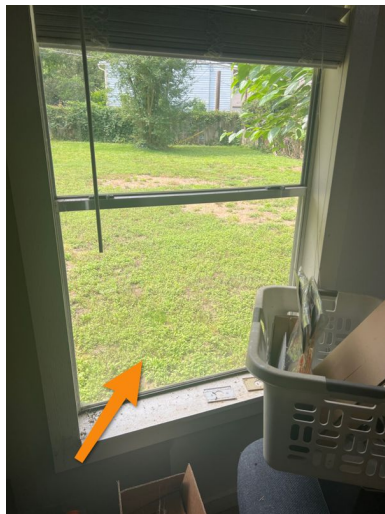
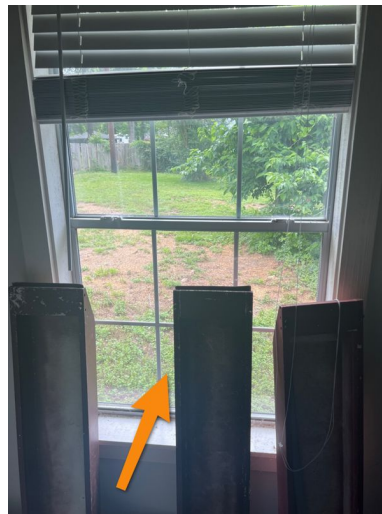
Try lubricating window to see if that corrects the function, as windows age they can be more difficult to open and close. Determine reason and repair or replace.

Recommendation: Contact a handyman or DIY project

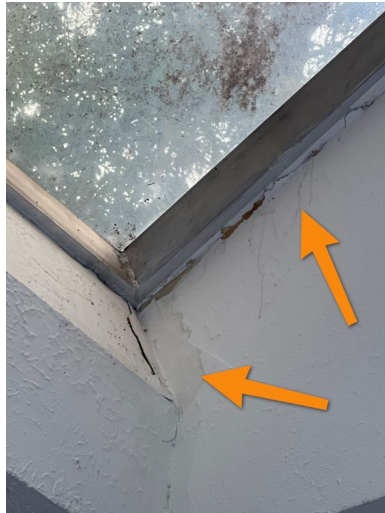
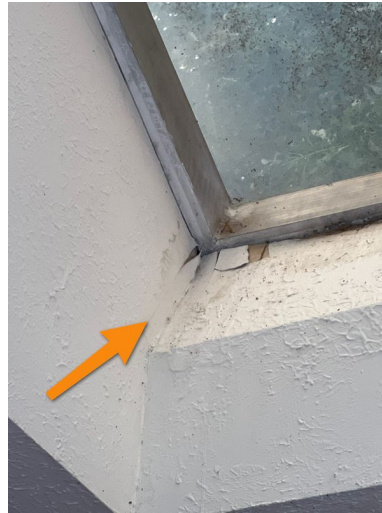
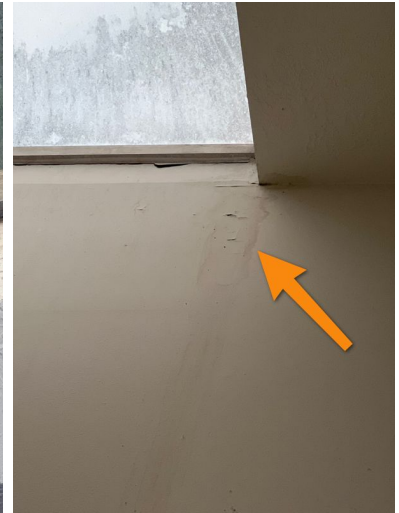
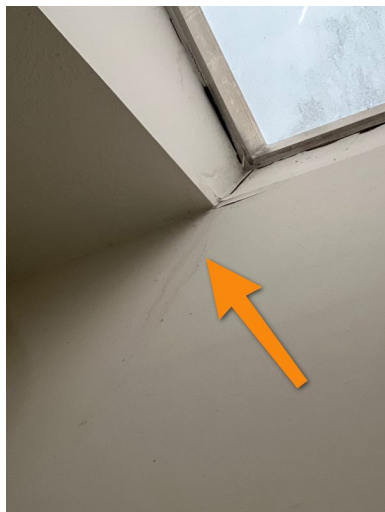
Windows need to be sealed inside and out to prevent water penetration. This can also be caused by condensation. Determine source of water intrusion and seal access.

Recommendation: Contact a qualified professional.

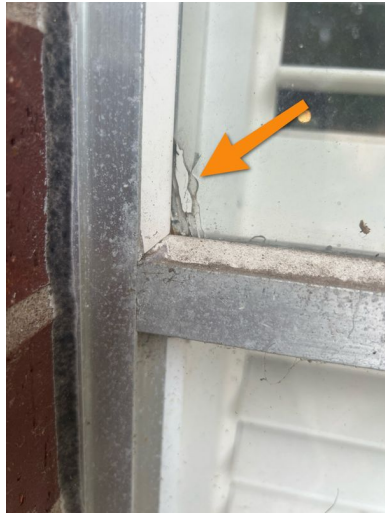
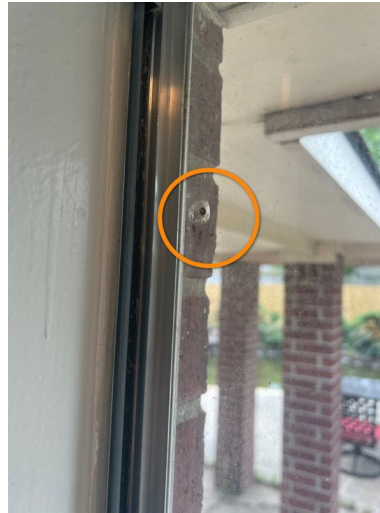
3: Glass pane is cracked, damaged or has gaps

Gaps or cracks in the window pane will cause the efficiency of the window to diminish, and provide an entrance for water/insects.

Recommendation: Contact a qualified professional.

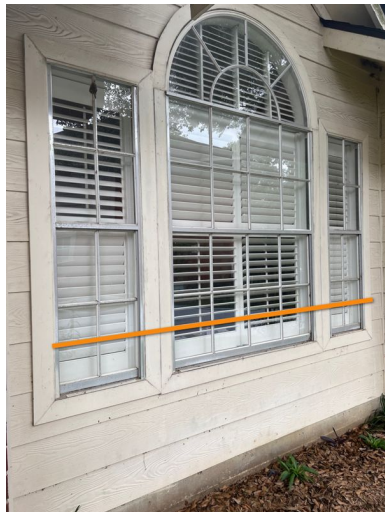
Left Side Exterior

4: Missing Screen(s)

One or more windows are missing a screen. Screens protect against insect intrusion when the window is open. Recommend replacement.

Recommendation: Contact a qualified window repair/installation contractor.

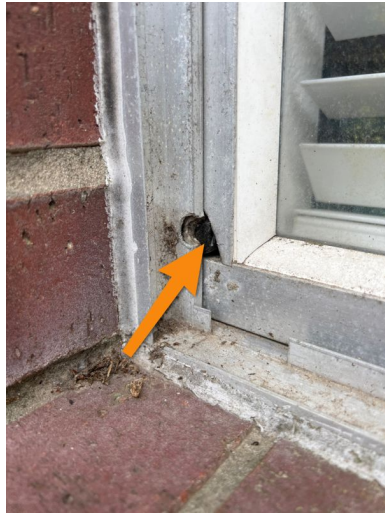
Right Side Exterior

5: Damaged window frame

Multiple window frames have drill holes. Recommend sealing drill holes to prevent moisture intrusion and energy loss.

Recommendation: Contact a qualified professional.

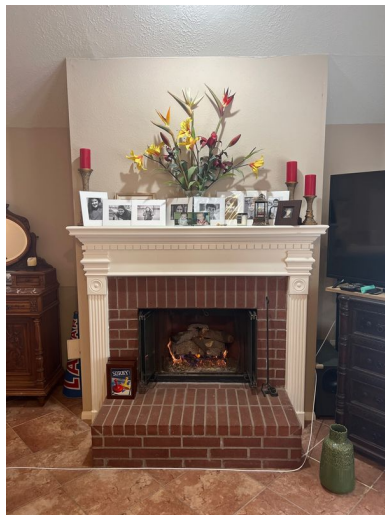
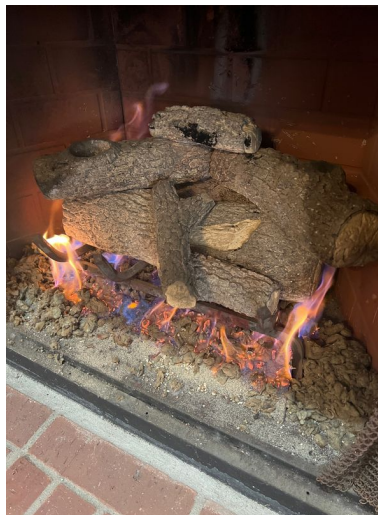
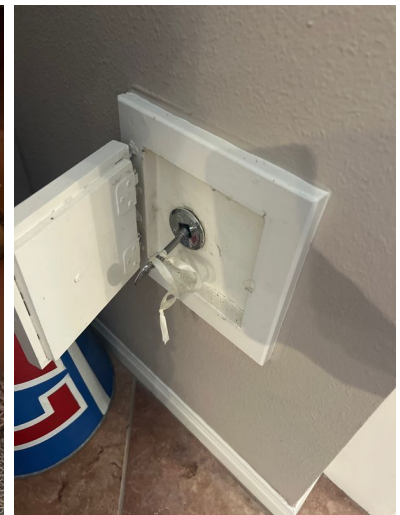
1: Damper needs a lock to keep it from closing

Recommendation: Contact a qualified professional.

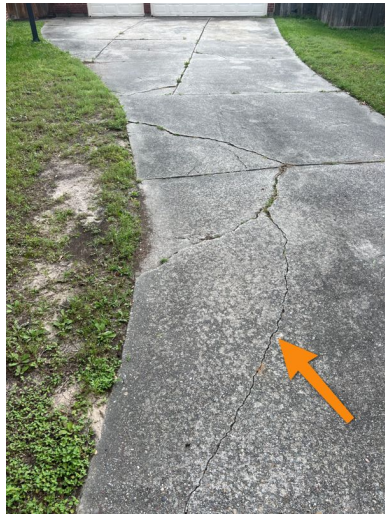
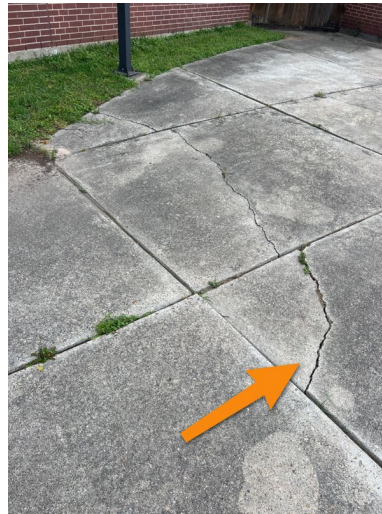
1: Cement on driveway or porch has cracks

Cracks should be sealed to keep water from penetrating the separations caused by the crack.

Recommendation: Contact a qualified professional.

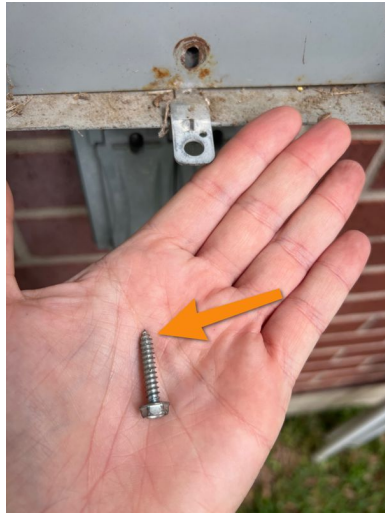
3: Improper mounting screws used

Pointed Screws Not Approved

Screws used for electrical panels need to have a flat dull end entering the electrical panel so they do not damage wires when installed.

Recommendation: Contact a handyman or DIY project

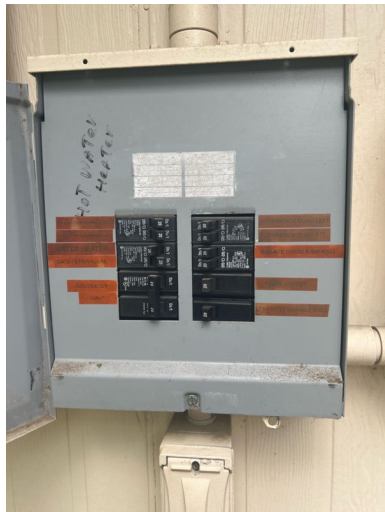
4: No main breaker or main breaker does not work

More than 6 throws requires a Main Shutoff

The main breaker is required so that power can be turned off to the entire panel. Recommend installing main breaker.

Recommendation: Contact a qualified electrical contractor.

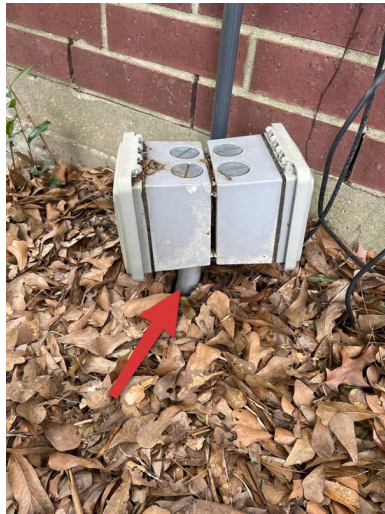
2: Conduit is loose, missing, or damaged

The conduit is meant to protect the wire from becoming damaged and posing a hazard.

Loose - Front Exterior

Recommendation: Contact a qualified professional.

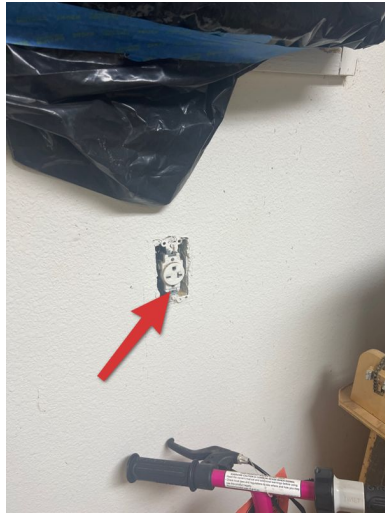
Garage

3: Cover plates missing

One or more receptacles are missing a cover plates. This causes a shock risk. Recommend installation of plates.

Recommendation: Contact a qualified electrical contractor.

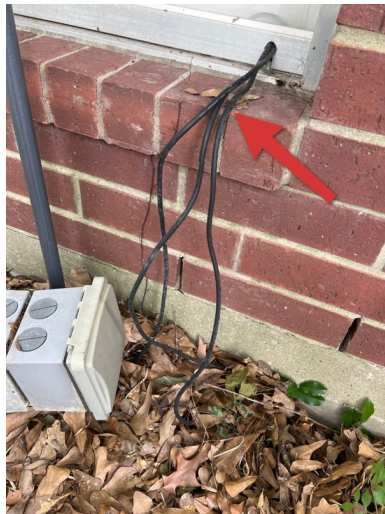
Front Exterior

4: Exposed wires

All exposed wires should be in conduit or inside a junction box. This protects the wire from damaged, and protects occupants from electrical hazards.

Recommendation: Contact a qualified electrical contractor.

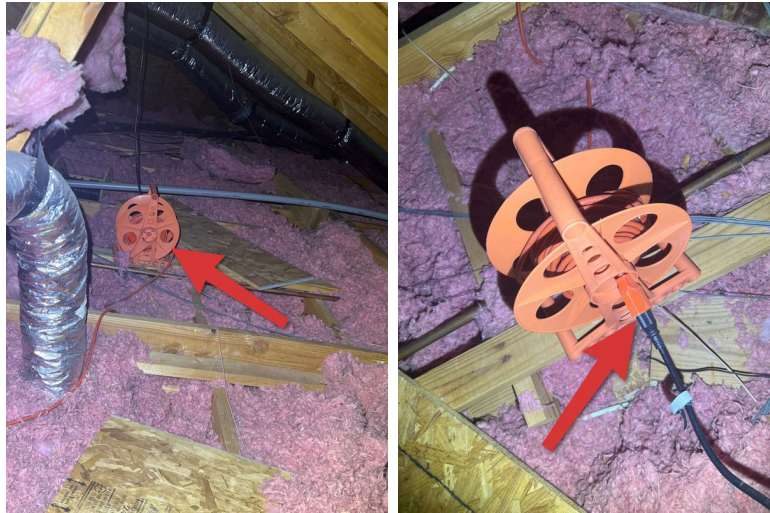
5: Extension cords are not approved permanent wiring

Extension cords can get damaged and deteriorate easily.

Recommendation: Contact a qualified professional.

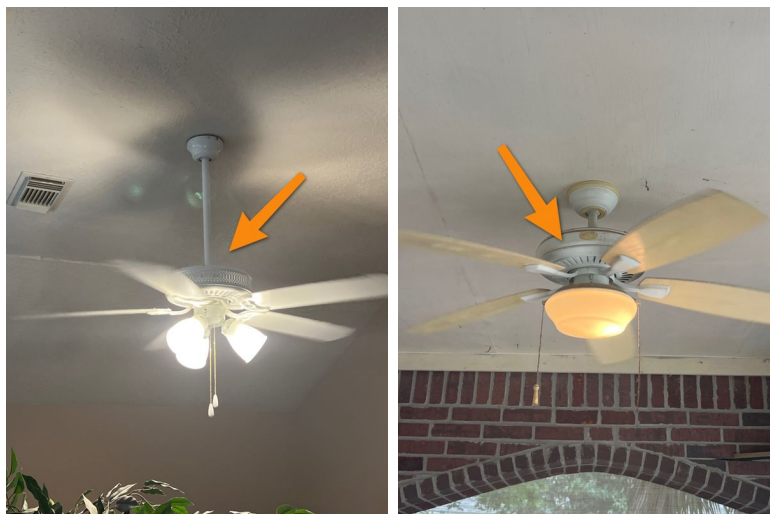
Master Bedroom

6: Fan wobbles as it rotates

This can cause the fan to come loose from the ceiling.

Recommendation: Contact a qualified general contractor.

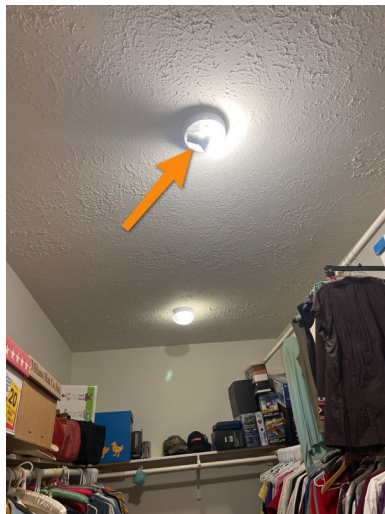
Master Bathroom Closet

8: Light fixture cover is damaged, missing or loose

Lights covers protect electrical components from insects and the elements.

Recommendation: Contact a qualified professional.

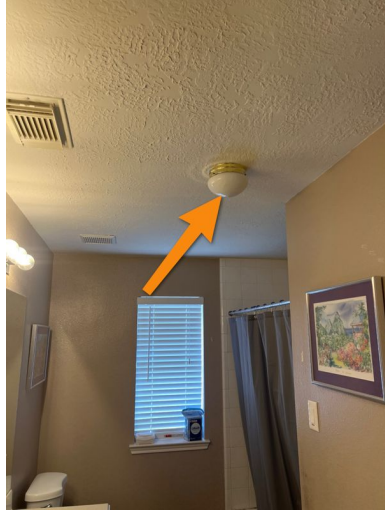
Hallway Bathroom

9: Light Inoperable

Recommendation: Contact a qualified electrical contractor.

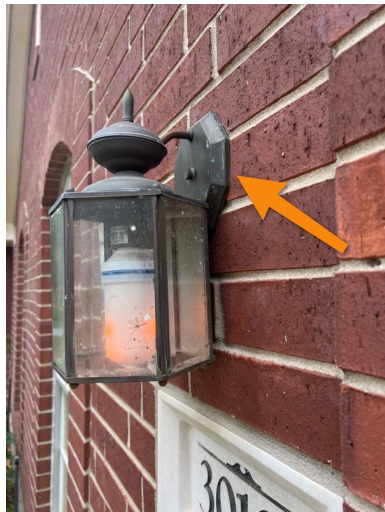
Front Exterior

10: Lights on the exterior are not sealed

Sealing the lights where they meet the siding keeps water and pests out of the electrical components and interior structure.

Recommendation: Contact a qualified professional.

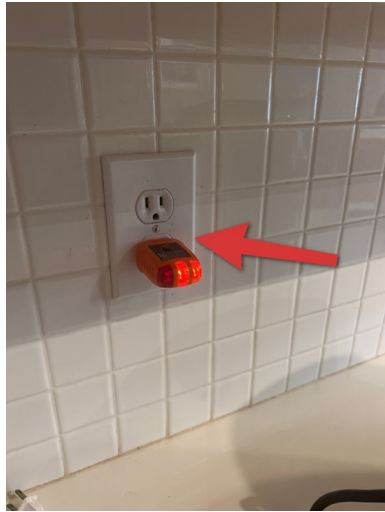
Kitchen

11: Missing GFCI protection where required

No GFCI protection. Recommend licensed electrician upgrade by installing ground fault receptacles. [Here is a link](#) to read about how GFCI receptacles keep you safe.

Recommendation: Contact a qualified electrical contractor.

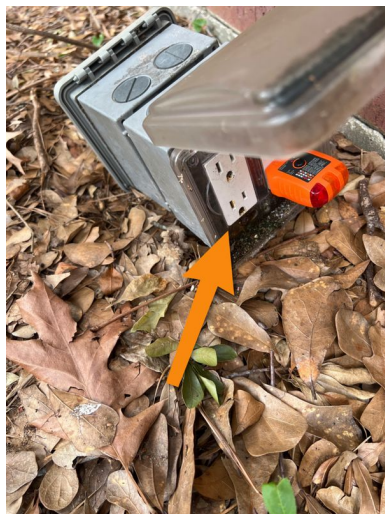
Loose Conduit and No Power - Front Exterior

Have a licensed electrician return power to the outlets.

Recommendation: Contact a qualified electrical contractor.

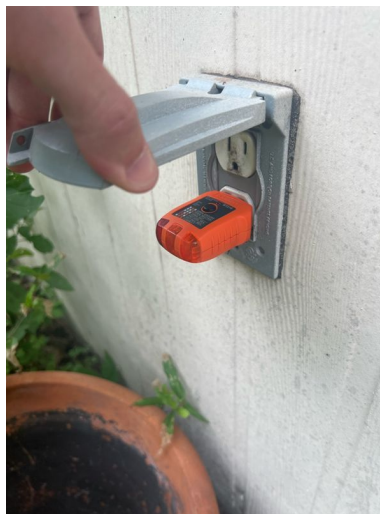
Garage

12: Outlet has no power

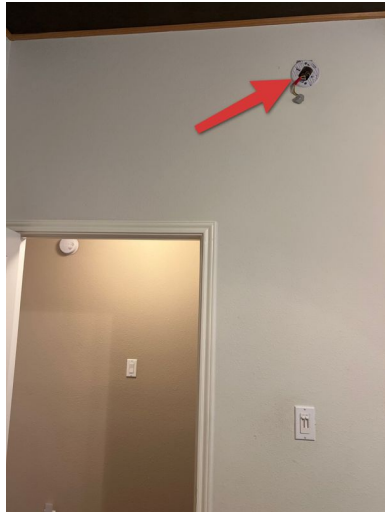
Front Bedroom

14: Smoke detectors are missing

Smoke detectors alert occupants to evacuate the building in a fire emergency. Smoke detectors should be located in every bedroom, and at least one on every floor.

Recommendation: Contact a qualified professional.

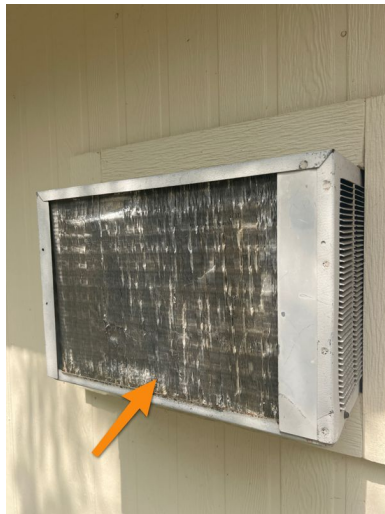
Garage

1: Condenser fins are dirty or damaged

Damaged or dirty condenser fins will not expel heat as efficiently.

Recommendation: Contact a qualified HVAC professional.

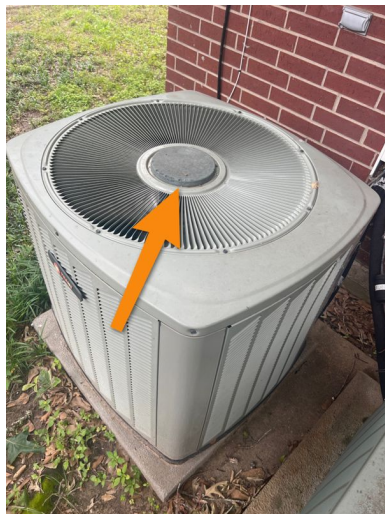
4: Fan is out of balance

The condenser fan is out of balance. With use the condition will worsen and cause damage to the unit. It also decreased the efficiency of the unit.

Recommendation: Contact a qualified HVAC professional.

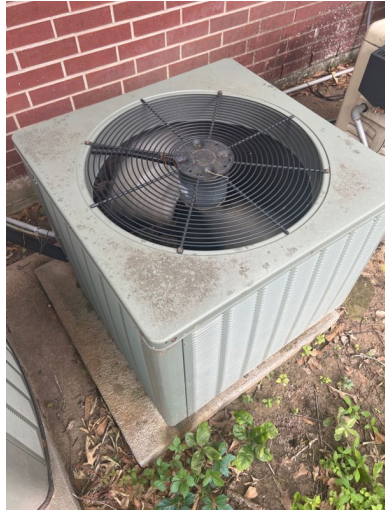
🔴 Recommendation

Compressor started and operated but unit was unusually noisy. Recommend licensed HVAC contractor evaluate.

Recommendation: Contact a qualified HVAC professional.

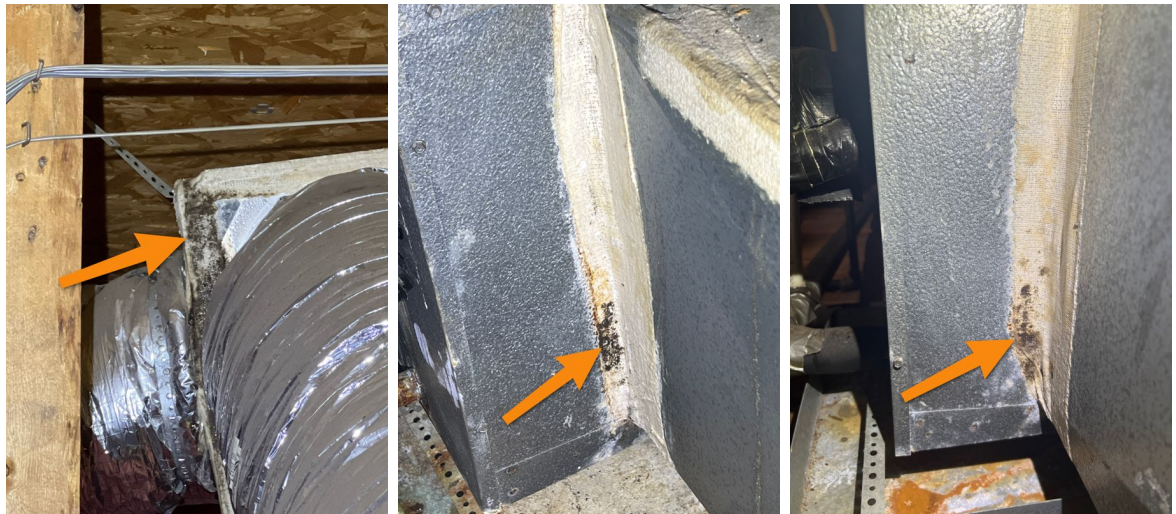
9: Unit has bio growth

Unit should be cleaned of bio growth, and cleaned periodically to make sure that bio growth does not return.

Recommendation: Contact a handyman or DIY project

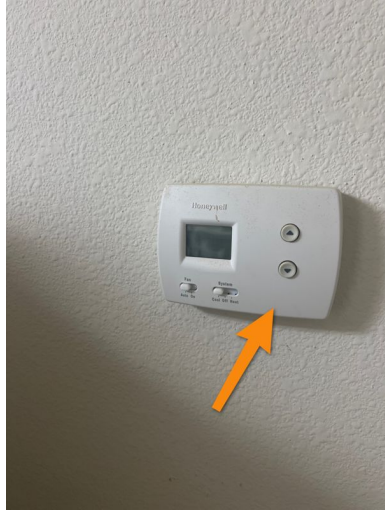
Inoperable - Garage

10: Thermostat is loose or not working properly

Recommendation: Contact a qualified professional.

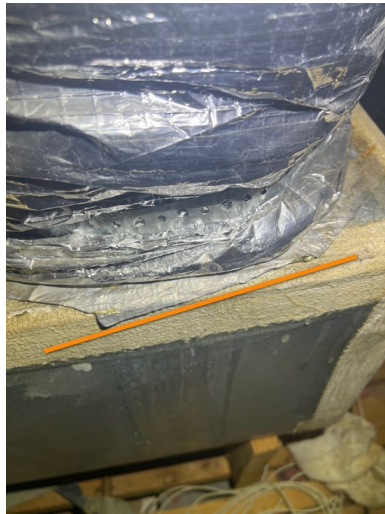
3: Condensation accumulating on Plenum

Source of moisture and condensation should be found and repaired

Recommendation: Contact a qualified HVAC professional.

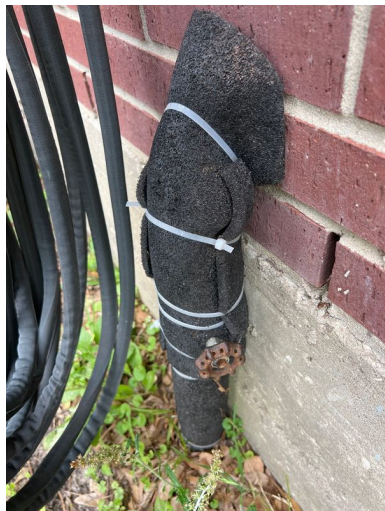
- A. Plumbing Supply, Distribution Systems, and Fixtures**
Location of Main Water Supply Valve : Exterior of Home

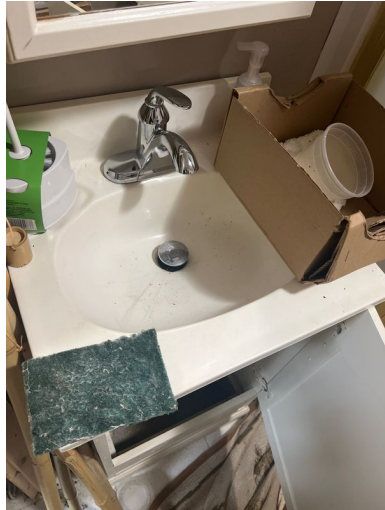
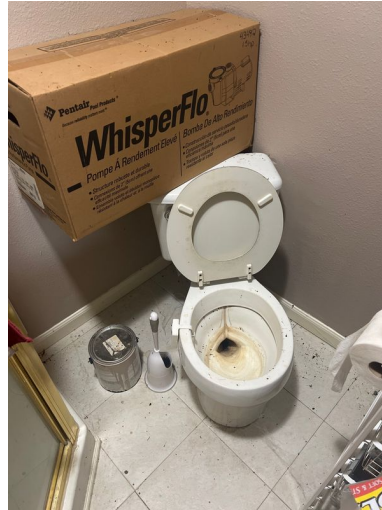
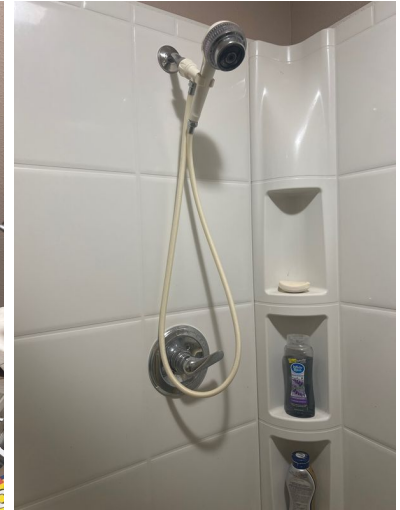
Garage

1: Caulking is missing or deteriorated

Caulking, while inexpensive is an important part of the home. Caulking around plumbing fixtures and at joints protects finishes and structural members from water damage.

Recommendation: Contact a handyman or DIY project

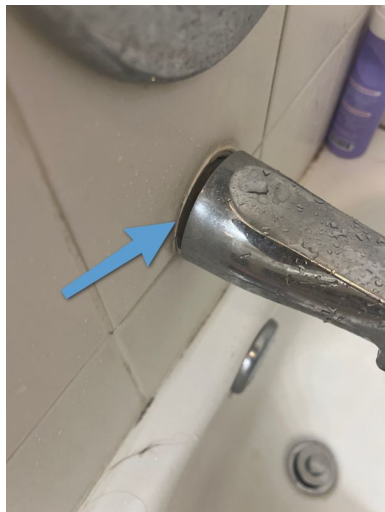
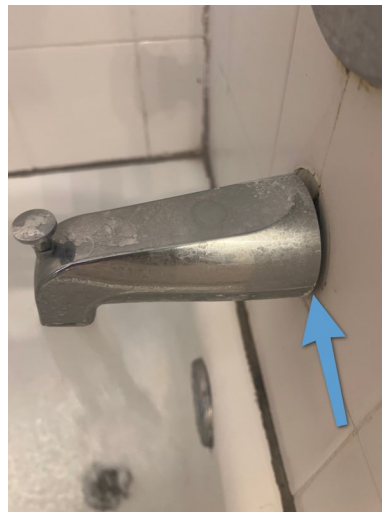
Hallway Bathroom

2: Evidence of previous water leak

Monitor area for future moisture. If moisture continues consult a licensed plumber.

Recommendation: Contact a qualified plumbing contractor.

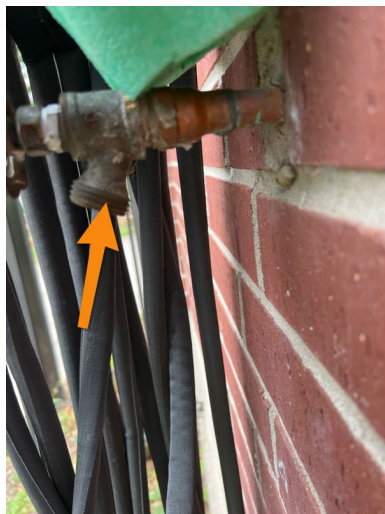
Right Side Exterior

4: Shower head is leaking from connection joint

Recommendation: Contact a qualified professional.

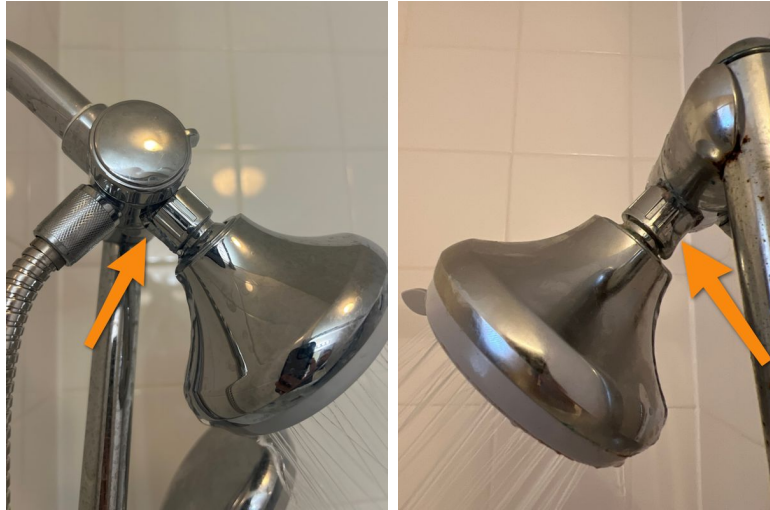
Hallway Bathroom

5: Toilet is loose from floor

Toilets have a wax ring that seals the connection of the toilet to the floor. If the seal is broken water and sewer gases can escape.

Recommendation: Contact a qualified professional.

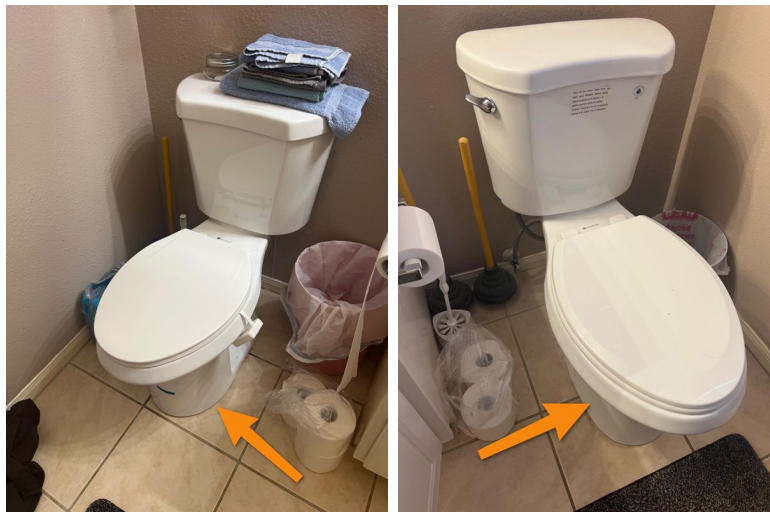
6: Shower walls are leaking

Recommendation: Contact a qualified professional.

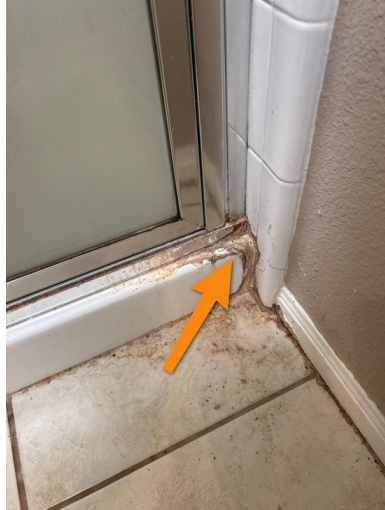
Master Bathroom

7: Faucet is inoperable

Faucet does not operate, needs to be repaired or replaced.

Recommendation: Contact a qualified plumbing contractor.

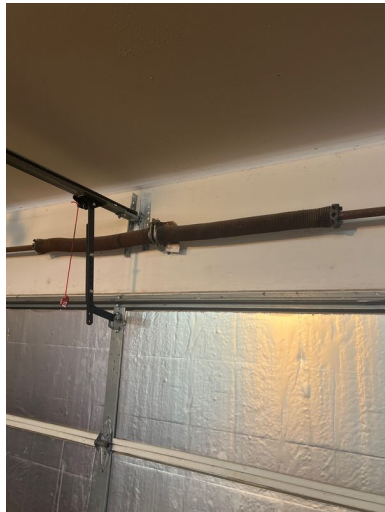
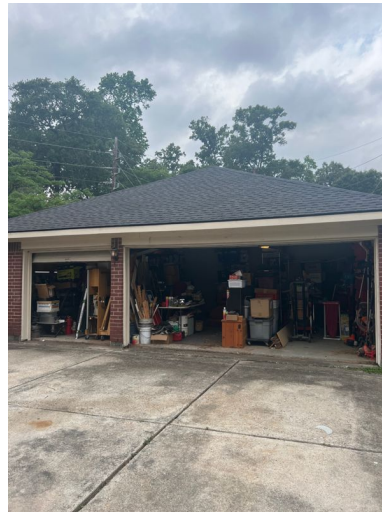
Obstructed:

Garage door operator was obstructed at the time of inspection. The garage door cannot fully be opened.
