# Wood Destroying Insect Report

Inspection Performed by Andrew Dabbs TPCL #828555 4/26/2024

1234 Lehman St

## TEXAS OFFICIAL WOOD DESTROYING INSECT REPORT

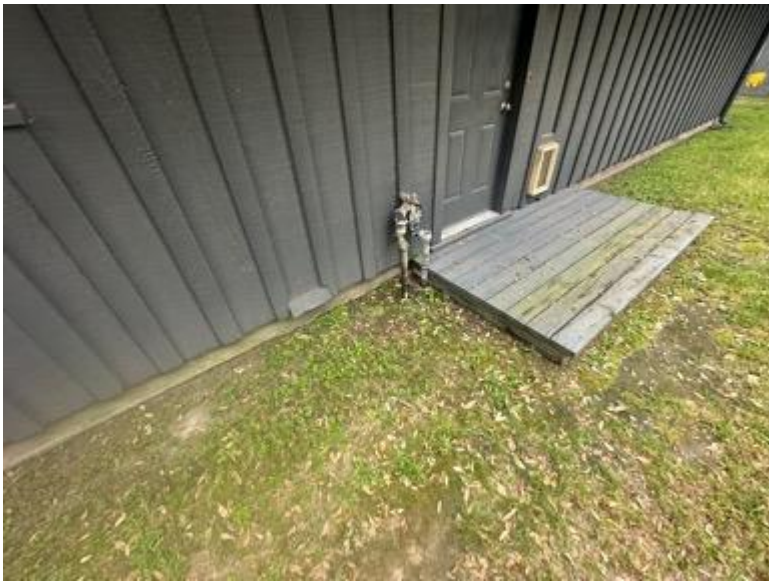
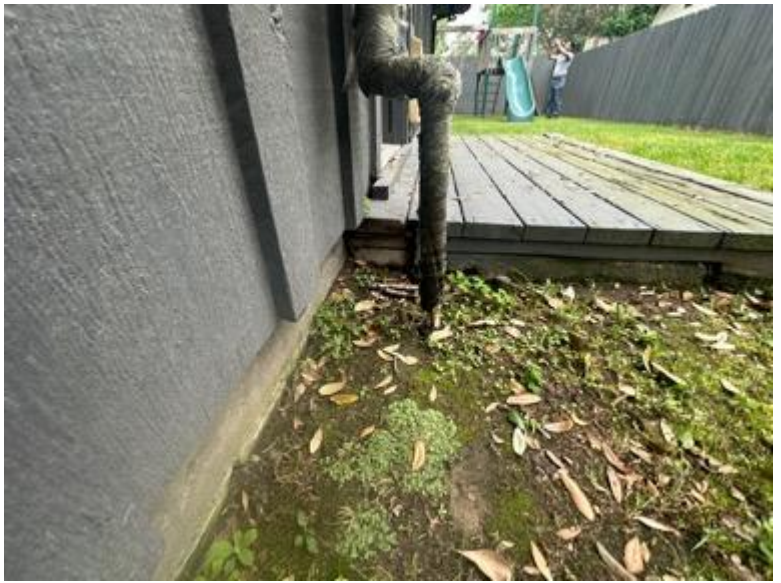
Deck obstructs view of foundation.

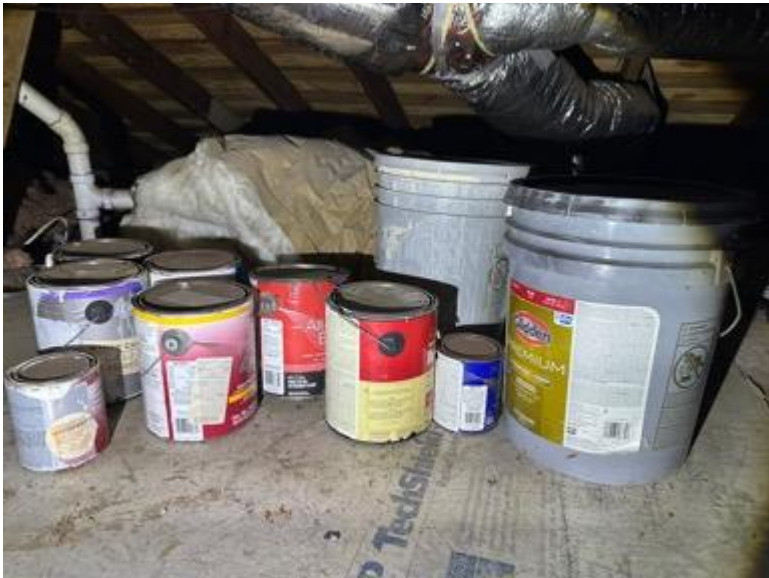
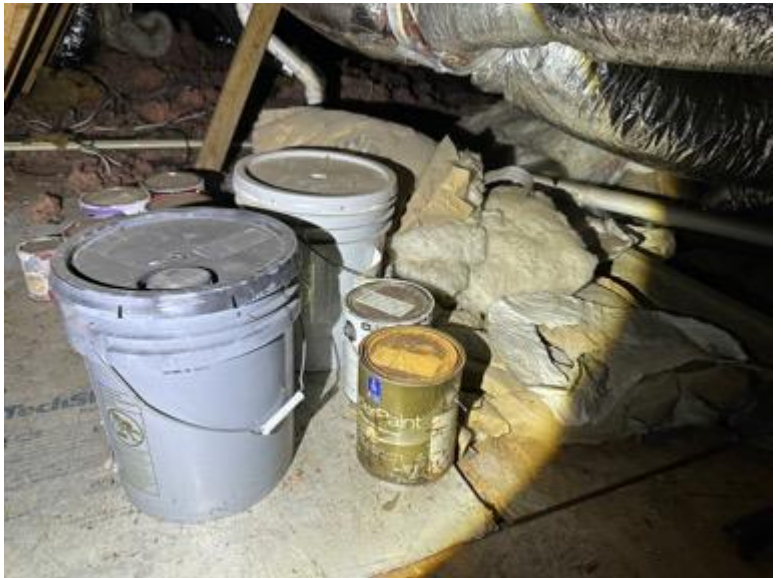
Stored items in the attic.

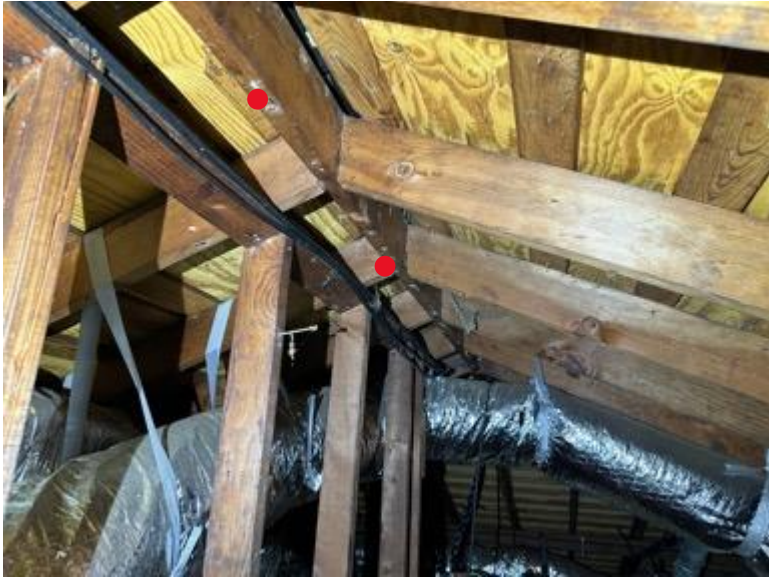
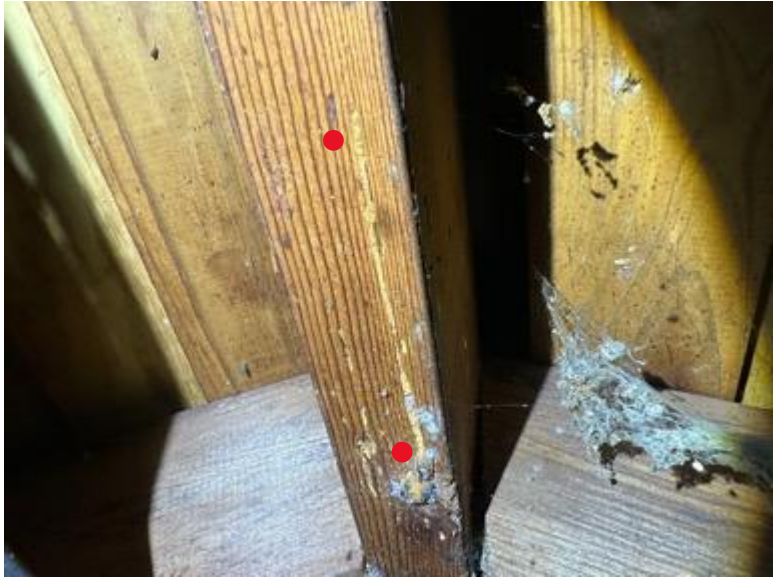
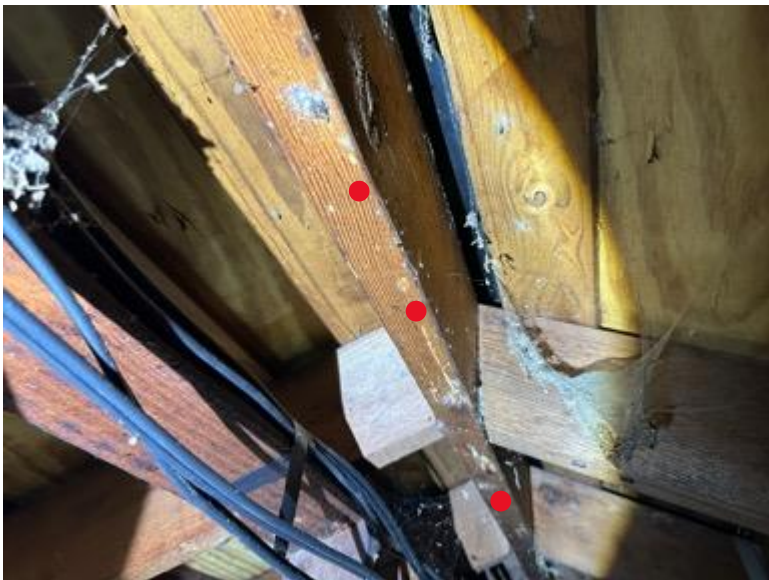
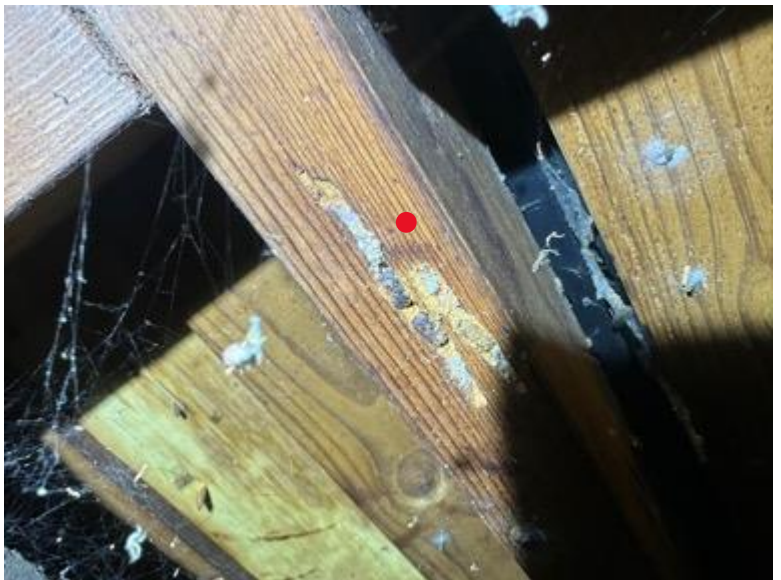
Evidence of previous wood boring beetles in the attic – The condition appears to be inactive – No treatment recommended.

**(PB) Wood Boring Beetles - Evidence of previous infestation. Condition appears inactive - No treatment is recommended.**

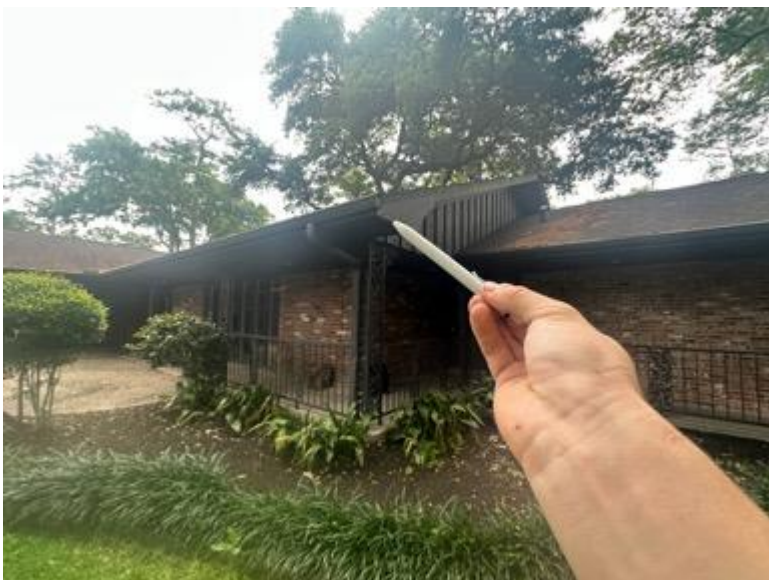
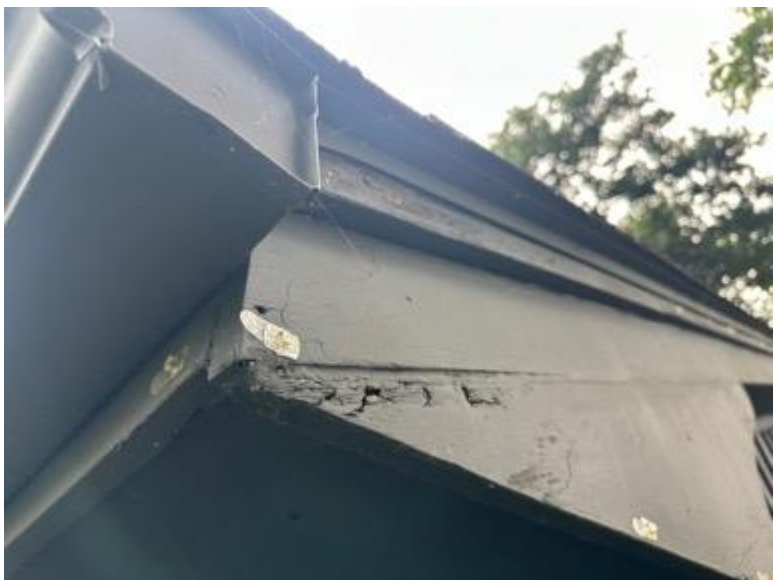
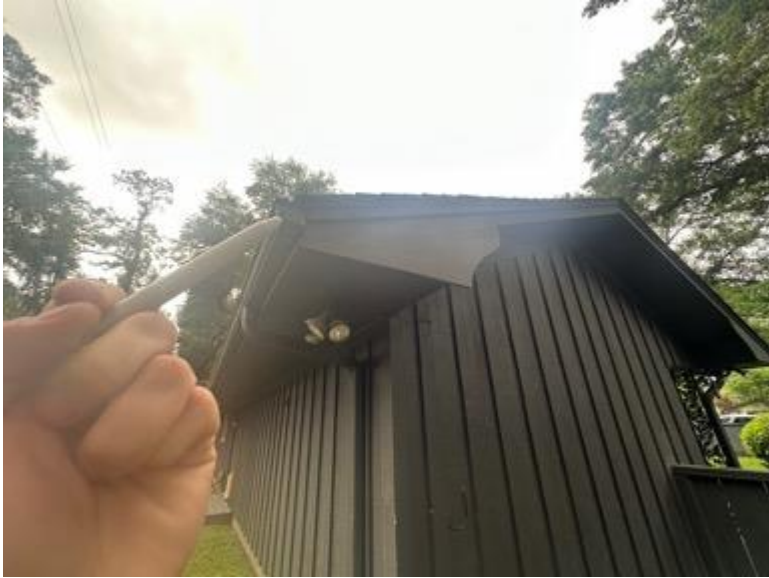
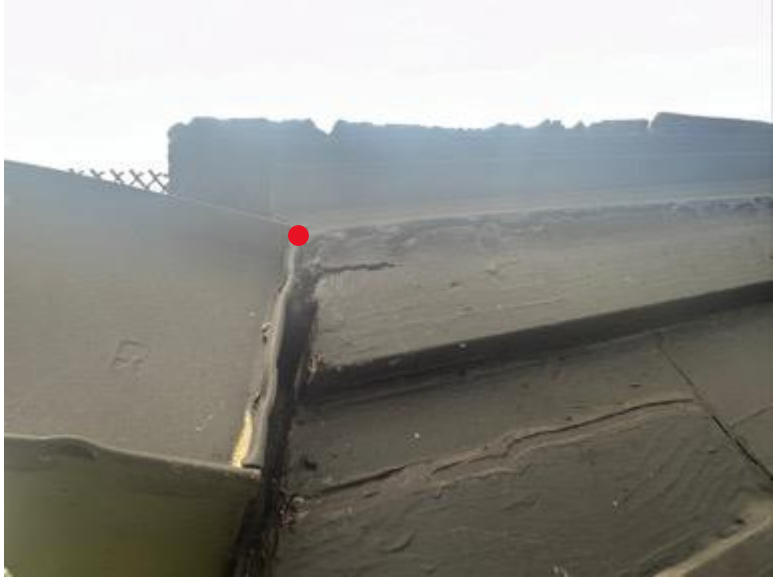
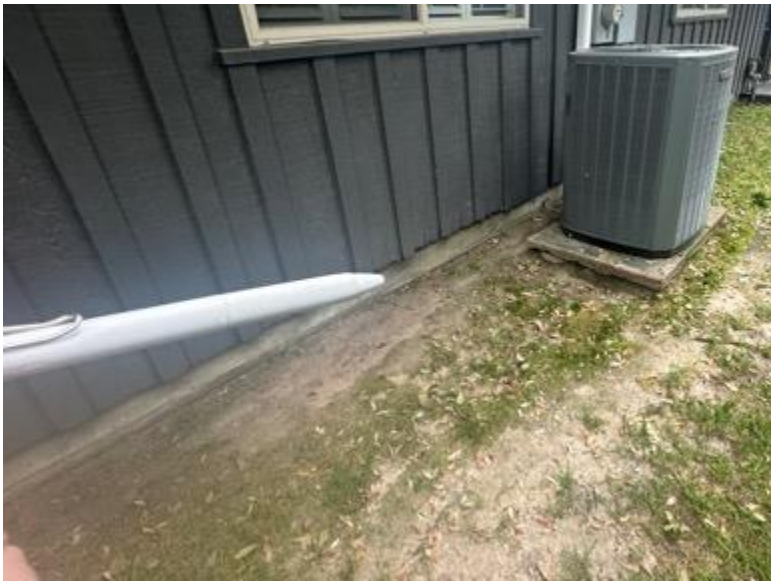
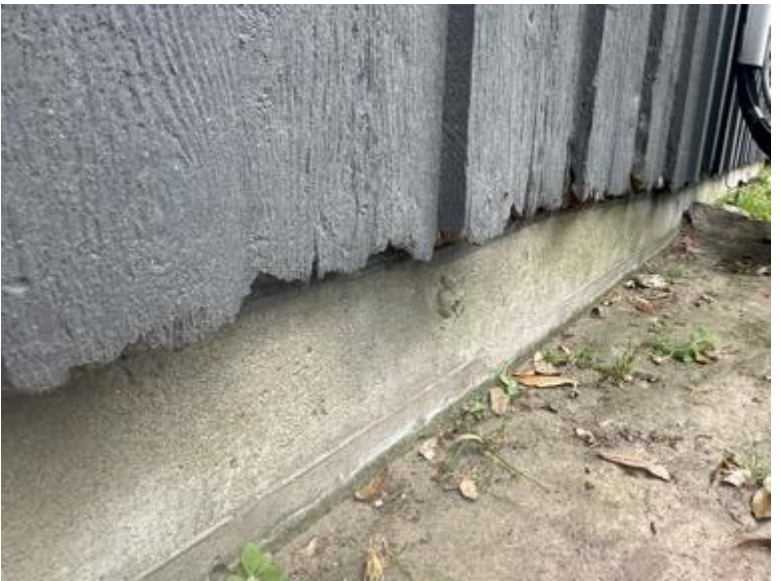
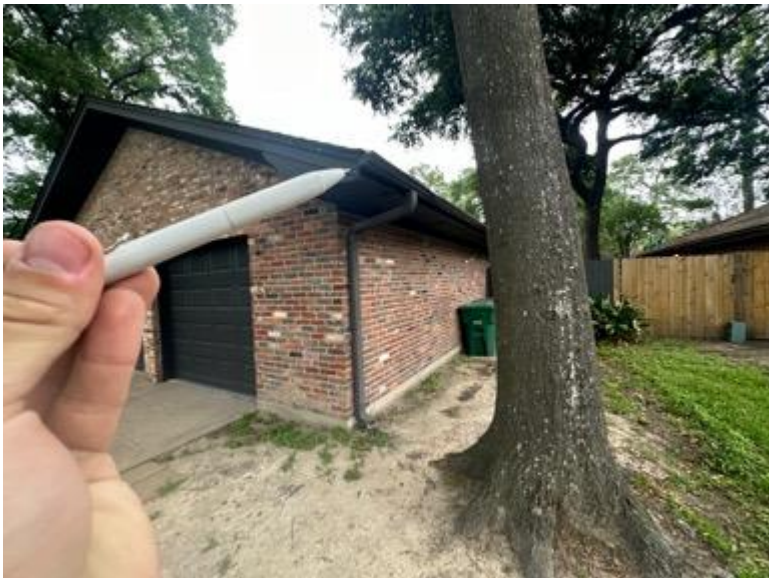
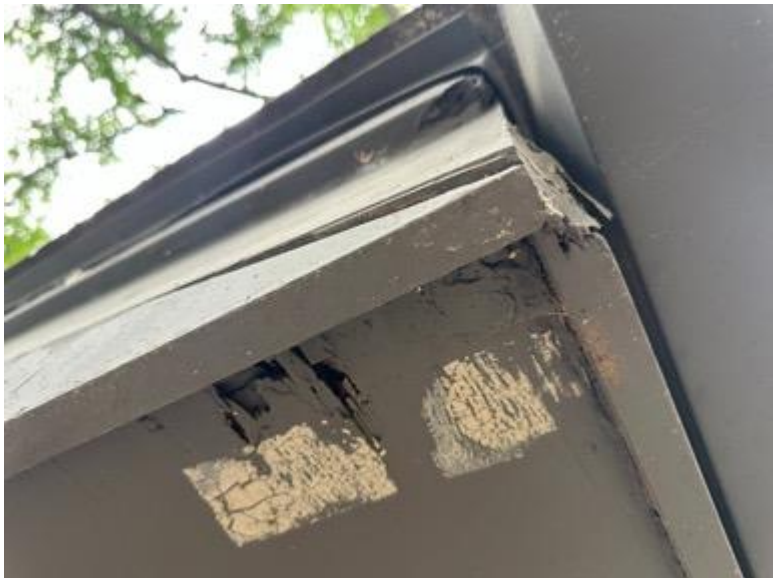
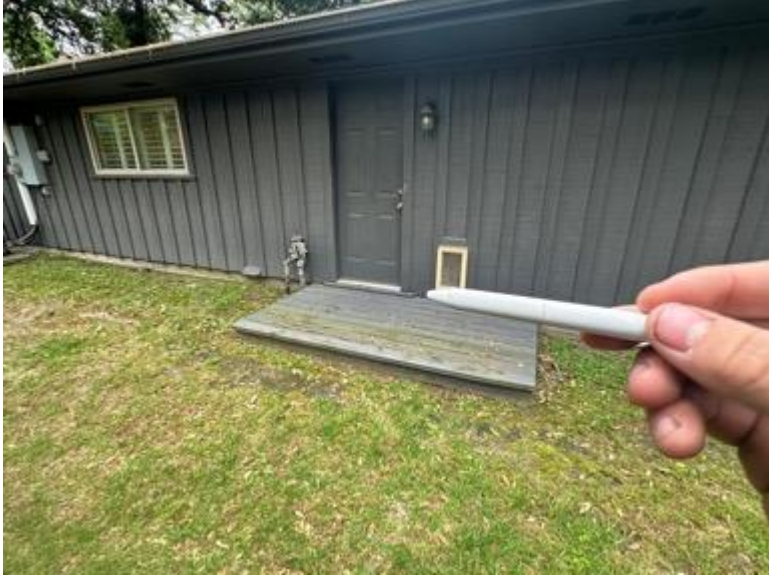
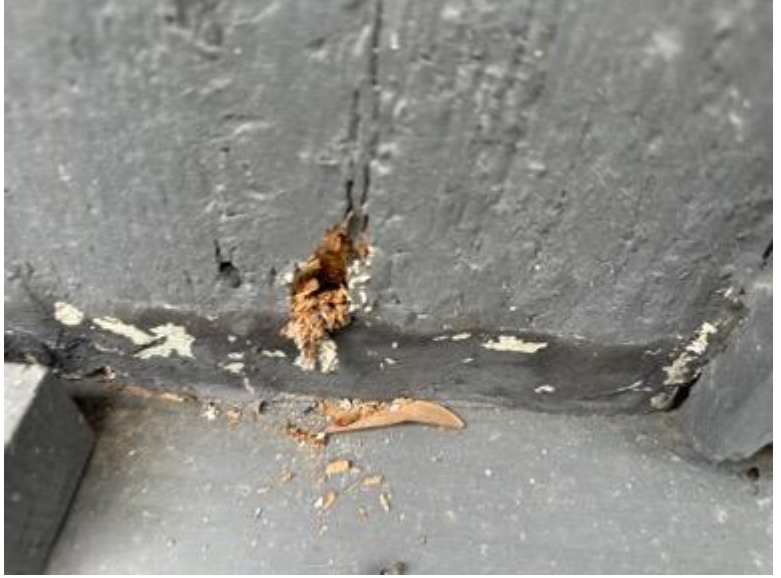
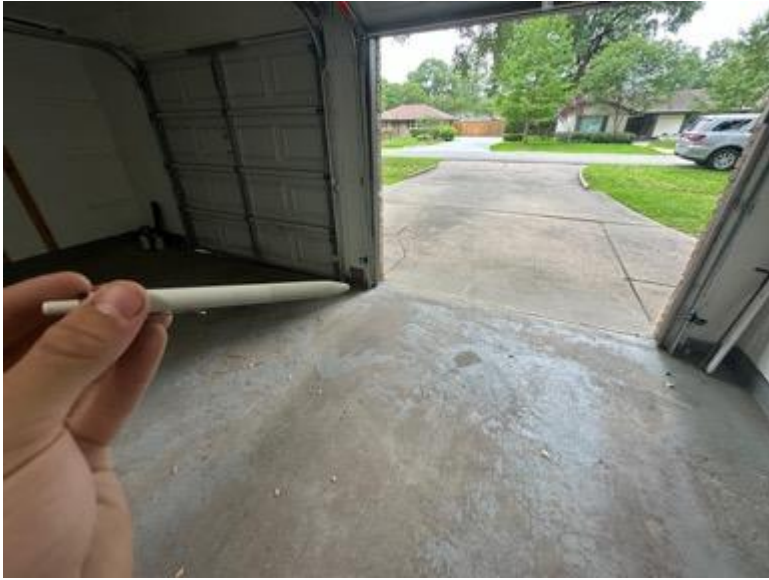
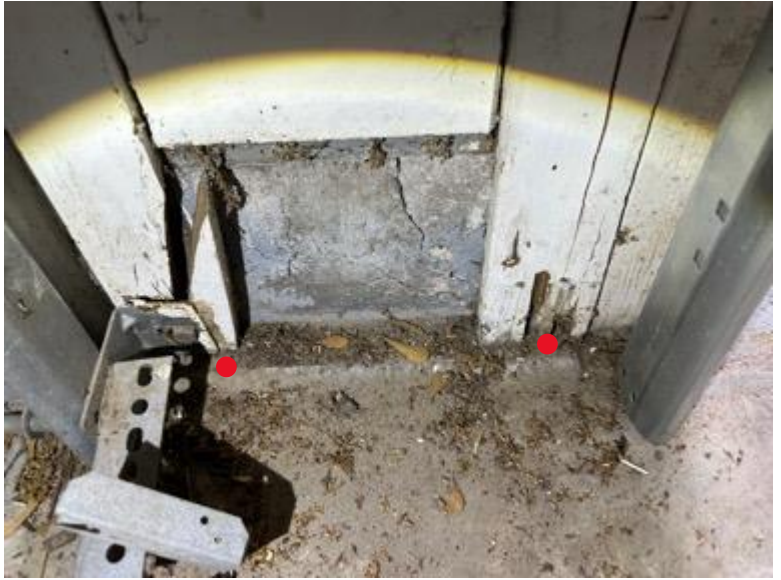
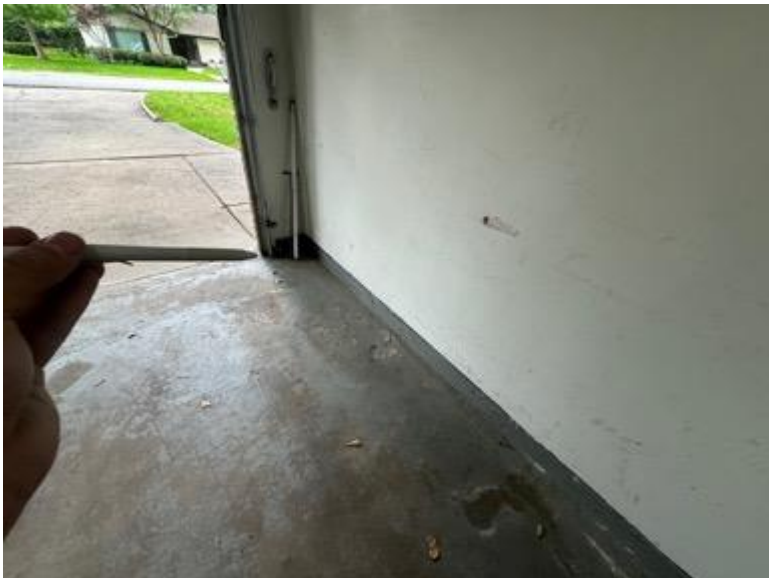
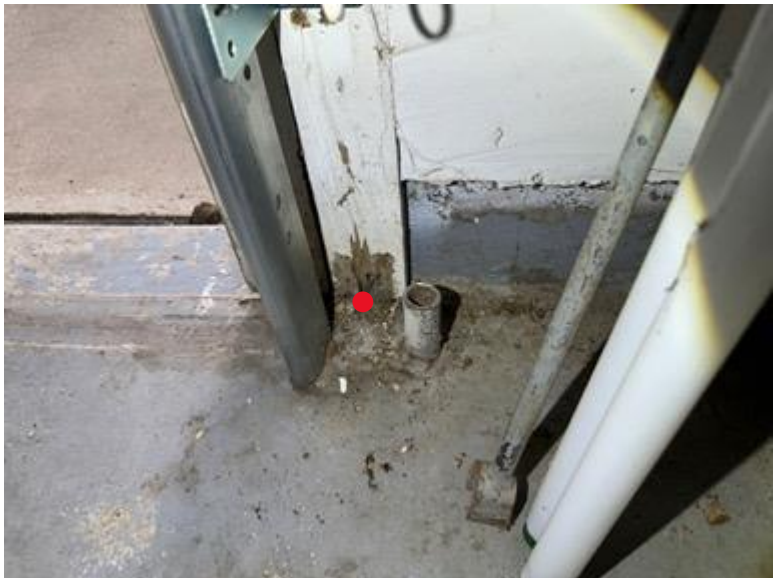
All damaged and rotten wood should be replaced.

Additional Comments: **(M) Wood Rot - All damaged or affected wood materials should be properly repaired or replaced.**
