Inspection for Property located at 9542 Wilder Rd
04/28/2023
Prepared for : Brandon Rogers

PROPERTY INSPECTION REPORT FORM

9542 Wilder Rd, Arcola, TX 77583

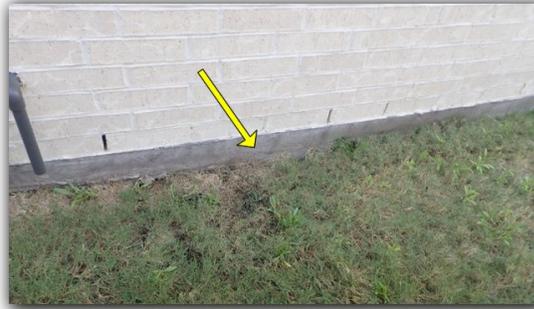
Slab dressing observed at one or more areas of foundation. Slab dressing is usually applied for cosmetic reasons but may be covering defects.

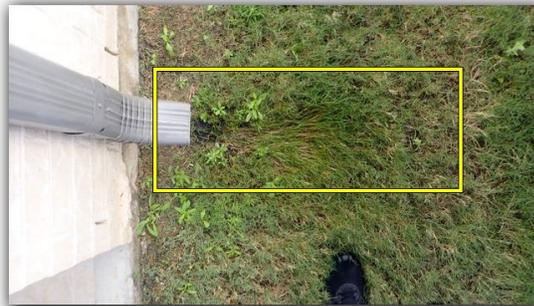
Comments: Downspouts need splash blocks at bottoms to prevent soil erosion.

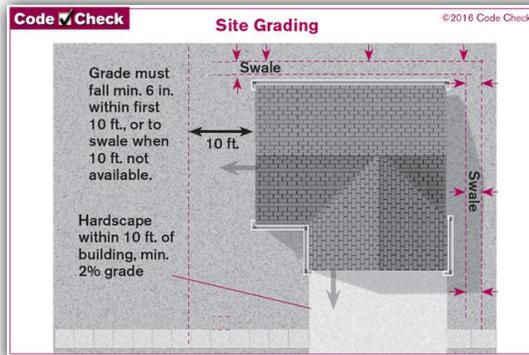
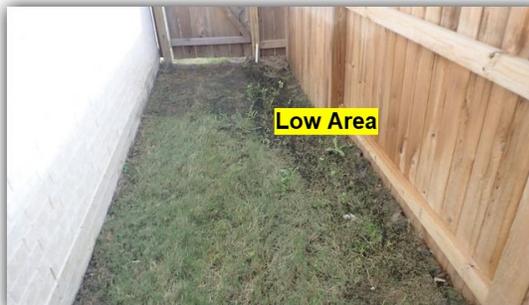
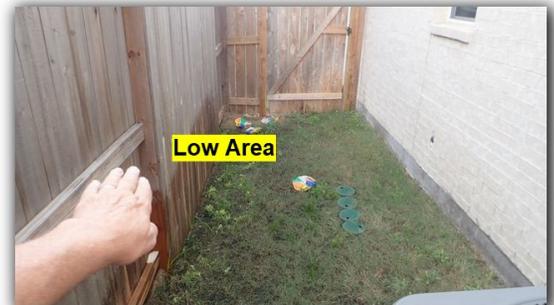
Drainage swale is not continuous at all sides The drainage swale must be clear and continuously sloped in order to drain water properly.

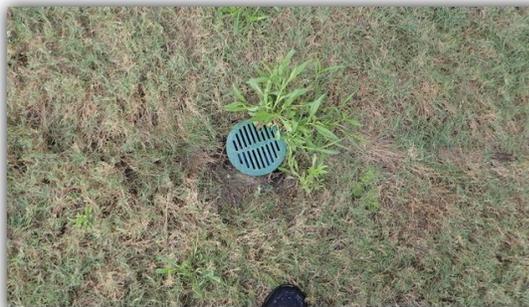
Underground yard and/ or pool deck drainage system not tested for flow, adequacy and placement.. Did not verify yard drains operate properly and that there are no collapsed or clogged areas. Inspector (or anyone else) is unable to induce sufficient quantity of water to determine if system will operate properly when needed. Recommend observing performance during heavy rains and ensure system is maintained / cleaned.

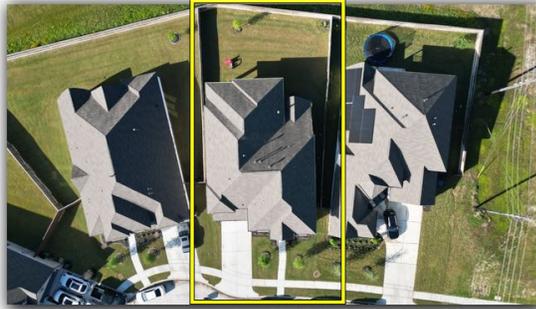
Comments: One or more areas of raised shingle tabs from fasteners not secured down properly or nail heads popping up through shingles.

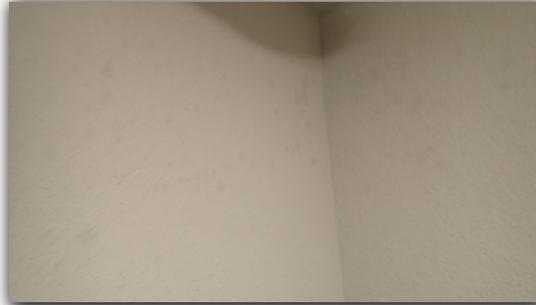
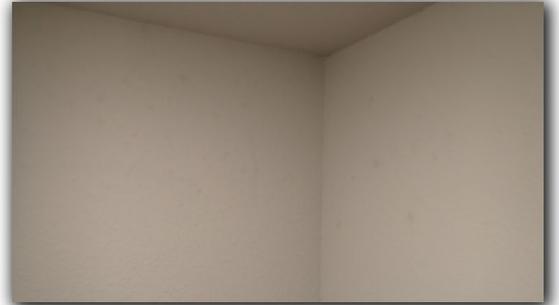
Comments: Spots observed on the upper wall around the attic access. Possible micro-organism growth (Mold) which may be a concern due to increased awareness of environmental issues associated with molds. Recommend removal of all sheetrock and other building materials containing visible mold growth plus an additional 2 feet surrounding area. If this is a concern or potential concern, Texas House Check recommends contacting us for further information / investigation / Testing.

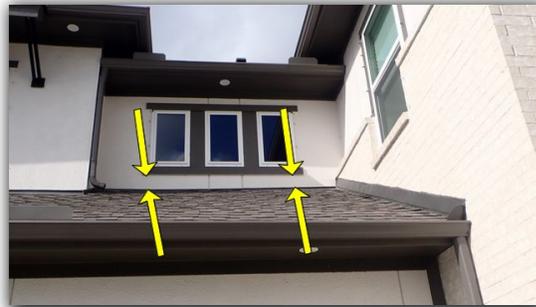
Exterior wall is not straight.

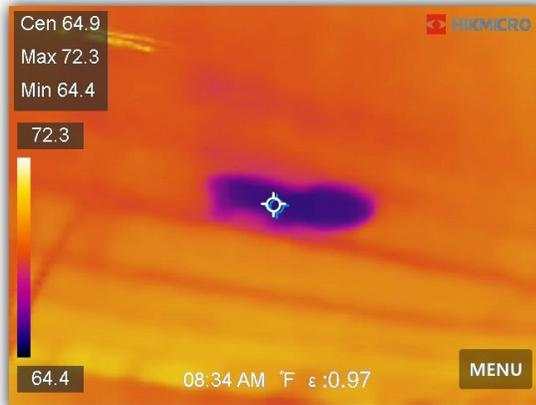
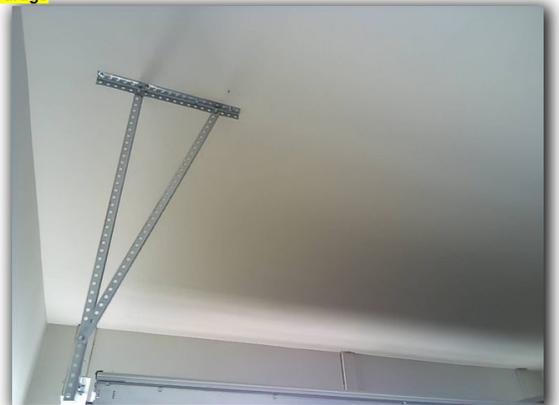
Garage

Comments: **Thermal imaging has detected a cool spot that appears to be caused by moisture. Moisture was confirmed by a penetrating moisture meter.**

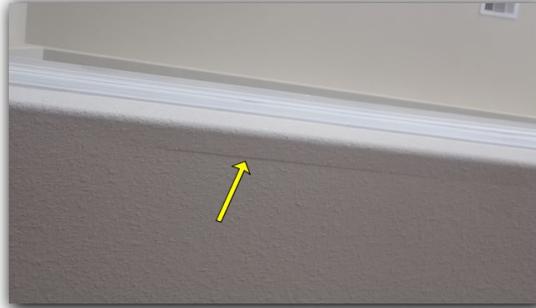
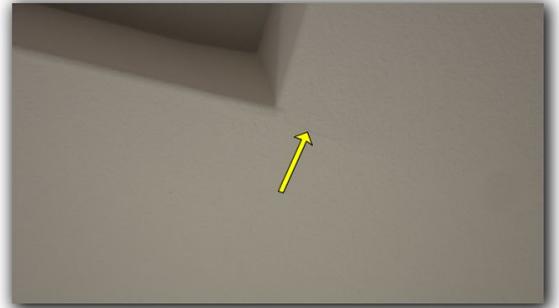
Observed cosmetic cracks and/or repairs in drywall ceiling of one or more rooms.

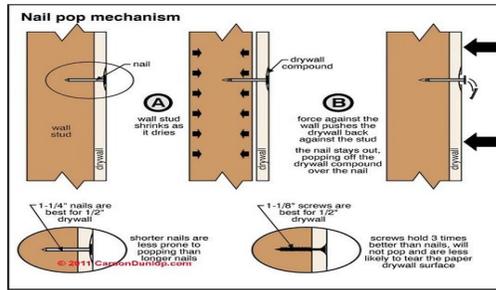
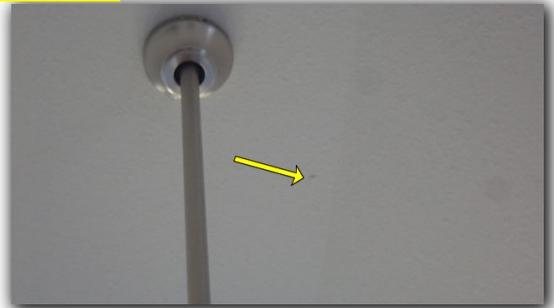
Master Bedroom

Nail heads observed to be pushing through the interior finish.

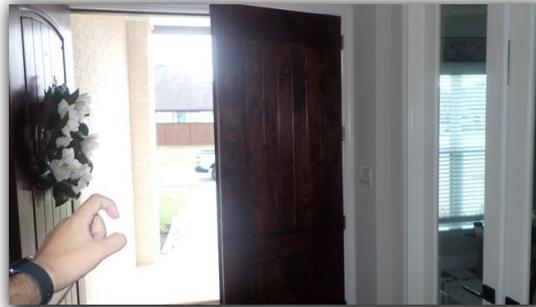
Comments: Door is self closing/opening. This indicates that the door is not installed correctly, needs adjustment or there is some foundation movement.

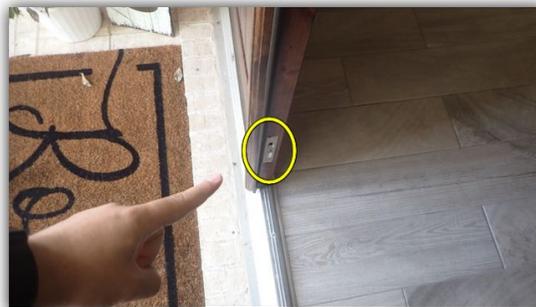
One or more door(s) have sticky hardware.

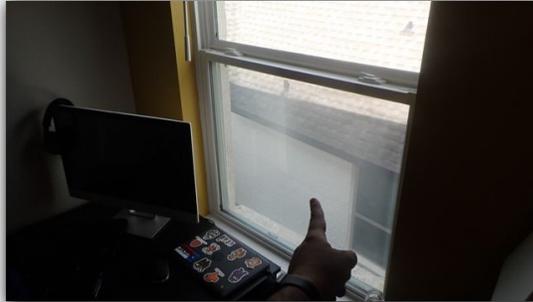
Comments: Double pane window vapor seals appear broken, including but not limited to: **Upstairs Secondary Bedroom**

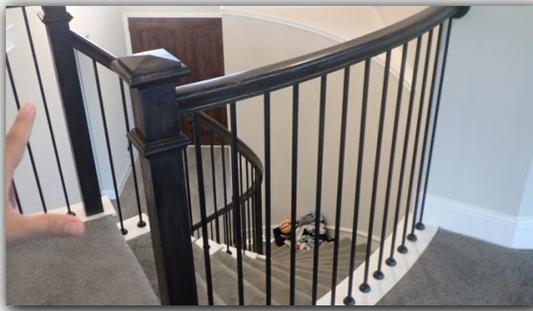
Comments: Guard rail deflects with moderate force. Does not appear to be capable of withstanding 200 lbs of force as required by current building standards. Ref IRC 2003 Section R301.5 Live Load.

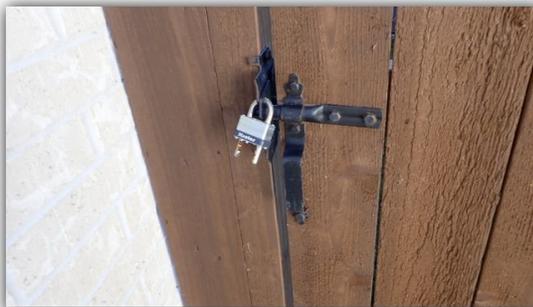
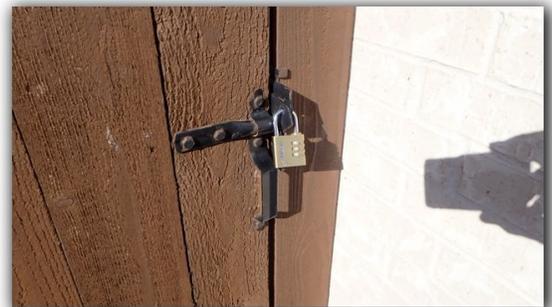
Comments: The fence gate is is locked and could not be operated/inspected.

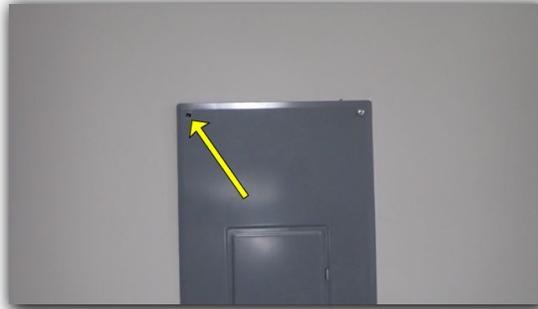
Comments: Dead front missing one or more securing screws. Need to ensure screws used do not have sharp / pointed ends that can penetrate live electrical wiring behind dead front and cause shock, fire, serious injury. Screw hole too big for current screws.

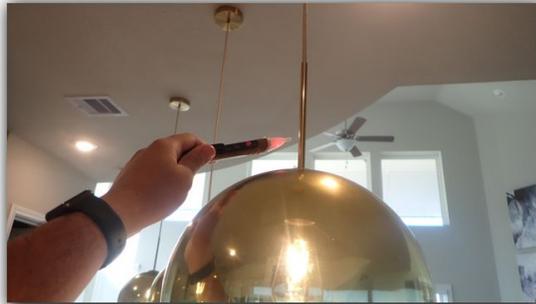
Comments: One or more light fixtures are not grounded.

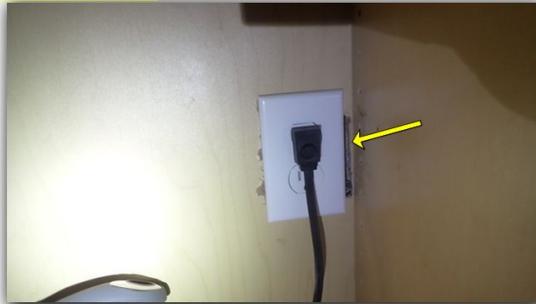
Inside Kitchen Cabinet

Excessive gap between side of electrical junction box and wall observed; exceeds 1/8 inch allowable by code. Reference NEC 370-21 and CABO 4406.6

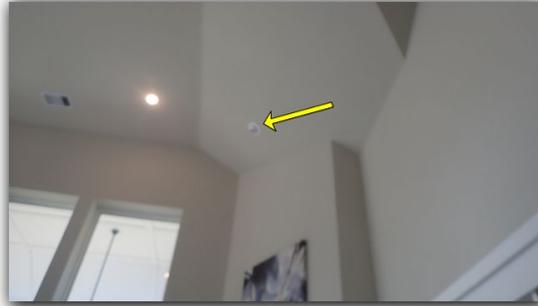
Light(s) found to be not functioning. Probably just a burned out bulb, or it could be a broken fixture / switch or improper wiring. Including but not limited to:

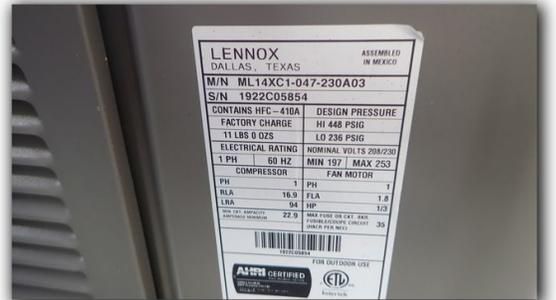
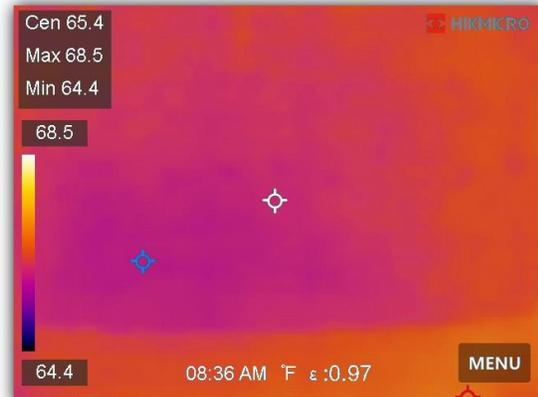
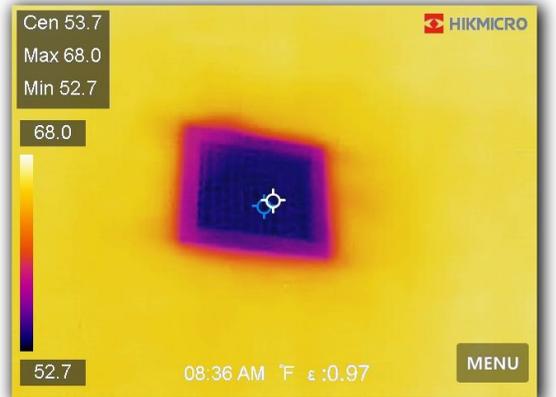
The first floor air conditioner produces a differential temperature of 15.8 degrees F.

The condenser has a 4 ton cooling capacity and was manufactured by Lennox in 2022.

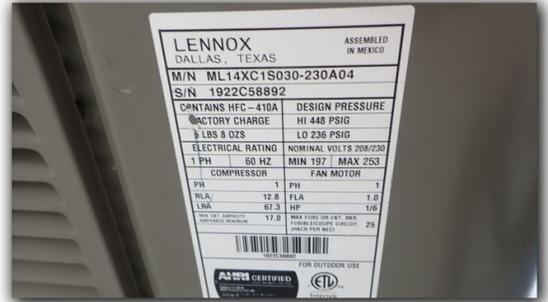
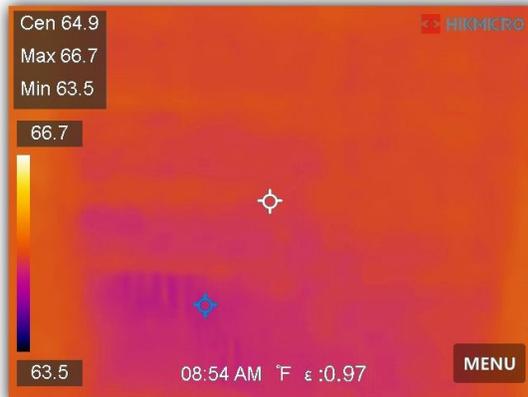
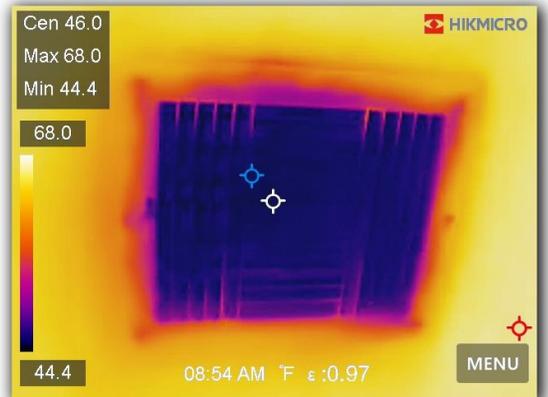
The second floor air conditioner produces a differential temperature of 22 degrees F.

The condenser has a 2.5 ton cooling capacity and was manufactured by Lennox in 2022.

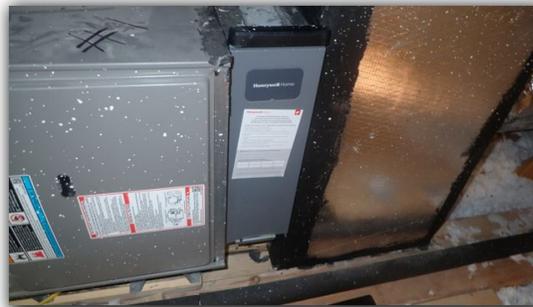
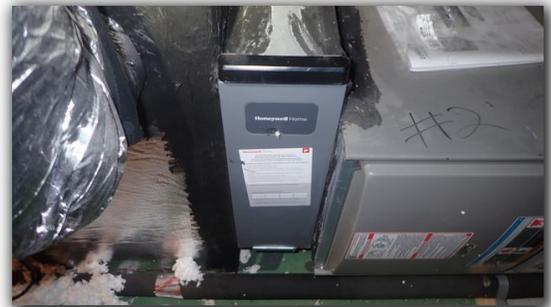
Comments: Media air filter(s) located in attic that requires changing/cleaning every 6 months, recommend checking guide for proper maintenance information.

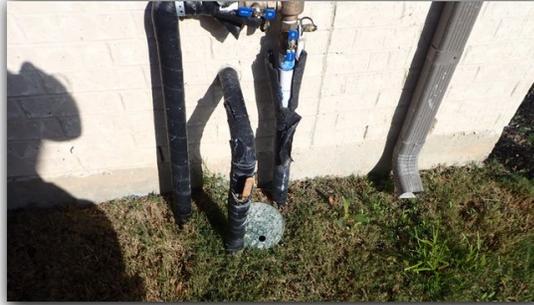
Static water pressure reading: 65 psi

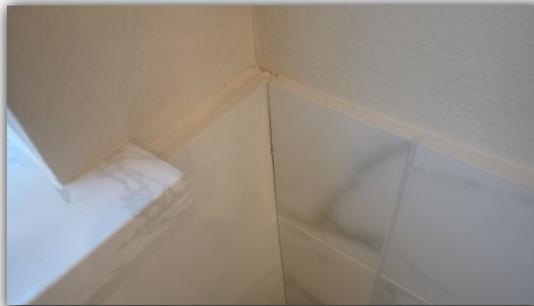
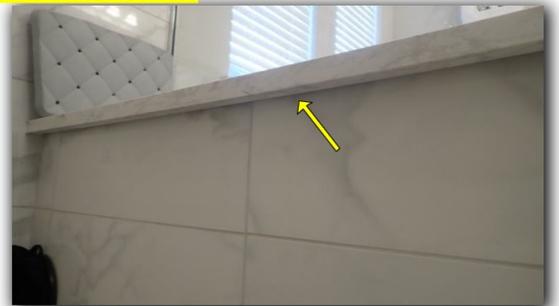
Under Master Shower Seat

Comments: Grout / caulking needed at vertical tile corners, cracks in tile and/or mortar between tiles, and where tile meets tub to prevent water entry behind wall.

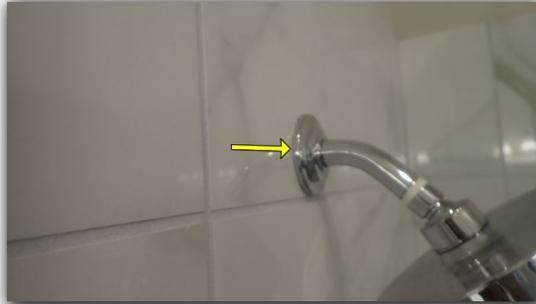
Recommend caulking around all tub/shower faucets and spouts to prevent water entry behind wall.

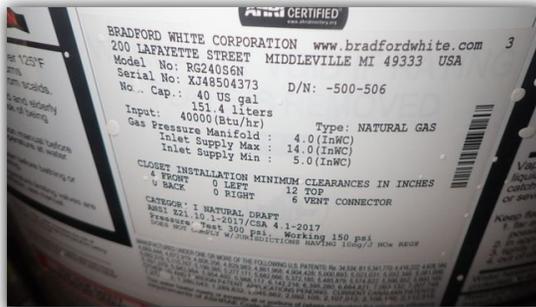
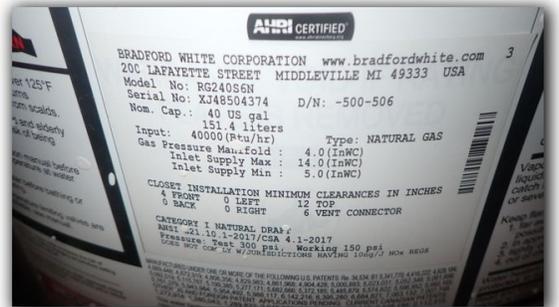
Energy Sources: Natural Gas
Capacity: 80 gallons (2 units at 40 gallons each)
Comments: The water heater data-plates indicate that both units were manufactured in 2021.

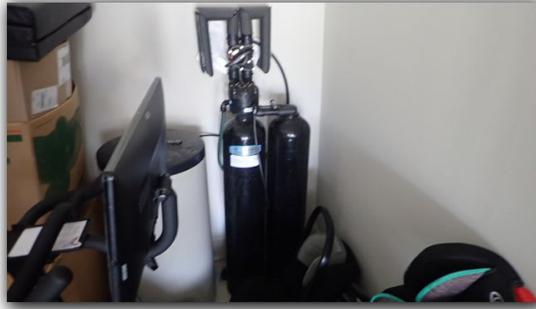
Comments: The water softener/filter systems were not checked. Suggest checking with the sellers to obtain user manual and maintenance schedule.

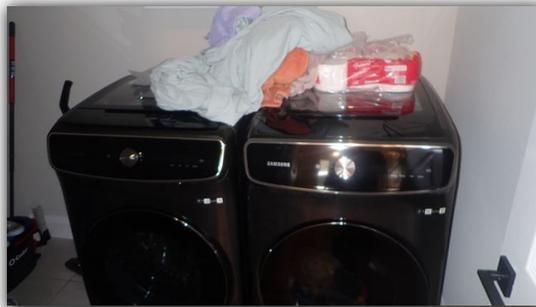
Comments: Interior dryer vent was not inspected due to being connected at the time of inspection.

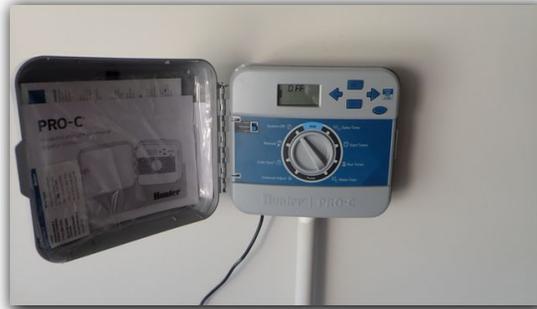
Comments: The sprinkler controller was off at the time of inspection. We turned the controller on for testing and then returned it to off before the inspection was completed.
