## General Summary

### Key Rose Inspections LLC

2005 Doolan Dr  
Conroe TX 77301

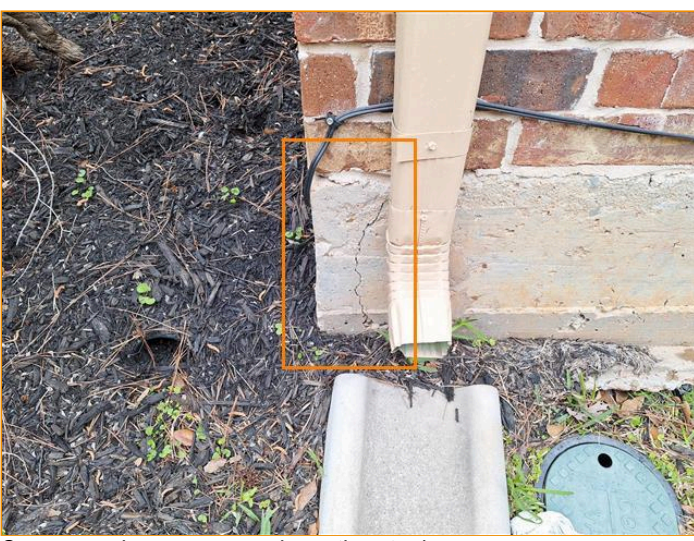
**Overall Performance:** Based on visual observations, the foundation appears to be performing as intended at the time of inspection. Movement and cracks were observed and expected however generally common but depending on the width, location(s) and size could be a determining factor if the home is experiencing foundation issues. Changes in weather, soil conditions, plumbing issues, trees and other factors are consistently affecting the structure of the home throughout its lifetime. Home inspectors take this and many other factors into account when rendering an opinion as to the performance of the structure. The best way to prevent damage to your home and its foundation is to monitor your home and keeping these factors in mind. Future performance of the foundation and/or structure cannot be predicted or warranted.

Corner cracks common and non threatening

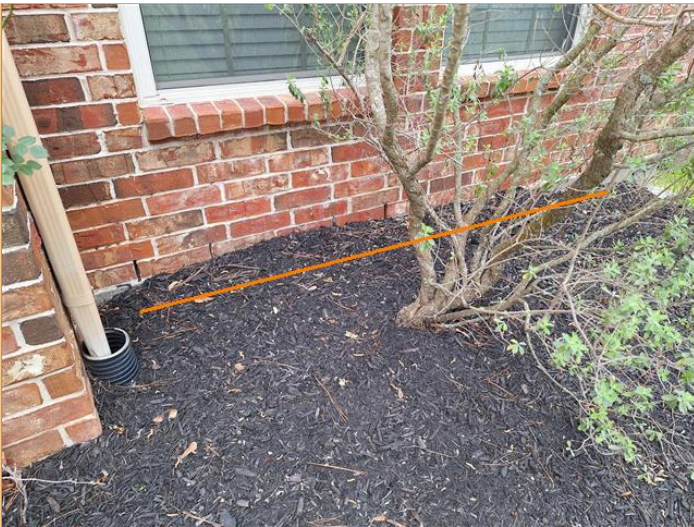
**Overall Condition:** The landscape around the dwelling appeared to be properly sloped away from the structure. Please be sure to keep the area maintained for future performance. Poor drainage and/or high soil around the home can contribute trapped water/moisture, deteriorate materials, negatively affect the foundation and create ideal environments for WDI (Wood Destroying Insects). *This is for your information.*

Recommend exposing foundation

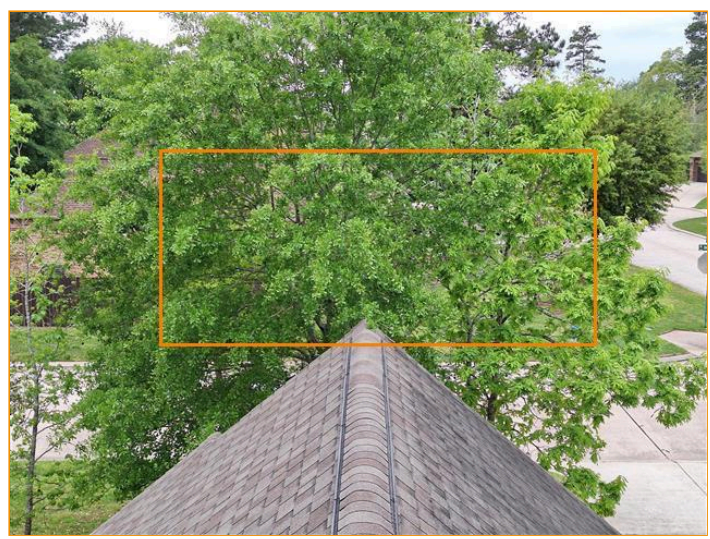
**Overall Performance:** Due to safety concerns (steep slopes), the roof covering or some sections of the roof covering could not be properly walked however accessible and visible sections of the roof covering appeared to be performing as intended at the time of inspection but had areas that need improvement. Unless flat, most, if not all roof coverings are designed to be water shedding and not waterproof. Roof penetrations for ventilation piping, skylights, installation of equipment or any other component are a common source of water leaks as it interrupts the continuity of the roof covering but if installed correctly, should not risk its water shedding capabilities. Future performance cannot be predicted and/or guaranteed.

Recommend cutting back branches

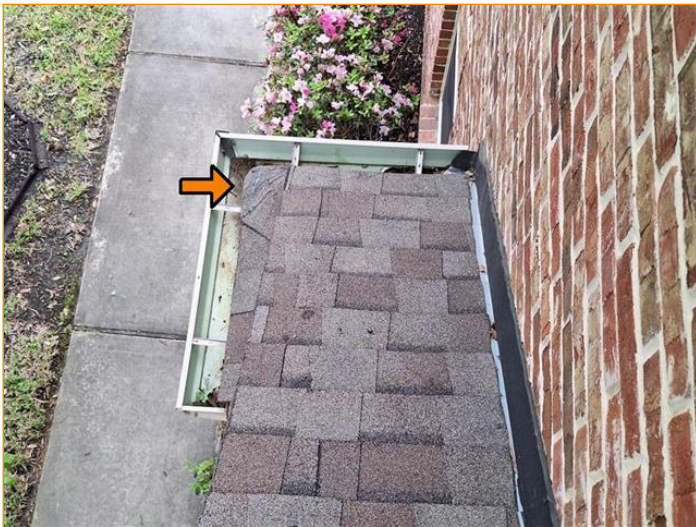
Light damage

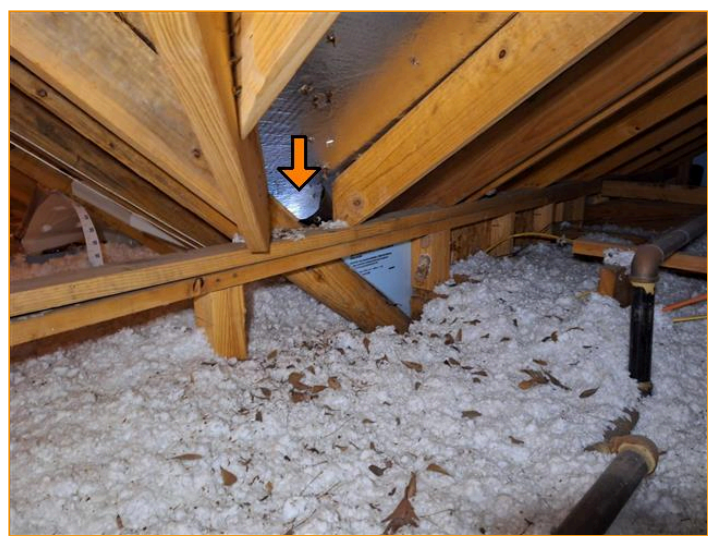
Opening appears to allow debris in

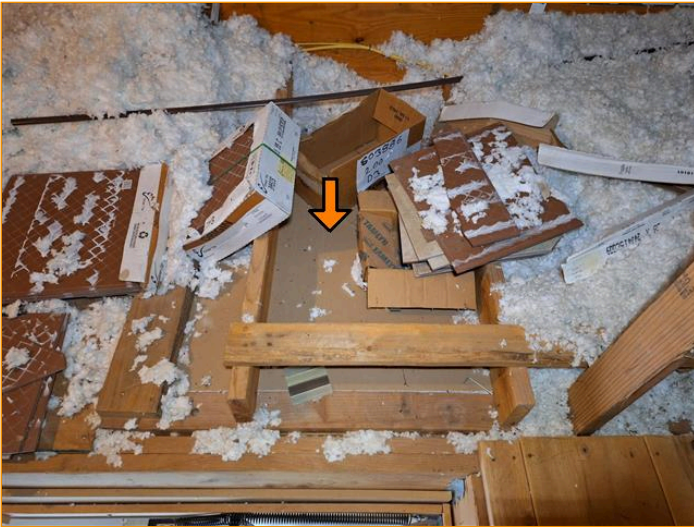
**Overall Synopsis:** The visible attic structure appeared acceptable with improvements recommended in areas. The overall average insulation levels inside the space appeared sufficient for its intended purpose.

Recommend filling in insulation voids

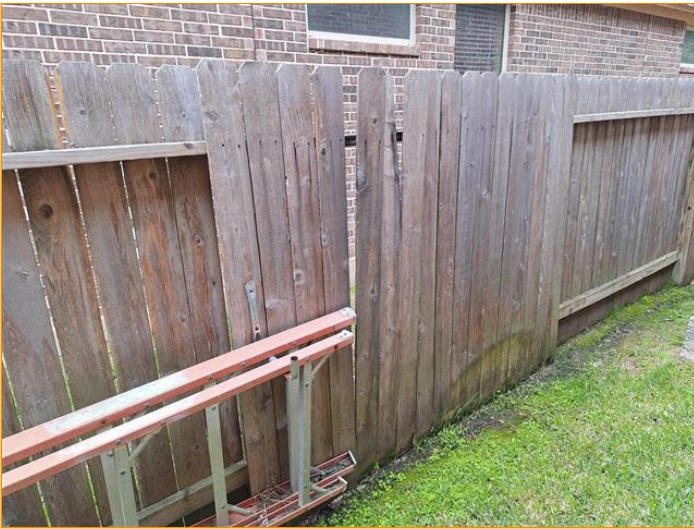
Nothing of significant concern was observed at the fence barrier however some sections appear to be a common or shared element meaning that maintenance, repairs and/or replacement costs are shared amongst neighbors. *This is for your information.*

Normal wear and tear and loose pickets in areas

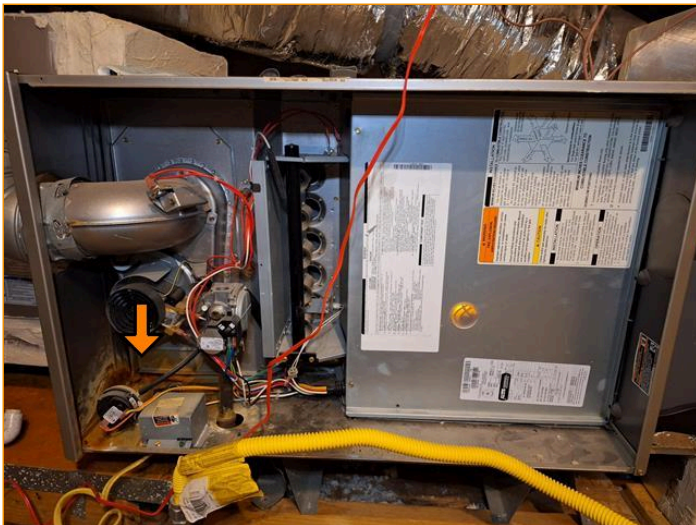
**Overall Performance:** The downstairs heating system worked as intended at the time of inspection however the furnace unit was rusting at the interior and missing a latch component.

Rust area

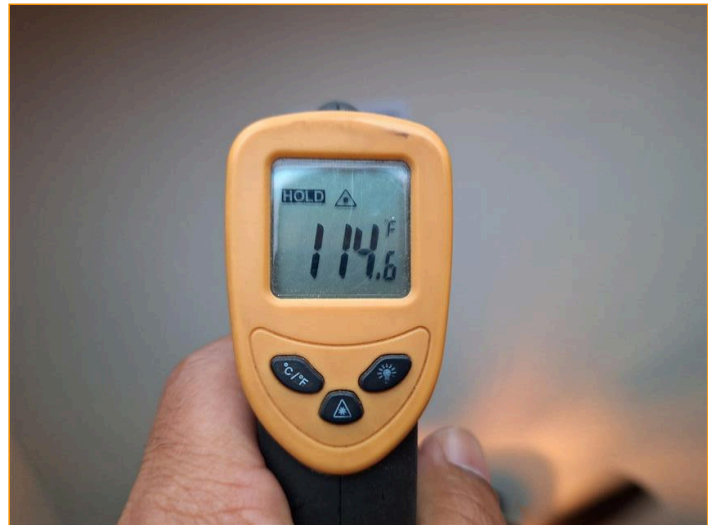
Output temp

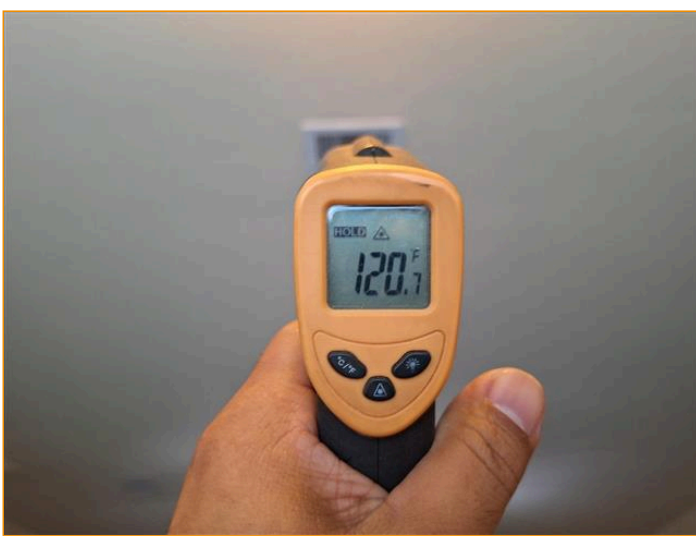
**Overall Performance:** The upstairs heating system worked as intended at the time of inspection. Future performance cannot be guaranteed or warranted.

Output temp

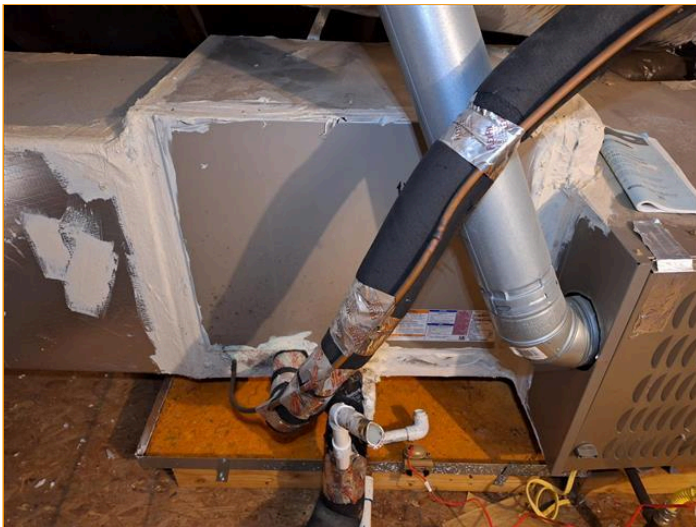
**Overall Performance:** The downstairs cooling system worked as intended at the time of inspection however the evaporator unit had organic growth which is typically common given the conditions and environment however can be regularly cleaned and maintained to prevent additional growth and spread.

Evaporator

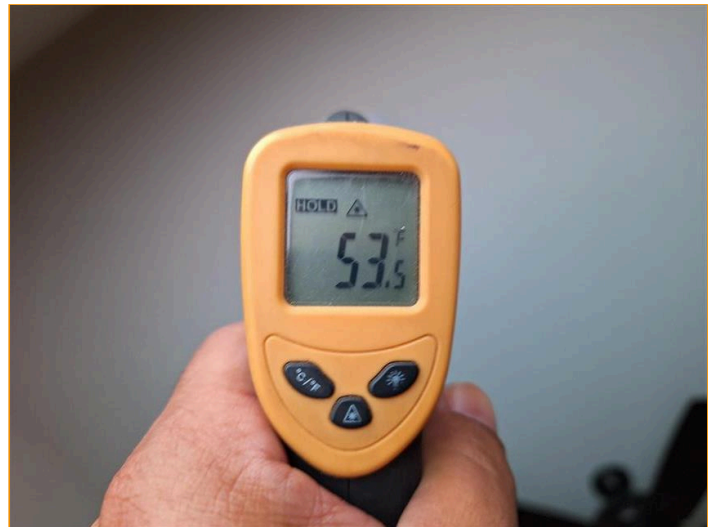
Output temp

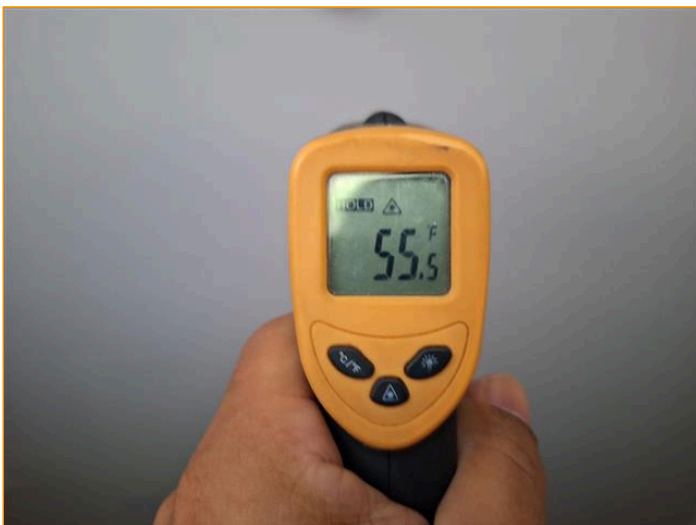
**Overall Performance:** The upstairs cooling system worked as intended at the time of inspection. Future performance cannot be guaranteed or warranted.

Output temp

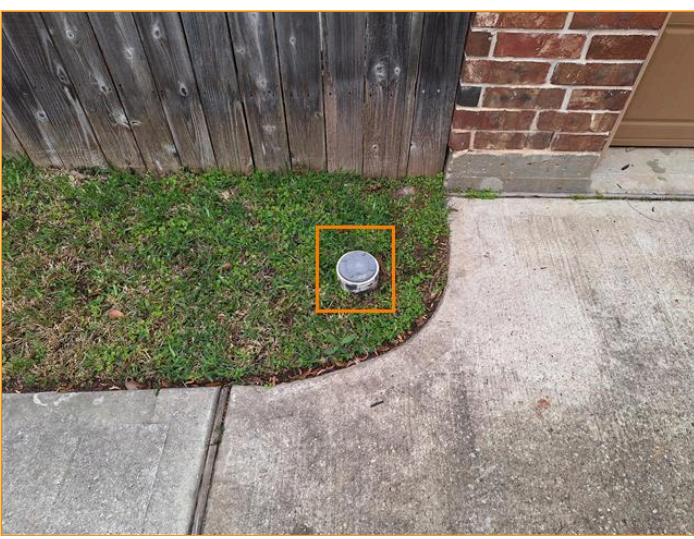
**Overall Performance:** The drainage system appeared to be performing as intended. Future performance cannot be predicted, guaranteed or warranted. The main clean out is a pipe or pipe(s) with a cap that provides access to the main line so that blockages can be removed. This underground lateral line connects your home to the main public sewer system.

Main clean out

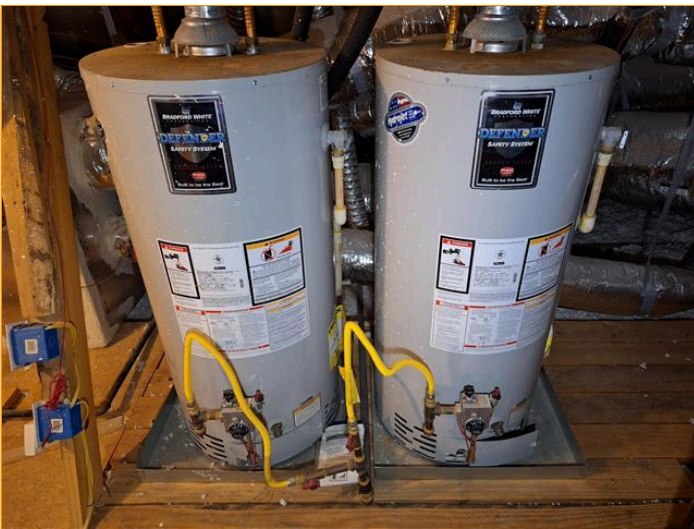
**Overall Synopsis:** The water heaters produced hot water at the time of inspection.

Water heaters

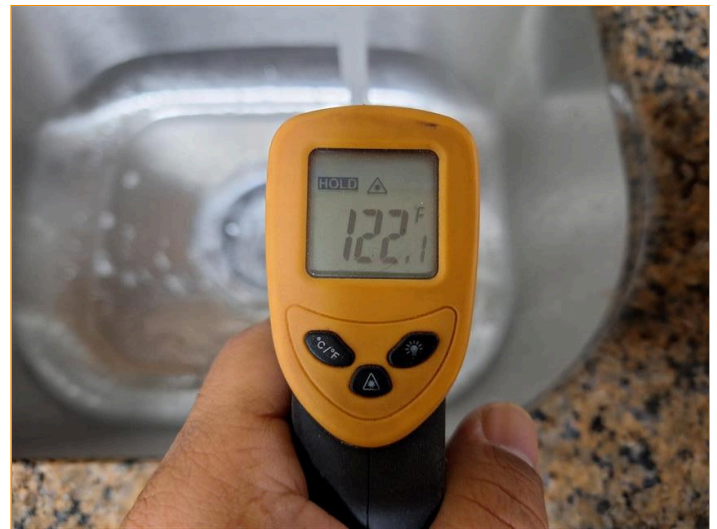
Output temp

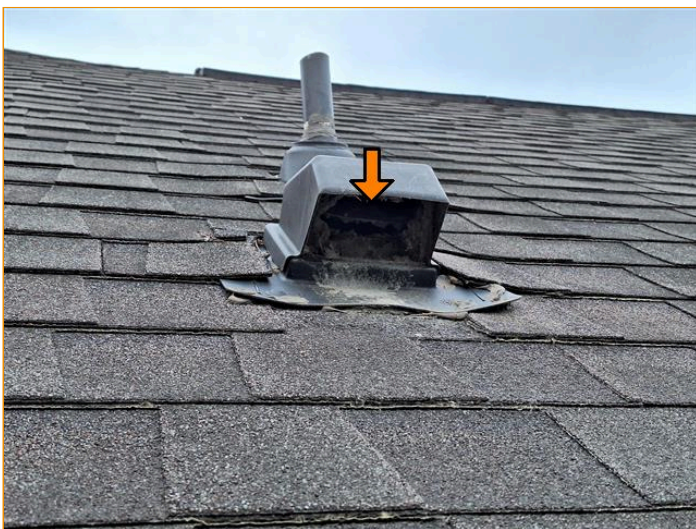
The dryer exhaust system had lint build up that should be cleaned. These systems should be cleaned periodically for optimal and safe use. Congested lint trapped within the pipe, can be a fire hazard if left unchecked. *This is for your information.*
