THREE 17 INSPECTIONS

# PROPERTY INSPECTION REPORT FORM

Walter Parlange <i>Name of Client</i>	08/21/2023 10:30 am <i>Date of Inspection</i>
22876 Delta Dr, Porter, TX 77365 <i>Address of Inspected Property</i>	
Aaron Prager <i>Name of Inspector</i>	TREC License #24240 <i>TREC License #</i>
<i>Name of Sponsor (if applicable)</i>	<i>TREC License #</i>

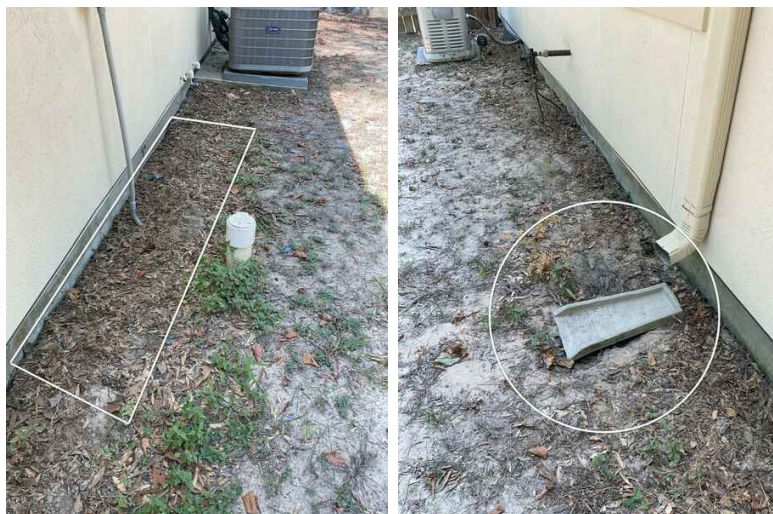
North Exterior

**1: Surface Grading – Ponding Near Foundation**

Some low areas were observed next to the foundation where water ponding can occur. Anytime water can gather near the foundation, it can potentially compromise the integrity of the structure. Inside corners are particularly vulnerable to structural settlement from water ponding near the foundation. While no indications of major foundation or structural problems were observed in these areas during the inspection, I do recommend grading improvements (adding top soil) so the land slopes way from the house and possibly installing a gutter system in these locations to avoid future problems. The ground should slope down 6 inches over the first 10 feet.

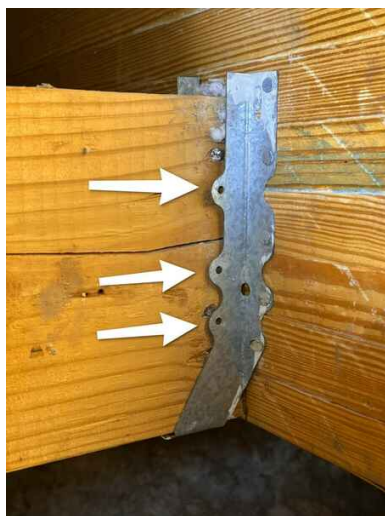
Example #1

**1: Structural – Joist Hanger: Improper Installation**

Joist Hangers should be completely nailed to the framing member. No holes should be unfilled. This can reduce the hanger's ability to retain a rigid connection as the house settles. Recommend further evaluation and correction by a qualified contractor.

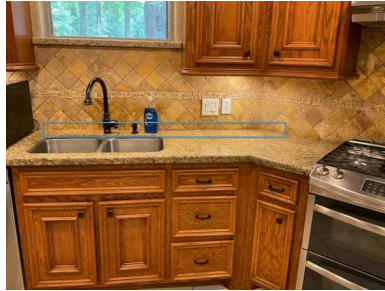
#1

The sealant between the counter top and the wall was missing/deteriorated in some places. I recommend removing any old/deteriorated sealant and applying new elastomeric sealant to prevent water entry into the wall cavity. This is a standard home maintenance item.

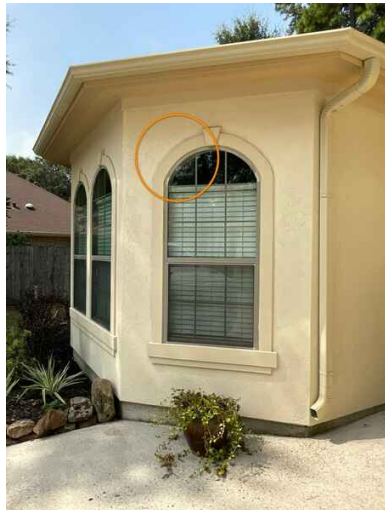
#1

**3: EIFS — Minor Crack**

Minor cracks were observed in the EIFS wall, likely due to settling of the structure. I recommend these cracks be sealed or repaired to prevent moisture entry.

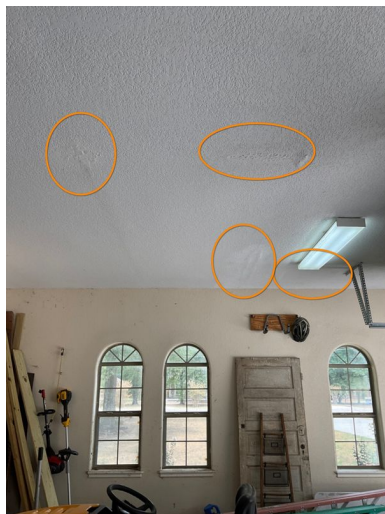
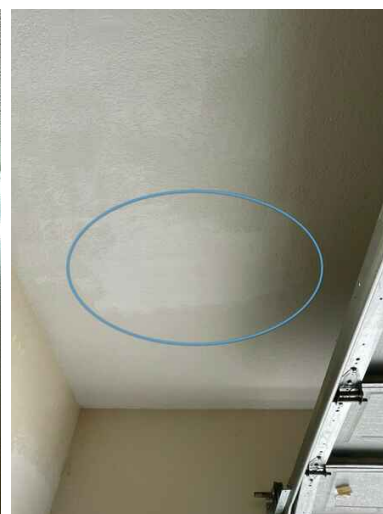
Evidence of drywall repair/patching was observed. I recommend inquiring with the sellers as to the reason for this repair and any documentation of work performed.

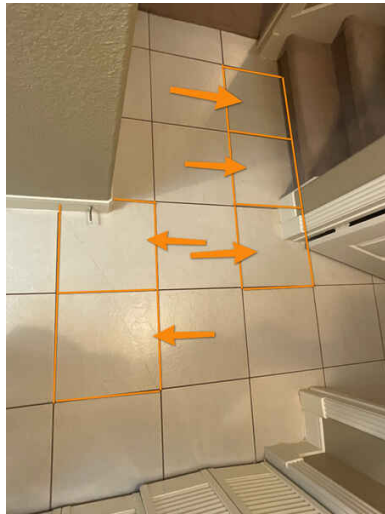
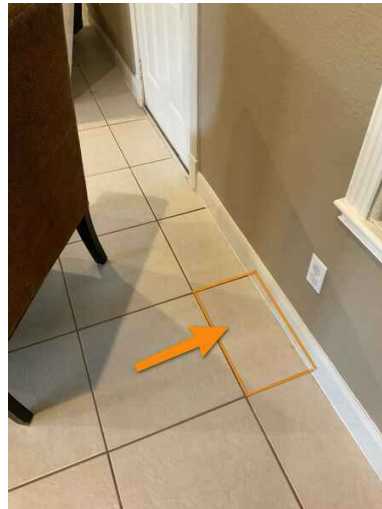
**2: Floor – Tile: Cracked**

Some cracked tiles were observed. You should ask the seller if spare tiles are available as matching replacements. Recommend repair.

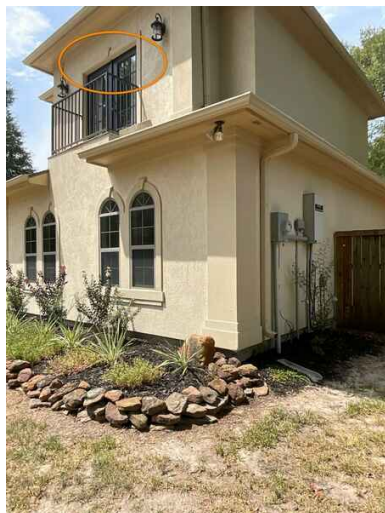
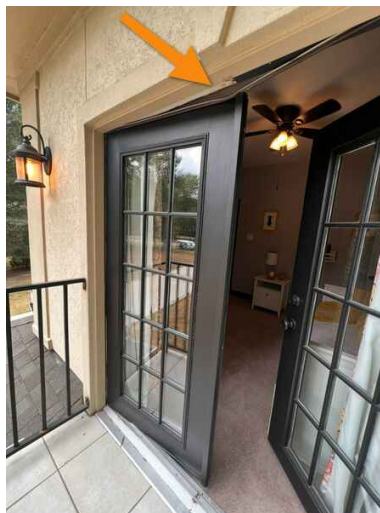
Upstairs Balcony

**1: Exterior Door – Weatherstripping: Damaged**

One of the exterior doors had damaged weatherstripping. Weatherstripping should be improved to improve energy efficiency.

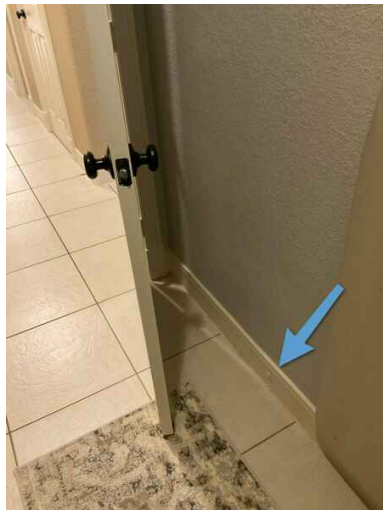
Example

### 6: Missing Doorstops

Some of the doors in the home were missing doorstops. This condition may result in wall damage. Recommend doorstops be installed to protect the wall.

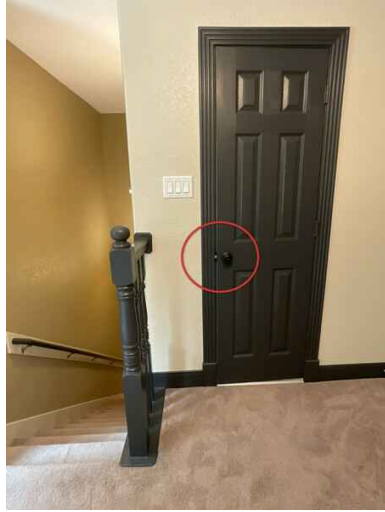
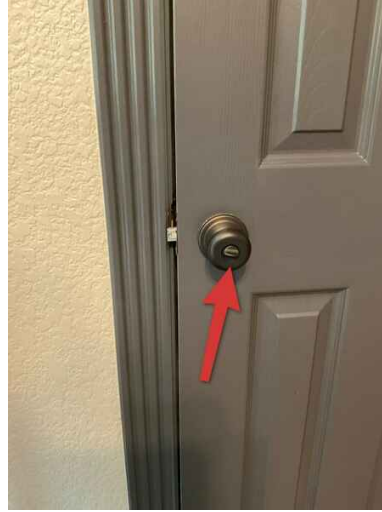
Outside

### 7: Entrapment Hazard

The attic access door has a lock that can be operated from the outside, but no means to unlock from the attic side. This can be an entrapment hazard. Recommend correction.

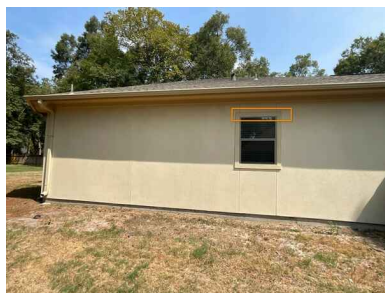
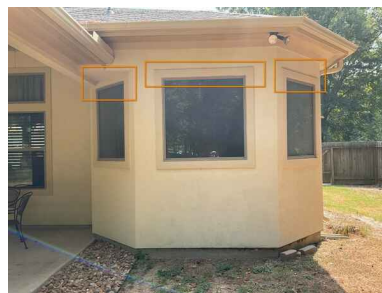
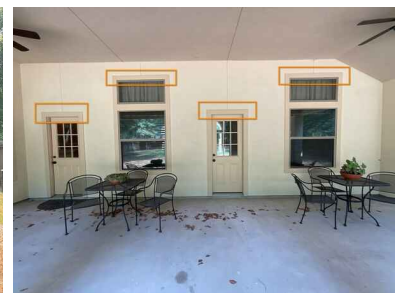
Various

**1: Cap Flashing Not Installed**

Exterior windows did not appear to have cap flashing properly installed at the top edge to help prevent water intrusion into the wall structure. Further evaluation and correction is recommended by a qualified professional.

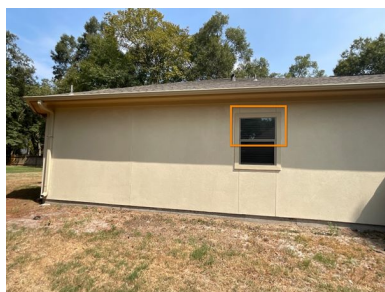
South Exterior

**2: Failed Seal – Stains**

Staining (a metallic sheen or oil-like substance) was observed between the panes on this double pane window, which indicates a loss of thermal integrity (i.e. a failed seal). I recommend further evaluation with a qualified window contractor.

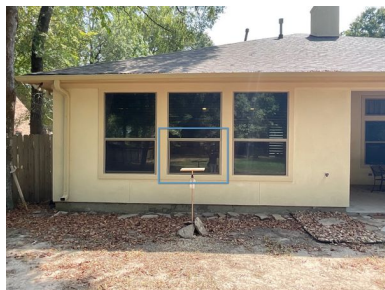
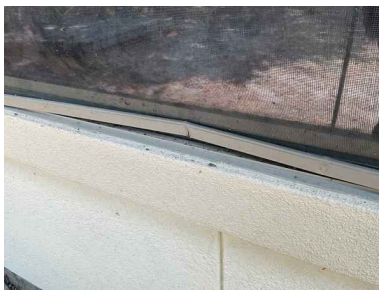
West Exterior

**3: Window Screens – Damaged**

Some of the window screens were damaged. Recommend repair or replacement.

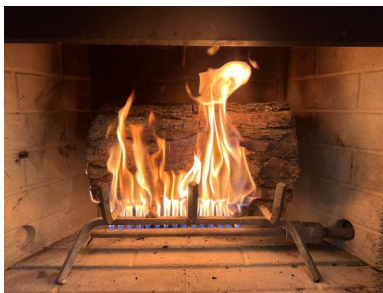
I operated the fireplace and found it to be performing as intended.

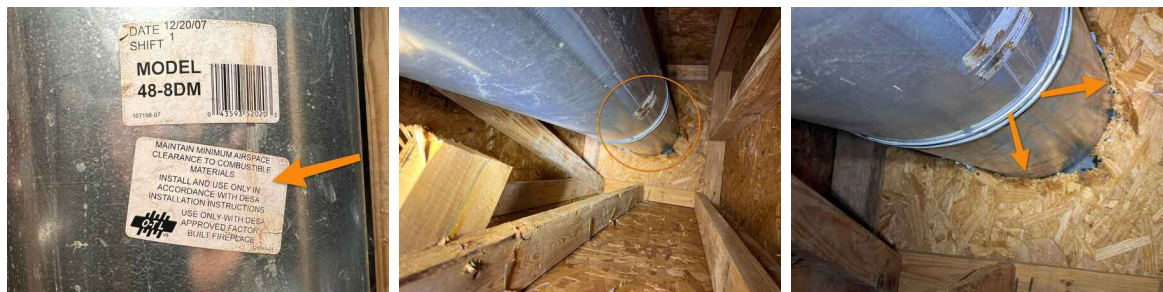
(Detail)

The flue pipe for the chimney appeared to have inadequate clearance to combustibles. Recommend correction as a safety precaution.

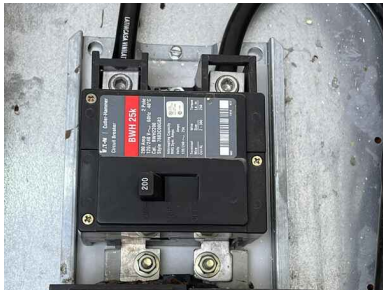
200 amp main breaker

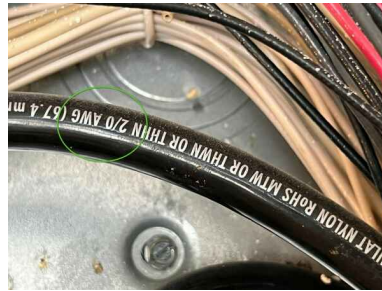
2/0 AWG Copper Service Entrance Conductors

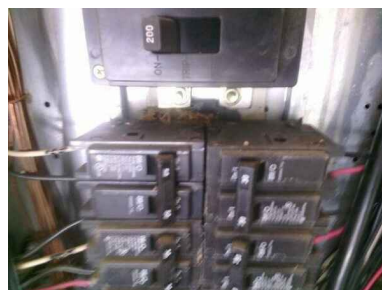
(Detail)

**1: Breaker — Elevated Temperature**

One of the breakers was had a slightly elevated temperature at the time of the inspection. This may be due to loose connections. Recommend further evaluation and correction if necessary by a licensed electrician.

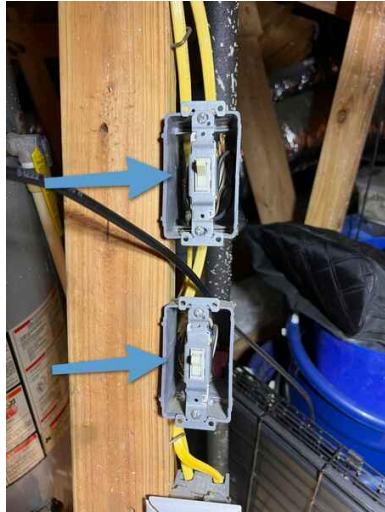
Attic

**1: Lights — Cover Plate Missing at Switch**

Some of the light switches were missing cover plates. This condition left energized electrical components exposed to touch, a shock/electrocution hazard. All switches should have cover plates installed.

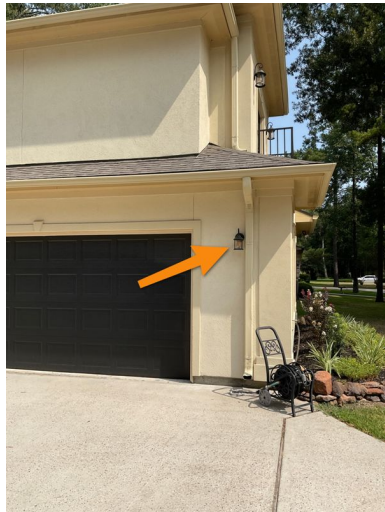
East Exterior

**2: Lights — Loose Fixture**

Some of the light fixtures were improperly or incompletely installed and loose at the time of inspection. Recommend improvement.

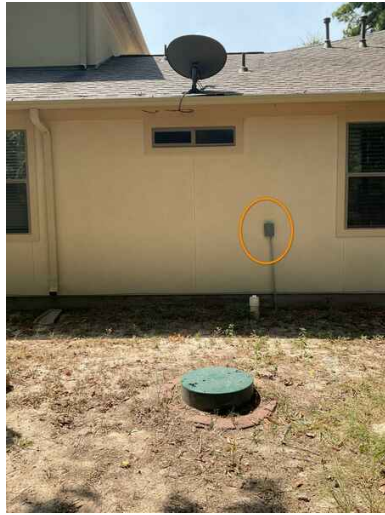
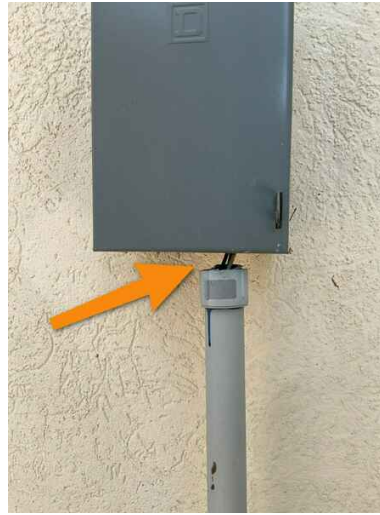
**3: Conduit Disconnected**

The electrical conduit was disconnected from an electrical subpanel. This can subject the wires to unnecessary stress and can lead to electrical failure of the component. Recommend correction.

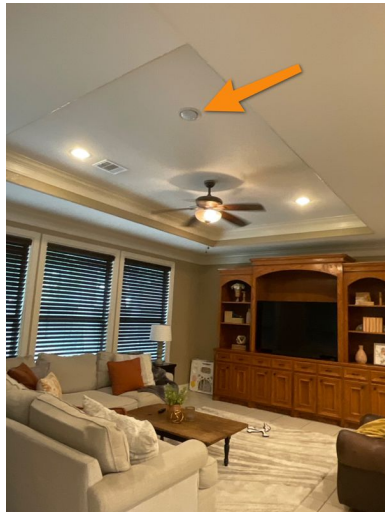
Family Room

#### 4: Lights — Flickering

One of the lights was flickering on and off at the time of the inspection indicating a faulty bulb or faulty electrical connections. Recommend further evaluation and repair if necessary by a licensed electrician.

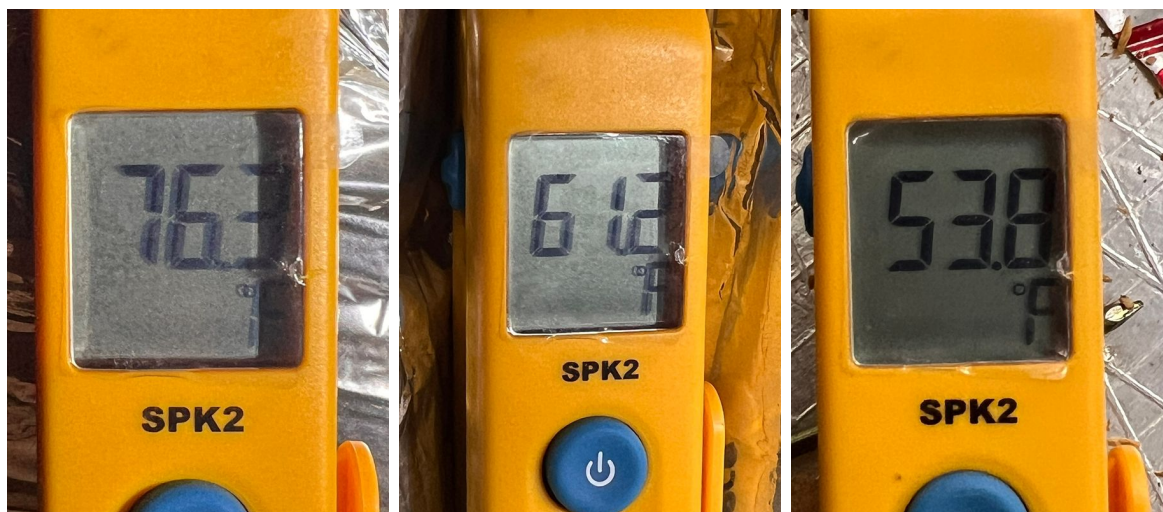
Zone 2 (Carrier) Temperature at Supply: 53.8°F

**Zone 2 (Carrier) Difference: 19.2°F**

The air-conditioning system operated, but the air temperature differential produced by the system was less than the minimum 17°–22°F that should be present in cool mode (across the coil). This HVAC unit is not performing as intended. I recommend further evaluation and service by a qualified HVAC technician.

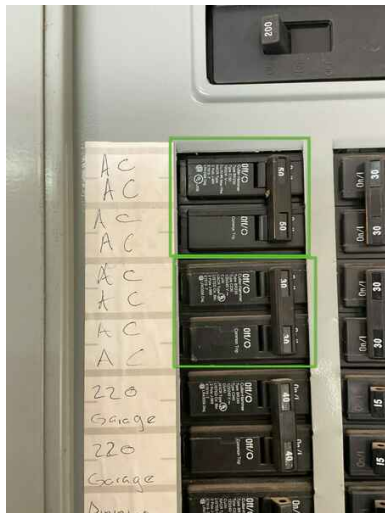
50 & 30 amp breakers

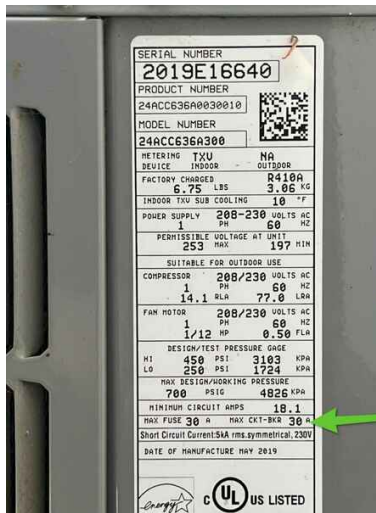
30 amp max breaker

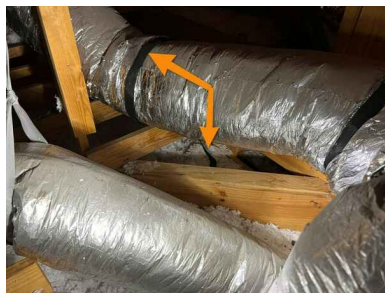
#1

The support straps that support the ducts was disconnected in one or more areas of the attic. These straps help minimize sagging which can lead to loss of airflow. Recommend re-securing these straps by a licensed HVAC technician.

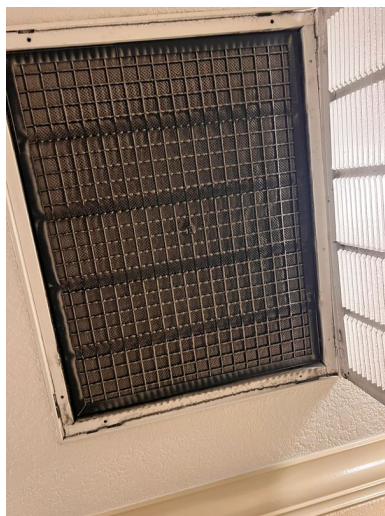
The disposable filter is clogged and is dirty. The filter needs to be replaced. A dirty filter can greatly affect the performance of the HVAC system. As part of routine home maintenance, the filter should be replaced every 2 to 3 months, or according to manufacturer's recommendations.

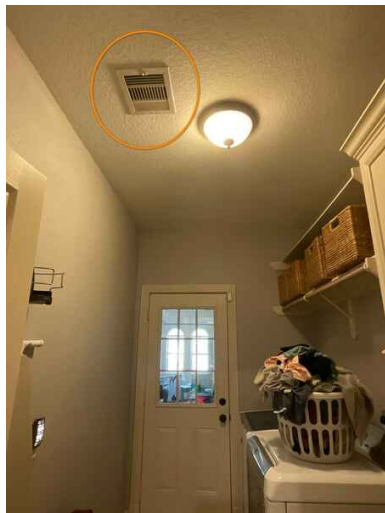
Laundry Room

### 3: Register — Inadequate Response

One of the registers in the house showed little or no signs of airflow. This could be a possible obstruction in the duct or a disconnected duct somewhere in the system. Recommend further evaluation and repair by a qualified HVAC technician.

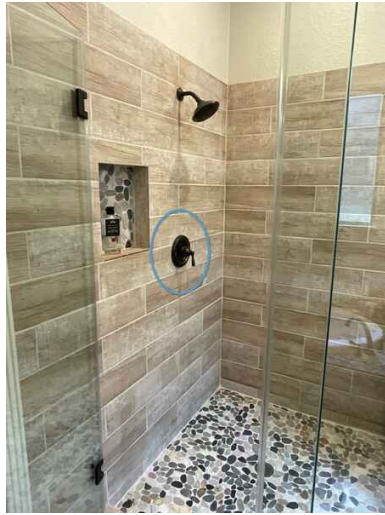
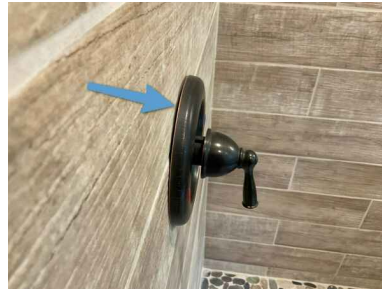
(Detail)

The tub spout was not sealed completely up against the shower wall and a gap was observed, which could allow water to enter the wall cavity. Recommend resealing this gap.

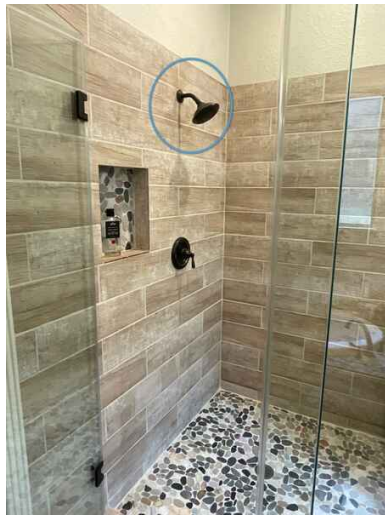
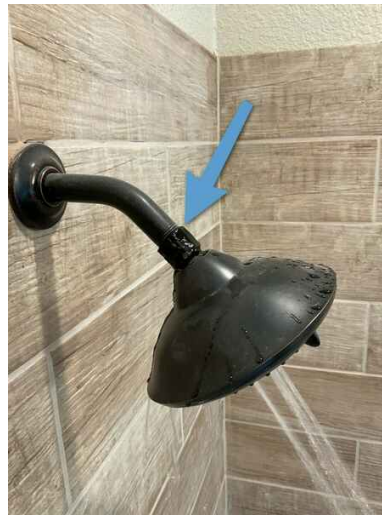
Master Bathroom

### 2: Shower — Leaking Showerhead

The showerhead connection leaked when the shower was operated.

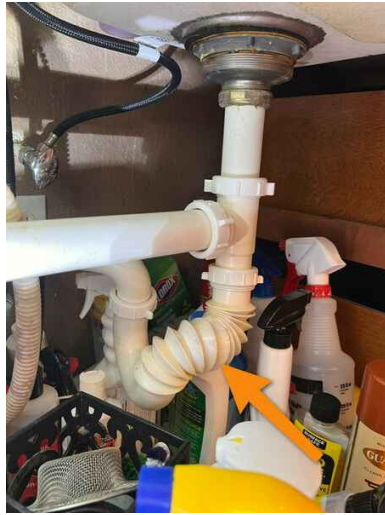
Kitchen

Drainage pipes must have a smooth interior waterway of the same diameter as the piping served. Drainage fittings can not have ledges, shoulders or reductions which can retard or obstruct drainage flow in the piping. Recommend correction by a licensed plumber.

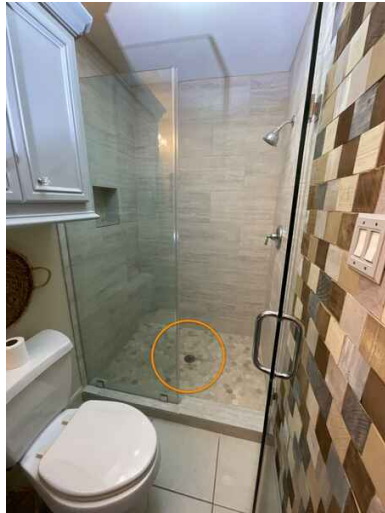
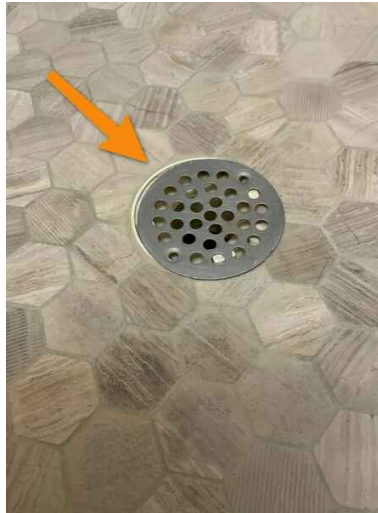
(Detail)

The drain cover is loose at the time of the inspection. This can allow for items to drop behind the cover and into the drain. Additionally, this can be a trip hazard. Recommend correction.

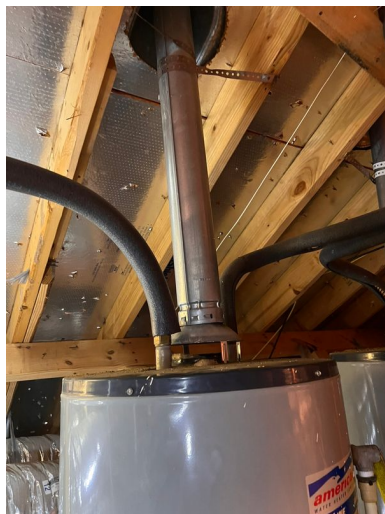
At this water heater, the draft diverter, vent, and exhaust flue designed to exhaust the invisible, odorless, tasteless, toxic products of combustion to the home exterior was disconnected. This condition will allow toxic exhaust gasses to enter the living space. Recommend correction.

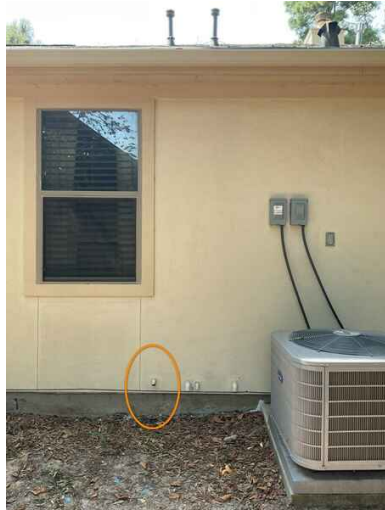
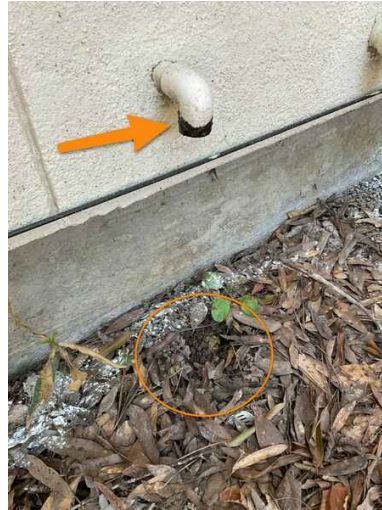
North Exterior

The Temperature & Pressure Relief (TPR) valve was leaking at the time of the inspection. Because the TPR valve is an important safety component it should be replaced by a qualified HVAC technician or plumbing contractor.

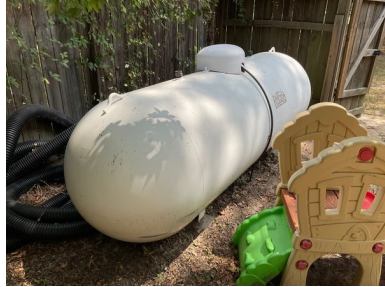
**1: Bonding Not Observed**

Proper bonding was not observed or confirmed during the inspection. Gas pipes should be bonded to the electrical grounding system. I recommend further evaluation and correction of bonding as needed by a licensed electrician.

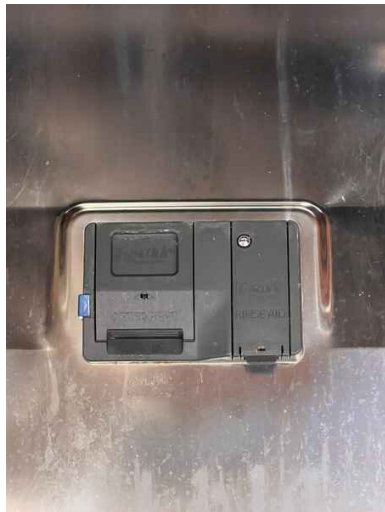
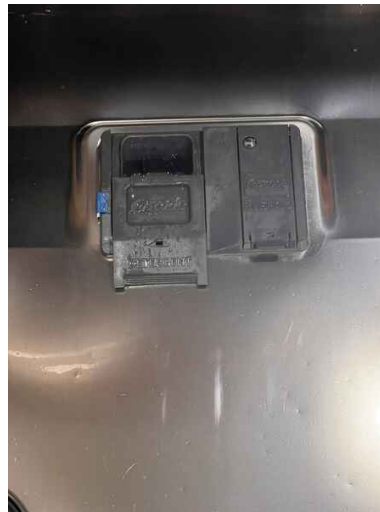
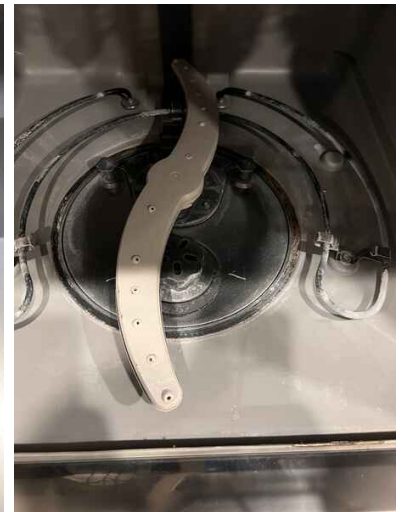
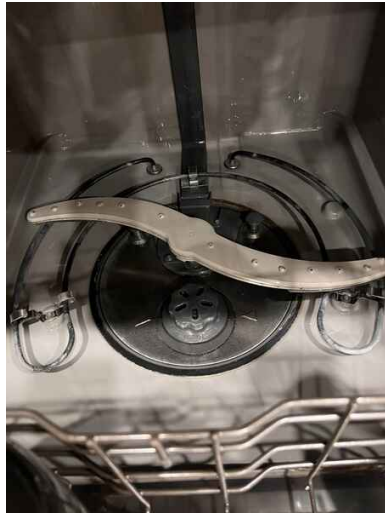
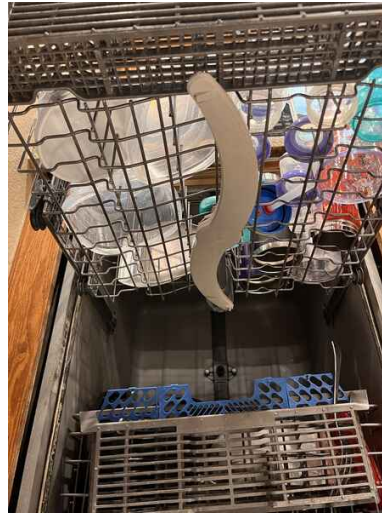
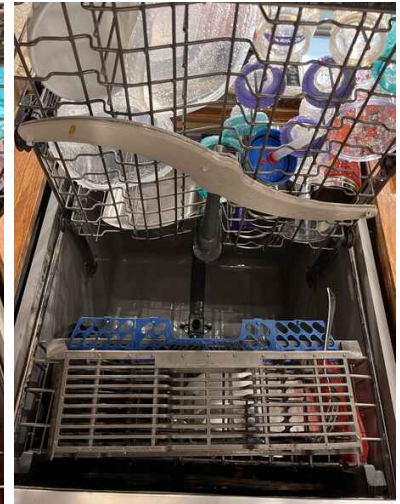
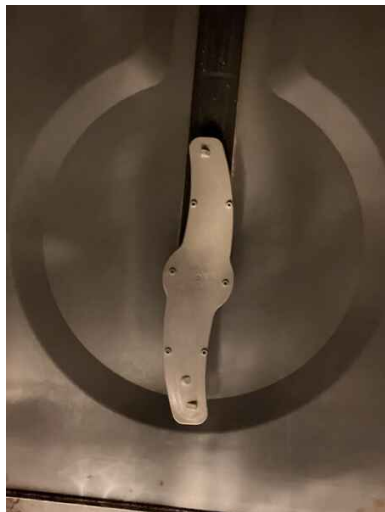
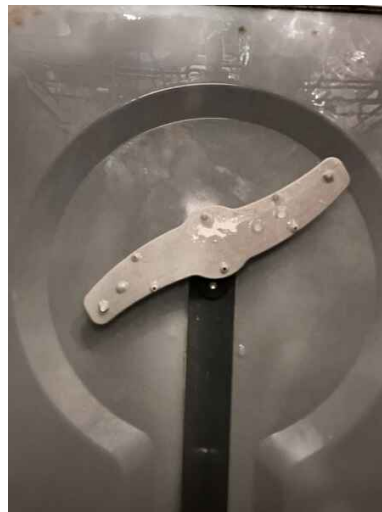
The position of the soap tray and all spray arm positions were documented before and after wash cycle to determine if they move during operation.

I operated the dishwasher on a Normal or One-Hour cycle and it was found to be performing as intended.

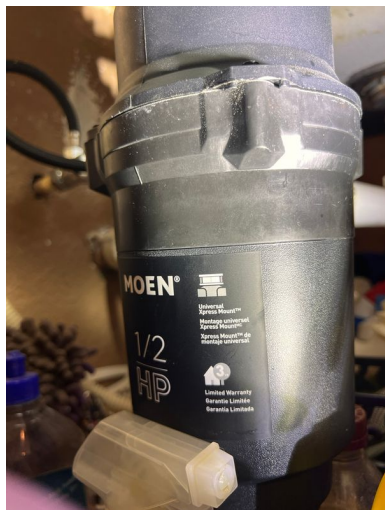
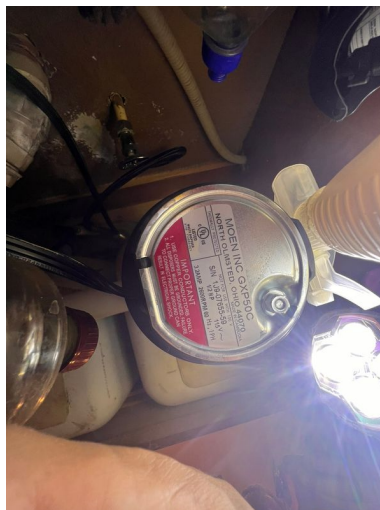
I operated the food waste disposer and found it to be performing as intended at the time of inspection.

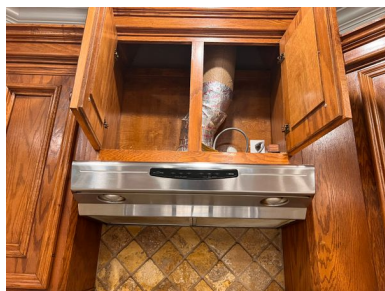
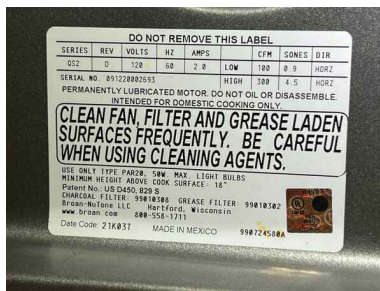
The range hood is properly pulling air into the vent as indicated by smoke pen.

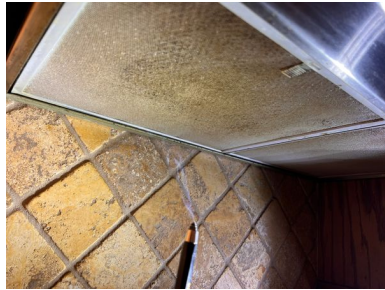
I operated the range hood and found it to be performing as intended.

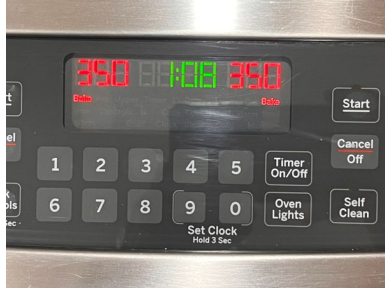
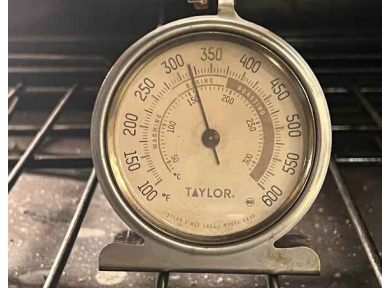
320°F (Upper Oven) – Inadequate

I operated the oven by setting the temperature to 350°F, and again to 450°F. After some time to reach operating temperature, I measured the temperature inside of the oven with a thermometer. The temperature readings on this oven were below the accepted range of +/-25°F, which means this oven runs cooler than the set temperature. I recommend adjusting accordingly when cooking; alternatively, one could consult a repair technician to recalibrate the oven thermostat.

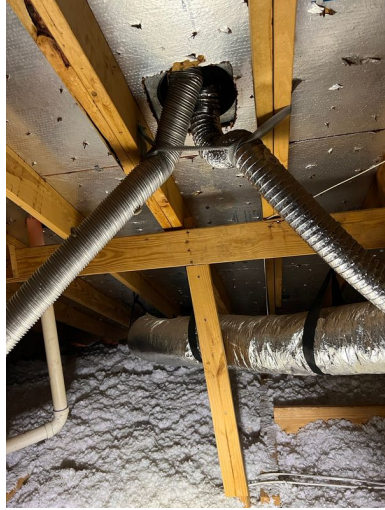
**1: Mechanical — Duct Termination Not Sealed at Roof**

The exhaust vent for one or more of the bathroom exhaust fans was pointed toward a roof vent, but not sealed at the vent. Although this was common practice at the time of construction, modern standards are that all exhaust vents should terminate at the home exterior to help prevent mold growth or damage to home materials.

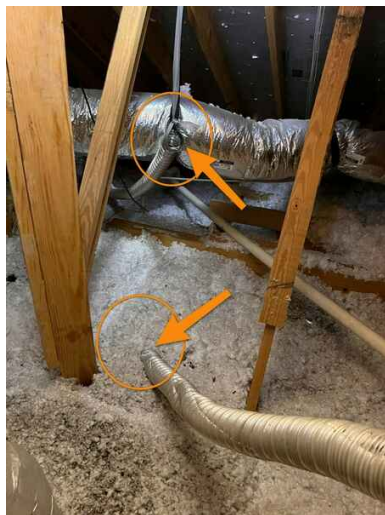
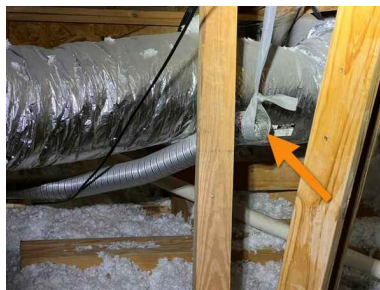
#1

The exhaust vent for one or more of the bathroom exhaust fans was separated from the roof vent and was blowing into the attic. This condition is improper and should be corrected to help prevent mold growth or damage to home materials. Exhaust vents should terminate at the home exterior.

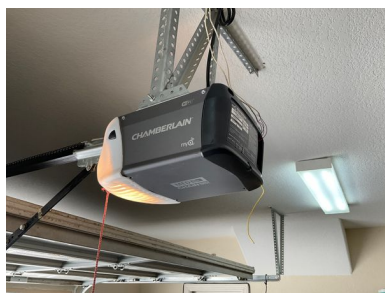
I operated the garage door opener(s) and found them to be performing as intended.
