HOME INSPECTION REPORT

2464 Bering Dr
Houston, TX 77057

PROPERTY INSPECTION REPORT FORM

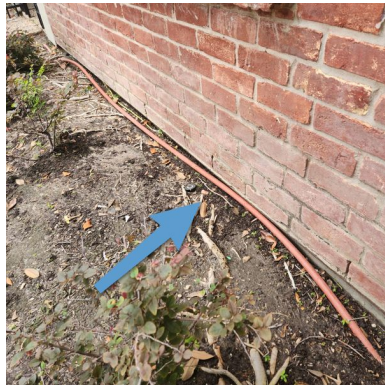
South

High soil obscures the view of the exterior foundation and can provide insect's direct access to the weep holes, or to the bottom of other siding materials. Current building standards require 4 inches of foundation wall visible under brick veneer siding, and 6 inches under other siding types.

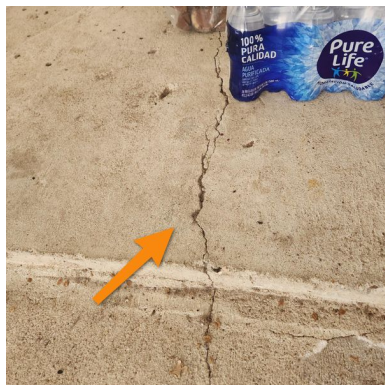
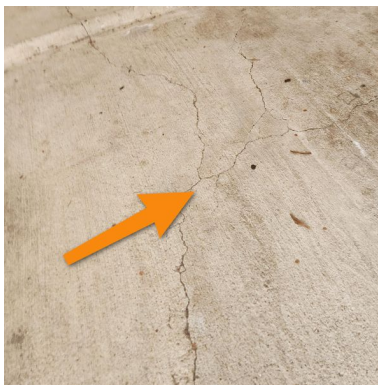
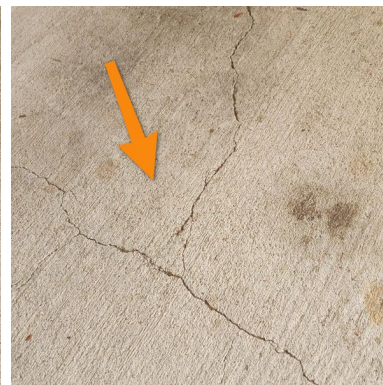
2: Foundation Cracks - Major

Severe cracking noted at the garage. This is typically consistent with soil movement and could lead to serious damage to structural components, foundation and/or slabs. Recommend a structural engineer evaluate and provide a report on course of action and remedy.

Recommendation: Contact a qualified structural engineer.

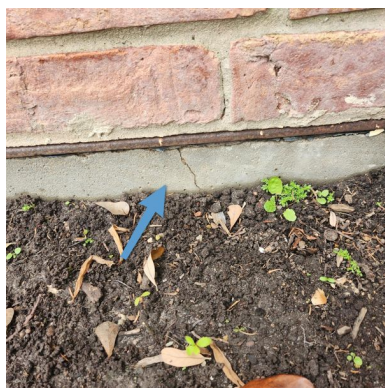
3: Foundation Cracks - Minor

Minor cracking was noted at the foundation. This is common as concrete ages and shrinkage surface cracks are normal. Recommend monitoring for more serious shifting/displacement.

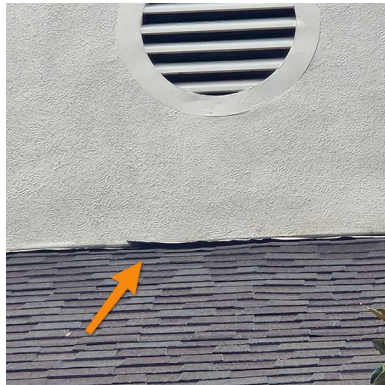
South

Observed a location where flashings have risen up. Wind driven rain water may penetrate the attic area.

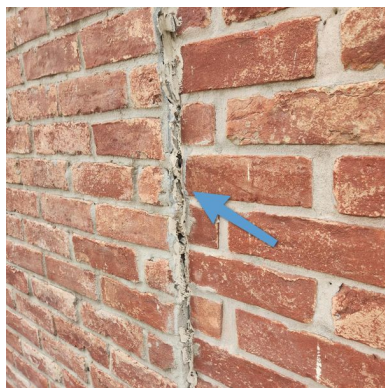
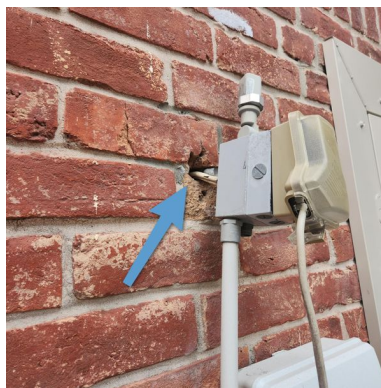
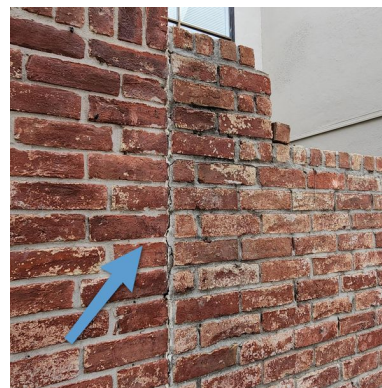
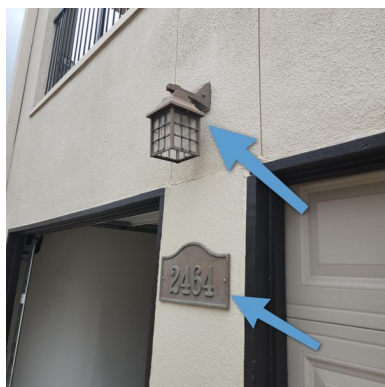
Caulking and sealing is needed around all exterior siding penetrations including, but not limited to: electrical panels, light fixtures, plumbing penetrations, vent terminations, expansion joints, etc. This will prevent water, insect, and/or unconditioned air penetrations.

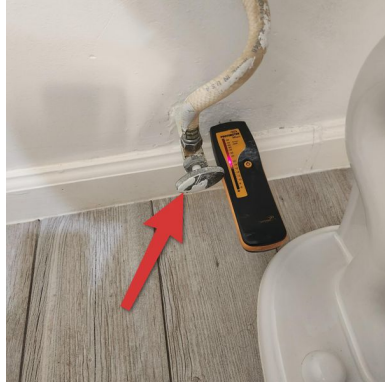
2: Wet area found

Observed what appeared to be a wet area in the wall. Area was verified as wet with a moisture meter.

Recommendation: Contact a qualified professional.

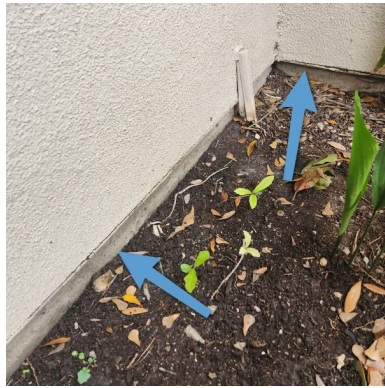
3: Siding damage

Observed damage to the siding.

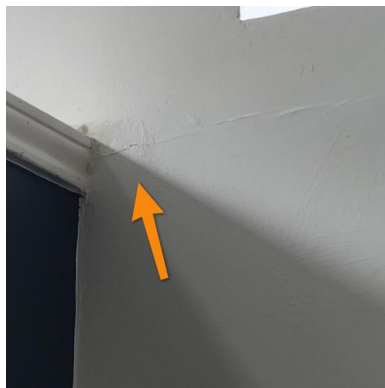
4: Wall damage

Observed holes, cracks, or repaired areas in the sheet rock walls.

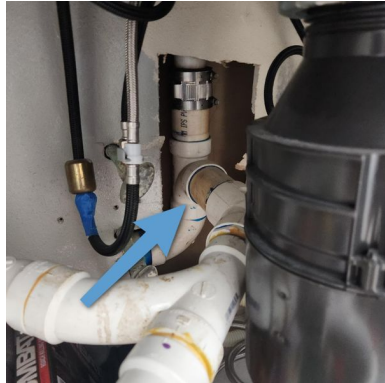
5: Holes beneath sinks

Observed holes in the walls below one or more sinks where plumbing pipes pass that are not properly sealed.

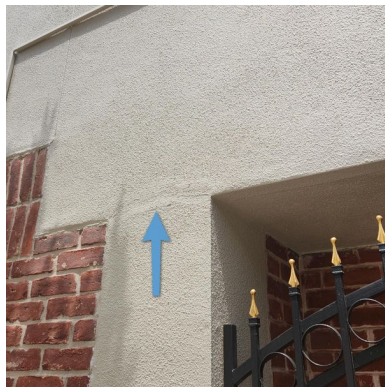
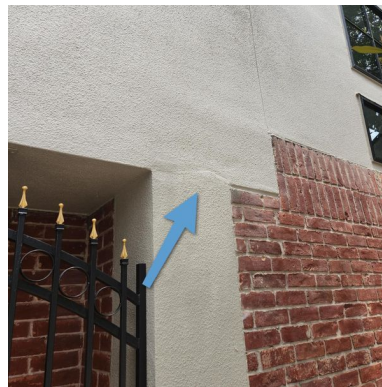
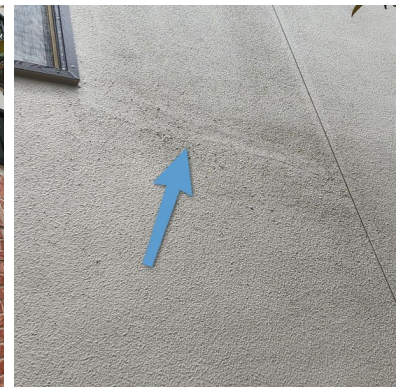
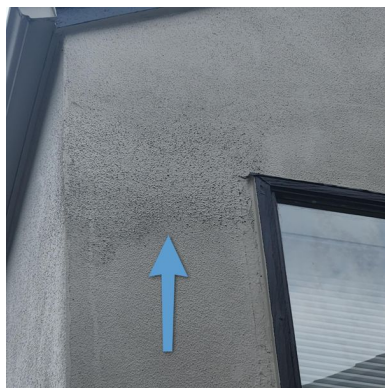
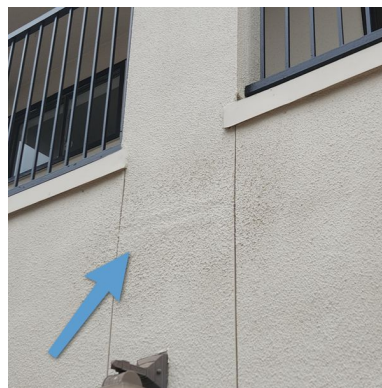
6: Previous repair exterior wall

Observed one or more areas with noticeable previous repairs in the siding.

Recommendation: Contact the seller for more info

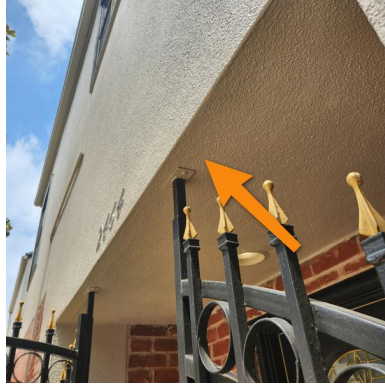
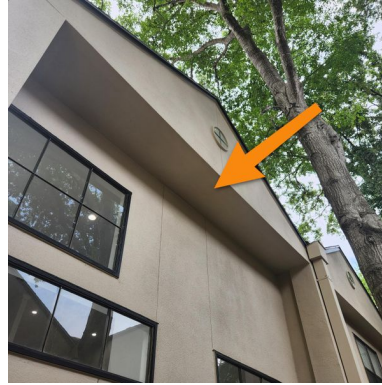
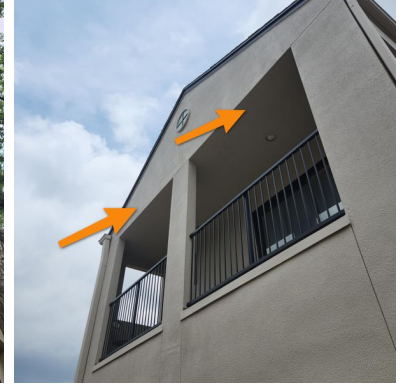
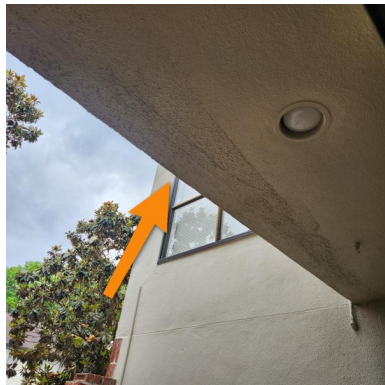
7: Stucco drainage

Observed there was no drainage for the horizontal portions of the stucco. This can lead to moisture being trapped behind the stucco.

Recommendation: Contact a stucco repair contractor

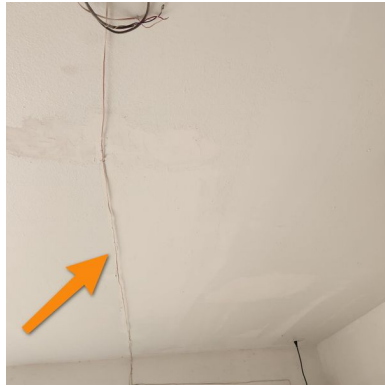
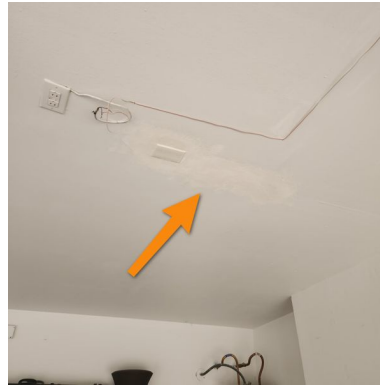
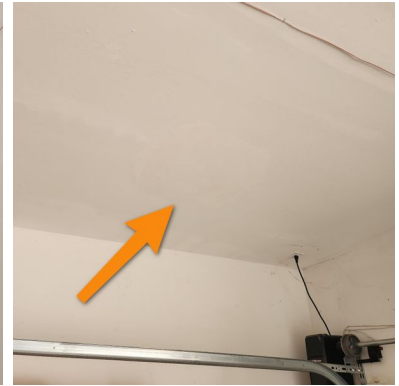
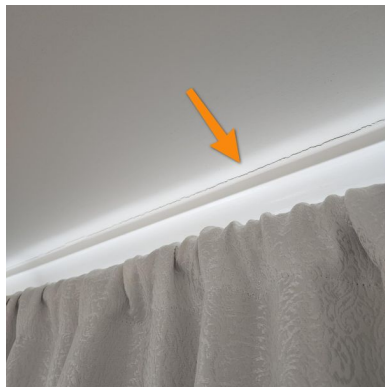
1: Ceiling damage

Observed holes, cracks, or repaired areas in sheet rock ceilings

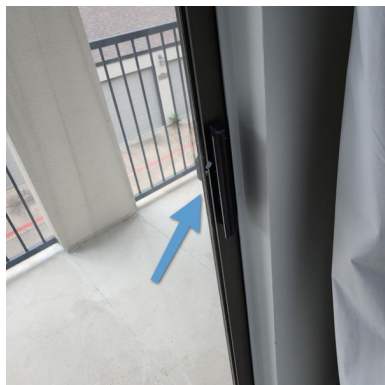
1: Missing/defective hardware

Observed missing, loose, or defective hardware devices on one or more doors.

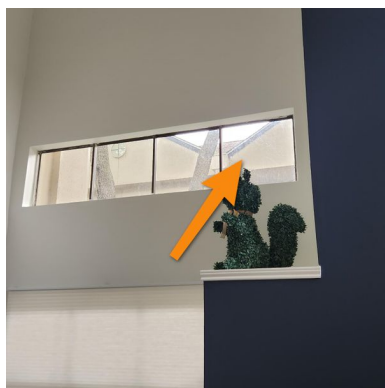
1: Broken glass

Observed at least one window with broken glass.

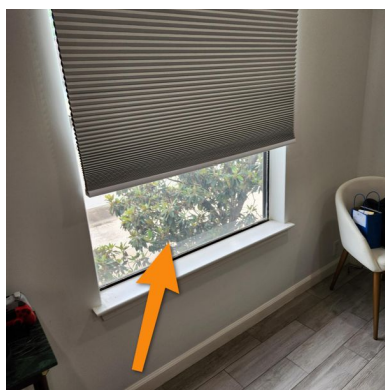
2: Broken spring

Observed at least one window with a broken or damaged spring. The window will not hold itself up safely.

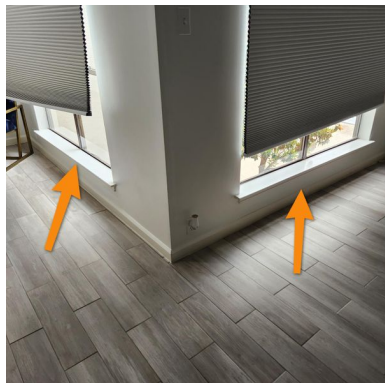
Observed upstairs windows with low sill heights that opened more than 4". This can be a fall hazard for children.

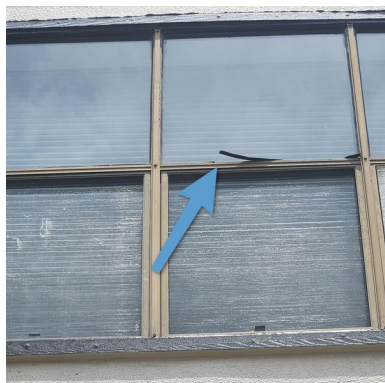
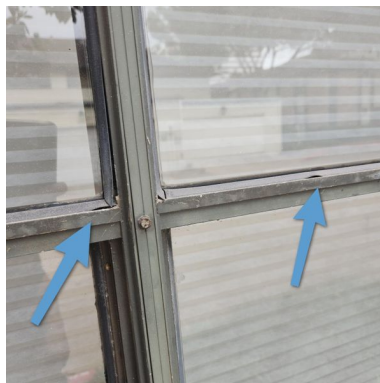
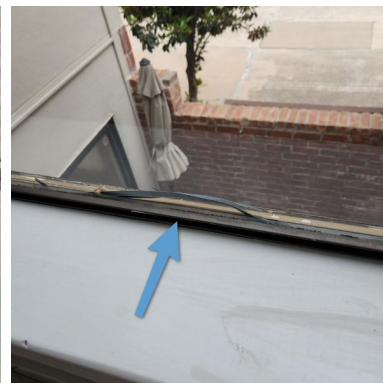
5: Plastic glazing strips damaged

Observed plastic retaining strips that are loose or damaged on the exterior of one or more windows.

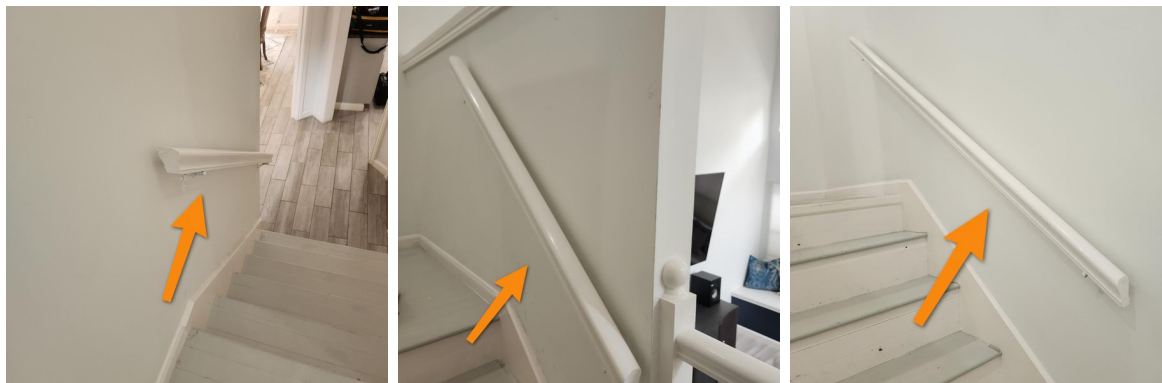
Observed the handrail does not return to the wall at the ends of the handrail as required by current building standards.

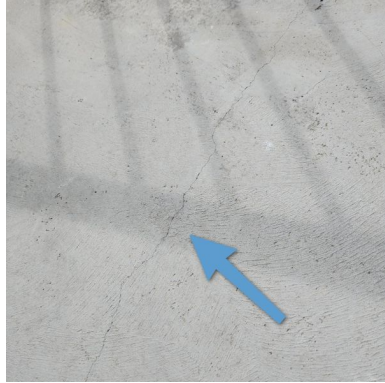
1: Cracked Exterior Floor

Porch, garage or balcony exterior flooring shows signs of cracking. These did not appear to be structurally significant at this time but should be checked periodically for any changes

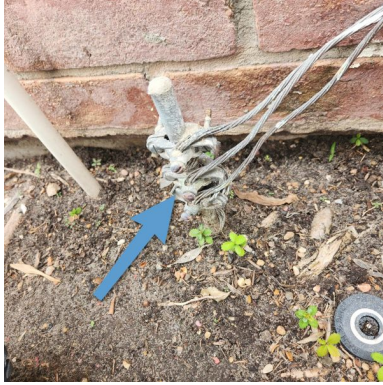
1: Improper ground clamp

Observed the grounding clamp is not the approved "acorn" type.

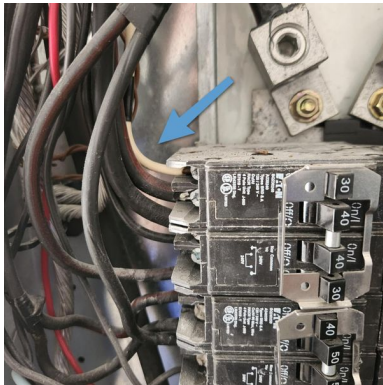
2: White wires

Observed white wires coming off of some of the breakers. Current building standards state the "hot" leads can be any color except white or green so as not to be confused with neutral and ground wires. The wiring should be marked in some manner.

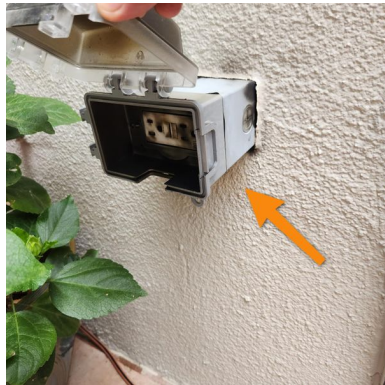
4: Damaged outlet/switch

Observed a damaged outlet/switch in at least one location.

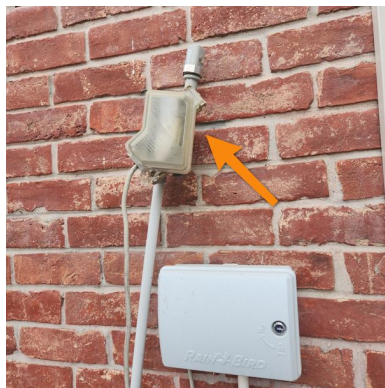
5: Ungrounded outlet

Observed at least one electrical outlet that is not properly grounded.

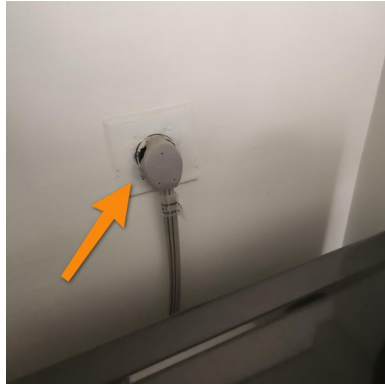
6: Dryer 3-prong

The three prong receptacle installed in the laundry room is an older style outlet. If a newer electric dryer will be used this receptacle should be replaced by a newer four prong outlet.

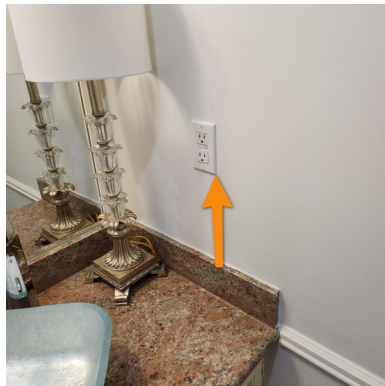
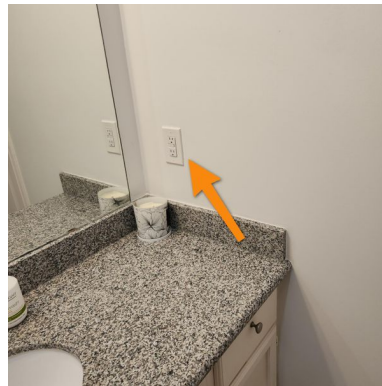
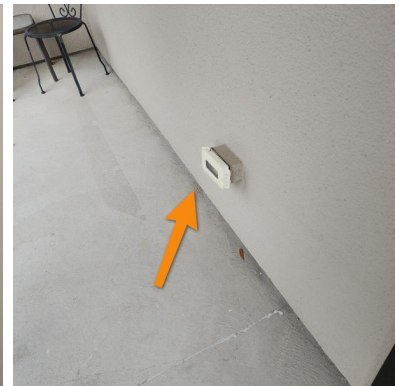
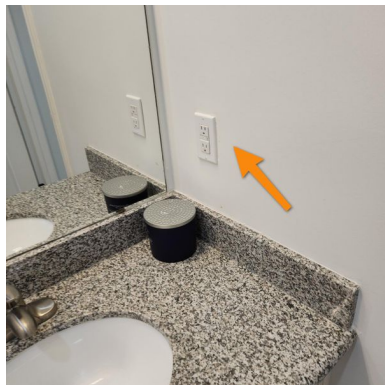
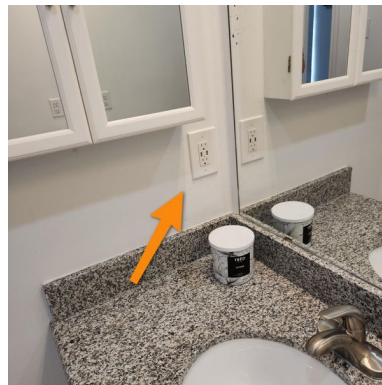
7: No power

Observed at least one outlet with no power.

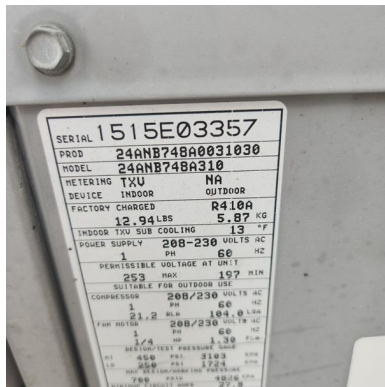
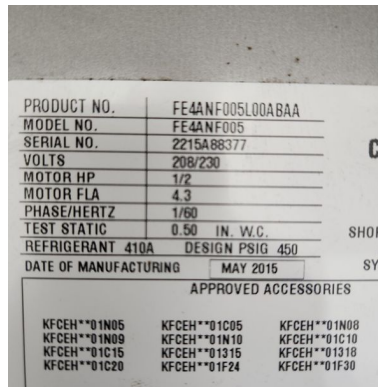
Evaporator Coil

Temperature Differential: 17 degrees.
Normally expected temperature is between 15 and 22 degrees Fahrenheit.
Make: 2015 Carrier

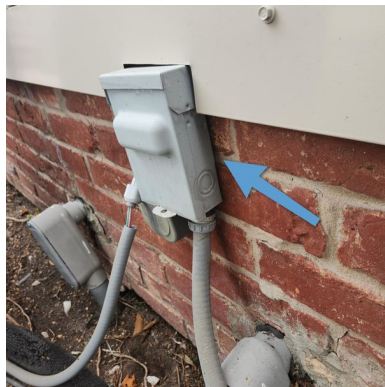
1: Caulk disconnect box

Observed the disconnect box is not properly caulked across the top and down the sides.

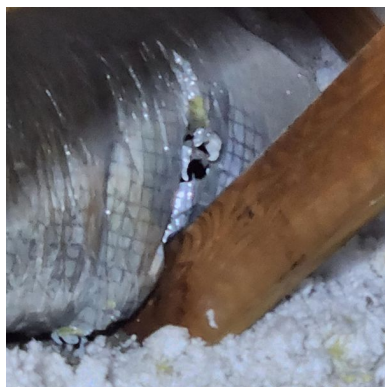
Air supply duct was damaged.

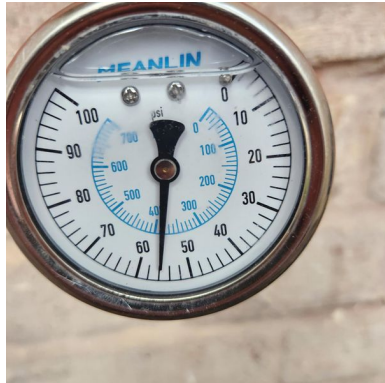
Types of water supply lines: Copper
Static Water Pressure Reading: 56 psi

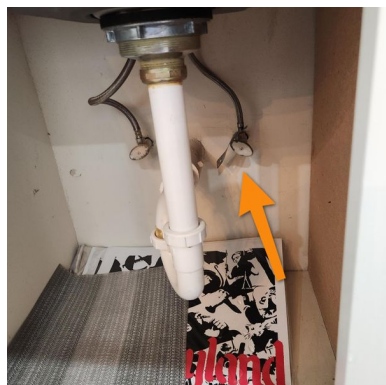
Observed at least one sink leaks under the unit.

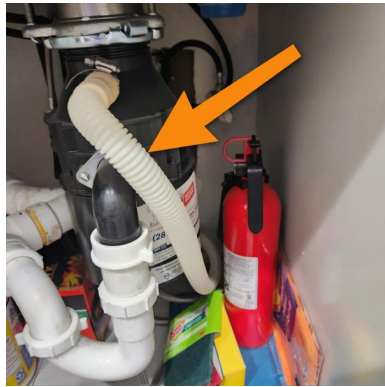
Observed the unit does not have the sink mounted air break or a high loop in the drain line. This can lead to dirty water flowing back to the dishwasher and causing bad odors.

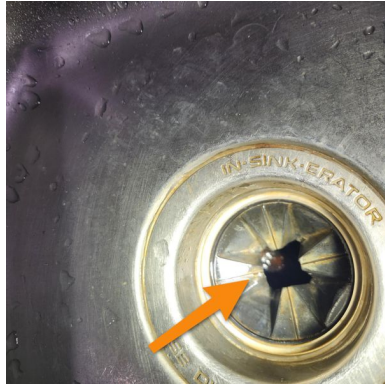
1: Rust

Observed the unit has rust on the face plate inside the drain and can eventually allow water to penetrate to the electrical motor and leak into the cabinet.

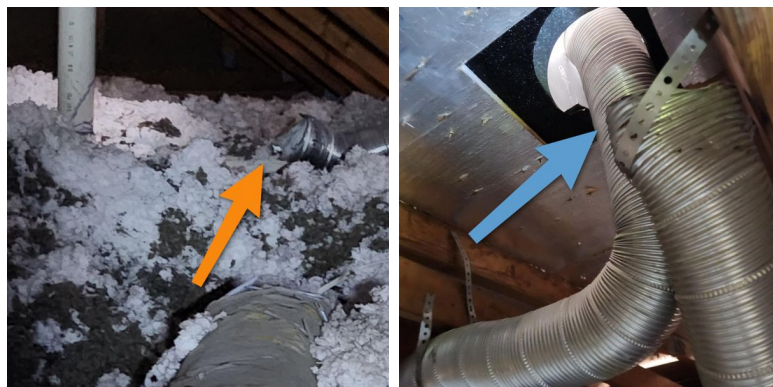
Vents terminate improperly at the soffit or inside attic and should be vented to exterior.

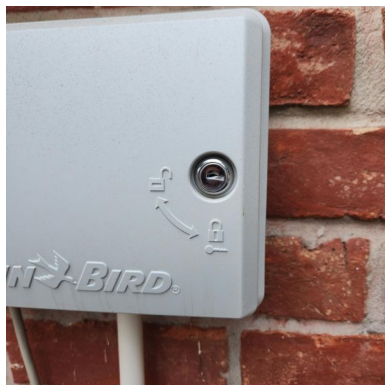
Observed control panel was locked. System was not tested. Inquire if the system is controlled by the HOA.
