## MECHANICAL REPORT

14333 Memorial Dr 75  
Houston, TX 77079

# PROPERTY INSPECTION REPORT FORM

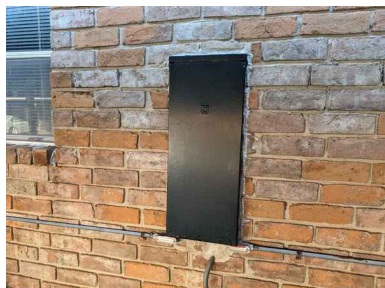
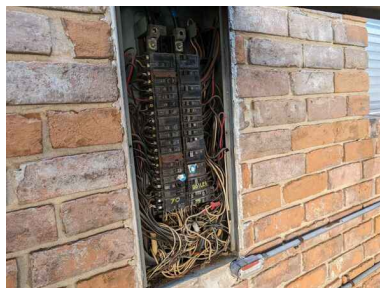
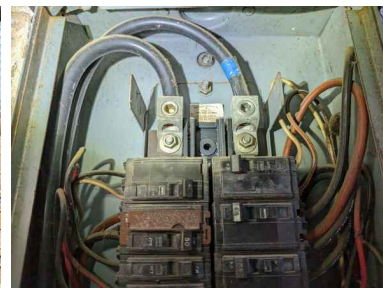
Circuit Breaker Wiring Diagram

The electrical service is provided by a 120/240 volt, single-phase. It is pointed out that the breaker panel includes two houses where each side is for a different house and is under the HOA. No main breaker or electric meter was visible.

<u>Location</u>	<u>Manufacturer</u>	<u>Rating - Amps</u>
Garage behind the house	Square D	Not visible

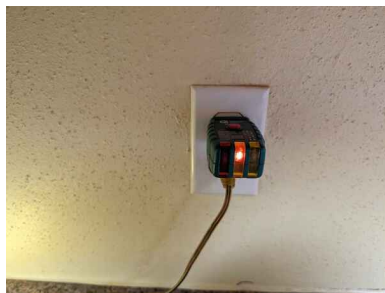
A three prong outlet that was not grounded properly was observed and the outlet needs to be repaired. It is recommended that an electrician be contacted to repair the outlet in an approved manner.

**Obtain Cost Estimate**

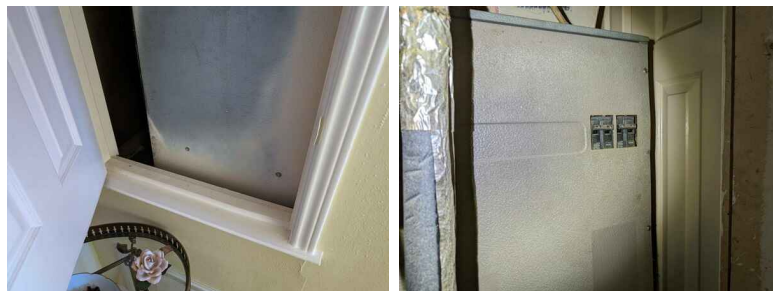
The heating for the property was provided by the following electric heating equipment:

<u>ZONE</u>	<u>BRAND</u>	<u>DATE</u>	<u>LOCATION</u>
House	Goodman	1997	Hallway closet

The electric heating equipment was observed to be operating and functional at the time of the inspection. The electric heating equipment was heating the air 25+ degrees, which is adequate.

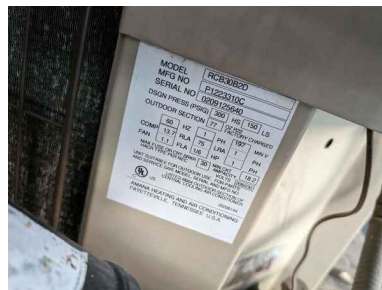
right side

Due to the age and/or condition of the equipment, it is our opinion that the equipment has only a limited amount of life remaining. It would be a prudent to have the equipment thoroughly checked by a licensed air conditioning service company and further investigation is recommended.

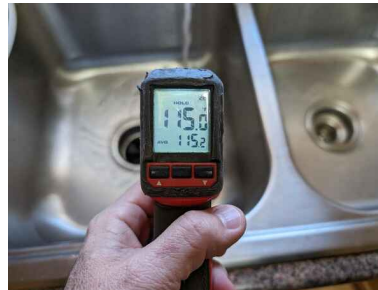
Figure P278.3  
TEMPERATURE BURN CHART

*Water Heater - Hot water supplied by building:*

The hot water was provided by a centrally supplied water heater system that was maintained by the building.

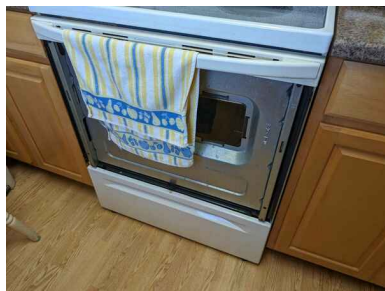
**2: Door - front missing**

The oven door cover was missing and needs to be replaced.

**Obtain Cost Estimate**
