# HOME SCOPE REAL ESTATE INSPECTIONS

## Property Inspection Report

**Concerning:** 3802 Rivermoss Ln, Katy

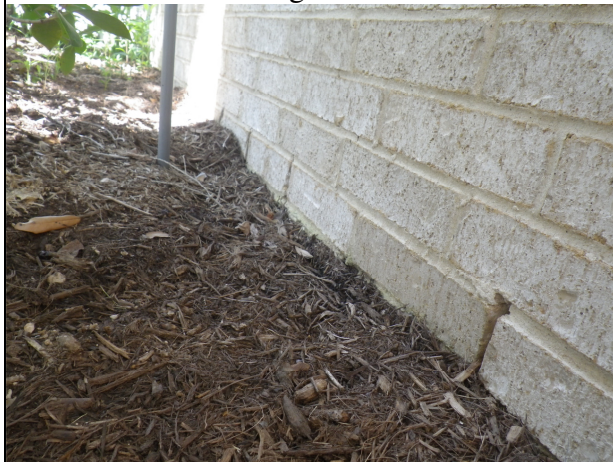
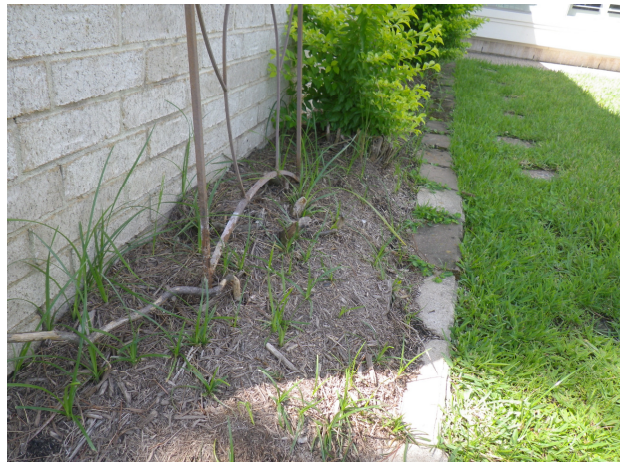
1. High soil levels (bark mulch) in flower beds against foundation perimeter edges at south and north sides of house. Foundation should have at least a couple inches of exposure around perimeter of house.

Sample pictures of built up bark mulch in flower beds cover foundation perimeter edges.

Recommend correcting issue mentioned in this section.

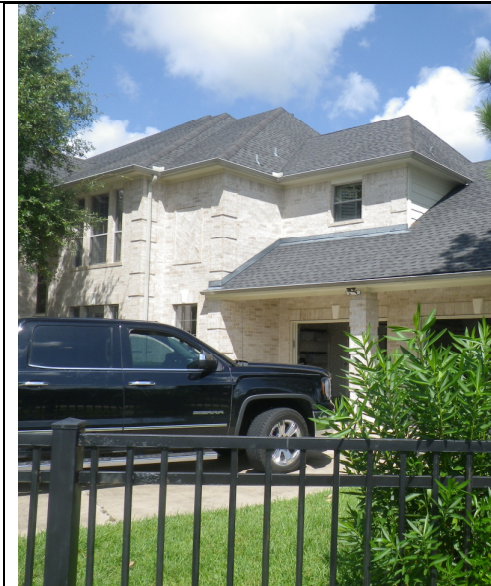
Picture from ground

Roof covering and its components appear to be functioning at time of inspection though are written as deficient due to;

Recommend professional roofing company to further evaluate roof covering and issues mentioned in this section.

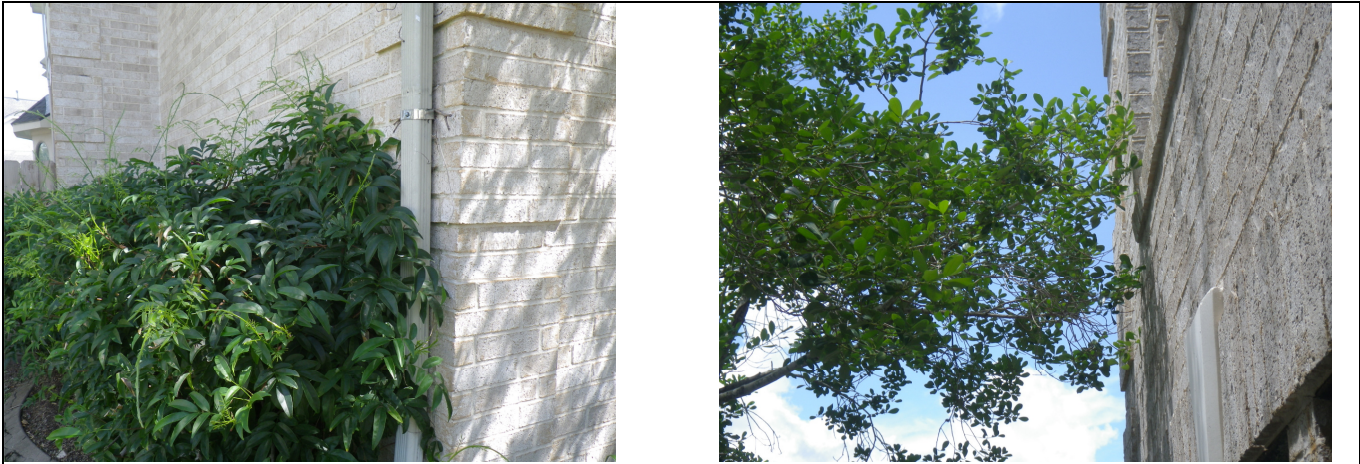
Pictures of shrub and tree limbs growing and or touching exterior walls.

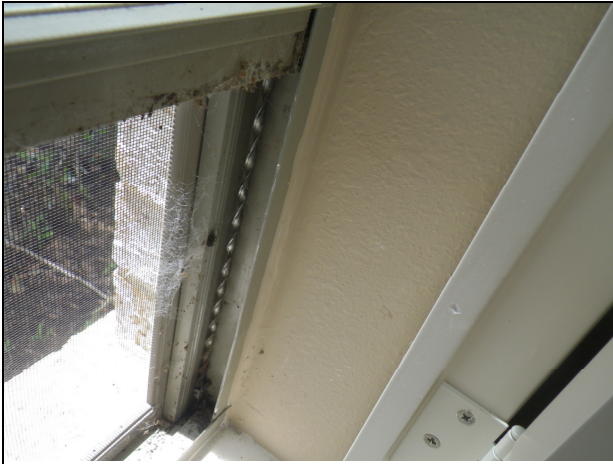
1. Numerous windows have broken and or disconnected guide tension bars thus windows do not properly operate.
2. Middle right window, middle left window, far left window in upstairs game room, right window in study and right window in upstairs southeast bedroom appear to be glazed. Glazed window means the internal seal between glass panes has failed thus allowing air and moisture particles between glass panes causing a glazed and or fogged effect and loses some of its efficiency as a double pane insulated window.

Sample picture of spiral metal guide tension bar that has come disconnected from bottom of window frame.

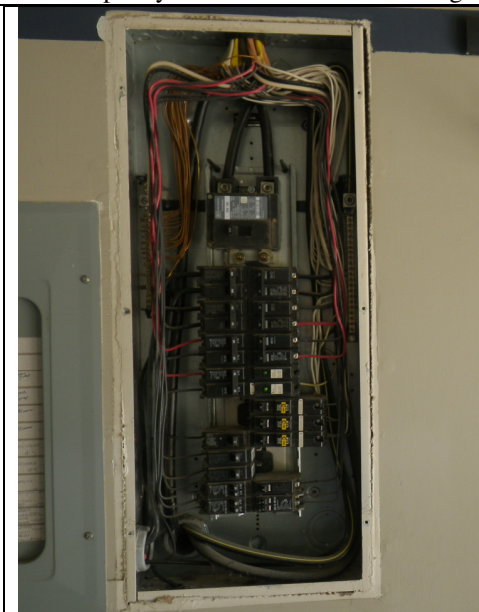
Picture of Main Breakers

Main breaker box, panel, wires and breakers appear to be functioning at time of inspection though are written as deficient due to;

Recommend licensed electrician to further evaluate issues mentioned in this section.

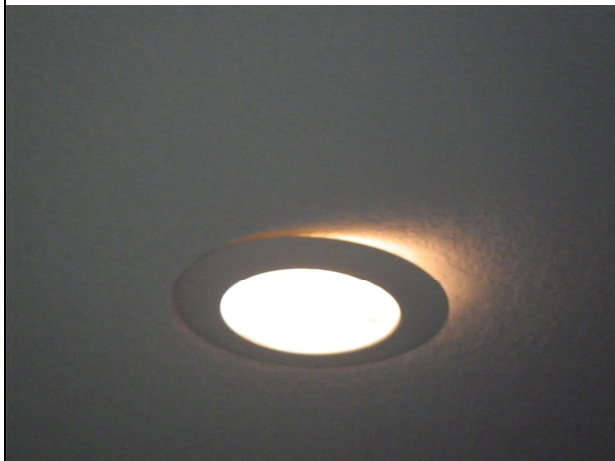
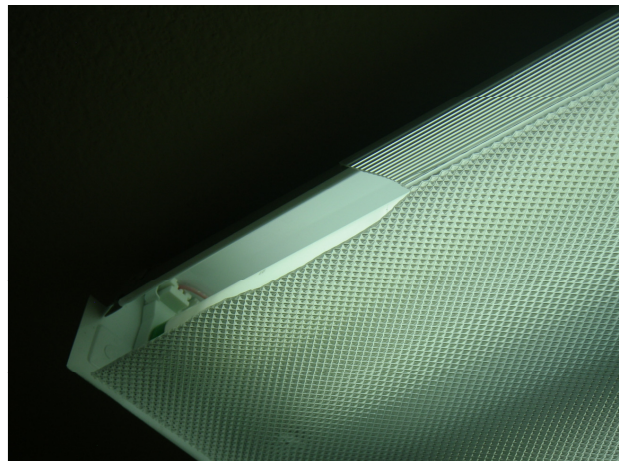
- 7.Floor outlet in living room is missing a plug cover.
- 8.Fluorescent light fixture in master closet has a damaged lens cover.
- 9.Door bell does not appear to be properly functioning (will not chime as intended).

Picture of recessed light not secured to ceiling over master bathroom shower and picture of damaged lens cover on fluorescent light fixture in master closet.

Recommend licensed electrician to further evaluate issues mentioned in this section.

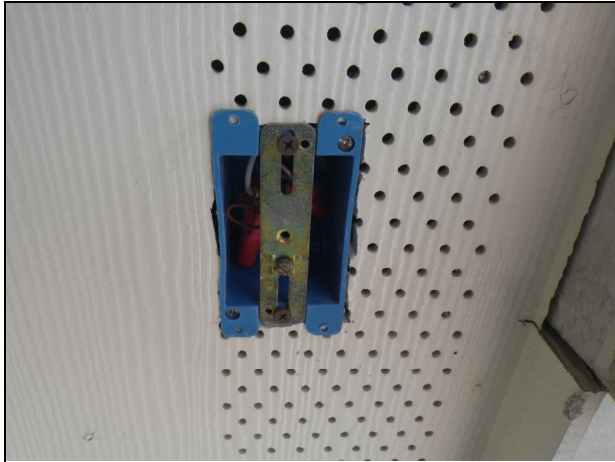
Picture of open junction box observed in soffit at back of house.

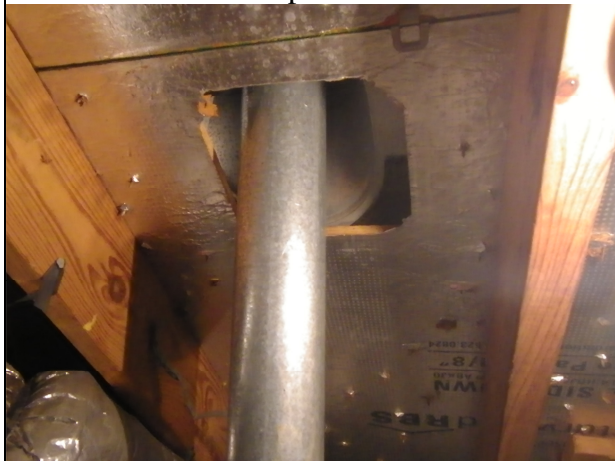
House has two Rheem gas water heater (manufactured in 2015) set in series. Gas water heater appears to be functioning at time of inspection though is written as deficient due to;  
 1. Flue vent pipe at right side water heater is not strapped in place where flue vent pipe terminates roof structure. Appears when water heater was replaced plumber did not re-installed metal strap around flue vent pipe.  
 Recommend licensed plumber to further evaluate issue mentioned in this section.

Picture of right side water heater flue vent pipe not strapped in place.

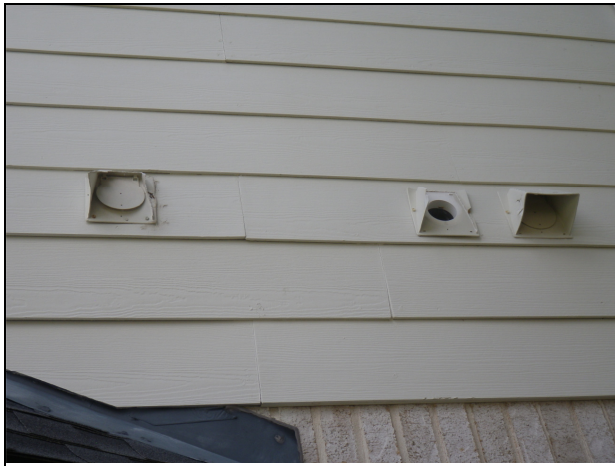
- 1.Exterior vent housings at west side of house are damaged and in need of being replaced.

Picture of damaged exterior vent housings observed at

west side of house.

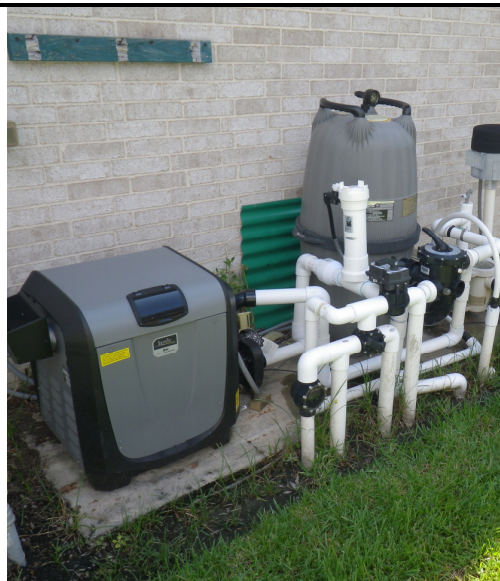
Picture of Pump Equipment

Pool and spa appear to be functioning at time of inspection though are written as deficient due to;  
 1.Pool/spa pump and motor system appears to be leaking.  
 2.Chlorinator appears to be leaking.  
 3.Compression coupler on intake side of filtration system is cracked.  
 4.Pool/spa lights did not function and or could not get them to come on.

Recommend professional pool company to further evaluate pool/spa and issues mentioned in this section.

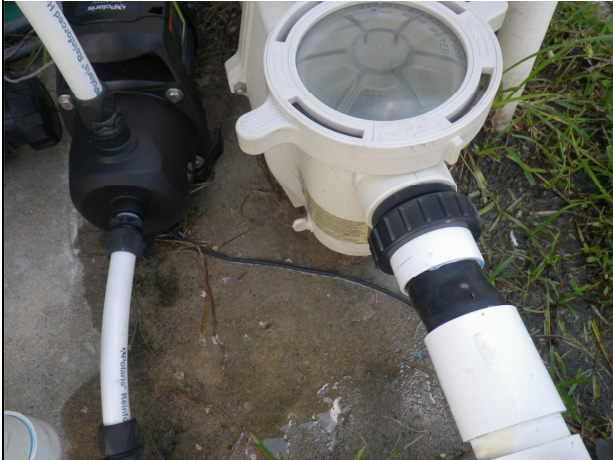
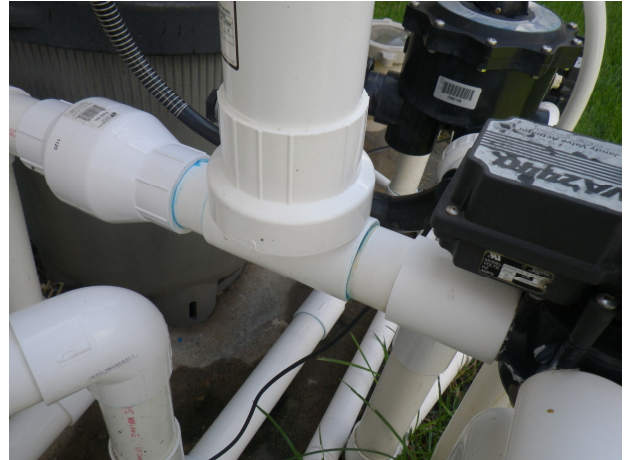
Picture of water leaking on concrete pad around pool/spa pump and motor. Picture of chlorinator leaking.

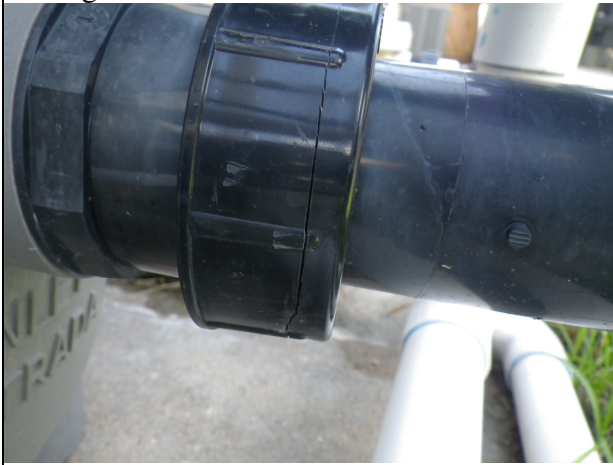
Picture of cracked compression coupler.
