**HOME SCOPE**  
**REAL ESTATE INSPECTIONS**  
**936-661-7771**  
**2200 FM 3018**  
**Oakhurst TX 77359**

**Property Inspection Report**

**Concerning:** 3802 Rivermoss Ln., Katy

7-6-2024

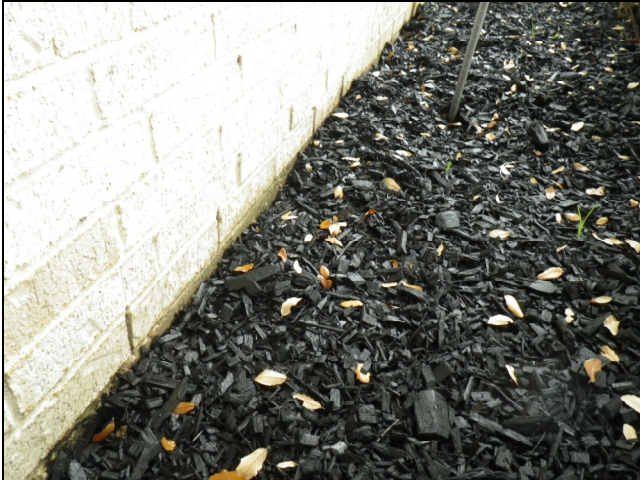
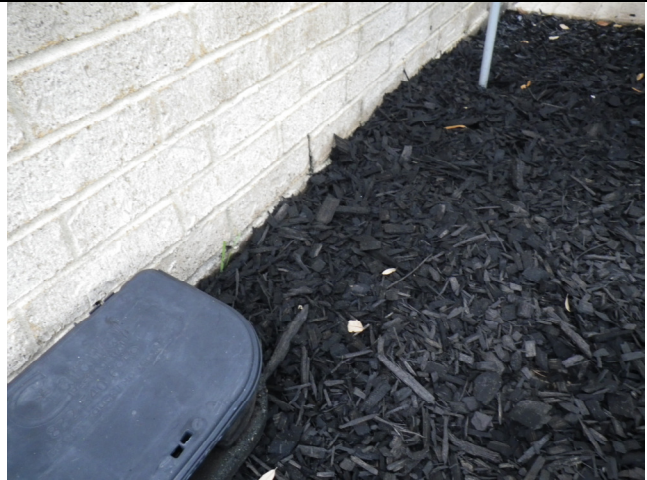
Grading and drainage appear to be functioning at time of inspection though are written as deficient due to;  
1. High soil levels (bark mulch) in flower beds against foundation perimeter edges at south side of house. Foundation should have at least a couple inches of exposure around perimeter of house.

Sample pictures of high soil levels (built up bark mulch) in front flower beds.

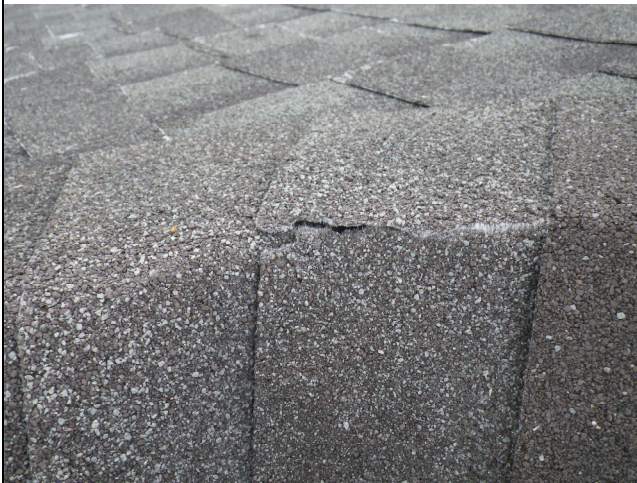
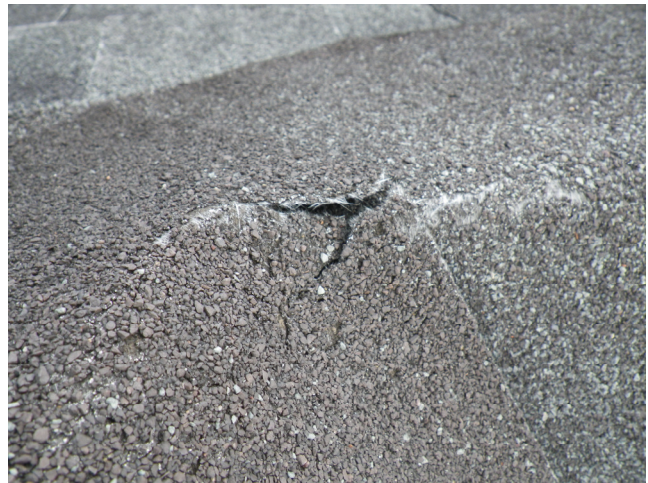
1. Composition roof shingles appear to be in average to aged condition. Shingles are written as deficient due to observing several cracked ridge shingles and shingles exhibit signs of delamination with loss of protective gravel coating.

Sample pictures of cracked ridge shingles observed on roof.

Recommend professional roofing company to further evaluate roof covering and issues mentioned in this section.

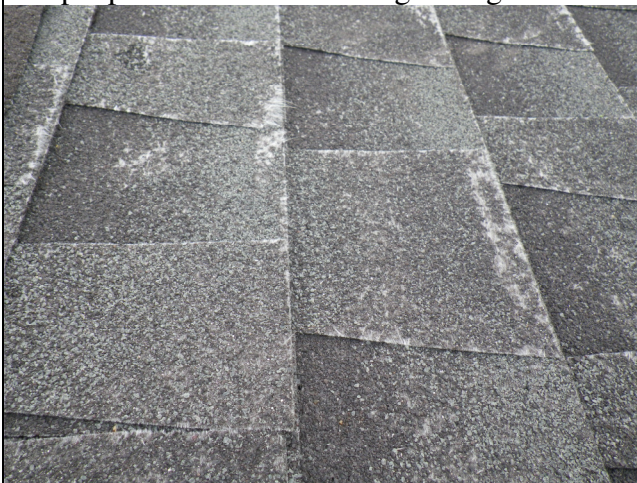
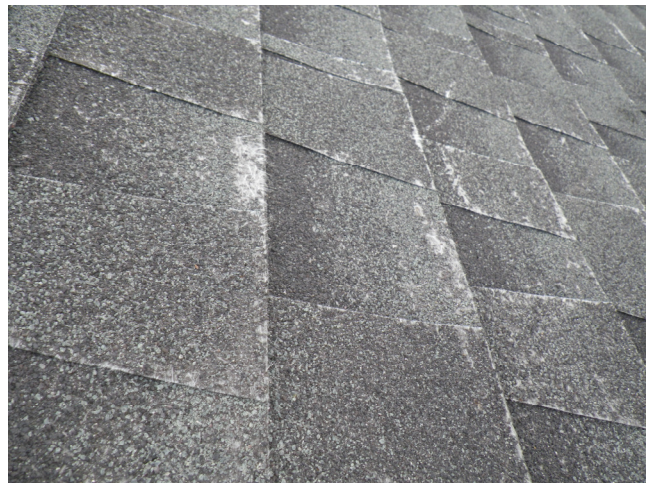
Sample pictures of shingles starting to delaminate.

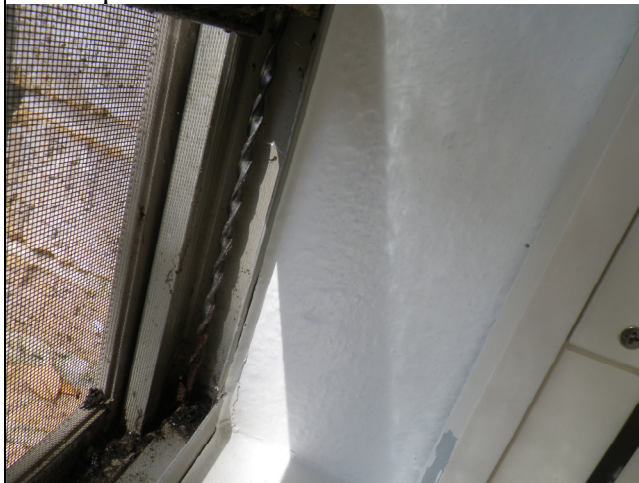
- 1.1. Numerous windows have broken and or disconnected guide tension bars thus windows do not properly operate.
2. Middle right window, middle left window, far left window in upstairs game room, right window in study, right north facing window in breakfast area, three windows in master bedroom and right window in upstairs southeast bedroom appear to be glazed. Glazed window means the internal seal between glass panes has failed thus allowing air and moisture particles between glass panes causing a glazed and or fogged effect and loses some of its efficiency as a double pane insulated window.

Sample picture of guide tension bar that has come disconnected from bottom of window frame.

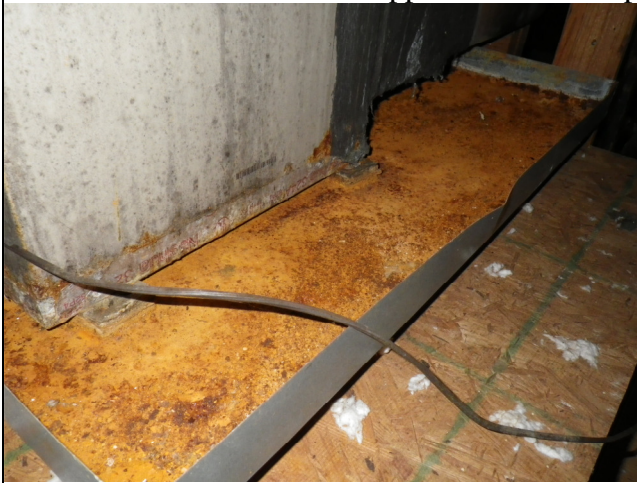
Note; safety pan under upstairs AC unit exhibits corrosion. Corrosion appears to be surface type corrosion and does not appear to have compromised the functionality of the safety pan.

Picture of corrosion observed in safety pan under

upstairs AC unit.

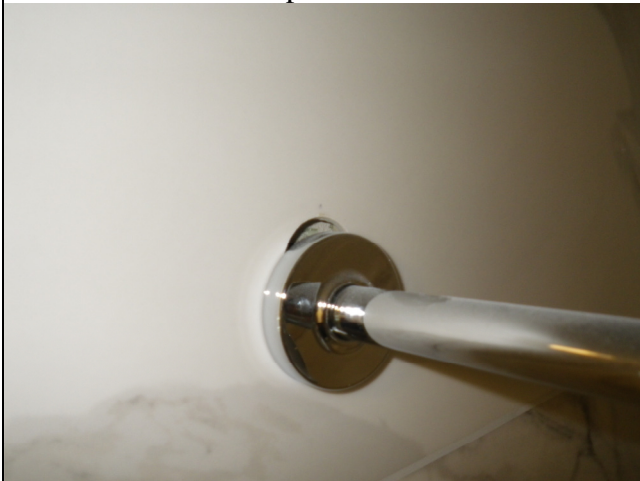
- 1.Exterior hose bibs are missing backflow preventers.
- 2.Tub/shower enclosure at upstairs east side guest bathroom exhibits an opening in enclosure over shower head that should be sealed.
- 3.Water at master bathroom shower would get warm but would not get hot. Mixing valve may be in need of adjustment.

Picture of opening above shower head in tub/shower enclosure at upstairs east side guest bathroom.

Recommend licensed plumber to further evaluate issues mentioned in this section.

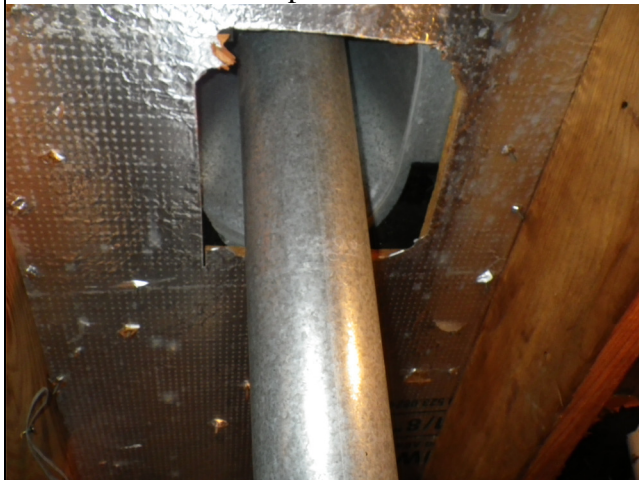
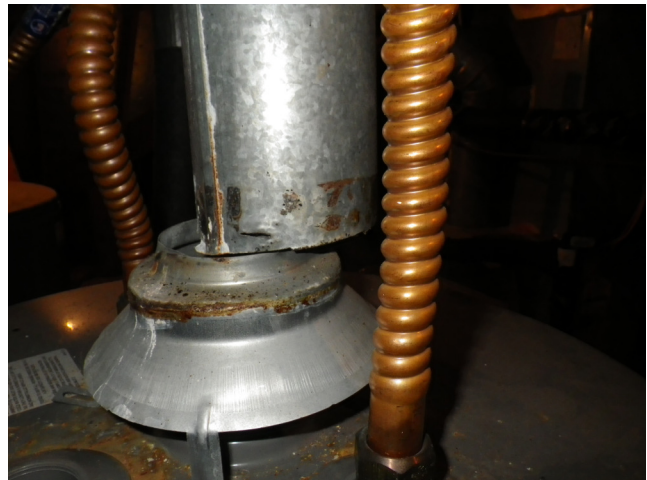
- 1.Flue vent pipe at right side water heater is not strapped in place where flue vent pipe terminates roof structure. Appears when water heater was replaced plumber did not re-installed metal strap around flue vent pipe.
- 2.Flue vent pipe at left side water heater does not appear to be properly installed over draft diverter at top of water heater tank.

Picture of flue vent pipe at right side water heater not strapped in place where flue vent pipe terminates roof structure and picture of flue vent pipe not properly installed over draft diverter at left side water heater.

Recommend licensed plumber to further evaluate issues mentioned in this section.

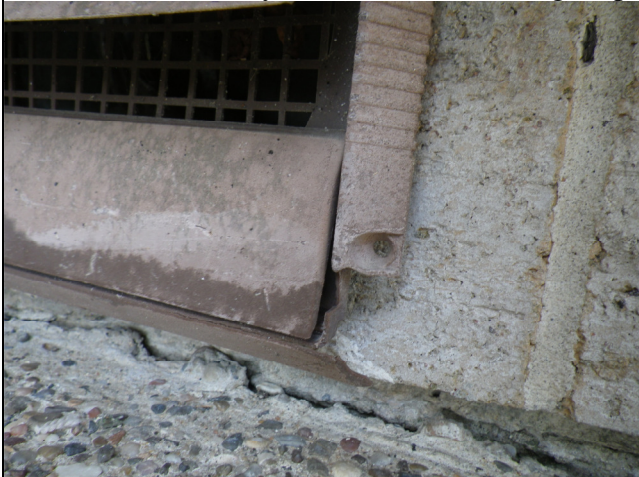
- 1.Exterior louvered vent for downdraft vent system at exterior east side of house appears to be dry rotted and damaged.

Picture of damaged louvered vent opening for

downdraft range hood at exterior east side of house.

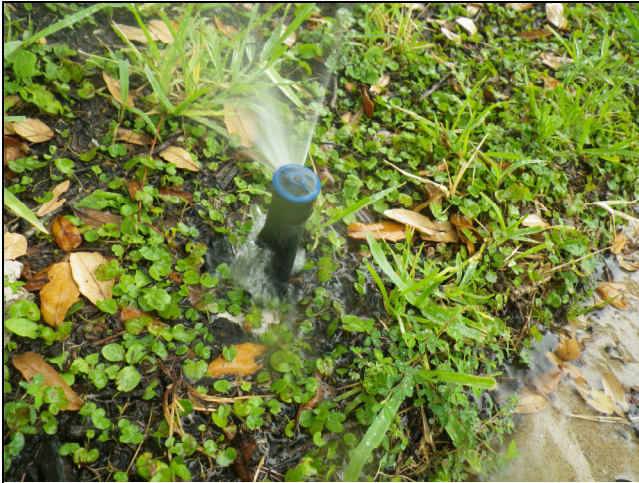
1. Zone 2 has water leaking around base of one of its pop up spray heads in front yard. Zone 8 did not appear to function when running through the zones thus northwest corner of backyard did not have full coverage.
2. Zone 8 did not appear to function when running through the zones thus northwest corner of backyard did not have full coverage.

Picture of water bubbling up around base of pop up spray head in zone 2.
