TEXAS PROFESSIONAL INSPECTIONS

TPI HOME INSPECTION

1104 Petersburg Ct
College Station, TX 77845

PROPERTY INSPECTION REPORT FORM

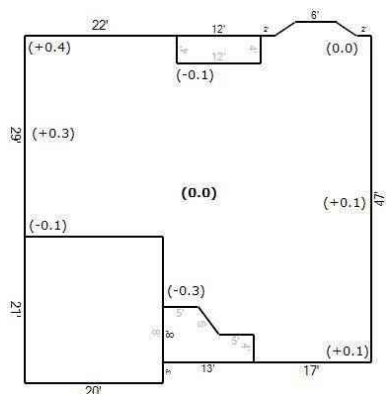
Elevation Survey:

Elevation measurements can be useful, but should not be relied on as a definitive statement of foundation condition. Elevation is measured against a benchmark "(0.0)" and indicated at lower " - " or higher " + " than the benchmark. Measurements are in inches.

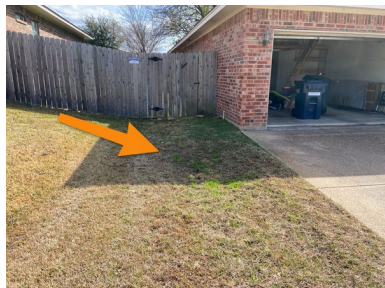
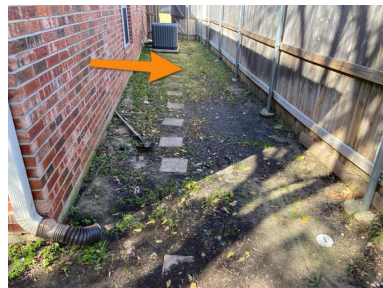
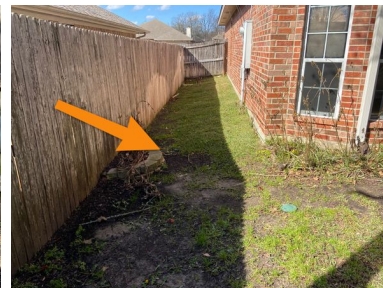
1: Poor yard drainage

Proper grading of the yard will allow efficient drainage of rain runoff away from the structure. Excessive moisture causes soil expansion and contraction that can move foundations and concrete flatwork. Recommend landscape professional re-grade soil or install French drain to move water away from the slab.

Recommendation: Contact a qualified landscaping contractor

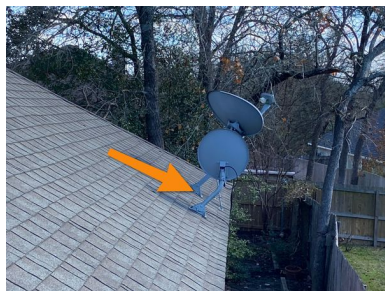
2: Improper antenna installation

Antenna installed on the roof surface is bolted /screwed through the shingles, which is an improper installation. The antenna wiring is improperly routed through a hole in the roof. These caulked penetrations for the antenna system may leak if antenna becomes loose from wind damage and may need periodic maintenance.

Recommendation: Contact a qualified roofing professional.

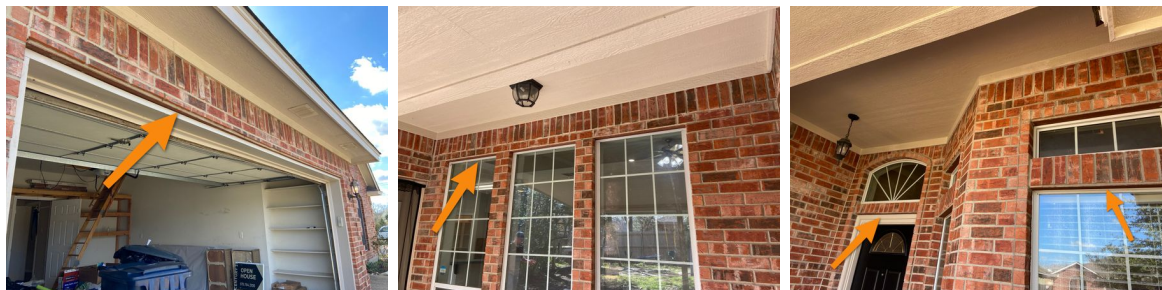
2: Metal lintel(s) paint covering inadequate /missing

Metal supports above windows and doors and other openings need to be painted for protection to prevent rust. Add paint rated for application to metal or replace damaged paint, as necessary.

Recommendation: Contact a qualified painting contractor.

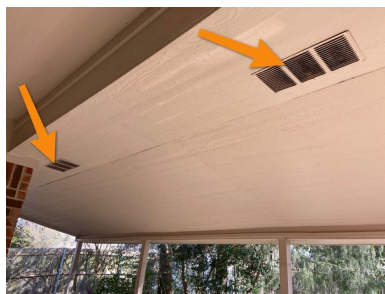
3: Soffit screens obstructed with dirt/debris

Soffit vent screens should be cleaned to allow efficient attic ventilation.

Recommendation: Contact a handyman or DIY project

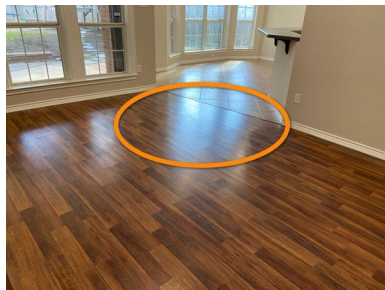
2: Buckled laminate flooring noted

Composite flooring material is damaged/buckled. Damage appears to be the result of moisture. Possibly due to lack of climate control, pets and/or leaking.

Recommendation: Contact a qualified professional.

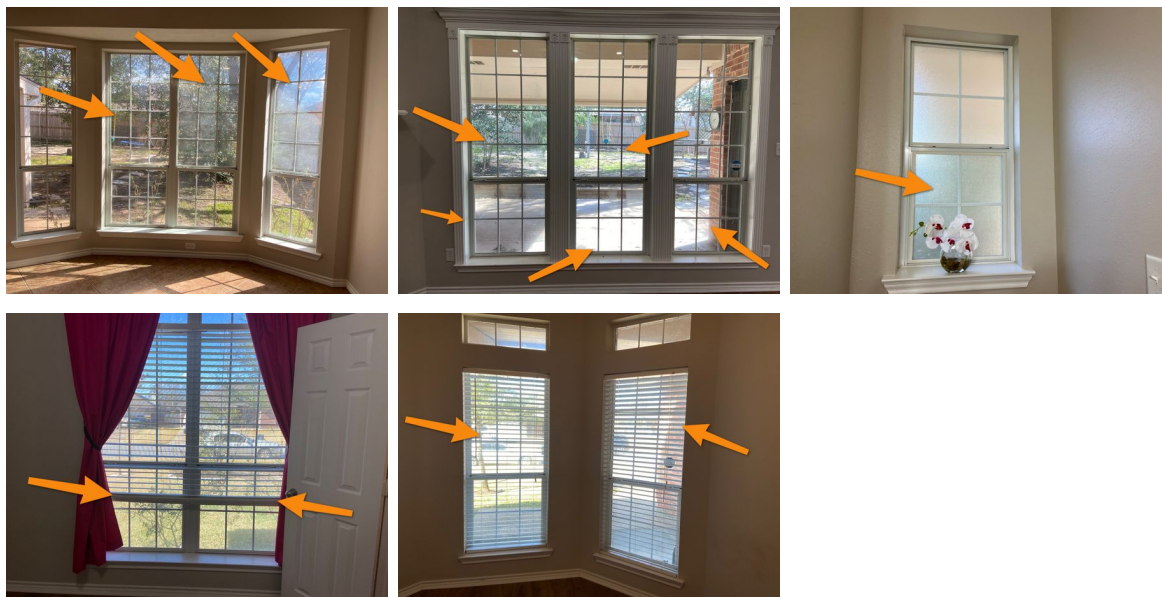
1: Double paned glass seal failure

dining room (3), living room (5), master bathroom (1), right bedroom (2), right front bedroom (2)
Evidence of seal failure noted. Recommend qualified window contractor evaluate & replace.

Recommendation: Contact a qualified window repair/installation contractor.

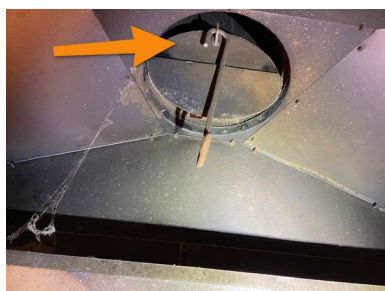
1: Excessive soot buildup in flue

Chimney liner had layer of creosote. Underlying structure could not be inspected for cracks. Recommend qualified chimney sweep company inspect and/or clean.

Recommendation: Contact a qualified chimney sweep.

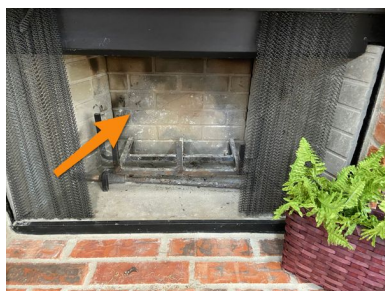
2: Fireplace refractory panel damaged

Excessive wear and tear of the ceramic refractory panels in the fireplace could lead to chimney damage or toxic fumes entering the home. Recommend a qualified fireplace contractor repair or replace.

Recommendation: Contact a qualified fireplace contractor.

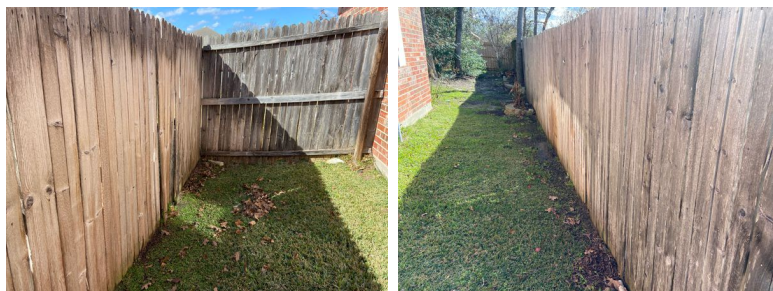
1: Fence Repair Needed

Fence posts and pickets are loose / leaning or deteriorated and fence framing is loose.

Recommendation: Contact a qualified fencing contractor

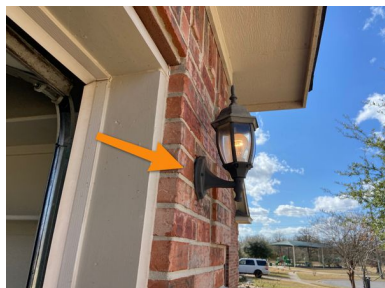
1: Light fixture loose

Loose electrical fixtures can cause flexing of the wires at their attachments leading to arcing/overheating.

Recommendation: Contact a qualified electrical contractor.

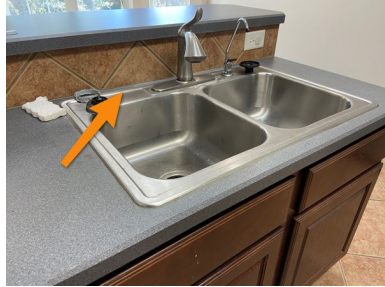
3: Seal counter / backsplash joint

kitchen

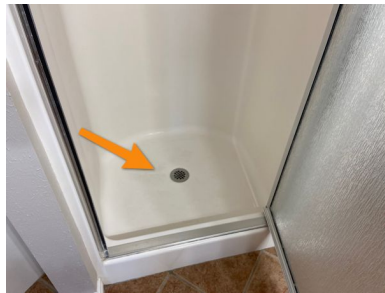
4: Excessive movement noted in shower pan

Flexing noted in fiberglass shower pan when weight applied. Additional support below pan may be necessary to provide adequate support and prevent leaking/damage in the future.

Recommendation: Contact a qualified professional.

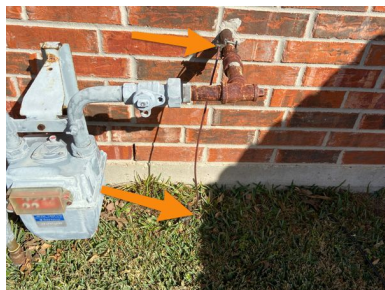
3: Gas service grounded improperly

Gas system should be bonded to existing ground system to prevent difference of potential, forcing electrical system to ground across gas system.

Recommendation: Contact a qualified professional.
