RESIDENTIAL HOME INSPECTION

2525 Malibu Glen Dr
Katy, TX 77493

PROPERTY INSPECTION REPORT FORM

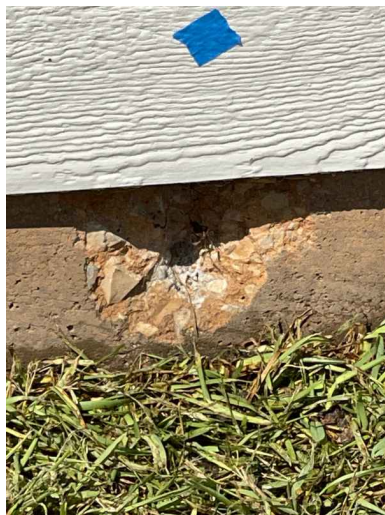
There are exposed post-tension cables on the foundation at the time of the inspection. I recommend sealing all exposed post tension cables with a concrete sealant.

Recommendation: Contact a qualified professional.

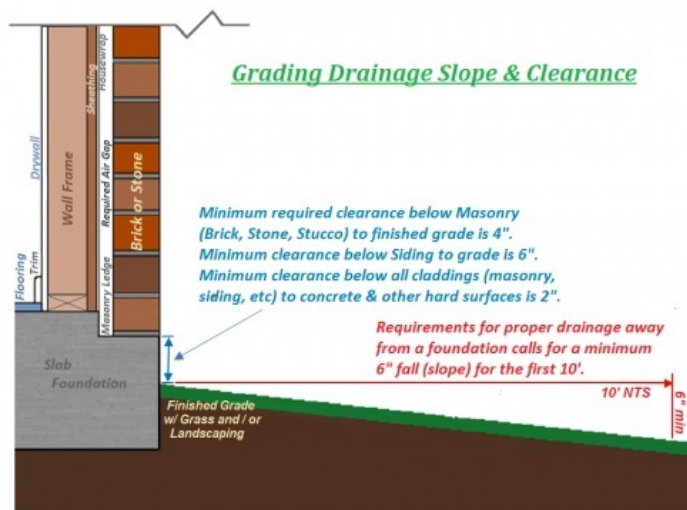
1: Depressions Around House

There are depressions around the home which may promote ponding of water during and after rainfall. These low areas need to be regraded so that water drains away from the property. Failure to correct this may lead to problems in the future.

Recommendation: Contact a qualified landscaping contractor

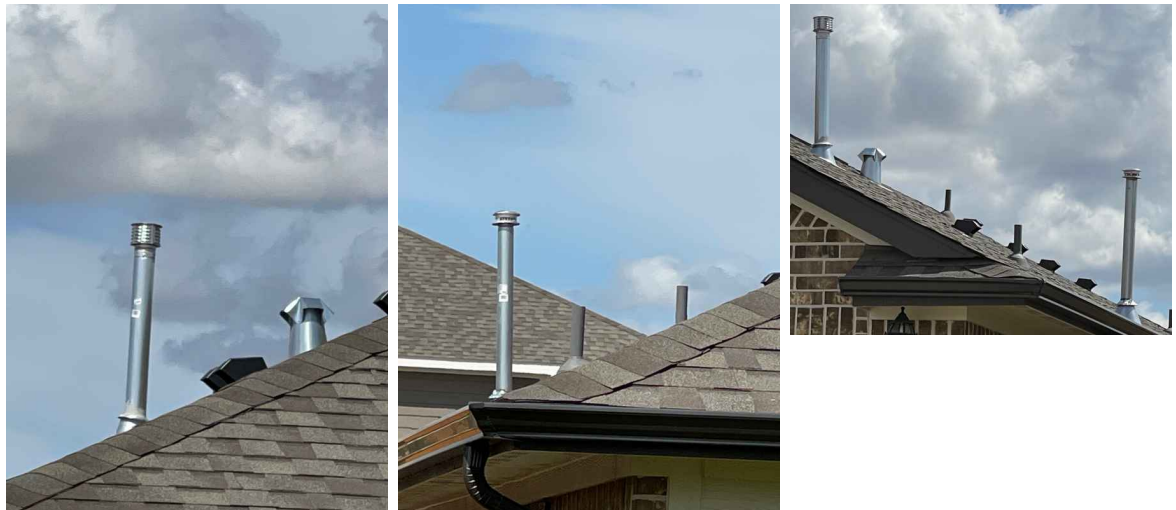
Unpainted vent caps and vents were noted on the roof at the time of the inspection. Painting will inhibit rusting and premature deterioration over time. I recommend painting all vent stacks.

Recommendation: Contact a qualified roofing professional.

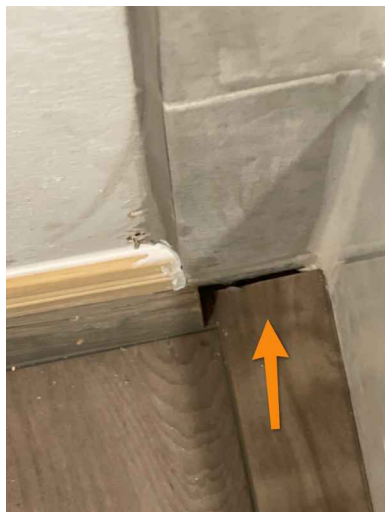
Hallway Bathroom

Gaps/cracks in floor were observed at several locations. This needs to be properly sealed to prevent any moisture from penetrating below the flooring.

Recommendation: Contact a qualified flooring contractor

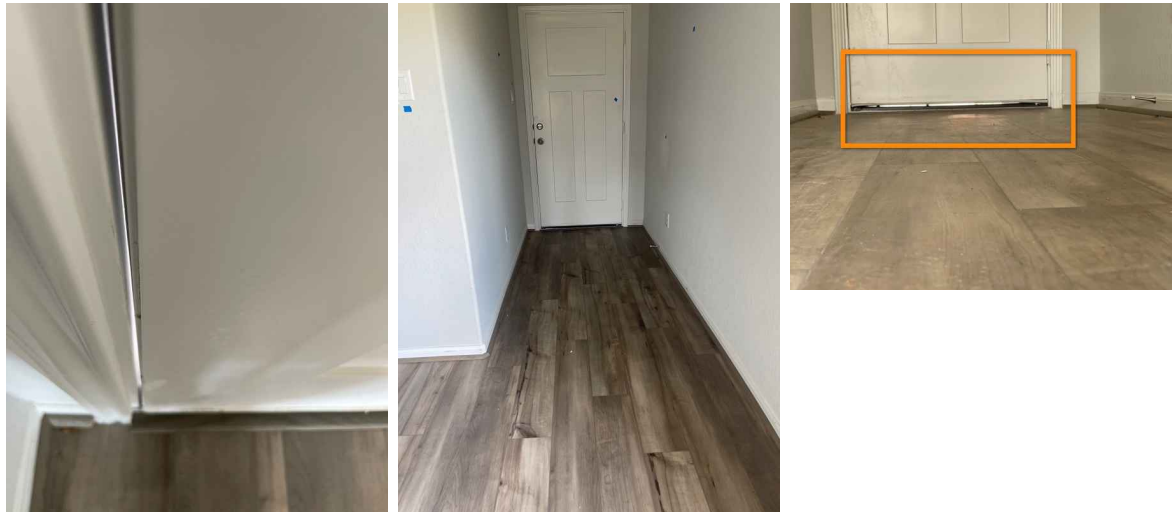
The weather stripping on the following exterior door is deficient. This can result in significant energy loss and moisture intrusion. Recommend installation of standard weatherstripping, or adjusting the closure space of the door in its frame.

Recommendation: Contact a qualified handyman.

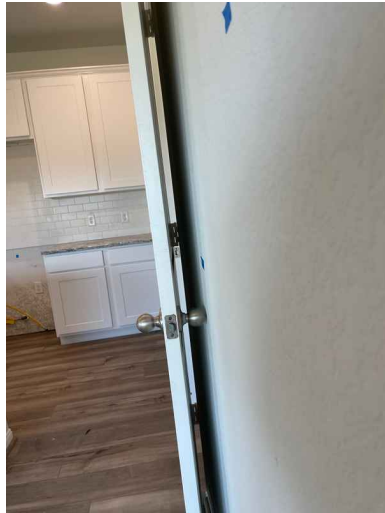
3: Noticeable Gaps

There are noticeable gaps around the following door of the home. Sometimes gaps in weather-stripping or gaps between the door and frame can lead to energy losses. I recommend that a qualified contractor evaluate and repair.

Recommendation: Contact a qualified door repair/installation contractor.

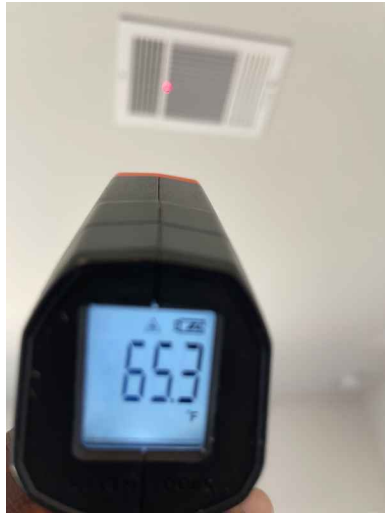
Living Room

The temperature recorded at the home's supply and return vents at the time of testing are included in the photos below.

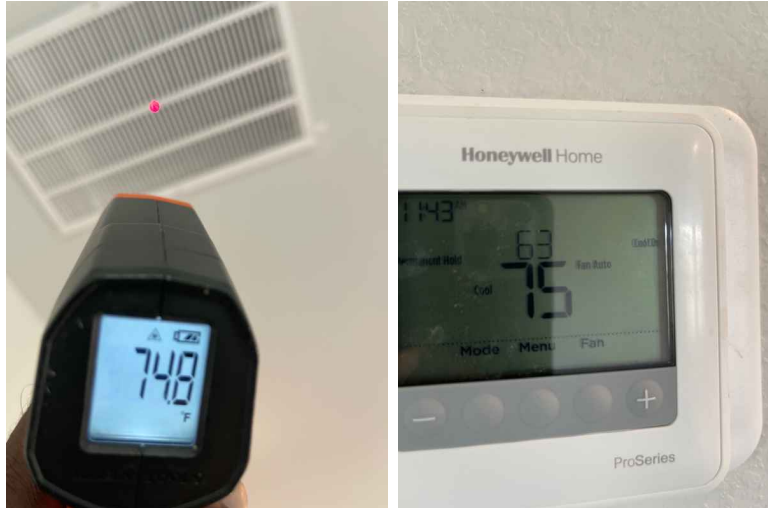
The unit was operating below the recommended cooling differential of 15 to 22 degrees F between supply and return air. I recommend evaluation and repair by a qualified HVAC professional.

Recommendation: Contact a qualified HVAC professional.

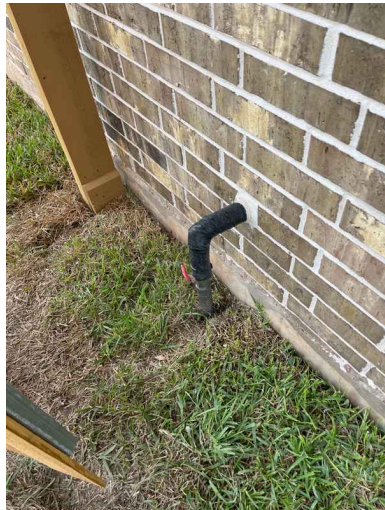
Static Water Pressure Reading: 50 -
The static water pressure was within the recommended water pressure of 40 - 80 PSI.

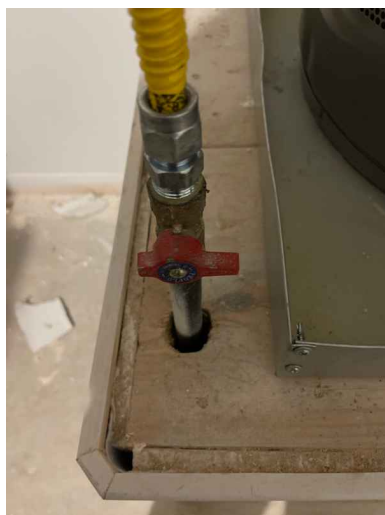
The water heating equipment was not functional at the time of the inspection, and was therefore not tested. The installation was also not complete. Inspectors are not required to turn on water heaters since the reason for the unit being off may not be known.

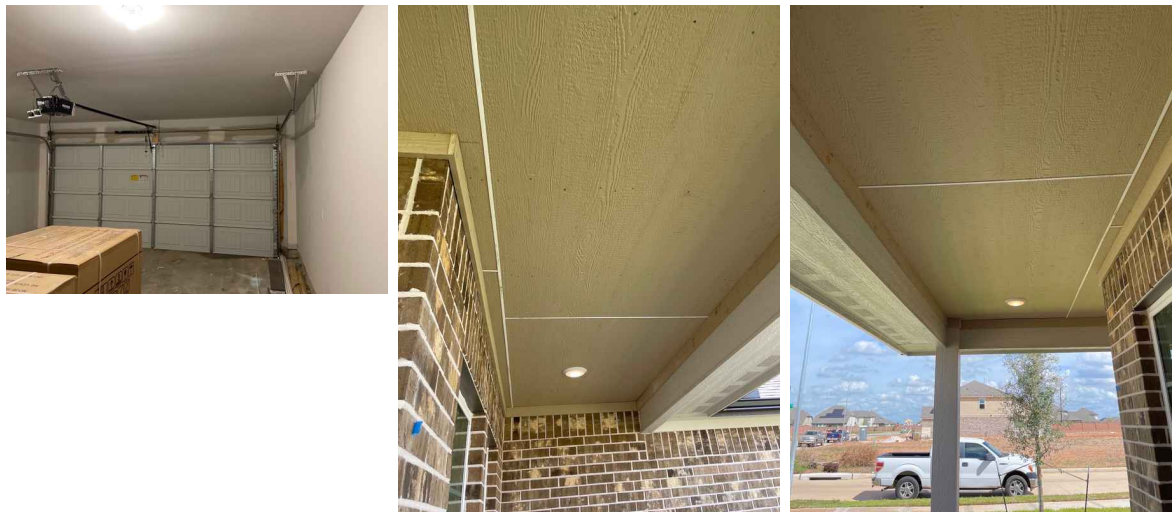
1: Painting improvements needed

Painting improvement needed in the following location(s).

Recommendation: Contact a qualified professional.
