HTX HOME INSPECTIONS

6123 Cameron Ct
League City, TX 77573

PROPERTY INSPECTION REPORT FORM

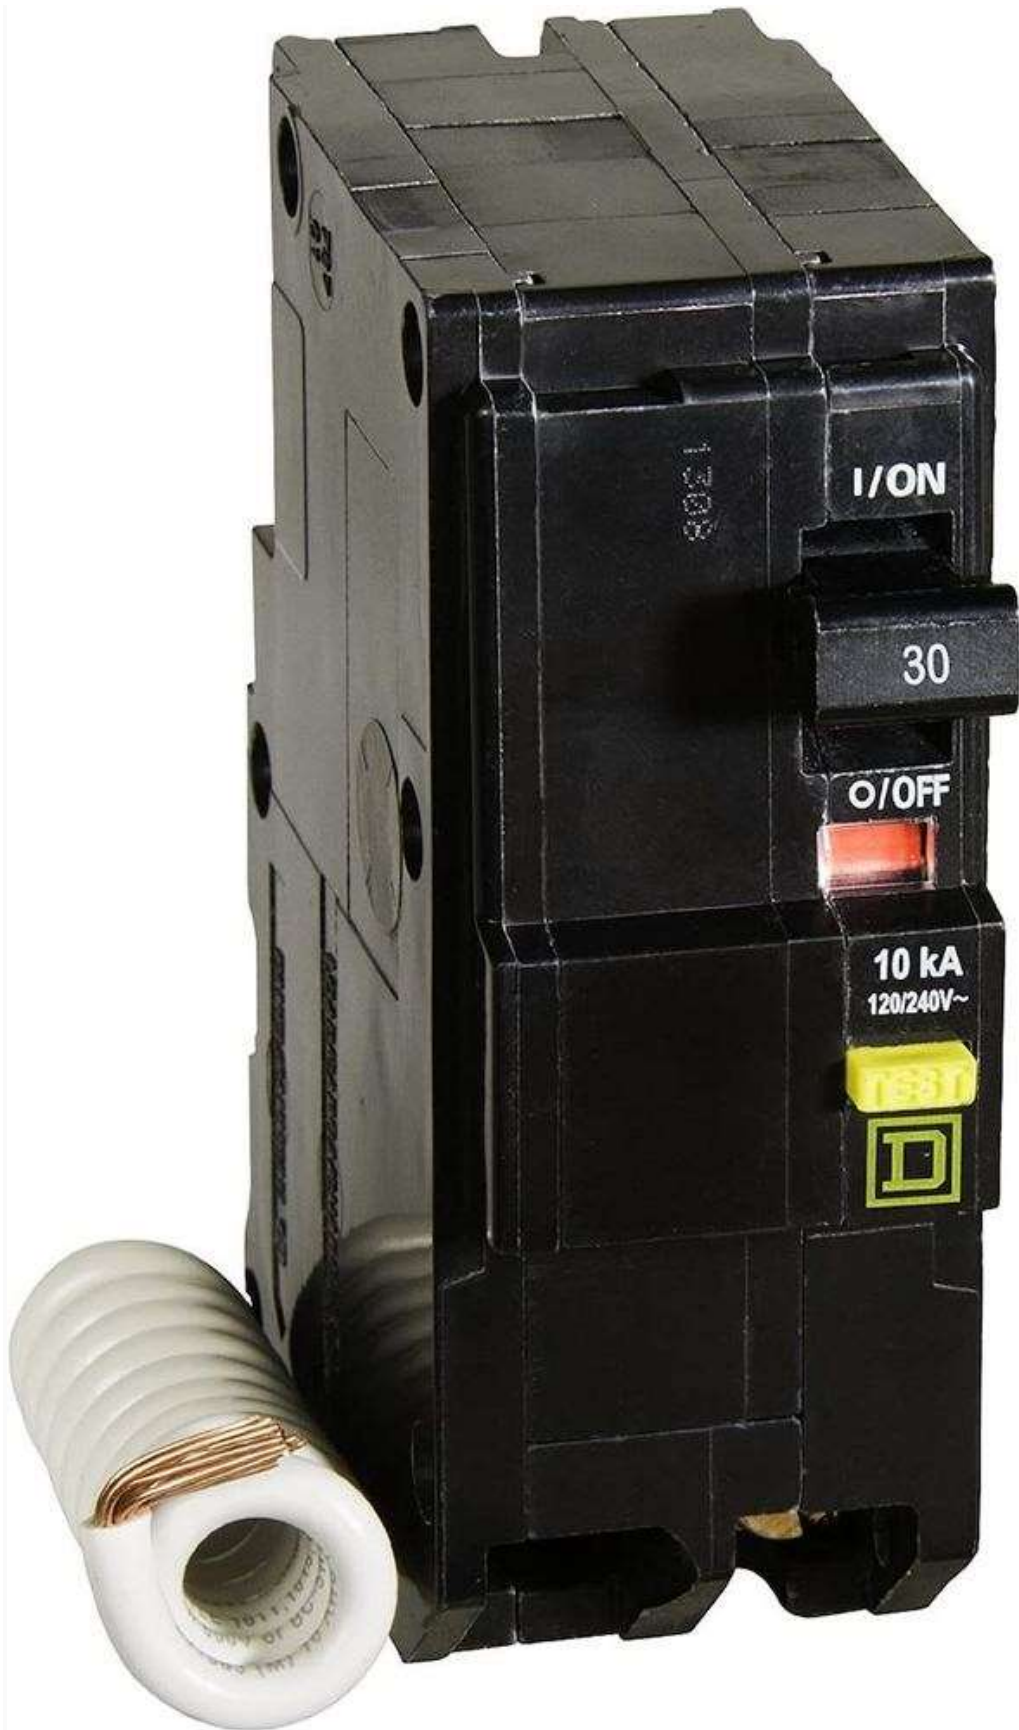
Example

3.1.5 II. Electrical Systems: A. Service Entrance and Panels - Dryer GFCI Protection

Observed missing GFCI protection for 240 volt dryer receptacle in breaker panel at time of inspection. All new construction home receptacles up to 250 volts located in bathrooms, garages, laundry rooms and kitchens must have GFCI protection. This was not required on homes built prior to 2020 and not required to report on by TREC inspectors until 2021, but if changes are being made to update the breaker panel this has to be changed to meet today's standards.

Recommendation: Contact a qualified electrical contractor.

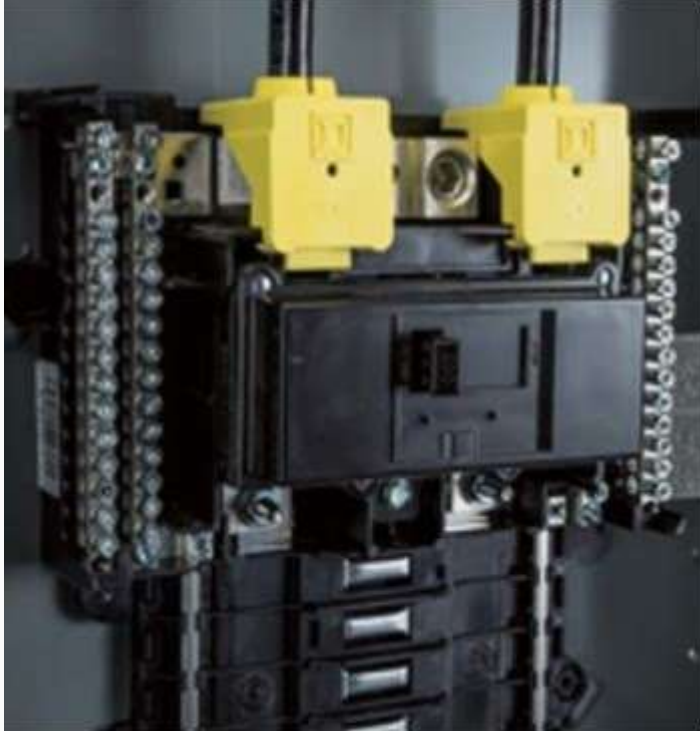
Example

Observed missing barrier protection on service terminals in breaker panel at time of inspection. Homes built prior to 2017 or have more than one service disconnect were not required to have this but as building codes and electrical standards change it helps to protect persons from potential shock when working in or around the breaker panel.

Recommendation: Contact a qualified electrical contractor.

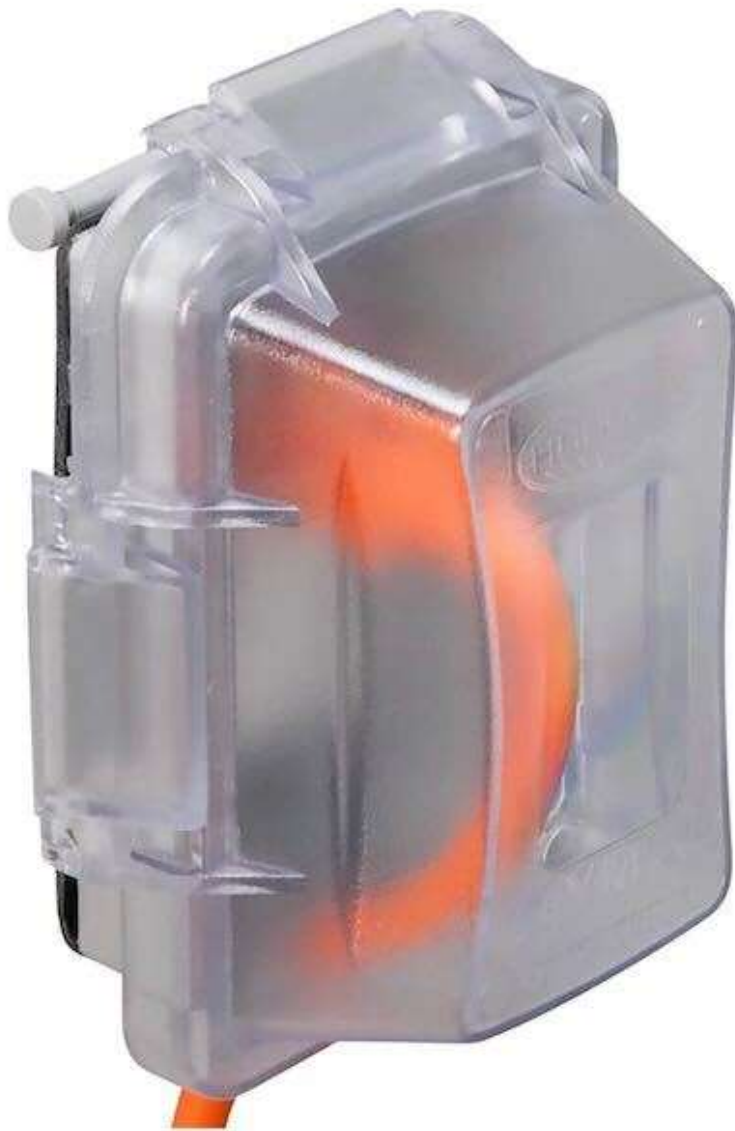
Example

3.2.1 II. Electrical Systems: B. Branch Circuits, Connected Devices, and Fixtures - Bubble Cover

Observed missing bubble cover at one or more exterior outlets. Bubble covers protect outlets from moisture more effectively when they are in use than flip cover protectors. Bubble covers are required on all new construction and therefore this recommendation may not apply to the current structure.

Recommendation: Contact a qualified electrical contractor.
