Inspection Report

Property Address:
16915 Farley Pass Dr
Houston TX 77095

HG Home Inspection/Hilsher Group LLC

PROPERTY INSPECTION REPORT FORM

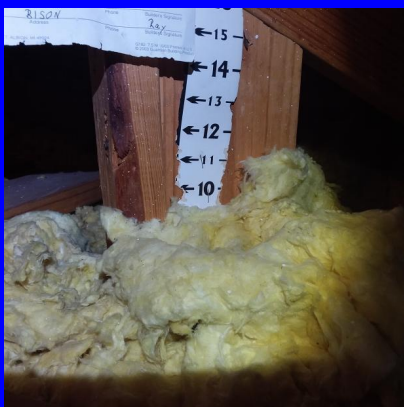
Insulation is approximately 10" deep

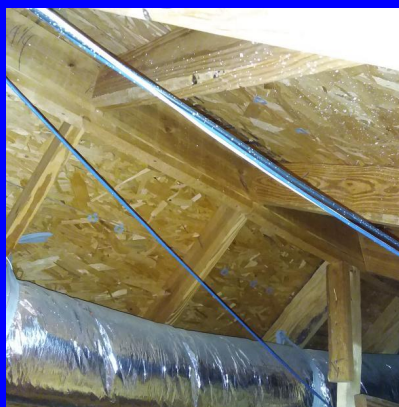
Stick built without radiant barrier

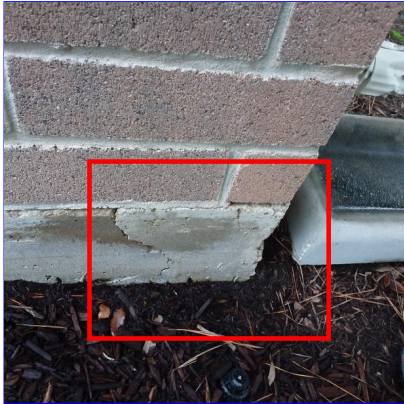
A. Item 1 (Picture) Foundation corners

- (1) This is not an engineering report, but is only an opinion based on observation of conditions known to be related to foundation performance, using the knowledge and experience of the inspector.
- (2) The foundation has minor corner pop(s) that are considered cosmetic. Further deterioration may occur if not corrected. I recommend having a qualified person make repairs as needed.

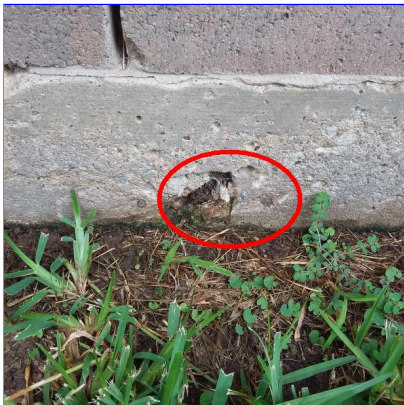
A. Item 2 (Picture) Areas around foundation perimeter

(3) The post tension foundation has exposed cable ends that are starting to show signs of deterioration. This is a maintenance issue. Further deterioration will occur if not corrected. I recommend having a qualified person make repairs as needed.

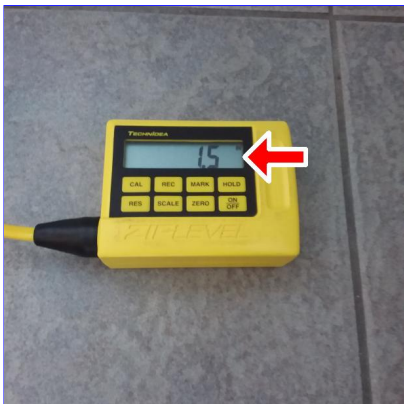
A. Item 3 (Picture) Rear left corner (kitchen nook)

(4) The foundation is showing signs of movement. I recommend consulting with a Structural Engineer or foundation professional.

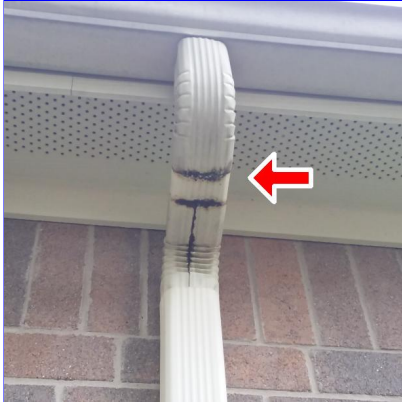
B. Item 1 (Picture) Multiple gutters

(1) Gutters are deteriorated and leaking. I recommend a qualified professional to further evaluate.

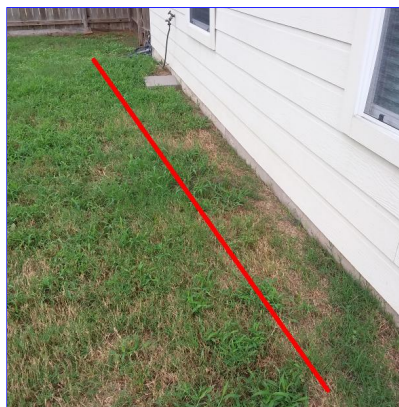
B. Item 5 (Picture) Rear

(2) Grading on the lot does not appear to drain water properly. I recommend having a qualified person grade lot properly.

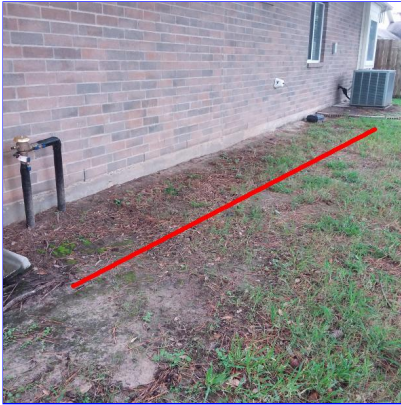
B. Item 6 (Picture) Right side

(3) The landscape at the exterior may require a trench or drain if water stands or puddles after heavy rain. I am unable to determine due to no rain during inspection period.

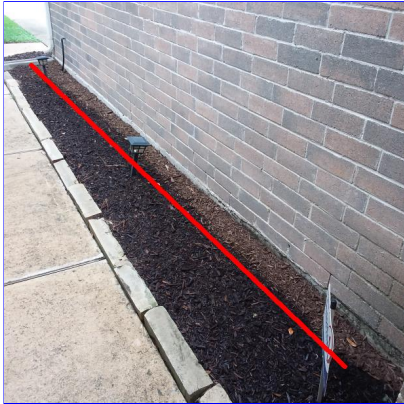
B. Item 9 (Picture) Front

(4) There is a negative slope towards the exterior areas. This area does not appear to drain water away from home and needs landscaping and drainage corrected to show a minimum of 4 inches of slab.

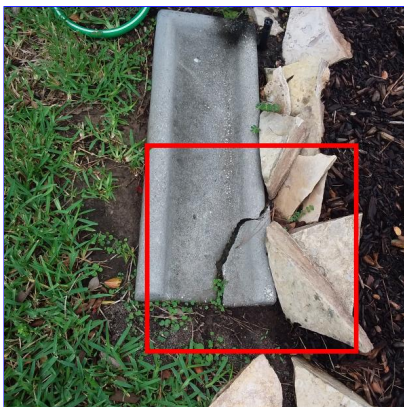
B. Item 13 (Picture) Left side

(5) Damaged splash block. This is for your information.

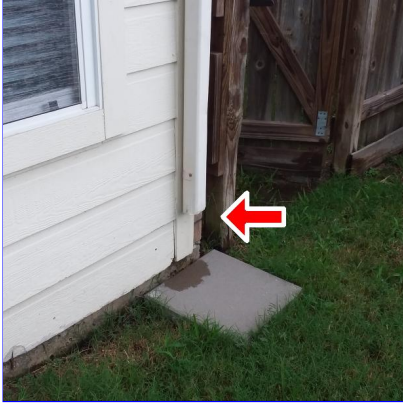
B. Item 14 (Picture) Rear

(6) Missing downspout and extension on gutter. This is for your information.

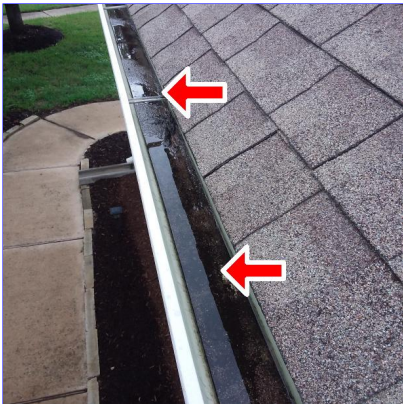
B. Item 15 (Picture) Multiple areas

(7) The gutters have standing water and debris in them. I recommend having a qualified person correct gutter drainage.

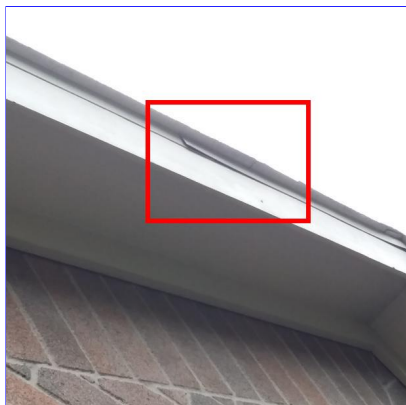
C. Item 1 (Picture) Drip edge flashing in the front

(2) Lifted flashing present in areas. I recommend a qualified professional to further evaluate.

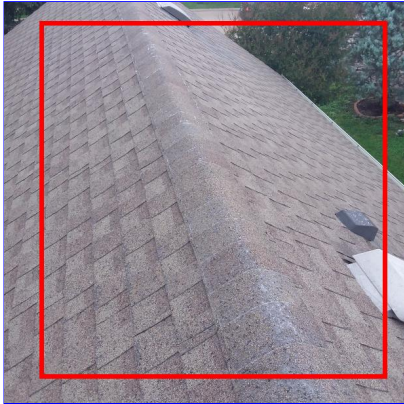
C. Item 3 (Picture) Throughout roof

(3) The roof is showing missing shingles, wear, tear and granular loss. (Granules provide UV protection for shingles. Once the granules erode away the sun is able to deteriorate the asphalt and shortens the life of the roofing material.) I recommend consulting with a roofing professional.. A qualified person should repair or replace as needed.

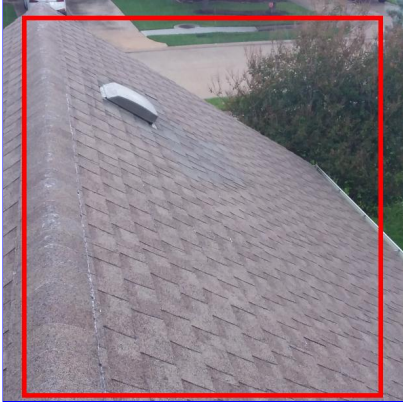
C. Item 9 (Picture) Front left

(4) Roof repairs present. This is for your information.

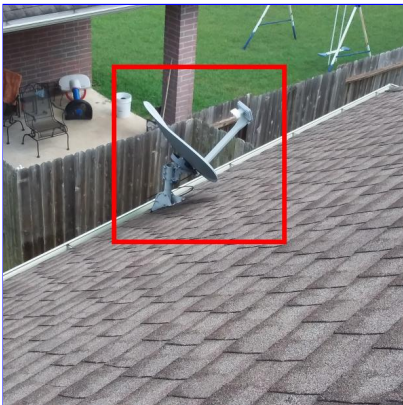
C. Item 10 (Picture) Left side

(5) There is a satellite dish bracket mounted on roof that is screwed directly through roofing surface. This is not considered to be today's standard. I recommend having a qualified person remove and patch roofing as needed. (The area will need periodic maintenance)

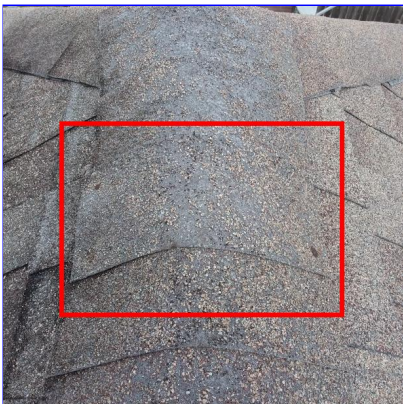
C. Item 11 (Picture) Multiple areas throughout roof

(6) The roofing surface has exposed nail heads that are showing signs of deterioration. Further deterioration will occur if not corrected. I recommend having a qualified person repair or replace as needed.

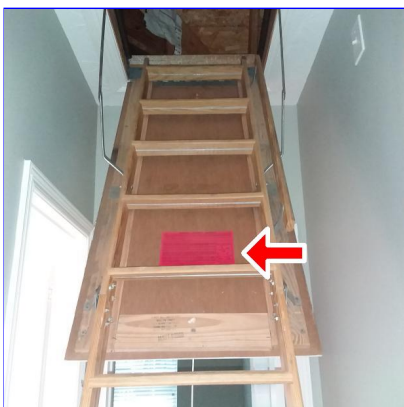
D. Item 1 (Picture) Pull down

(2) The pull down stairs are not properly insulated. This can cause some heat loss in winter and loss of cool air in summer if not corrected. I recommend repair as desired.

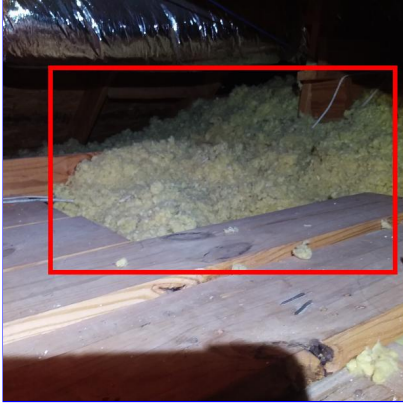
D. Item 2 (Picture) Multiple attic areas

(3) The attic space has areas of thin insulation. This is causing energy loss and is not today's standard. I recommend having a qualified person evaluate and add insulation as needed.

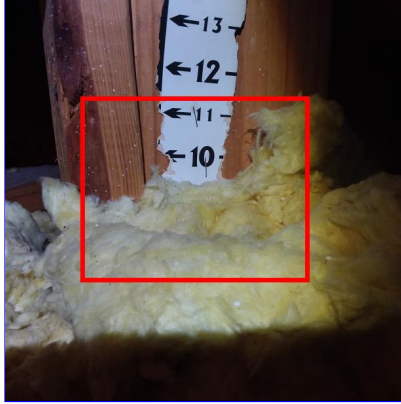
D. Item 3 (Picture) At least 12" is recommended

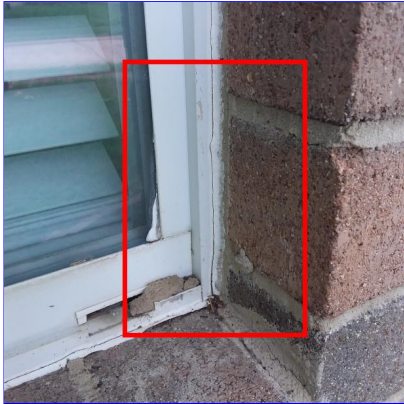
E. Item 1 (Picture) Multiple areas in window frames around home perimeter

(1) All exterior cracks, gaps, penetrations, holes and openings should be properly sealed to avoid water and vermin intrusion. This is a maintenance recommendation.

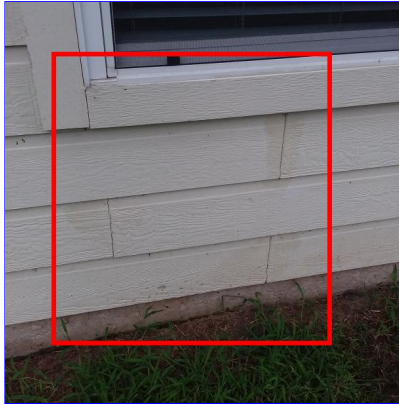
E. Item 6 (Picture) Gaps between siding boards and exterior window frames

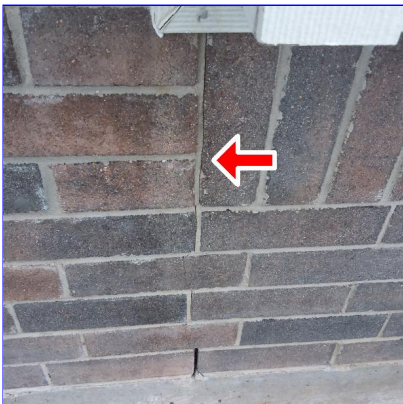
E. Item 8 (Picture) Right side

(2) The Brick siding at the exterior has step cracks caused from settlement. Deterioration can eventually occur if not corrected. A qualified contractor should inspect and repair as needed.

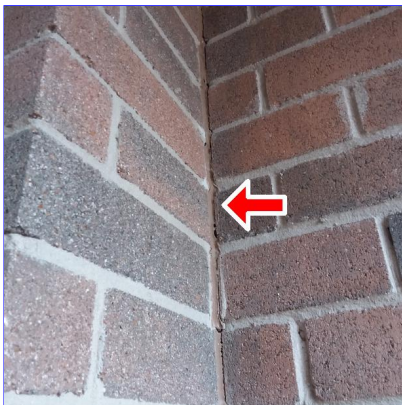
E. Item 12 (Picture) Next to front door

(3) The brick siding at the exterior of the home has expansion joint sealant that is weathered or missing. Further deterioration can occur if not corrected. A qualified person should repair or replace as needed.

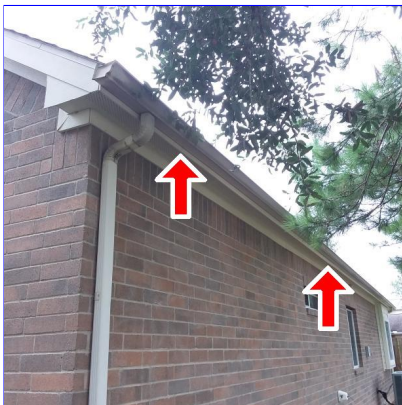
E. Item 13 (Picture) Left side

(4) There is vegetation growth on exterior of the home. This can cause damage, contribute to premature deterioration and create conducive conditions for certain wood destroying insects. I recommend removal of vegetation and having a qualified pest control company inspect and treat as needed.

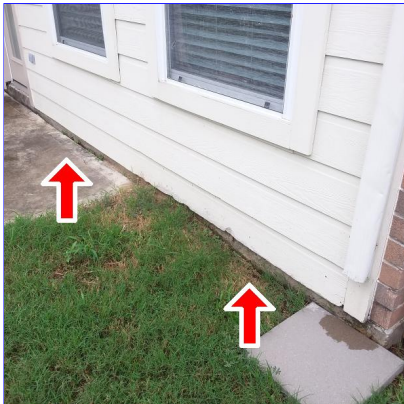
E. Item 15 (Picture) Rear

(5) The exterior siding and trim is deteriorated in areas. Further deterioration will occur if not corrected. A qualified contractor should inspect and repair as needed.

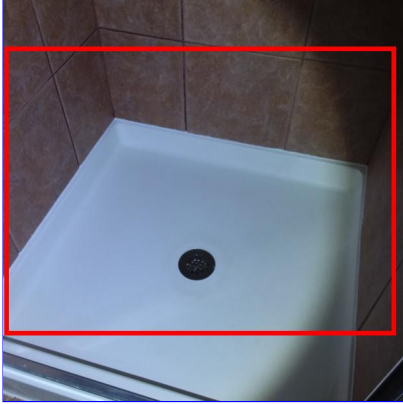
E. Item 20 (Picture) Master shower

(6) Missing weep holes on shower wall. I recommend a qualified professional to further evaluate.

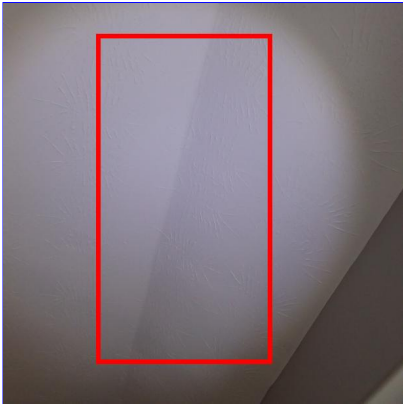
F. Item 1 (Picture) Kitchen and nook

(1) The Drywall on the ceiling reveals tape line and/or cracking. This damage is considered cosmetic. A qualified contractor should inspect and repair as needed.

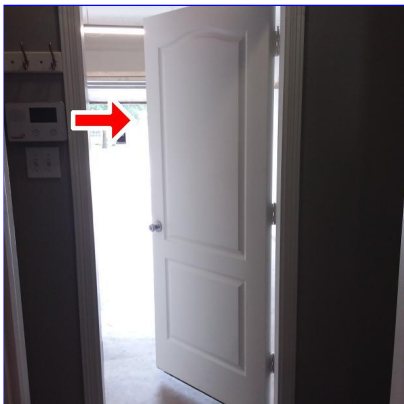
G. Item 1 (Picture) Garage entry door

(1) The interior garage door does not have the required self closing hinge. This is not considered to be today's standard. I recommend having a qualified person make repairs as needed.

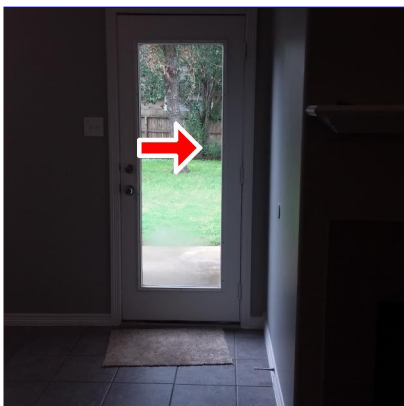
G. Item 2 (Picture) Back door

(2) Deteriorated glass on door. This is for your information.

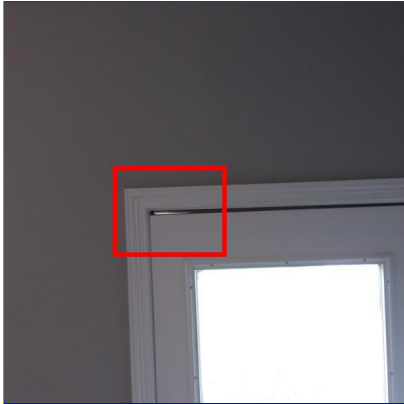
G. Item 3 (Picture) Back door

(3) The entry door reveals daylight at threshold when latched. This can cause some heat loss in winter and loss of cool air in summer if not corrected. A qualified contractor should inspect and repair as needed.

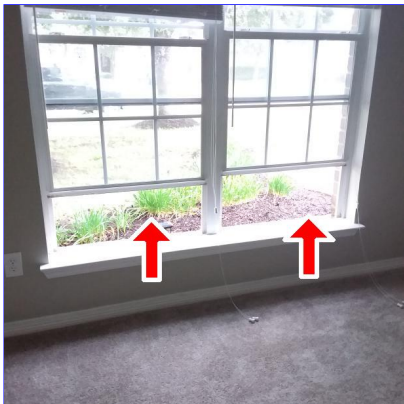
H. Item 1 (Picture) Multiple areas throughout home

(1) Windows have damaged or missing screens. This is not considered to be today's standards. I recommend having a qualified person make repairs as needed.

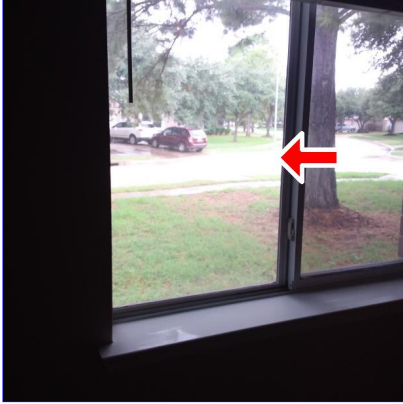
H. Item 2 (Picture) Middle bedroom

(2) The glazing between glass panes appear to be failing at some windows causing cloudy glass (If there are multiple windows that are the same age and style it is safe to assume others will soon start to fail as well). I recommend having a qualified person make repairs as needed.

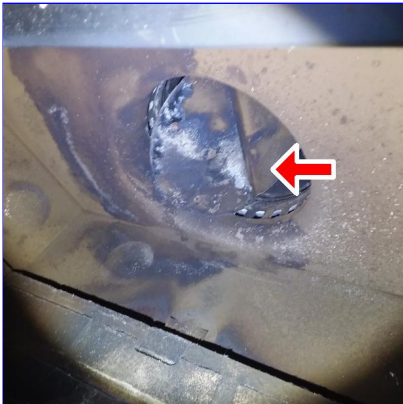
J. Item 1 (Picture) Inside fireplace

(2) Deterioration present inside fireplace. I recommend a qualified professional to further evaluate.

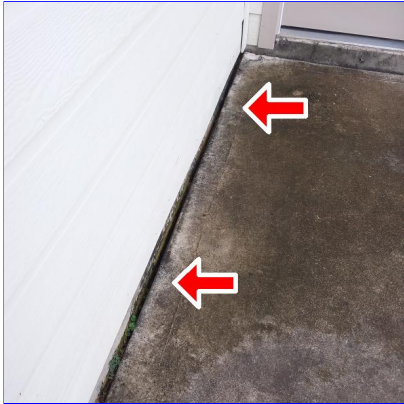
K. Item 1 (Picture) Back porch

(2) Gap between back porch and siding should be sealed to avoid water pooling. I recommend a qualified professional to correct.

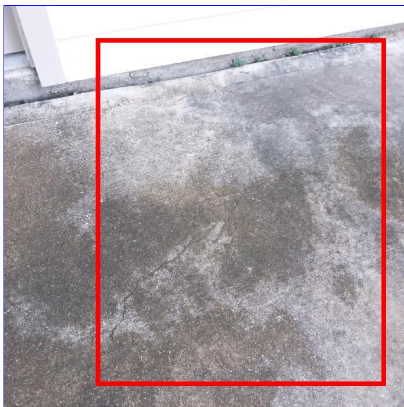
K. Item 3 (Picture) Back patio

(3) Cracking present on patio. This is for your information.

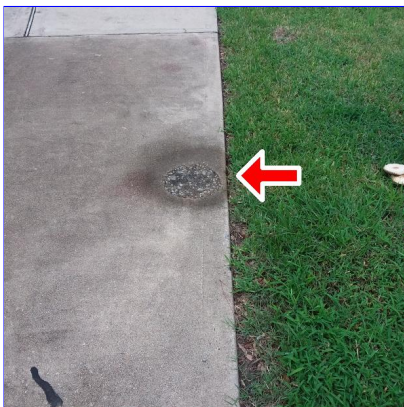
K. Item 4 (Picture) Driveway

(4) Deterioration and water pooling pm driveway. This is for your information.

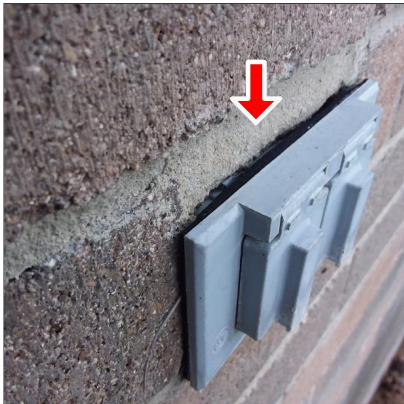
L. Item 1 (Picture) Around exterior outlets

(1) Areas of the home have caulking or grout missing or damaged. Deterioration could occur if not corrected. I recommend having a qualified contractor inspect and make repairs as needed.

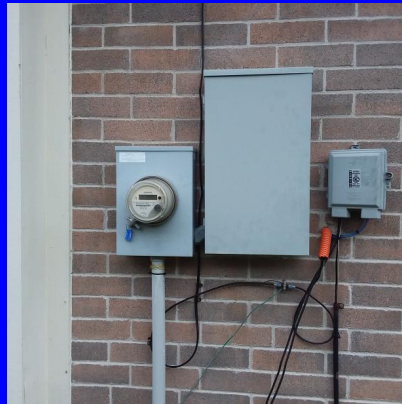
Below ground service and main panel located on the left side of the home

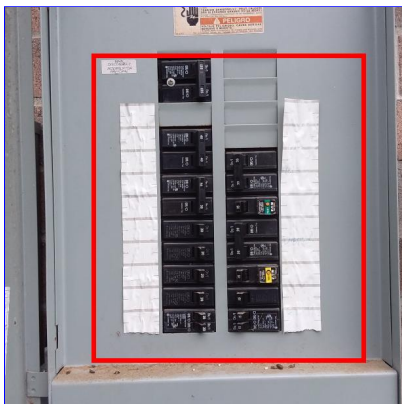
A. Item 1 (Picture) Main panel

(1) The panel is missing circuit identification. **This is a safety hazard.** I recommend having a qualified person mark circuits as needed.

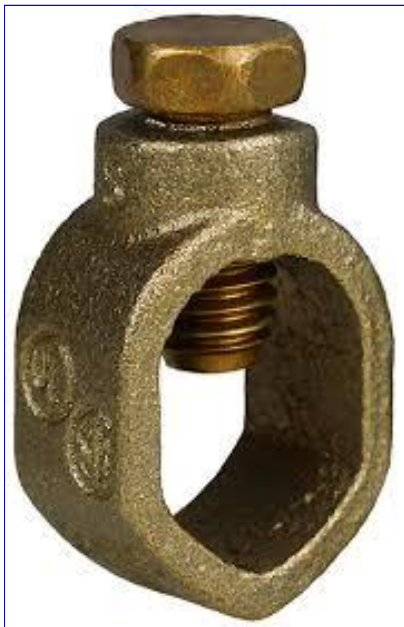
A. Item 2 (Picture)

(2) The grounding rod near meter is using improper clamp for grounding of main panel (solid brass clamp is recommended). This is not considered to be today's standard. I recommend having a qualified person replace with proper clamp to assure proper grounding.

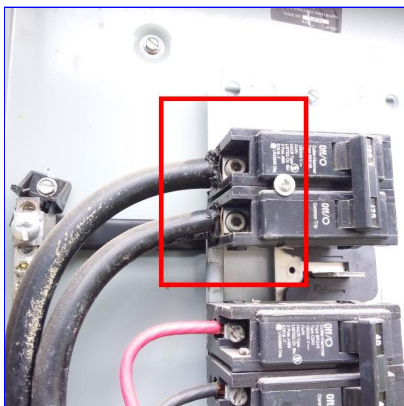
A. Item 4 (Picture) Main panel

(3) Lug covers were not installed at the service entrance wires. This is not considered today's standard.

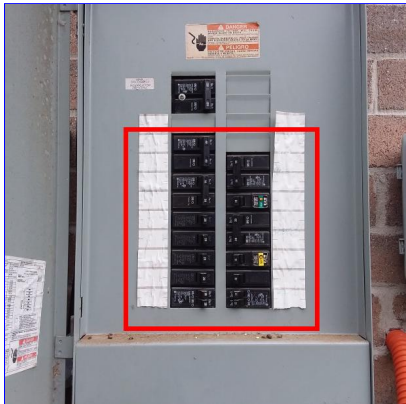
A. Item 5 (Picture) Main panel

(4) The main panel does not have a whole house surge protector. This is not today's standard. I recommend consulting a licensed electrician.

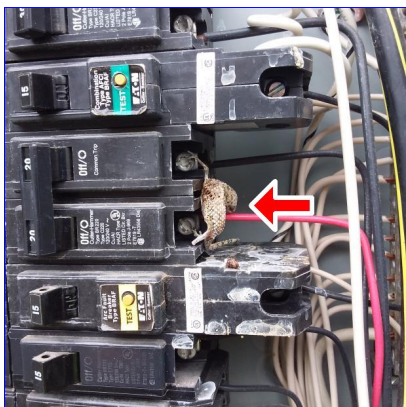
A. Item 6 (Picture) Main panel

(5) Debris present inside panel. I recommend a qualified professional to further evaluate and correct.

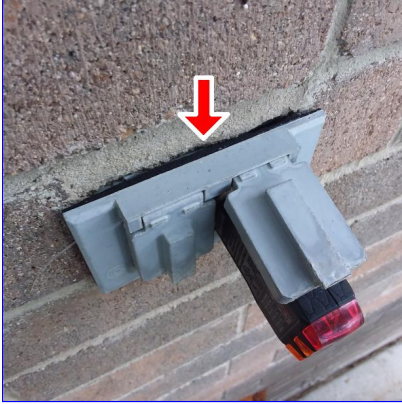
B. Item 6 (Picture) Exterior next to condenser

(3) Outlet is loose and improperly sealed. I recommend a qualified professional to further evaluate and correct.

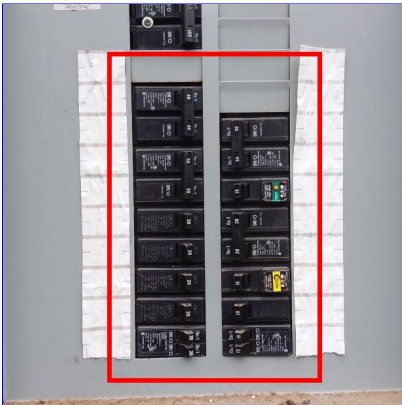
B. Item 7 (Picture) Main panel

(4) Arc fault breakers are not in required areas of home at electrical panel. This is not considered today's standard. I recommend having a qualified electrician inspect and make repairs as needed.

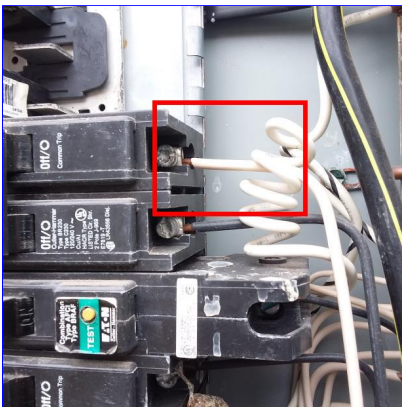
B. Item 8 (Picture) Main panel

(5) Problem(s) discovered with Branch Circuits such as wire not labeled or identified and any other problems that an electrical contractor may discover while performing repairs need correcting. I recommend a licensed electrical contractor inspect further and correct as needed.

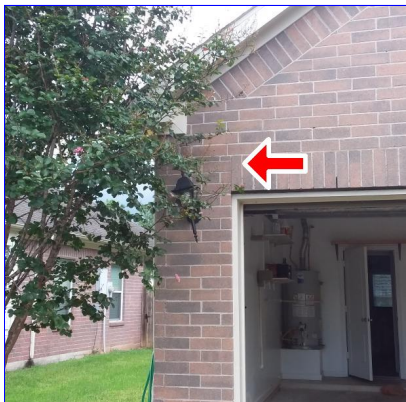
B. Item 9 (Picture) Garage light

(6) Exterior light is crooked. This is for your information.

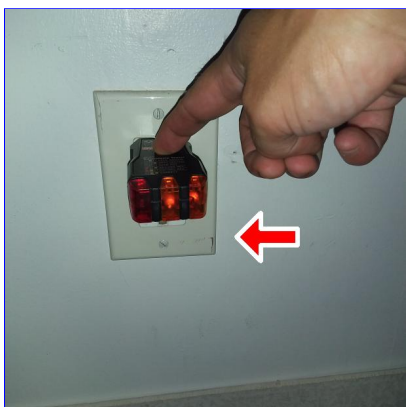
B. Item 10 (Picture) Garage

(7) Deficient GFCI outlet present, it does not reset, I recommend a qualified professional to further evaluate and repair.

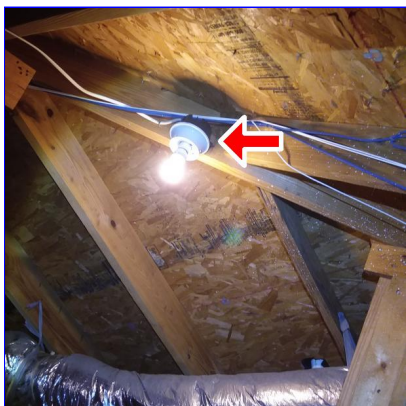
B. Item 11 (Picture) Attic

(8) The light fixture is missing cover at the in areas. This is a safety issue that needs to be corrected. A qualified licensed electrical contractor should correct as needed.

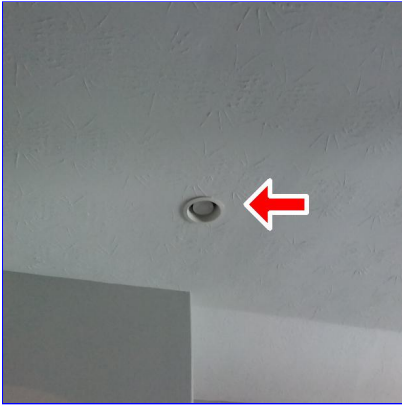
B. Item 12 (Picture) Kitchen

(9) The light fixture does not work (try bulb first). Electrical issues are considered a hazard until repaired. A qualified licensed electrical contractor should perform repairs that involve wiring.

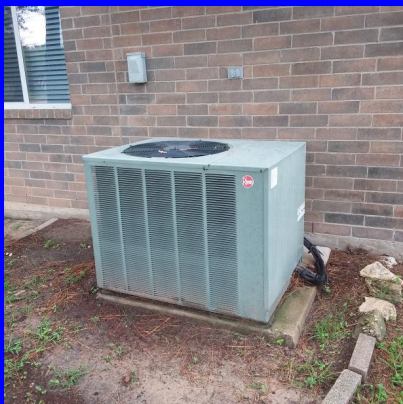
Exterior HVAC condenser located on the right side of the home

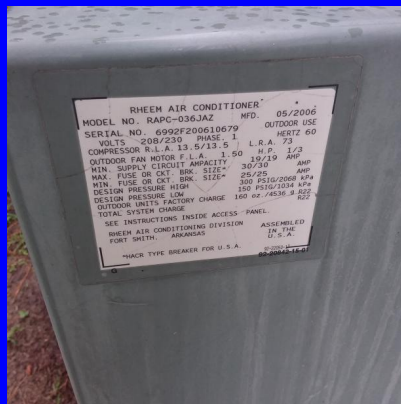
2006 Rheem condenser

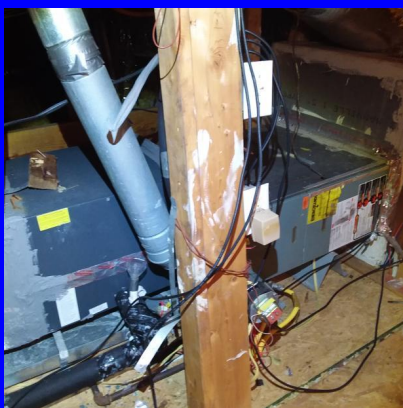
Gas furnace/air handler located in attic

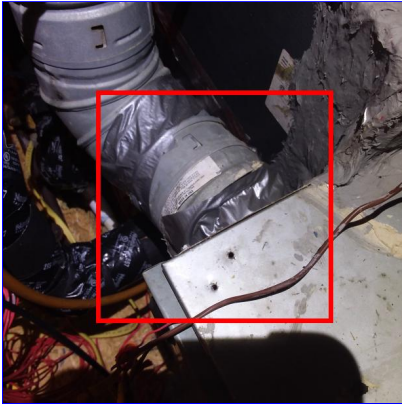
A. Item 1 (Picture) Furnace flue in attic

- (1) It is recommend to have heating systems serviced annually.
- (2) Furnace flue appears to be loose and improperly sealed. I recommend a qualified HVAC professional to further evaluate.

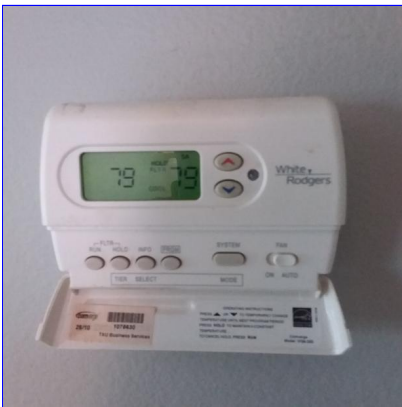
B. Item 1 (Picture) Before

(1) Thermostat before and after HVAC inspection.

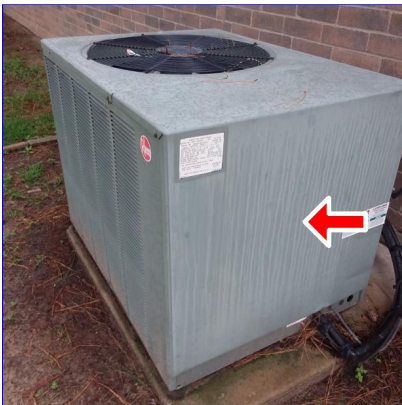
B. Item 5 (Picture) 2006 unit

(3) The condenser outside (AC unit) is old and deteriorated; may last a few years more, but maybe not. I have seen units fail shortly after a home inspection during the seasonal change from mild to hot weather. I cannot determine how long your AC will last before a replacement is necessary. I recommend a qualified HVAC professional to further evaluate.

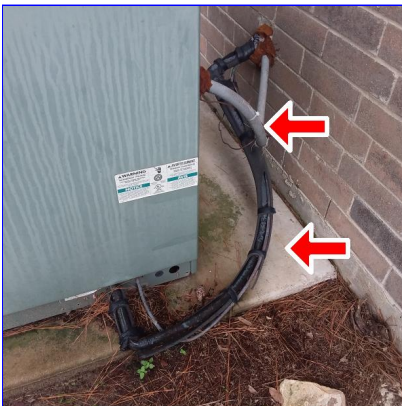
B. Item 6 (Picture) Suction line at condenser

(4) The condenser is missing foam sleeve in area(s). A replacement is needed. A licensed HVAC contractor should service or repair unit.

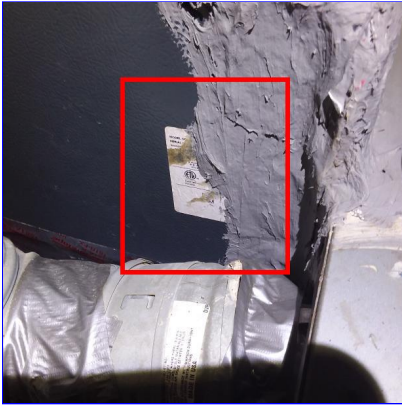
B. Item 7 (Picture) Attic unit

(5) HVAC condenser unit manufacturer plate is missing/faded. Unable to determine the nature of the unit at the time of inspection. This is for your information.

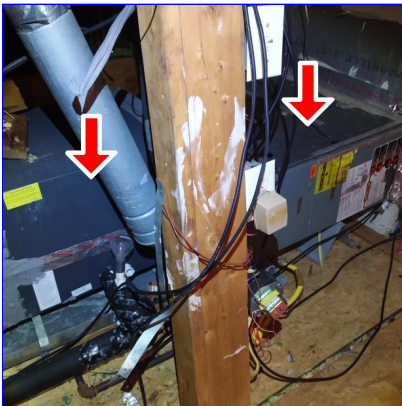
B. Item 8 (Picture) Attic

(6) I am unable to determine the age of the air handler and the furnace, both in the attic. I recommend a qualified HVAC professional to further evaluate.

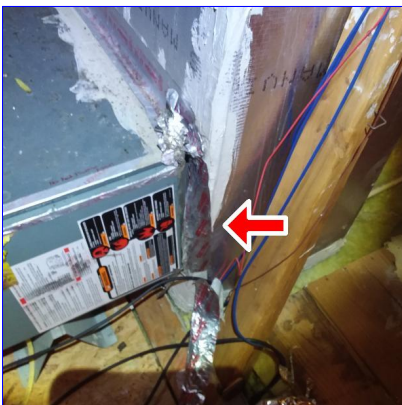
B. Item 9 (Picture) Attic HVAC

(7) Attic unit is improperly sealed. It is leaking air into the attic; I recommend a qualified HVAC professional to further evaluate.

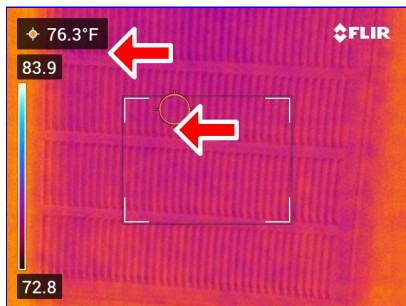
B. Item 10 (Picture) Return

(8) The ambient air test was performed by using infrared thermal equipment at the supply vents of Air conditioner to determine if the difference in temperatures of the supply and return air are between 15 degrees and 22 degrees which indicates that the unit is cooling as intended. The supply air temperature on your system read 63 degrees and the return air temperature was 76 degrees. This indicates that the unit is **not** cooling properly and a licensed Heat/Air contractor should inspect for cause or problem.

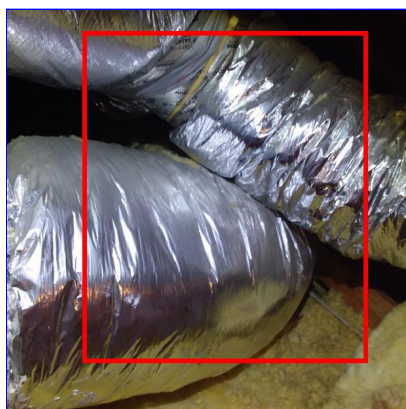
C. Item 1 (Picture) Attic areas

- (1) I recommend changing all HVAC filters upon move in.
- (2) Duct piping appears to be in contact with one another in the attic space. Condensation could occur if not corrected. I recommend having a qualified HVAC contractor further evaluate and make repairs as needed.

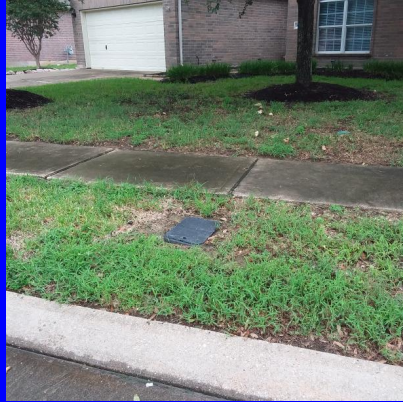
Water meter is located in front of the home to the right

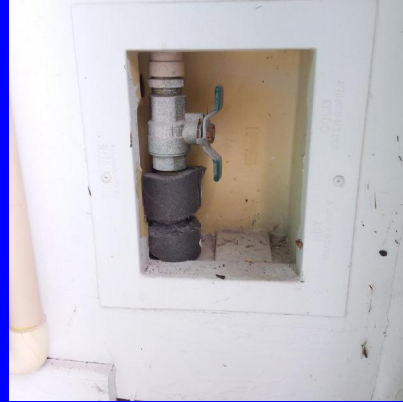
Main water shut off is located in the garage

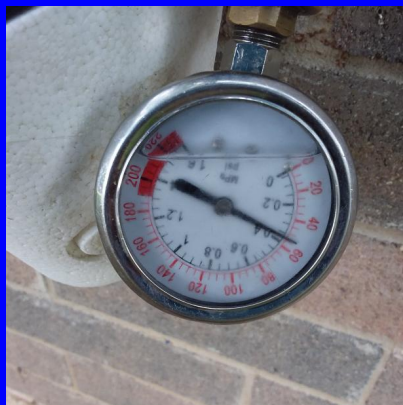
Water pressure is 55 psi

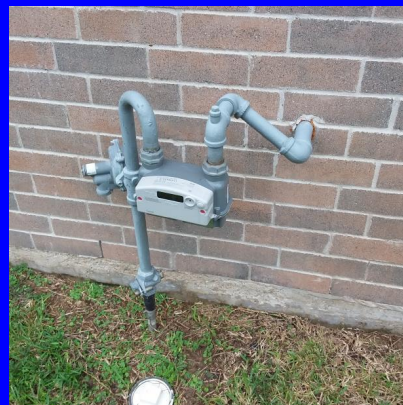
Gas meter is located on the left side of the home

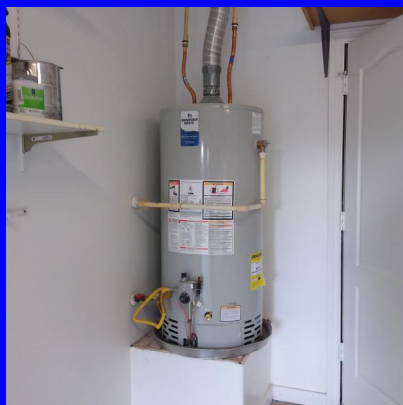
Gas water heater located in the garage

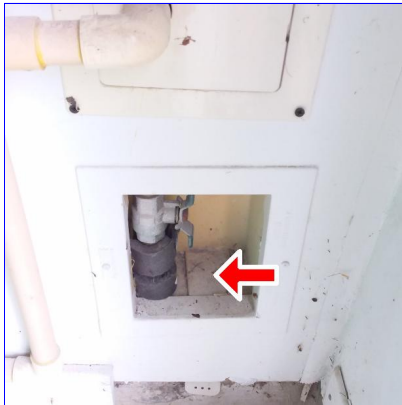
A. Item 1 (Picture) Main water supply

(2) Supply line is not properly insulated in areas. I recommend having a qualified plumber inspect and repair as needed.

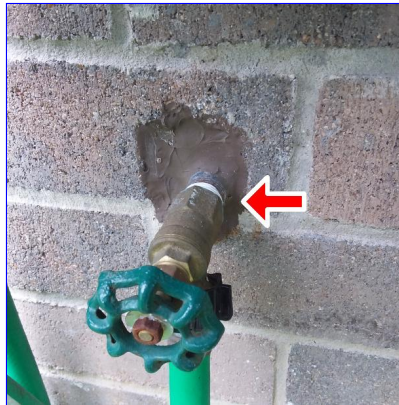
A. Item 2 (Picture) Exterior faucets

(3) There is no Anti Siphon device installed on exterior faucet(s). This is not considered to be today's standard. I recommend having a qualified person make repairs as needed.

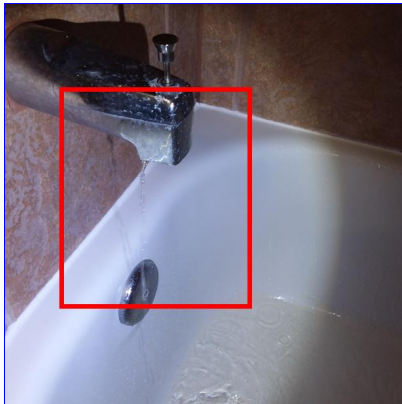
A. Item 6 (Picture) Guest bathroom

(4) Diverter is leaking while on shower mode. I recommend a qualified plumber to further evaluate.

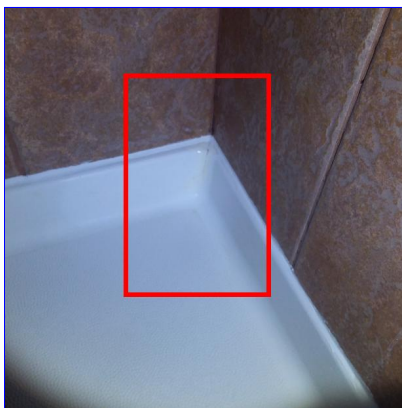
A. Item 7 (Picture) Shower

(5) Damaged master shower pan. This is for your information.

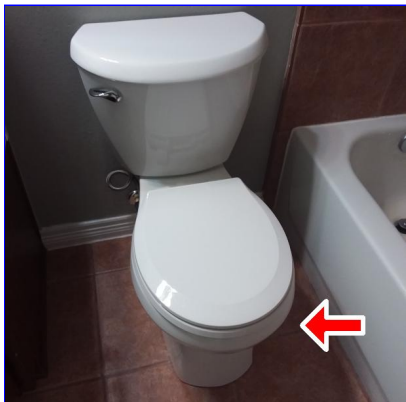
B. Item 1 (Picture) Guest bathroom

(2) The toilet is loose at floor at the bath. Repairs may involve re-setting the toilet on a new wax seal. I recommend a qualified licensed plumber repair or correct as needed.

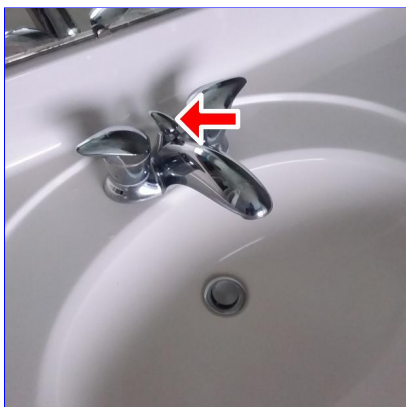
B. Item 2 (Picture) Master sink

(3) The bath sink stopper mechanism is not working properly. I recommend repairs as needed.

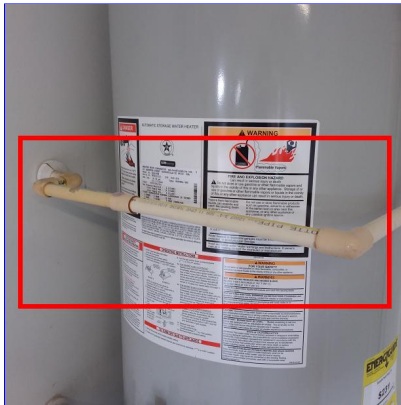
C. Item 3 (Picture) Water heater

(2) The existing piping for T&P valve on water heater is piped horizontally. This is a safety issue and should be repaired. A qualified licensed plumber should repair or correct as needed.

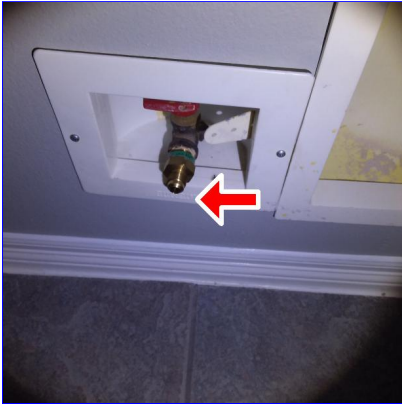
E. Item 1 (Picture) Dryer line in laundry room

(1) Unused gas lines should be properly capped off. I recommend correcting.

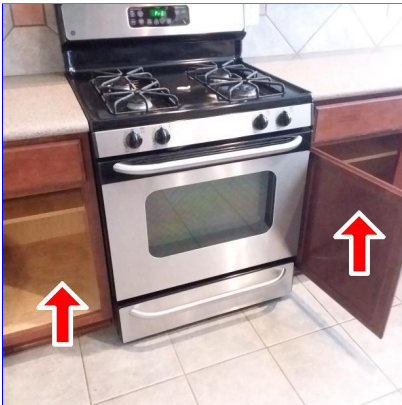
E. Item 2 (Picture) Range

(2) Range does not appear to have an easily accessible gas shutoff valve. This is not considered today's standard. I recommend having a qualified plumber repair as needed.

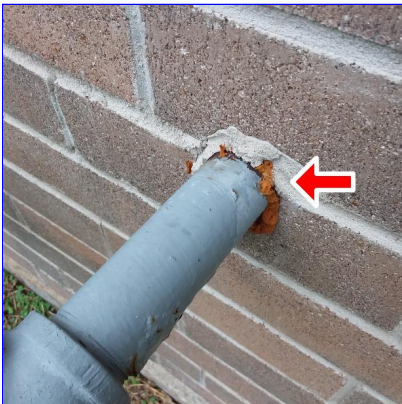
E. Item 3 (Picture) Gas meter

(3) Missing protective sleeve on gas line entering the home through brick siding. I recommend a qualified professional to further evaluate.

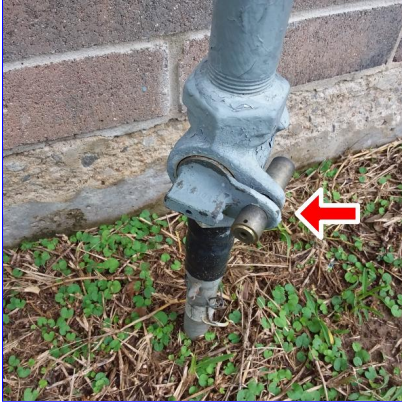
E. Item 4 (Picture) Gas meter

(5) Gas was off to the home at the time of inspection. This is for your information.

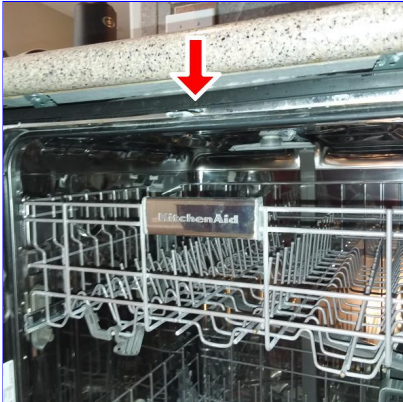
A. Item 1 (Picture) Dishwasher

The dishwasher is loose and needs securing to underside of countertop (using a proper length screw). I recommend repair as necessary.

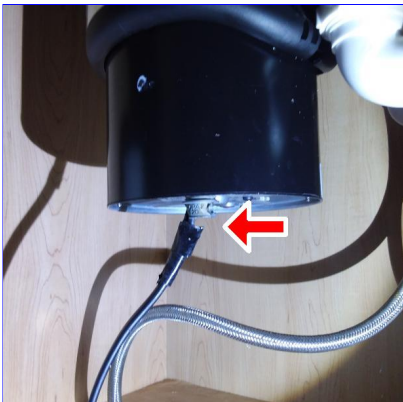
B. Item 1 (Picture) Disposer

The food disposer wiring is missing a wire connector (anti-strain device). I recommend repair as needed.

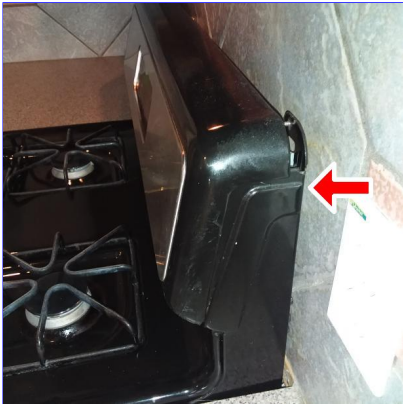
D. Item 1 (Picture) Range

(1) Loose range panel cover, this is for your information.

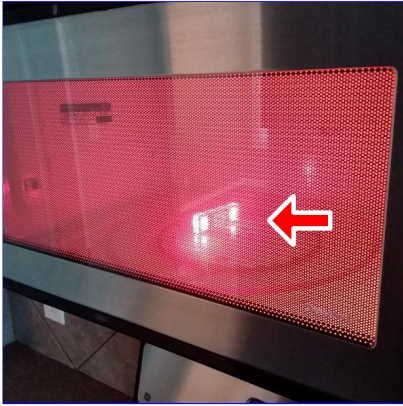
E. Item 1 (Picture) Radiation leak tester inside microwave indicates the unit is working

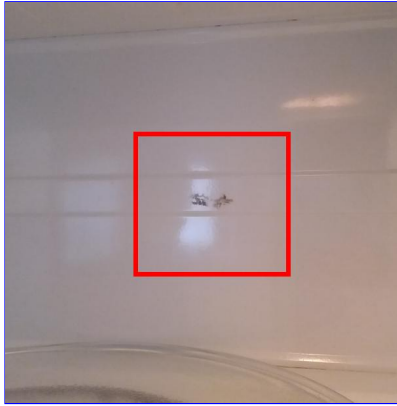
E. Item 2 (Picture) Deterioration

Tested and working at the time of inspection. However, there is a small area showing deterioration inside unit. I recommend a qualified professional to further evaluate.

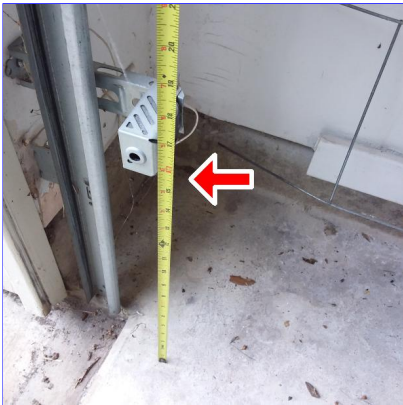
G. Item 1 (Picture) Both sensors

(2) The automatic opener for at the garage has electronic sensors located higher than six inches off floor which may not be installed according to manufacturers specification. This is considered unsafe and needs correcting. A qualified person should repair or replace as needed.

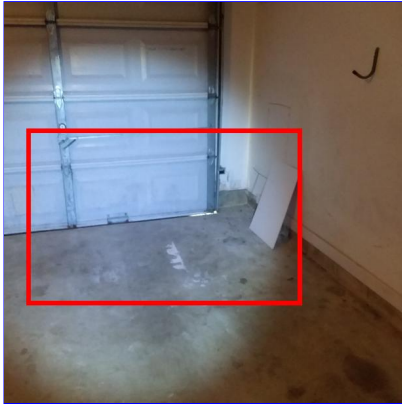
G. Item 2 (Picture) Garage door

(3) Garahe door doesn't close all the way. I recommend a qualified professional to further evaluate.

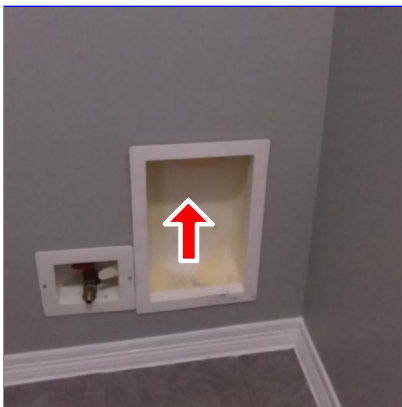
H. Item 1 (Picture) Laundry room

The dryer vent piping is long and vertical which can trap lint at elbow. Vent pipes should be cleaned regularly if they are longer than normal (10 feet or more) or vented vertically. I recommend cleaning and/or repair as needed.

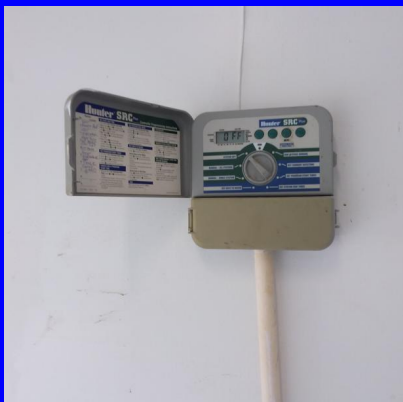
Sprinkler system control panel is located in the garage

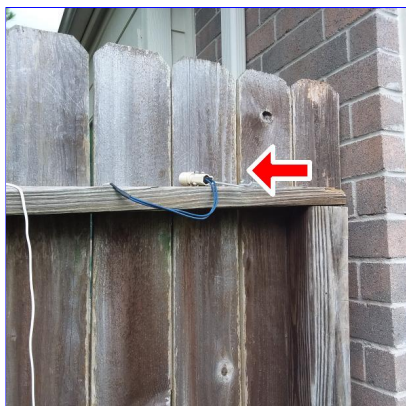
A. Item 1 (Picture) Rear

(1) Loose bypass rain sensor. This is for your information.
