## HOME INSPECTION REPORT

104 April Point Dr N  
Montgomery, TX 77356

# PROPERTY INSPECTION REPORT FORM

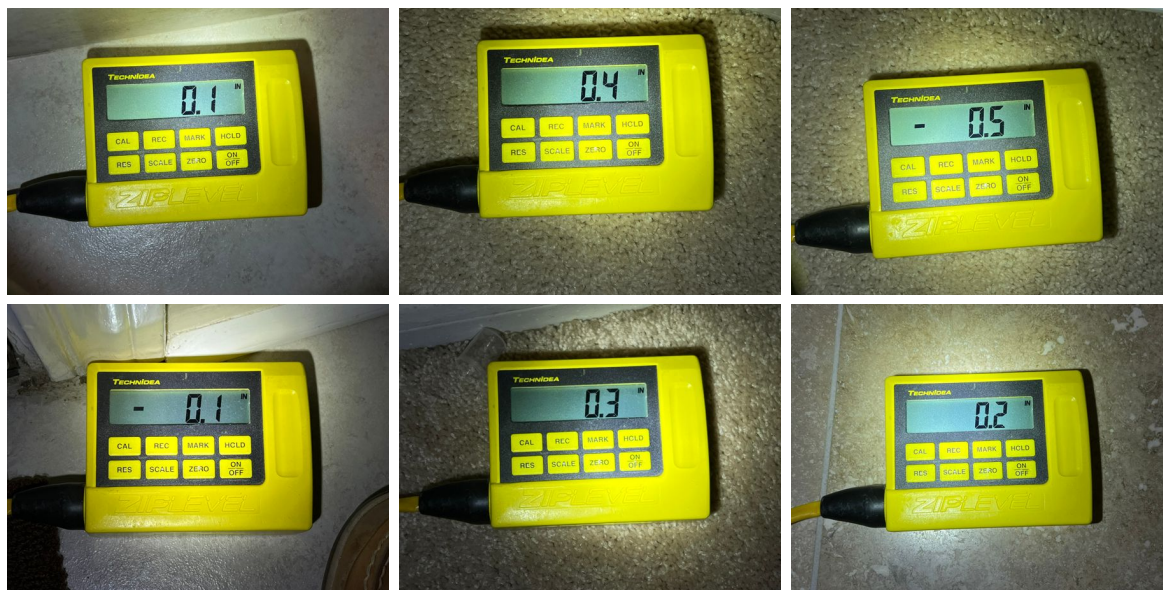
This foundation was measured with the use of an electronic digital measurement tool. Multiple elevation points were registered on the foundation throughout the property to determine if there are elevation variations that indicate excessive movement of the foundation. At the time of this inspection, the measured areas did not indicate any variations that, in this inspectors OPINION, indicate any need for invasive repairs to the foundation.

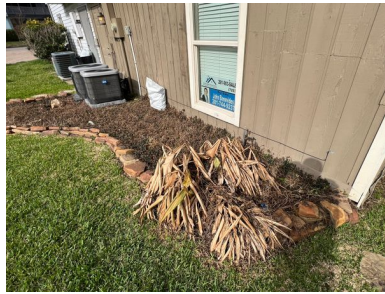
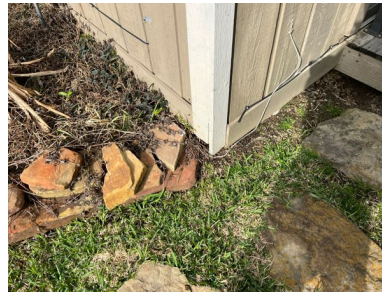
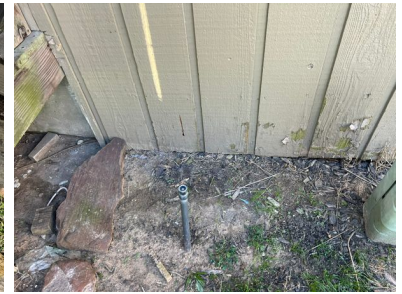
**1: Soil - Inadequate Clearance**

There was soil located too close to the siding at one or more locations. This condition can provide an entrance for moisture and/or wood destroying insects. Ideally, at least 4 inches of clearance should be maintained between the soil level and the base of the siding.

Recommendation: Contact a qualified professional.

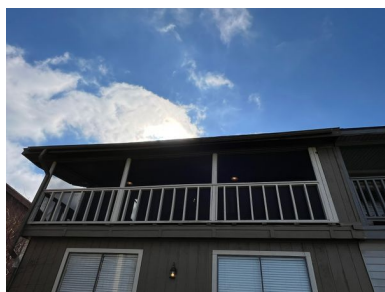
The gutters at one or more locations were incorrectly sloped. This condition can result in improper drainage, spillage and water to pool in the gutters, which can encourage corrosion and shorten the lifespan of the gutters.

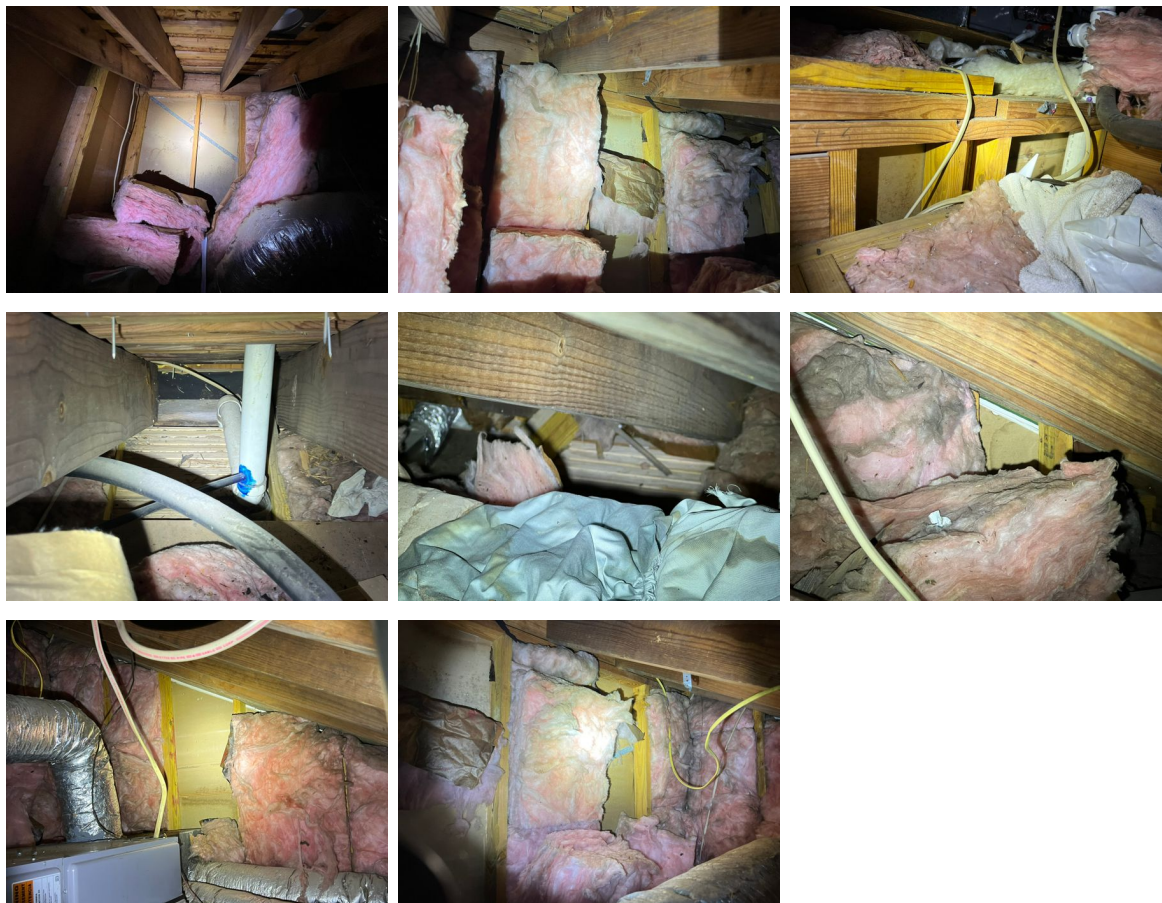
The insulation was missing/displaced/inadequate at multiple areas. This condition can result in increased heating and cooling costs and reduced comfort levels in the house. The insulation should be properly distributed to cover all portions of the attic located above the living space.

Recommendation: Contact a qualified insulation contractor.

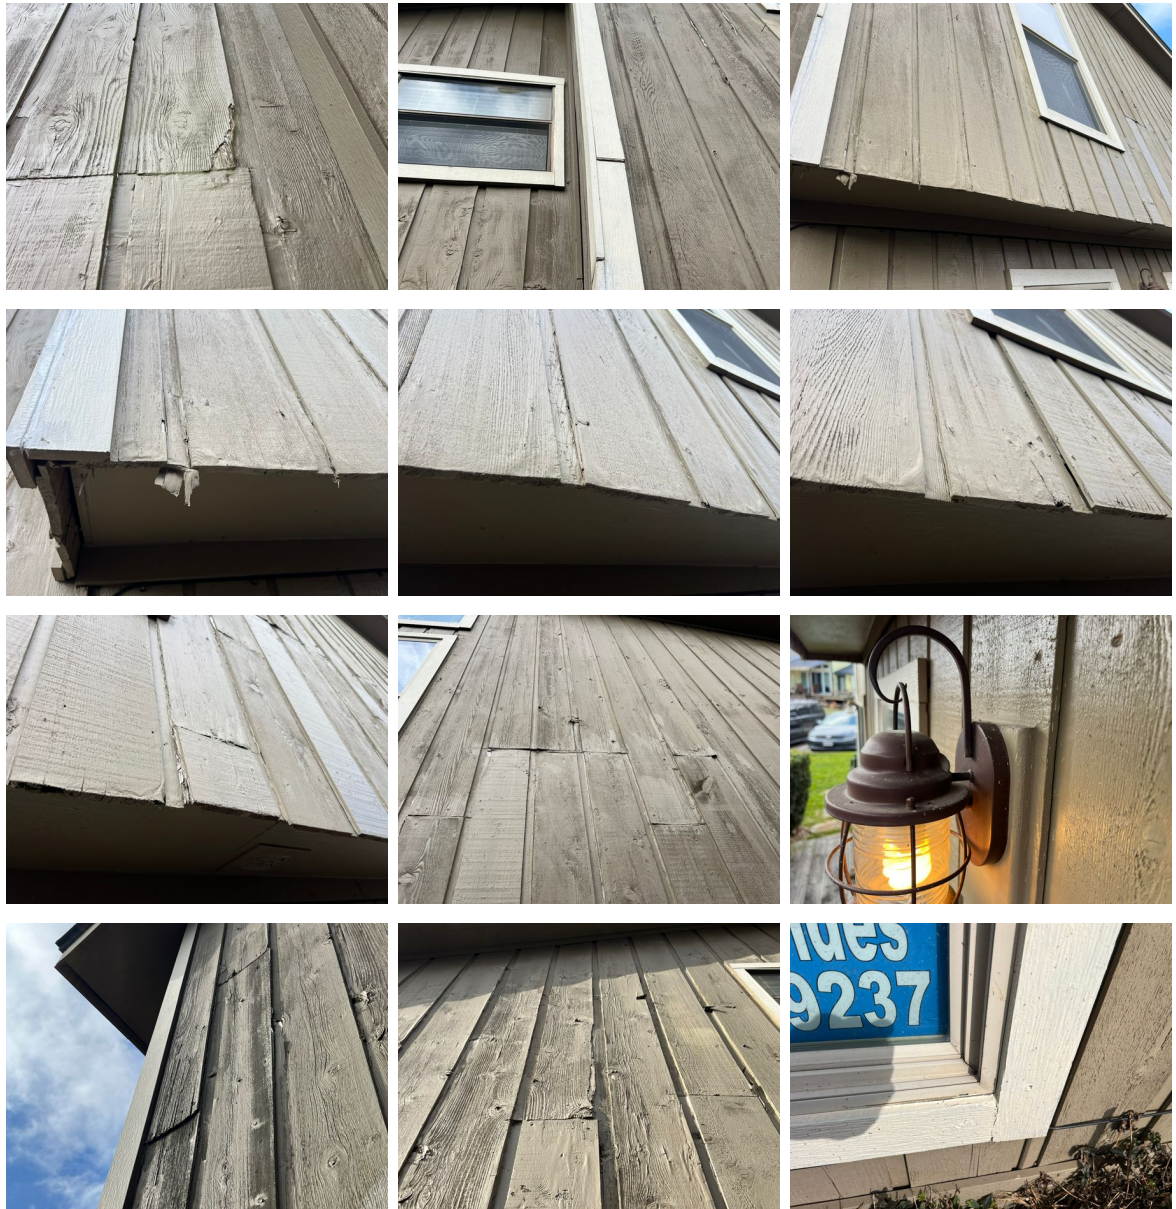
**1: Siding - Repair Recommended**

Maintenance/repairs to the siding/trim are recommended: damaged, deteriorated or loose sections should be repaired/secured, all flashings and penetrations should be evaluated and sealed/repaired as needed.

Recommendation: Contact a qualified siding specialist.

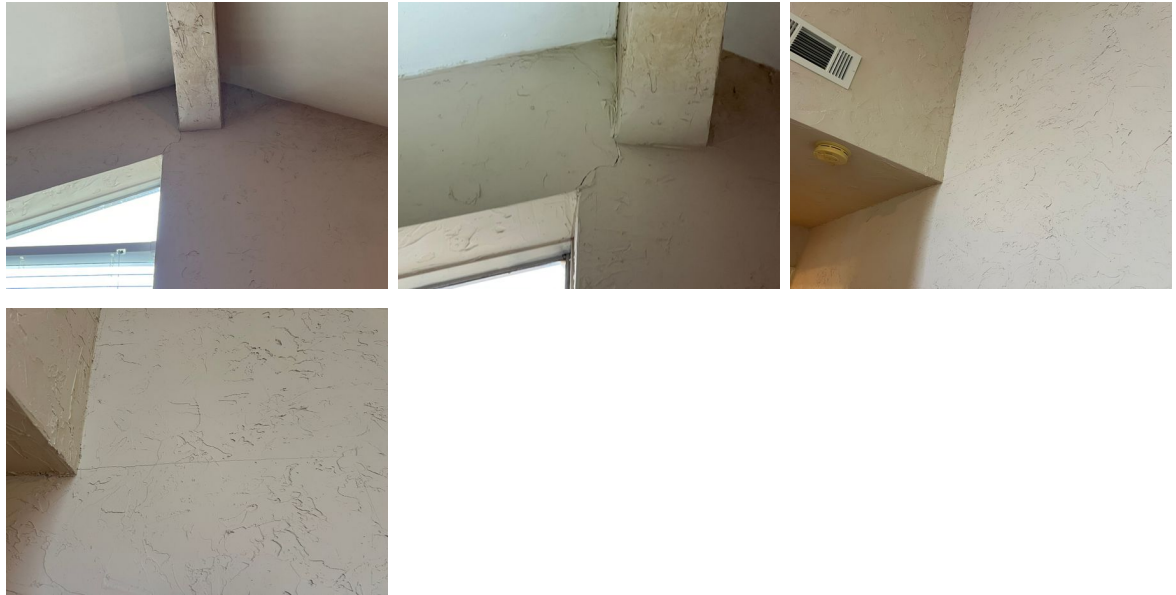
**2: Drywall - Cracks**

There were cracks noted at the interior walls.

Recommendation: Contact a qualified drywall contractor.

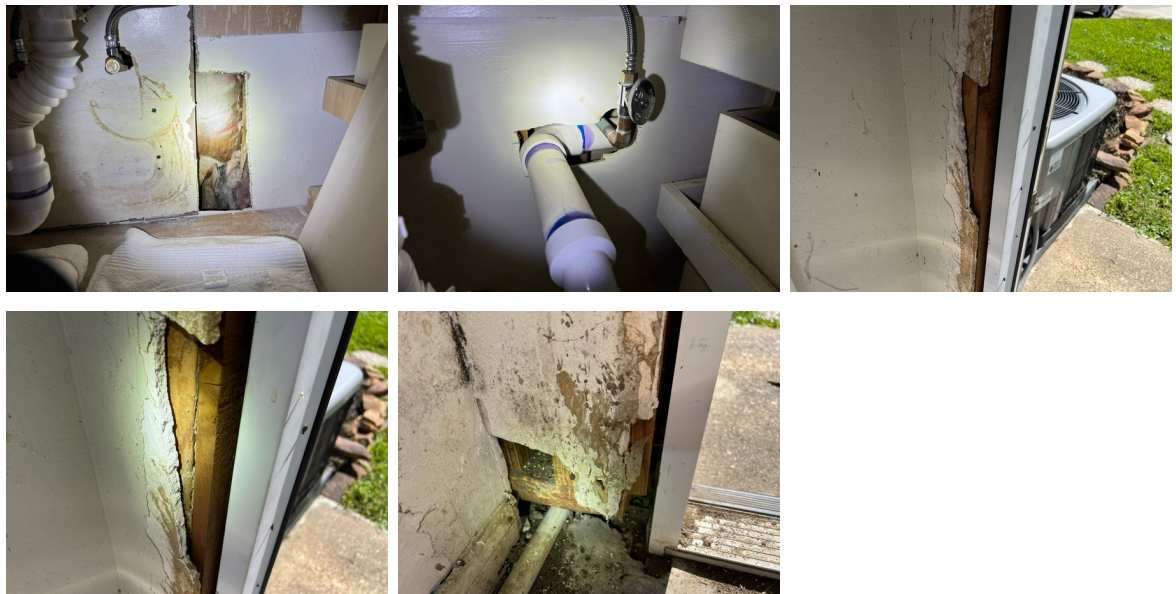
### 3: Drywall - Damaged

Upstairs Bath , Primary Bath , Exterior Closet ,  
Damaged drywall was observed.

Recommendation: Contact a qualified drywall contractor.

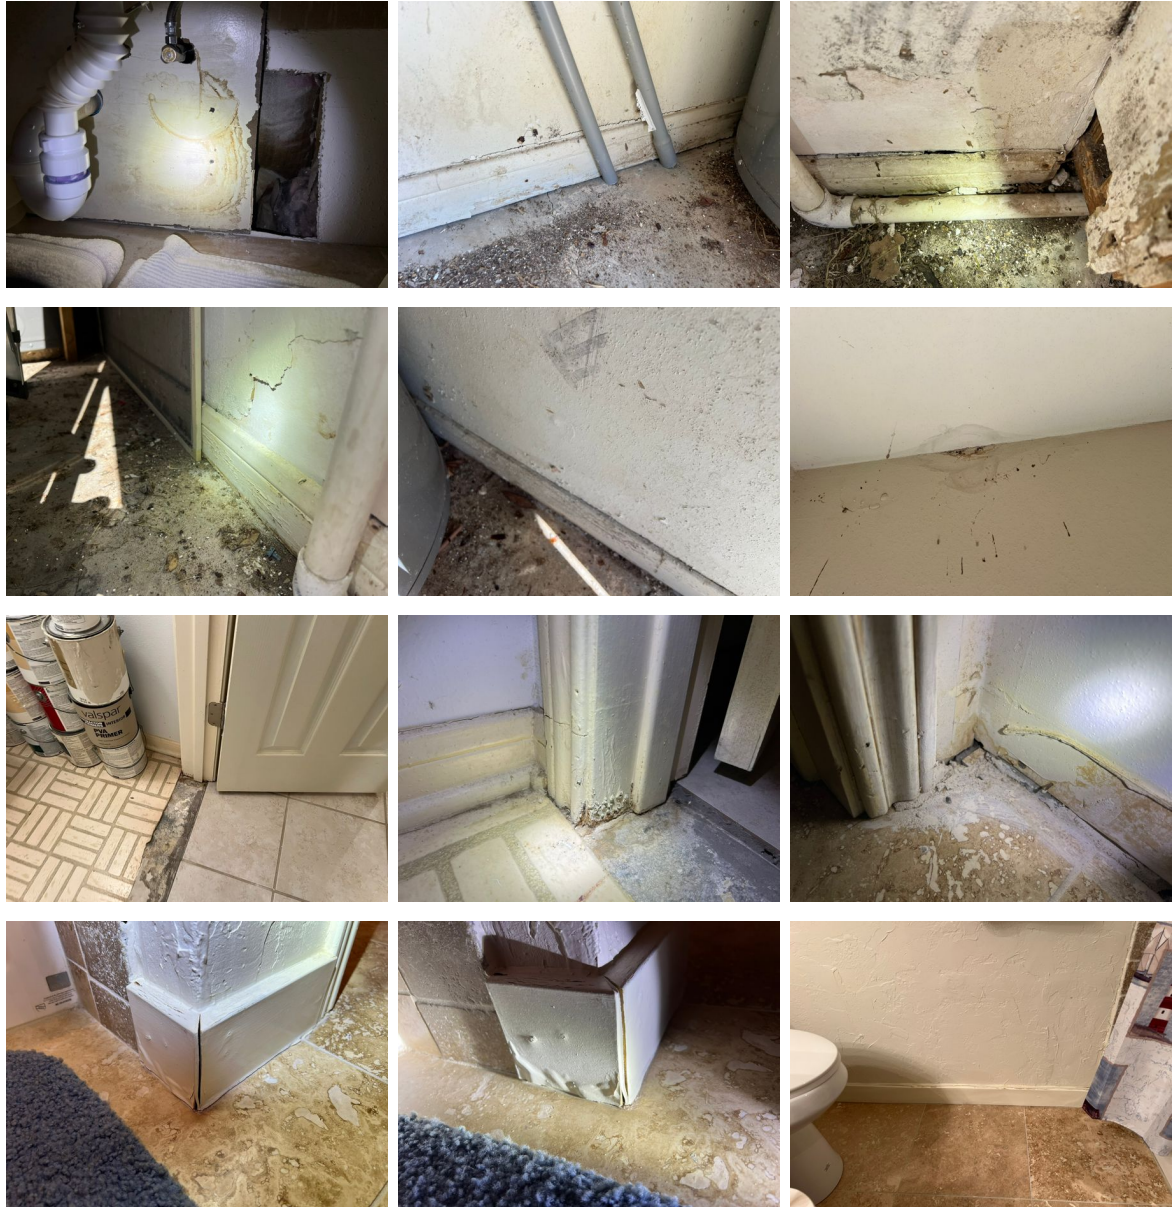
### 4: Water Staining/Damage

Water staining/damage was observed. No active moisture was measured at the time of inspection, however monitoring is recommended to determine if a moisture source contributes to its presence. If further evaluation is desired contact a qualified contractor.

Recommendation: Contact a qualified professional.

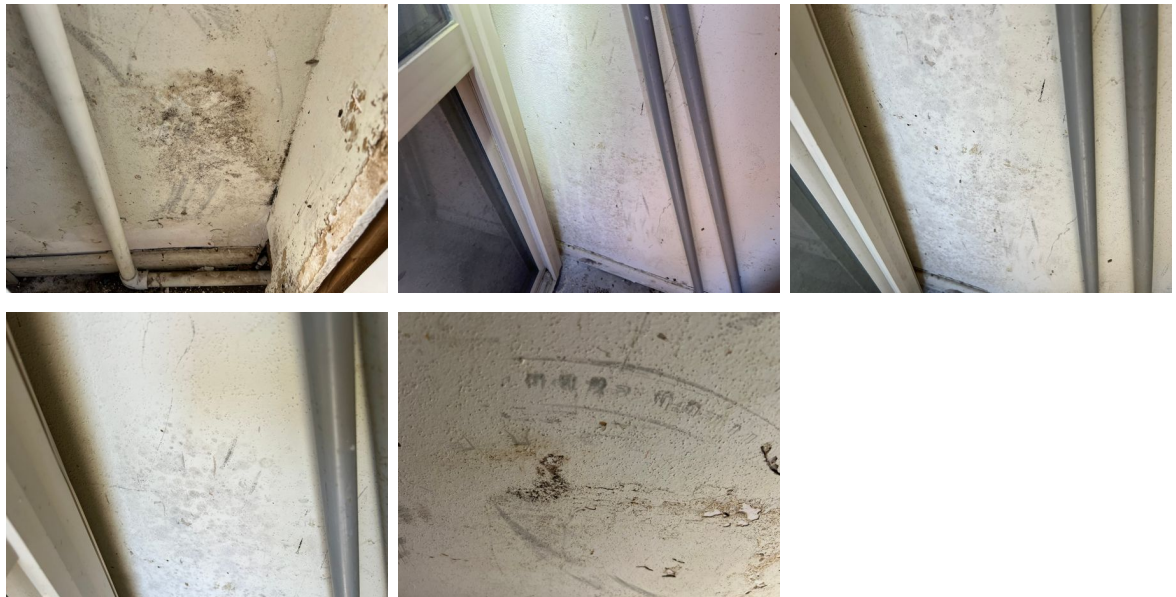
**5: Mildew Type Growth**

An unidentified mildew type growth was observed. This should be further evaluated to determine if a moisture source continues to contribute to its presence. If so, corrective actions should be taken to stop the moisture source. If there are concerns about the nature of this growth, an expert in microbial growth should be retained to evaluate it.

Recommendation: Contact a qualified professional.

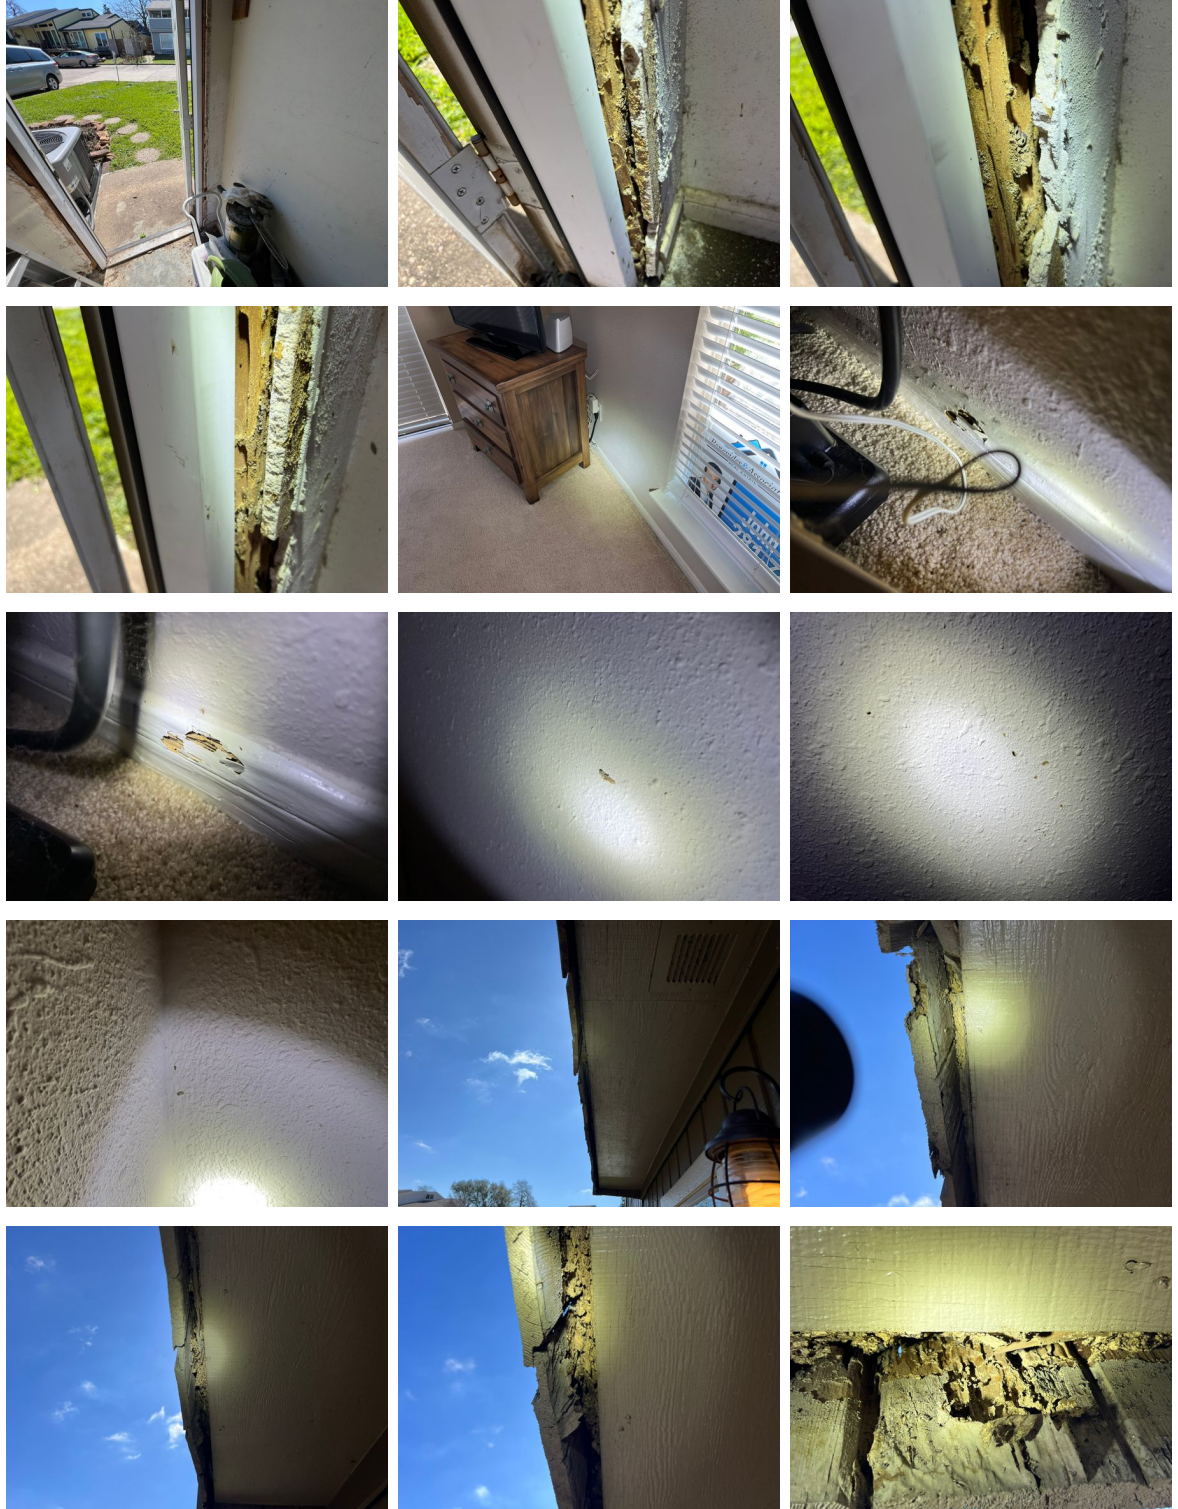
**6: Damage**

Exterior Closet , Primary Bedroom , Right Exterior ,  
Damage to the wall was observed. Further evaluation by a qualified contractor is recommended.

Recommendation: Contact a qualified professional.

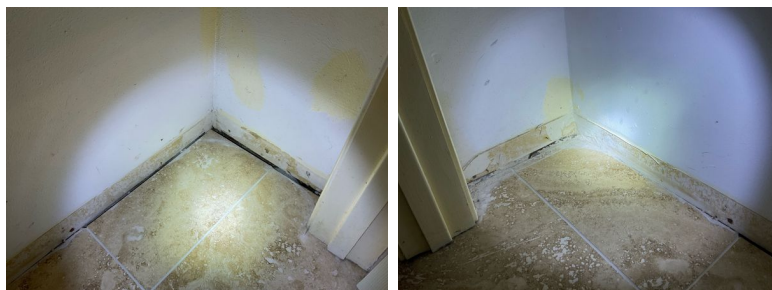
**7: Baseboard - Missing**

Primary Bath Closet , Upstairs Bath ,  
Missing baseboard was observed.

Recommendation: Contact a qualified professional.

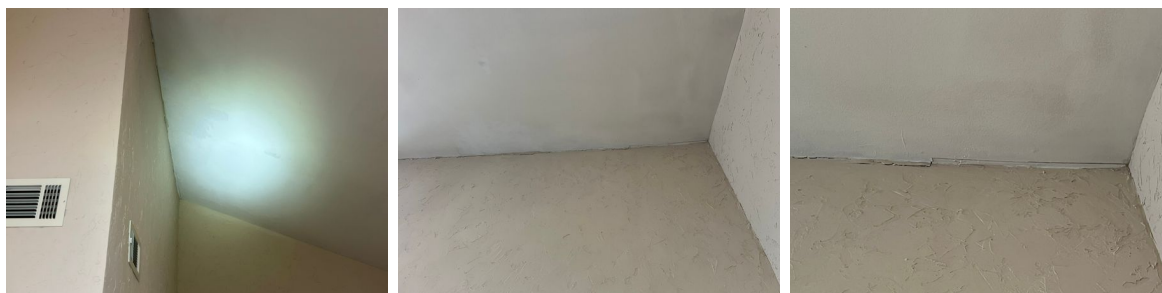
**1: Drywall - Cracks**

Cracks in the drywall were observed.

Recommendation: Contact a qualified drywall contractor.

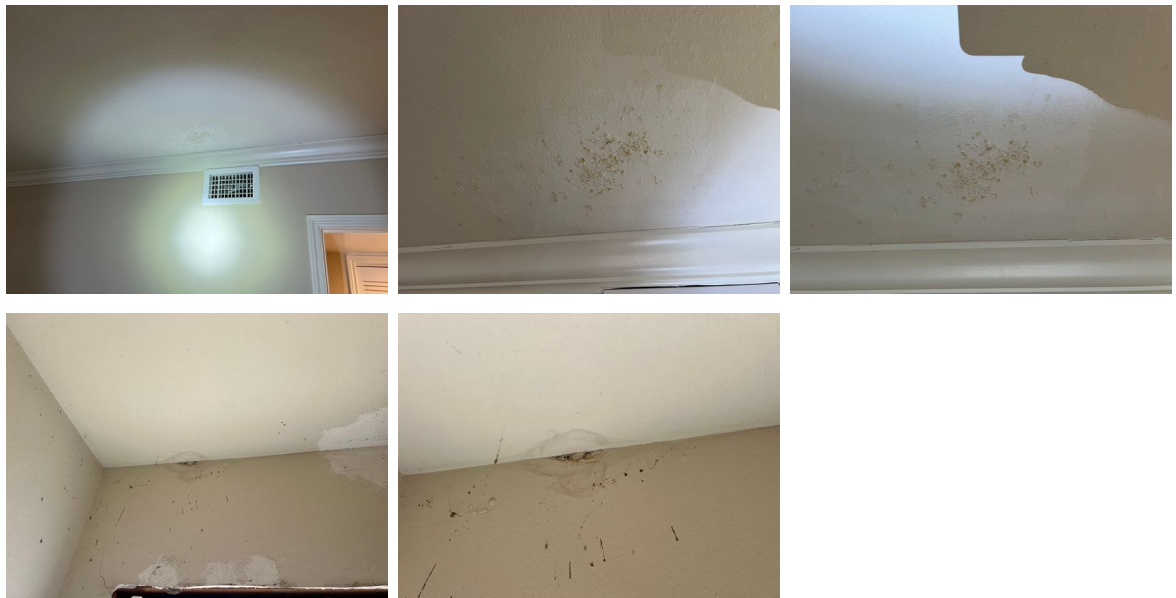
**2: Water Staining/Damage**

Downstairs Rear Right Bedroom , Exterior Closet , Upstairs Bath , Living Room ,  
Water staining/damage was observed. This area should be further evaluated to determine if a moisture source contributes to its presence, if so repairs should be undertaken.

Recommendation: Contact a qualified professional.

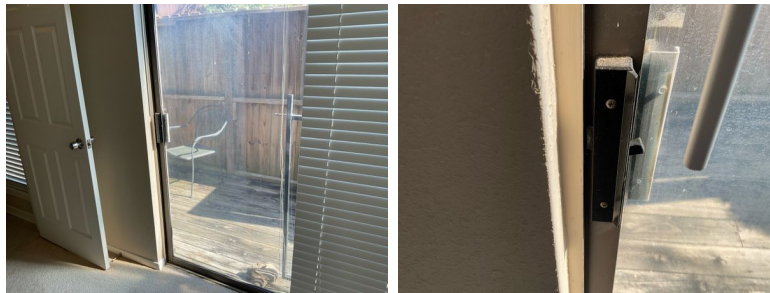
Right Exterior, Primary Bedroom Exterior ,  
The door did not latch/close properly.

Recommendation: Contact a qualified door repair/installation contractor.

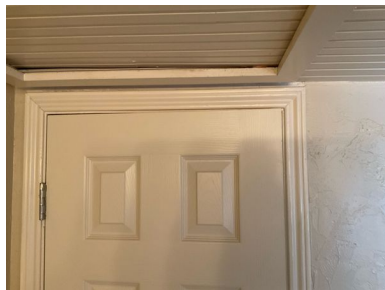
**2: Sticks In Frame**

Upstairs Bath ,  
The door binds/sticks in the frame.

Recommendation: Contact a qualified door repair/installation contractor.

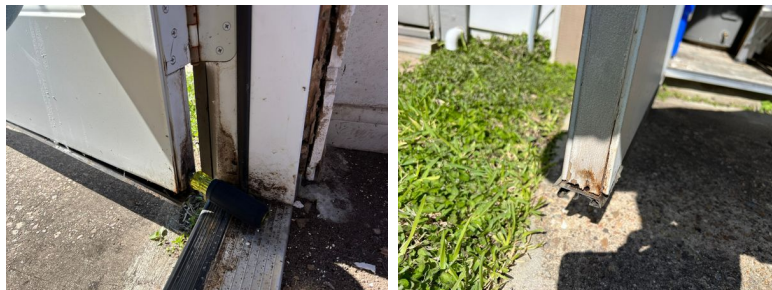
**3: Deterioration**

Exterior Closet ,  
There was deterioration/damage observed at the exterior door and/or door frame.

Recommendation: Contact a qualified door repair/installation contractor.

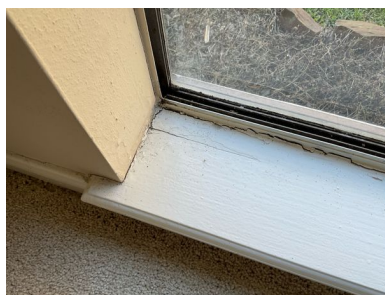
### 3: Water Staining

Water contact/damage was observed at the perimeter of the window. Sealing at the exterior and monitoring is recommend.

Recommendation: Contact a qualified handyman.

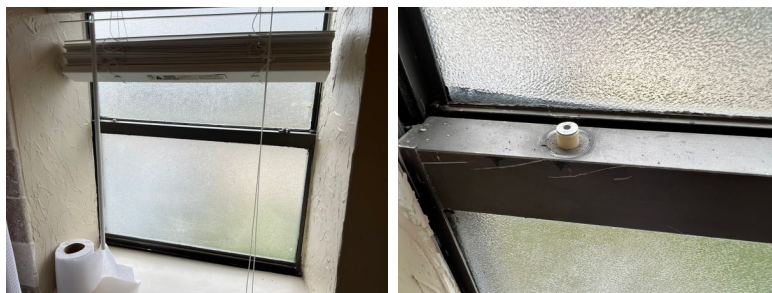
### 4: Hardware - Damaged

Damaged hardware was observed.

Recommendation: Contact a qualified window repair/installation contractor.

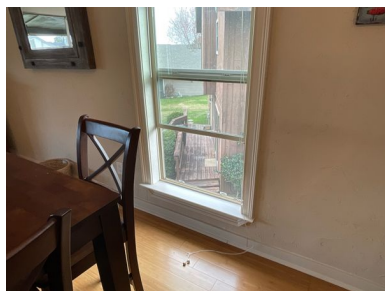
### 5: Fall Protection - Missing

exterior grade. The fall protection should limit the opening of a window that meets these requirements so that a object 4 inches or larger cannot pass through the opening.

Recommendation: Contact a qualified window repair/installation contractor.

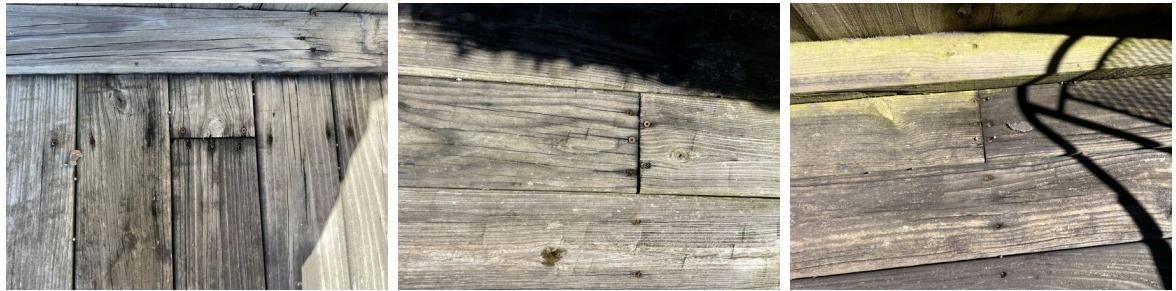
Minor wear/deterioration/damage was observed at the deck boards.

Recommendation: Contact a qualified professional.

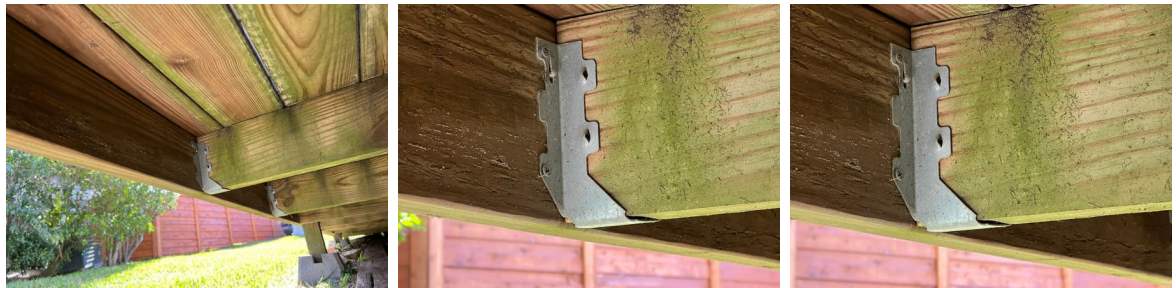
**2: Deck - improper support**

The deck was improperly supported at multiple areas.

Recommendation: Contact a qualified professional.

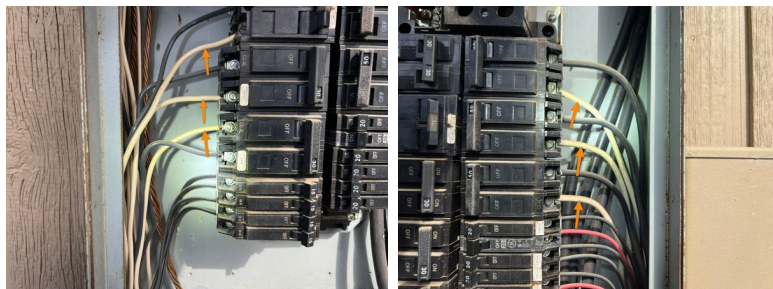
Any wires with white sheathing that are used as hot wires (connected to breakers) should have black tape or markings on them to indicate to service personnel that they are used as hot wires and not as neutrals.

Recommendation: Contact a qualified electrical contractor.

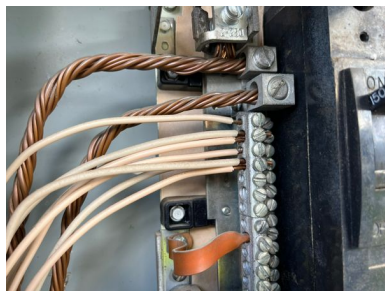
There was double lugging (multiple wires under one screw) present on one or more neutral lugs in the electrical panel. One neutral wire per lug is standard.

Recommendation: Contact a qualified electrical contractor.

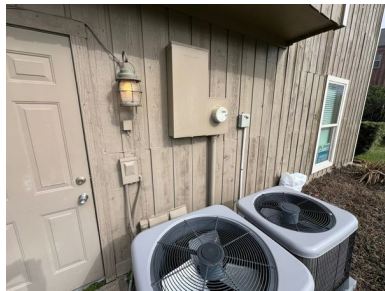
The electrical panel did not have proper clearances. The clear working space required in front of a panel is 30 inches wide by 36 deep with a minimum headroom clearance of 6 feet-6 inches.

Recommendation: Contact a qualified professional.

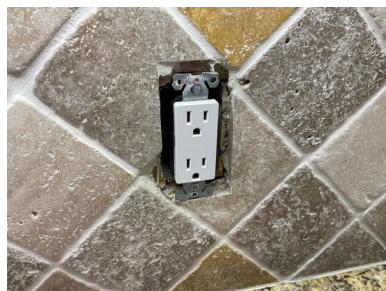
The electrical box was not flush with the wall (recessed into wall). A box extender should be installed so that the box is flush with the front face of the wall.

Recommendation: Contact a qualified professional.

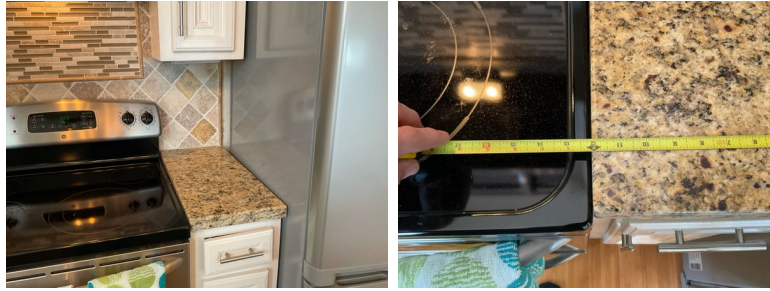
There was no outlet present at one or more of the kitchen countertops. Any countertop 12 inches wide or more should have an outlet present.

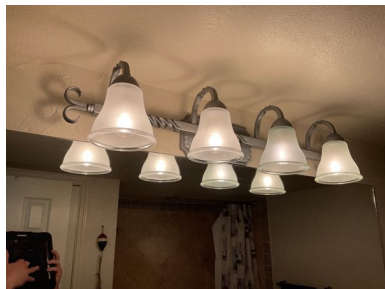
**8: Light - Loose**

An improperly secured light fixture was observed.

Recommendation: Contact a qualified professional.

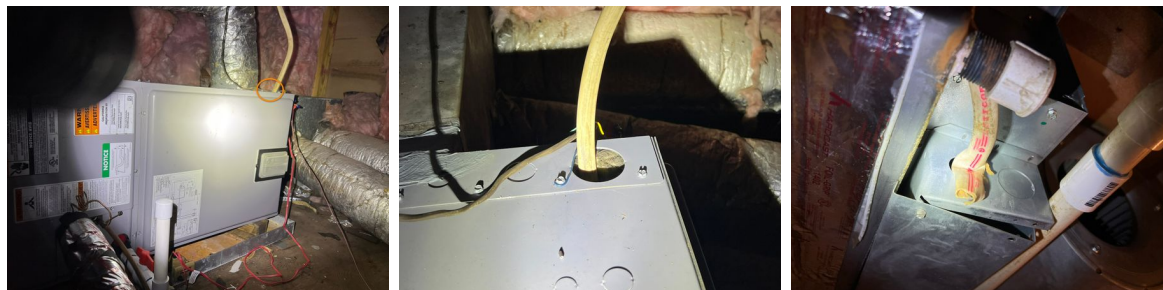
Grommets were missing at one or more locations where wiring passes into/through a metal enclosure. Grommets serve to protect the wiring from the metal edges of the enclosure.

Recommendation: Contact a qualified electrical contractor.

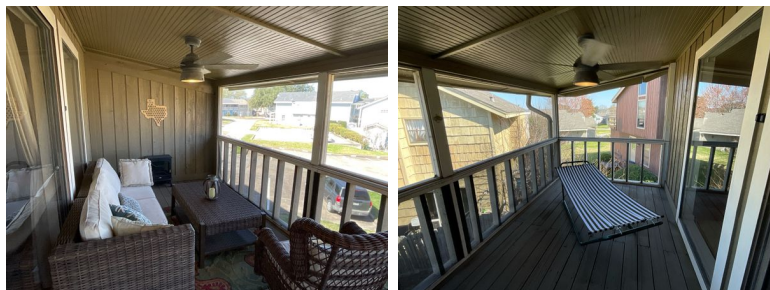
The ceiling fan was not raised to the required 7 feet above the floor.

Recommendation: Contact a qualified electrical contractor.

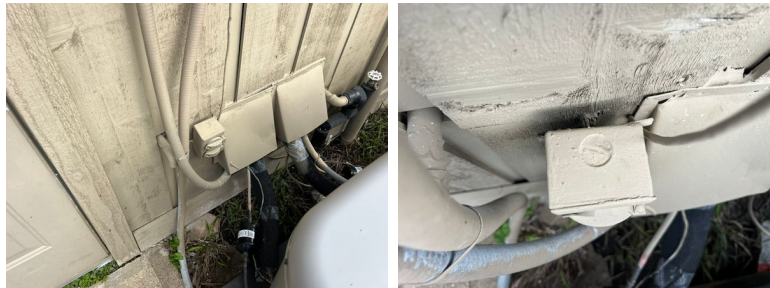
An improperly secured junction box was observed.

Recommendation: Contact a qualified professional.
