TPI FOUNDATION PRE-POUR INSPECTION REPORT

2915 Rehburg Rd
Brenham, TX 77833

TPI OPEN FRAME INSPECTION REPORT

TPI HOME INSPECTION

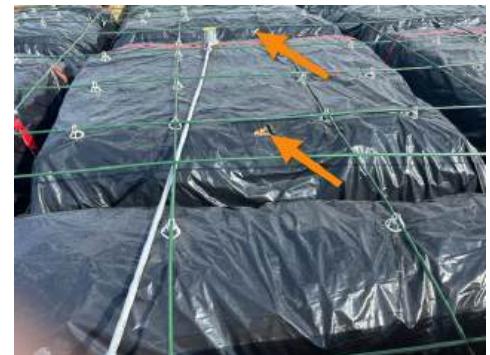
3.1.1 Foundation

PATCH/TAPE NEEDED ON PLASTIC VAPOR BARRIER

Recommendation

Contact a qualified professional.

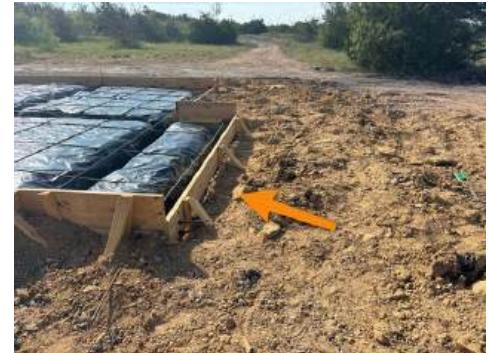
3.1.2 Foundation

BACK FILL NEEDED PRIOR TO POUR

Recommendation

Contact a qualified professional.

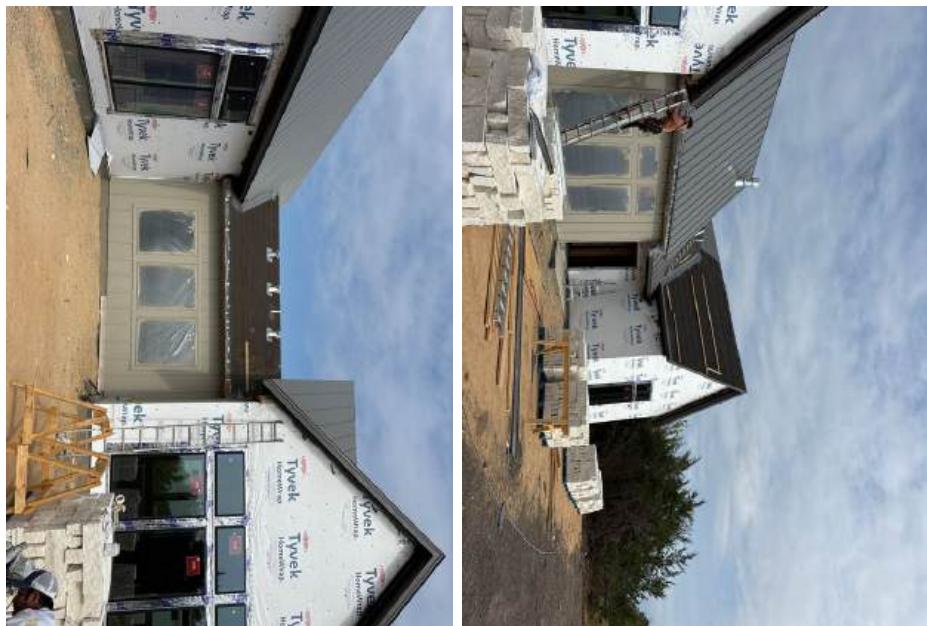
Coverings: General Condition

Installation Incomplete

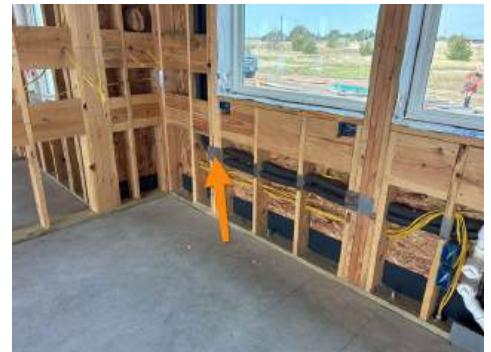
LOOSE NAILING PLATES

Nail plate needs to be fully driven to provide proper support.

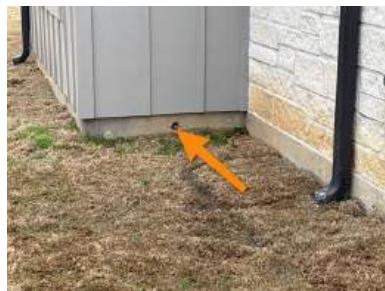
Exposed/rusted post tension cable ends were noted at the foundation perimeter beams. Tensioned cables embedded in the slab terminate at the edge of the foundation and exposure to the elements can cause rusting and reduced strength. The cables should be cleaned and covered over with a non-shrink/non-metallic grout.

Recommendation: Contact a qualified concrete contractor.

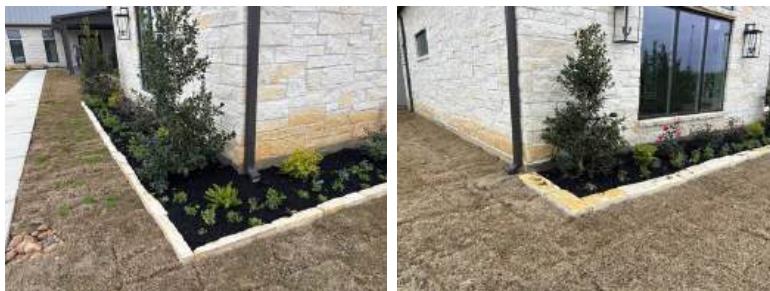
**1: Foliage in contact with structure****Deficient - Maintenance Item**

Bushes/trees/vines should not contact exterior wall coverings or windows. Foliage allows for wind driven abrasion damage, provides insects access into the structure, and the moisture promotes decay of building materials.

Recommendation: Contact a qualified pest control specialist.

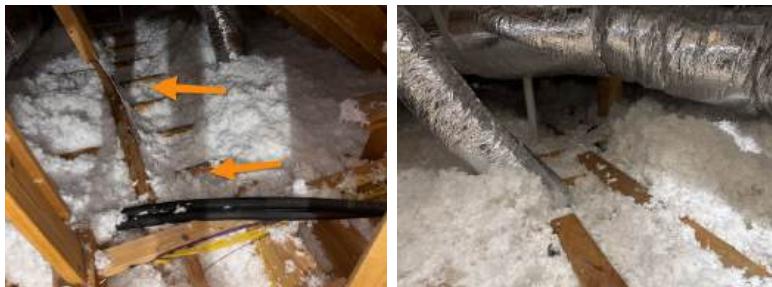
1: Uneven attic insulation

Attic insulation is inadequate in several areas. The insulation has been moved by foot traffic for repair / remodeling and was not redistributed evenly in some areas. Gaps in the insulation can cause condensation and heat loss. Replace insulation as necessary for adequate thermal protection. Current requirements are 12-14 inches of insulation.

Recommendation: Contact a qualified insulation contractor.

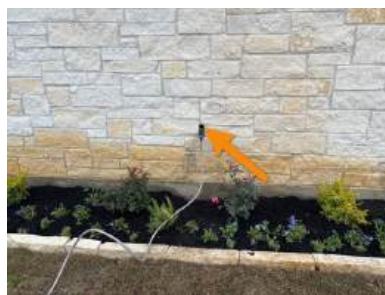
Gaps at exterior walls can develop due to several factors, including natural settlement of the home, improper installation of building materials, thermal expansion and contraction, or moisture infiltration. These gaps, if left unaddressed, can lead to further structural issues, water intrusion, and reduced energy efficiency.

1. Sealing Small Gaps: For minor gaps, applying a high-quality, exterior-grade caulk or sealant can help fill and seal the gaps. This prevents water penetration, insect intrusion, and energy loss. The caulk should be flexible enough to accommodate future movement in the materials.
2. Repairing or Replacing Damaged Materials: For larger gaps or areas where the exterior wall materials are damaged, repair may involve replacing the affected siding, brick, or stucco, and ensuring proper flashing and moisture barriers are in place.
3. Ongoing Maintenance: Regular inspection and maintenance of exterior walls, including monitoring for new gaps and maintaining caulking and seals around windows, doors, and joints, can help prevent future issues.

Recommendation: Contact a qualified painting contractor.

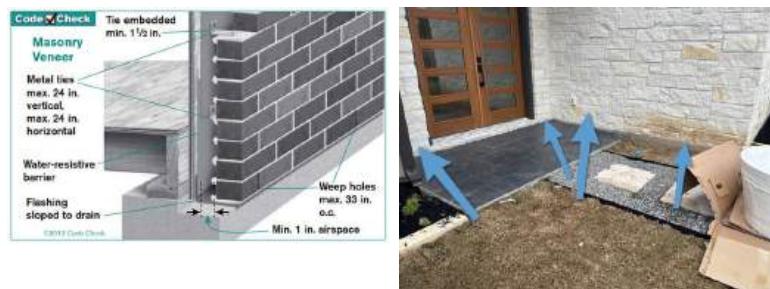
2: No weep holes are installed in masonry walls

Weep holes in masonry walls allow moisture to drain out the bottom of the wall.

Recommendation: Contact a qualified masonry professional.

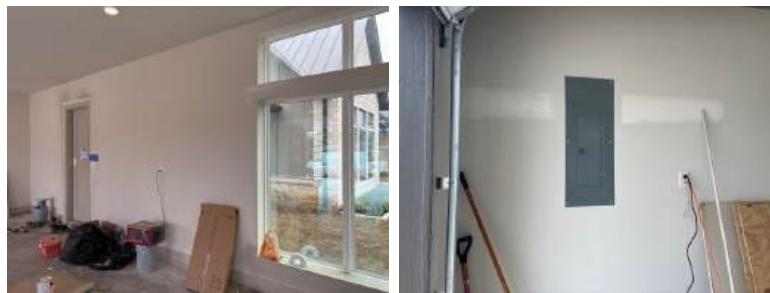
3: Exterior unfinished work / cosmetic repairs

Unfinished work, painting and cosmetic repairs or touch ups are needed.

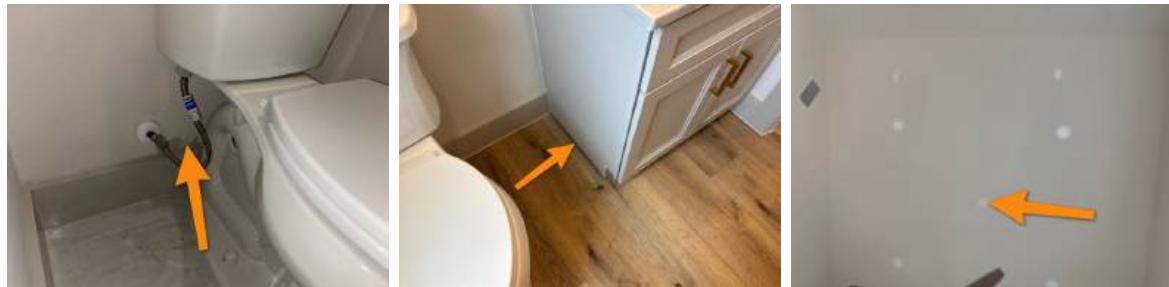
I NI NP D**4: Interior unfinished work/cosmetic repair needed**

Unfinished work, painting and cosmetic repairs or touch ups are needed. Cosmetic surface damage that is readily noticeable should be repaired.

Recommendation: Contact a qualified professional.

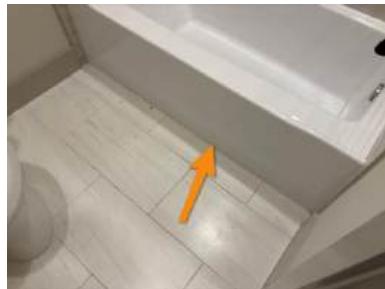
The floor covering is not sealed at the tub in bathroom. Spill-overs from the tub will penetrate beneath floor covering.

Recommendation: Contact a handyman or DIY project

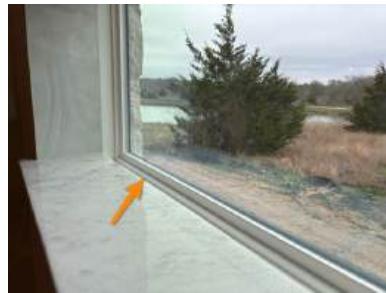
1: No outlet for window moisture

Window moisture and over spray has no way to drain

Recommendation: Contact a qualified professional.

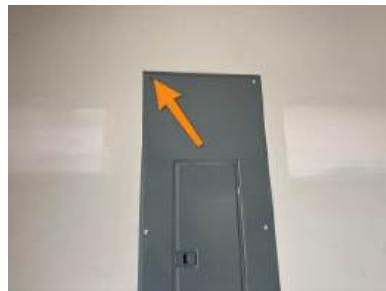
1: Missing screws at panel cover

All designated fastening points should be used to secure breaker panel covers in place.

Recommendation: Contact a qualified electrical contractor.

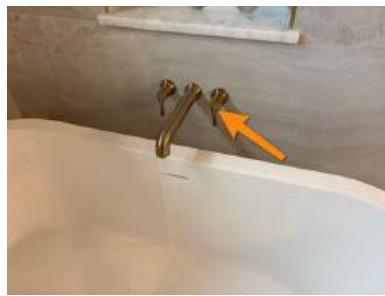
1: Handle loose

Valve handle needs to be tightened.

Recommendation: Contact a qualified professional.

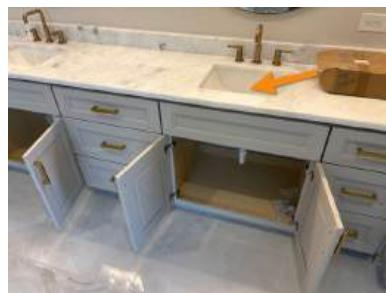
Mechanical drain stop linkage was disconnected or damaged.

Recommendation: Contact a qualified plumbing contractor.
