REDFISH INSPECTIONS HOUSTON

131 Lissa Ln
Sugar Land, TX 77479

PROPERTY INSPECTION REPORT FORM

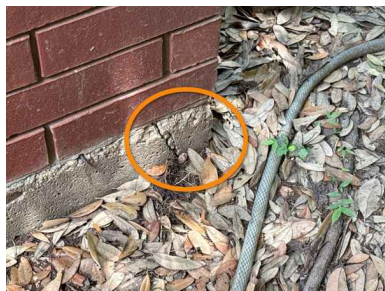
Example Right Rear

Corner pops/cracks were noted on one or more corners of the foundation. Corner pops/cracks are generally caused by the early removal of form boards and/or improper flashing installation between the slab and the brick veneer/stone veneer. This has or can lead to the foundation no longer providing the proper support for the brick cladding, and/or can be a conducive condition for wood destroying insects. We recommend having these areas patched/sealed/repared.

Recommendation: Contact a handyman or DIY project

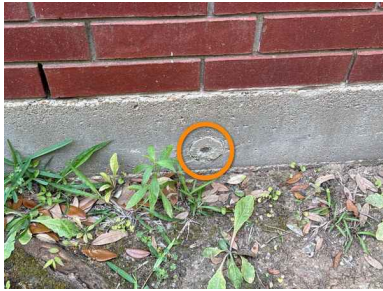
Example Left

can be used to enhance bond of the patch material to the concrete; however, it is important that the recommended application instructions from the bonding agent manufacturer are followed. 4. If an encapsulated system is used, the posttensioning material supplier's recommendations for cutting, capping and patching should be followed. 5. Under no circumstances should the concrete patch material used for filling the pocket former recesses contain chlorides or other chemicals known to be deleterious to the pre-stressing steel. 6. The pocket former recesses should be completely filled eliminating all voids and finished to match as closely as possible the surrounding edge of the foundation.

Recommendation: Contact a qualified professional.

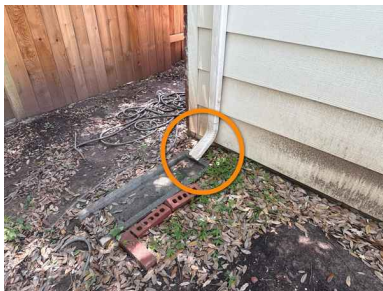
Example Right Rear

One or more downspouts were discharging too close to the foundation. We recommend having downspouts discharge water at least five (5) feet from the structure. Storm water should be encouraged to flow away from the building at the point of discharge.

Recommendation: Contact a handyman or DIY project

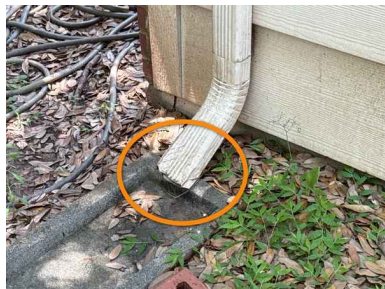
Example Right Rear

Loose/damaged downspouts were noted. We recommend having these repaired.

Recommendation: Contact a qualified professional.

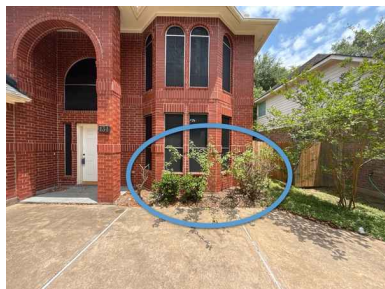
Example Front

Foliage was noted close to the structure. We recommend trimming all bushes and tree limbs at least 1 foot away from buildings. Bushes and trees too close to the structure can prevent the walls from drying properly, their roots can affect the foundation, and their branches can damage the roof.

Recommendation: Contact a handyman or DIY project

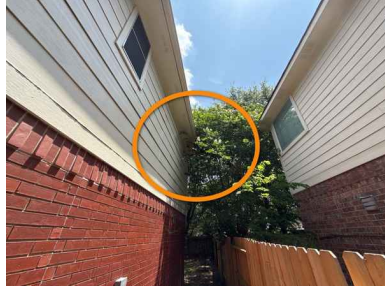
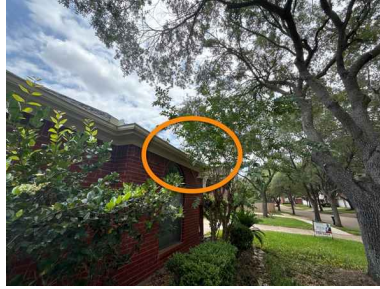
Example Right Rear

4: Vegetation Touching Building / Roof Line

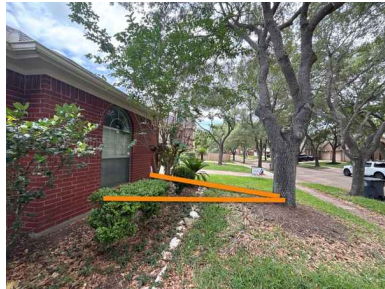
Example Front

Tree roots and large shrubs adjacent to the structure could have a potential of damaging the foundation. We recommend consulting with a professional, competent and qualified arborist for the best solution to protect the structure as well as the tree.

Recommendation: Contact a qualified professional.

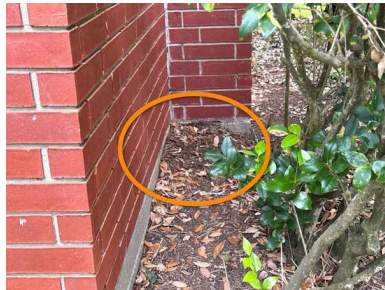
Example Front

High soil was observed around the structure. We recommend having 4 inches minimum clearance between soil/brick and 6 inches minimum clearance between soil/siding and/or stucco, in order to prevent moisture intrusion/damage, as well as conducive conditions for wood destroying insects and other pests.

Recommendation: Recommended DIY Project

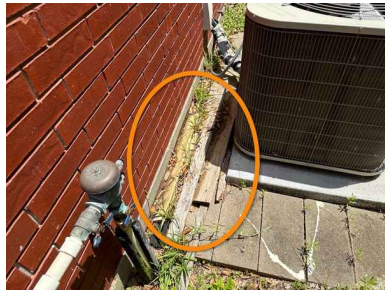
Example Right

A wood pile was observed against the structure. This can be a conducive condition for wood destroying insects. We recommend removing the wood pile.

Recommendation: Recommended DIY Project

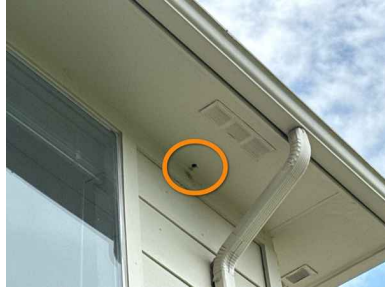
Example Rear

A hole/gap was observed in the soffit or fascia material. We recommend having this patched/blocked to prevent pest intrusion.

Recommendation: Contact a handyman or DIY project

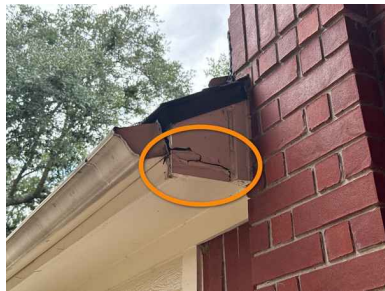
Example Front

Wood decay was observed on the fascia and/or soffit. We recommend repairs/replacement to all decayed wood to prevent further deterioration and conducive conditions for wood destroying insect activity.

Recommendation: Contact a qualified general contractor.

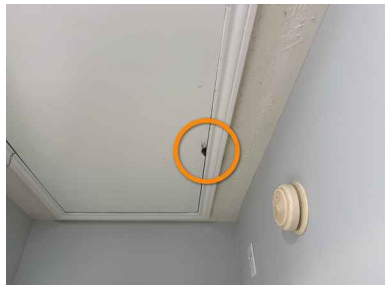
Example

The attic hatch door was found to be damaged. We recommend repair or replacement.

Recommendation: Contact a handyman or DIY project

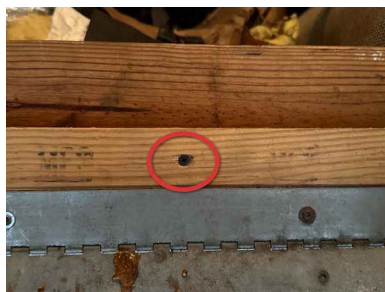
Example

Improper fasteners (nails/screws) were use to secure the attic pull down stairs to the structure. 16d penny nails or 1/4" x 3" lag screws should be used. We recommend repair.

Recommendation: Contact a qualified professional.

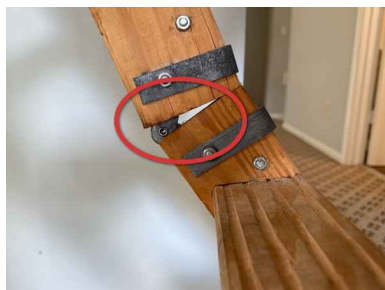
Example

The attic pulldown stairs was overextended. For safety reasons, we recommend repair prior to using.

Recommendation: Contact a qualified professional.

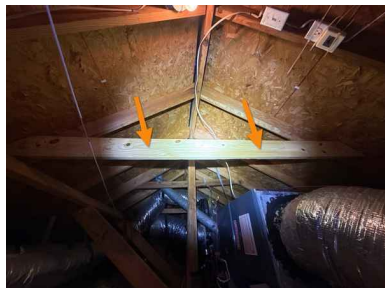
Example

Prior repairs to the roof structure were evident. It may be wise to consult the current owner regarding their knowledge of the roof structure and/or any repairs that became necessary.

Recommendation: Contact the seller for more info

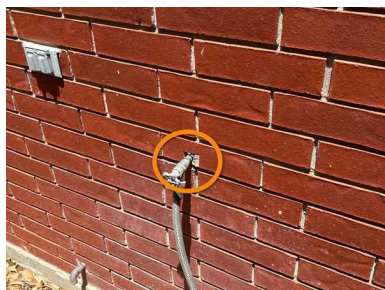
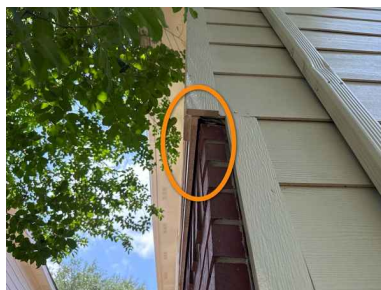
Example Right

Exterior wall protrusions should be caulked/sealed to prevent pest and moisture intrusion.

Recommendation: Contact a qualified professional.

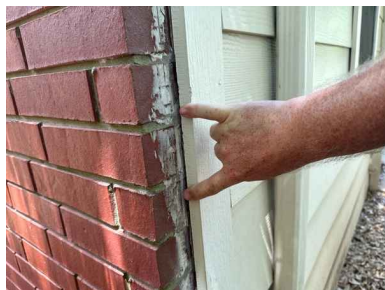
The exterior caulking in multiple areas around the house at various siding transitions, expansion joints, wall protrusions, doors, windows and other areas, was deteriorated or insufficient. Exterior caulking is the first energy efficient measure to install. This helps minimize air flow and moisture through cracks, seams, utility penetrations and openings. Controlling air infiltration is one of the most cost effective measure in modern construction practice. Good caulking and sealing will reduce dust, dirt, and prevent damage to structural elements. We recommend updating regularly.

Recommendation: Contact a qualified professional.

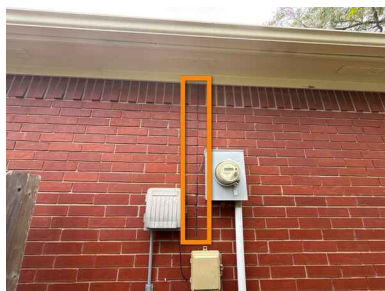
Example Left

An expansion joint in the exterior brick wall was deteriorated or missing caulk. We recommend caulking to prevent excessive moisture and insect intrusion.

Recommendation: Contact a qualified professional.

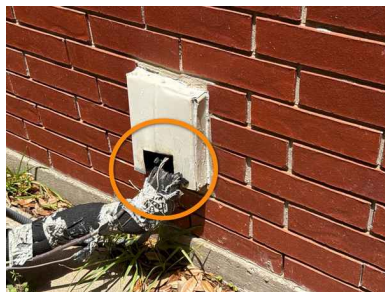
Example Right

A hole was noted where the air conditioning refrigerant lines entered the structure. We recommend sealing the area with foam insulation to prevent pest intrusion.

Recommendation: Contact a qualified professional.

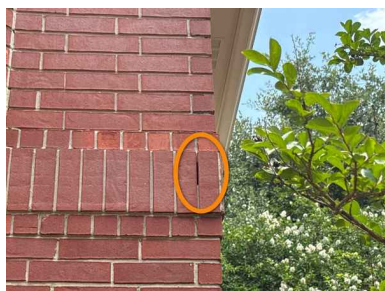
Example Front Right

The mortar at the exterior brick/stone veneer was cracked and/or deteriorated. We recommend having these areas repointed to prevent excess moisture intrusion.

Recommendation: Contact a qualified masonry professional.

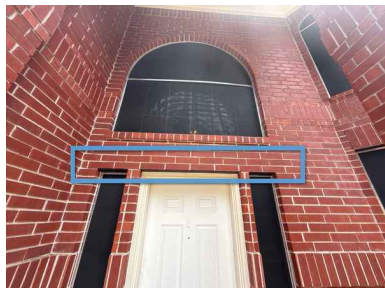
Example Front

base of the wall as well as over the windows and doors where the brick veneer is support by lintels. No indication of moisture damage was noted on the inside structure. It might do more harm than good to try and create these as this point in time. We recommend monitoring the areas and contacting a qualified masonry contractor if signs of excessive moisture are observed.

Recommendation: Recommend monitoring.

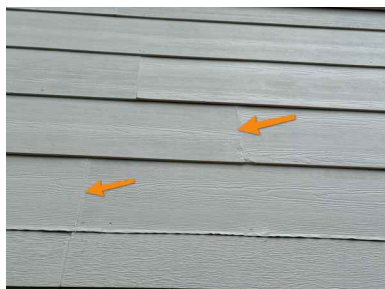
Example Left

The siding joints were open. Because these appeared to have been previously caulked, we recommend having them recaulked to prevent moisture intrusion.

Recommendation: Contact a handyman or DIY project

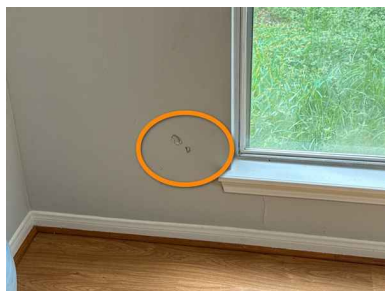
Example Living Room

General damage was noted at the Sheetrock/Drywall. We recommend to repair as needed.

Recommendation: Contact a qualified handyman.

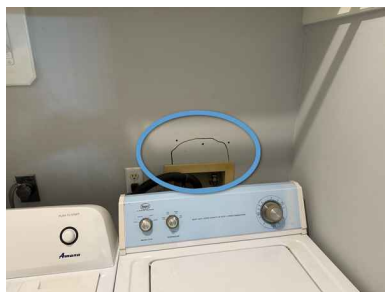
Example Laundry

Wall patching was noted. This indicates previous work was performed. We recommend monitoring the area.

Recommendation: Recommend monitoring.

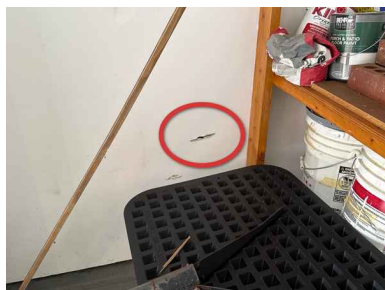
Example

One or more holes/gaps were noted in the garage drywall. This breached the structure's fire separation. We recommend having these patched/repaired.

Recommendation: Contact a qualified professional.

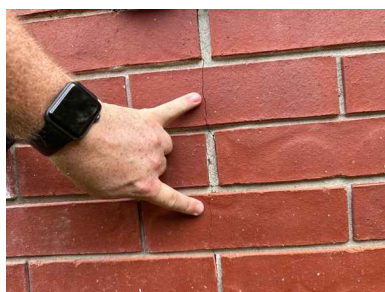
Example Left

Cracks were noted in the wall exterior veneer through bricks and mortar. This is an indication of structural movement. We recommend further evaluation by a foundation company or structural engineer.

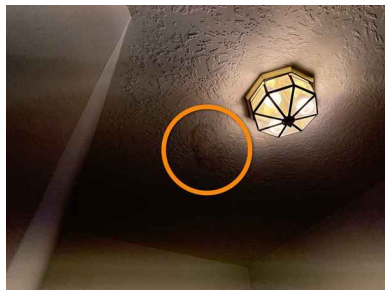
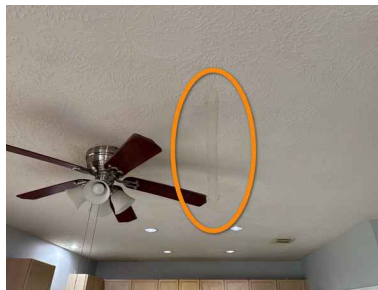
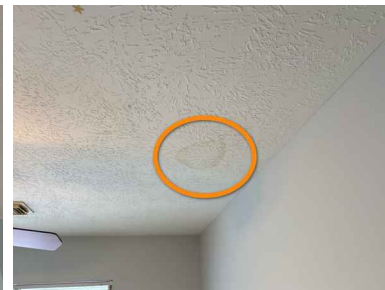
Moisture staining/damage was noted and the area was confirmed with a moisture meter and/or infrared thermal Imager to be dry at the time of inspection. We recommend consulting the seller about any history of moisture issues and obtaining any related receipts or warranties for previous work performed. The area(s) should be monitored, and the cause of any active water intrusion/leaks identified and repaired.

Example 1st Floor Hall

Example Kitchen

Example Guest Bedroom 1

Recommendation: Contact a qualified professional.

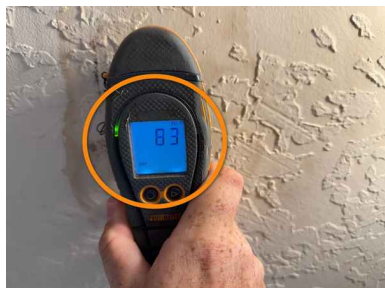
1st Floor Hall confirmed dry

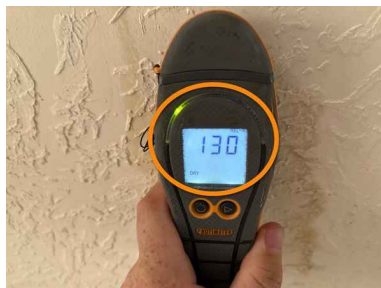
Kitchen confirmed dry

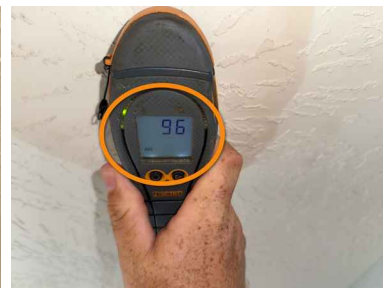
Guest Bedroom 1 confirmed dry

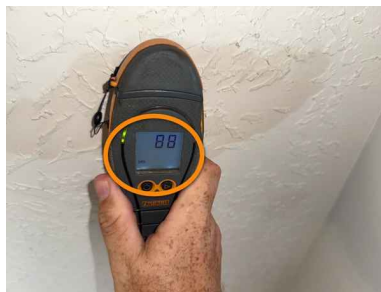
Guest Bedroom 1 confirmed dry

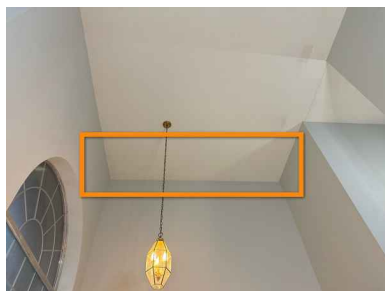
Example Foyer

A thermal anomaly consistent with missing or improperly installed insulation was observed in a section of a ceiling with an infrared thermal imager. The surface was considered to be large enough that it could affect energy consumption and/or comfort of living. We recommend consulting with an insulation contractor to determine cost for repairs.

Recommendation: Contact a qualified professional.

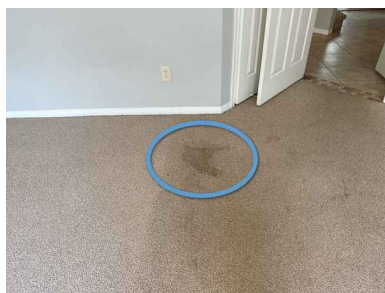
Example Primary Bedroom

Cosmetic stains were noted on the interior floor finishes. We recommend having the floors professionally cleaned prior to moving in.

Recommendation: Contact a qualified professional.

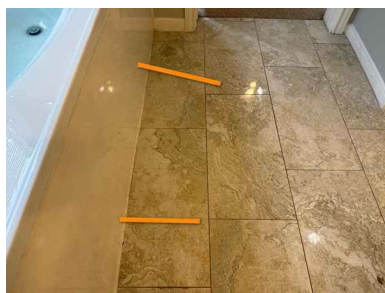
Example 1st Floor Primary Bathroom

Cracked floor tile was noted in the house. The tile sounded solid when knocked on which suggested the condition was not the result of structural movement. We recommend monitoring and replacing if the condition gets worse.

Recommendation: Contact a qualified professional.

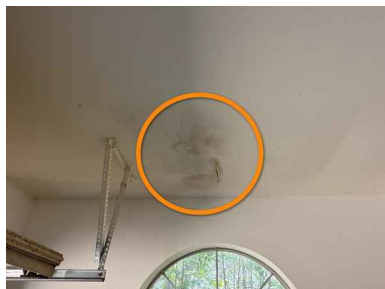
Garage Example 1

Signs of organic growth were observed. The area was confirmed with a moisture meter to be dry at the time of inspection. We recommend having the area cleaned and monitored. Any active moisture sources should be identified and repaired.

Recommendation: Recommended DIY Project

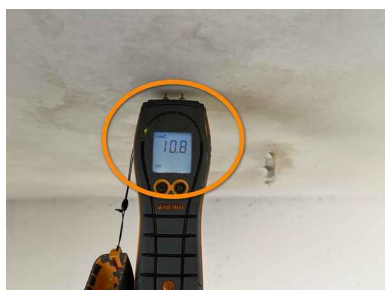
Garage Example 1 confirmed dry

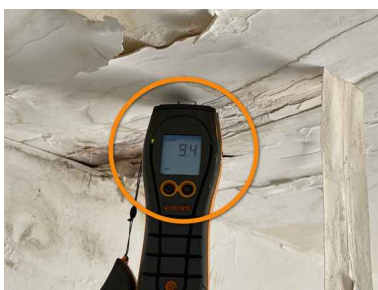
Garage Example 2 confirmed dry

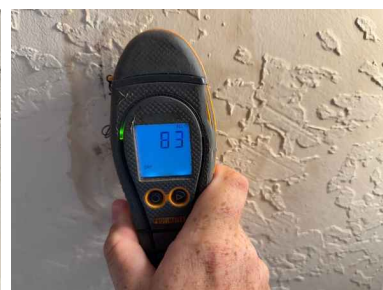
1st Floor Hall confirmed dry

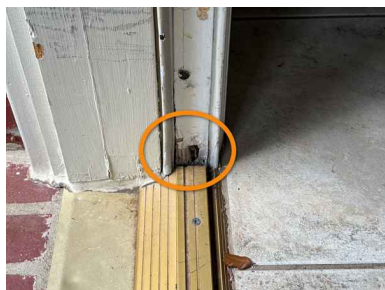
Example Front door

Damaged door trim was noted. We recommend repair.

Recommendation: Contact a handyman or DIY project

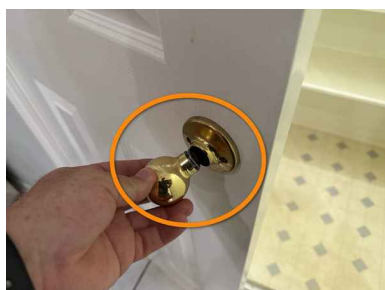
Example pantry

Damaged/inoperative door hardware was noted. We recommend having this repaired or replaced.

Recommendation: Contact a handyman or DIY project

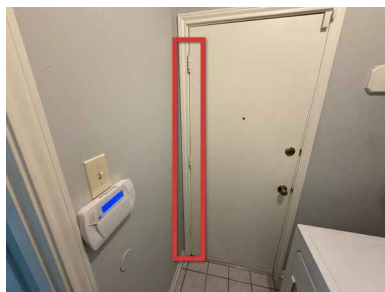
Example

Today's standards typically require doors leading from living spaces into attached garages be equipped with self-closing hinges, or a similar device, that prevents the door from being left open which could allow harmful exhaust, or other chemical fumes from items commonly stored into garages, to enter the living areas, as well as avoid a breach in the fire barrier of the structure. We recommend having this detail added.

Recommendation: Contact a handyman or DIY project

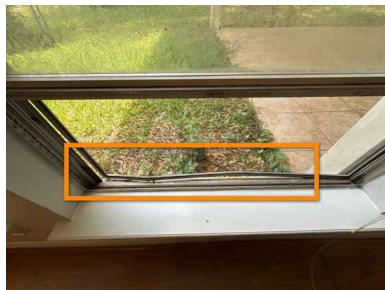
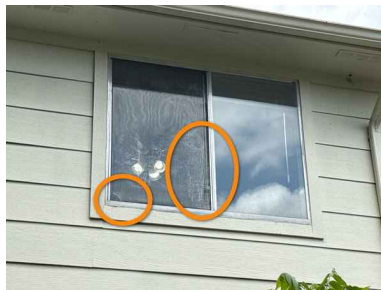
Example Rear

Damaged window screens were found. We recommend having these replaced to prevent insect intrusion.

Recommendation: Contact a handyman or DIY project

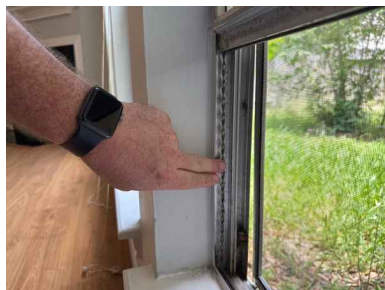
Example Living Room

Window hardware was damaged/inoperative. We recommend repair.

Recommendation: Contact a qualified professional.

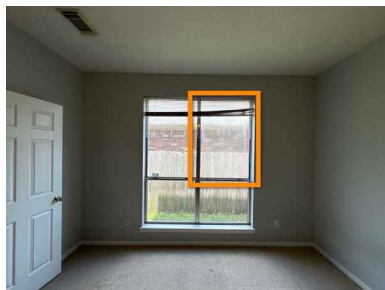
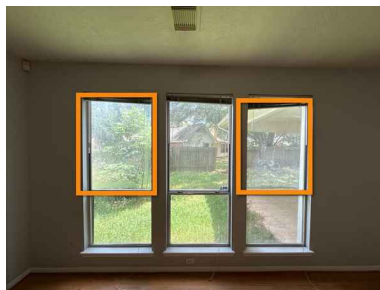
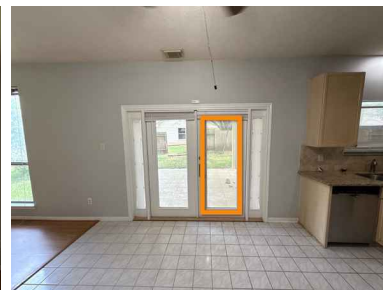
One or more windows had lost its seal and/or experienced low-E failure. This had resulted in condensation/discoloration developing between the panes of glass. This is primarily a cosmetic deficiency, but can cause the window to lose some of its insulating properties. We recommend having the glass replaced as needed.

Recommendation: Contact a qualified window repair/installation contractor.

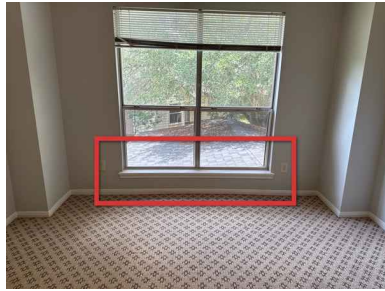
Example 2nd Floor game room

Windows on the 2nd floor were installed less than 24 inches from the floor. This is a safety hazard especially for small children. A window guard should be installed to keep the windows from opening more than 4 inches.

Recommendation: Recommended DIY Project

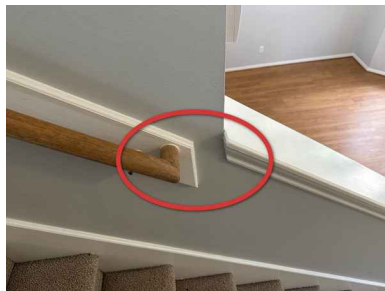
Example

The stairway handrail did not run continuously from the bottom of the stairwell to the top of the stairwell so to cover all of the steps (treads). Today's standards typically require handrails to run continuously for the full length of the stair flight. The handrail should be improved to start directly above the lowest step and run continuously to end directly above the top step.

Recommendation: Contact a qualified carpenter.

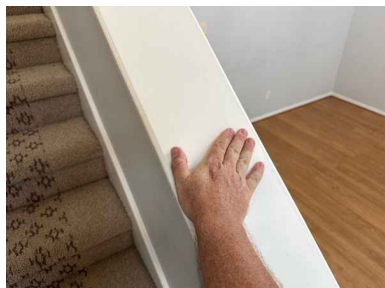
Example

The stairway handrail did not meet the definition of “graspable” as defined by generally-accepted current standards. We recommend you consider having the handrail altered or replaced to make it safer.

Recommendation: Contact a qualified professional.

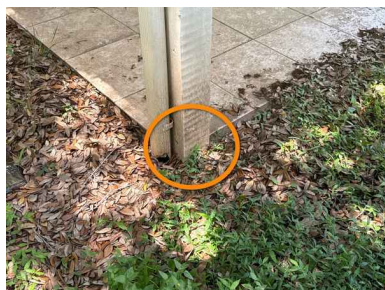
Example Rear

Wood components were in contact with the soil. This should be avoided as it could lead to structural wood decay and wood destroying insect activity. We recommend having this improved. In some cases, immediate correction may be impractical. In these situations, it is prudent to maintain a preventive termite treatment around the related structure.

Recommendation: Contact a handyman or DIY project

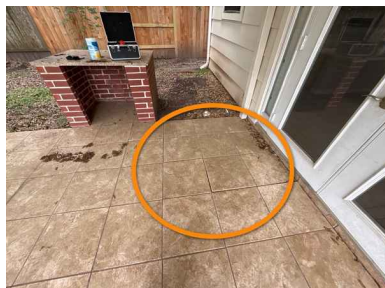
Example

Cracked, loose, and/or damaged tiles were noted at a porch, patio or additional structure. We recommend to replace tiles as needed to prevent potential trip hazards.

Recommendation: Contact a qualified professional.

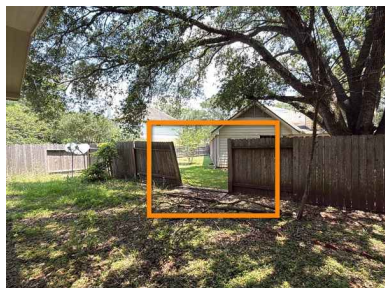
Portions of the fences were found to be aged and in poor condition. We recommend consulting with a professional contractor to determine cost for repairs/replacement.

Example Rear - damage

Recommendation: Contact a qualified professional.

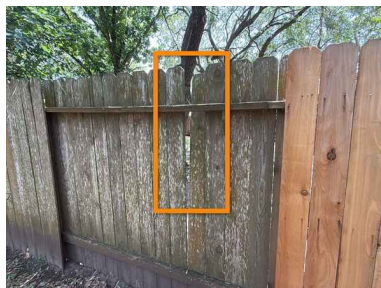
Example Right Rear - loose picket

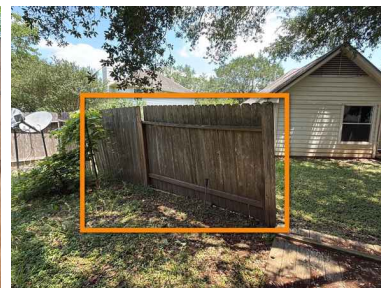
Example Rear - leaning

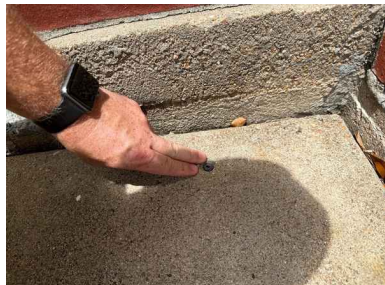
Example Front

Evidence of previous wood destroying insect treatment was observed. We recommend asking the sellers when the house was last treated as warranties might be transferable.

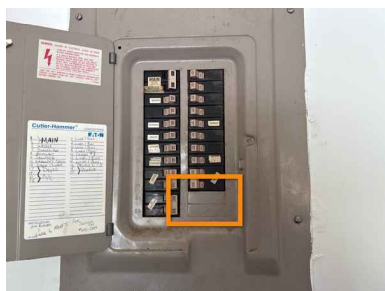
The service equipment was not equipped with a surge protector. Today's standards require a surge protector to be integrated with or installed near the service entrance in order to protect the whole house from electrical surges. The 2020 NEC (National Electric Code) has made surge protection required for service replacements and upgrades. With a new service, service upgrade, or service replacement, there must now be a type 1 or type 2 surge protector installed at the panel.

Recommendation: Contact a qualified professional.

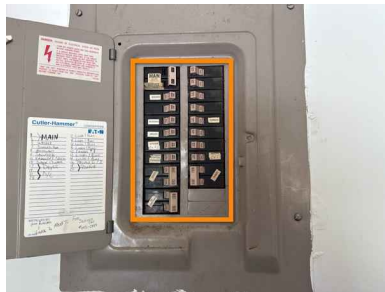
Insufficient Arc Fault Circuit Interrupter (AFCI) protection was installed. Building codes with which new homes must comply require the installation of AFCI protection of all 15 and 20 amp circuits providing power to outlets/lighting in residential family rooms, dining rooms, living rooms, parlors, libraries, dens, bedrooms, sun rooms, recreation rooms, closets, hallways, and similar rooms. This type of protection is designed to detect electrical arcing, which is a potential fire hazard. Although AFCI protection may not have been required at the time the home was originally constructed, as general knowledge of safe building practices has improved with the passage of time, building standards have changed to reflect current understanding. We recommend you consider updating the existing electrical to provide adequate AFCI protection. Arc-fault protection can be provided using AFCI circuit breakers installed at the electrical panel which provide this protection to all non-AFCI outlets on the circuit controlled by that AFCI breaker.

Recommendation: Contact a qualified professional.

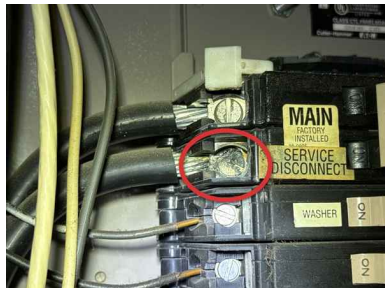
Example

A breaker was found to be damaged. We recommend to replacement.

Recommendation: Contact a qualified electrical contractor.

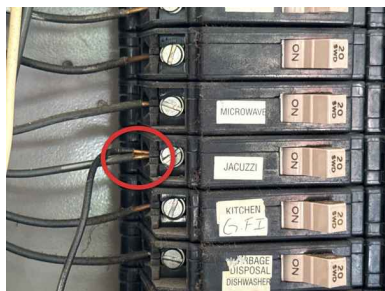
Example

Double-tapping was found on electrical panel breakers. Each breaker should have only one set of wires. We recommend repair. This became a requirement in 2002 by NEC.

Recommendation: Contact a qualified electrical contractor.

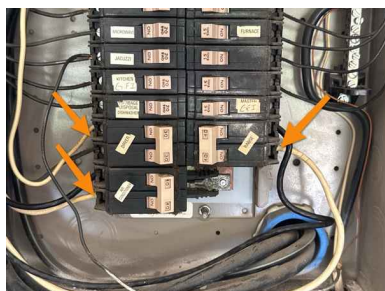
Example

One or more electrical conductors were improperly identified. Wires are typically color coded with white sheathing indicating neutral, green or bare wires indicating grounds, and black or red indicating hot. It is most common to see white wire leads providing power to appliances and HVAC system. We recommend having conductors appropriately marked. This can usually be accomplished with a piece of electrical tape or partially marking the wire with a marker.

Recommendation: Contact a qualified professional.

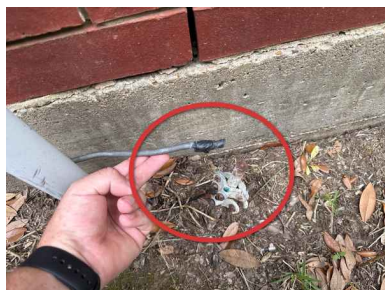
Example Left

The grounding conductor was loose and improperly secured to the grounding rod. We recommend having this tightened. Replacement of the clamp be necessary for repair.

Recommendation: Contact a qualified professional.

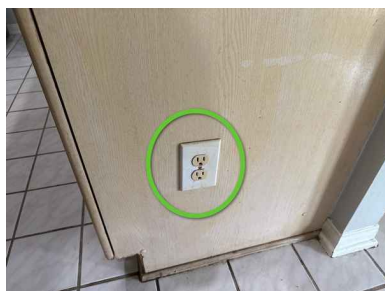
Example

Outlet receptacles were present on the side of the kitchen island/peninsula. While installation of receptacles in these locations is not prohibited, since 2023, it has come to be considered a potential safety hazard by many experts as the cord for common cooking appliances could be pulled or snagged resulting in impact or burn injuries. Safer receptacle designs capable of being installed on the top surface are available by various manufacturers. Extra care should be taken when using these receptacles to prevent hazards, particularly if/when children are present.

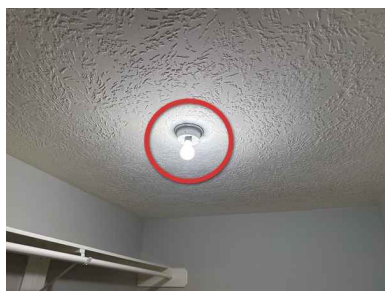
Today's standards require having a globe cover protecting closet light fixtures. We recommend making the upgrade for improved safety.

Recommendation: Contact a qualified professional.

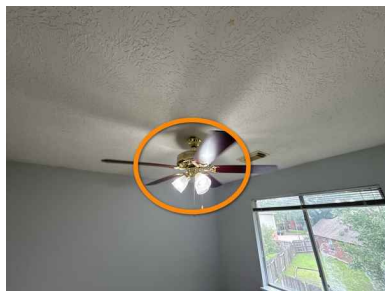
A ceiling fan was inoperable and/or noisy at the time of inspection. We recommend having this further investigated to determine the cause and have any necessary repairs made.

Example Guest Bedroom 2 - noisy

Recommendation: Contact a qualified professional.

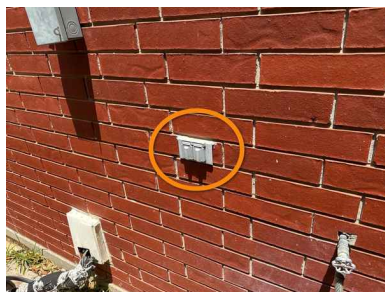
Example Right

Today's standards typically require exterior outlets/switches exposed to the elements to be housed in a bubble - style cover. We recommend to upgrade or repair covers as needed.

Recommendation: Contact a qualified electrical contractor.

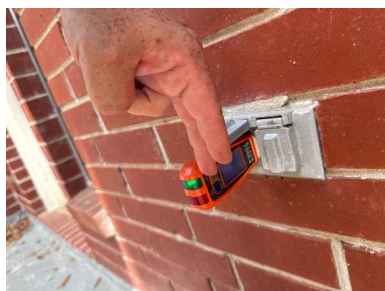
Example Exterior Front

One or more outlets lacked proper Ground Fault Circuit Interrupter (GFCI) protection. Today's standards require GFCI protection be installed at all 120 and 240 volt circuits in the kitchen, laundry rooms, basements, crawl spaces, garages, exterior outlets, as well as any interior receptacles located within 6 feet of a plumbing fixture as measured by flexible cord, in order to avoid potential electric shock or electrocution hazards. It is also a best practice for floor outlets to be GFCI protected. We recommend having proper GFCI protection installed per today's standards.

Recommendation: Contact a qualified electrical contractor.

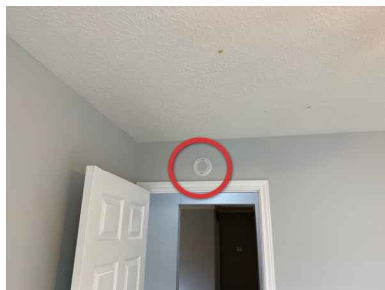
Example Guest Bedroom 1

2: Smoke/Carbon Monoxide Detector Missing

Smoke/Carbon monoxide detector is not present at time of inspection. Recommend installation before closing.

Recommendation: Contact a qualified professional.

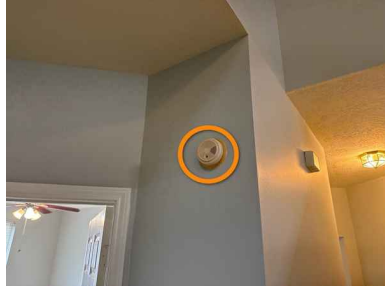
Example 1st Floor

3: Outdated smoke/CO detectors

One or more smoke and/or carbon monoxide detectors appear to be outdated. Smoke and carbon monoxide detectors have a reliable lifespan of 10 years. Recommend replacing.

Recommendation: Contact a qualified professional.

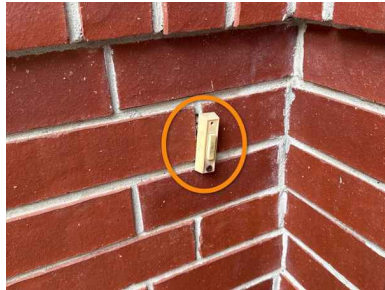
Example

1: Loose Door Bell

The doorbell is loose at the wall mount.

Recommendation: Contact a qualified professional.

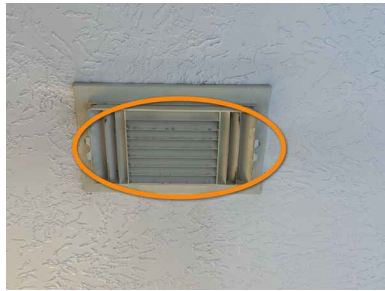
2: Organic Growth / Moisture Stains / Rust at Vent or Register

Moisture stains, rust, and/or organic growth was noted on and around the AC enclosures. This could indicate leaks in the ductwork. It is recommended to have any leaks sealed for enhanced efficiency and energy savings and prevent mold growth. We recommend having this further evaluated, cleaned, and repaired as needed.

Example 1st Floor Primary Bathroom - organic growth

Recommendation: Contact a qualified professional.

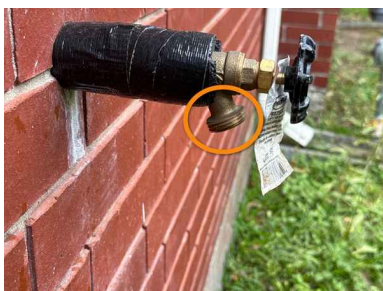
Example Left

1: Anti-siphon / Backflow Prevention Device Missing

One or more exterior hose bibs did not have a back flow preventer. Anti-siphon devices keep contaminated water from entering the potable water of the house plumbing. These devices are typically affordable and can be found in most home improvement stores. We recommend having these added.

Recommendation: Contact a handyman or DIY project

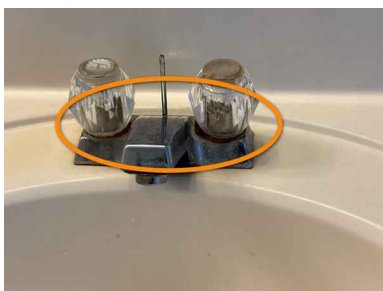
Example 1st Floor Primary Bathroom

2: Knob Damaged / Missing

One or more exterior control knob(s) was damaged or missing. We recommend having this replaced for easy use of the fixture.

Recommendation: Contact a qualified professional.

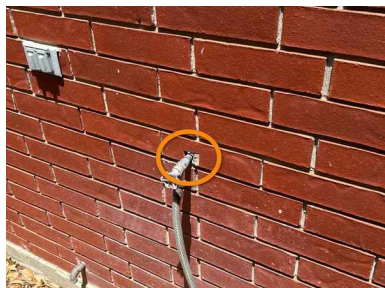
Example Right

3: Missing Sheathing

Today's standards require plumbing distribution lines to be protected at all wall protrusions by a sheathing/insulation to prevent pines from bonding to the mortar. No indication of moisture damage was noted on the inside of the structure in these areas. It may not be cost effective to add this level of protection at this point in time. We recommend monitoring these areas on the interior.

Recommendation: Contact a qualified professional.

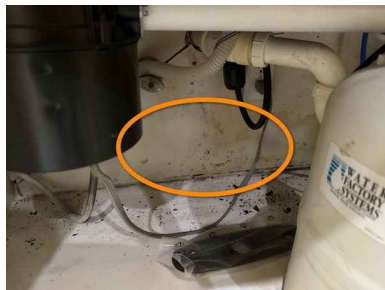
Example

4: Kitchen Sink - Organic Growth

There were signs of organic growth observed under the kitchen sink. We recommend having the cause of the growth identified and repaired prior to having the area repaired/cleaned.

Recommendation: Contact a qualified professional.

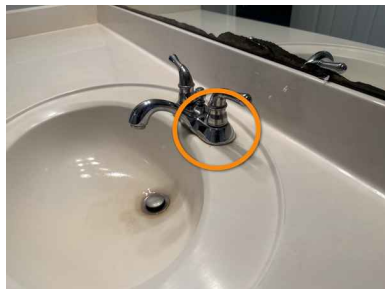
Example 2nd Floor Primary Bathroom

5: Leak At Control

A leaking faucet control was noted. We recommend repair to prevent damage to the cabinets or structure.

Recommendation: Contact a qualified professional.

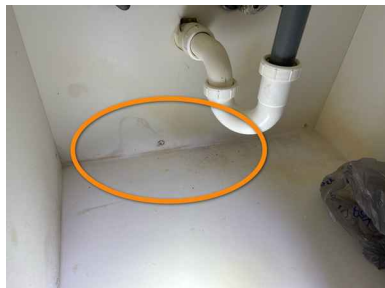
Example 1st Floor Primary Bathroom
Right lavatory

6: Lavatory - Under Cabinet Damage

An under lavatory cabinet had water damage which appeared to be the result of past leakage. The moisture meter showed no elevated levels of moisture present in the cabinet floor at the time of the inspection indicating that the source of leakage may have been corrected.

Recommendation: Contact a qualified professional.

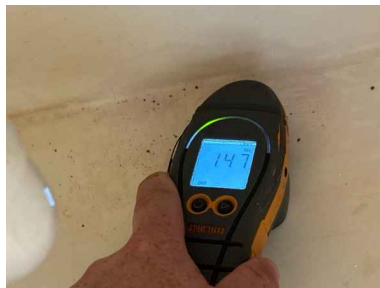
1st Floor Primary Bathroom confirmed
dry

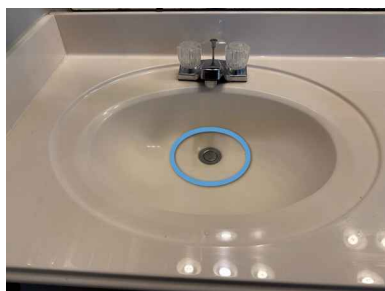
Example 1st Floor Primary Bathroom

7: Inoperable Lavatory Stopper(s)

A lavatory stopper was not functional at a bathroom lavatory. We recommend having stoppers adjusted or repaired to retain water as designed.

Recommendation: Contact a handyman or DIY project

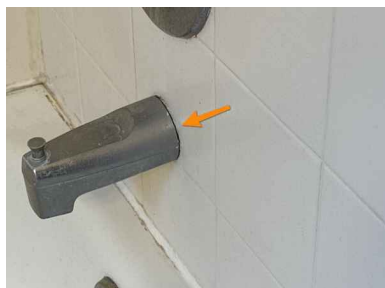
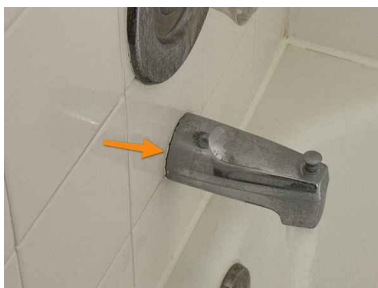
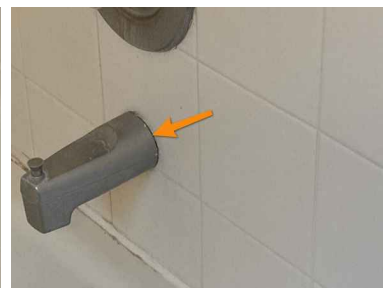
All shower and bathtub handles, faucets, spouts and shower heads should be caulked at the wall. Be sure to caulk any gaps that may appear between the hardware & tile of the fixtures or shower enclosures. Most tile surfaces will have gaps in the grout that can also allow for water penetration past the tile work. A leak in any one of these areas can cause concealed structural damage that would not be obvious in a visual inspection.

Recommendation: Contact a qualified professional.

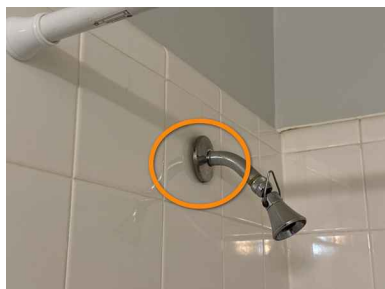
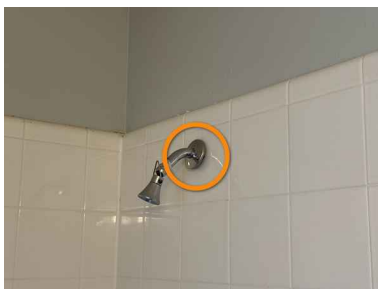
10: Escutcheon Plate Seal

We recommend having escutcheon plates sealed/caulked to the wall to prevent water intrusion into the wall where it can cause damage.

Recommendation: Contact a qualified professional.

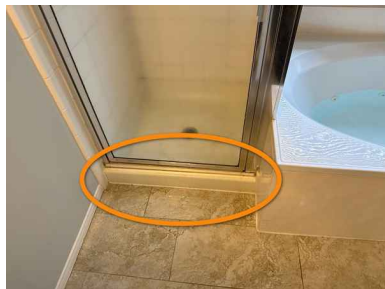
Example 1st Floor Primary Bathroom

11: Leak at shower wall assembly

A leak was noted at the shower wall assembly. We recommend having the caulking updated to prevent water leaking outside the shower area and damaging the surrounding structure.

Recommendation: Contact a qualified professional.

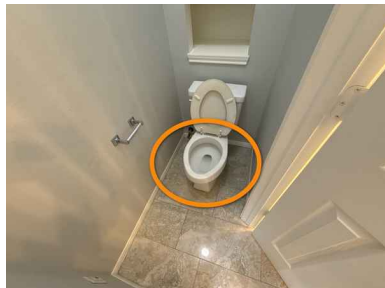
Example 1st Floor Primary Bathroom

12: Loose Toilet

A loose toilet was noted. If the subfloor is wood there is the possibility for water damage. We recommend having the necessary repairs made.

Recommendation: Contact a qualified professional.

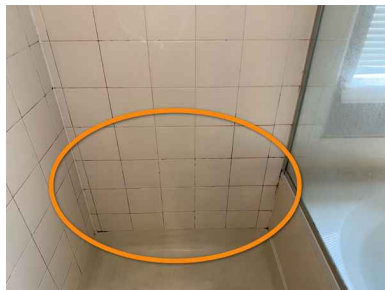
Example 1st Floor Primary Bathroom

13: Organic Growth at Shower / Tub

Organic growth was noted at a bathtub or shower. We recommend cleaning.

Recommendation: Contact a handyman or DIY project

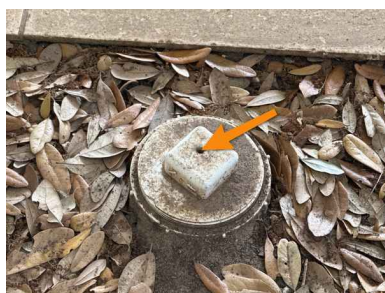
Example

1: Drain Cleanout - Damaged / Missing Cap

The cap to a drain cleanout was missing or damaged. We recommend having this repaired to prevent pest intrusion or debris from clogging the line.

Recommendation: Contact a qualified professional.

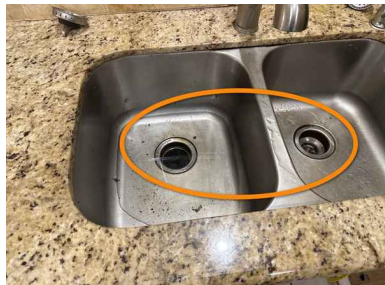
Example Kitchen

2: Slow Drain(s)

Slow, less than functional drainage was observed at one or more bathroom lavatory, tub or shower. We recommend having this further evaluated and repaired as needed.

Recommendation: Contact a qualified professional.

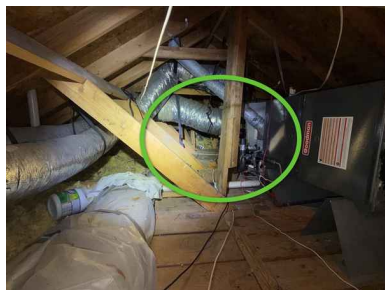
Photos Unit 1: Access restricted to water heater

The design of the attic structure, attic ductwork, and/or occupant's belongings blocked access to the water heater at the time of the inspection. We were unable to test for proper response and operation due to the water heater being off at the time of inspection. We recommend having this evaluated after access is provided and the water heater has been turned on.

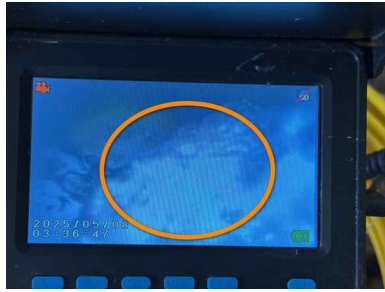
Example 1

1: Blockage

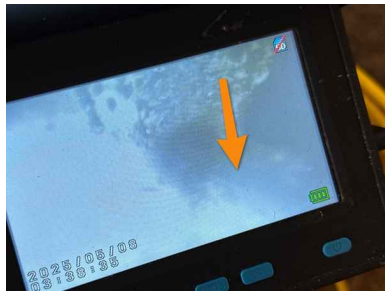
Example

2: Standing Water

Standing water was observed in the line. We recommend having the line pressure jetted by a licensed plumber, re-inspected, and repaired as needed.

Recommendation: Contact a qualified plumbing contractor.

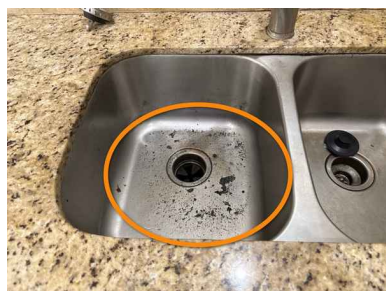
The dishwasher backs up into sink when operated. Recommend to repair.

Recommendation: Contact a qualified appliance repair professional.

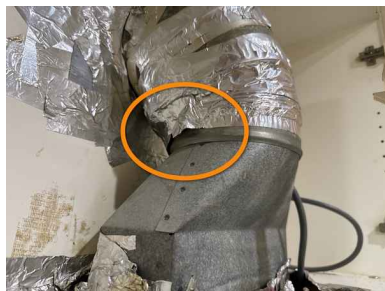
Example

1: Air leak

An air leak was observed at the top of the unit. We recommend having this improved to ensure all exhaust fumes are expelled through the ductwork to the exterior

Recommendation: Contact a qualified professional.

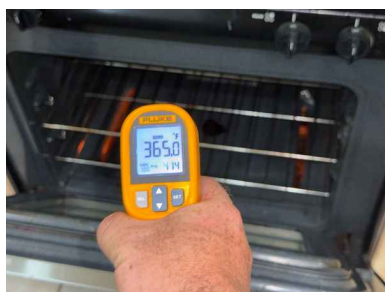
Overview of Cooktop Burners on High:

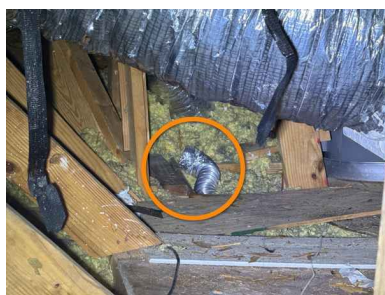
Example

One or more bathroom exhaust vents terminated in the attic space. This condition is improper and will introduce excessive amounts of moisture to the attic space. Excessive moisture deposited into the attic may result in damage to home materials from decay or encourage the growth of microbes such as mold. Exhaust vents should terminate at the home exterior. We recommend correction by a qualified contractor.

Recommendation: Contact a qualified professional.

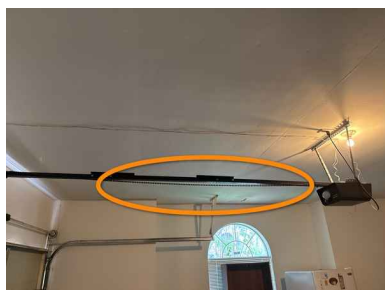
Example

1: Loose Drive Belt/Chain

The drive train For the garage door opener is loose. recommend tightening.

Recommendation: Contact a qualified professional.

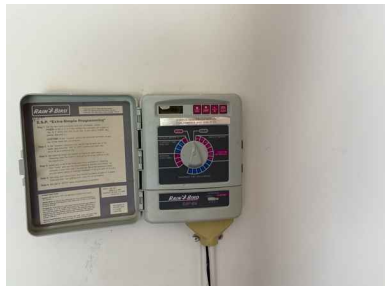
Garage

Photo of Control Panel:

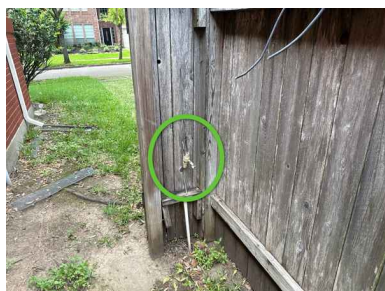
Left Fence

Photo of Rain Sensor:

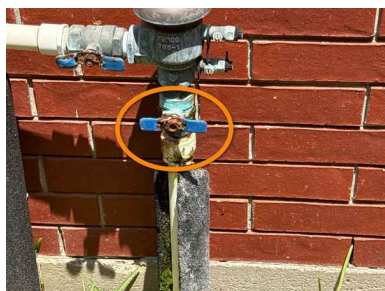
Example

1: Pipe Insulation Missing / Insufficient

Missing, damaged, deteriorated or insufficient was noted. Pipe insulation improvement recommended.

Recommendation: Recommended DIY Project

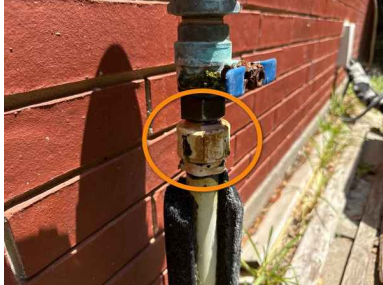
Example

3: Leak at Backflow Preventer

A leak was noted at the backflow preventer. We recommend repair.

Recommendation: Contact a qualified landscaping contractor
