5405 Schumacher Ln _____ Houston _____ 77054

VISUAL INSPECTION

1A. **B&P TERMITE INSPECTIONS**   1B. **11706**

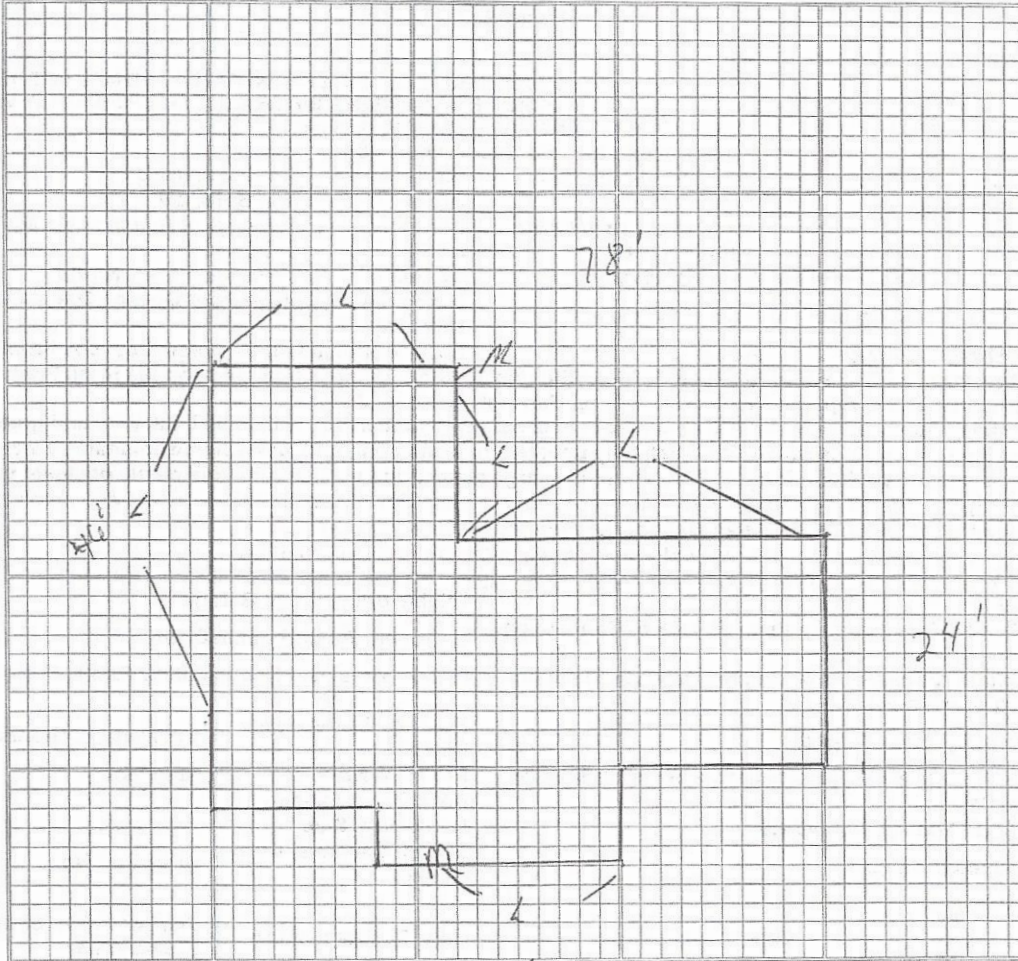
Diagram of Structure(s) Inspected

Additional Comments_____ Front   76' _____
