## Inspection Report

**Property Address:**  
16208 Pinewood Dr  
Porter TX 77365

# PROPERTY INSPECTION REPORT

**By:** Derrick McMullen 7117 / AK Inspection Services/AK Termite and Pest Control 4/2/  
2019  
(Name and License Number of Inspector) (Date)

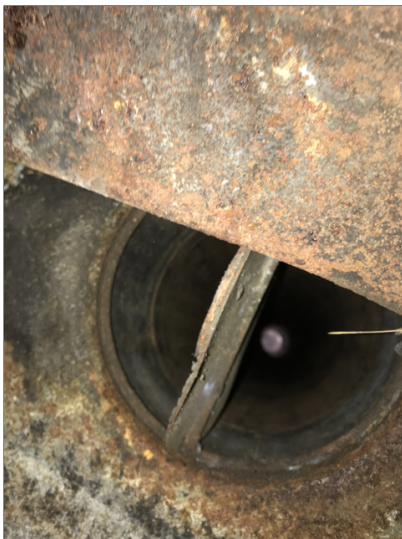
J. Item 3(Picture)

(2) Inspection of the flue was greatly limited. Visibility in the flue was limited due to design and installation practices. Item 2(Picture)

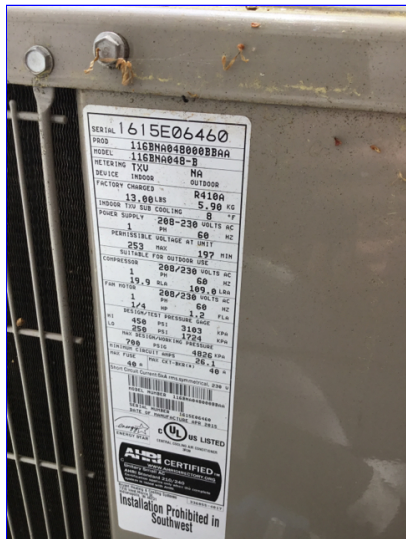
B. Item 3(Picture)

The condenser unit appeared to be manufactured in: 2015.

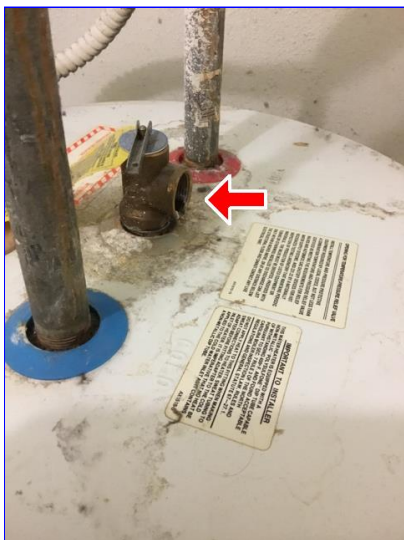
C. Item 1(Picture)

Corrosion was observed on the water heater, below the heating element. It appeared that water had leaked prior to the inspection. Item 2(Picture)

An overflow pan was not provided at the water heater. A pan should be provided if damage may occur in the event of a leak. It is recommended that an overflow pan and drain line be installed at the water heater.

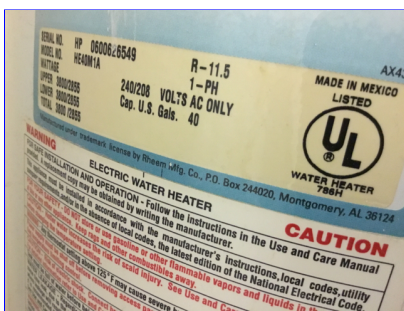
C. Item 3(Picture)

Notice: §535.227(5) (A)(iii) Departure “ An inspector may depart from the inspection of a component or system required by the standards of practice only if, in the reasonable judgment of the inspector, conditions exist that prevent inspection of an item. Testing this temperature and pressure relief valve (T&P), or valves, as observed could cause damage and it was not tested due to the lack of a drain line.
