Structure Home Inspection

Property Inspection Report

5239 Dumore Drive, Houston, TX 77048
Inspection prepared for: Juquan Tellis
Date of Inspection: 3/12/2019 Time: 3:00 PM
Age of Home: 57 Years Size: 1,184 SF
Weather: Sunny 75 degrees

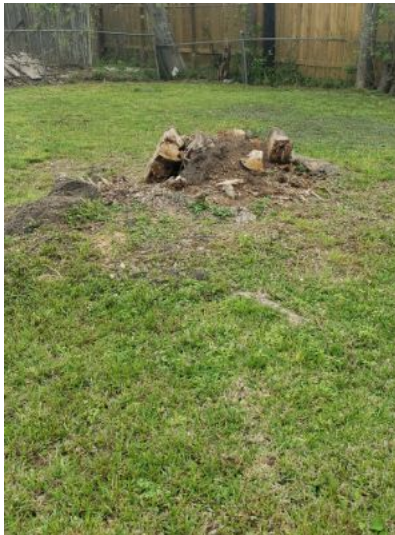
Large tree stump in the back yard should be removed.

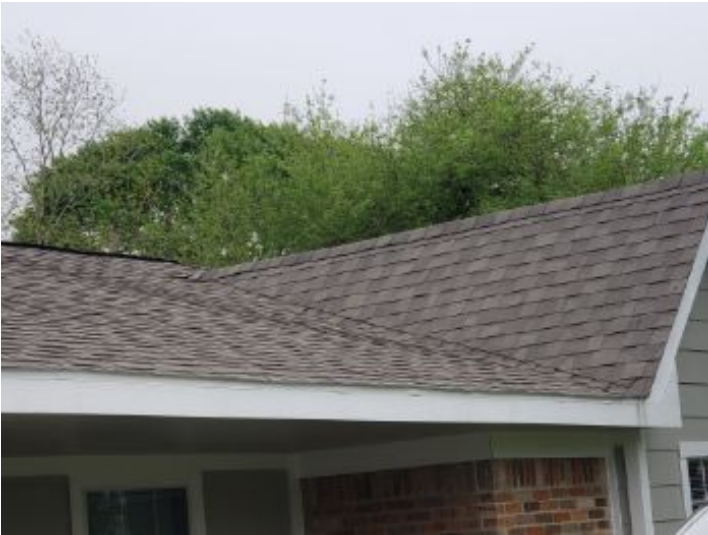
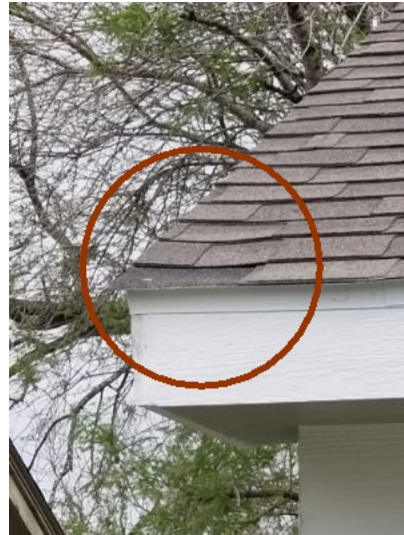
Front left corner of roof (over previous garage) missing shingles and needs repair.

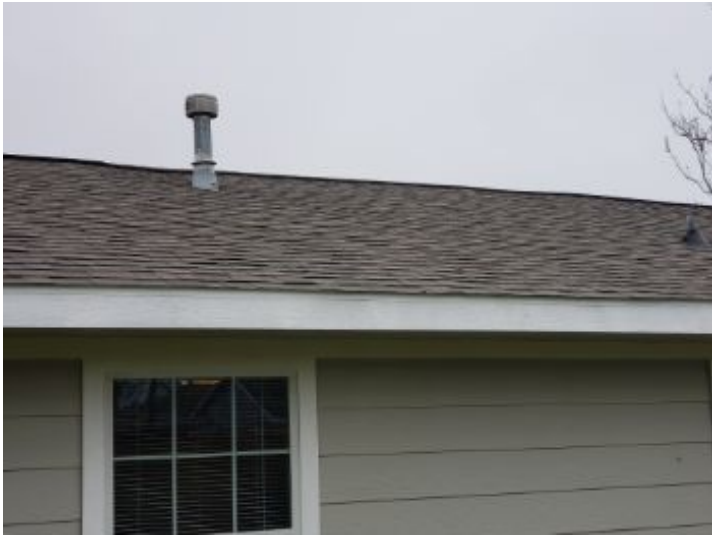
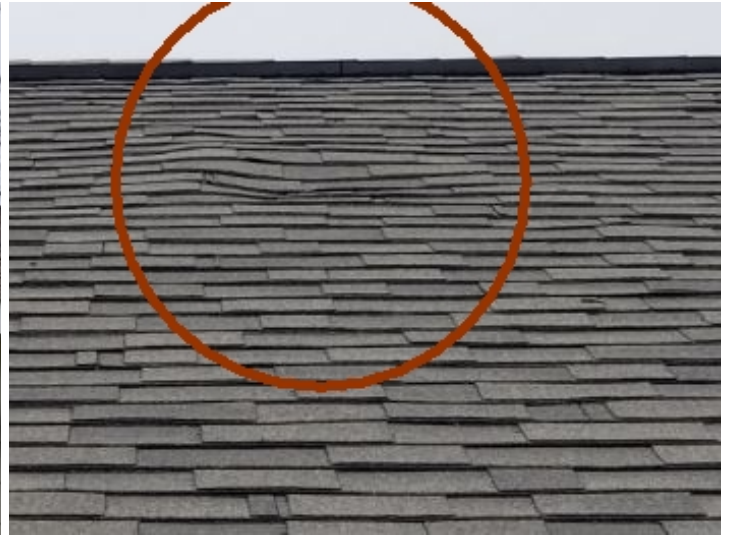
Area at the rear section of the roof appears to have a dip or deflection in the shingles. This should be investigated further by a qualified roofing contractor and repaired.

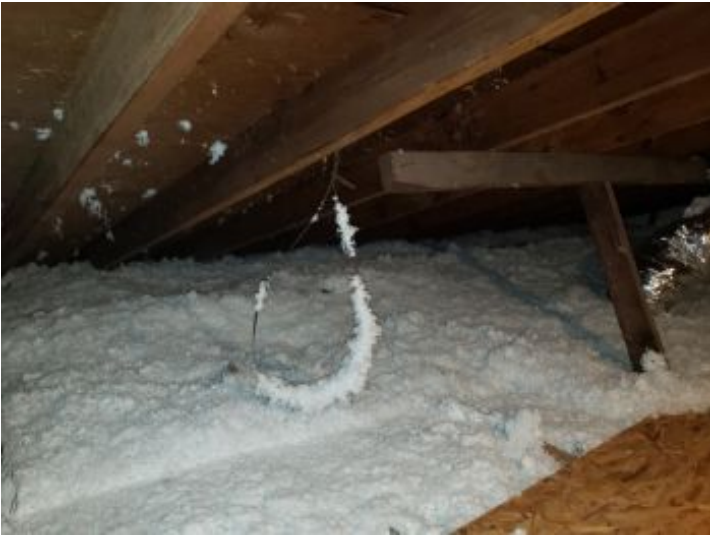
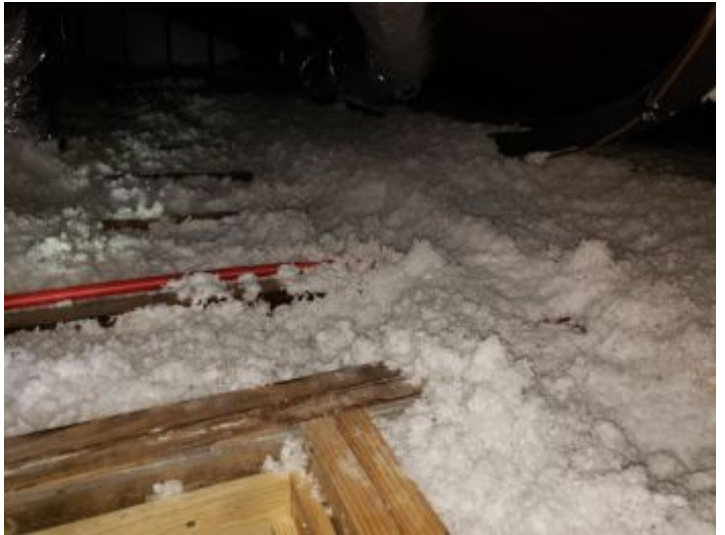
Split ridge beam observed in the attic area and needs repair.

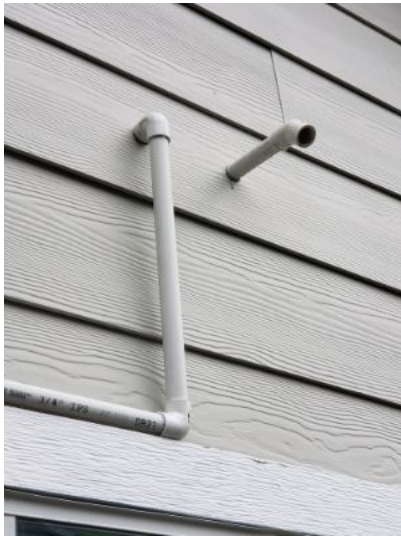
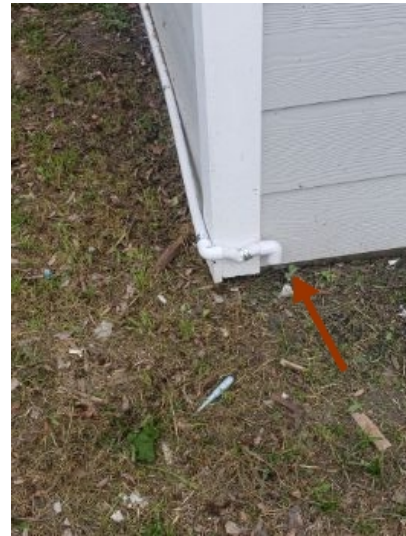
- Temperature differential: The temperature differential was measured by taking the difference in the lowest supply reading and the main return air reading. Temperature differentials for cooling should always be between 15 - 20 degrees. The temperature differential was measured at 7 degrees (not acceptable).
- A licensed HVAC contractor should investigate further as the system is not cooling properly with a temperature differential of only 7 degrees. If low on freon, the system should be checked for freon leaks. If leaking at the condenser, the condenser should be replaced.
- The main condensation line drains to the exterior. We highly recommend the line be tied into an existing sewer vent pipe so the area outside will not be constantly wet during hot months.

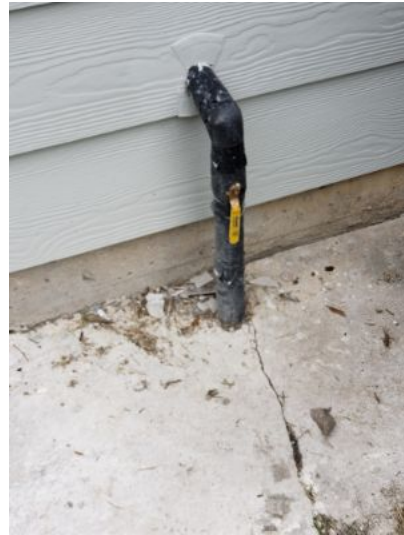
One or more of the exterior water hose bibs {faucets} was not equipped with a back flow and/or anti-siphon {vacuum breaker} device. An anti-siphon device prevents unsanitary water from being pulled back through a garden hose and/or lawn sprinklers and contaminating the household water system
