## Property Inspection Report

1327 Falling Leaf Ln, Seabrook, TX 77586  
Inspection prepared for: Regan Bullers  
Real Estate Agent: Allison Houser - Keller Williams Realty Metropolitan

Date of Inspection: 3/17/2016 Time: 12:00 PM; 2:30 PM  
Age of Home: 26 years old Size: 2870 sqf  
Weather: Overcast

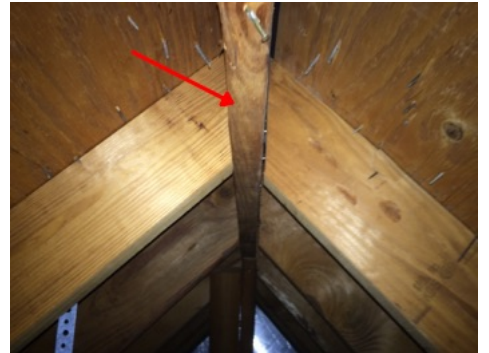
Undersized ridge board

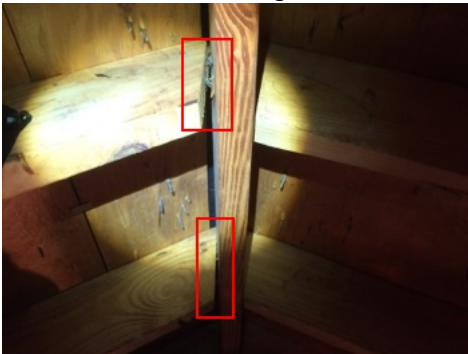
Rafters separated from ridge board

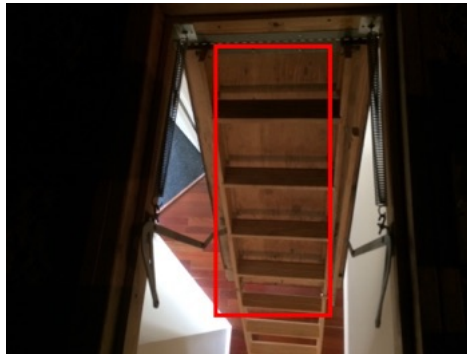
Pull-down stairs/scuttle panel lacked insulation

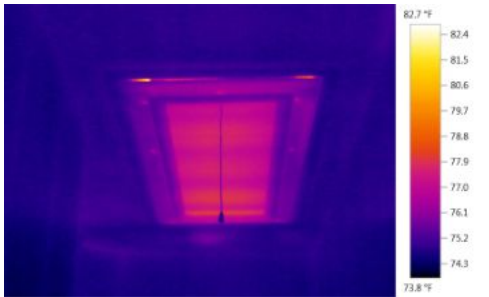
Pull-down stairs/scuttle panel lacked insulation

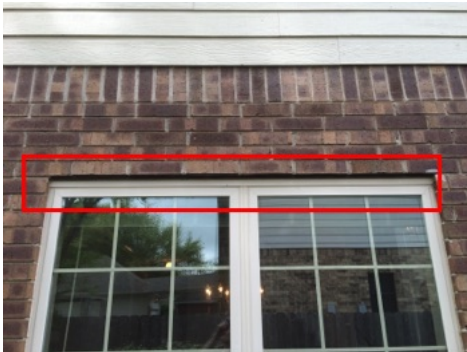
Missing weep holes

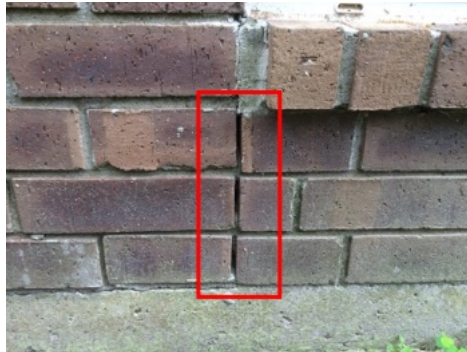
Left: Caulk missing at expansion joint

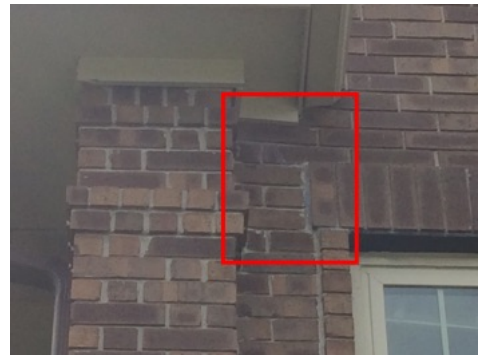
Front left: silicone caulk used for grout patchwork

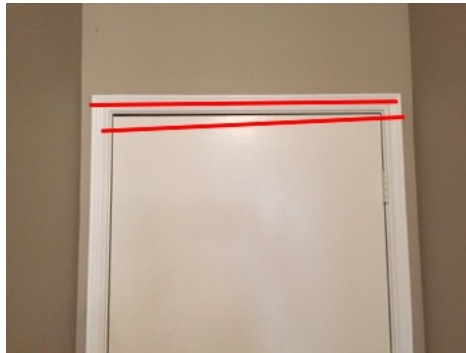
A door was noted out of square, which indicates movement within the structure, but still operate as intended. It is impossible to determine the rate of the movement in a one time inspection. We recommend monitoring the door and adjusting if needed. This was observed in the garage man door.

Garage man door: out of square

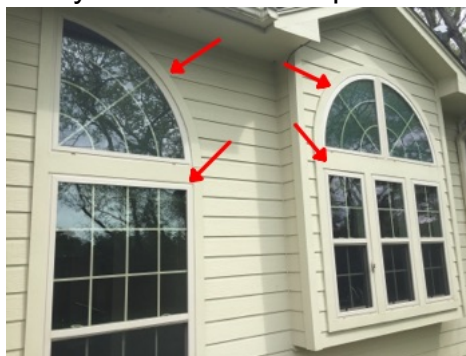
Left and rear: flashing not visible

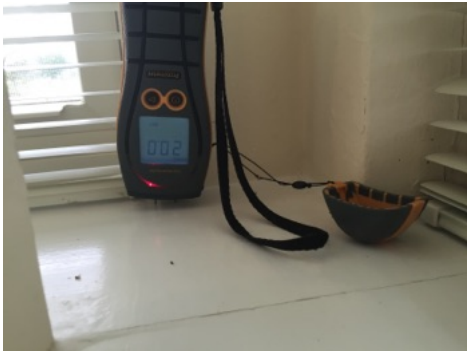
Bathroom 1: elevated moisture at corner of windows

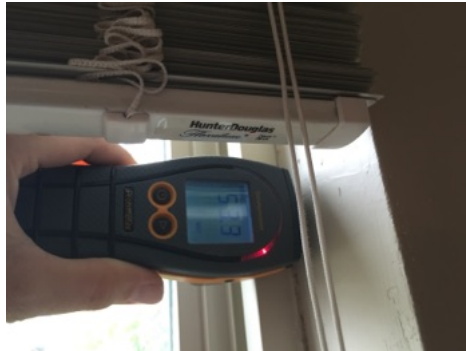
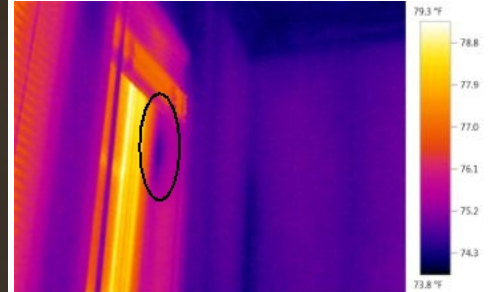
Front room: patchwork with elevated moisture at right window

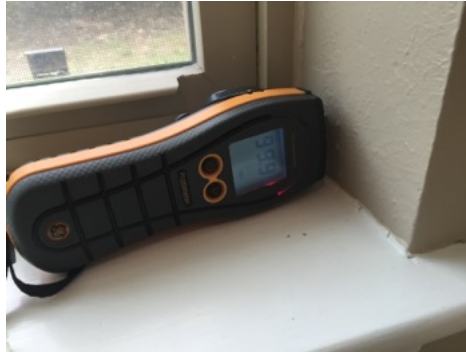
Breakfast nook: elevated moisture near sill at both sides

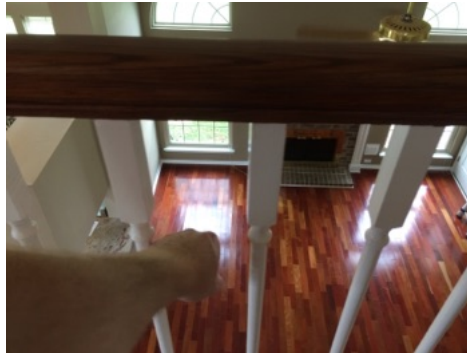
Guardrail: Spindles more than 4" apart

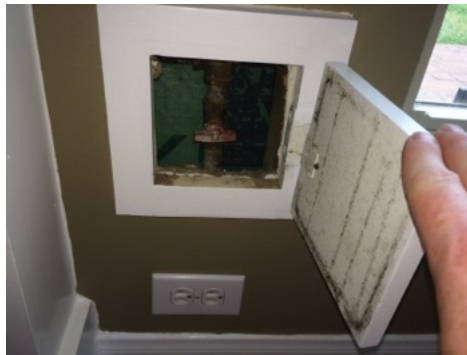
No locking mechanism on valve hatch

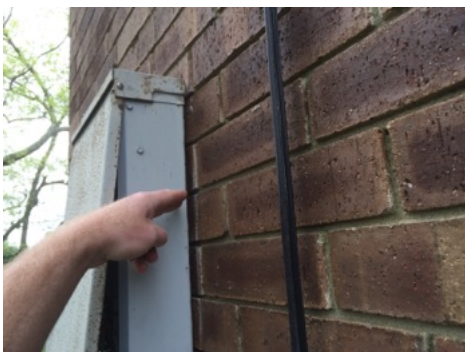
Top and side: Caulk missing at wall connection

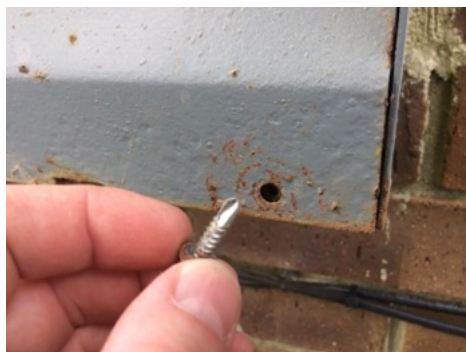
Improper screw used

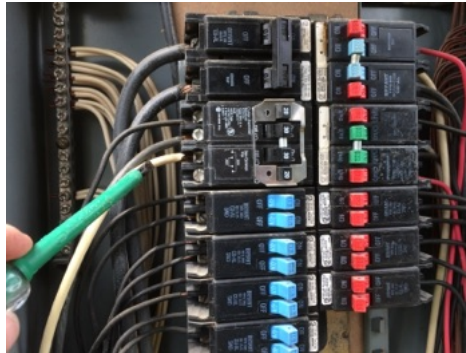
Conductor improperly color labeled

NOTE: We recommend all repairs on the electrical system and in the electrical panel be performed by a licensed, professional, competent and qualified electrician.

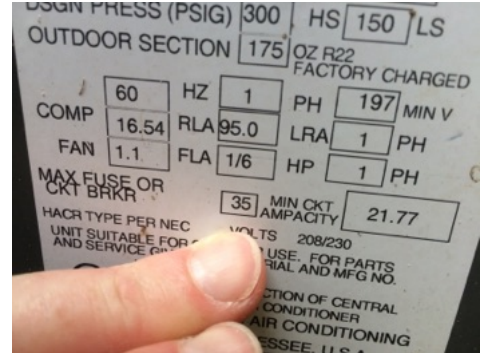
Condenser 1 max rated breaker 35 amps

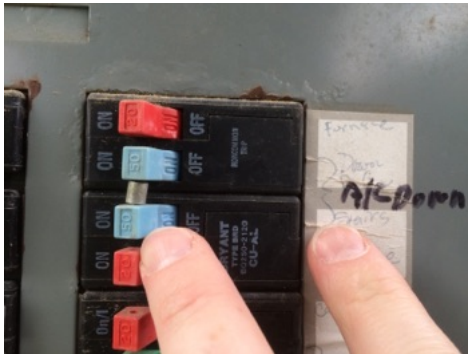
Condenser breaker rated 50 amps

The breaker serving the condensing coils unit 1 was oversized by 15 amps per the unit's manufacturer's data plate maximum rated breaker. We recommend having this repaired/replaced with an adequately sized breaker to prevent potential damage to the condensing coils. (See Service Entrance and Panels section of this report)

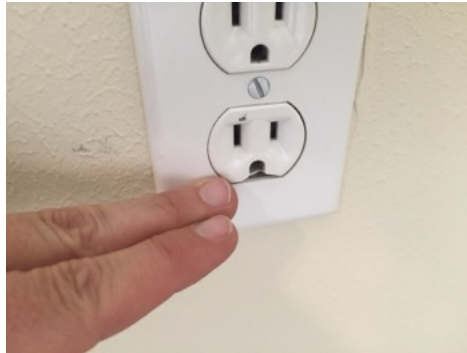
A damaged outlet was noted at the time of inspection. We recommend having this replaced. This was observed in the dining area and bedroom 4.

Bedroom 4: damaged outlet

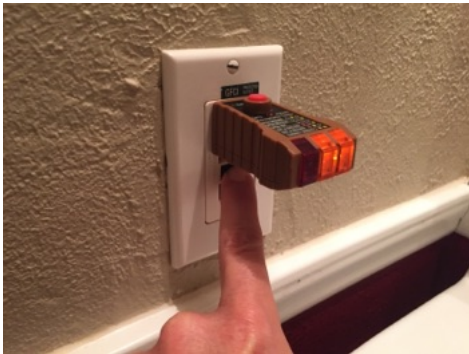
A Ground Fault Circuit Interrupter (GFCI) electrical outlet in the home did not re-set, was slow to re-set or made a buzzing sound when re-set. This is a safety issue. We recommend replacement of this GFCI outlet to ensure that it operates correctly when required. We observed this in the half bathroom,

Had bath: faulty GFCI outlet- would not trip

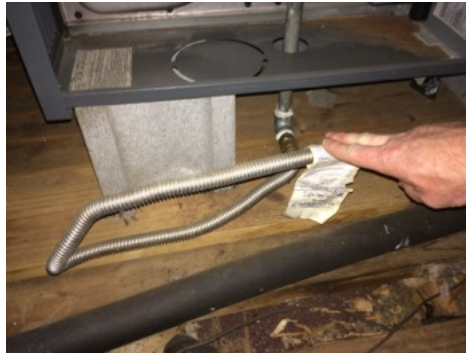
The gas supply pipe to the furnace 1 contained no drip leg. A drip leg is generally recommended but not always required, depending on the local Authority Having Jurisdiction (AHJ). The purpose of a drip leg is to prevent particulates or moisture

from condensation from entering and clogging the furnace gas valve, which can cause the furnace to shut down. You may wish to consult with a local licensed, professional, competent and qualified HVAC technician concerning the advisability of installing a drip leg in the gas line.

Unit 1: Missing drip leg

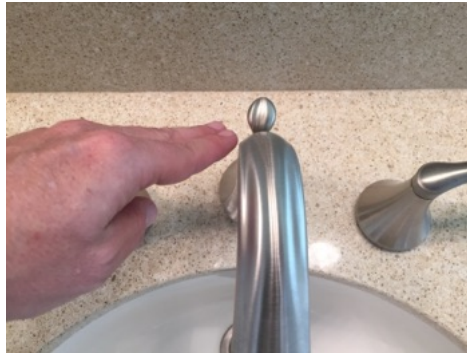
MAINTENANCE: A stopper was not functional at a bathroom lavatory/tub. We recommend having stoppers adjusted or repaired to retain water as it is designed. This was noted in bathroom 1 at the right lavatory and the left lavatory in bathroom 2.

Bathroom 1: drain stop would not retain water at right lavatory

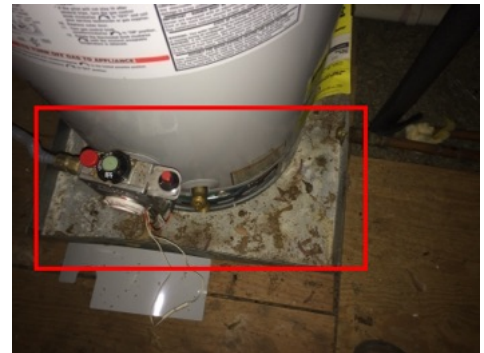
Debris in safety pan

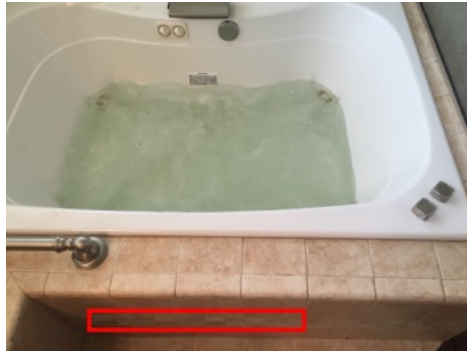
Whirlpool on with no access panel to pump/drain line

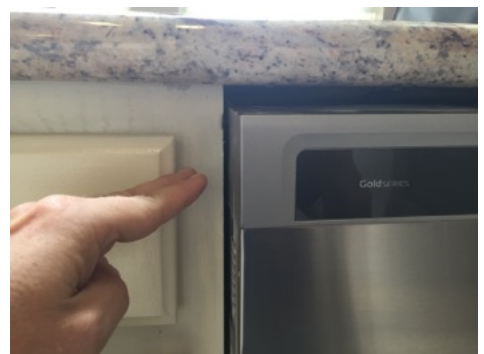
The door rubbed on the left side which made it somewhat difficult to close. We recommend having this adjusted.

Door rubbed on left side
