HOUSTON INSPECTIONS

PROPERTY INSPECTION REPORT

Concerning: 11219 Bottlebrush Ct, Houston, TX 77095
(Address or Other Identification of Inspected Property)

By: Dennis Inman, Lic #20664 05/07/2015
(Name and License Number of Inspector) (Date)

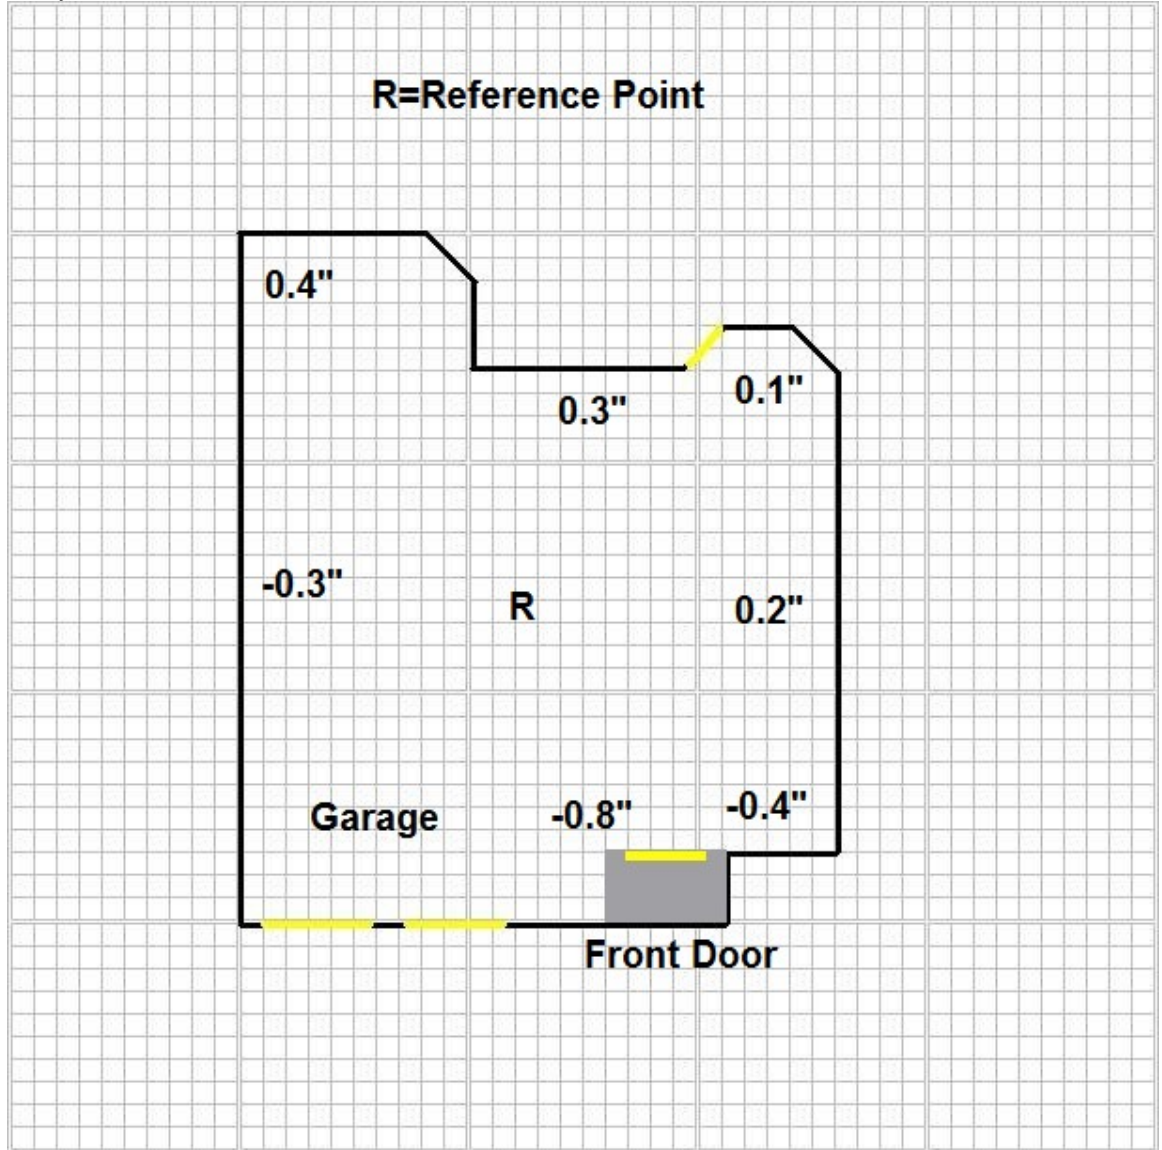
The below graph reflects measurements taken during the inspection to assist with determining the levelness of the foundation. The outline / drawing is not to scale and does not accurately reflect every detail of the foundation walls.

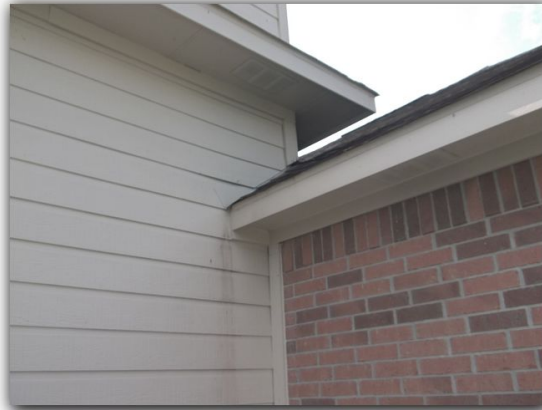
Kickout Flashing @ Wall & Roof Intersections - High Possibility of Water Penetrations without flashing being installed

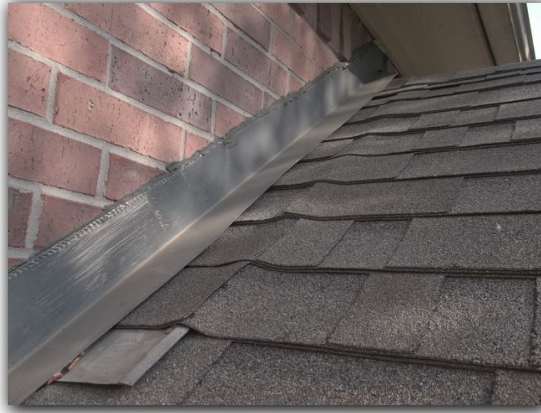
Damaged and / or missing shingles were found during the inspection of the roof covering. Recommend repairs by a qualified tradesman.

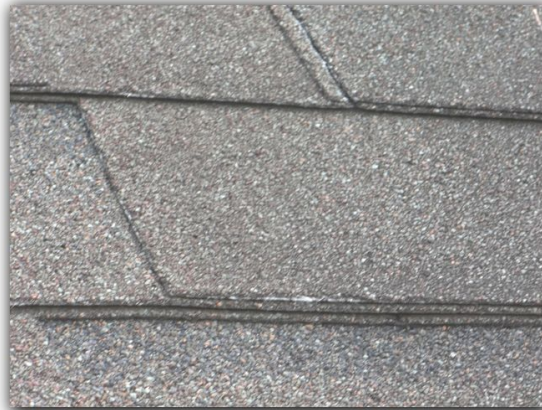
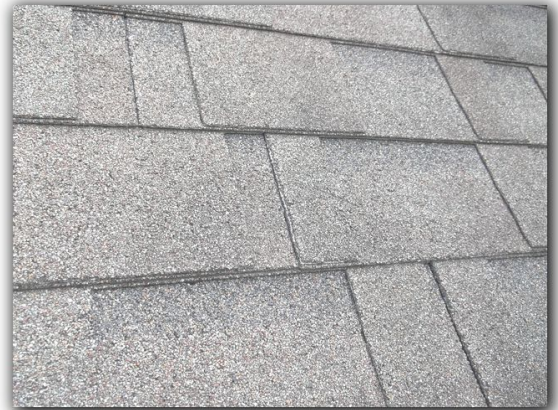
The shingles have become brittle as evident by cracked and damaged shingles. This is something that occurs to composition shingles as they age. This is an indicator that the shingles are more than half way through their serviceable lives. As the roof continues to age, unexpected repairs can and will most likely occur. The client should budget and anticipate repairs and replacement in the near future. Immediate repairs should include replacement of the damaged and / or non functional items by a qualified tradesman.

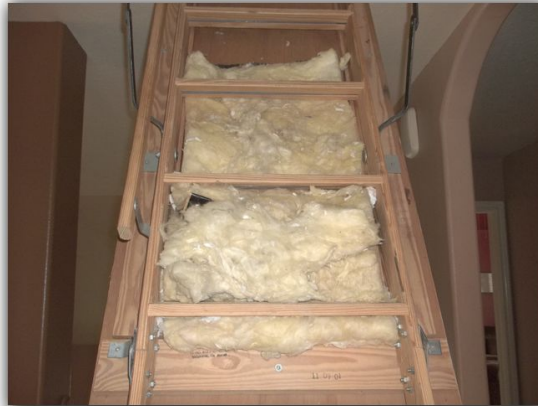
The batt insulation installed at the attic door has become a trip hazard when using the ladder. Recommend improvements to prevent falls from the ladder.

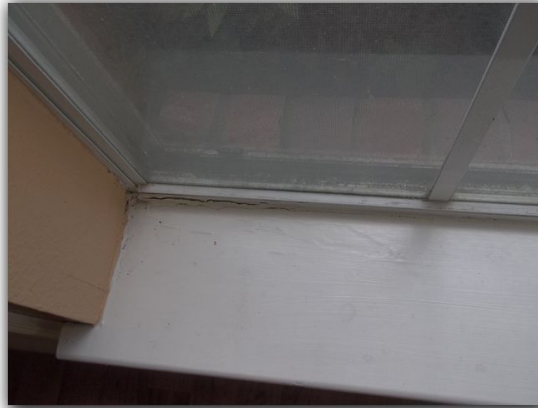
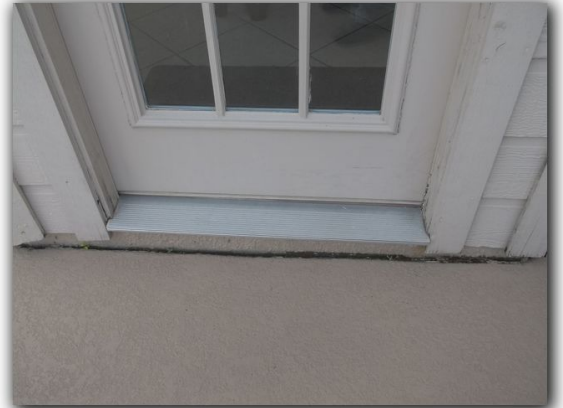
Damaged and missing sealant / caulking was found at joints, transitions, and voids on the exterior veneers. This material acts as a moisture barrier to prevent water from moving to the underlying wall cavity. The re-sealing of the exterior veneers should be considered.

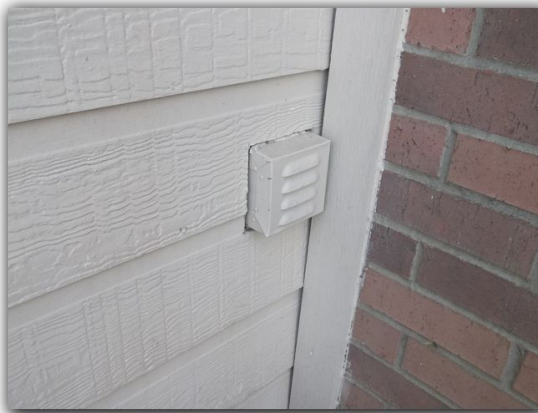
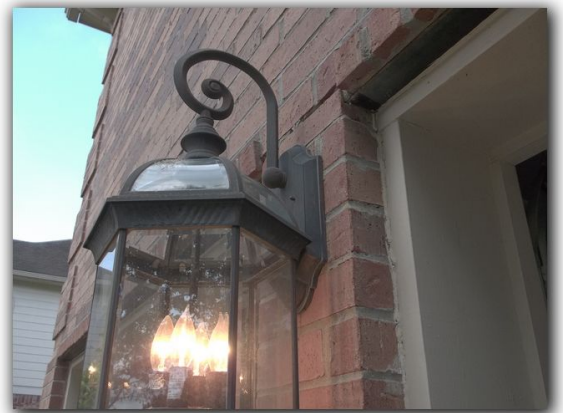
All exterior wall penetrations (electrical panels, electrical disconnects, light fixtures, etc.) and openings (expansion joints, windows, door thresholds, etc.) should be sealed with an approved material to prevent water penetrations into the wall cavities. Properly sealed exterior veneers help provide a barrier against the weather, insects, and enable environmental control of the interior spaces.

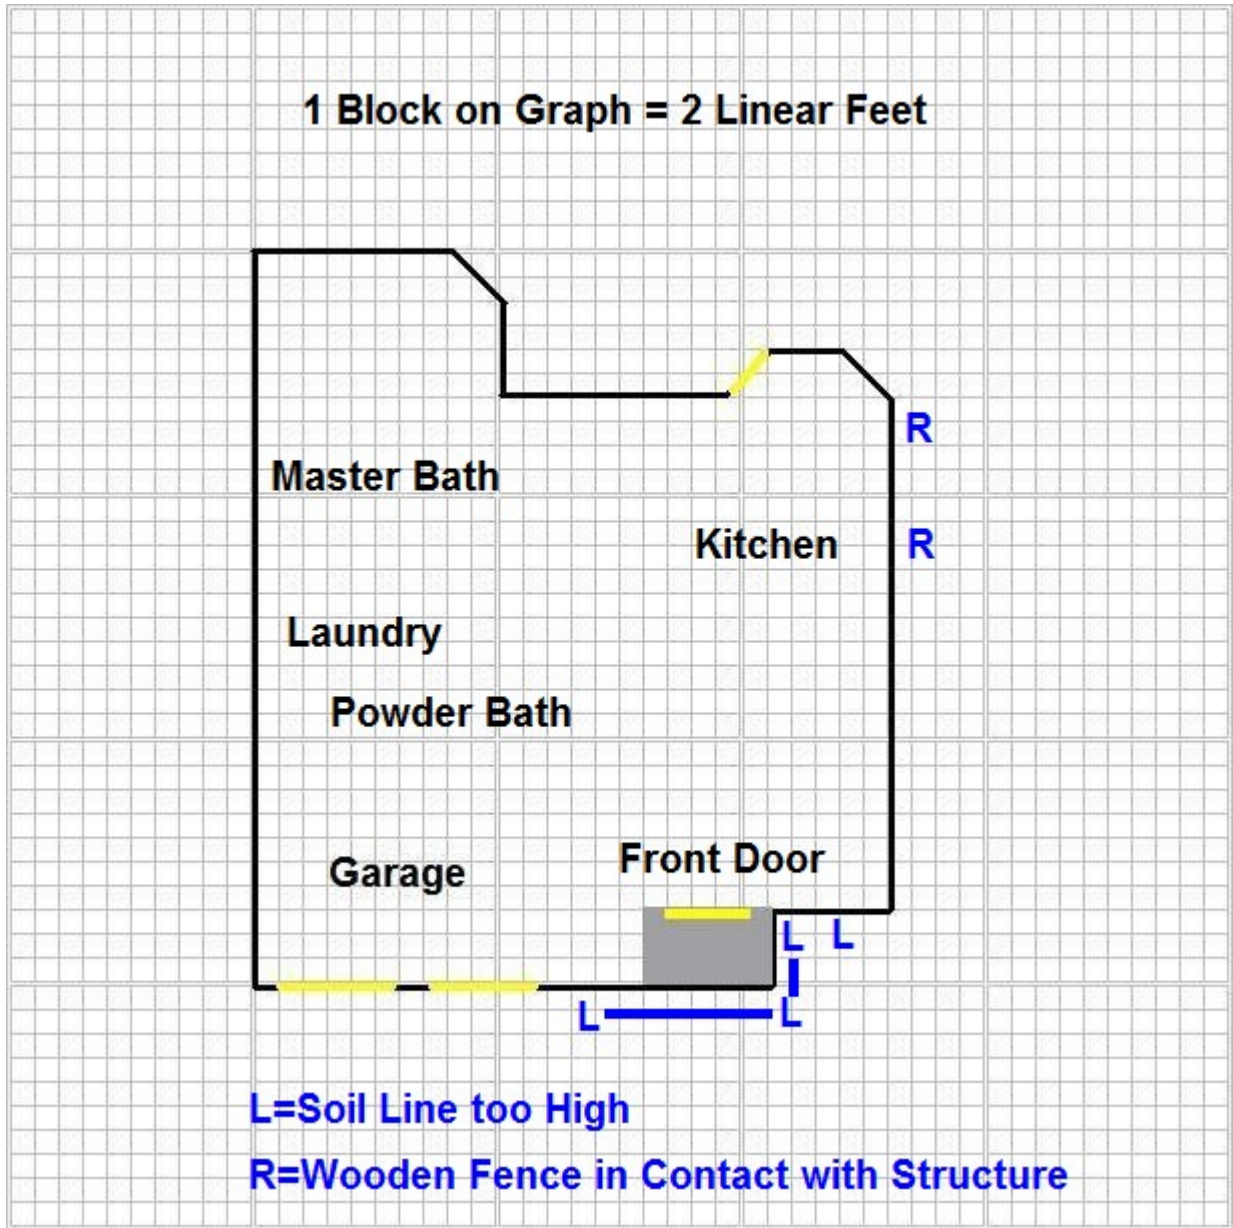
Diagram of Structure(s) Inspected

Additional Comments Conductive conditions were found during the inspection of the property, which could conceal insect activity or promote future insect activity or conceal damage. DUE TO THE CONDUCTIVE CONDITIONS FOUND WE CANNOT GUARANTEE THE ABSENCE OF WOOD DESTROYING INSECTS. The conducive conditions should be corrected. After the conducive conditions have been corrected it is recommended that the property be re-inspected for wood destroying insects. The client should take into consideration the cost of associated with correcting the conducive and / or performing a subterranean termite treatment and plan accordingly.

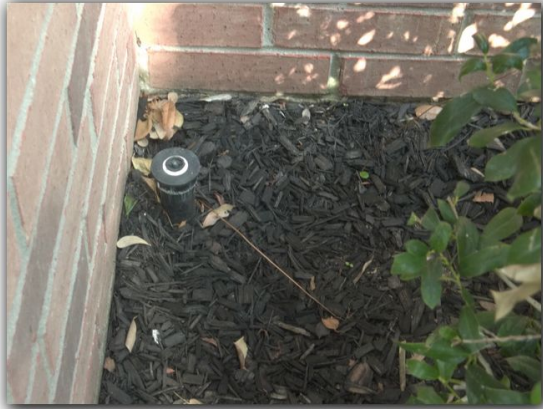
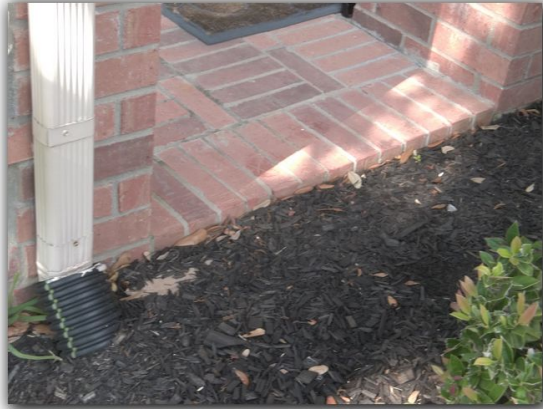
High Soil
