# PROPERTY INSPECTION REPORT

**Concerning:** 2913 Port Rose Ln, League City TX 77573  
(Address or Other Identification of Inspected Property)

**By:** Nick Jones - TREC #9019 05/02/2019 10:00  
(Name and License Number of Inspector) am (Date)

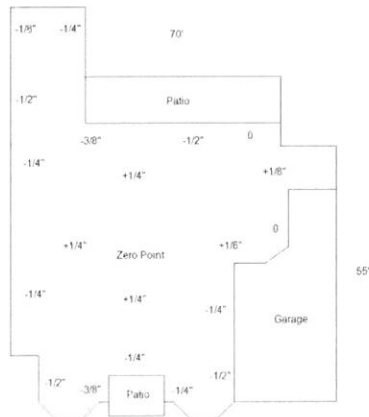
Zip Level system was used at the time of inspection to measure the overall levelness of the foundation. The zip level revealed no signs of any issues at the time of inspection. See the drawing provided below for the measurements taken at time of inspection.

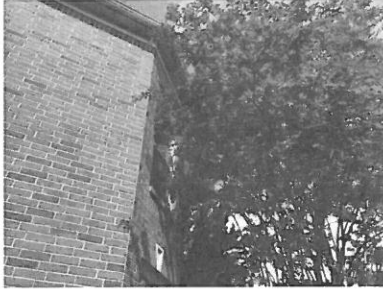
**2: Gutters & Downspouts: No Gutters**

No gutters were observed to be installed along the sides of the home. Installation is highly recommended to prevent further erosion of the soil resulting in standing water near the foundation. Some areas along the left exterior of the home where soil erosion was observed. Recommend correction.

Recommendation: Contact a qualified gutter contractor

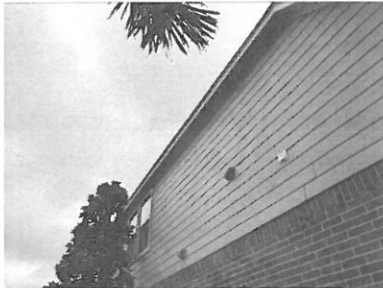
**3: Gutters & Downspouts: Missing Splash Blocks**

Splash blocks were missing from multiple downspouts. Splash blocks placed under the downspout discharge helps disperse the water away from the foundation and to prevent soil erosion. Correct as needed.

Recommendation: Contact a qualified professional.

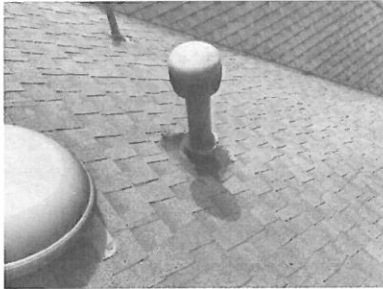
**2: Flashing lifted**

Sections of the flashing at the back lower roof slope are lifted need properly secured and sealed. Recommend correction.

Recommendation: Contact a qualified roofing professional.

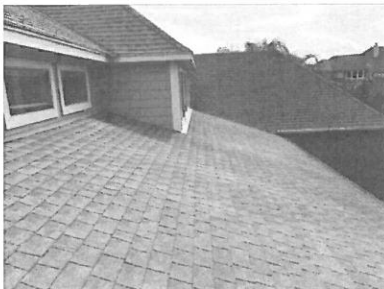
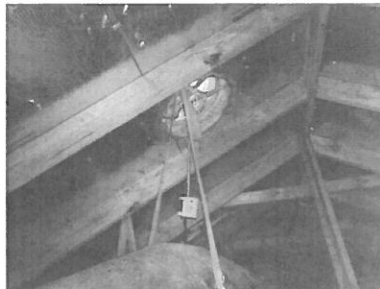
### 3: Degraded/moisture damaged insulation

Several locations throughout the attic space where the insulation has been damaged from moisture issues, or the insulation is degraded or displaced. These locations include above the master bedroom area, where moisture issues from roof leaking as well as ductwork have degraded the insulation, as well as multiple locations throughout the attic space where the insulation has been displaced. Thermal imaging revealed multiple locations with poor insulation that should be supplemented. Recommend further evaluation and correction as needed for energy efficiency reasons.

Recommendation: Contact a qualified insulation contractor.

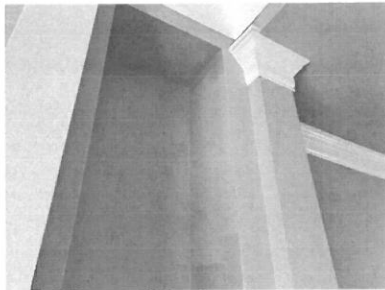
#### 1: Caulking & Sealing

Caulking and sealing is needed various locations to prevent any possible moisture penetration into the building or other issues. These locations include around wall vent covers, electrical outlets/fixtures, transitions between siding, plumbing penetration, brick control joints, A/C lines, and gaps in shower enclosures and backsplash.

Recommendation: Contact a qualified professional.

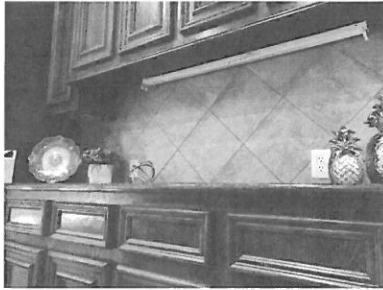
### 3: No GFCI protection

No GFCI protection present for the outlets at the kitchen counter closest to the living area, one of the outlets beneath sitting area in master bathroom, and the outlets in the laundry room. Modern codes require GFCI protection at all outlets in kitchen, bathrooms, and laundry rooms. Recommend correction.

Recommendation: Contact a qualified electrical contractor.

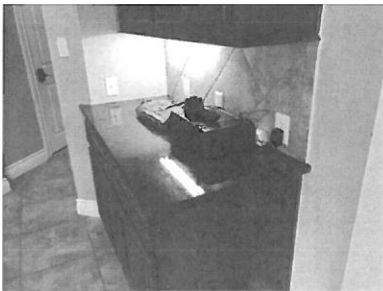
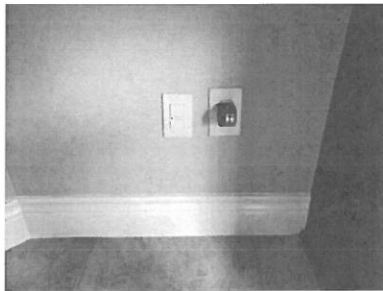
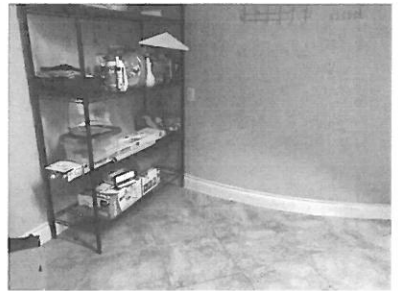
### 4: Outlets loose/Covers damaged

Multiple locations throughout the home where the outlets are loose and need properly repaired. Multiple locations around the home where cover plates are damaged and need replaced. Recommend further evaluation and correction as needed.

Recommendation: Contact a qualified electrical contractor.

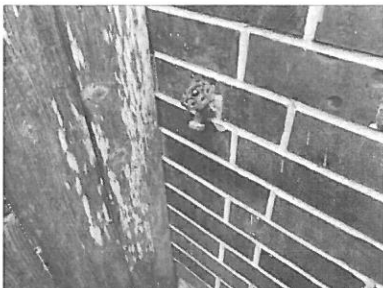
**2: Minor leak at shut off valve**

Minor leaking observed around the valve stem at the shut off on the right exterior of the home. Recommend correction.

Recommendation: Contact a qualified plumbing contractor.

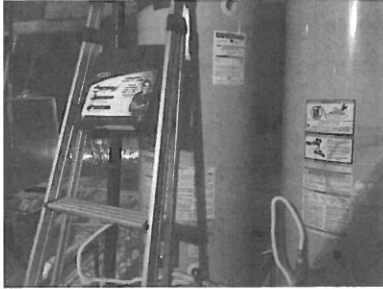
**2: Right unit not lit**

The right water heater was not lit at the time of inspection. The inspector did light the pilot and the unit appeared to operate properly at time of inspection. Recommend further evaluation to ensure proper function of the equipment.

Recommendation: Contact a qualified professional.

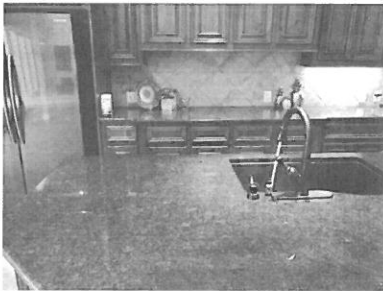
The switch for the disposer unit is located at the exterior wall and not at the kitchen sink. Recommend caution with this switch and considering relocation.

Recommendation: Contact a qualified electrical contractor.

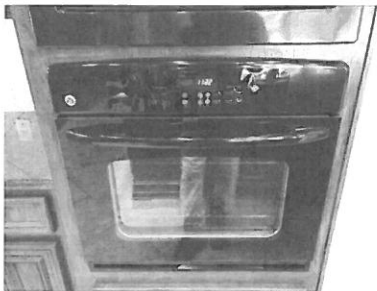
**1: Oven control panel damage**

The control panel for the oven unit is damaged. Recommend repair or replacement.

Recommendation: Contact a qualified professional.

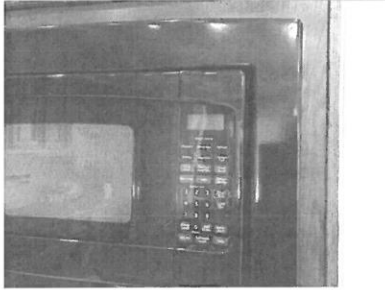
**1: Display worn**

The display for the microwave unit is excessively faded and difficult to read. Recommend correction as desired.

Recommendation: Contact a qualified professional.

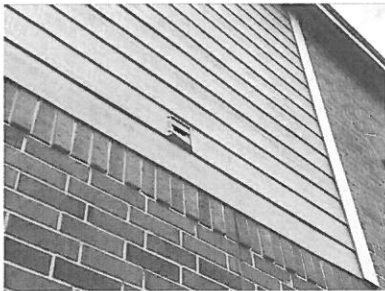
**1: Vent cap damaged**

One of the exhaust vents at the left exterior of the home is missing a louver from the. Recommend correction to prevent potential pest intrusion into the structure.

Recommendation: Contact a qualified professional.

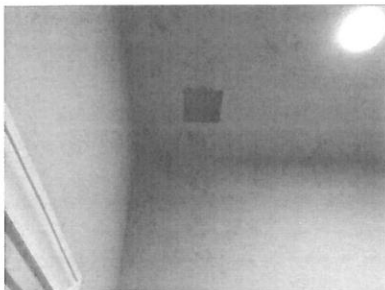
**2: Fan at up right bathroom**

The fan at the upstairs right bathroom appears to be absent from the box. Recommend further evaluation and correction as needed.

Recommendation: Contact a qualified professional.

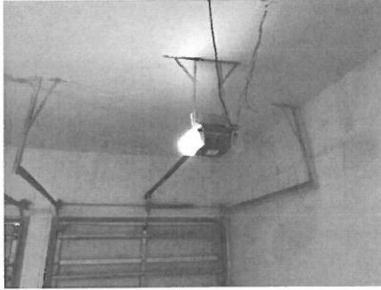
**1: Auto Reverse Sensor Not Working**

The auto reverse sensor was not responding at time of inspection. This is a safety hazard to children and pets. Recommend a qualified garage door contractor evaluate and repair/replace.

Recommendation: Contact a qualified garage door contractor.

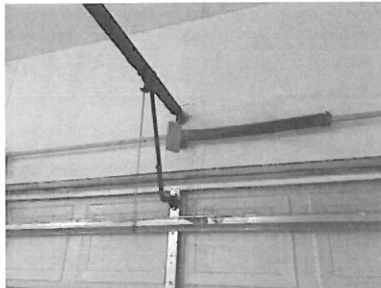
**2: Spring Out of Balance**

Spring for the overhead garage doors was observed to be out of balance when manually operated. Recommend adjustment to prevent stress on the operator.

Recommendation: Contact a qualified garage door contractor.

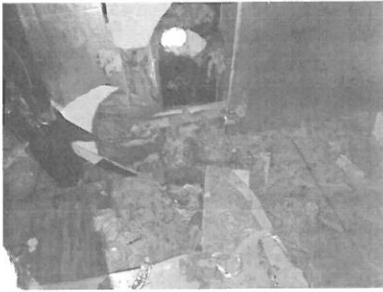
**1: Dryer vent**

Improper termination of the dryer exhaust vent observed at the back right lower attic space. Signs of excessive lint buildup were observed at this location. A flexible vent appears to be in use for the dryer at the time of inspection. This vent type is not permitted, and code requires a rigid duct to be used for dryer vents. Recommend consulting with a qualified contractor to fully evaluate the dryer duct assembly to determine the extent of necessary repairs.

Note: ensure that contractor evaluated the length of the dryer duct to determine if a blower assist motor is needed.

Recommendation: Contact a qualified professional.

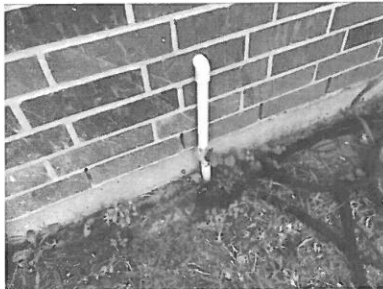
**1: Damage to control wire conduit**

The conduit protecting the control wires at the right exterior of the home is damaged and needs repaired or replaced.

Recommendation: Contact a qualified professional.

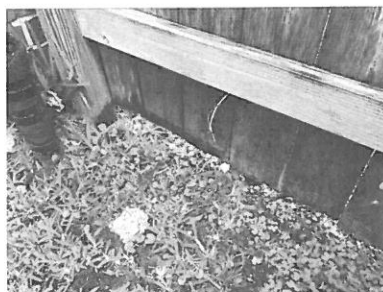
**2: Rain sensor wires cut**

The wiring for the rain sensor at the left exterior of the home has been cut near the base of the fence. Recommend correction and further about UHN to ensure proper operation of this device.

Recommendation: Contact a qualified professional.

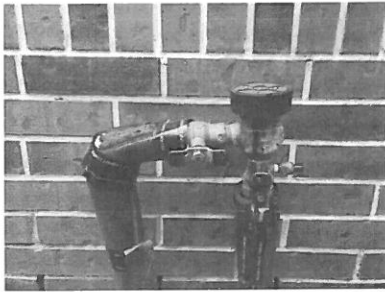
**3: Leaking at vacuum breaker**

Leaking observed around the vacuum breaker assembly at the time of inspection. Recommend further evaluation and correction

Recommendation: Contact a qualified professional.

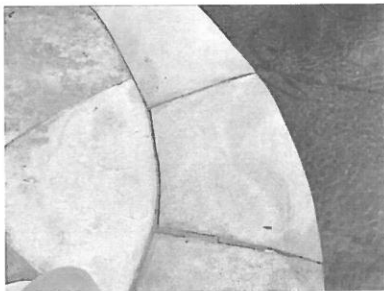
**1: Cracking at grouting/mortar**

Minor cracking/separation was observed on the mortar and grout joints for the tile at the decking around the pool. Recommend these areas be repaired or filled to prevent further deterioration or moisture penetration.

Recommendation: Contact a qualified professional.

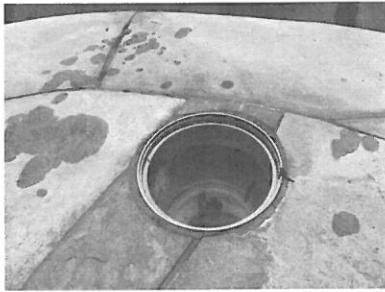
**2: Flapper weirs absent**

The flapper weirs are absent from the skimmer basket assemblies. Recommend correction.

Recommendation: Contact a qualified professional.

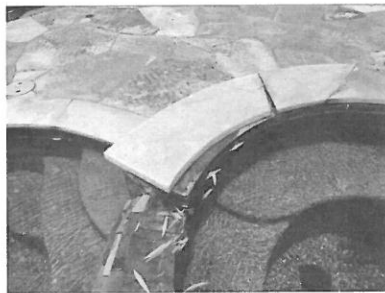
### 3: Coping

Sections of the stones used for coping were observed to be loose and in need of repair, this includes the area around the spa. Recommend further evaluation and correction as needed.

Recommendation: Contact a qualified professional.

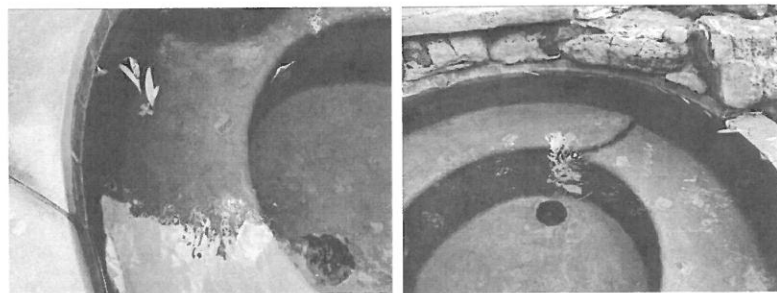
### 4: Finish at spa

Note: minor deterioration of the finish at the spa area was observed at the time of inspection. This deterioration includes minor cracking as well as the finish being dirty and needing cleaned.

Recommendation: Contact a qualified professional.

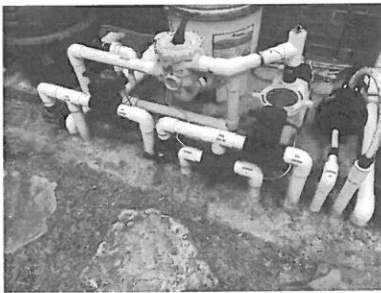
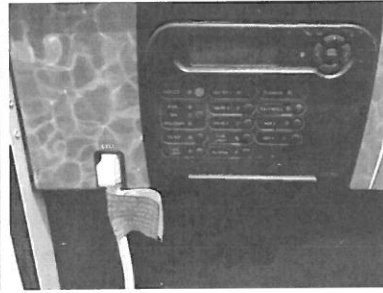
### 6: Spa setting

Note: recommend further evaluation to ensure proper settings are in place for the control valves. When the system was set to a spa mode from the exterior control box the valves were not turned the proper position. The controller at the interior of the home was not used at time of inspection. Recommend all settings be evaluated by a qualified contractor.

Recommendation: Contact a qualified professional.
