Moisture Assessment Report

2715 Newman Street,
Houston, Tx 77098
05/05/2015

Judy and Jim Paukert

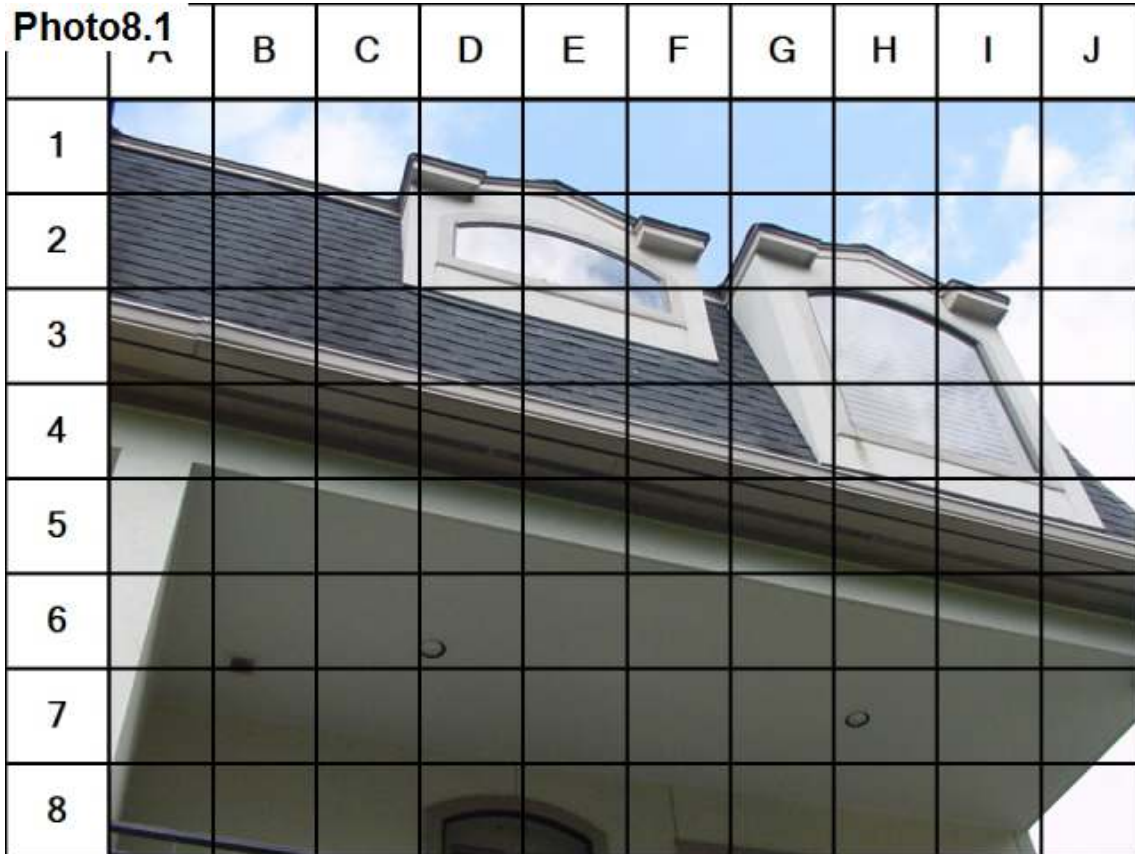
Grid Location	Item Description	Moisture Readings	Substrate Condition	Observations-Photo #8.1	Chapter Reference
				Always maintain sealants at all windows, doors and penetrations. Reseal all as needed.	Ch 3.1,3.2

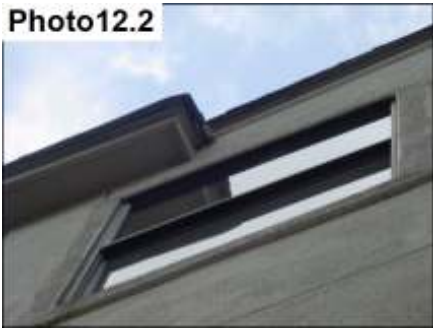
Seal all flashing terminations

Grid Location	Item Description	Moisture Readings	Substrate Condition	Observations-Photo #12.1	Chapter Reference
.	.	.	.	Always maintain sealants at all windows, doors and penetrations. Reseal all as needed.	Ch 3.1,3.2
D7	Window Lower Left	28%	Semi Firm	High moisture probe was made below window lower left	
Circle	Sealant Separation			Sealant separation noted at this window. Assess all windows and seal / reseal all separated areas as needed. See Detail #12.2	
Re Arrows	Roof FLASHing Terminations			Roof flashing terminations lack sealants. See Detail #12.3 - Seal all roof flashing areas as needed.

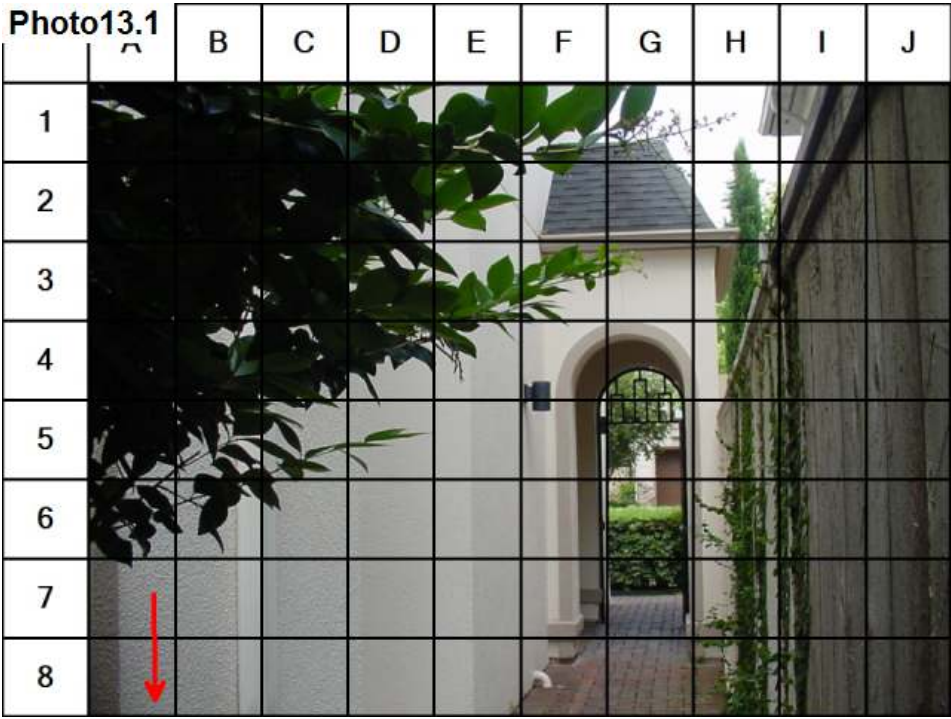
Grid Location	Item Description	Moisture Readings	Substrate Condition	Observations-Photo #13.1	Chapter Reference
				Always maintain sealants at all windows, doors and penetrations. Reseal all as needed.	Ch 3.1,3.2
Arrow	Sprinklers			Sprinkler overspray suspected in this area. Redirect all sprinkler heads away from stucco exterior. See Detail #13.2 and #13.3
