PROPERTY INSPECTION REPORT

Concerning: 2816 Newman Street, Houston, TX 77098
(Address or Other Identification of Inspected Property)

By: Samuel H. Sahagian, TREC #7669 06/03/2018
(Name and License Number of Inspector) (Date)

Home is approximately 3,200 sq. ft., 3 story and faces S for inspection purposes

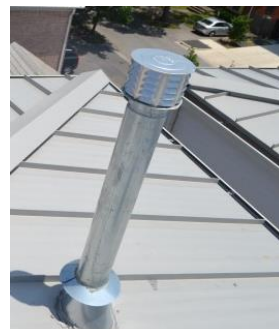
- The flue pipes and roof jacks were not painted on rooftop.

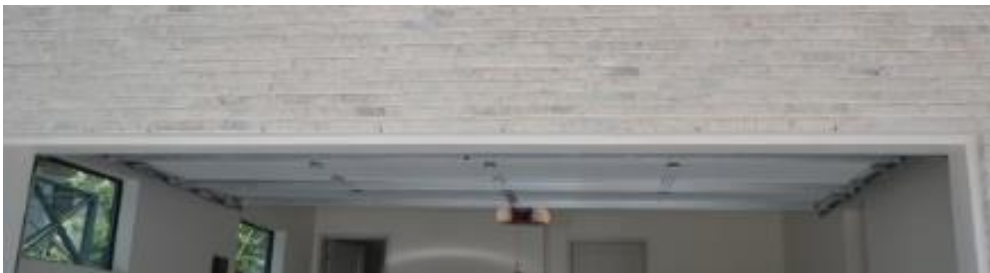
Above garage door

- We did not visually observe through wall flashing at steel lintels above garage, at 3rd floor balcony windows and at base of brick wall at 3rd floor balcony (brick sitting on steel lintels at base of wall). Note: if flashing is missing, the steel lintel will corrode over time and cause the expansion of steel lintels which in turn will cause gaps/separation of brick mortar due to expansion of corroded steel lintels.

6-Mil poly should be draped over the TOP of the lintel to be used as lintel flashing

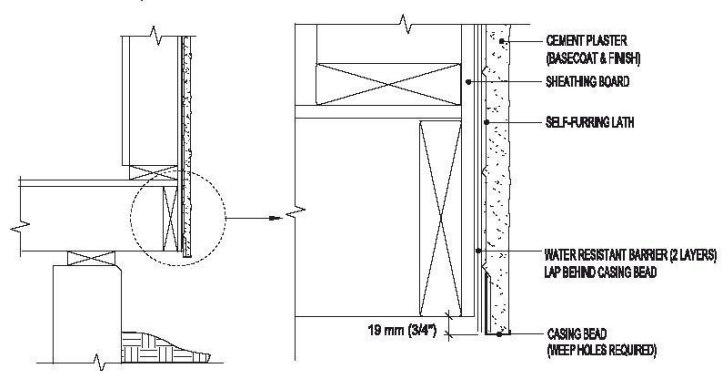
- We did not observe drainage plane above front wall.

- Information: IRC R703.6 Exterior plaster. Installation of these materials shall be in compliance with ASTM C 926 and ASTM C 1063 and the provisions of this code.
- Information: ASTM A2.2.3 Where vertical and horizontal exterior plaster surfaces meet, both surfaces shall be terminated with casing beads with the vertical surface extending at least 1.4 in. (6 mm) below the intersecting horizontal plastered surface, thus providing a drip edge. The casing bead for the horizontal surface shall be terminated not less than 1.4 in. from the back of the vertical surface to provide drainage.

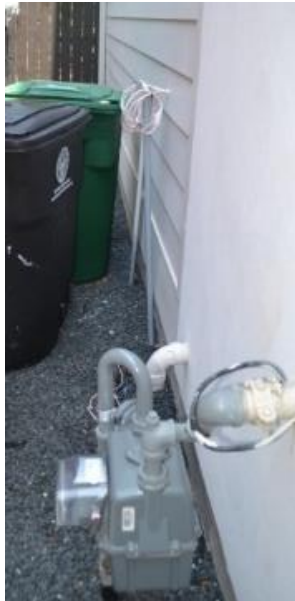
- Note that modern standard requires a second grounding electrode unless testing shows <25 ohms resistance at existing electrode. We did not observe supplemental electrode (Rod type grounding electrodes spaced a minimum of 6 feet apart)
 - Information: 250.52(A)(1) through (A)(4). NEC 250.56 where resistance needs to be 25 ohms or less.

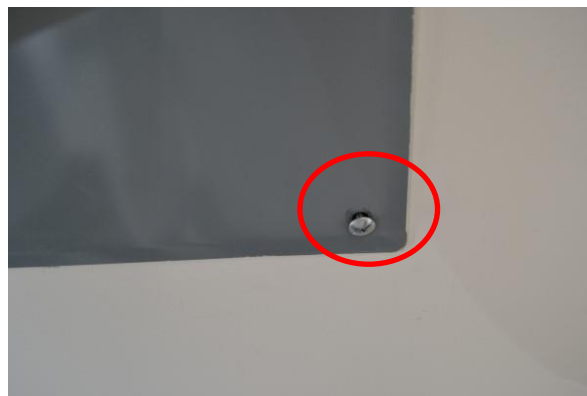
- Panel box lower right dead front cover does not engage to secure screw.

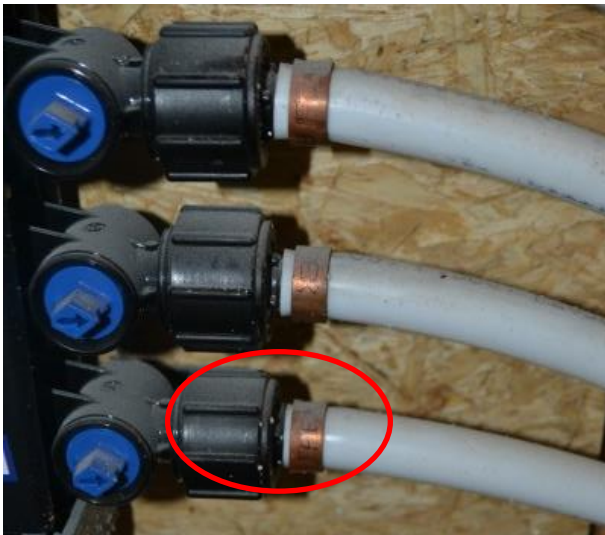
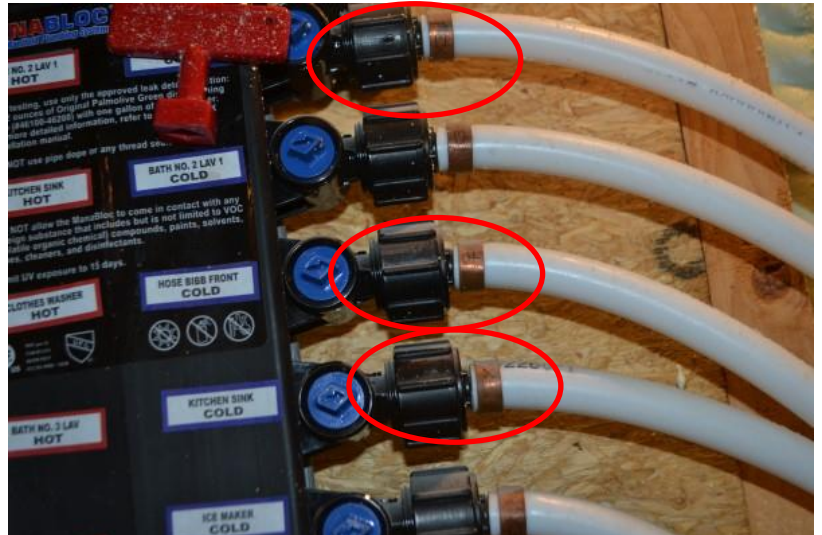
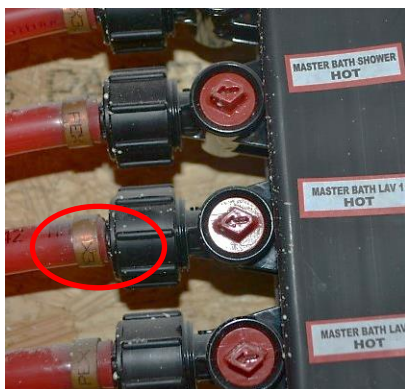
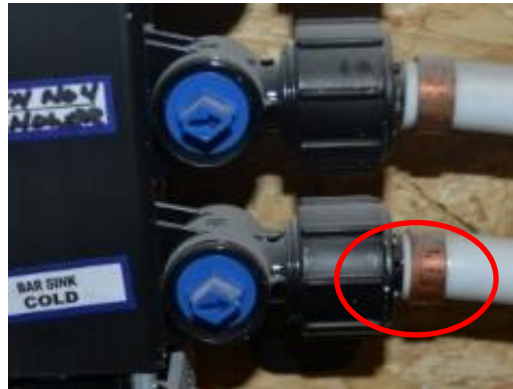
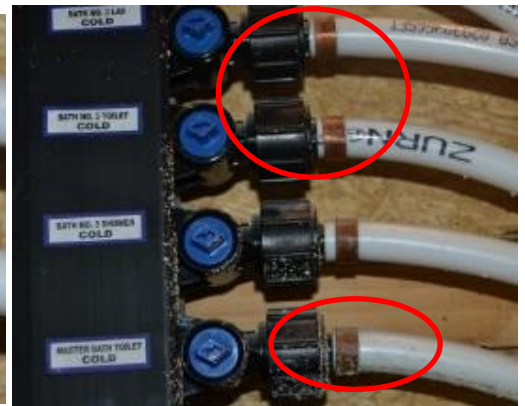
- Observed multiple improperly installed PEX crimps at the PEX manifold in 3rd floor attic. Improper positioning of Crimp fitting on the PEX tubing
 - Information: A 1/8" to 1/4" inch of tubing should project past the inside of the crimp per the manufacturer installation instructions. Manufacturer indicates crimp ring at end of tube does not cover enough fitting ribs to mount/hold the pipe. [ref: IRC R102.4 - manufacturer installation instructions] ["The PEX tubing must be placed to the fitting shoulder. For fittings without a shoulder, the PEX tubing must be placed far enough to cover all the fitting barbs. The crimp ring is placed 1/8" to 1/4" from the shoulder or end of the PEX tubing."] Recommend checking all PEX water lines at the crimp rings. *see example image below from manufacturer and photo images*

3. Slide the swivel nut (D) back to brass adapter and slide the crimp ring (C) to within 1/8" to 1/4" from the end of tube. Crimp the ring with an appropriately sized full-circle crimp tool.
DO NOT CRIMP TWICE.

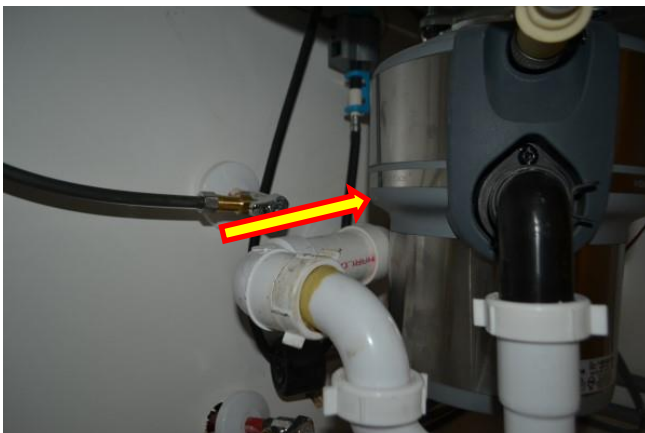
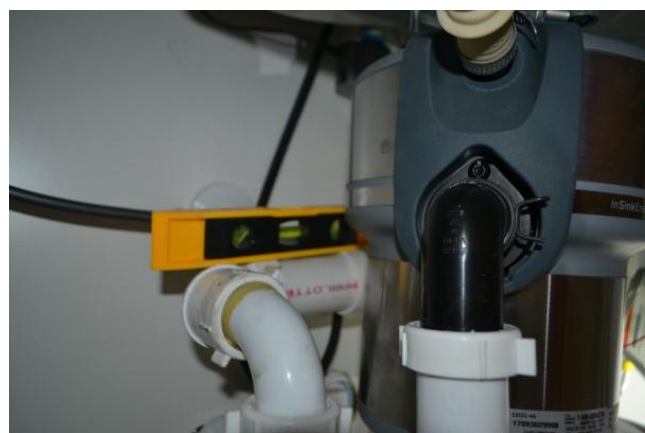
- Kitchen drain line draining uphill. Have plumber properly pitch drain line under kitchen sink.

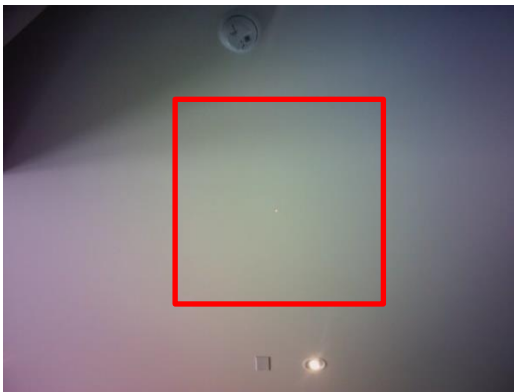
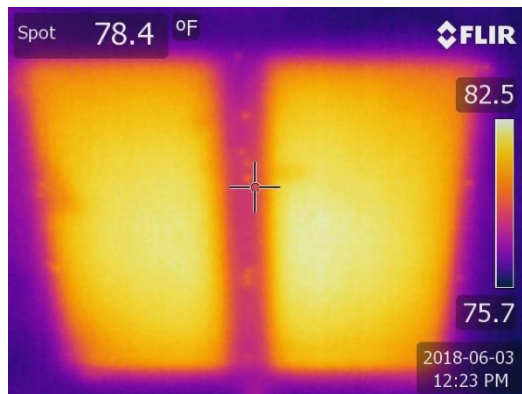
3rd floor above hallway by smoke detector

- Elevator was functional all three floors.
- Missing, folded, shallow or displaced insulation noted at ceiling in several rooms, these were detected with infrared Thermography camera. (bright yellow areas indicate missing, displaced or fallen insulation.)
