Property Inspection Report #190121AL-2816 Newman Street  
8616 Daffodil St. Houston, TX 77063

## PROPERTY INSPECTION REPORT

**Prepared For:** Rob & Ellen Blasio  
(Name of Client)

**Concerning:** 2816 Newman Street, Houston, TX 77098  
(Address of Inspected Property)

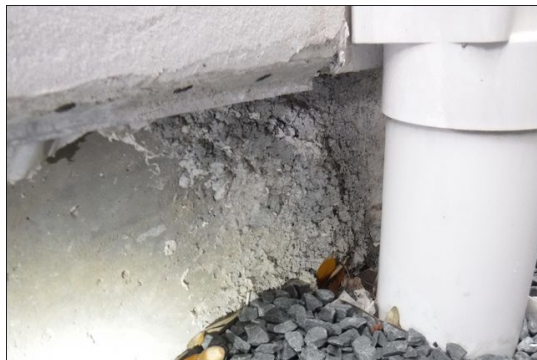
Slab dressing observed at one or more areas of foundation.

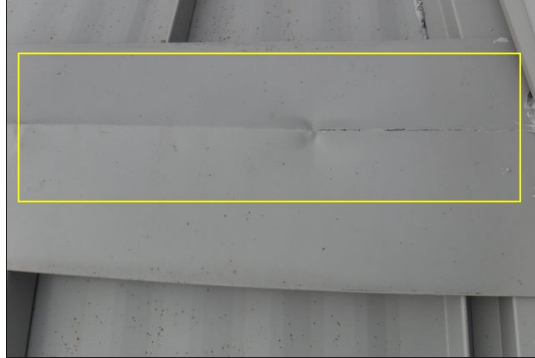
Ridge cap is damaged/deformed at one or more areas on roof surface; possibly from foot traffic.

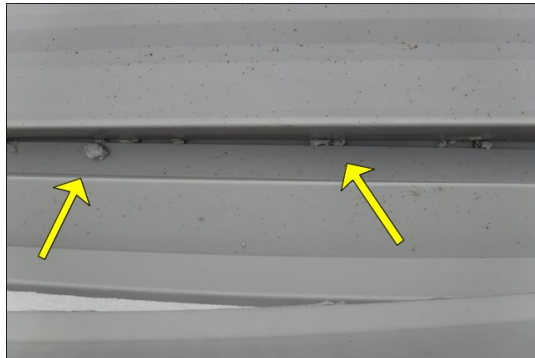
Recommend clearing debris from roof surface to allow for proper water drainage.

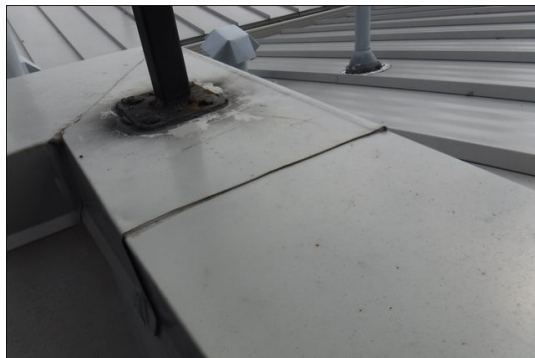
Observed railing bolted down to the top of the cap flashing on the balcony and roof surface. These penetrations are potential areas for water entry, recommend monitoring and maintaining sealant.

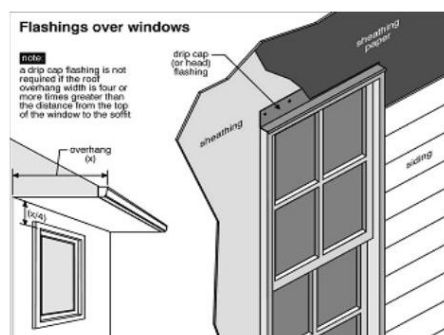
Head flashing missing over some windows / doors. Head flashing helps prevent water penetration. Without head flashing windows/ sealing must be maintained as the only defense against water penetration.

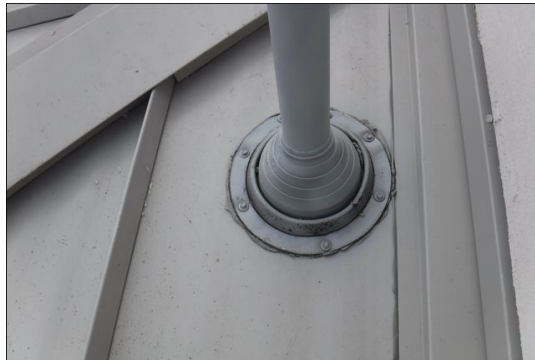
Rubber gasket of drain waste vent is inverted, may prevent proper drainage of water.

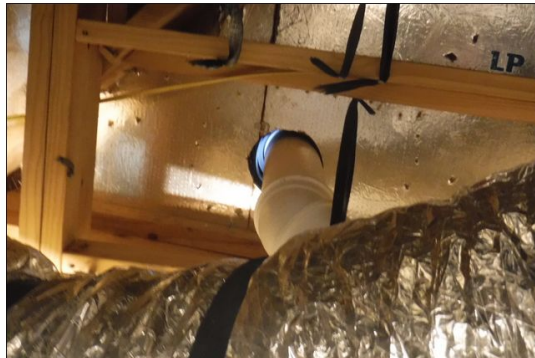
Daylight observed in attic around water heater exhaust vent penetration. This could be a potential point of water penetration.

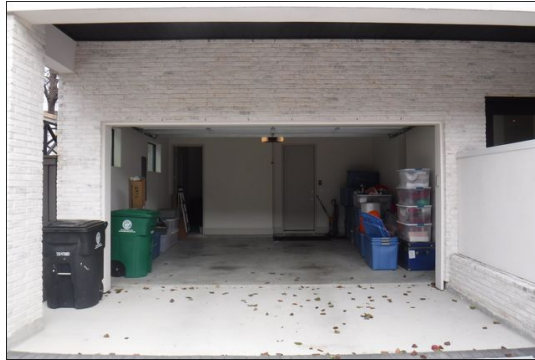
Sag in double header over garage door. Indication of improper/inadequate framing.

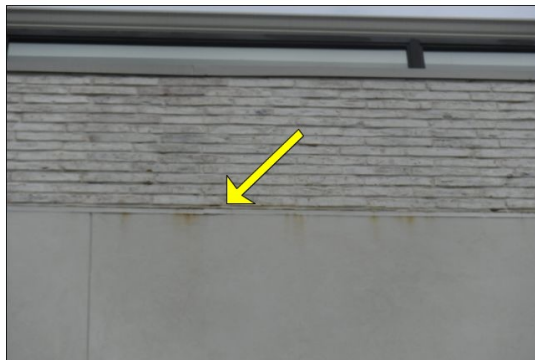
Rust/corrosion observed below flashing at top of stucco wall at front of house. This could indicate water penetration behind flashing. Recommend further evaluation.

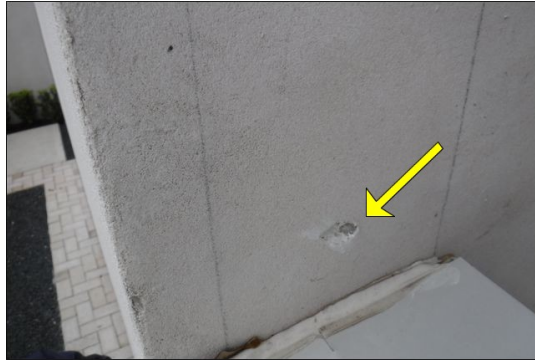
Stucco finish is damaged at top of guard wall at southeast corner of house.

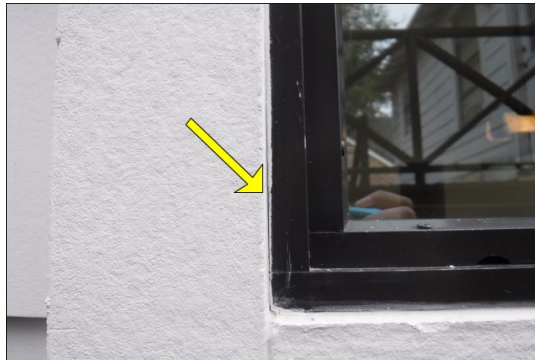
Caulking deficient around one or more windows, will allow water penetration during heavy / wind driven rains.

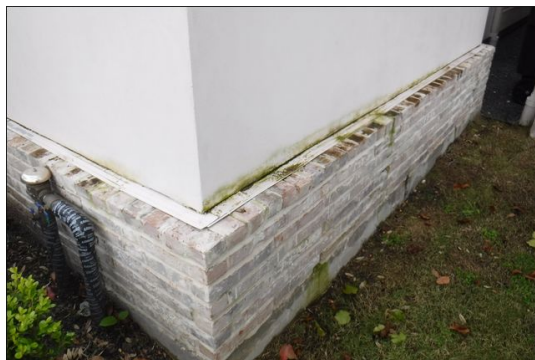
*Staining observed on side of guard east side of front guard wall, possibly due to lack of sunlight.*

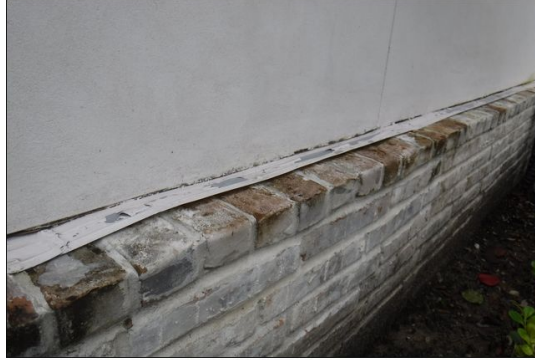
Recommend painting flashing at base of guard wall at front of house to prevent possible corrosion. Lower edge of flashing is not sealed down well.

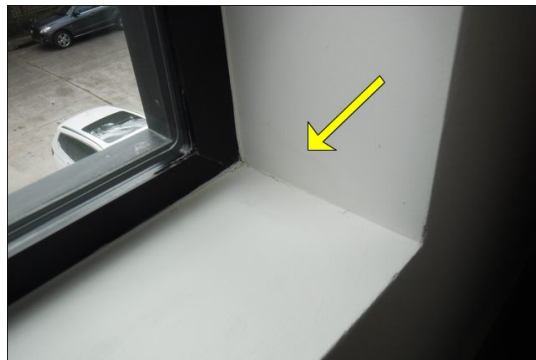
Water stains / damage on interior of one or more window jambs. (second floor middle guest bedroom)

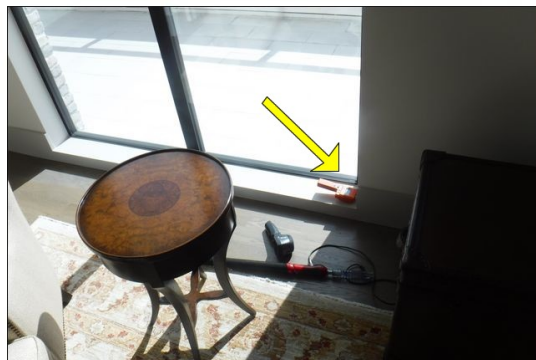
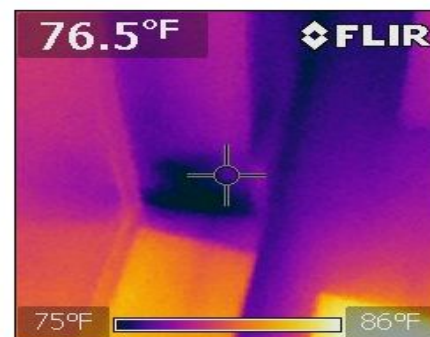
**Water penetration observed at the following location(s): at third floor fixed window. Recommend further evaluation/repair.**

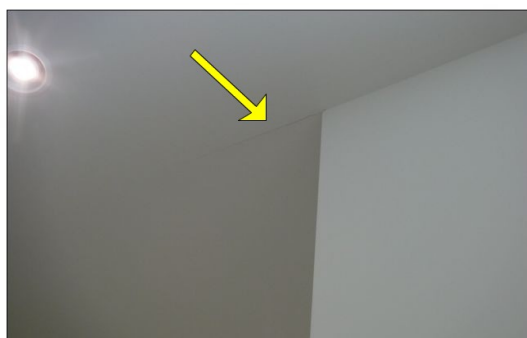
Cosmetic cracks and/or repaired cracks in sheetrock observed in ceiling; third floor around stairwell.

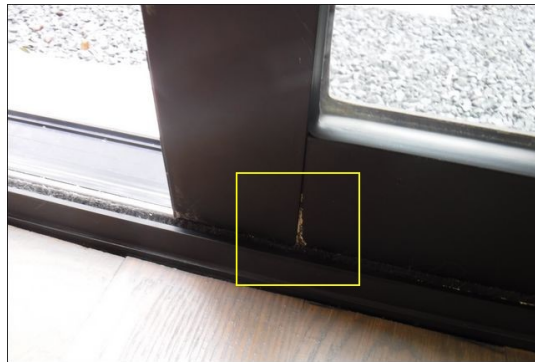
Observed water penetration though bottom corner of sliding glass door at first floor.

Recommend sealing exterior joints.

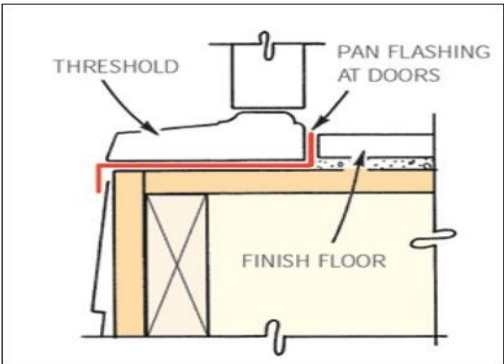
Did not observe door pan flashing at exterior door location(s). Properly installed door pan flashing helps prevent wind driven rain / water penetration from damaging interior building components. *High risk areas include exterior doors with little to no roof or balcony overhang protection from the elements. It is not uncommon for Fox Inspection Group inspectors to observe evidence of water penetration (water damaged wood flooring or water stained carpet tack strip) at second floor balcony doors. For additional information you may watch a 5 minute video on flashing where the first few minutes shows door pan flashing by copying and pasting this link*

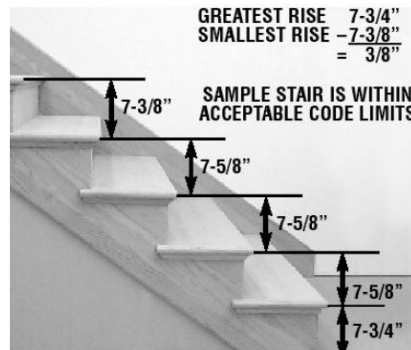
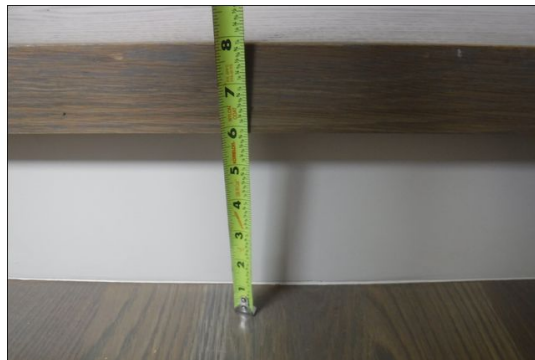
Stairway has tripping hazard, Risers are not same height along the entire height of steps.  
Stairway does not comply with current industry standard, (code). CABO 314.2 &  
UBC 1006.3 requires "The greatest riser height within any flight of stairs shall not  
exceed the smallest by more than 3/8 inch."

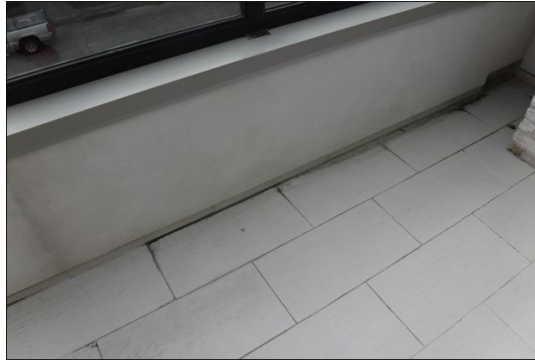
Some staining observed on balcony floor along wall, which may indicate pooling water. Recommend monitoring drainage after a heavy storm to ensure no water is left standing.

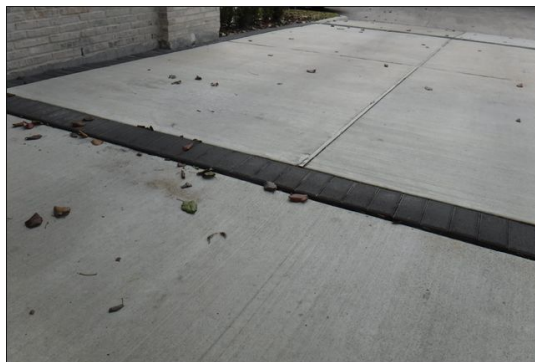
Tripping Hazard(s), walks and/or driveways are uneven.

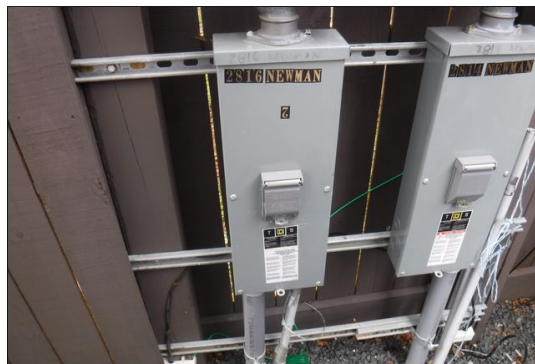
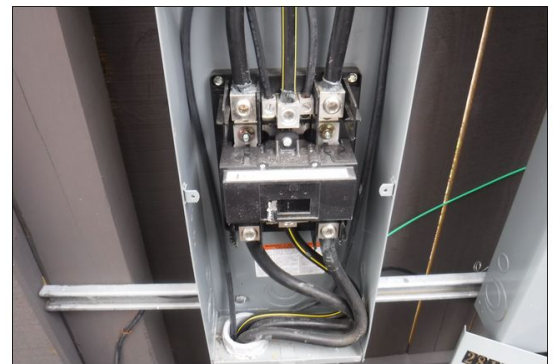
200 AMP ELECTRICAL SERVICE PANEL LOCATED ON THE WEST SIDE OF THE HOUSE

No significant deficiencies or anomalies observed at the time of inspection.

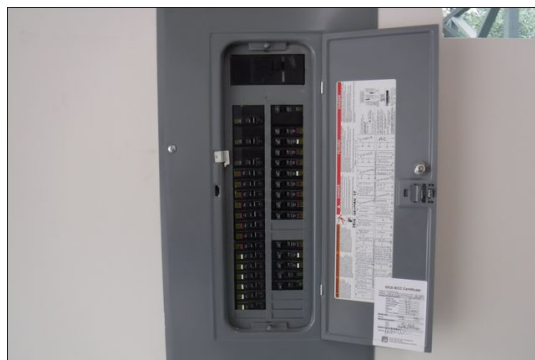
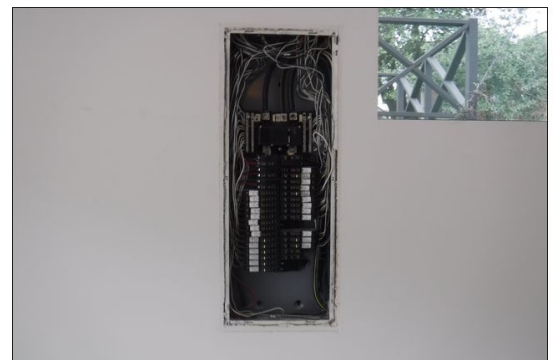
**200 AMP ELECTRICAL SUB PANEL LOCATED IN THE GARAGE**

No significant deficiencies or anomalies observed at the time of inspection.

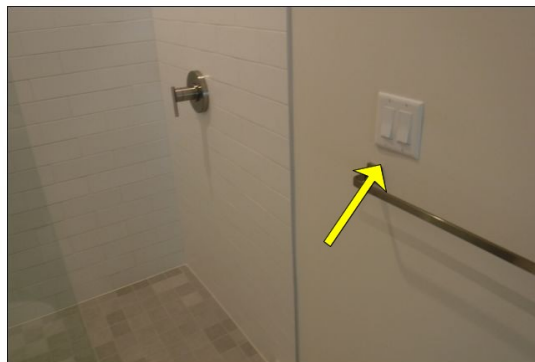
Switch/outlet can be operated while standing in tub/shower, shock hazard. Install switch on back side of wall or just ensure it is not operated while standing in tub.

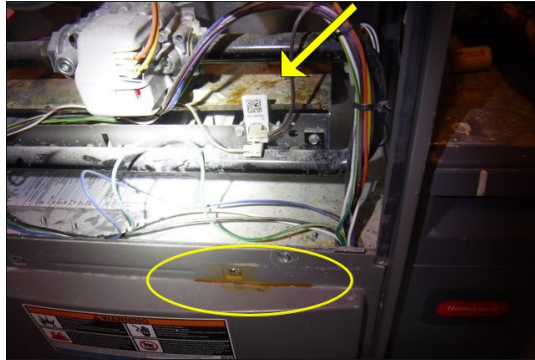
Some rust/corrosion observed inside of heater cabinet, possibly from previous leak or excess condensation on evaporator coil above.

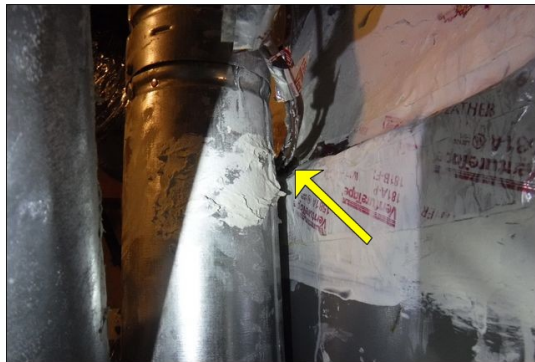
Recommend adjusting thermostat wiring away from heater exhaust vent.

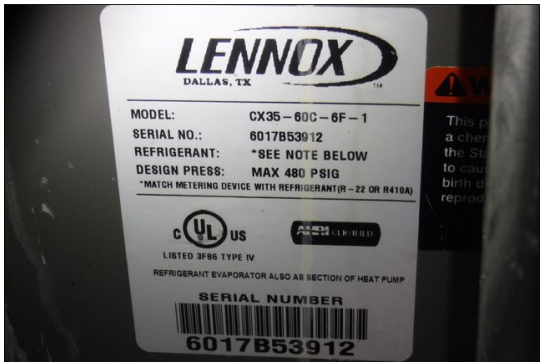
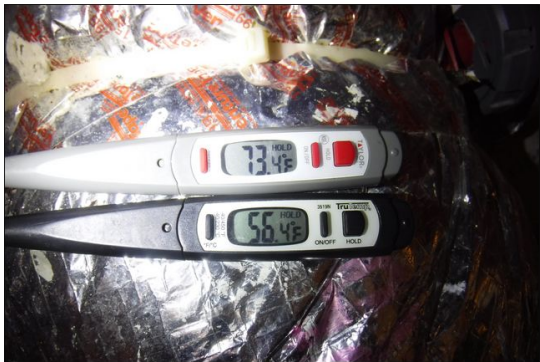
EVAPORATOR COIL: 2017 LENNOX 5 TON

Temperature Differential:  
Return Temp: 73.4      Supply Temp: 56.4      Difference: 17.00  
Age: 2 YEARS OLD      Typical life expectancy: between 15 - 25 years as reported by Nachi [Click here for more information](#)

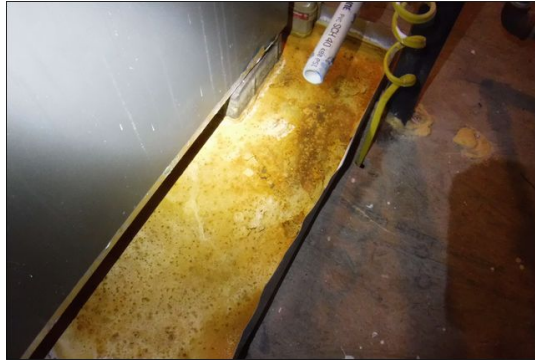
**CONDENSATION DRAIN PAN/DRAIN LINES:**

*Secondary drain pan is rusted; indication coil (or previous coil) has history of leaking/dripping condensation into pan.*

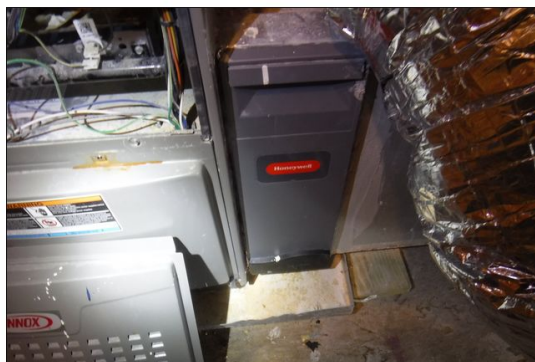
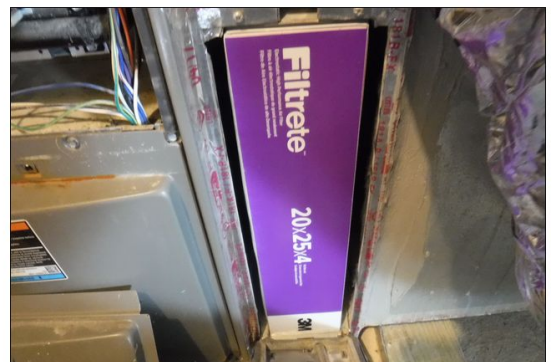
*Media air filter(s) located in attic that requires changing/cleaning every 6 months, recommend checking guide for proper maintenance information.*

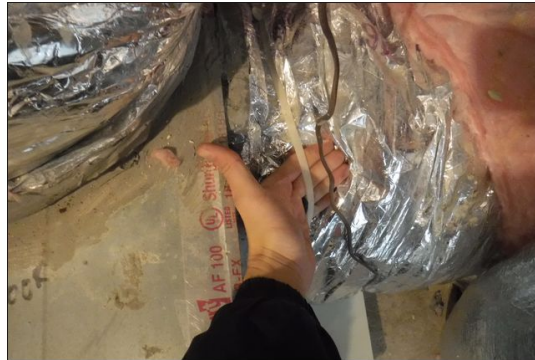
Observed areas in attic where flex duct mechanical connection zip ties are not snug fit / are loose as required by current industry standards. Appears proper use of zip tie synching tool was sporadic. Loose mechanical connections increases chance of duct separation in future, recommend repair.

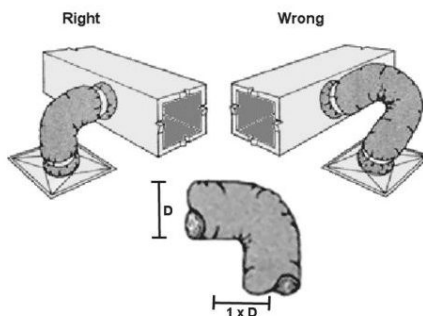
Some flex duct observed to be improperly routed with sharp bends and / or excess material in bends. Improper routing increases frictional loss in the duct and reduces heating and cooling efficiency. Radius at centerline of the bend should be no less than the diameter of the duct.

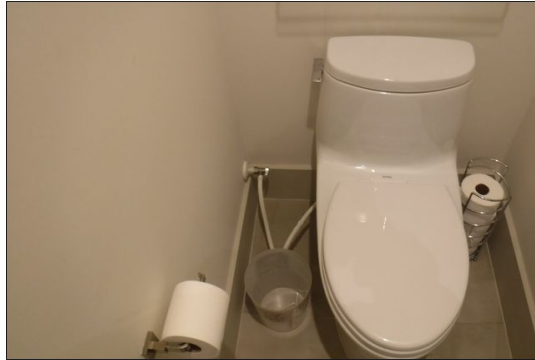
Observed 2 water lines amateurishly tied together at master bathroom commode in order to clear the distance. The water supply line is normally located directly behind the commode.

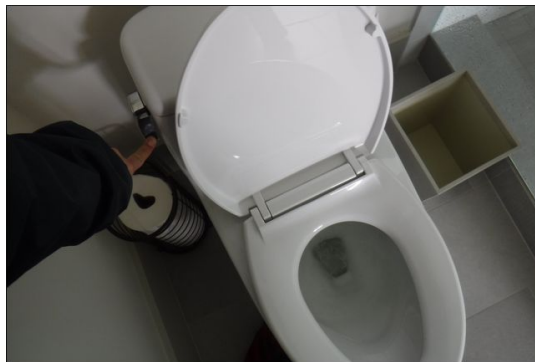
#### COMMODOES:

Does not flush properly, must hold down handle for proper flush; third floor bathroom.

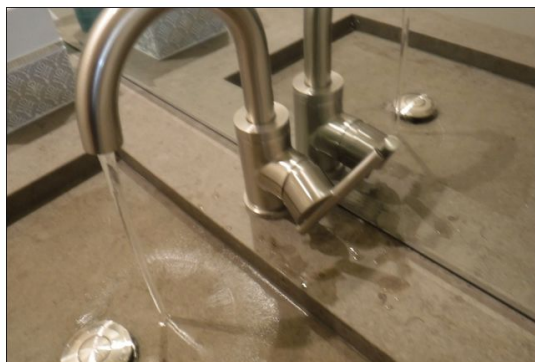
#### FAUCETS:

The faucet handle at the first floor bathroom hits the mirror.

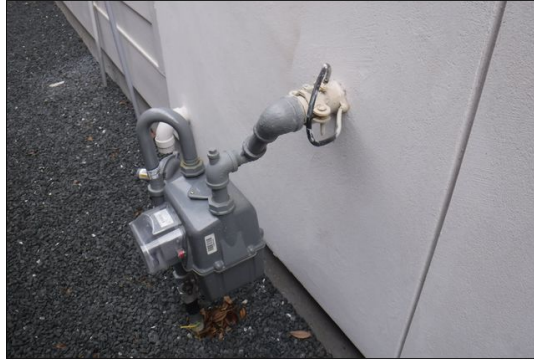
Gas piping not sleeved as it passes through masonry wall as required by Code [CABO 2608.3] IRC 2603.3.

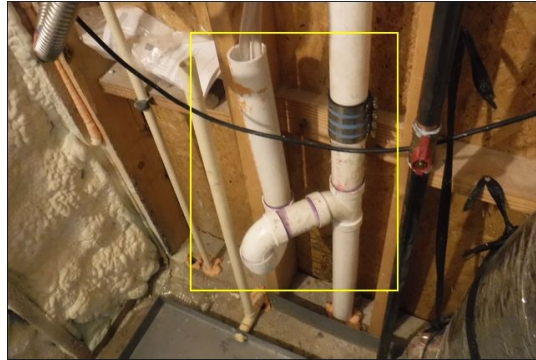
Open drain observed in attic, below water heater, which may allow sewer gases to enter into attic if P-Trap dries out.

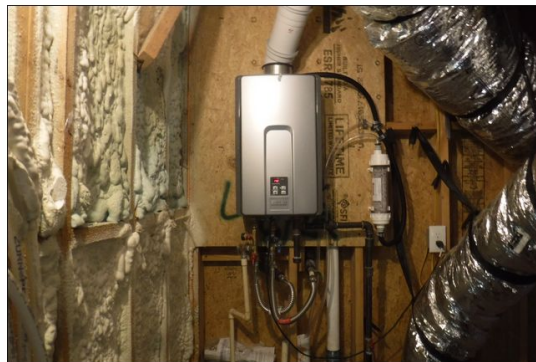
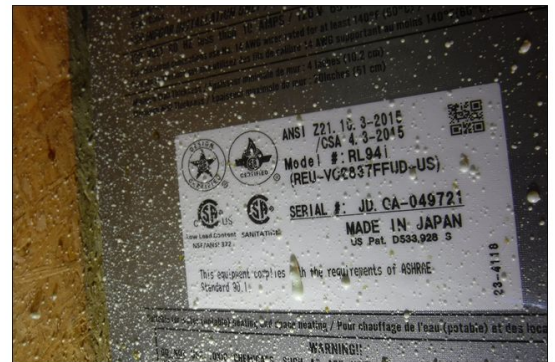
**WATER HEATING UNIT(S): 2018 RINNAI (1 YEAR OLD)**

Drain pan is located far below unit and may not catch all water from potential leaks.  
Drain pan is not secured properly in place.

The condensate drain line and components do not appear to have been installed properly to allow for proper drainage. Hose is missing required drip loop and the line is crimped at one or more locations and not properly secured in drain. Recommend further evaluation by a qualified professional.

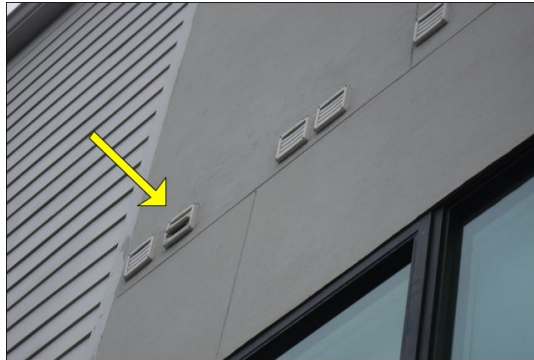
Flappers stuck open on one or more vents (observed at third floor on west side of house).

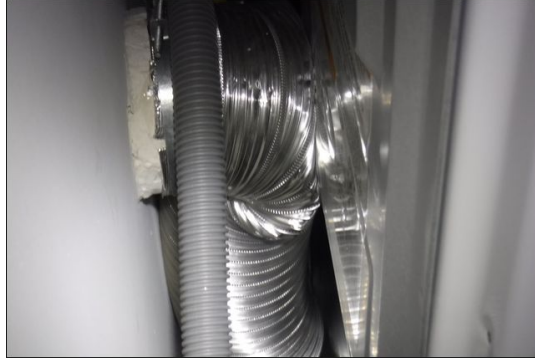
Dryer venting damaged/restricted behind dryer. Correct existing condition to reduce fire hazard.

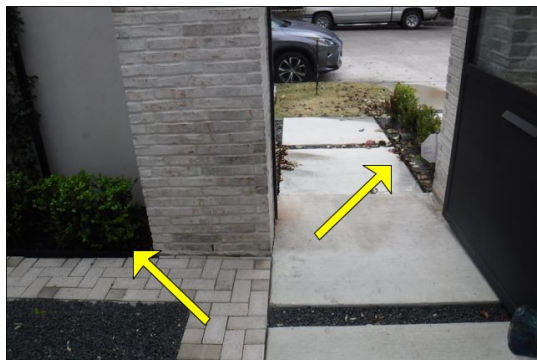
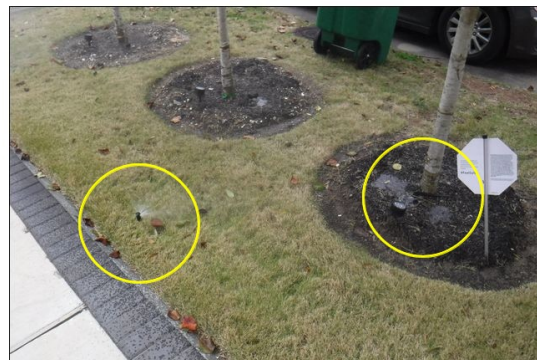
Observed mixed head types (i.e., rotating and spray heads) on the same stations. The two head types have different coverage rates and should not be mixed on the same zone.
