Response to Fox Inspection Jan 21/2019

2816 Newman St.

Inspection report repaired items:

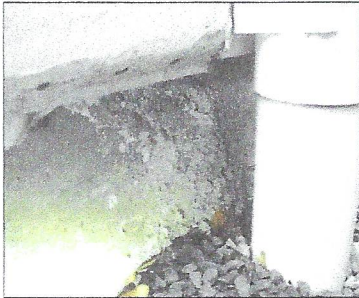
Concrete repairs

Repaired- smoothed

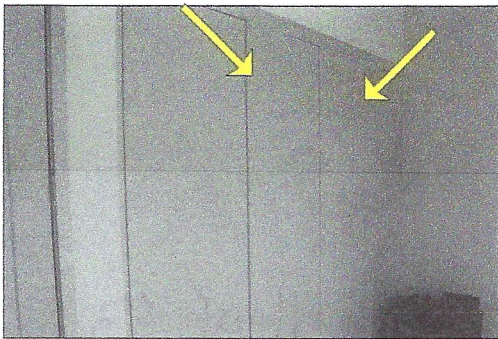
pg 10 of 43

Some of the cabinets in the bedrooms do not stay closed completely.

magnets changed
on third floor
closet

Repaired- magnets changed

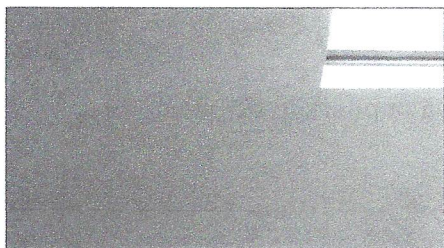
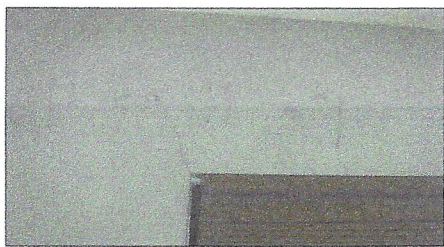
pg 10 of 43

Cosmetic cracks

Repaired – all sheetrock cracks fixed due to settlement

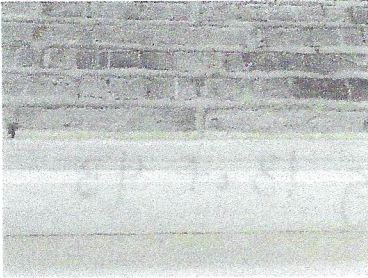
pg 15 of 43

Cracks in brick veneer and/or repairs, one or more locations

Repaired – all brick cracks fixed due to settlement

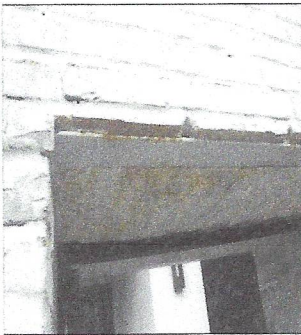
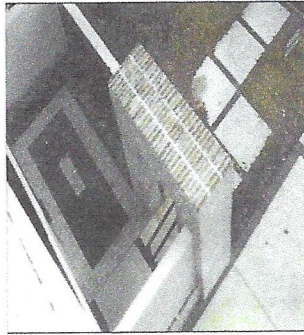
pg 15 of 43

Metal lintel(s) over window/door openings are not flash

Repaired- metal cap added on top of the gate, lintels painted

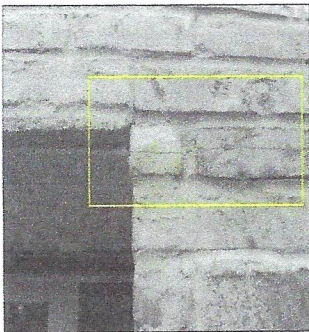
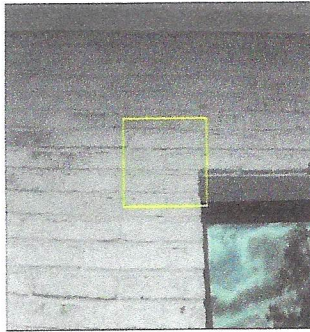
pg 15 of 43

Cracks at upper corners of brick

Repaired – cracks fixed due to settlement

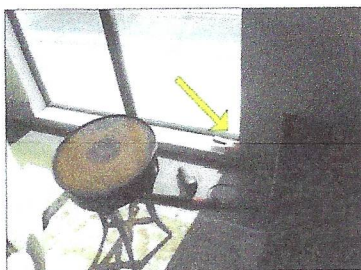
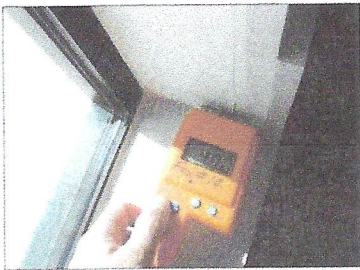
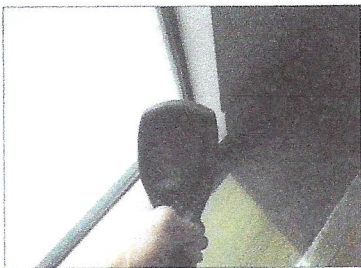
Pg 16 of 43

Water penetration observed at the following location(s): at third floor fixed window.
Recommend further evaluation/repair

Repaired – water coming thru the glass, glass removed and resealed see pics below

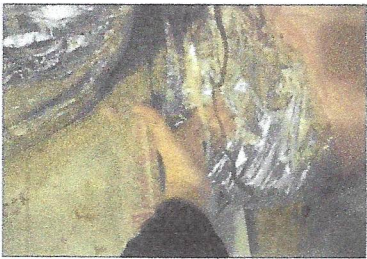
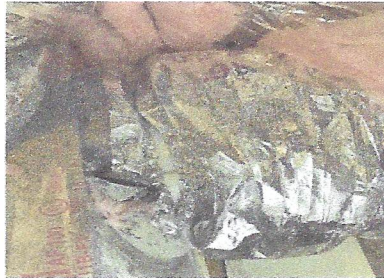
pg 30 of 43

Observed areas in attic where flex duct mechanical connection zip ties are not snug fit

Repaired – tied zip ties

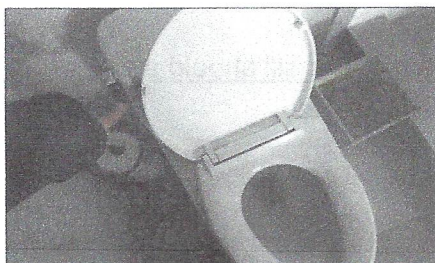
see Appendix 1
Pg 31 of 43

COMMODOES: Does not flush properly

Not Repaired – ~~normally functioning~~

repaired

Third Floor Commode, pg 20 of Newman report and page 31 FOX report
- repaired, was not flushing properly due to water levels, adjusted by plumber Feb 20, 2019

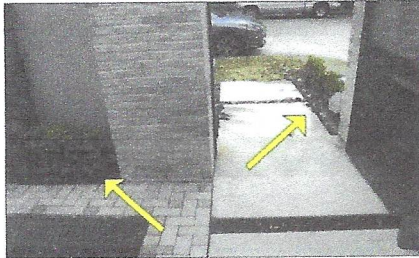
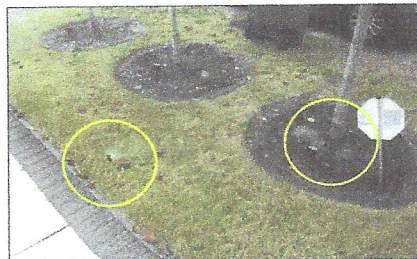
Pg 39 of 43

Observed two head types have different coverage rates and should not be mixed on the same zone.

Repaired- all heads changed
