**N****Noles Inspections LLC**

**INSPECTION REPORT**

Property Address: 2506 Potomac Drive #B, Houston, TX 77057  
Inspection Date: 06/12/2019  
Inspection Number: 20190612-2  
Inspection Type: REI-7-5

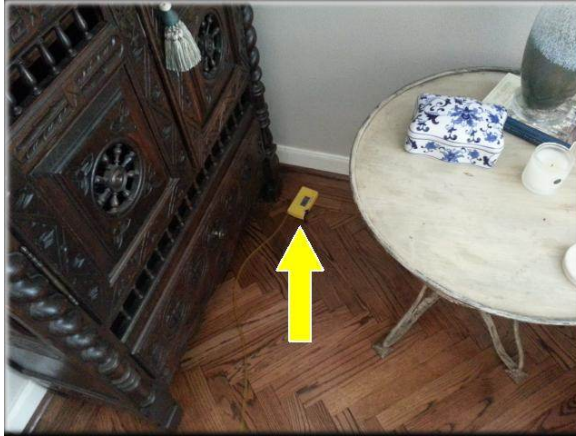
The Front and Left of the living room is -0.3 inches.

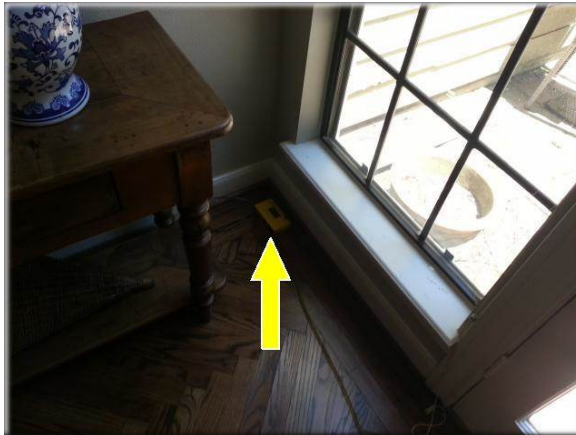
The Back and Left of the living room is --0.2 inches.

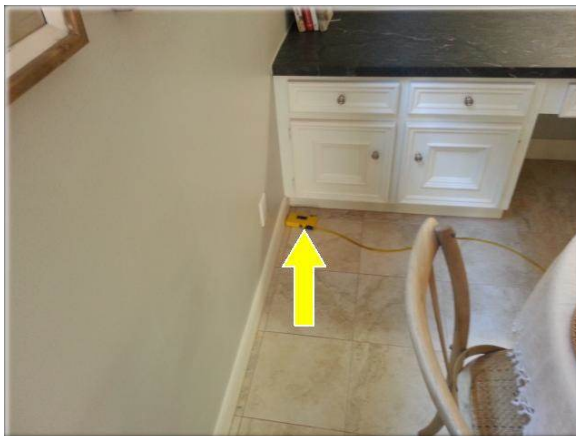
The Back and Right of the home and breakfast room is -0.4 inches.

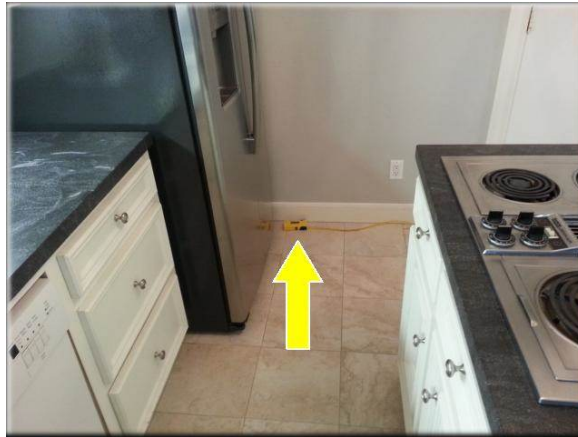
The Front and Right of the kitchen is -0.5 inches.

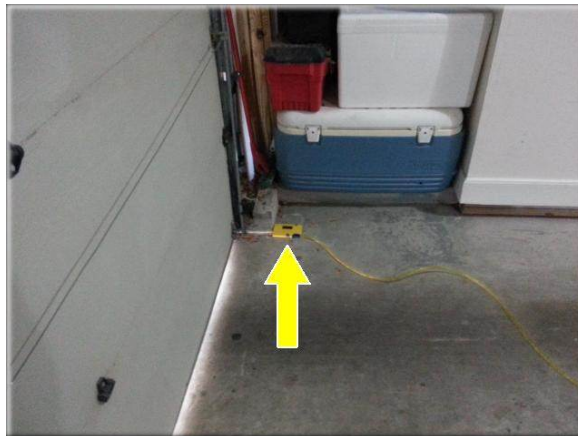
The Front and Left of the Garage Interior is -5.9 inches.

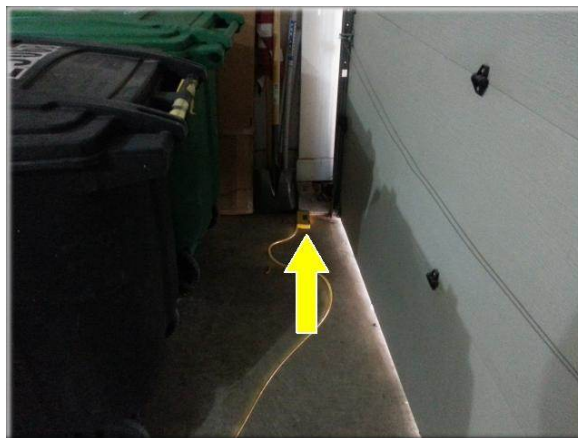
The Front and Right of the Garage Interior is -6.3 inches.

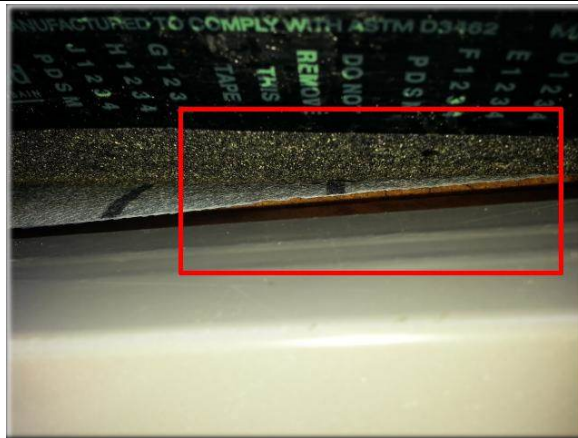
**The roofing paper underlay was either short or installed under the drip edge around the eave of home. The roofing paper underlay should be on top of drip edge at the eave and under rake edge to avoid moisture penetration; recommend review by a qualified roofing contractor.**

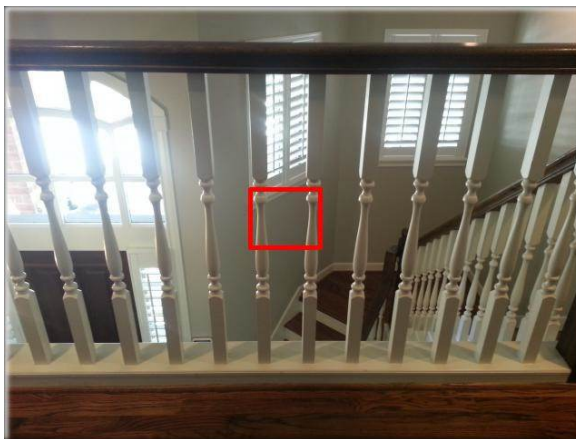
Spacing between balusters appears larger than 4 inches, which may allow small children to crawl through the space. Client may wish to reduce spacing as a child safety enhancement.

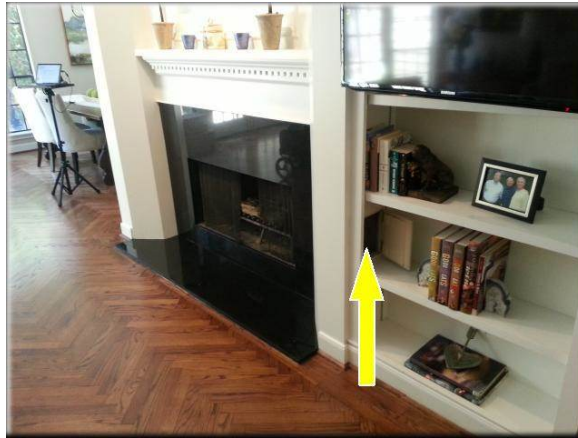
The fireplace gas valve was located at the Right side of the fireplace. Gas fireplaces are not operated unless they are automatic.

**Recommend permanently blocking the fireplace damper open as is currently required when a fireplace is gas burning.**

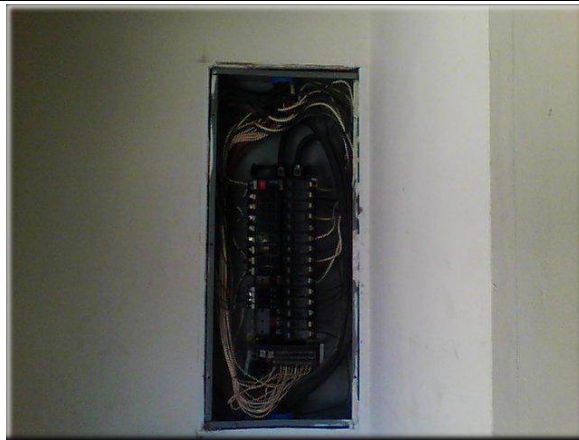
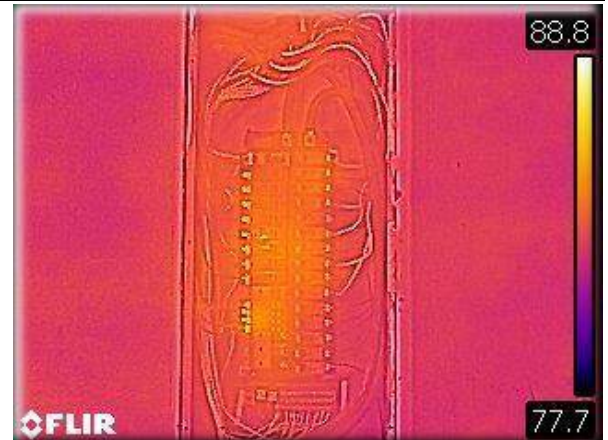
**Some of the electrical panel screws were missing. The panel should be secured with the appropriate type screws. (note: Never use pointed screws, which can pierce the outer insulation causing electrocution, is a safety hazard)**

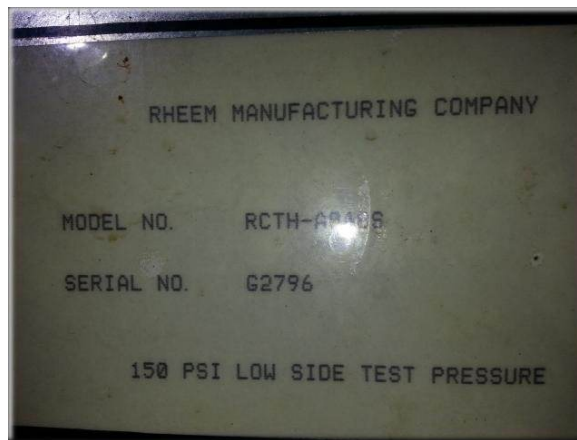
Evaporator coil information in the image below for your reference. Brand: Rheem, Manufacture Year: 1996.

These units appear to use older R-22 refrigerant which is being phased out of production. This may result in high repair costs. Consult your licensed HVAC professional for more information. (front attic unit)

**The supply air sample temperature taken varied between 71 and 82 degrees.  
The return air sample temperature taken was 82 degrees. (front attic unit)**

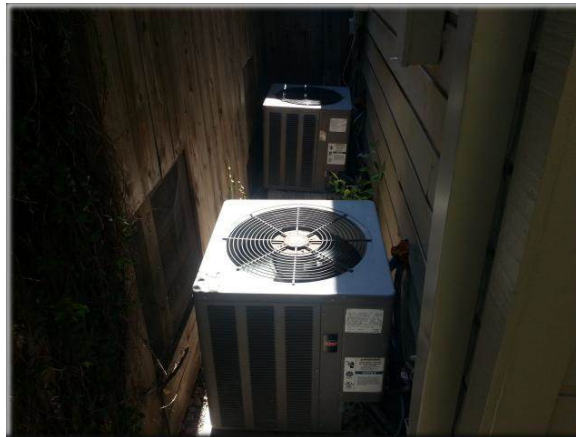
The supply air sample temperature taken was 61 degrees.  
The return air sample temperature taken was 76 degrees.  
The temperature differential between the supply and return was 15 degrees at the time of inspection.

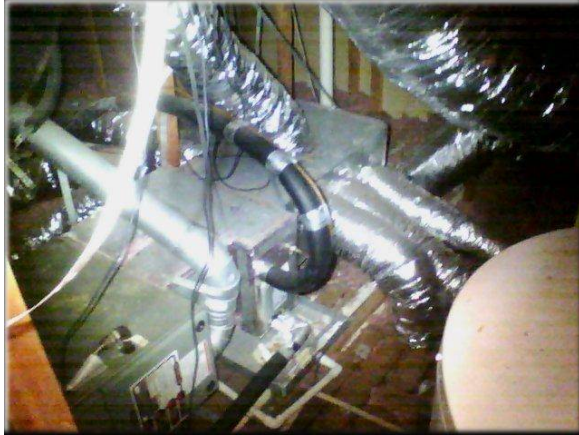
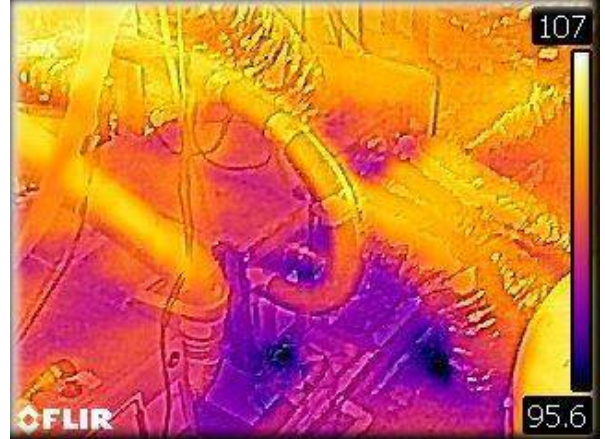
As part of duct maintenance, it is recommended to add additional insulating tape/mastic to help prevent cold areas in the attic at the duct connections/plenum to help prevent condensation which can cause discoloration, duct connection damage over time and potential growth.

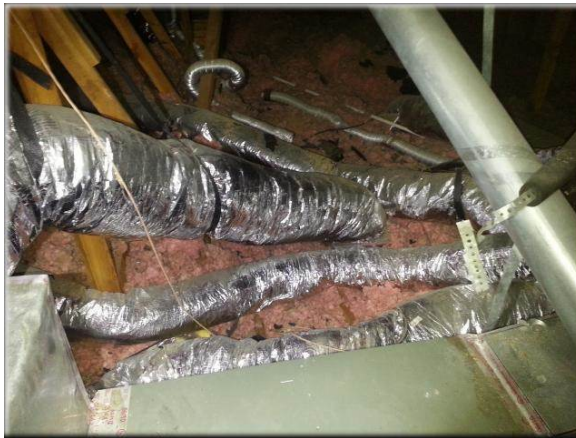
**The ductwork is lying on the insulation in the attic. Current standards now require the ducts to be properly suspended from the rafters above the insulation at intervals no greater than 5' and the hanger material should be at least 1 1/2" wide so it doesn't reduce the internal diameter of the duct. The maximum permissible sag is 1/2" per foot of spacing between supports. With older homes, this may not have been a requirement when this home was built. If ducts are replaced, make sure they are installed to today's standards.**

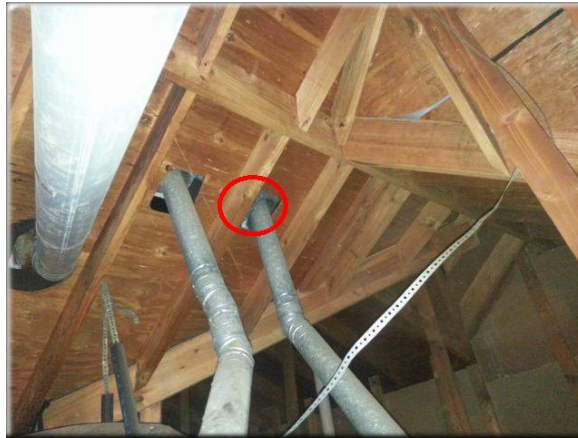
**Clearance around the water heater flue vent pipe is inadequate, which is a fire hazard. B-Vents require a least a one-inch air clearance to combustibles and one-inch open clearance around the flue to prevent overheating of the vent; recommend correction by a licensed contractor.**

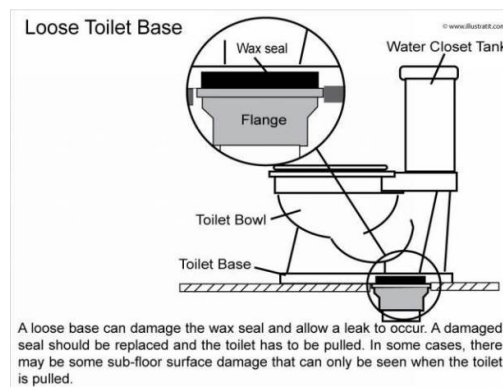
**The toilet bowl is loose and not secured to the floor properly in the half bathroom. The wax ring inside the unit must have a snug, secure fit in order to keep from leaking. Recommend replacing the wax seal and re-securing the toilet to prevent water leakage and damage to the sub-floor. This type of damage is not always visible or accessible to the inspector at time of inspection; recommend review by a qualified plumbing contractor for repair or replacement, as necessary.**

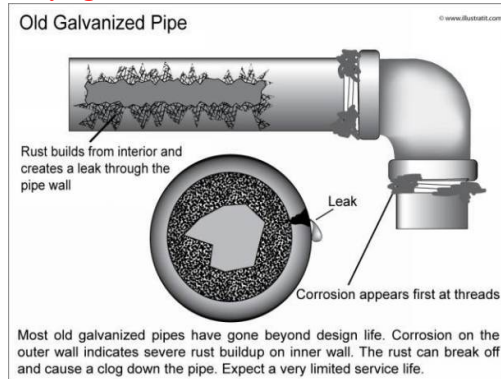
**A water flow test was performed on the galvanized water lines by simultaneously turning on the water at three locations. Water flow appeared to be inadequate at the time of inspection. Low water flow indicates the galvanized water lines are clogged or restricted on the inside. This is a normal process with galvanized water lines as they age.**

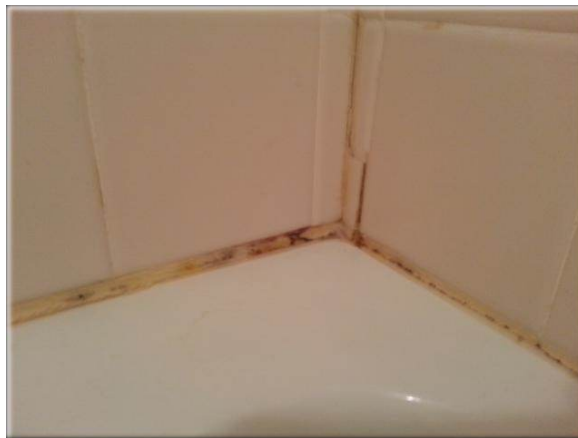
**The shower door is loose in the master bathroom. If the door is not hung properly or the seals are not tight, moisture may escape causing damage to the surrounding area.**

**The water temperature is above 125 degrees at the faucets. As a precaution, the maximum water temperature should be no more than 120-130 degrees.**

**The bathtubs/showers in the home require caulking maintenance to help remain leak free. Over time if not adequately sealed, moisture can creep behind surfaces and cause damage.**

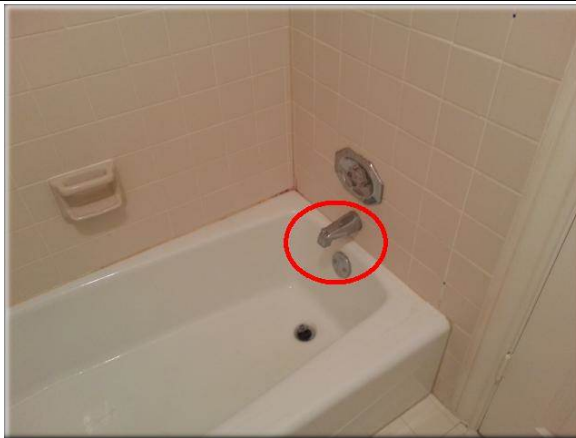
**The shower diverter does not operate properly because not all of the water flow is diverted to the shower in the upstairs and jack and jill bathroom. Water still flows from the tub spigot when the shower head is activated; recommend repairs by a licensed plumbing contractor.**

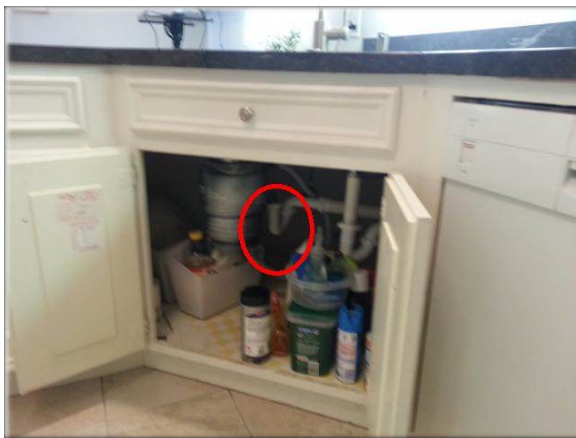
**The kitchen sink trap is leaking at time of the inspection in the kitchen; recommend review for repair or replacement, as necessary.**

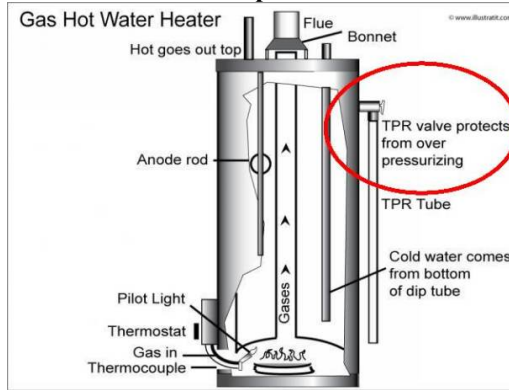
The temperature and pressure relief valve on water heaters are not operated due to frequency of failure. In most cases, the valve will not reset, which would allow water to run continuously through the drain pipe. The safety relief valve should be operated at least once a year by the water heater owner to insure waterways are clear. The safety relief valve should be inspected by a licensed plumber every 3 years. If this has not been done, it is recommended to replace this relief valve.

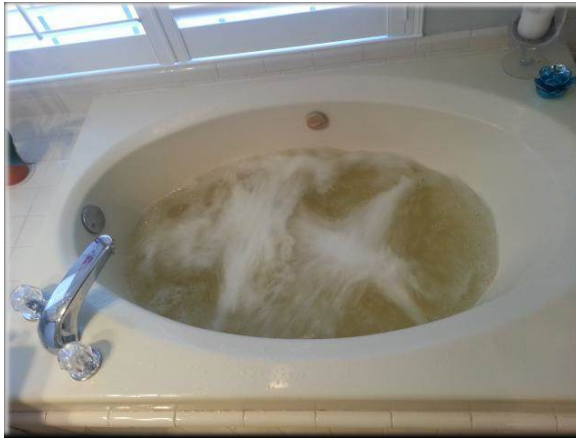
A Hydro Therapy tub is present. Tub was filled to a level above the water jets and operated to check intake and jets. Pump and supply lines were not completely accessible. The items tested appeared to be in serviceable condition. If a more detailed report is desired, the client is advised to consult a qualified plumber.

**Access panel not provided to inspect the drain, motor, and electrical connections. It is unknown whether the motor casing is properly bonded and/or if the drain assembly leaks.**

It is recommended that you contact the manufacturer of the Hydro Therapy tub for proper cleaning instructions of the jets, supply hoses, and air controls or call a local company qualified in cleaning the Hydro Therapy tub.

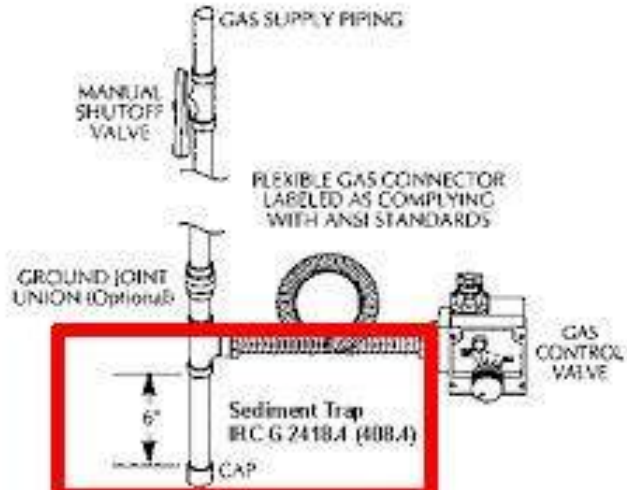
### GAS PIPING WITH FLEXIBLE CONNECTOR

The fuel type is gas with shut-off valve for the heater. A sediment trap is not installed on the gas line for this appliance; recommend installing drip leg to help prevent moisture or debris from affecting combustion and burner operation. See illustration below.

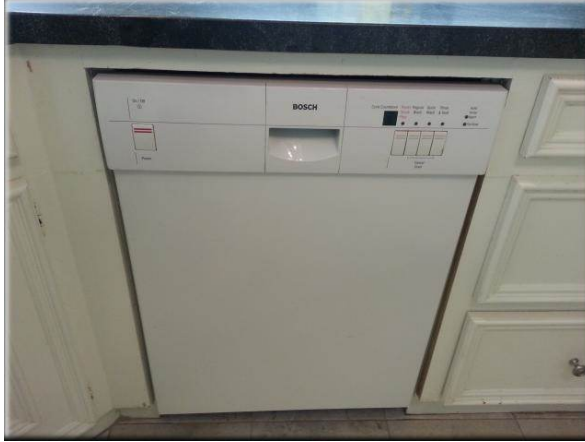
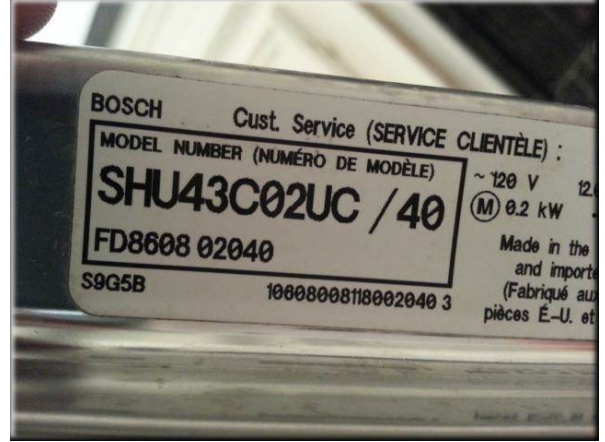
Dishwasher information in the image below for your reference.

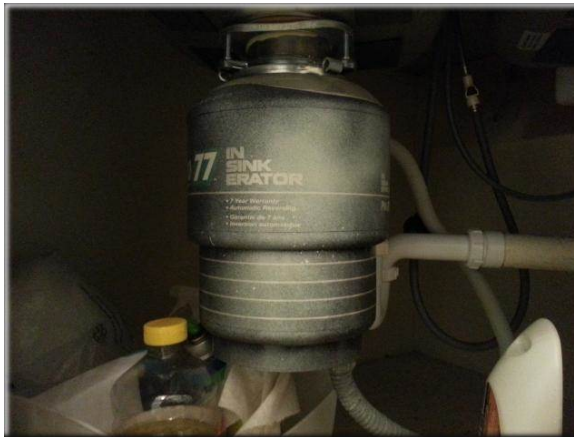
The waste disposal was functional at time of the inspection.

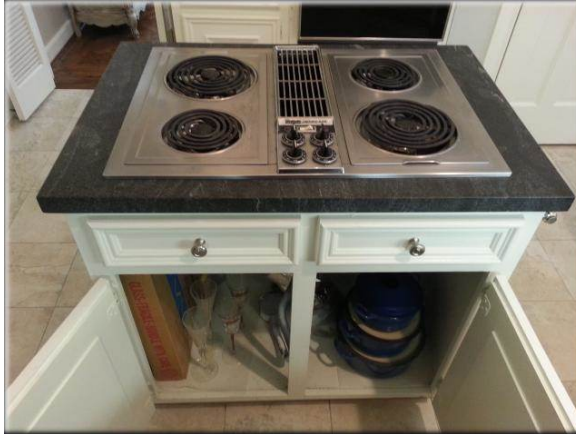
**The downdraft vent stopped working after about 1 minute of operation. Recommend repair/replacement by a qualified contractor. The fan had a burning odor while running.**

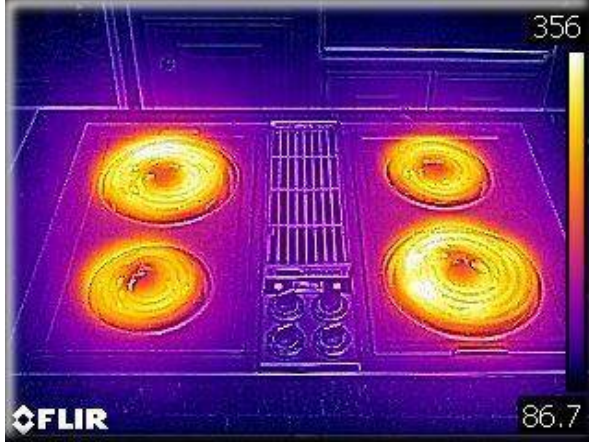
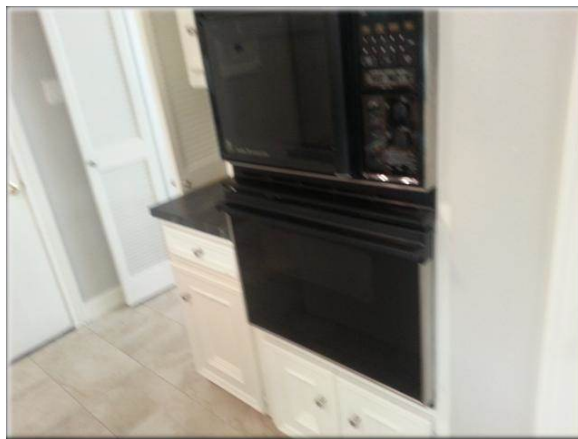
The burners were functional on low, medium and high settings. These can fail at anytime without warning. No warranty, guarantee, or certification is given as to future performance or life expectancy.

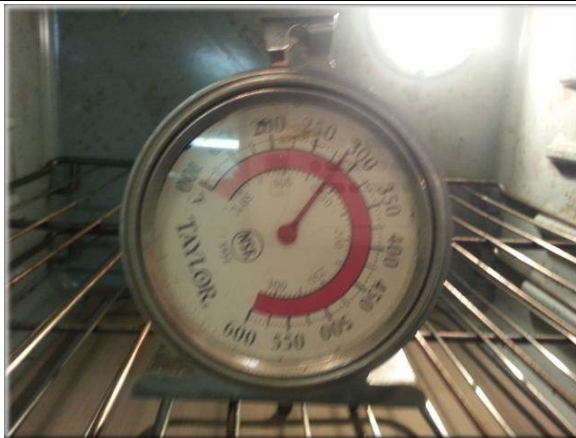
**The oven setting of 350°F gives an actual temperature of 275°F. We recommend adjusting or repairing the thermostat as necessary to allow a temperature within 25°F of the set position. Information Note: Ovens with a manual knob for setting the temperature can be adjusted if there are set screws on the back of the oven temperature knob by: Placing an oven thermometer inside the oven and set the oven to 350 degrees. If the reading is off, remove the oven temperature knob, loosen the screws, turn the dial until the knob indicates the same temperature as the oven thermometer; and then tighten the set screws. Ovens with electronic controls or control knobs without screws normally need servicing by a qualified appliance contractor for adjustment.**

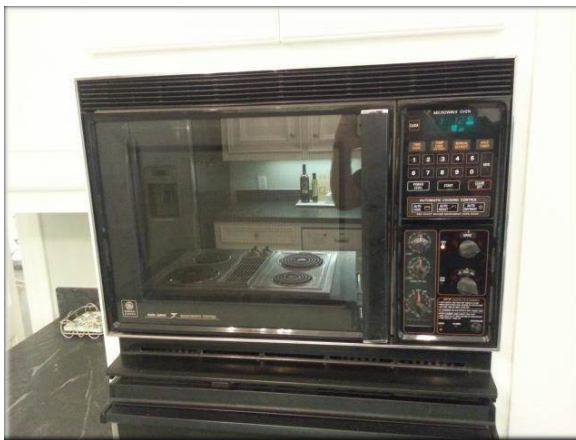
The microwave appears to be operational at the time of inspection. These can fail at anytime without warning.
