PROPERTY INSPECTION REPORT

ADDRESS: 751 Lakeside Wimberley, TX 78676
PREPARED FOR: Randy Betz
DATE: 5/23/2019
BY: Gary Thompson
Professional Real Estate Inspector
TREC #5414

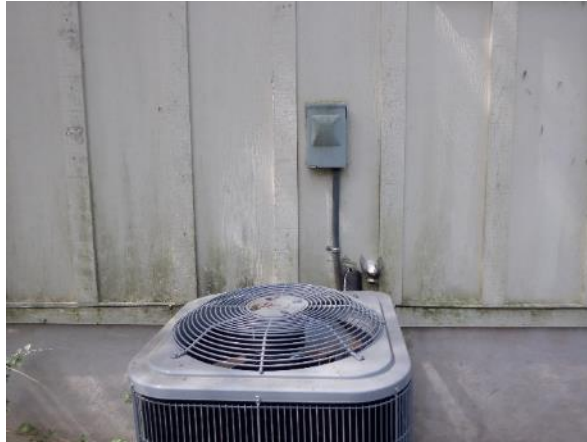
- Not all breakers are labeled, so I could not confirm proper breaker sizes for the condensers. This should be verified when breakers are all accurately labeled.
